## **Survival Factors Photographs**

**Belton, South Carolina**

**HWY20FH001**

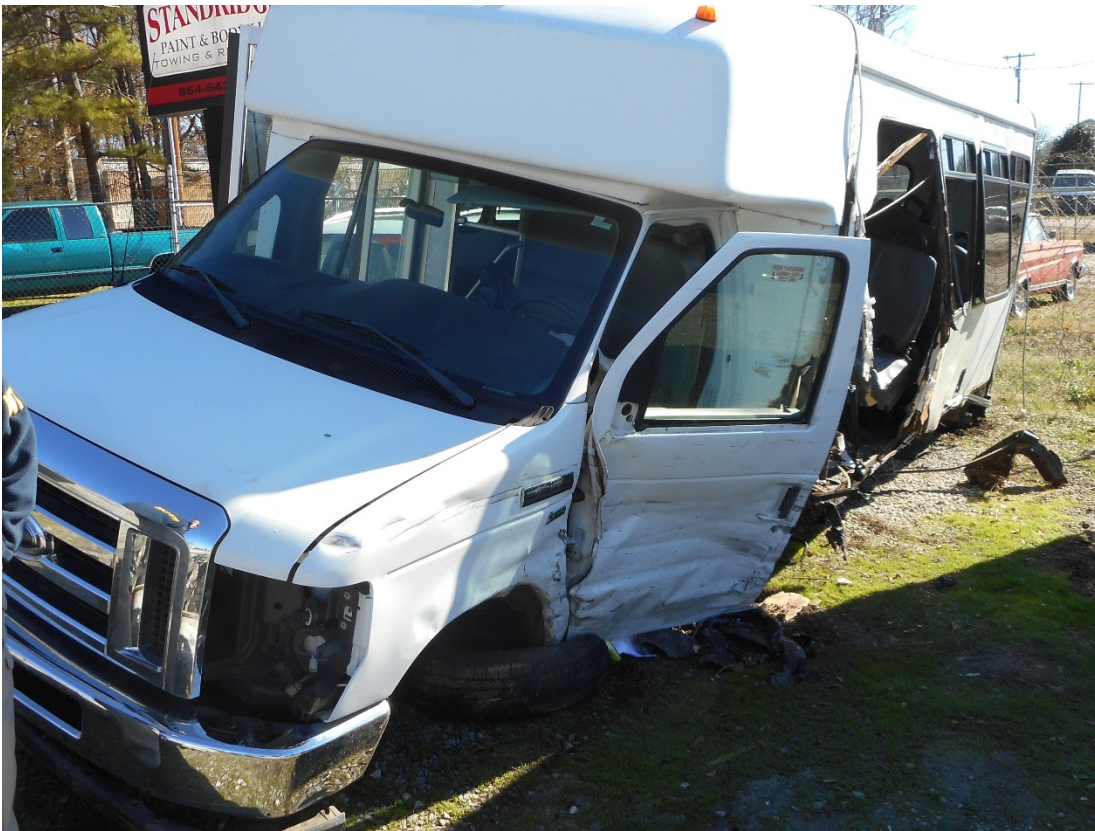
Photo 1 – Frontal left angle view of deformation to left side of 2009 Ford E350 with Goshen 14-passenger medium-size bus body.

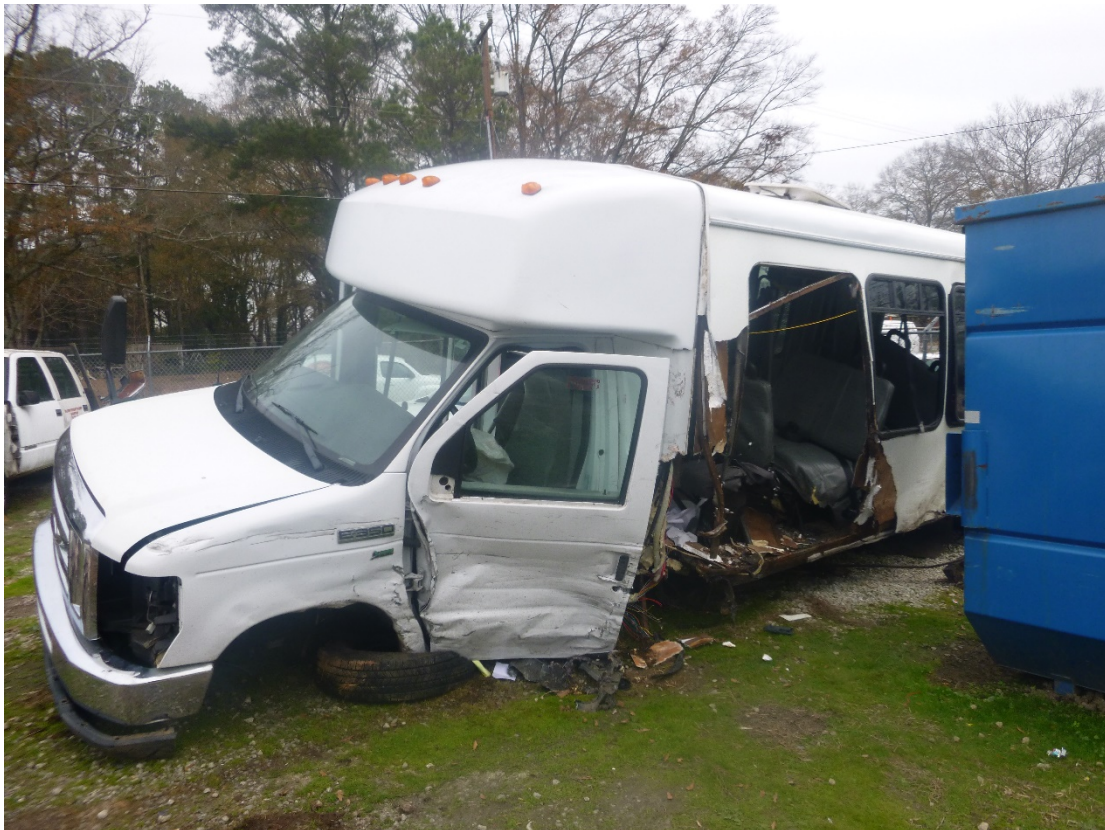
Photo 2 – Left side angle view of deformation and integrity loss to left side of bus chassis and body.

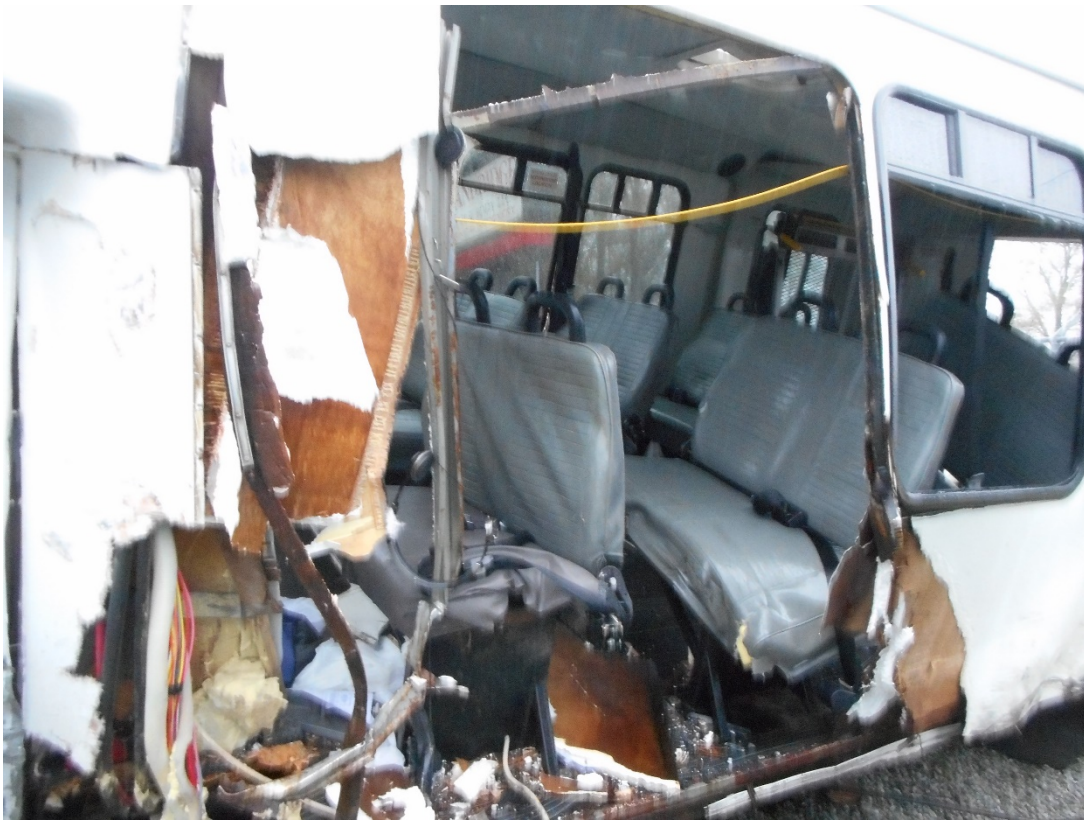
Photo 3 – Left side close-up view of damage and integrity loss to Goshen bus body.

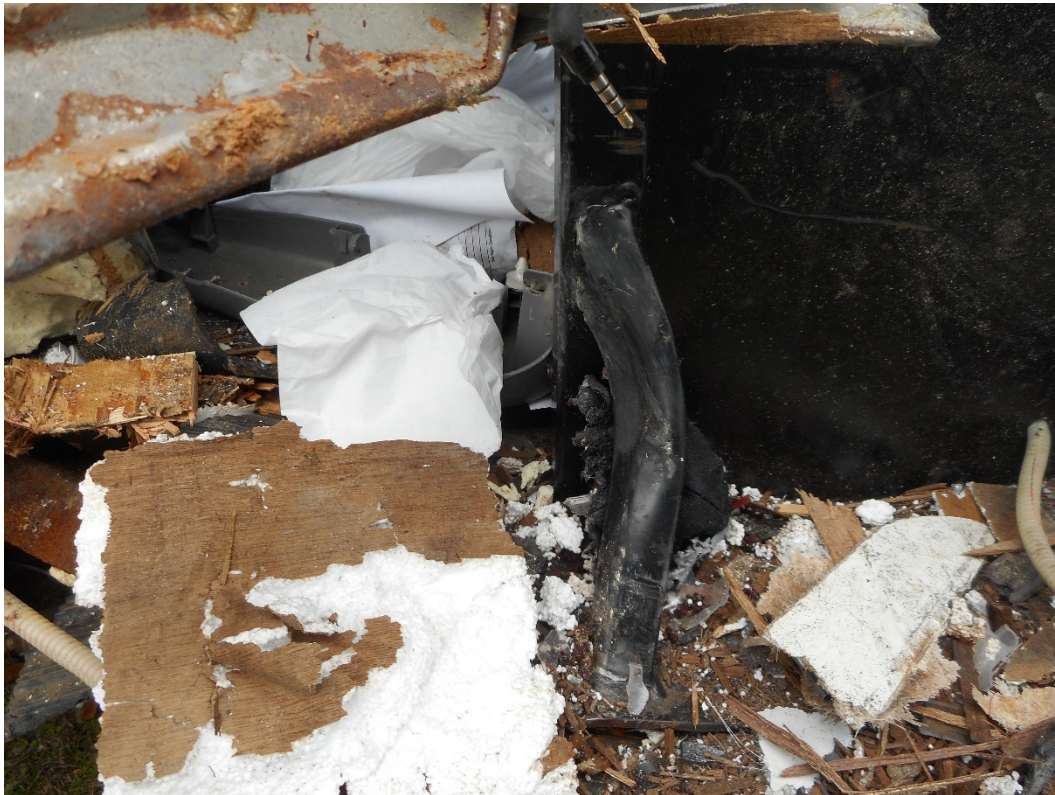
Photo 4 – Close-up of deformation to first row seat anchor. (NOTE: rusted metal with Styrofoam insulation attached to thin particle board illustrates inadequate construction of sidewalls in medium-size buses.)

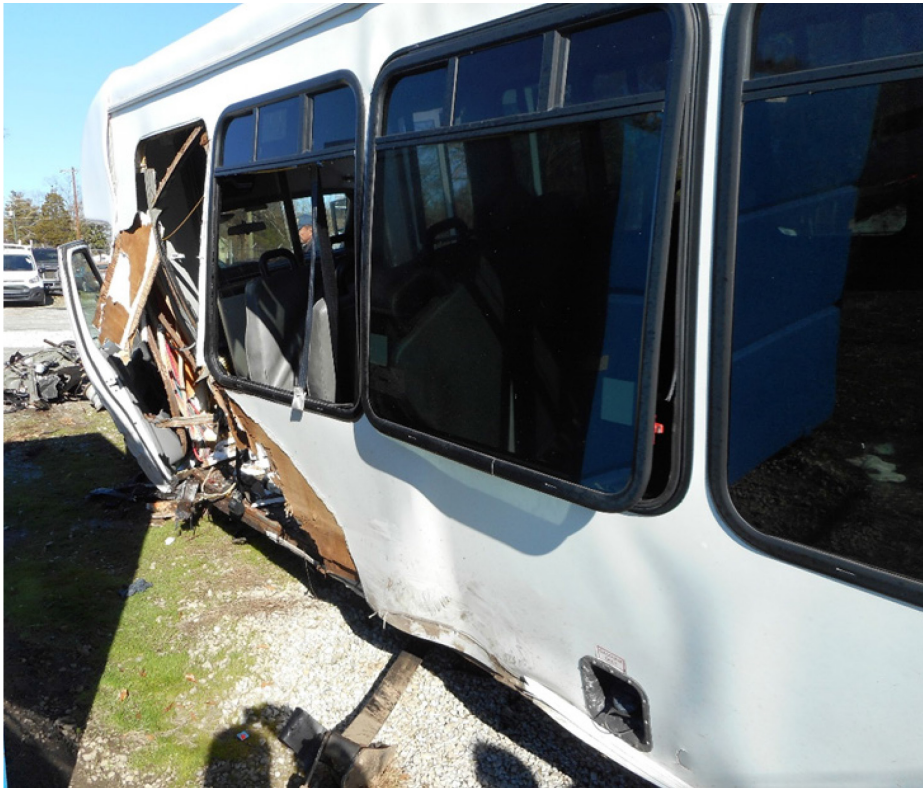
Photo 5 – Left rear angle view of left side damage to Goshen 14-passenger medium-size bus body.

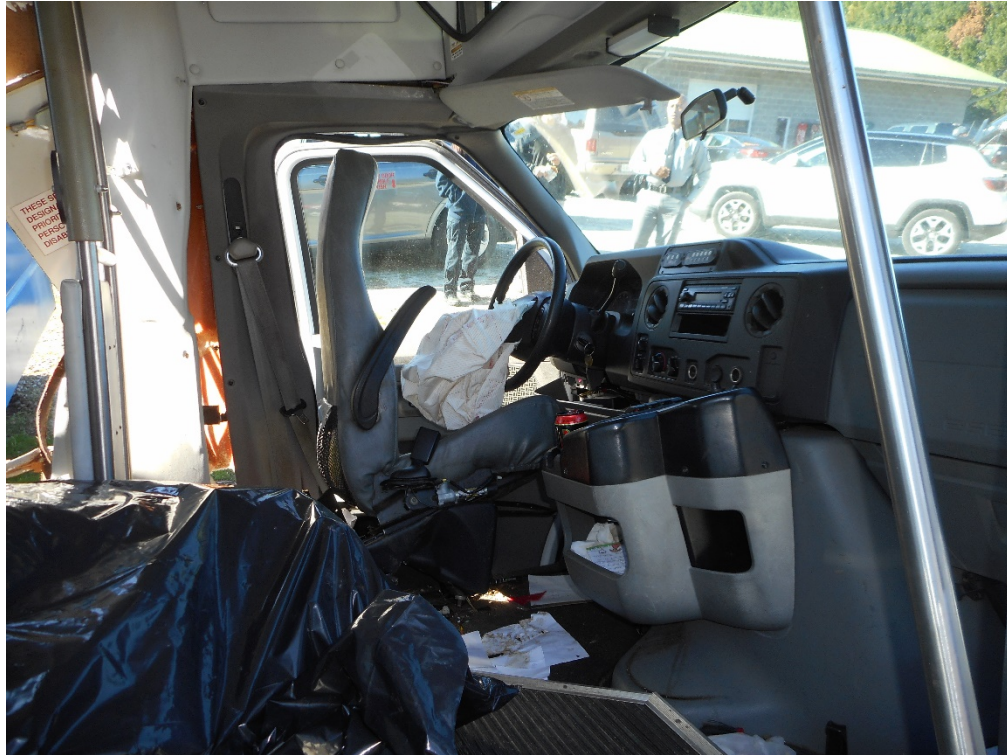
Photo 7 – Interior view of driver seating area showing seat damage from ACM removal and deployed airbag.

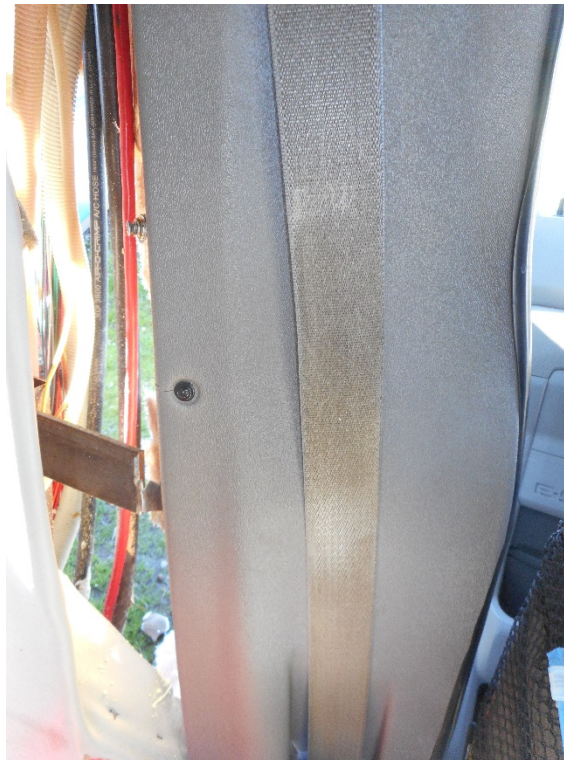
Photo 8 – View of heat abrasion mark on shoulder belt webbing of bus drivers seat belt.

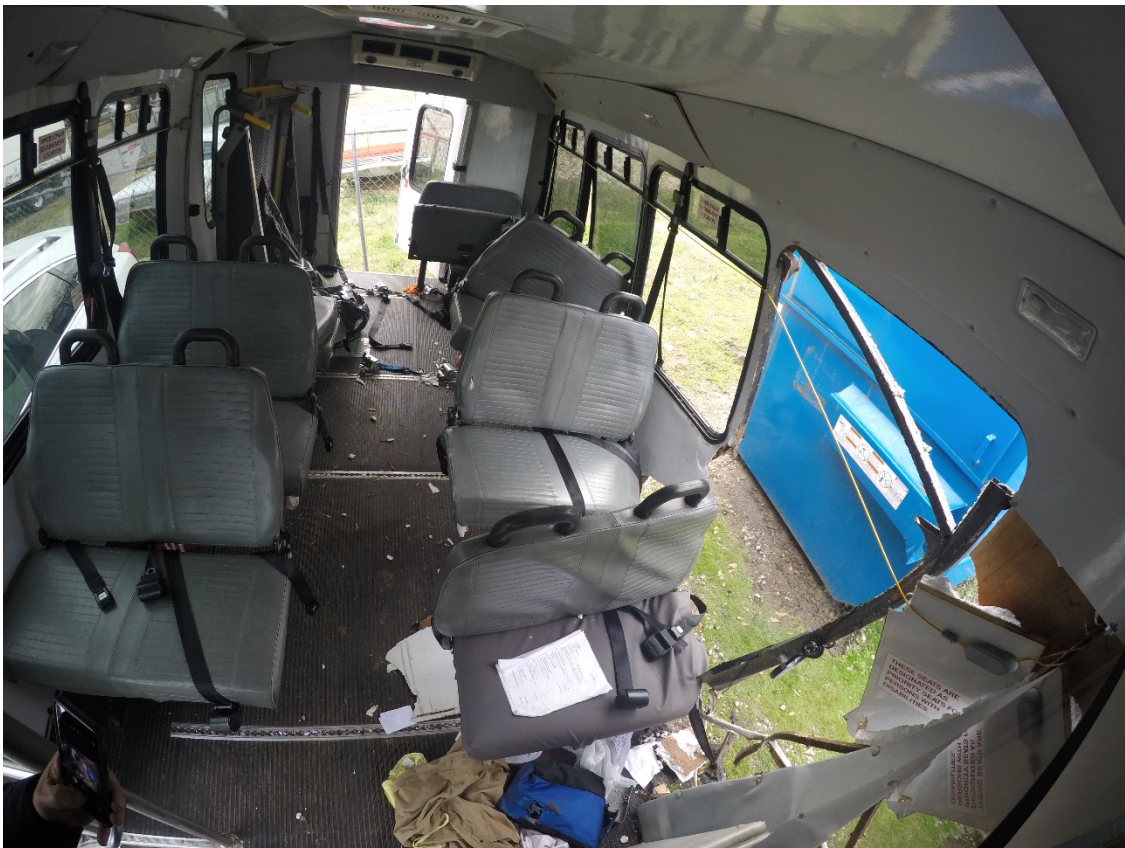
Photo 9 – Interior fisheye view looking from front to rear at interior bus damage.

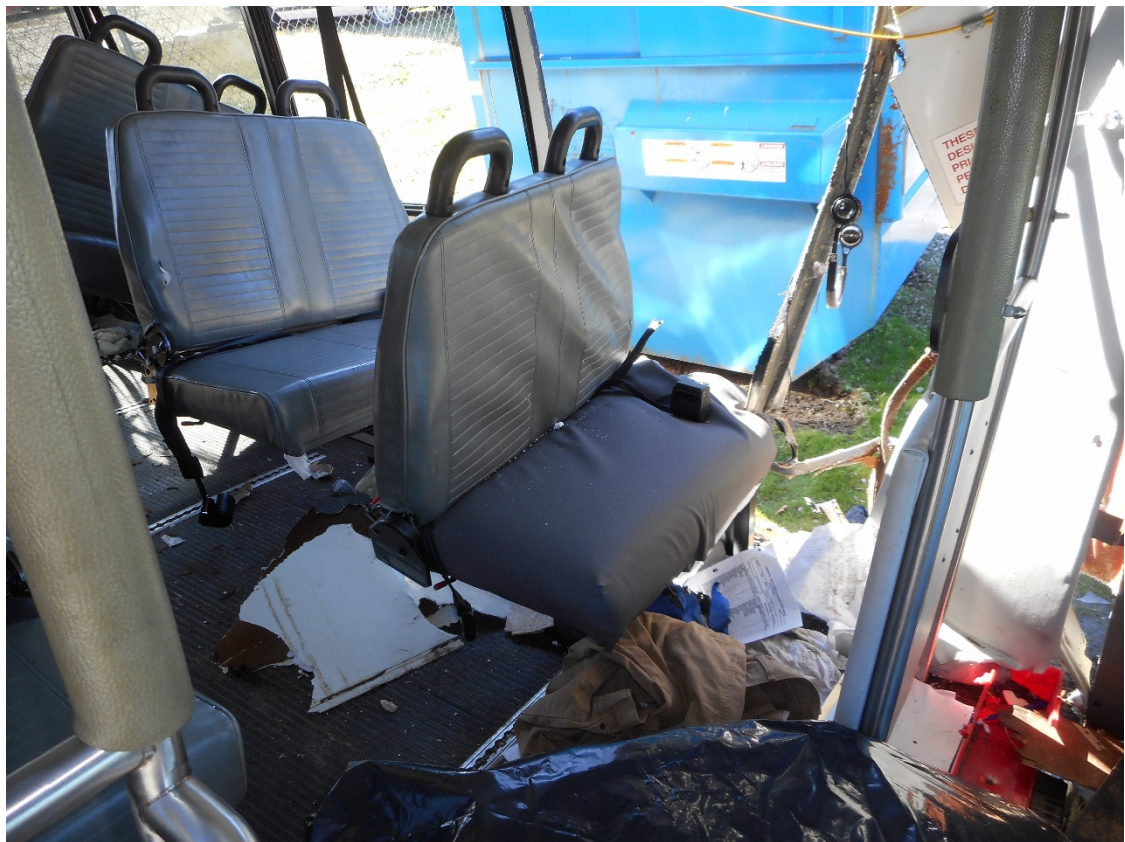
Photo 10 – Interior view of first row seat damage and area of integrity loss to bus.

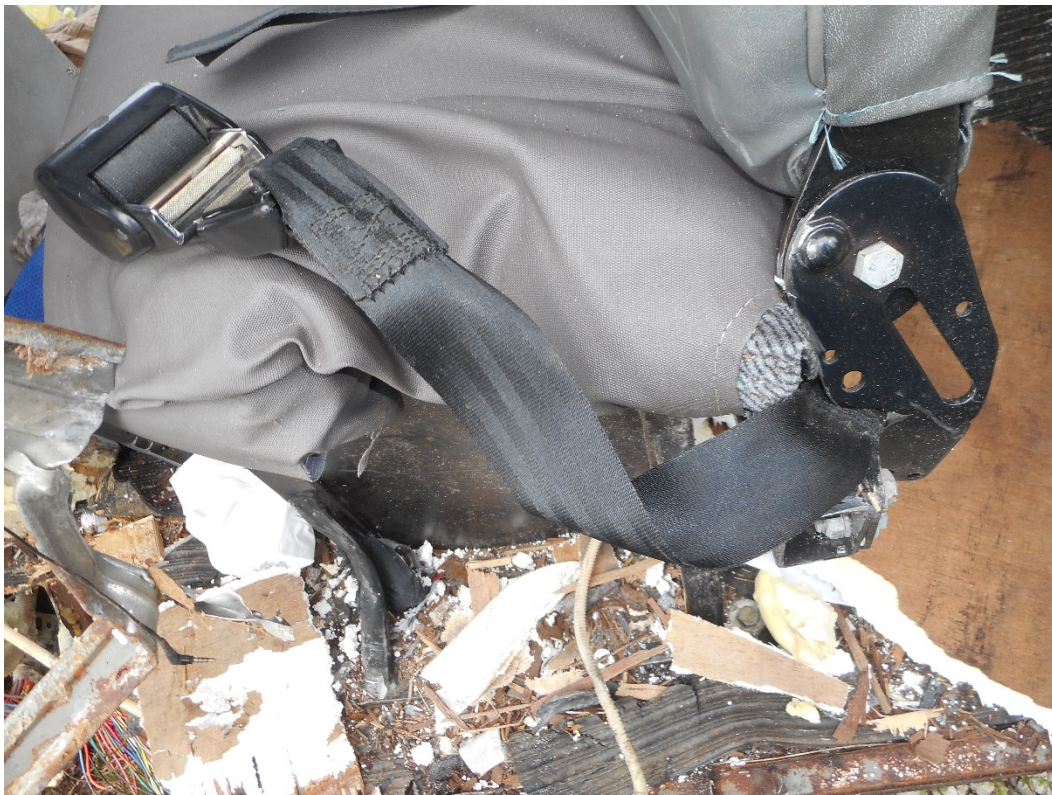
Photo 11 – View of seat damage and cut lap belt for partially ejected passenger.

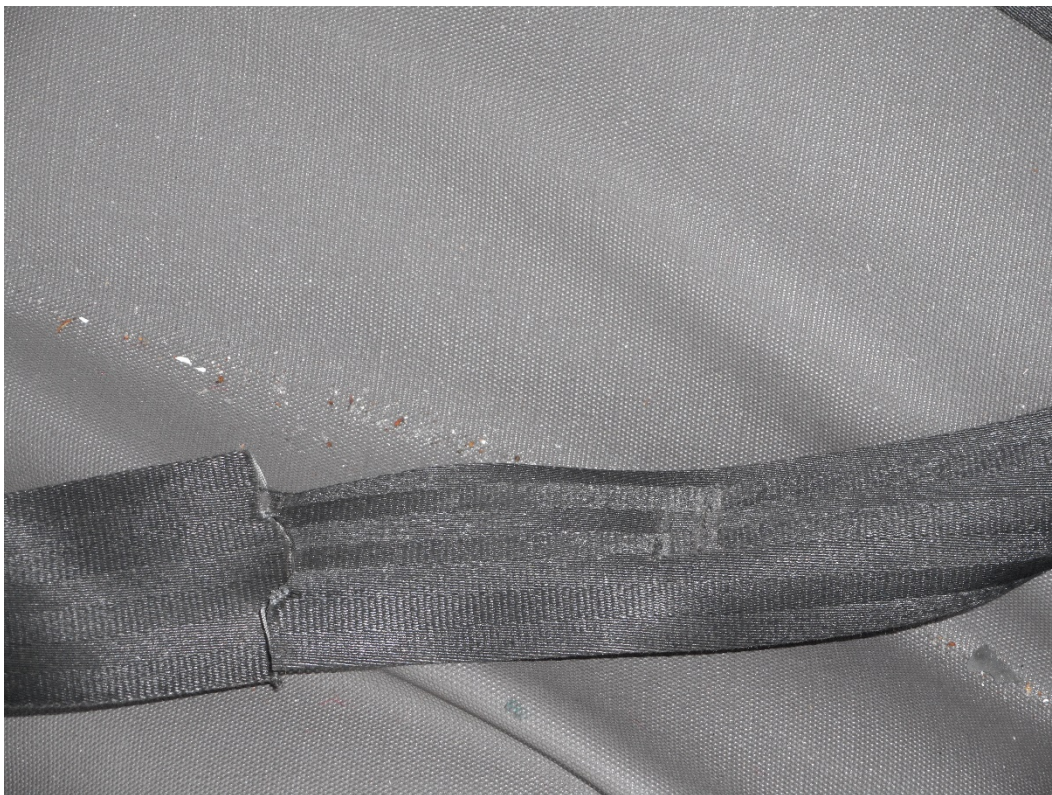
Photo 12 – Close-up view of cut lap belt webbing showing area of heat abrasion.

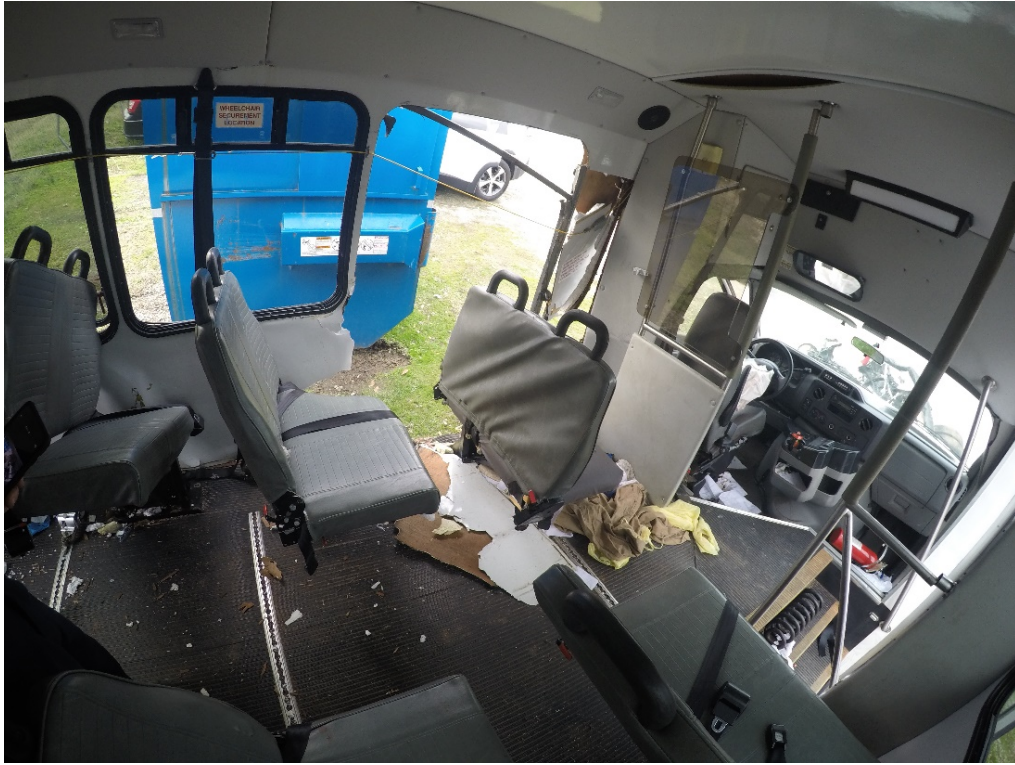
Photo 13 – Interior view looking at damage and area of integrity loss in Goshen bus.

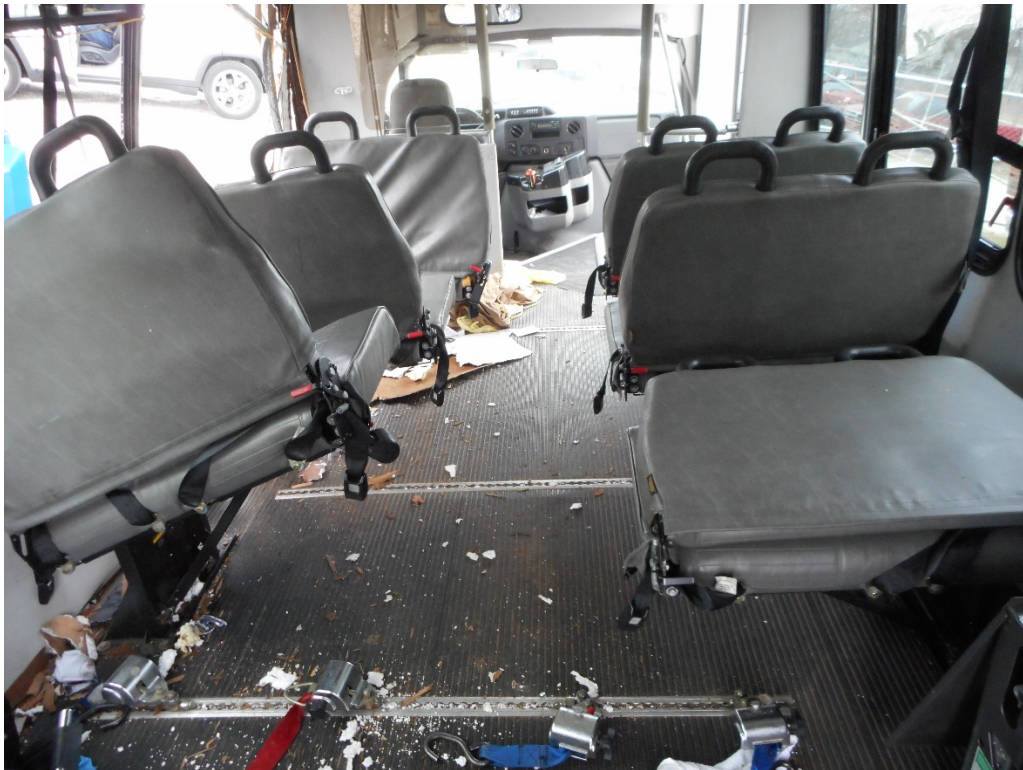
Photo 14 – Interior view looking from rear to front in Goshen bus showing seat damage.

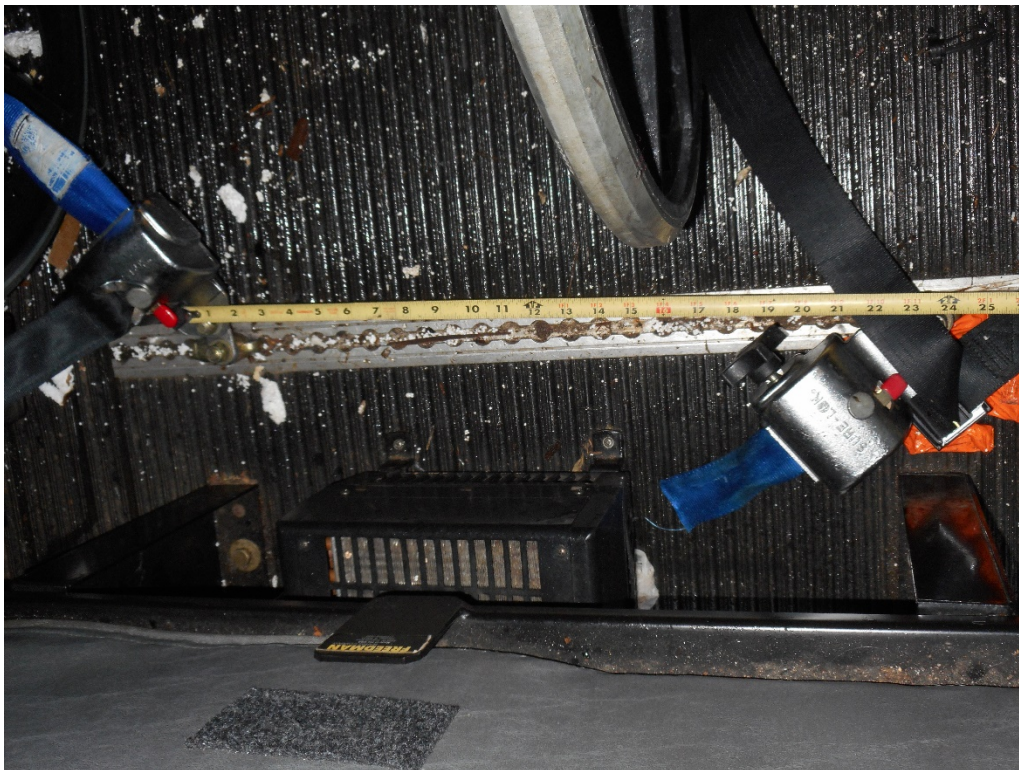
Photo 16 – Interior view looking down at left side wheelchair rear securement retractor positions in Goshen bus. (NOTE: inside positioned retractor strap was cut off).

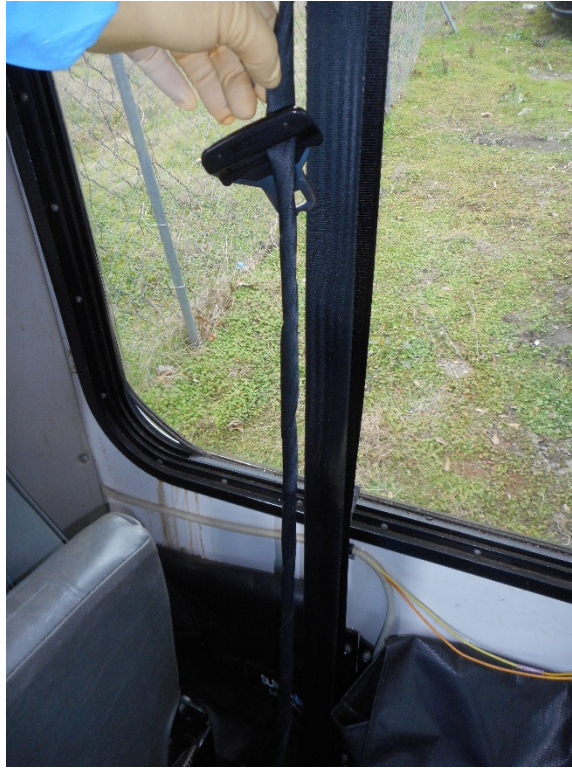
Photo 17 – Interior view looking at severely twisted left side wheelchair shoulder restraint in Goshen bus.

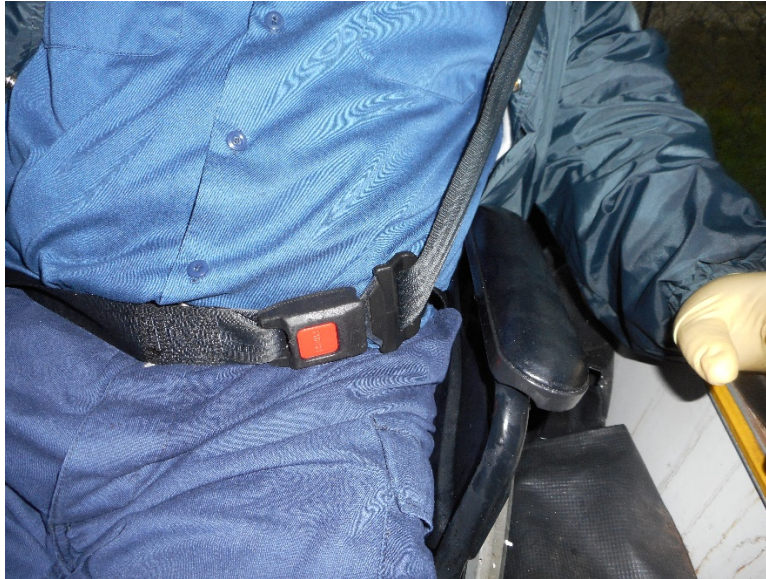
Photo 19 – Interior view looking at improper placement of lap/shoulder restraint for left rear wheelchair in Goshen bus.

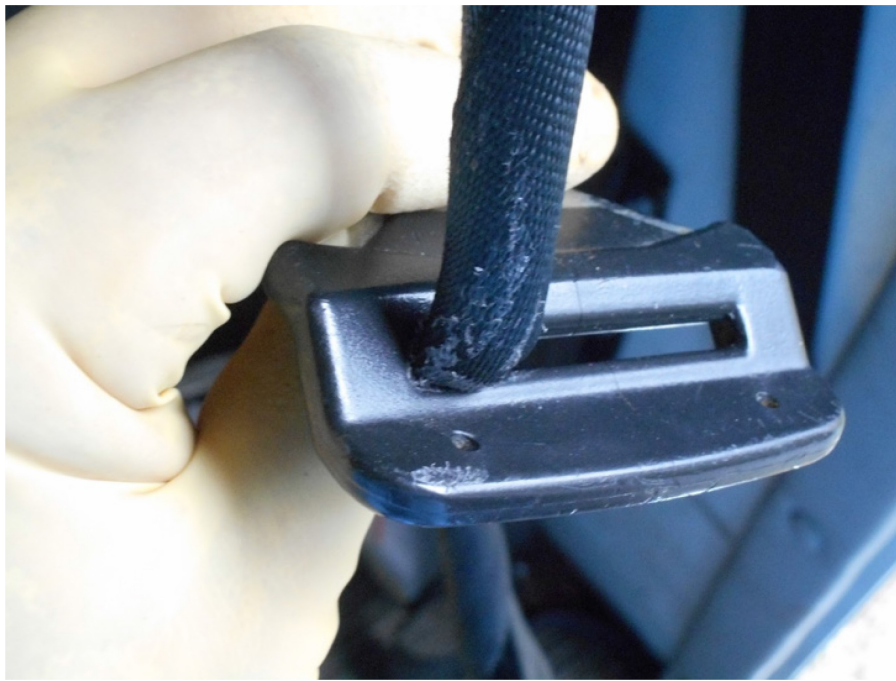
Photo 23 – Interior close-up view looking at heavy heat abrasion to shoulder restraint for right wheelchair passenger. (NOTE: webbing twisted similar to left side wheelchair shoulder restraint.)

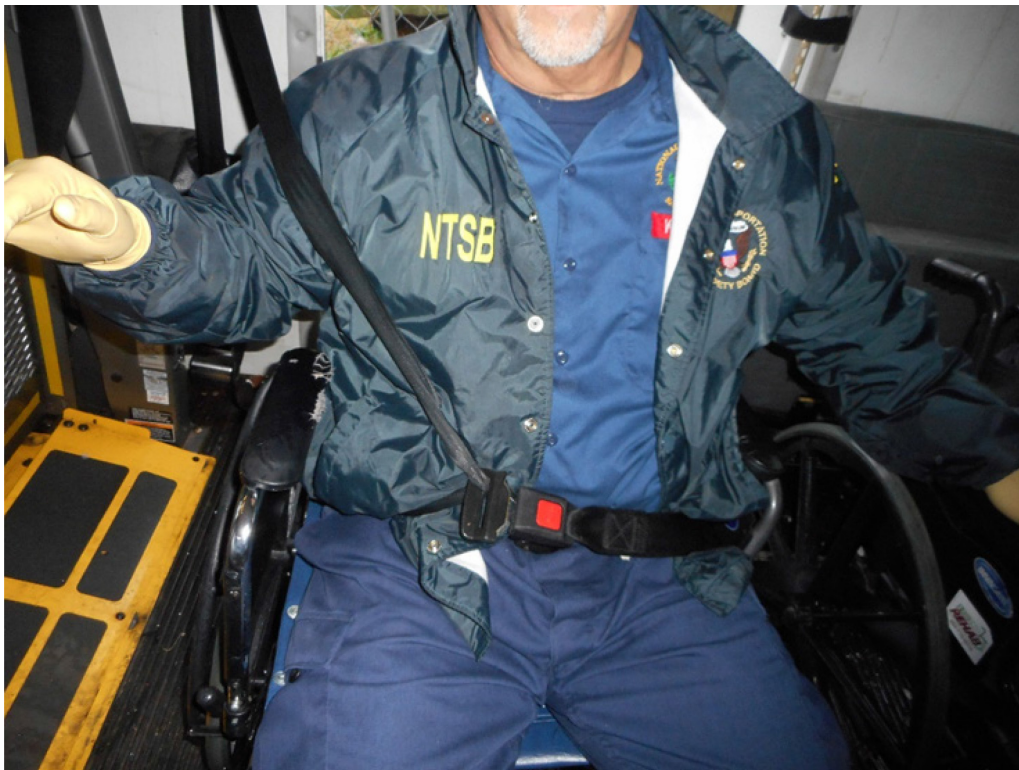
Photo 24 – Interior view looking at improper restraint placement for right rear wheelchair passenger in Goshen bus.

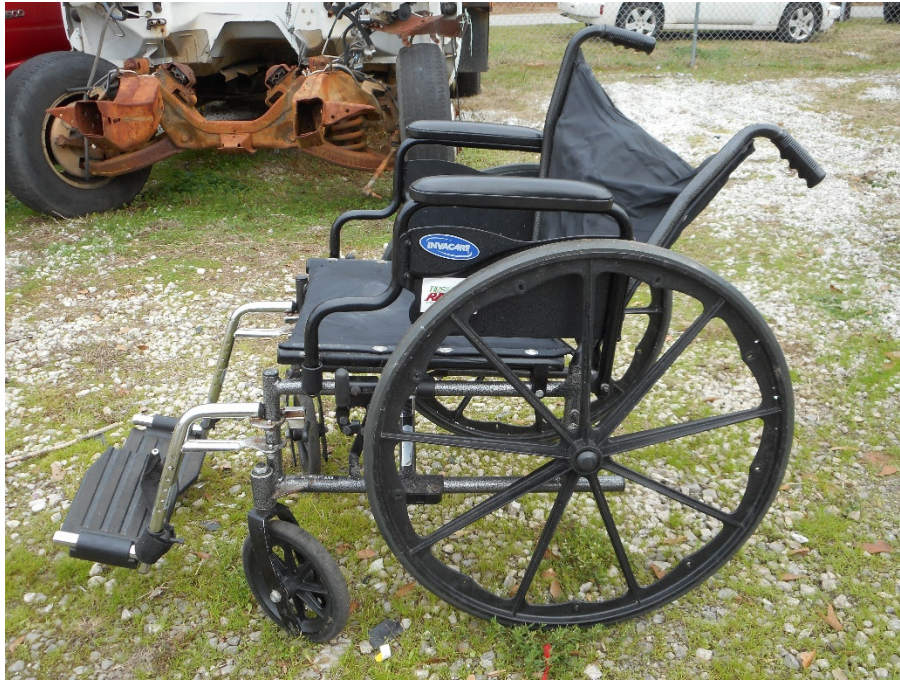
Photo 25 – Side view looking at damaged left hand grip on wheelchair.

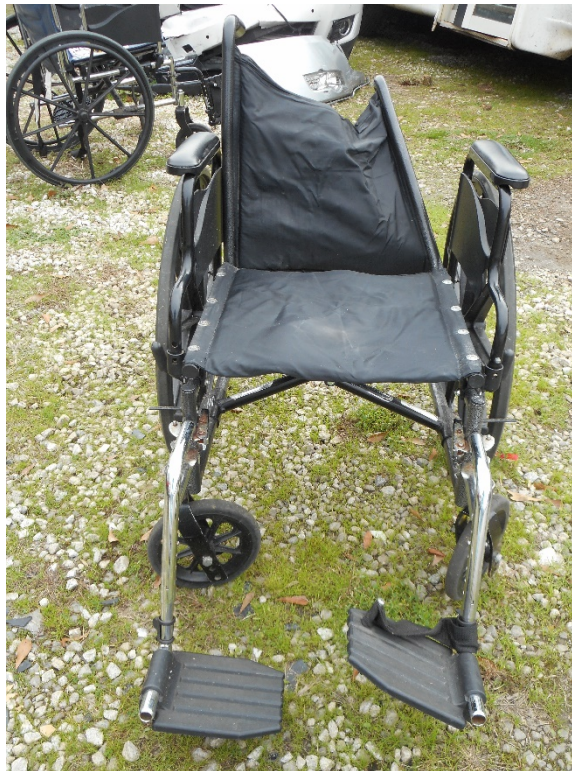
Photo 26 – Frontal view looking at damaged left hand grip on wheelchair.

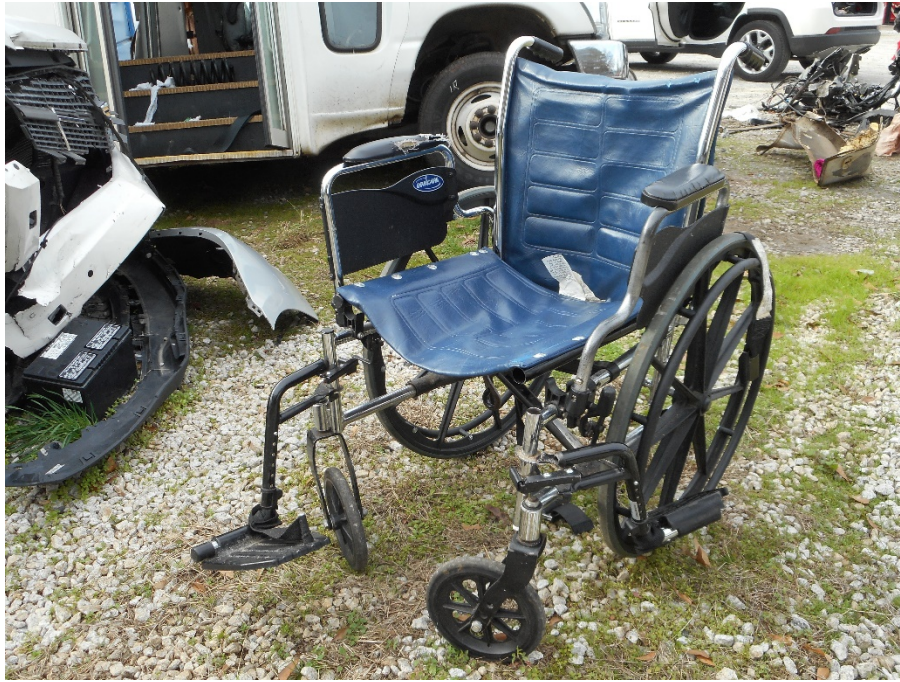
Photo 27 – View looking at damaged left swing away leg rest on wheelchair.

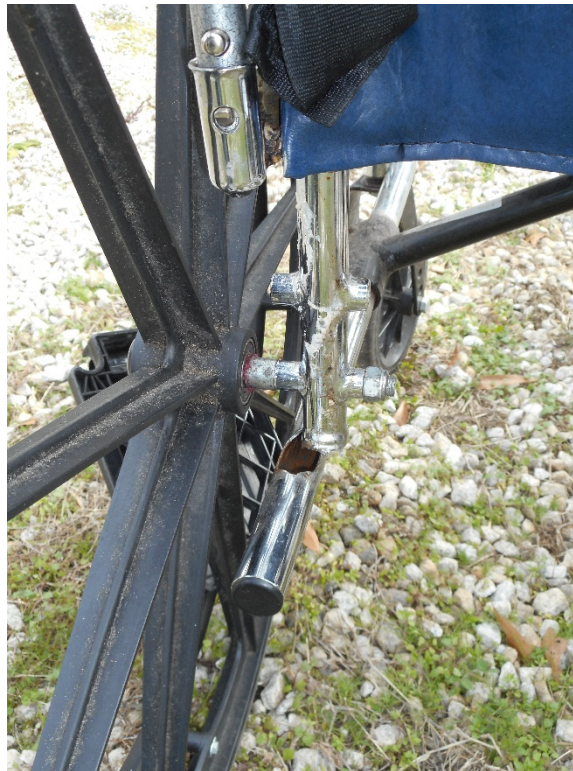
Photo 28 – View of separated weld on wheelchair cross member.

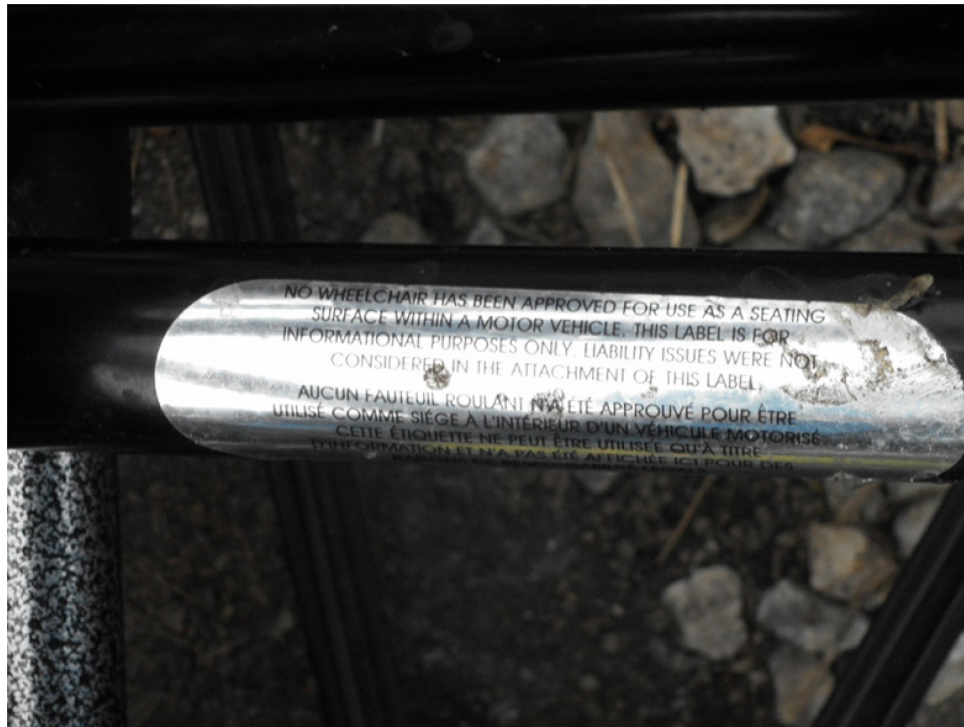
Photo 29 – View of label on wheelchairs stating they are not to be used for seating in a motor vehicle.
