**VEHICLE FACTORS GROUP PHOTOGRAPHS**

**Belton, SC**

**HWY20FH001**

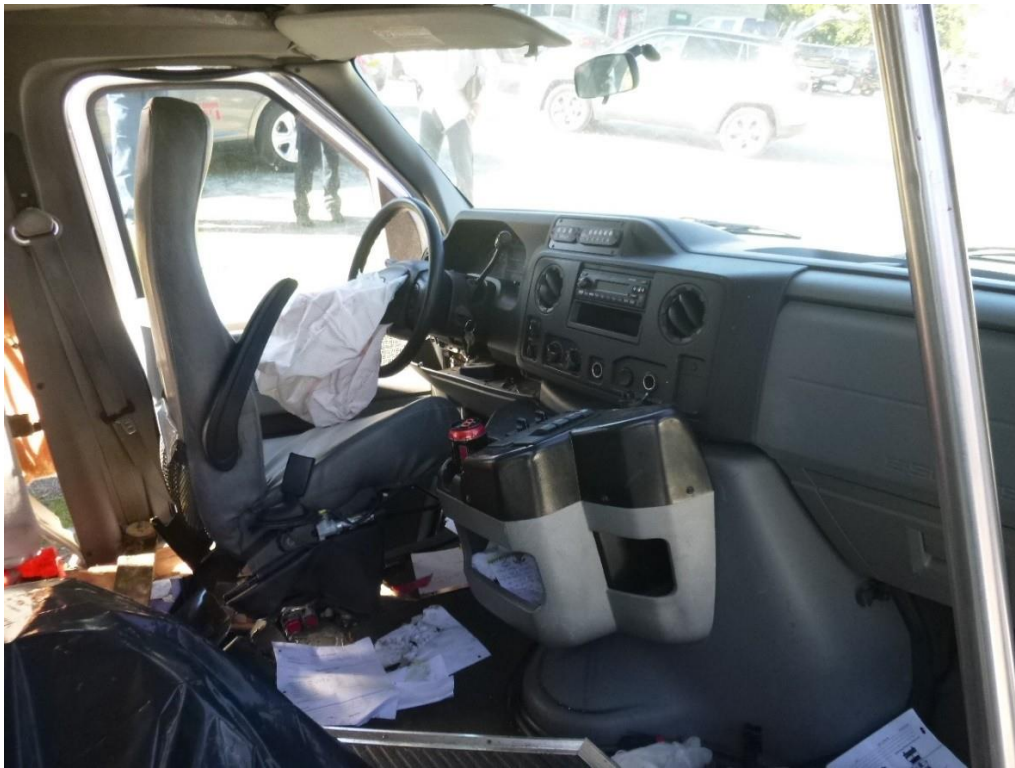
Photograph 1 – View of the 2009 Goshen Coach medium-size bus drivers' compartment depicting driver controls and deployed airbag.

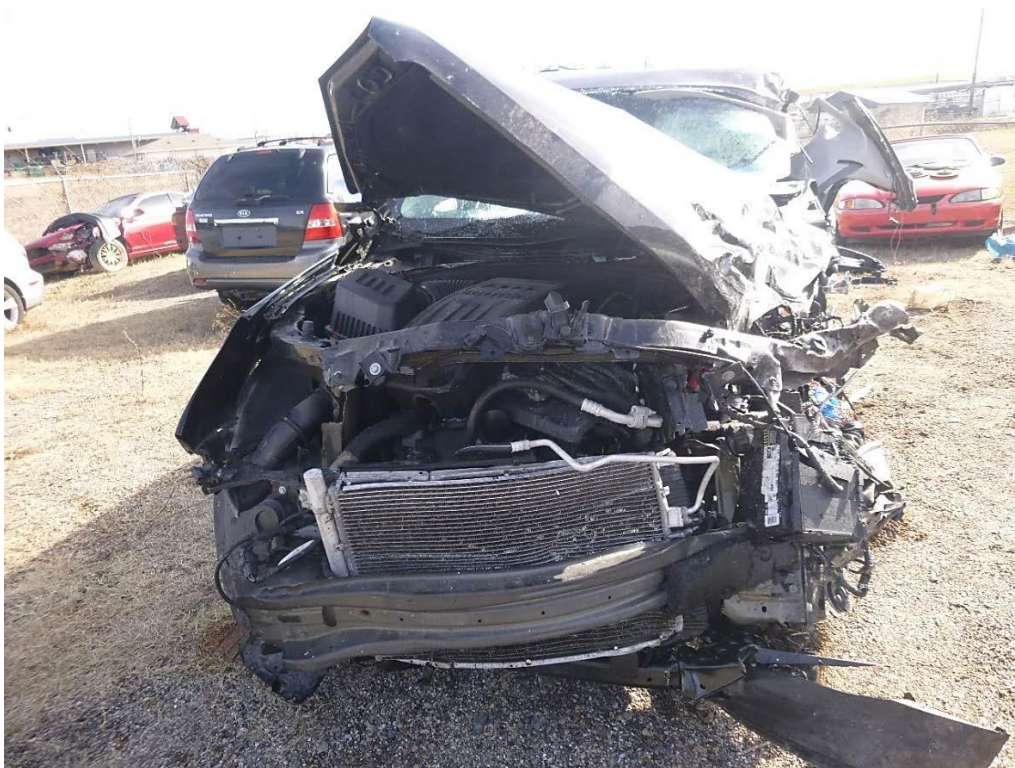
Photograph 2 – Front view of the 2015 Chevrolet Equinox depicting collision damage.

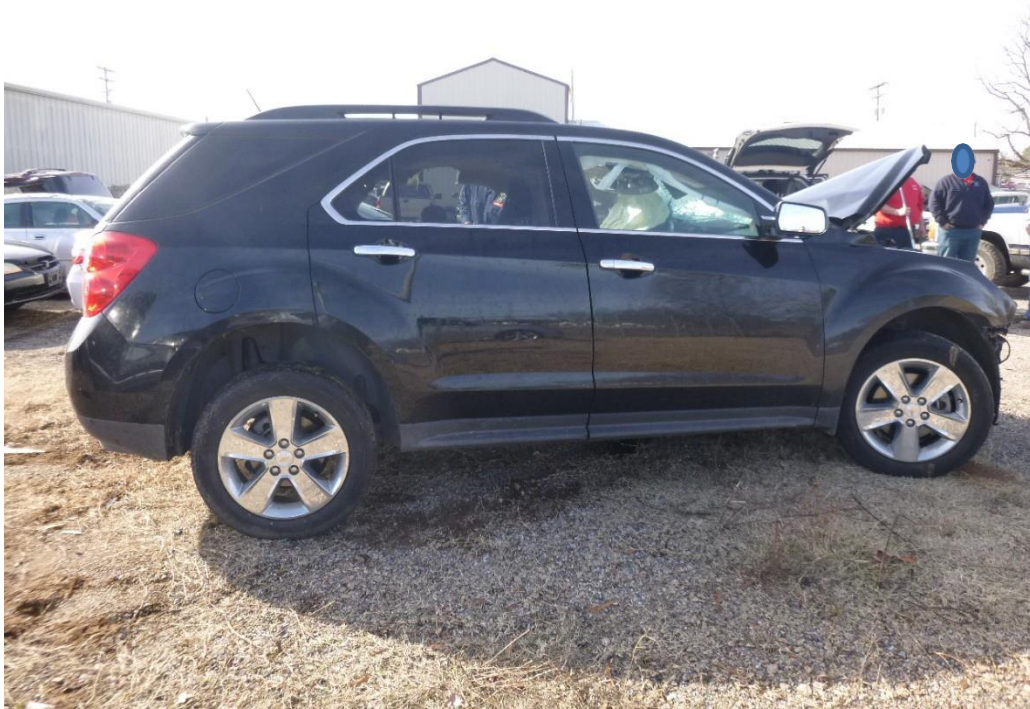
Photograph 3 - Right side view of the 2015 Chevrolet Equinox.

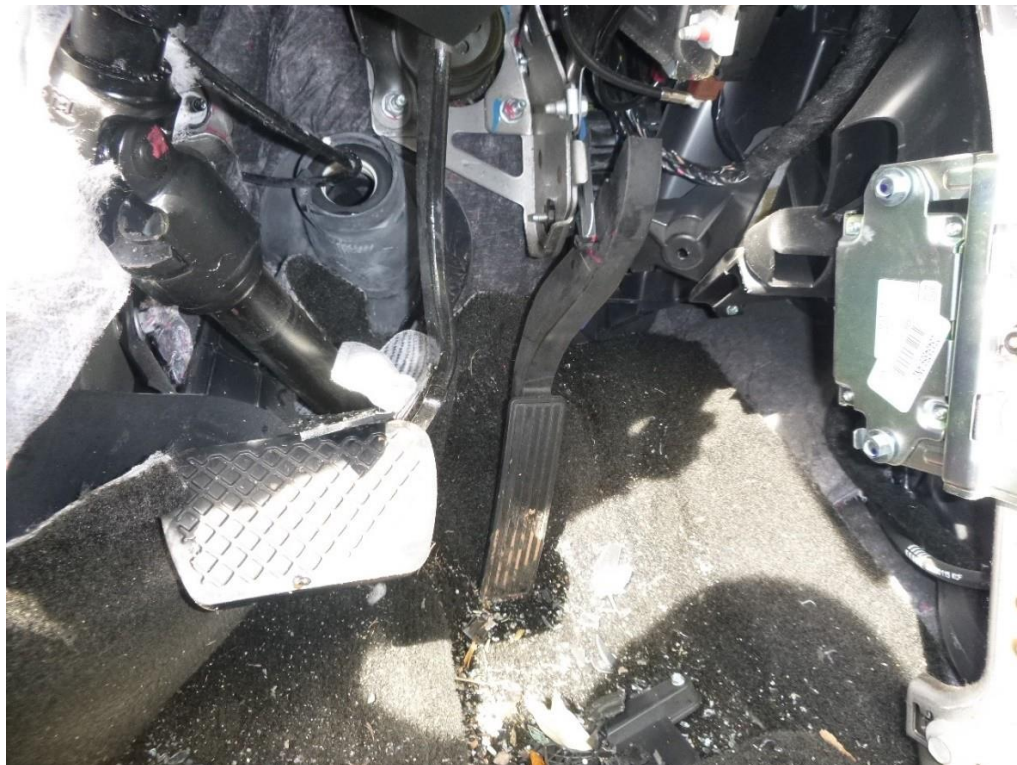
Photograph 4 - Depicting Drivers' foot well area and accelerator pedal and mounting bracket of the 2015 Chevrolet Equinox.

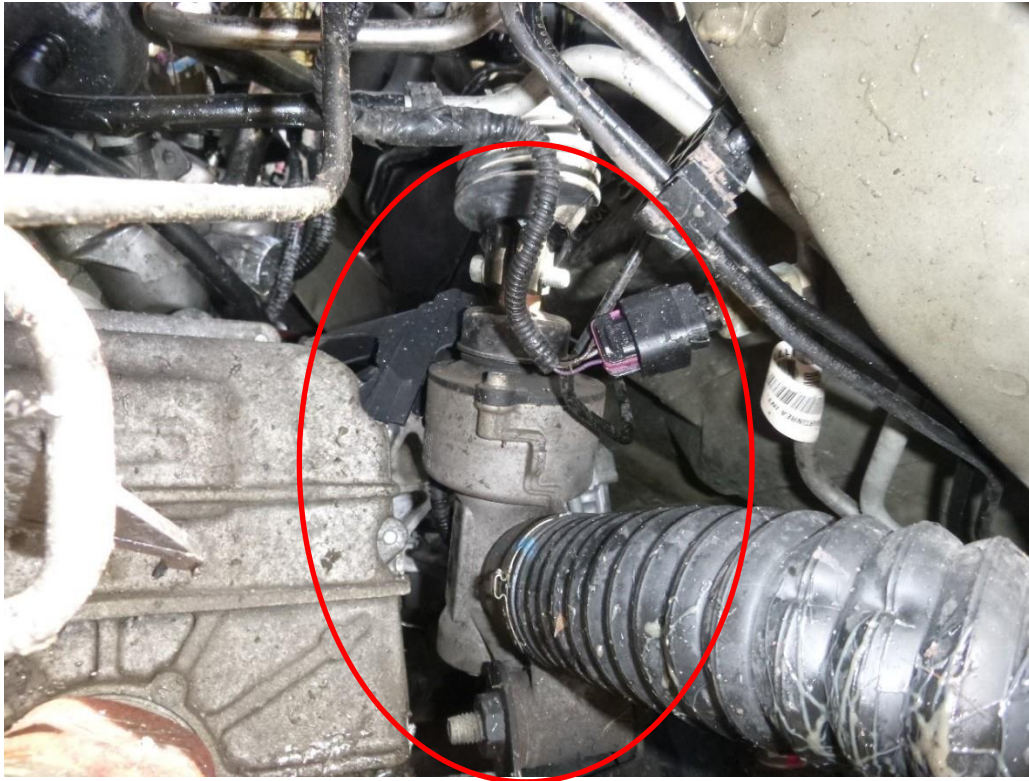
Photograph 5 - Depicting the 2015 Chevrolet Equinox power steering unit circled in red.

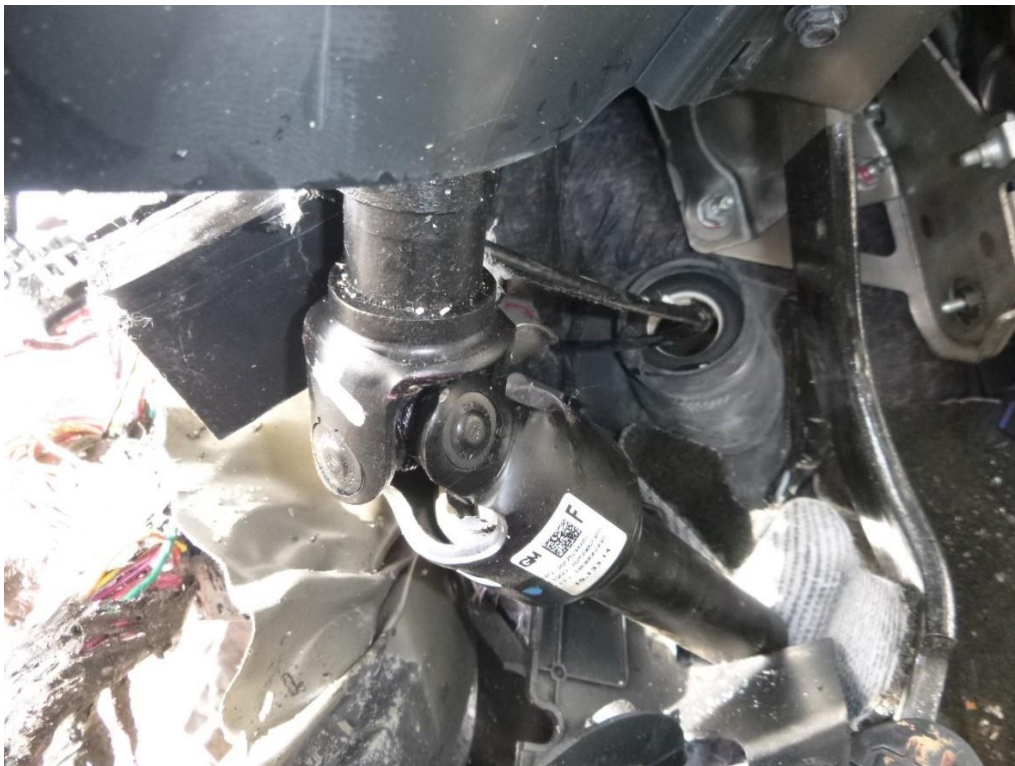
Photograph 6 - Depicting the 2015 Chevrolet Equinox steering column and couplings.

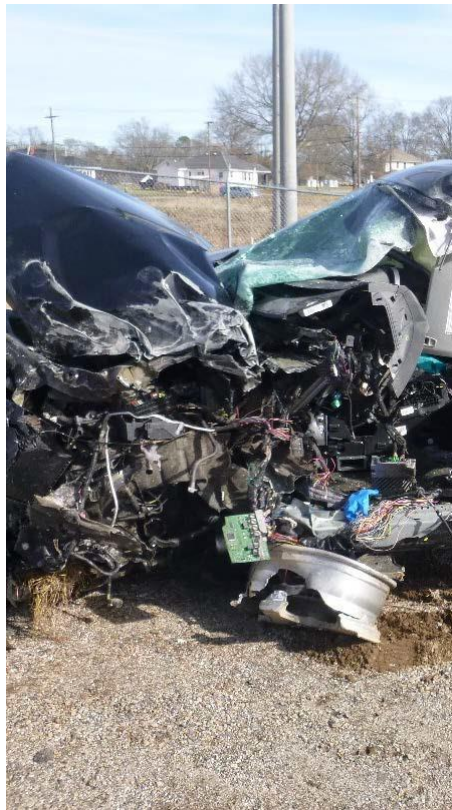
Photograph 7 - Depicting the damage to left front suspension coil spring, strut, and tie rod on the 2015 Chevrolet Equinox.

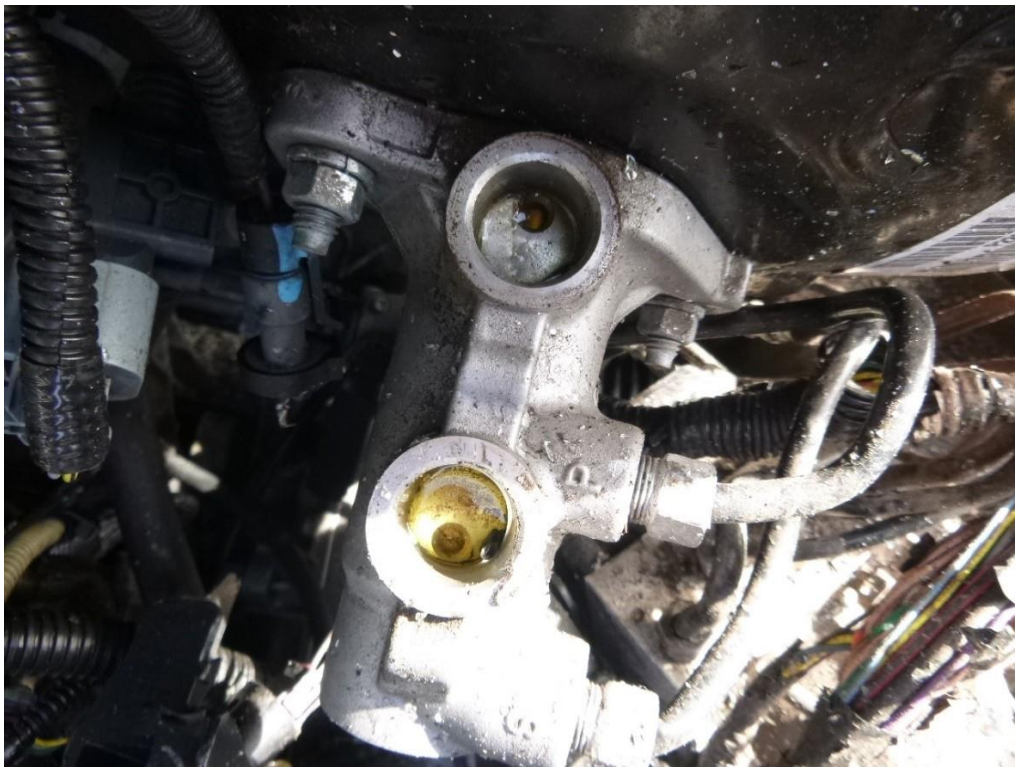
Photograph 8 - Depicting the damage to the master cylinder on the 2015 Chevrolet Equinox.

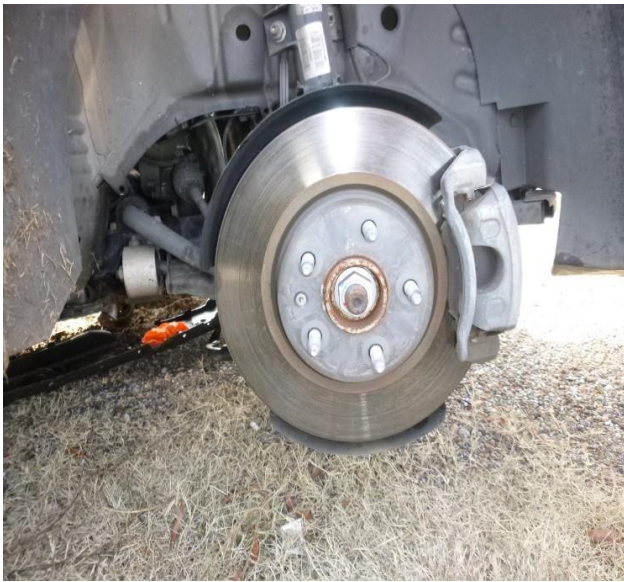
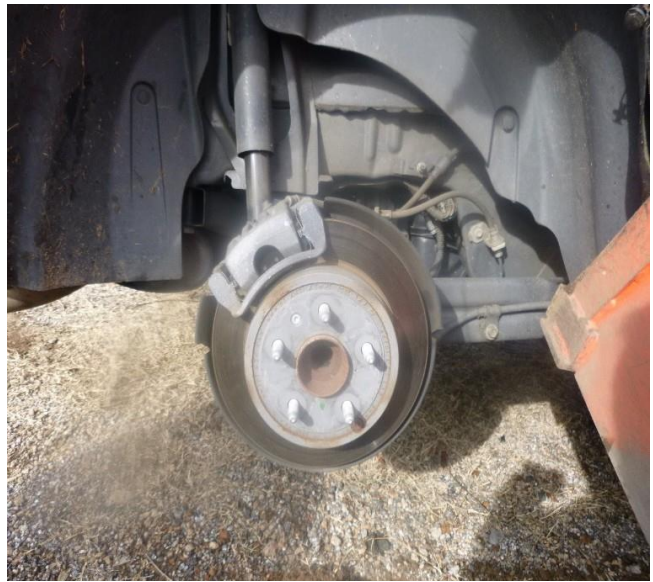
Photograph 9 - Depicting the right front and left rear rotor and brake assembly on the 2015 Chevrolet Equinox.
