# PRELIMINARY REPORT

## HIGHWAY

### HWY20FH001

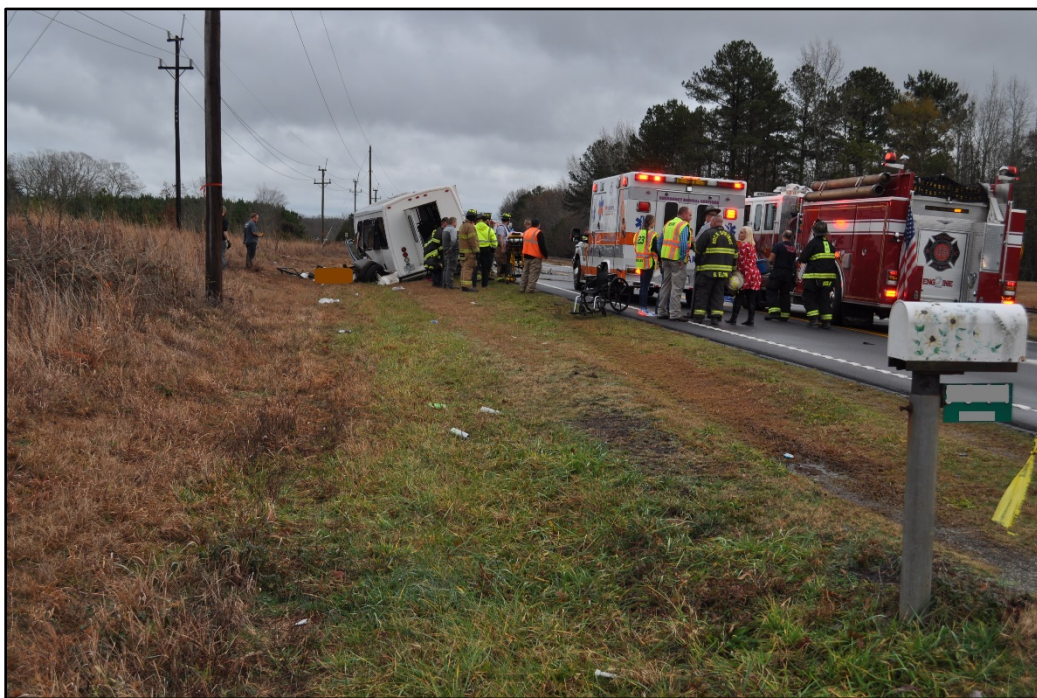
**Figure 1.** Westbound view of crash scene showing bus on grassy area and emergency vehicles and responders. (Source: Anderson County Coroner's Office)

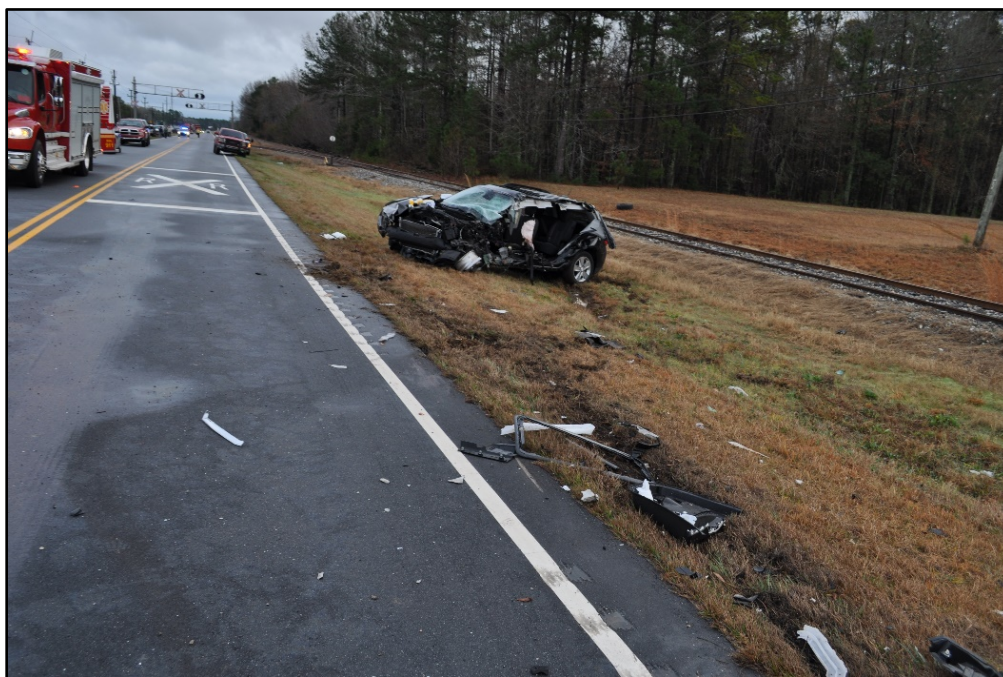
**Figure 2.** Westbound view of crash scene showing damaged SUV on grassy embankment. (Source: Anderson County Coroner's Office)
