## **Highway Factors Photographs**

**Belton, South Carolina**

**HWY20FH001**

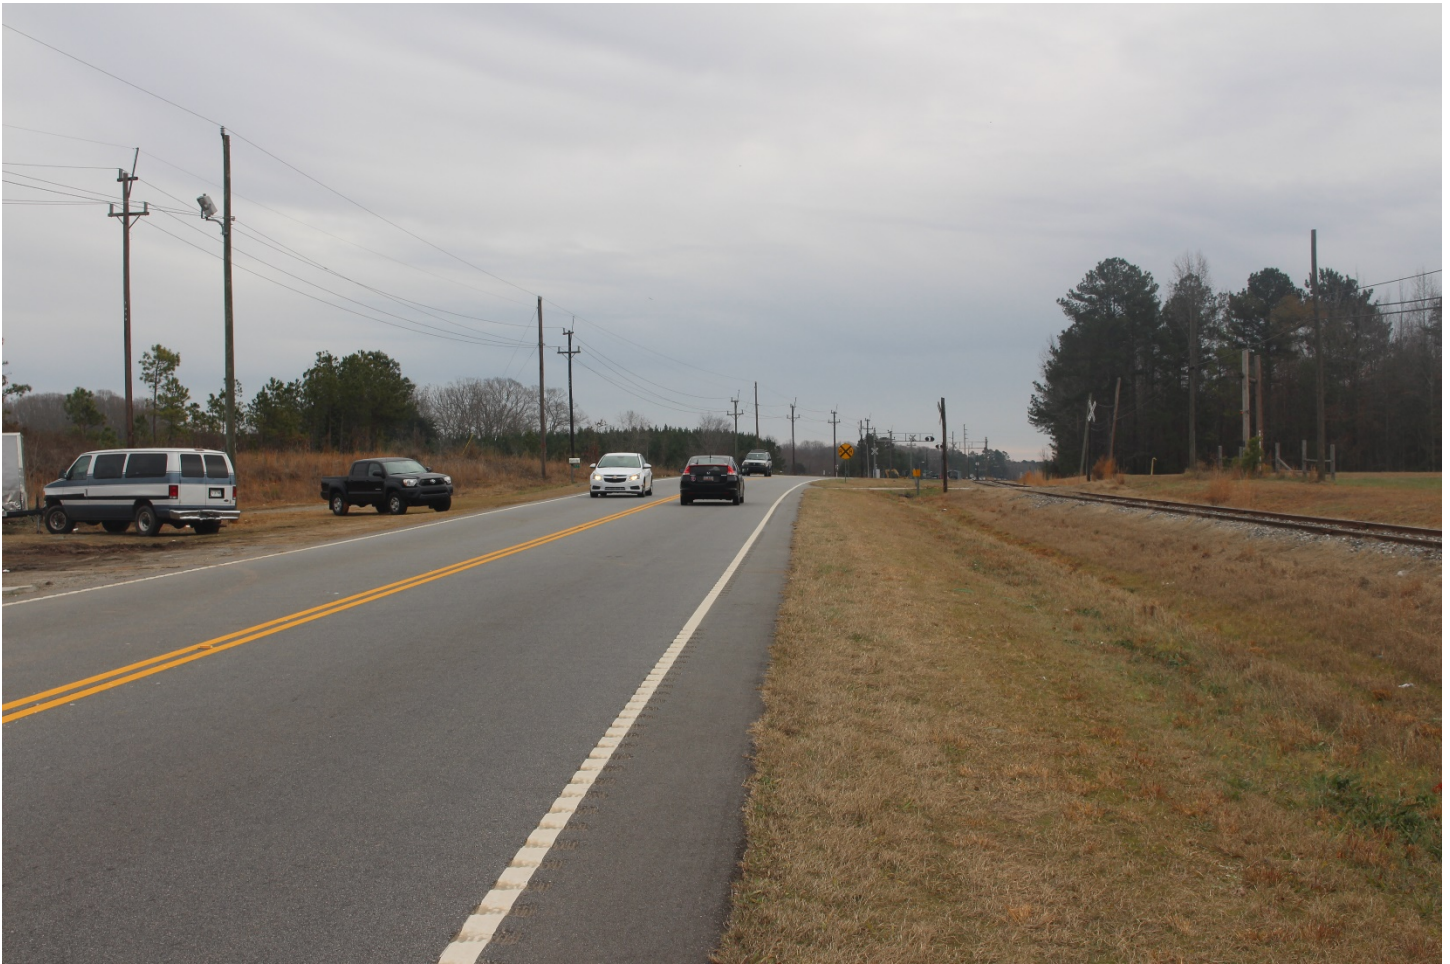
Highway Photo 1- This photo shows US-76 looking east the direction the SUV was traveling when it crossed over into the opposing traffic lane at the curve in the background.

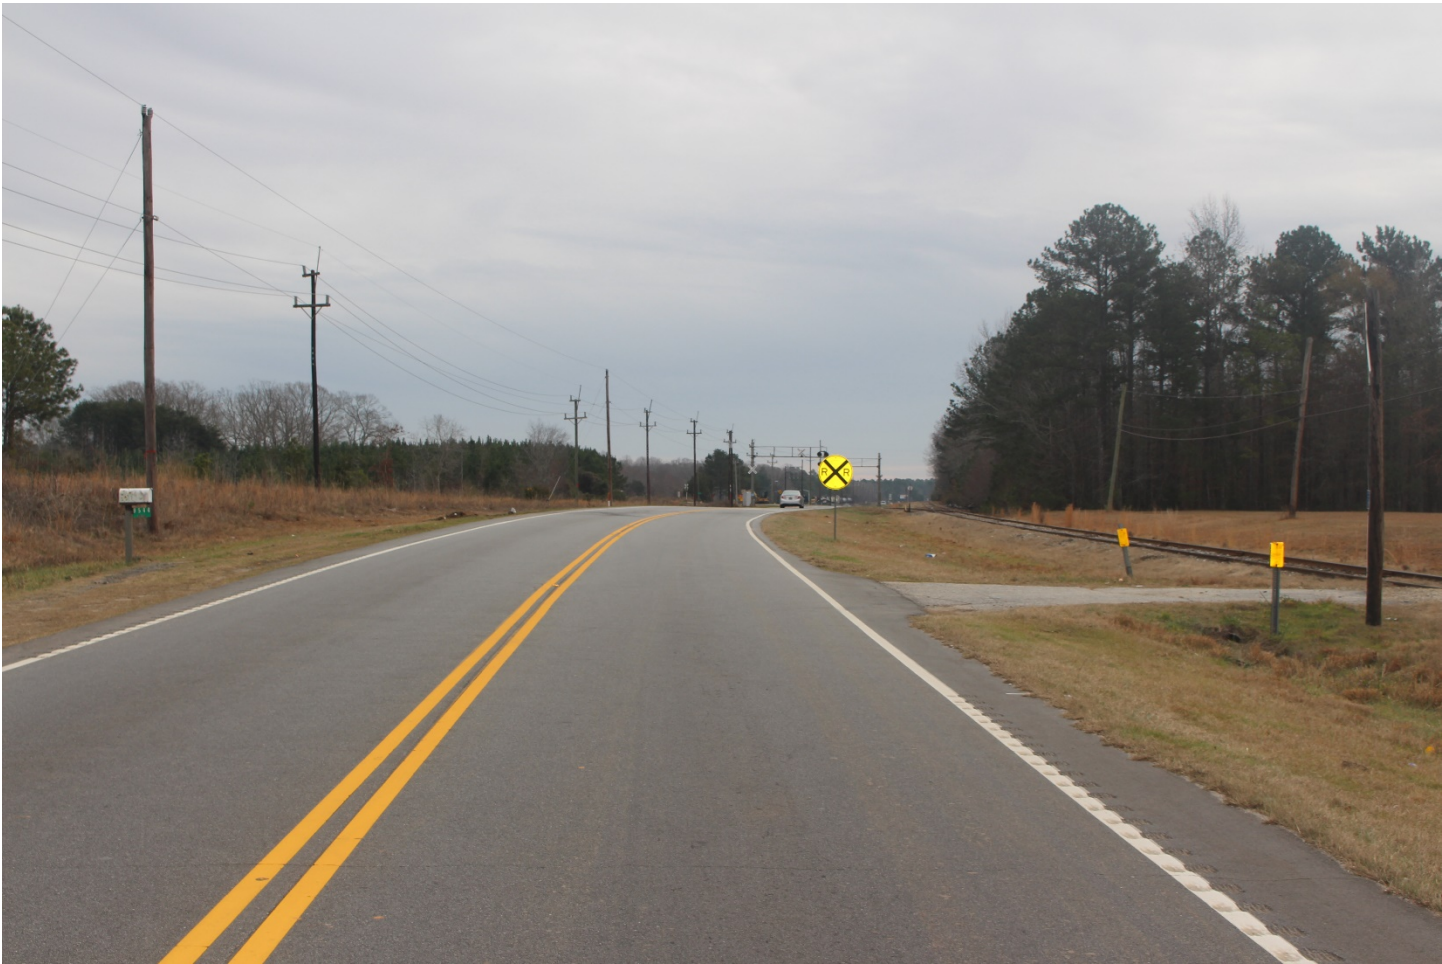
Highway Photo 2 – Closer view of SUV driver’s approach to the curve where the crash occurred.

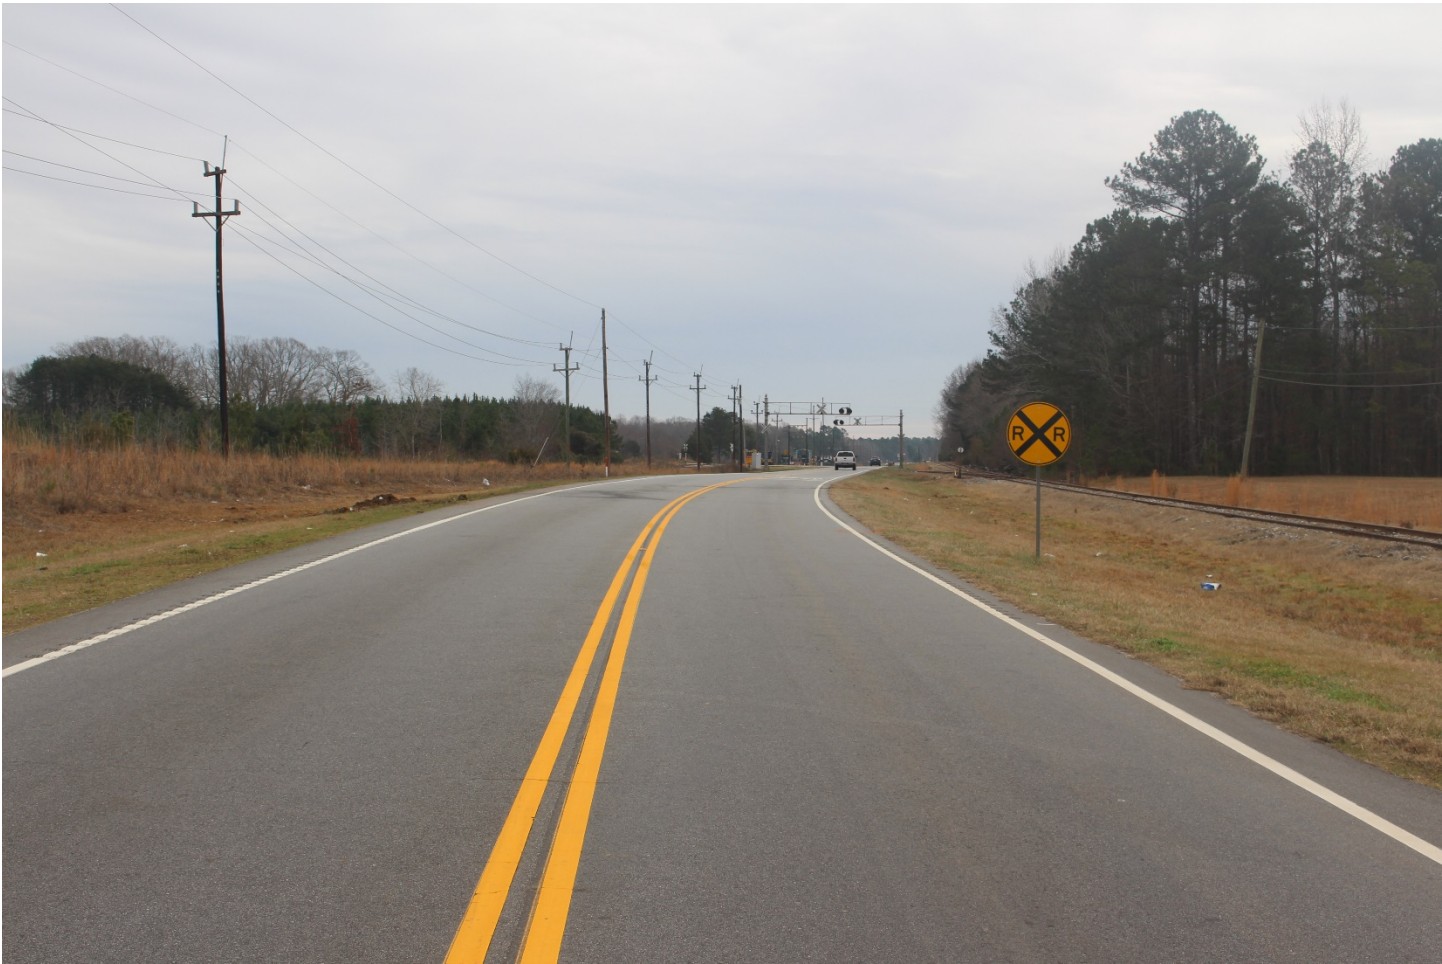
Highway Photo 3 – Eastbound view of the curve alignment on US-76 with the impact area in the westbound lane.

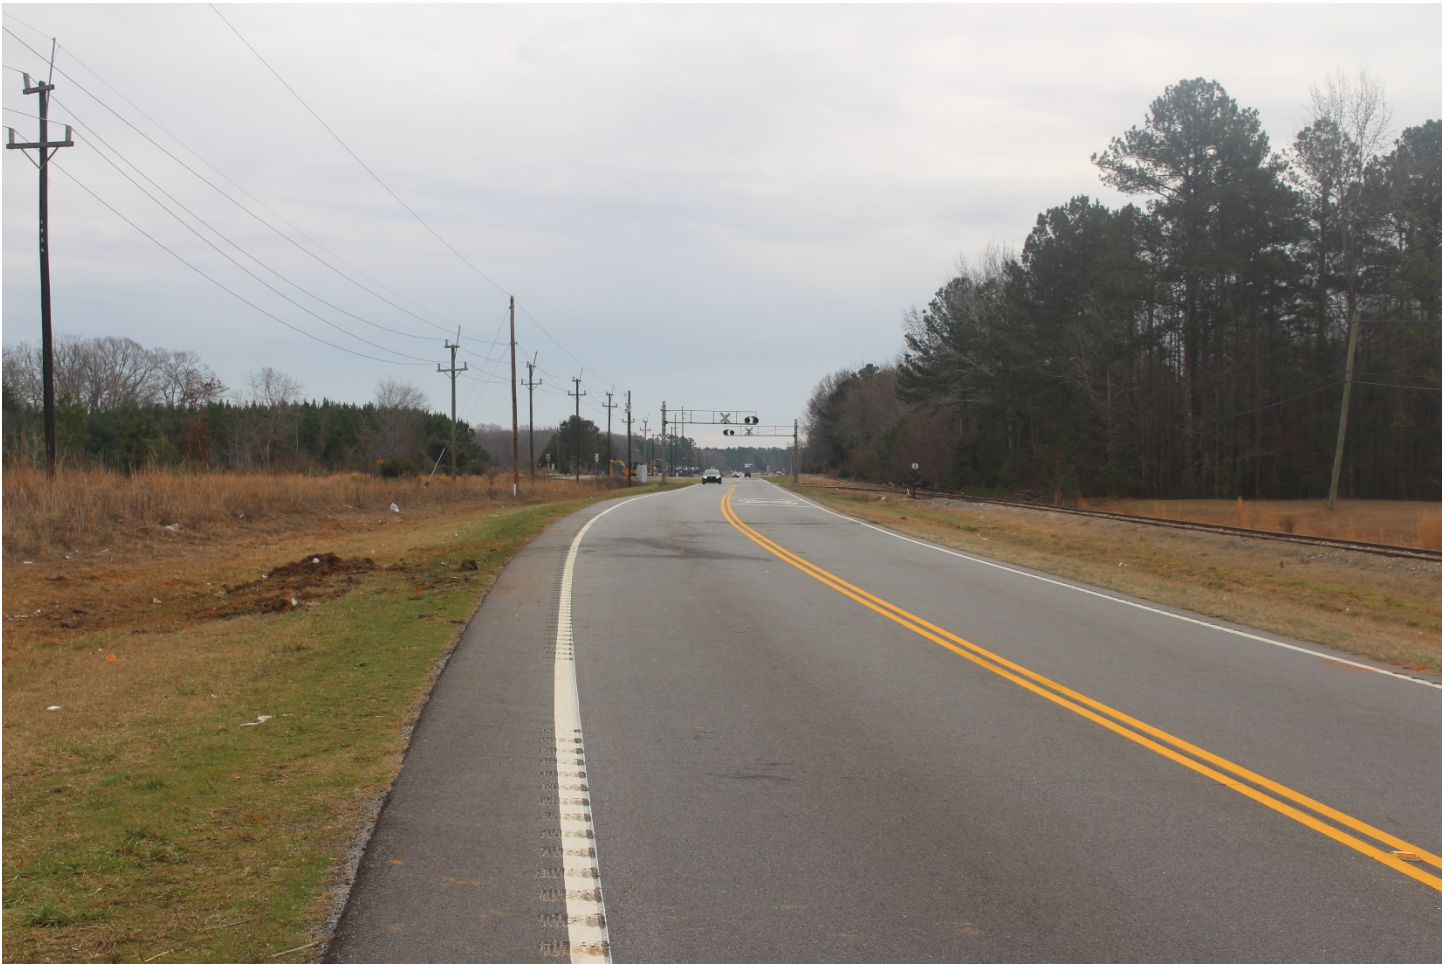
Highway Photo 4 – View of US-76, looking east in the westbound lane, showing the darkened pavement area where the impact occurred.

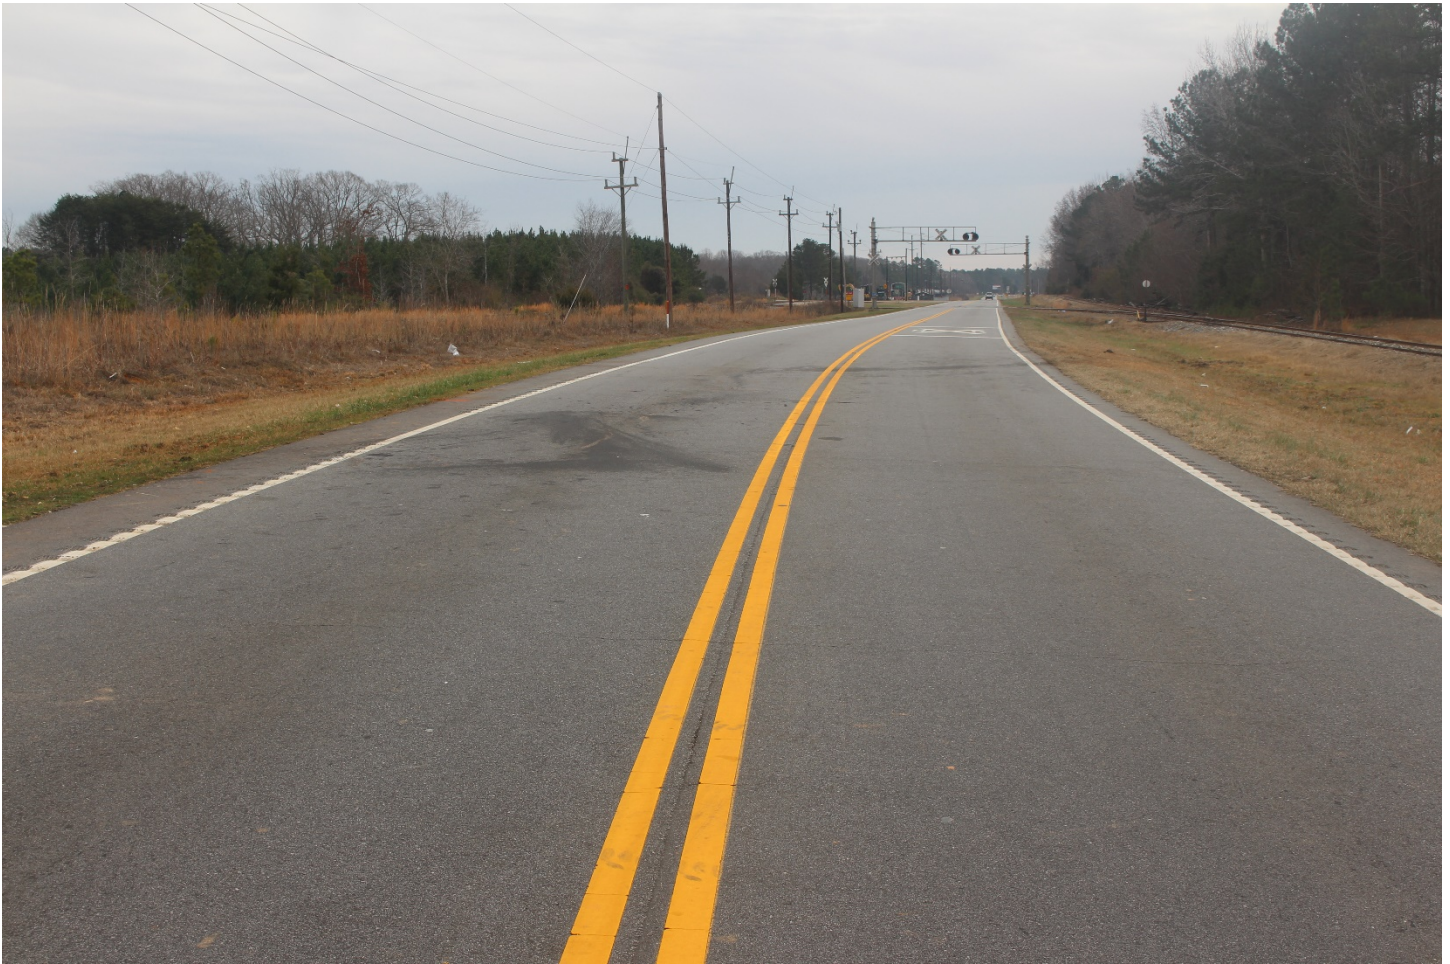
Highway Photo 5 – View from US-76 centerline double yellow pavement stripe, showing the impact marks in the westbound lane with SUV’s departure tiremarks leading back across the eastbound lanes onto the south roadside.

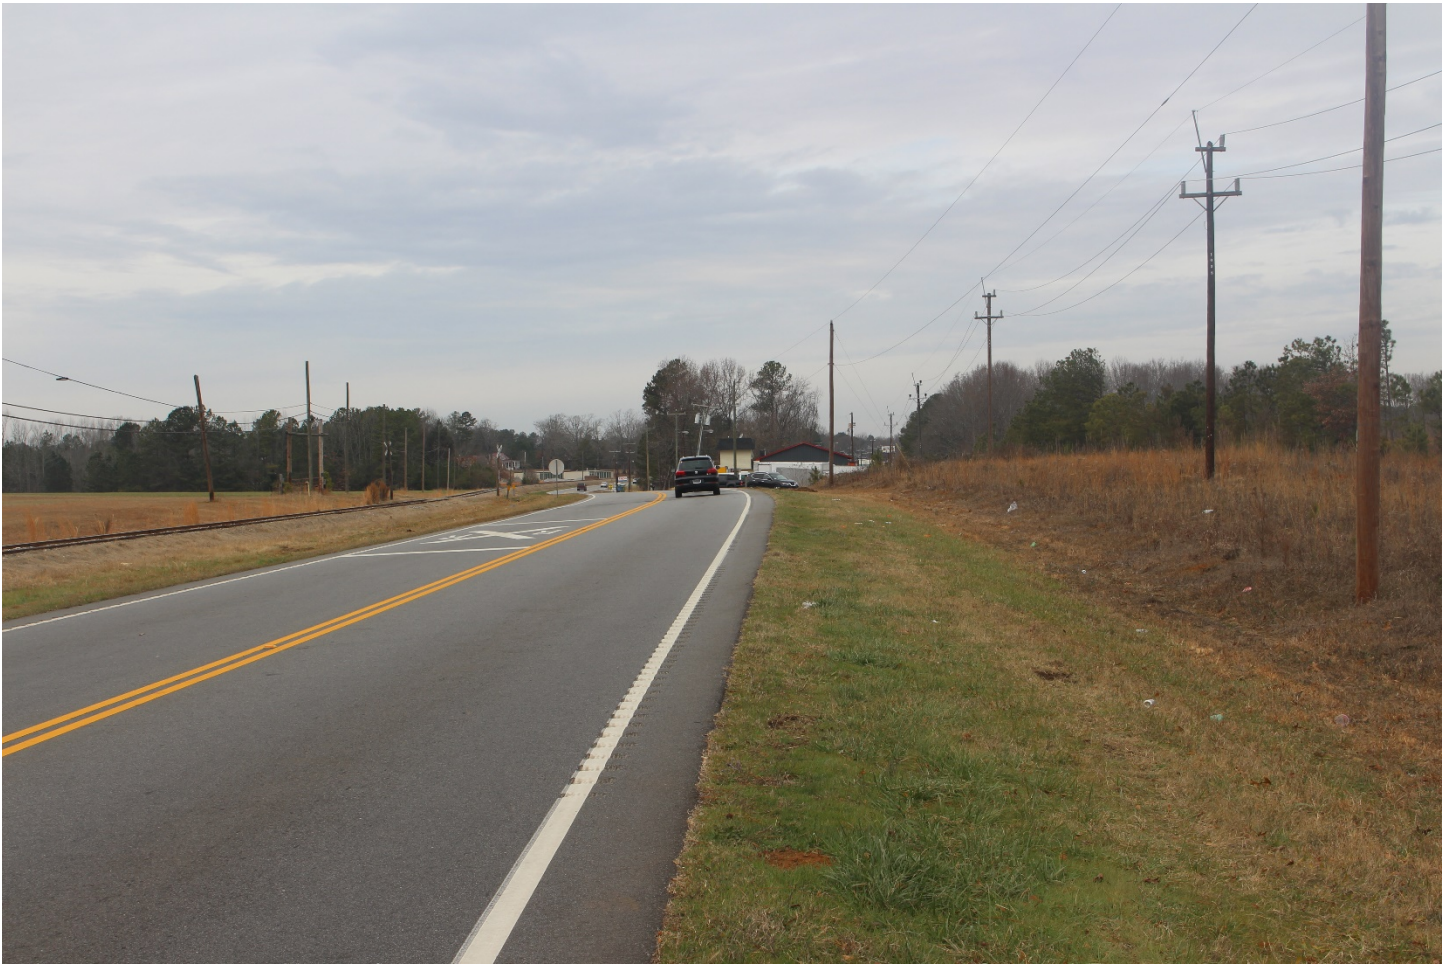
Highway Photo 6 – Westbound view of the curve on US-76 where the crash occurred. A vehicle is seen in the photo entering the curve so the reader can see the roadway alignment.

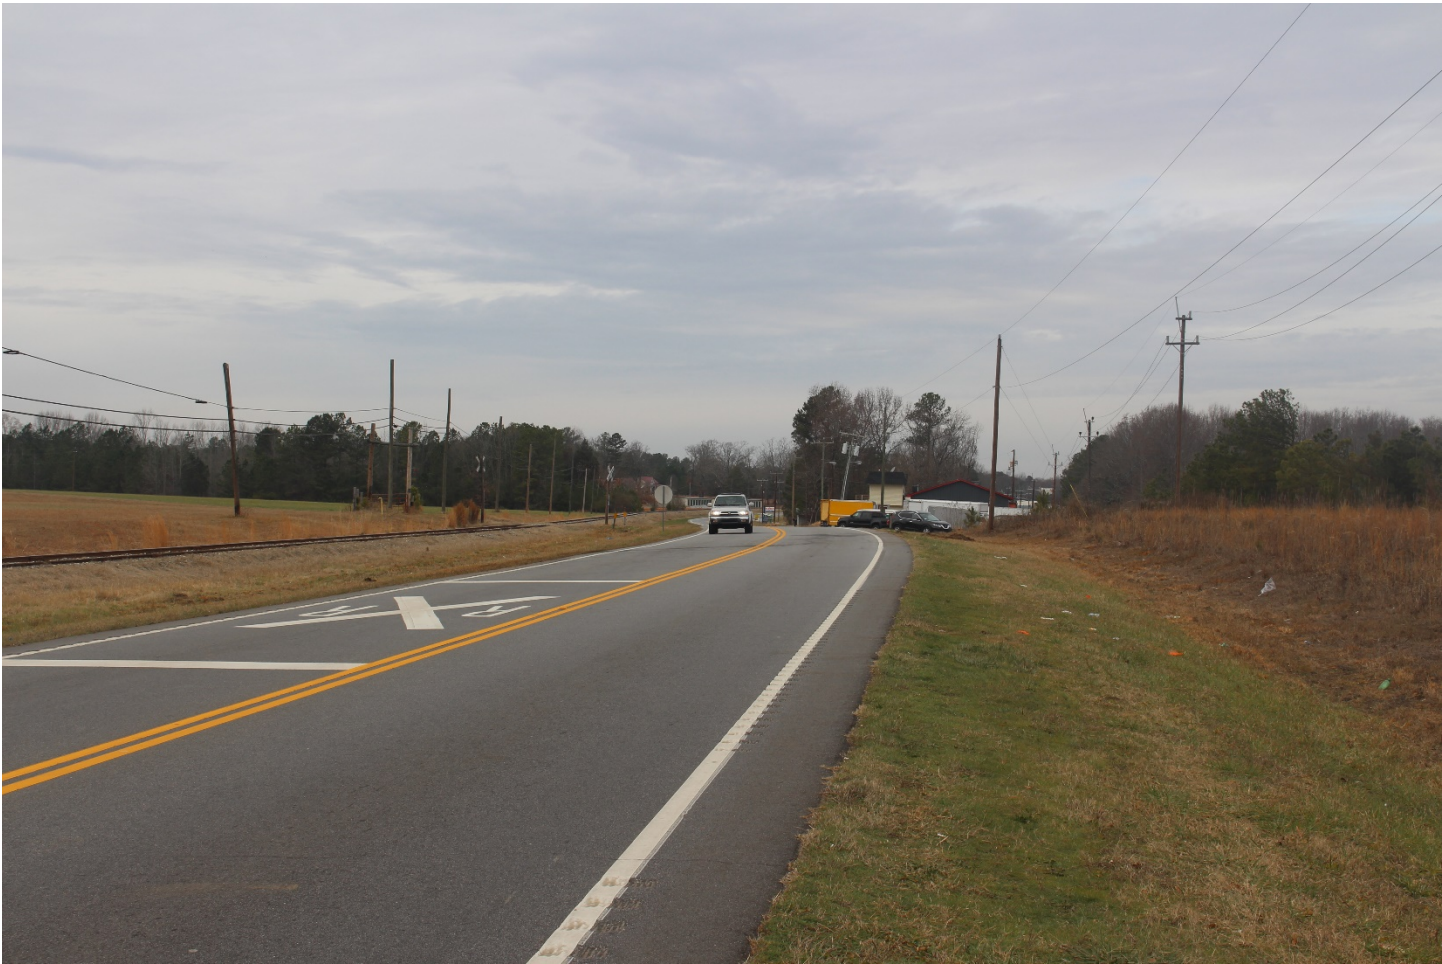
Highway Photo 7 – Westbound view of the curve where the crash occurred with an approaching SUV in the eastbound lane.

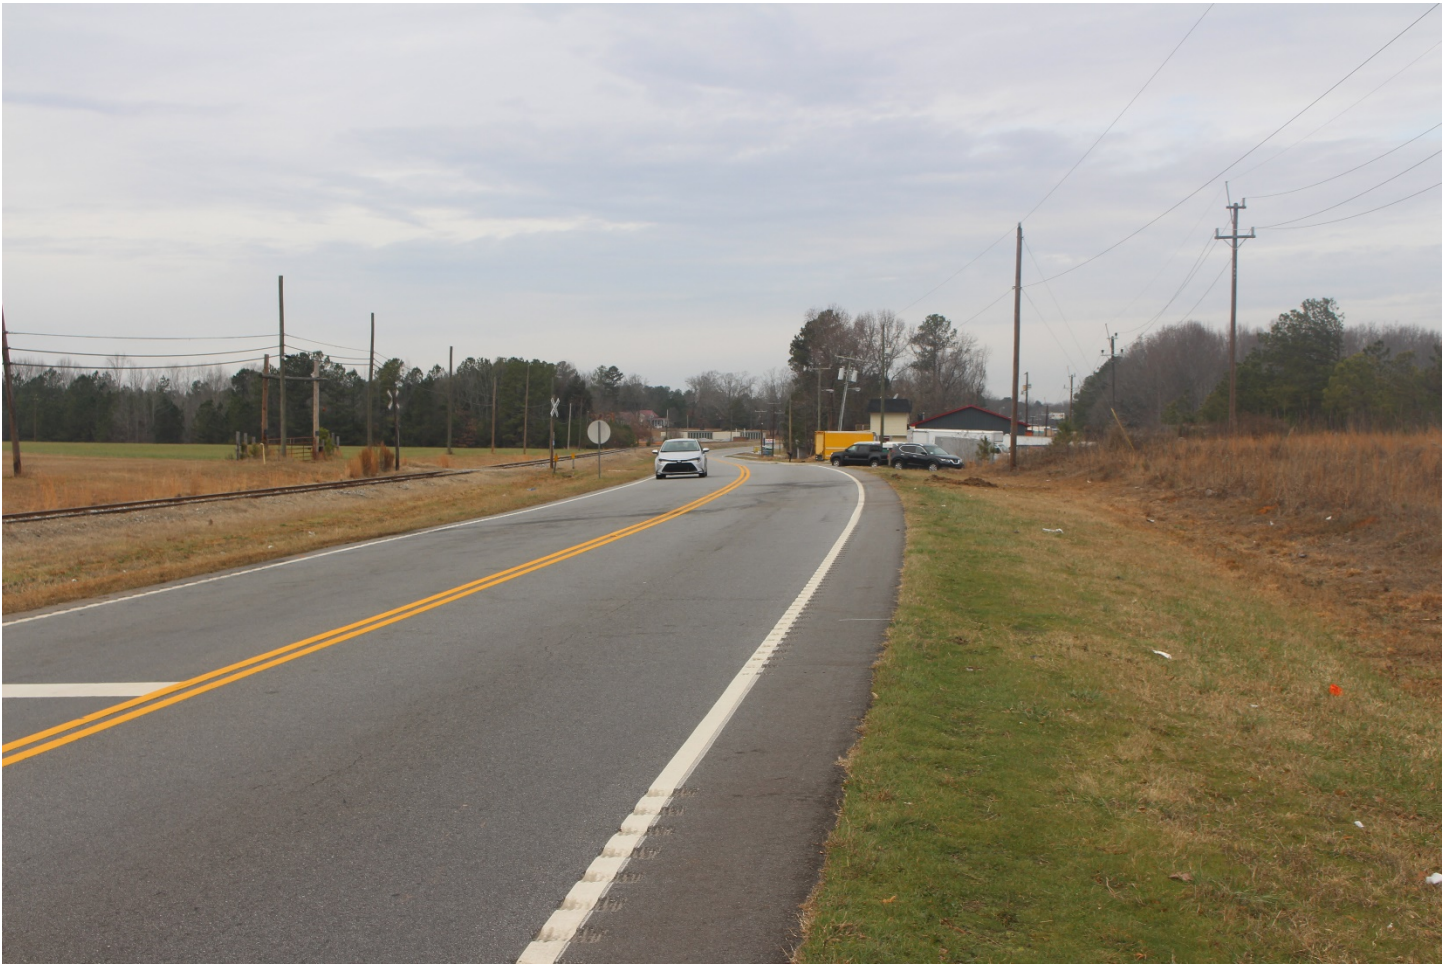
Highway Photo 8 – Closer view of curve alignment from the westbound lane.

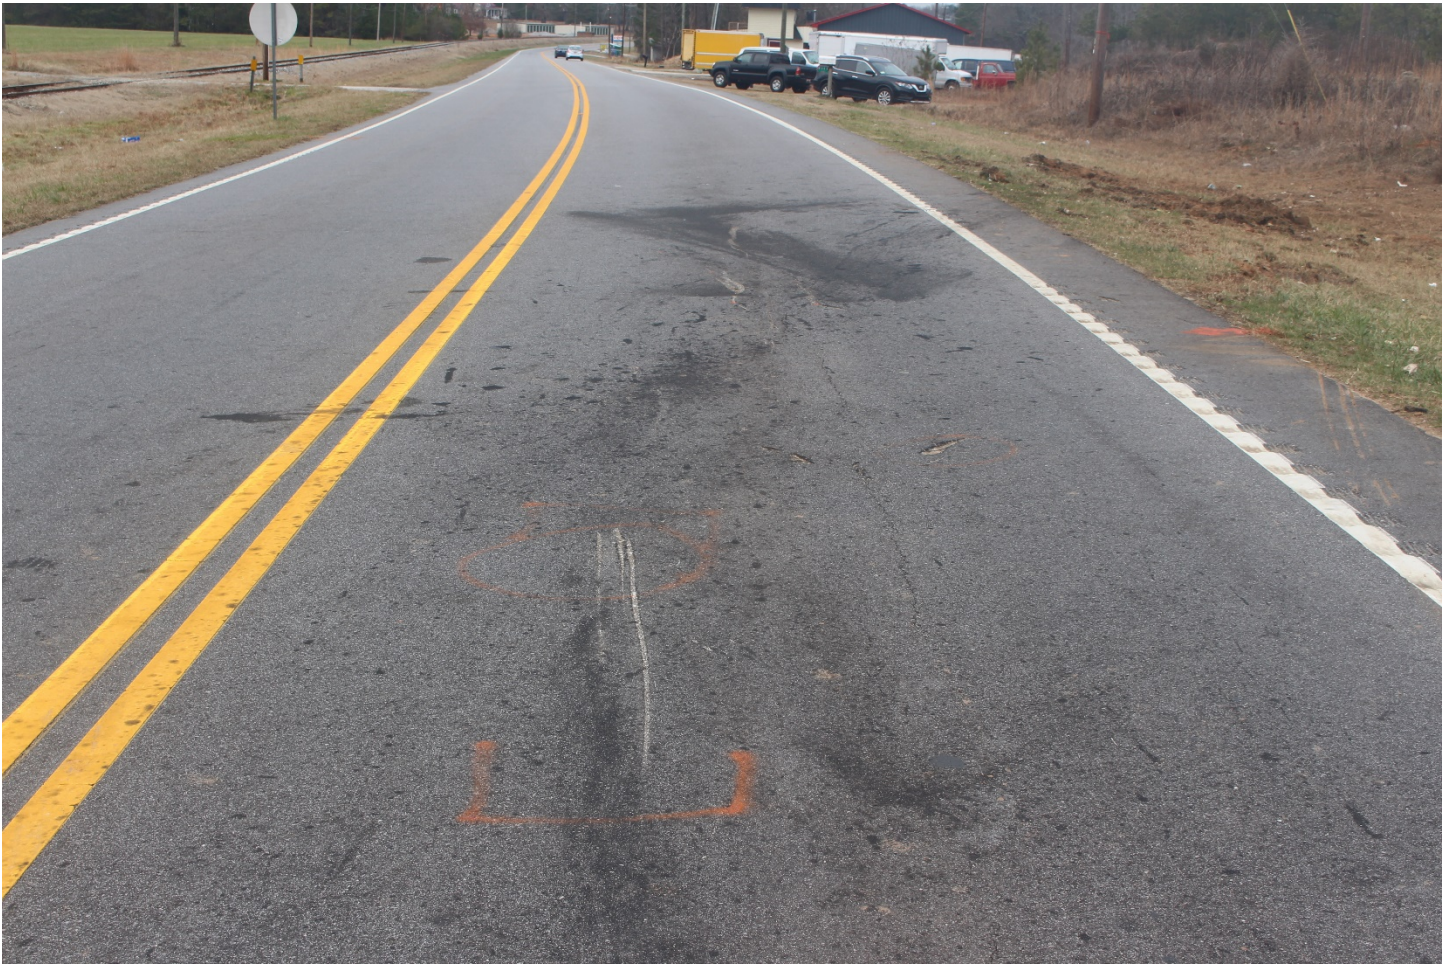
Highway Photo 9 – Close-up view of impact area in the westbound lane where the SUV crossed into the opposing traffic lane. Gouges and tiremarks on the pavement show where the vehicles collided head-on.
