ANC15FA032- Wreckage diagrams

The Safety Board investigator-in-charge performed an on scene wreckage documentation and initial examination on June 1, 2015. The main fuselage was located at 60.332588N -161.054495W, about 270 feet from the first observed point of impact, on a magnetic heading of approximately 010 degrees.

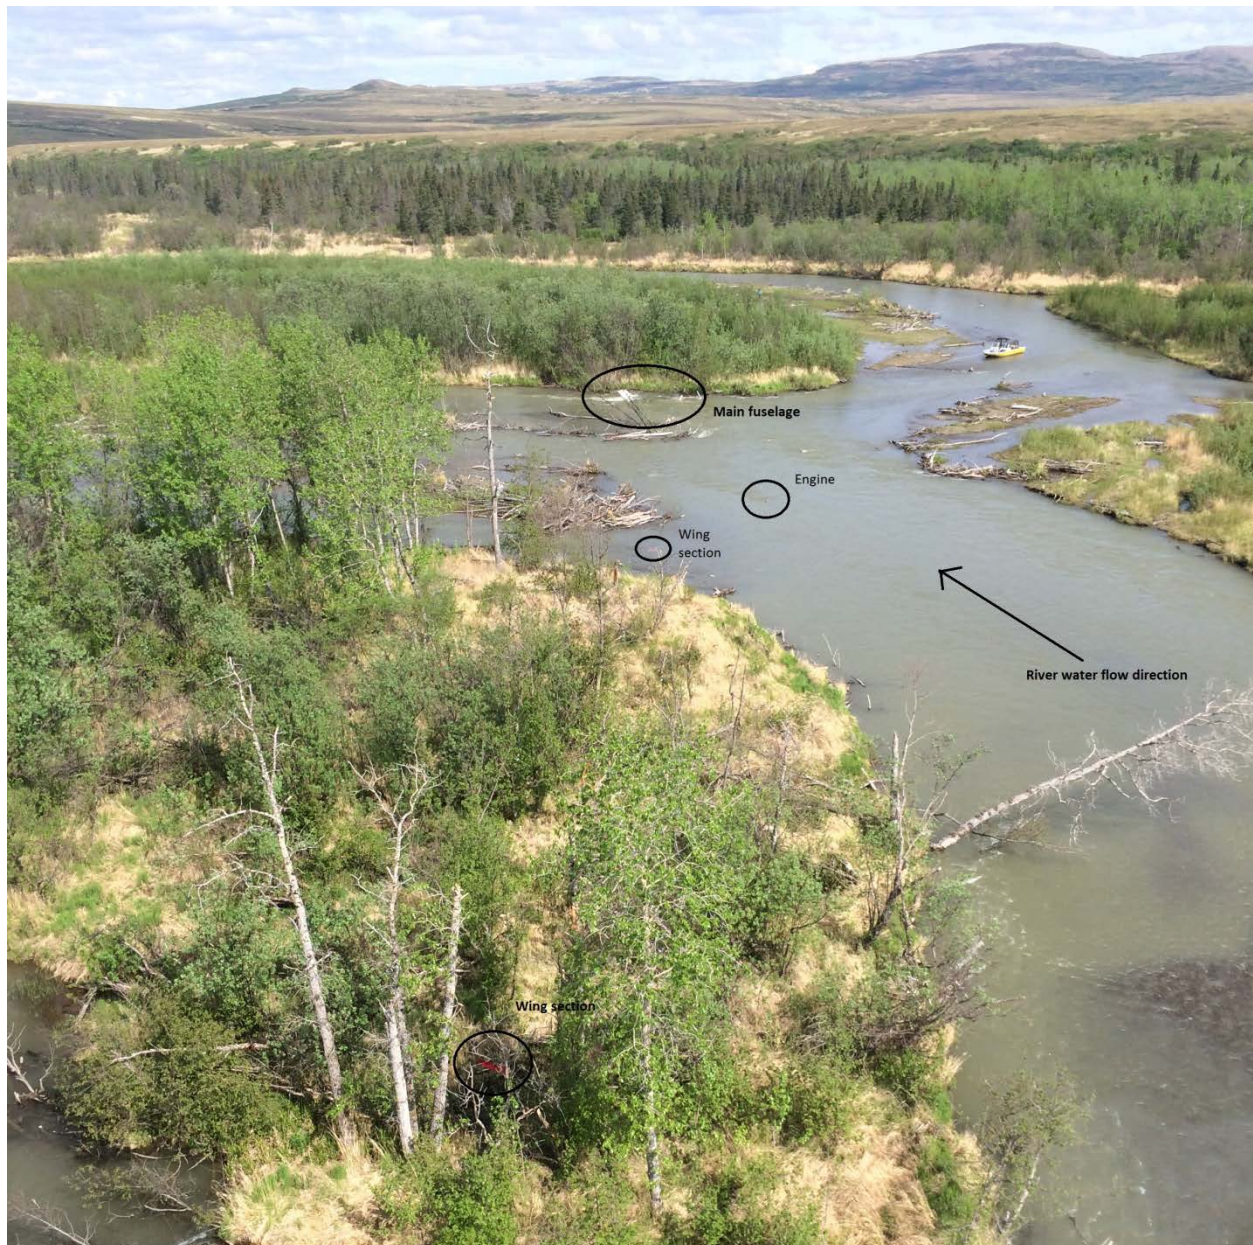
Figure 1: Illustrated aerial picture of the wreckage site

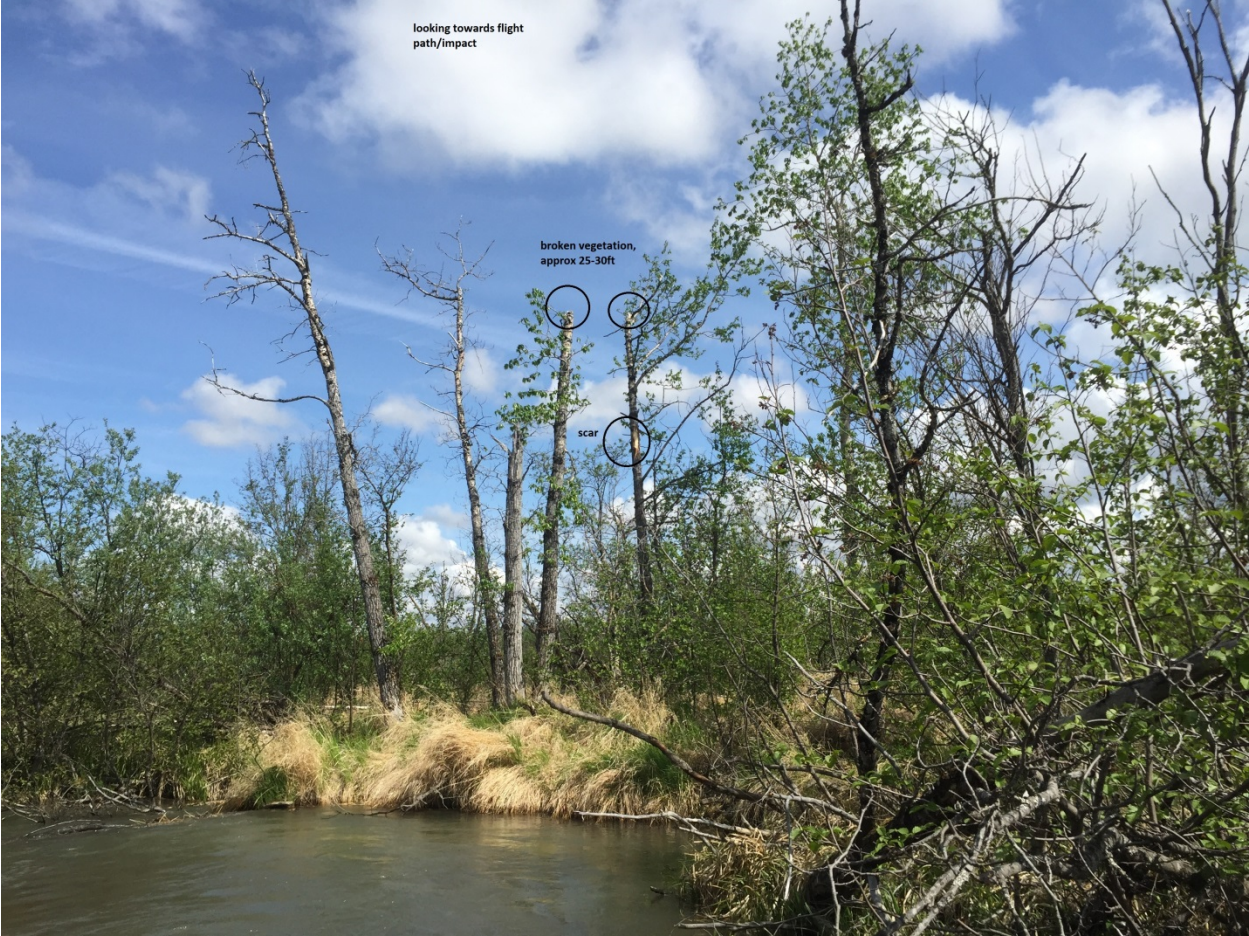
Figure 2: Broken trees looking back in the direction of flight path

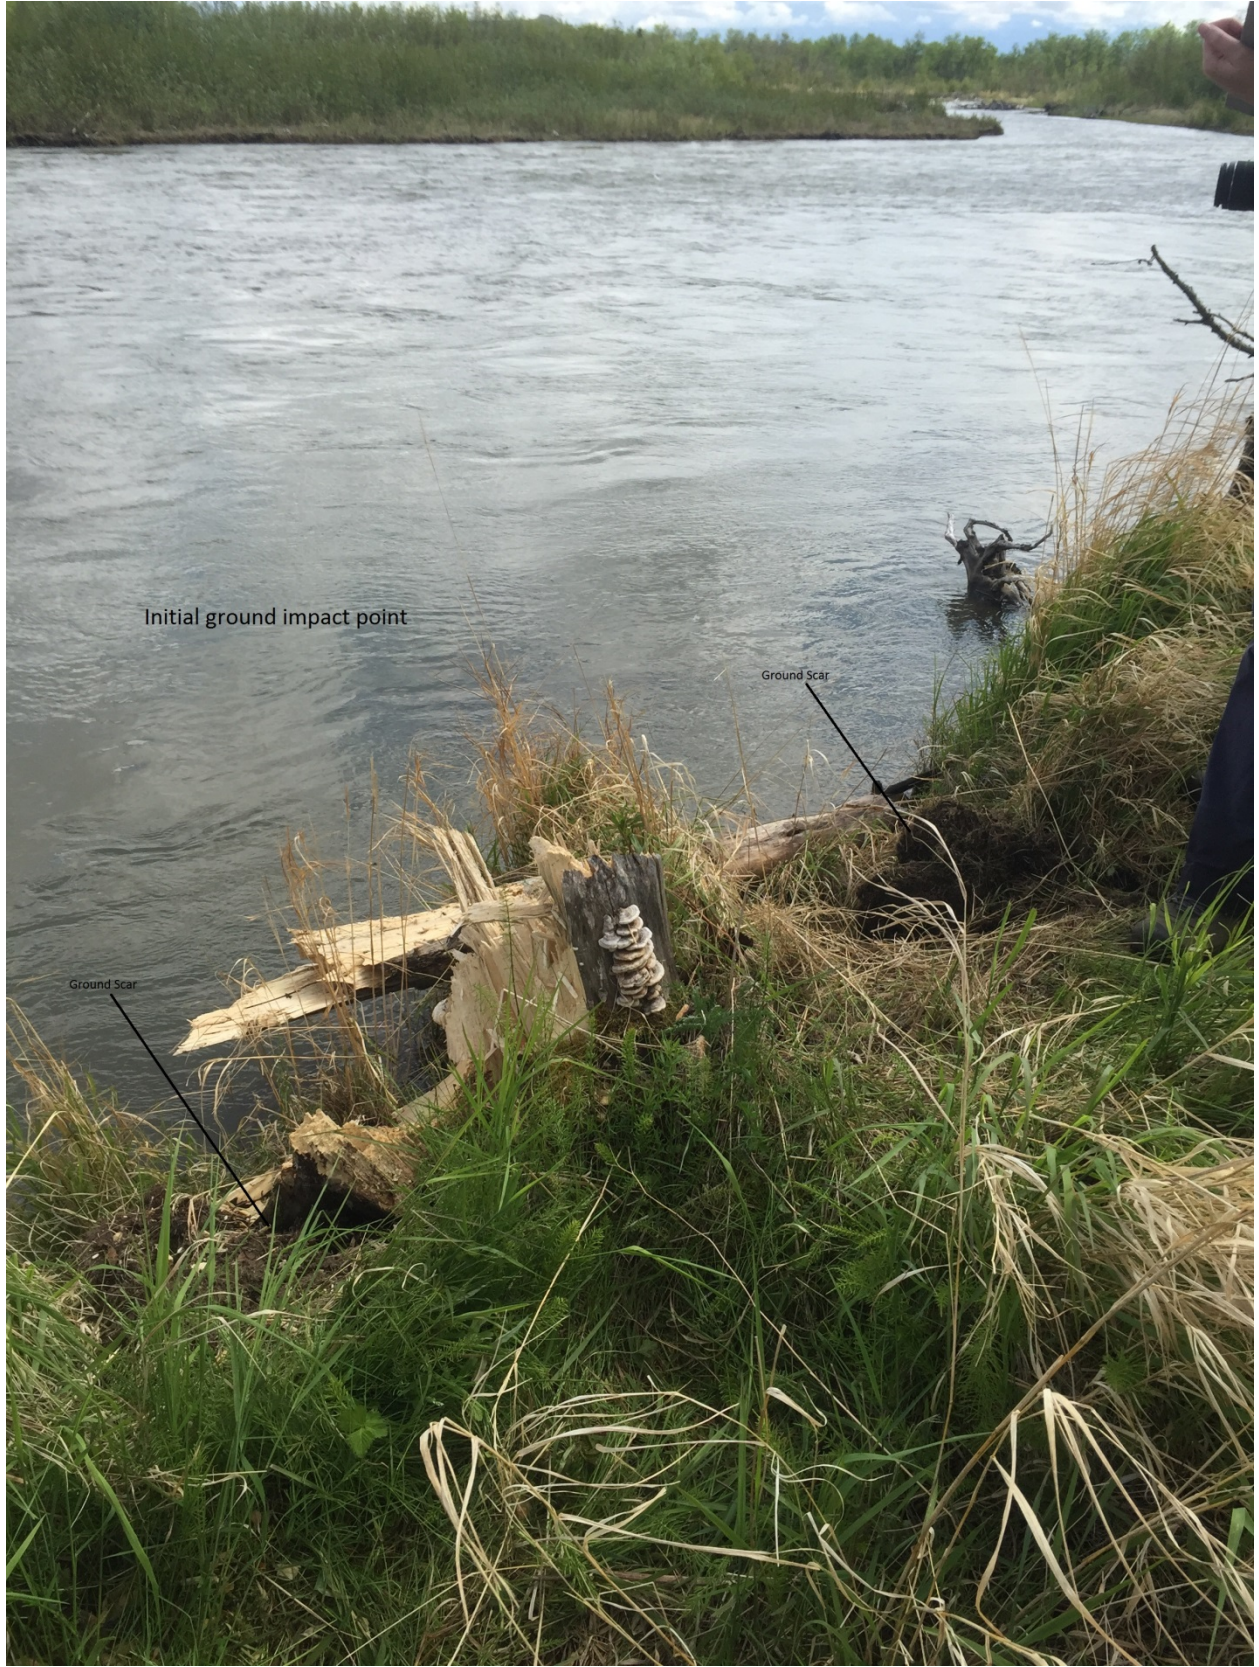
Figure 3: Initial ground impact point

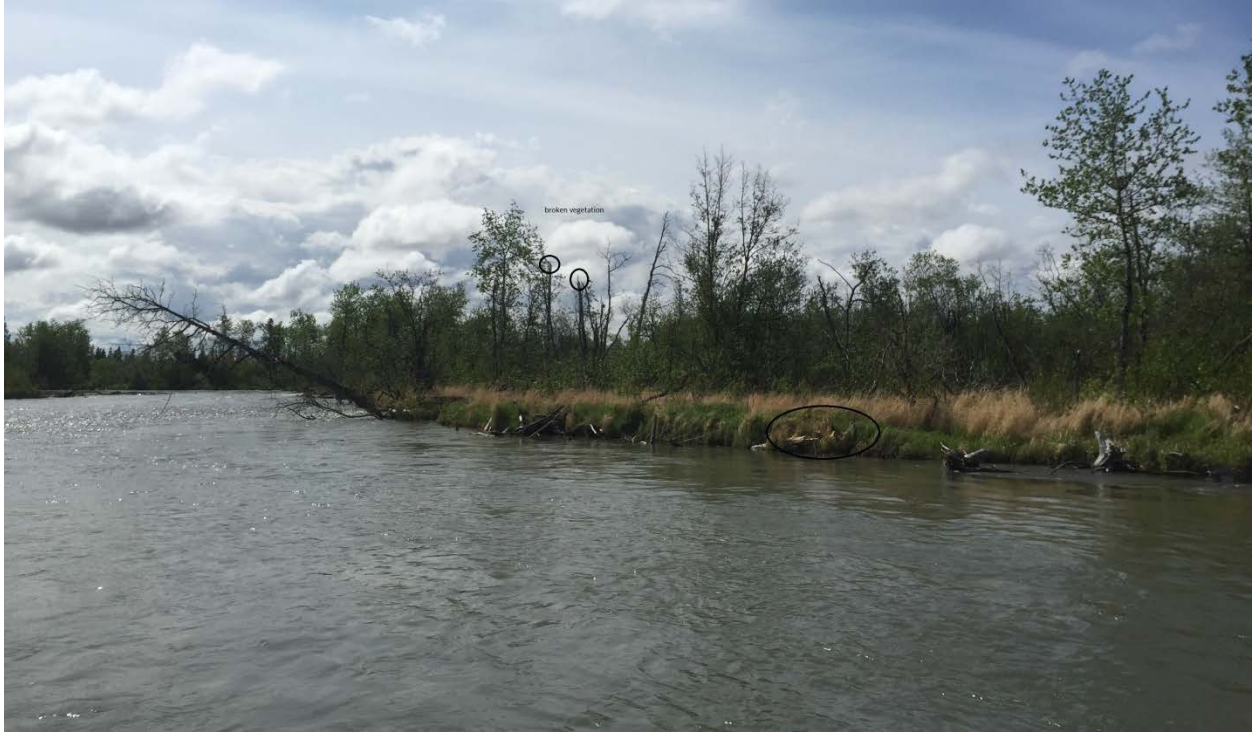
Figure 4: Looking back at the flight path from the main fuselage

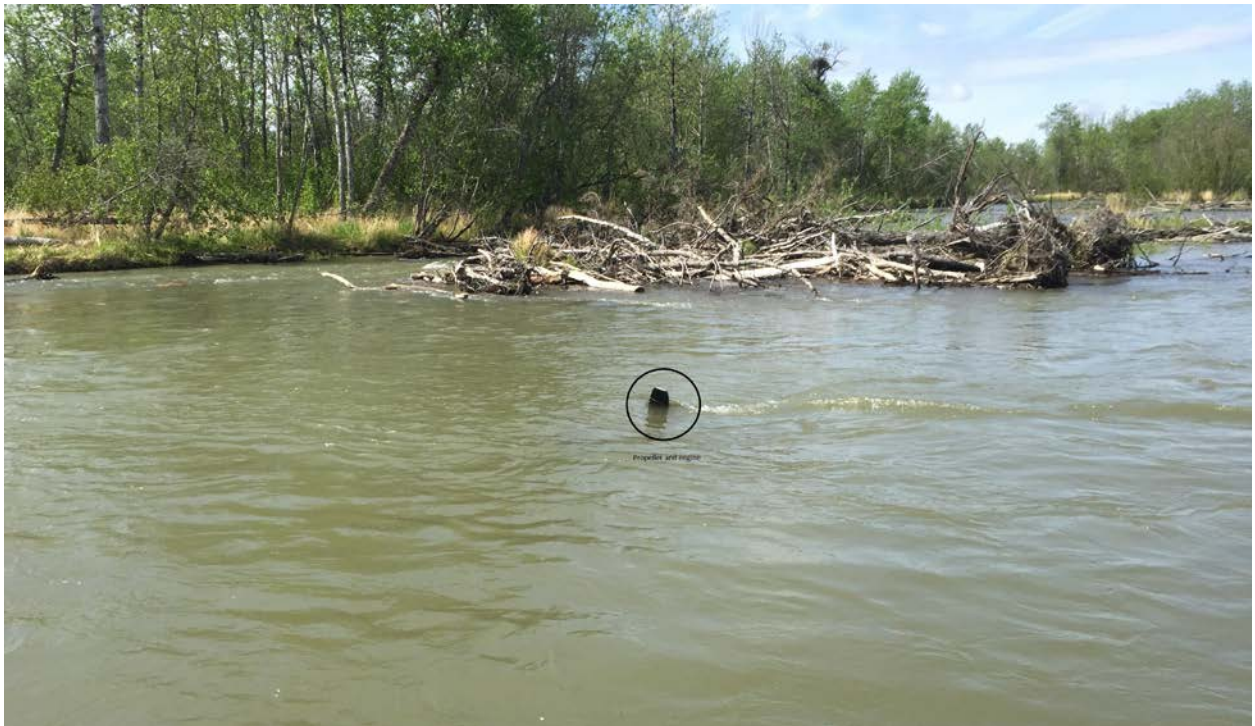
Figure 5: Propeller tip sticking out of the water
