NATIONAL TRANSPORTATION SAFETY BOARD

Group Chairman's Factual Report

HIGHWAY FACTORS

HWY22FH001

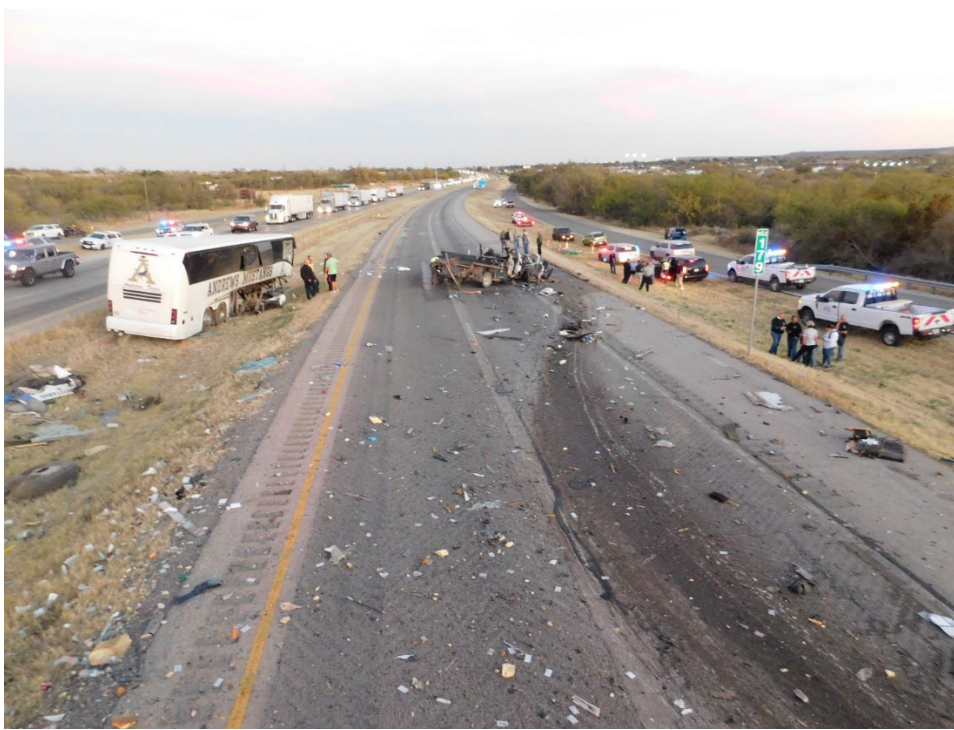
Figure 3. View of impact area near mile marker 179 with motorcoach at final position in the median and the pickup in the right-hand eastbound traffic lane.

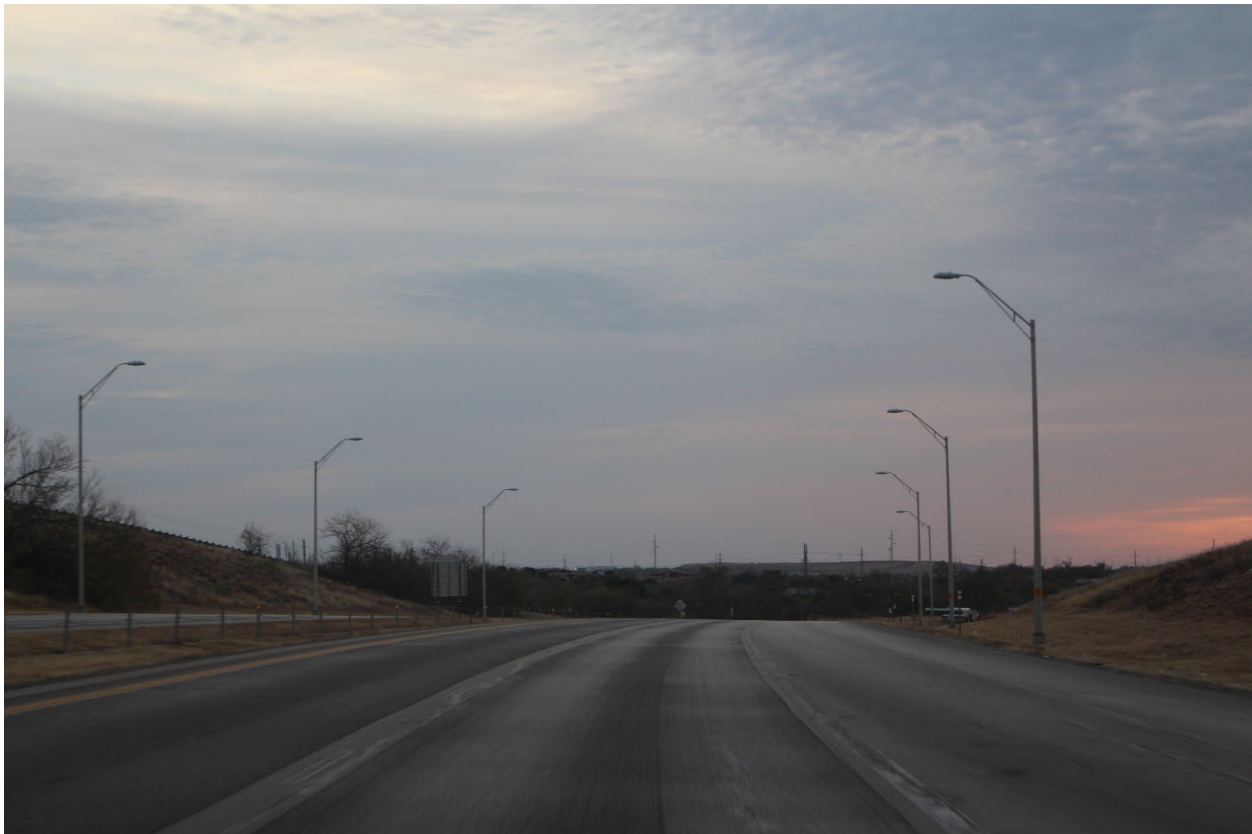
The crash was in a 4,230 foot-long, right-hand horizontal curve that had a radius of 1-degree or 5,229.58-feet and sloped downward on an approximate 2.8 percent downgrade. The impact area (station number 826+67) was approximately 2,990-feet from the beginning of the curve at station number 796+77.06. The crash location was also located east of an 1,100-foot crest vertical curve.⁵ The vertical curve began at station number 818+50 or approximately 817 feet before the impact area. See Figure 4 showing a view of the curved eastbound approach.

Figure 4. View of eastbound I-20 showing the horizontal and crest vertical curve on the approach to the crash location.

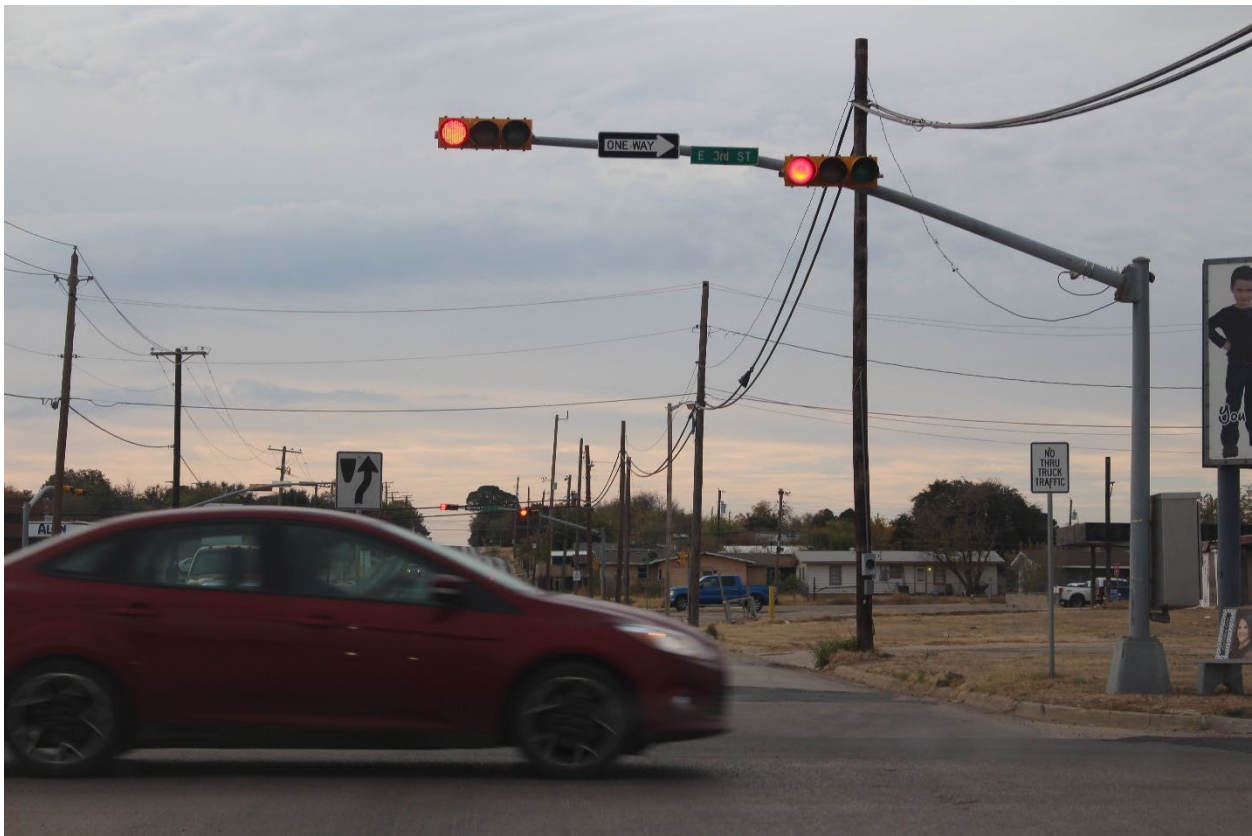
The security video from Hull Meat Company on Birdwell Lane showed the pickup truck driver departed the business and traveled to 3rd St. where he turned left on the one-way street. TXDOT indicated 3rd Street had been a one-way street for at least the preceding 34 years. See Figure 5 for a view of the one-way signage on 3rd St. and Figure 6 for the additional WRONG WAY sign on 3rd St. The one-way sign had a mounting height of 13.5-feet and was 36-inches by 12-inches in dimension. The wrong way sign had a mounting height of 7-feet and was 36-inches by 24-inches.

Figure 5. View of ONE-WAY sign on 3rd St. where the pickup driver turned left traveling east on the westbound one-way road.

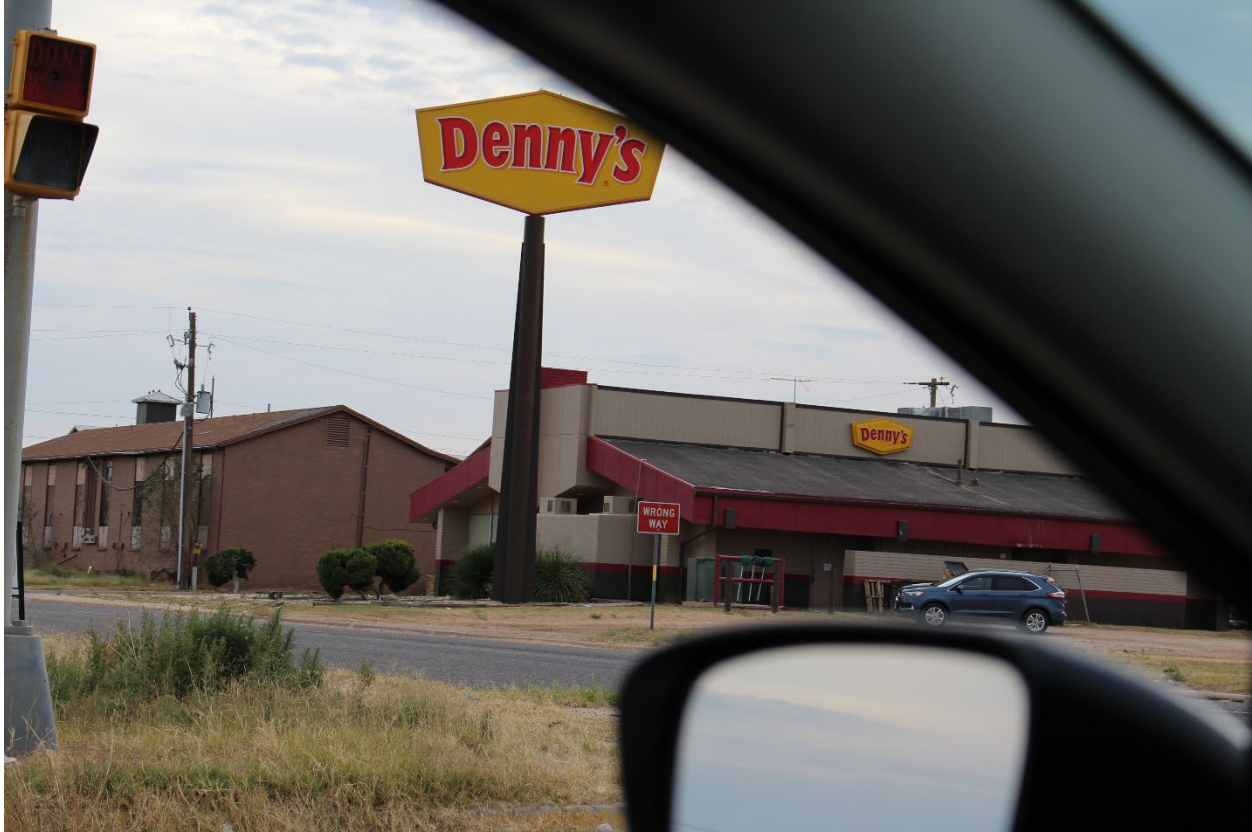
Figure 6. View of WRONG-WAY sign on 3rd St. viewed from Birdwell Lane.

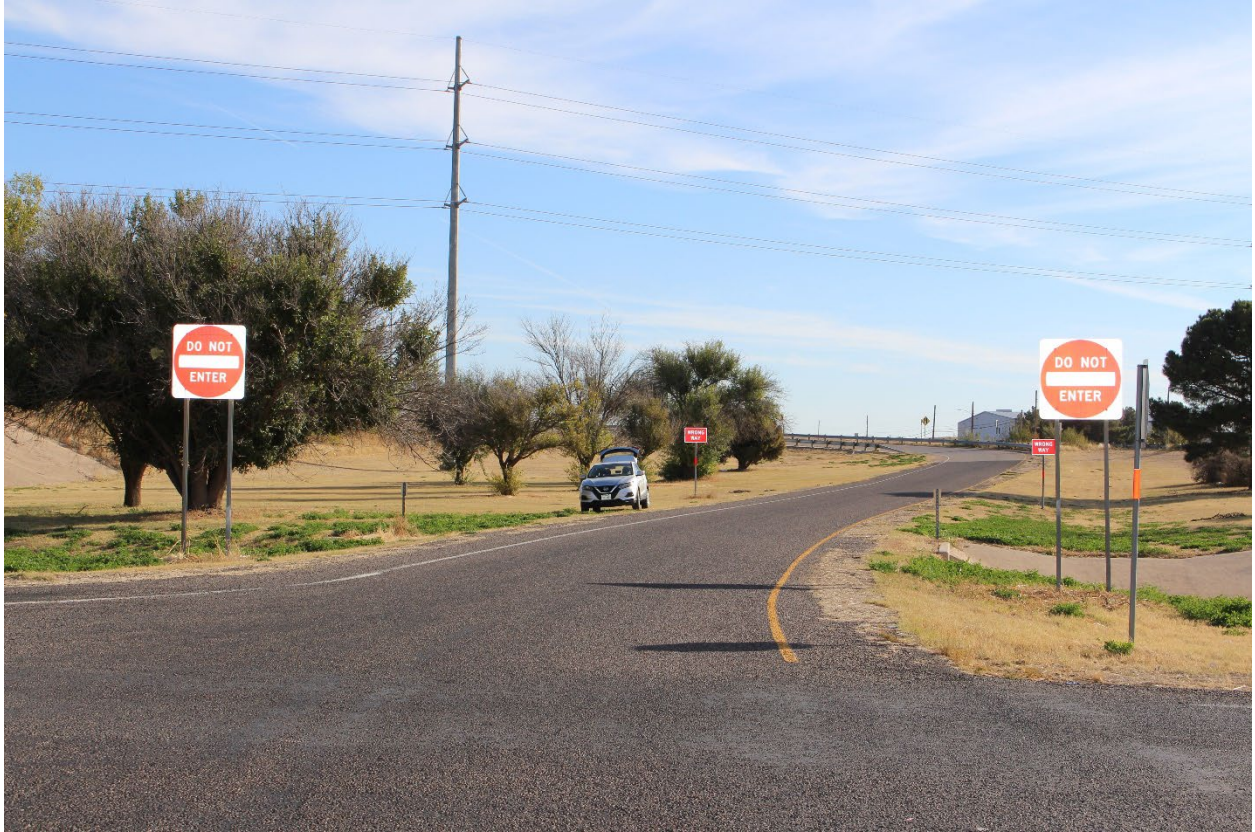
Figure 7. View of DO NOT ENTER signs followed by WRONG WAY signs on the exit ramp where the pickup driver traveled to enter I-20.

The following dimensions were measured for the lateral placement, mounting height, and dimensions of the signage. The DO NOT ENTER signs were located 53-feet east of the Tulane St. intersection. They were posted on both the left and right sides of the exit ramp. The 48-inch square signs were located 14-feet from the road edge and had a 7-foot mounting height from the pavement to the center of the sign.

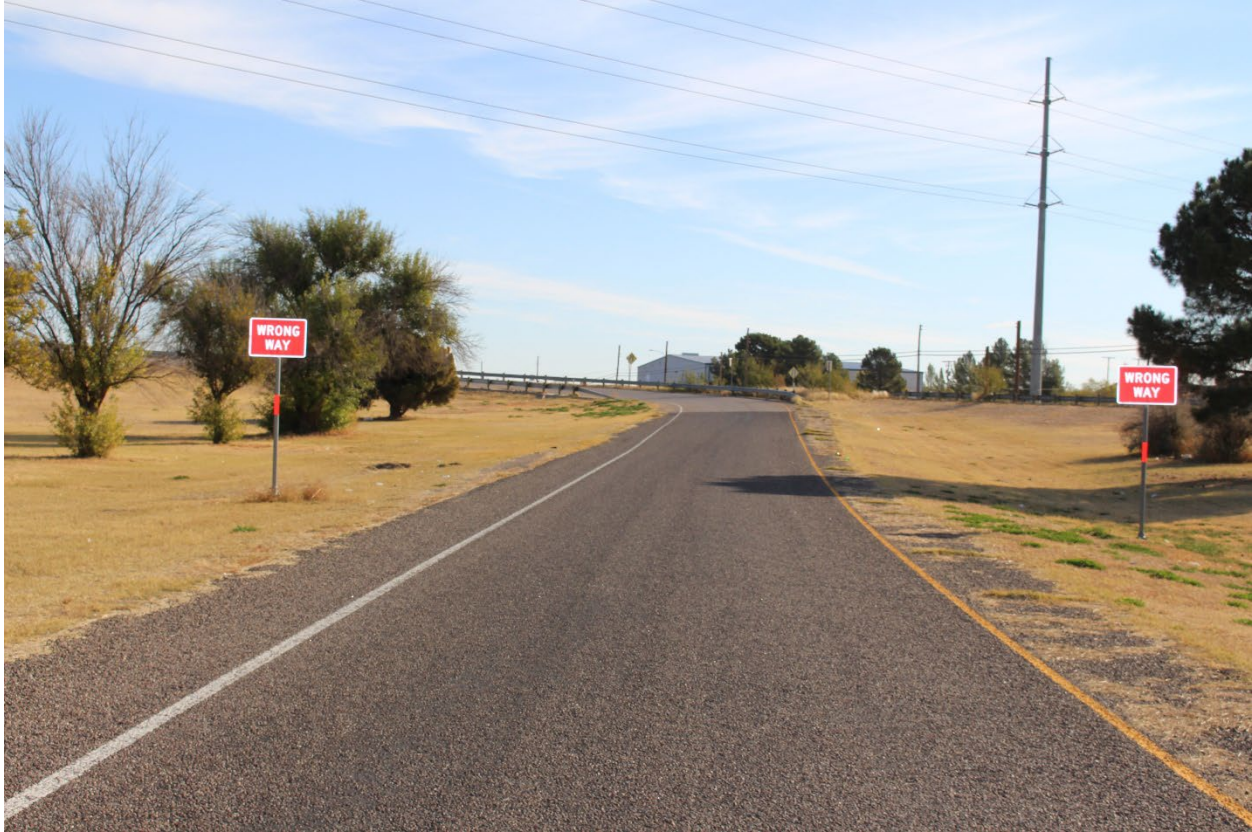
Figure 8. View of WRONG WAY signs posted 150-feet after the DO NOT ENTER signs.

The WRONG WAY signs were located 150-feet past the DO NOT ENTER signs. The 36-inch-wide by 24-inch-tall signs were located 14-feet from the pavement line and mounted 7-feet above the pavement to the center of the sign.⁸ The sign pole had a 12-inch-tall red reflective tape located 57-inches above the pavement. Traveling the wrong way, the yellow shoulder stripe was on the right and the white shoulder stripe was on the left, opposite as it would appear to a driver driving the correct direction.

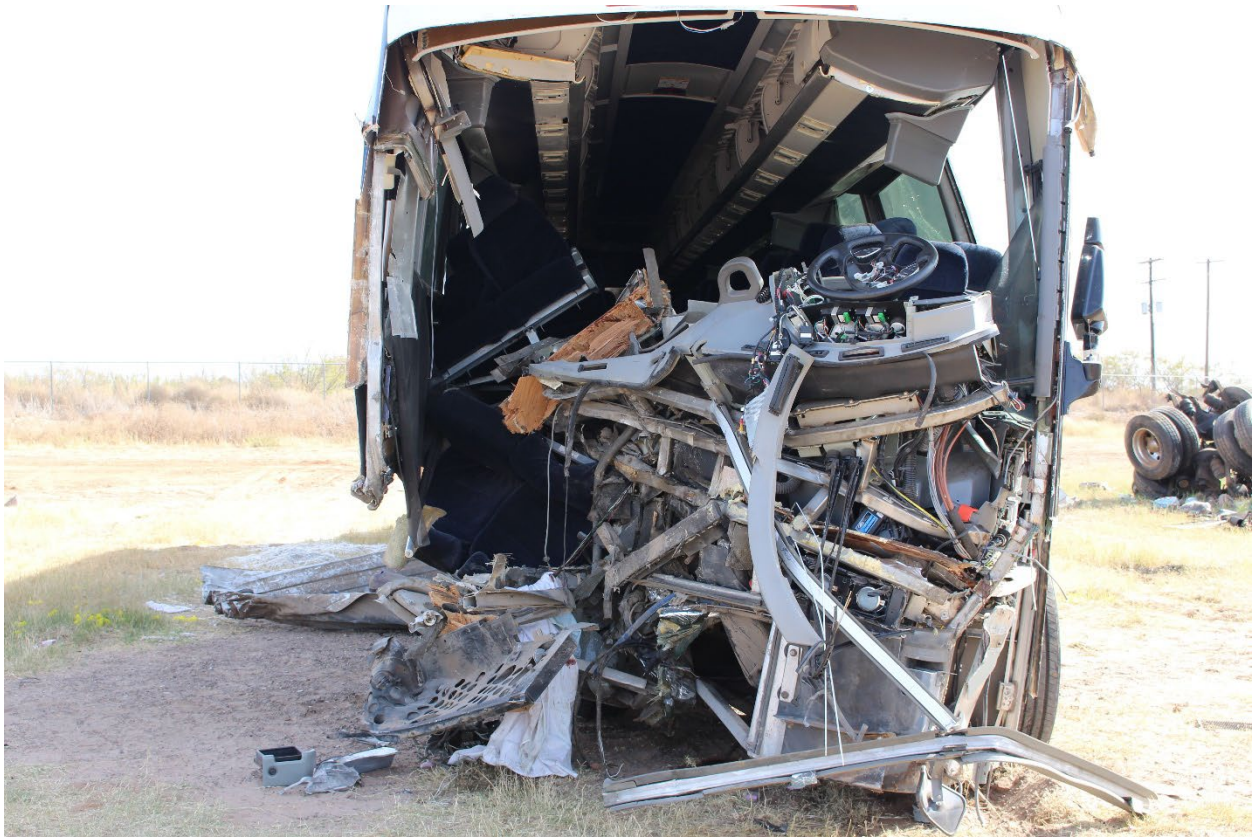
The frame on the right side of the 2005 MCI motorcoach was displaced inward 7-feet over a 42-inch-wide area. The wheelbase on the right-hand side was reduced 42-inches. The right side of the motorcoach had contact and intrusion damage along a 26-foot-long area to the rear of the baggage compartment. See Figure 10 for a view of the motorcoach damage. Three of the cable barrier posts were bent over at the base to the ground from the impact. None of the three steel wire ropes were fractured.

Figure 10. View of frontal damage to the 2005 MCI motorcoach.

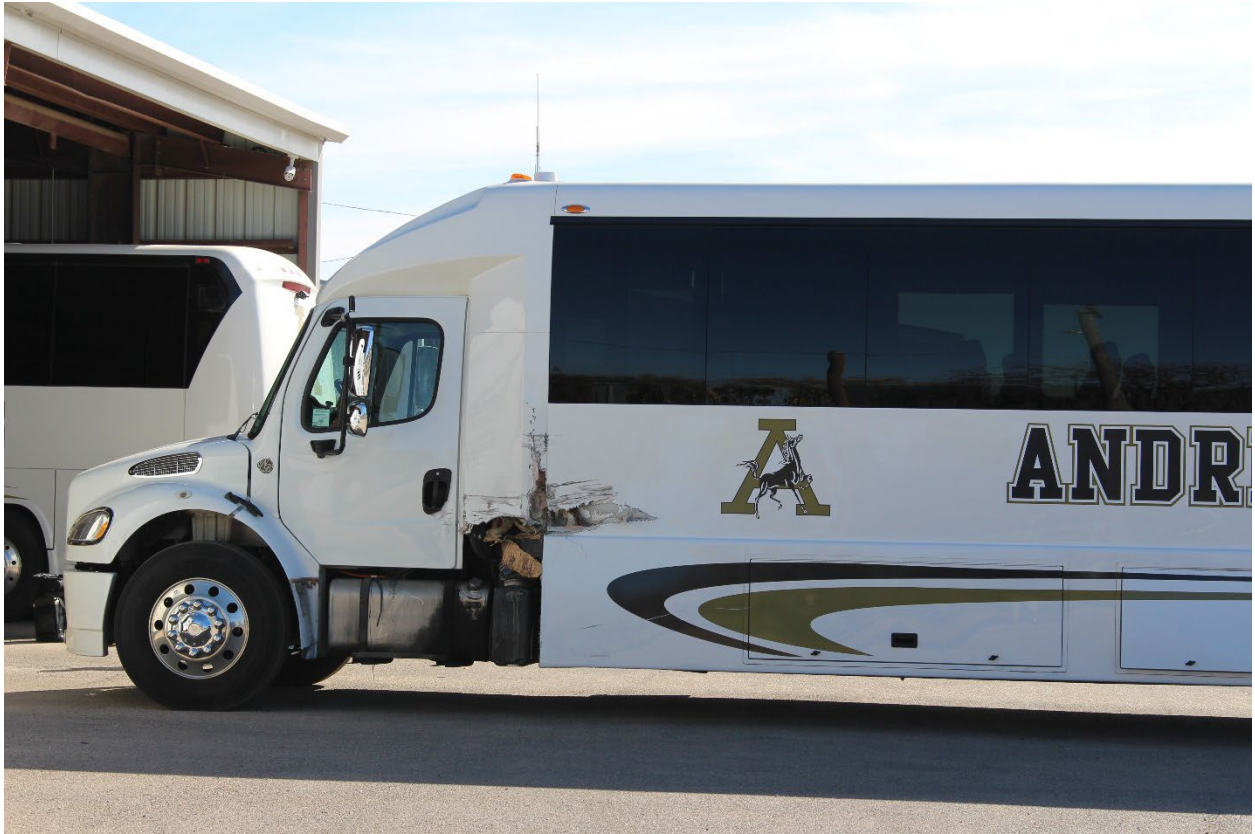
The Ford F-350 pickup truck was destroyed by impact and the postcrash fire. The 2018 Freightliner bus had sideswipe damage beginning at the front of the bus body and running the length of the bus. See figure 11 and 12 for view of sideswipe damage. See Figure 13 for a view of pickup truck damage.

Figure 11. View of damage to left forward edge of the bus body.

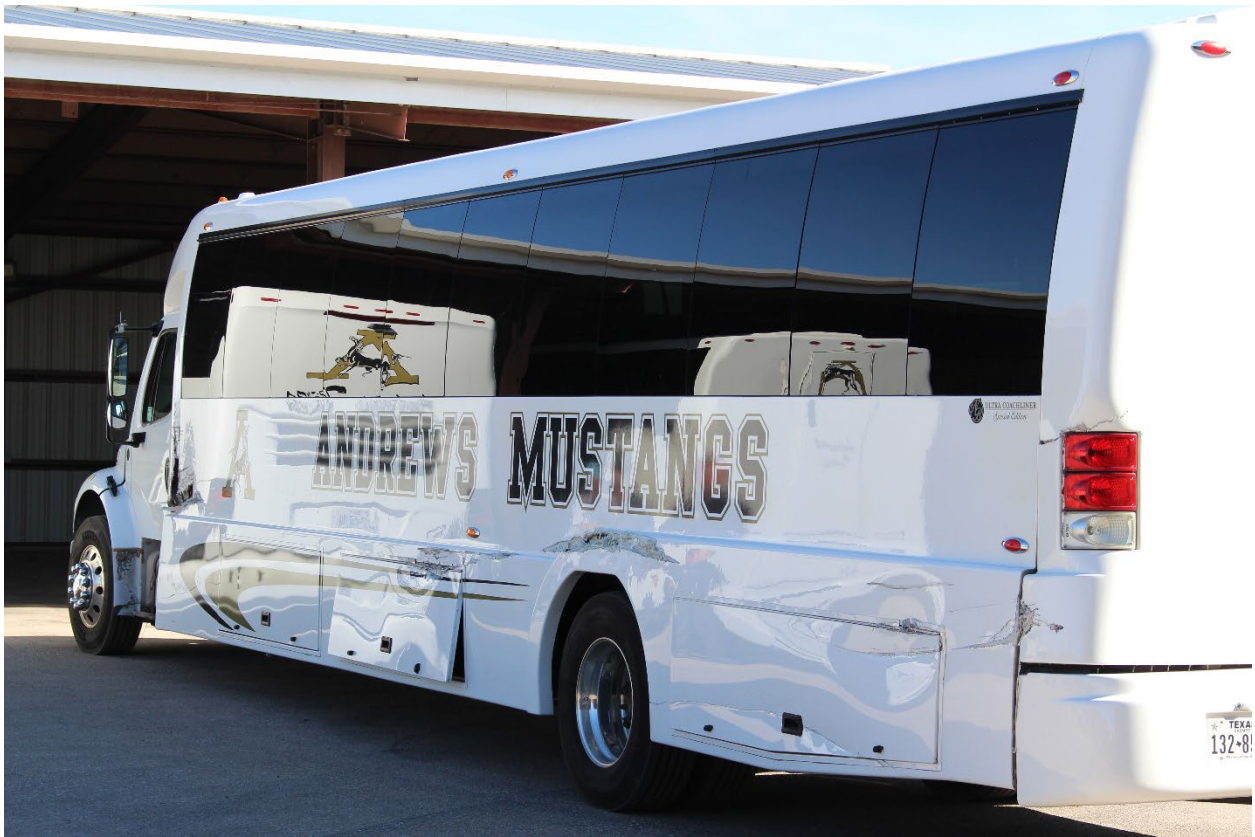
Figure 12. View of sideswiped damage along the left side of the 2018 Freightliner bus body.

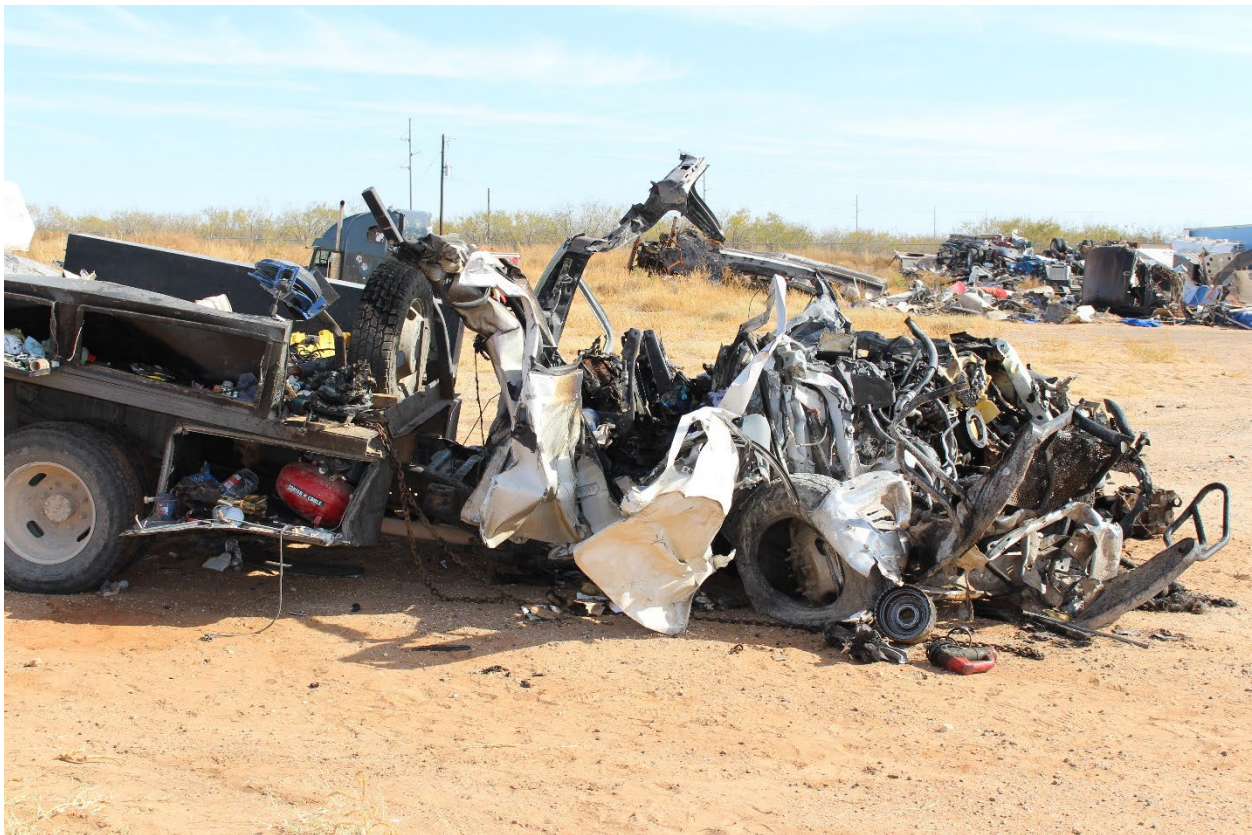
Figure 13. View of damage to the Ford F-350 pickup truck.

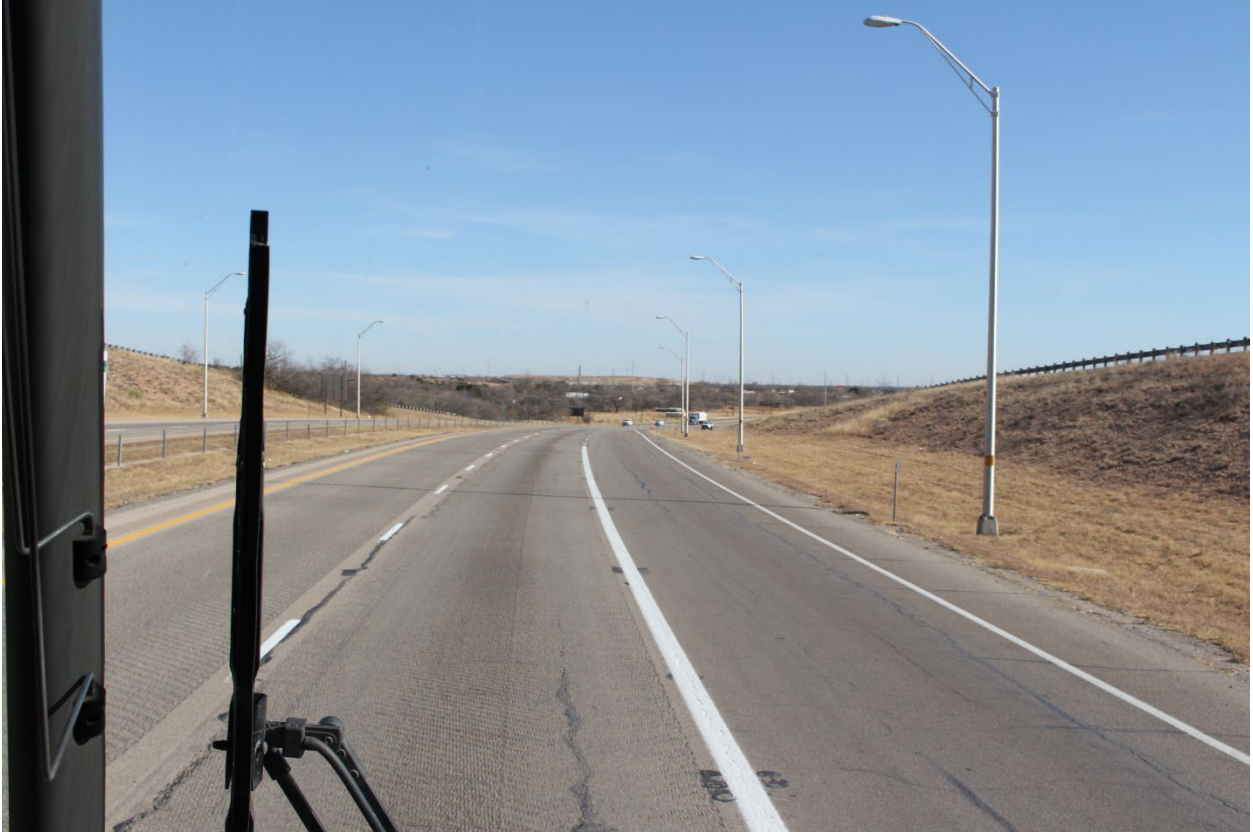
Figure 14. Test motorcoach driver's view of Ford pickup in right-hand lane at the bottom of the hill in the right center of the photograph.

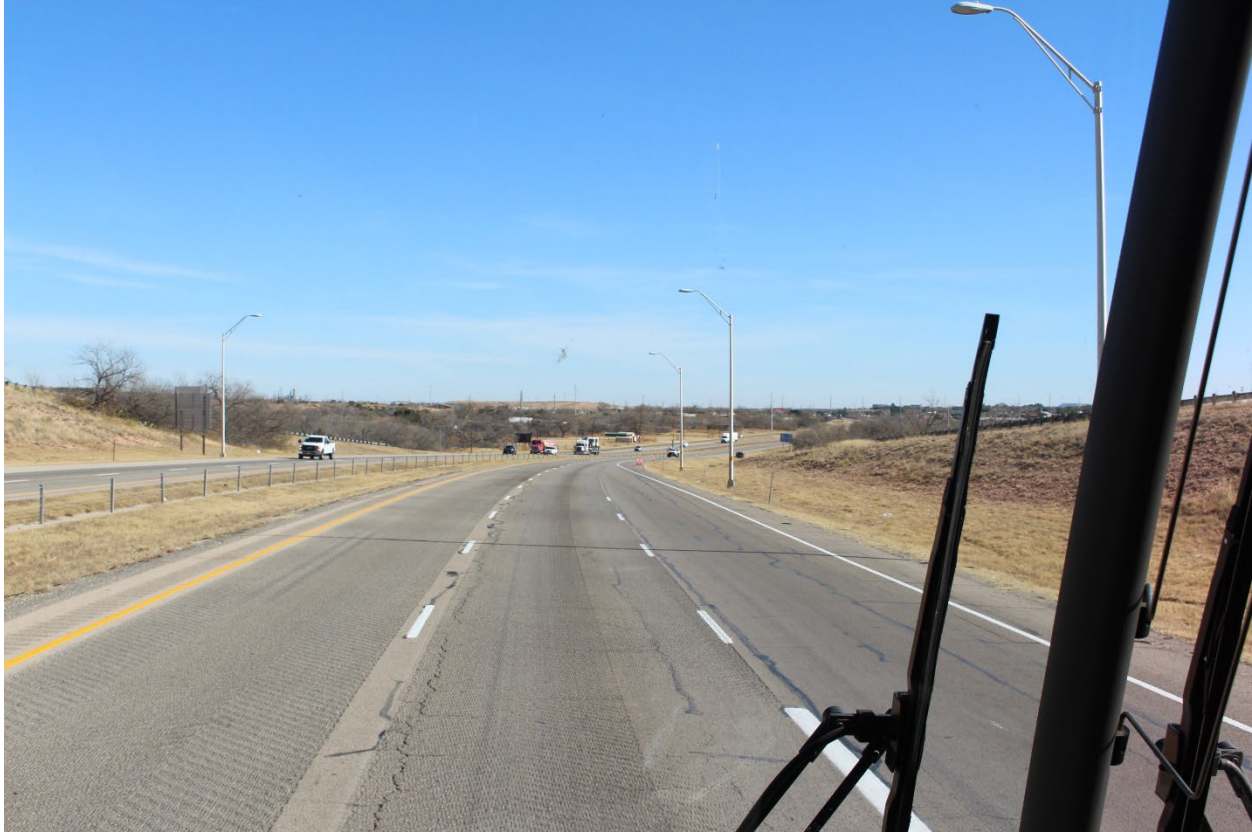
Figure 15. Test motorcoach driver’s view of Ford pickup truck located 1,055 feet ahead.
