NATIONAL TRANSPORTATION SAFETY BOARD

FACTUAL REPORT OF INVESTIGATION

HWY22FH001

Location: Big Spring, Texas
Date: November 19, 2021
Time: 4:01 p.m. CST
Vehicle 1: 2016 Ford F-350 Pick Up Truck (truck). Private Owner
Vehicle 2: 2005 MCI Motorcoach (motorcoach). Andrews Independent School District
Vehicle 3: 2018 Freightliner Bus (bus). Andrews Independent School District

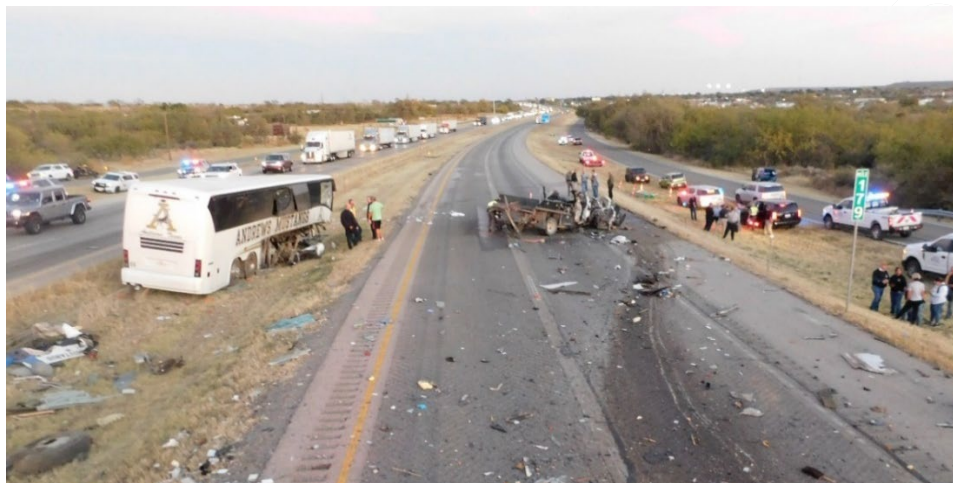
Figure 1. View of impact area near mile marker 179 with motorcoach at final position in the median and the pickup in the right-hand eastbound traffic lane (Courtesy of the TXDPS).

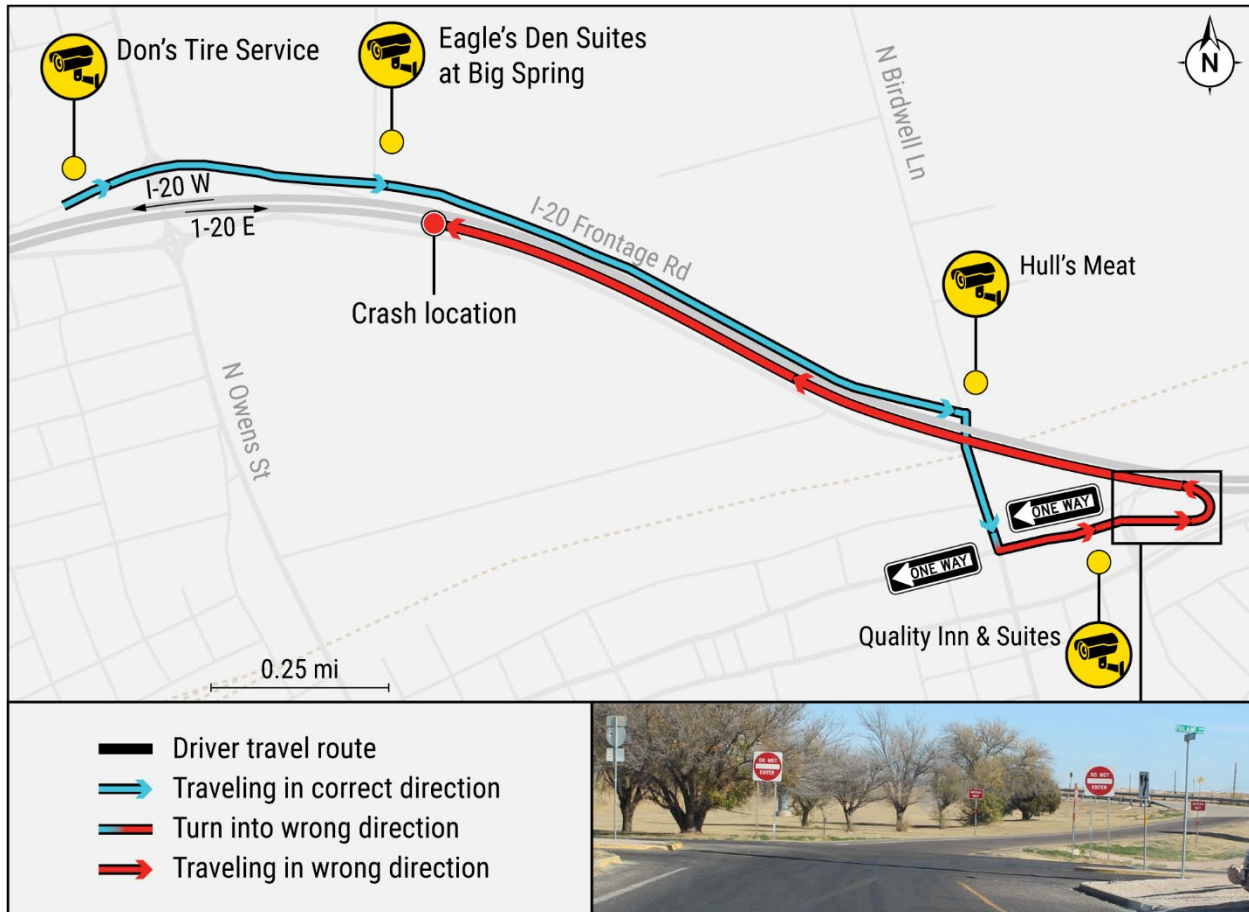
The TXDPS obtained video surveillance footage of the truck driver as he traveled the north frontage road adjacent to westbound I-20 in Big Spring (figure 2).⁸ Surveillance video from Don's Tire Service showed the truck driver traveling east on the frontage road and making a left into Don's. The truck driver stopped there, exited his vehicle, and separately approached and spoke with the drivers of three other vehicles. Afterwards, he returned to his vehicle and drove away. Surveillance video from Eagles Den Suites, east of Don's Tire Service and on the same frontage road, showed the truck driver stopping and separately speaking with two other individuals. Surveillance video from Hull's Meat Company at the intersection of the same I-20 frontage road and Birdwell Lane showed the truck driver parking, speaking with someone in the parking lot of the meat market, then heading to the Big Spring Livestock Auction adjacent to the meat market before heading back to his vehicle. Finally, the truck driver appeared to speak very briefly with another driver while they are both in their vehicles.

Figure 2. Path of truck driver prior to the crash, based on surveillance video obtain by TXDPS.

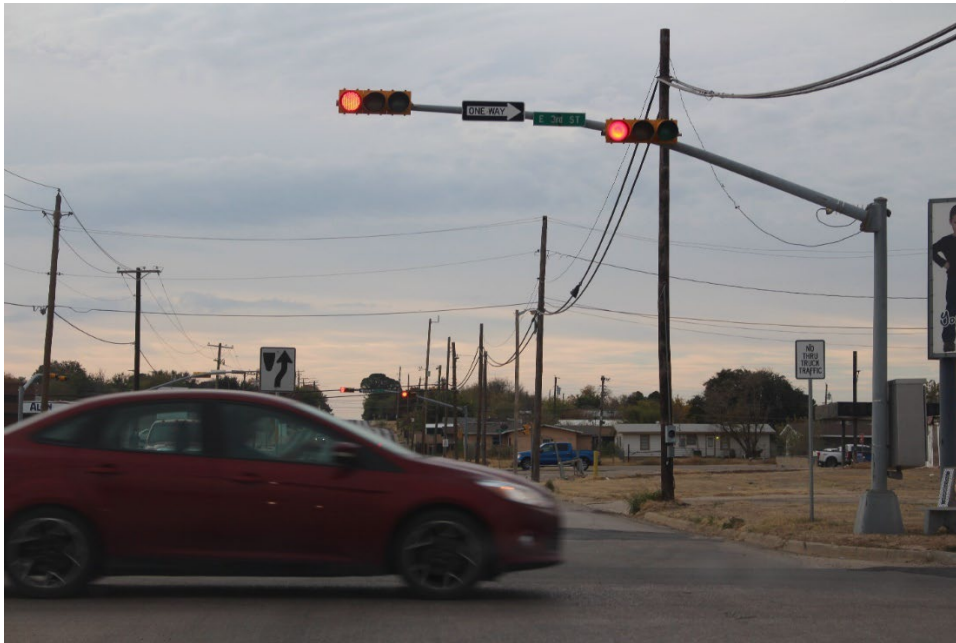
The security video from Hull Meat Company on Birdwell Lane showed the pickup truck driver departed the business and traveled to 3rd St. where he turned left on the one-way street. TXDOT indicated 3rd Street had been a one-way street for at least the preceding 34 years. See

The one-way sign had a mounting height of 13.5feet and was 36inches by 12inches in dimension. The wrong way sign had a mounting height of 7feet and was 36-inches by 24-inches. There was an additional One-Way sign posted on the right-hand side of 3rd St., approximately 155-feet east of the Birdwell intersection that preceded the WRONG WAY sign. After the pickup driver turned left onto 3rd St. it was approximately 0.25 mile to where 3rd St transitioned to the exit ramp for the I-20 exit 179. Figures 5 and 6 show the signage on the exit ramp to deter wrong-way entry.

Figure 3. View of ONE-WAY sign on 3rd Street where the truck driver turned left traveling east on the westbound one-way road.

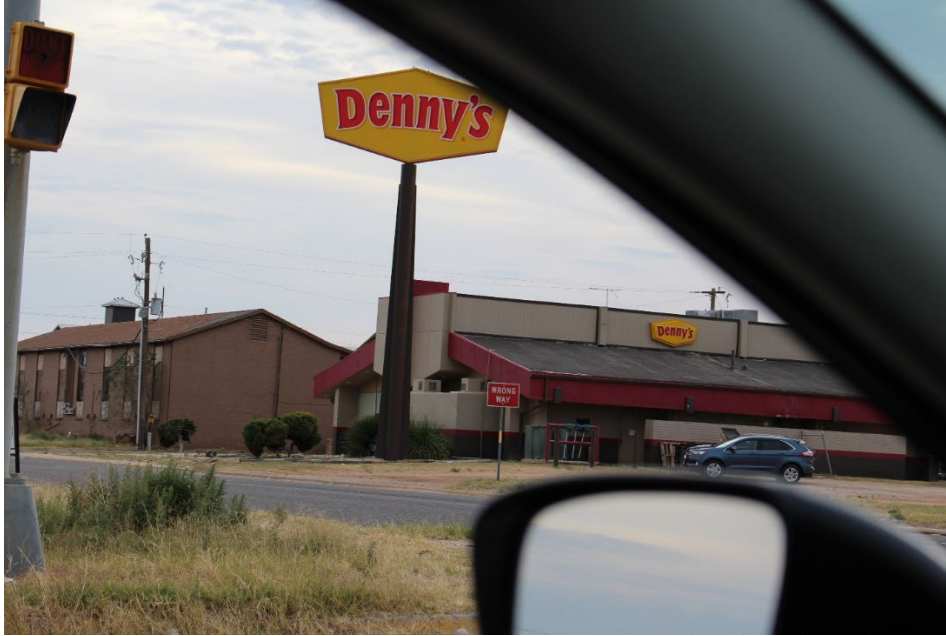
Figure 4. View of WRONG-WAY sign on 3rd St. viewed from Birdwell Lane.

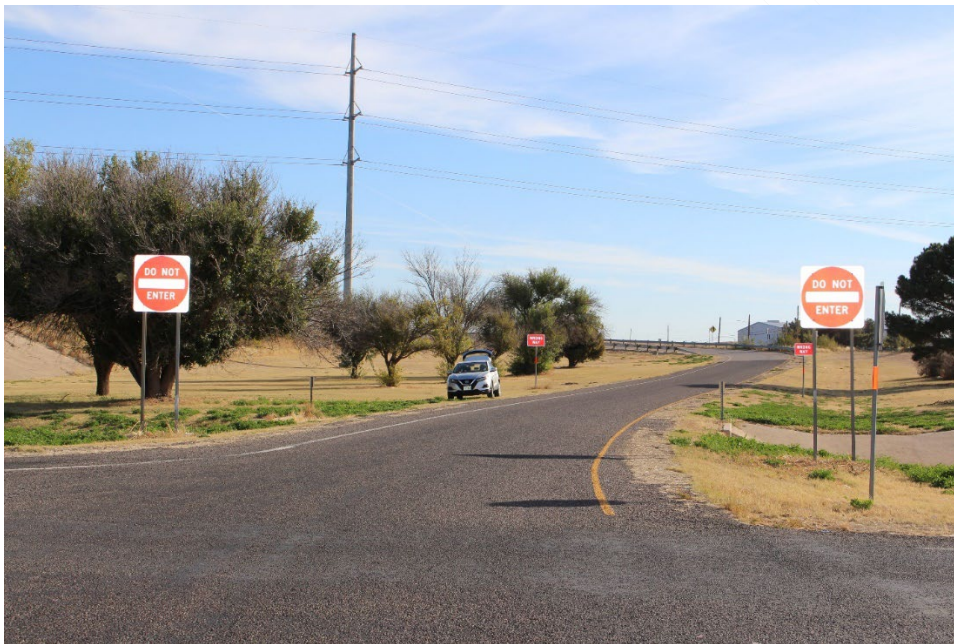
Figure 5. View of DO NOT ENTER signs followed by WRONG WAY signs on the exit ramp where the truck driver traveled to enter I-20.

The following dimensions were measured for the lateral placement, mounting height, and dimensions of the signage. The DO NOT ENTER signs were located 53-feet east of the Tulane St. intersection. They were posted on both the left and right sides of the exit ramp. The 48-inch square signs were located 14-feet from the road edge and had a 9-foot mounting height from the pavement to the center of the sign.

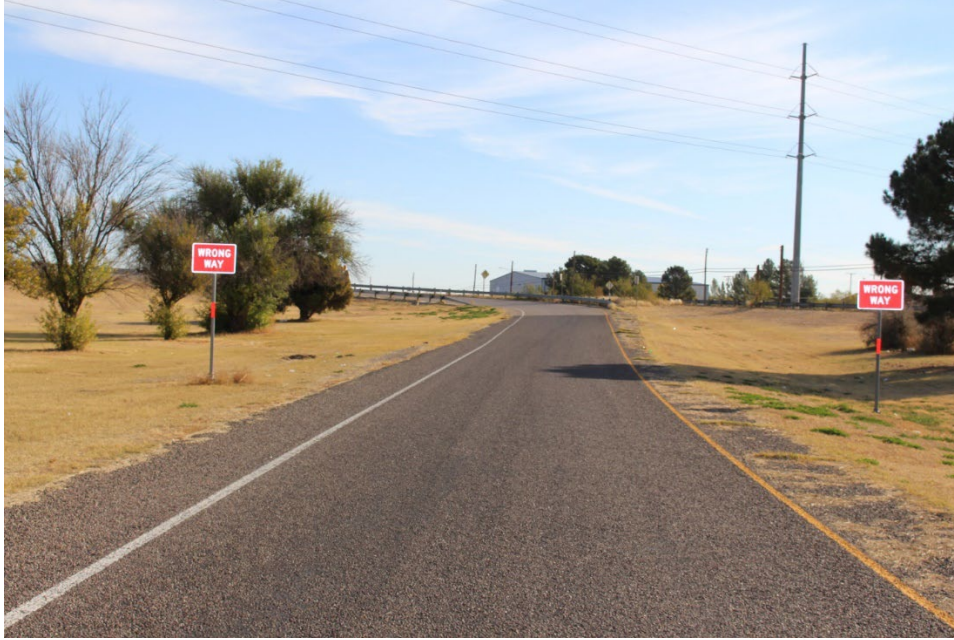
Figure 6. View of WRONG WAY signs posted 150 feet after the DO NOT ENTER signs.

The WRONG WAY signs were located 150-feet past the DO NOT ENTER signs. The 36-inch-wide by 24-inch-tall signs were located 14-feet from the pavement line and mounted 8-feet above the pavement to the center of the sign.²² Also, the sign pole had a 12-inch-tall red reflective tape located 57-inches above the pavement. Also, traveling the wrong way the yellow shoulder stripe was on the right and the white shoulder stripe was on the left or just the opposite as it would appear driving the correct direction.

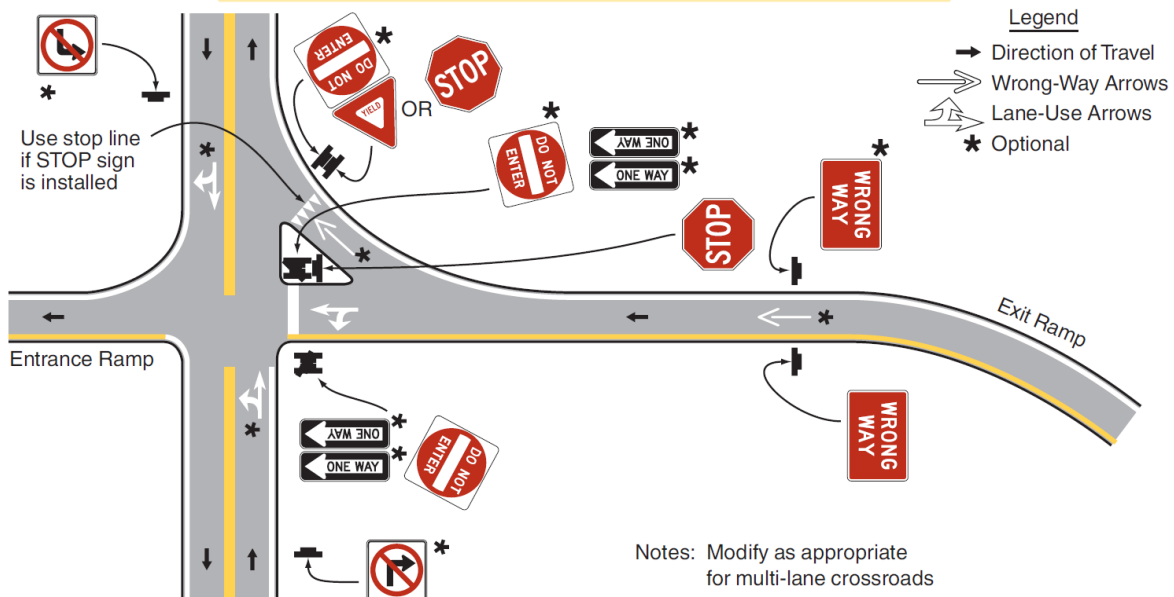
Figure 7 depicts Figure 2B-18 from the Texas Manual on Uniform Traffic Control Devices (TMUTCD), which shows an example application of signage at an exit ramp to deter wrong-way entry.

Figure 7. View of TXMUTCD figure 2B-18 which provides example applications on signing exit ramp termination to deter wrong-way entry.

Only one DO NOT ENTER sign and one WRONG WAY sign are required to be installed on the right-hand side of the road. The additional DO NOT ENTER sign and WRONG WAY sign that were installed on the left-hand side of the road were optional features that TXDOT chose to install.²³

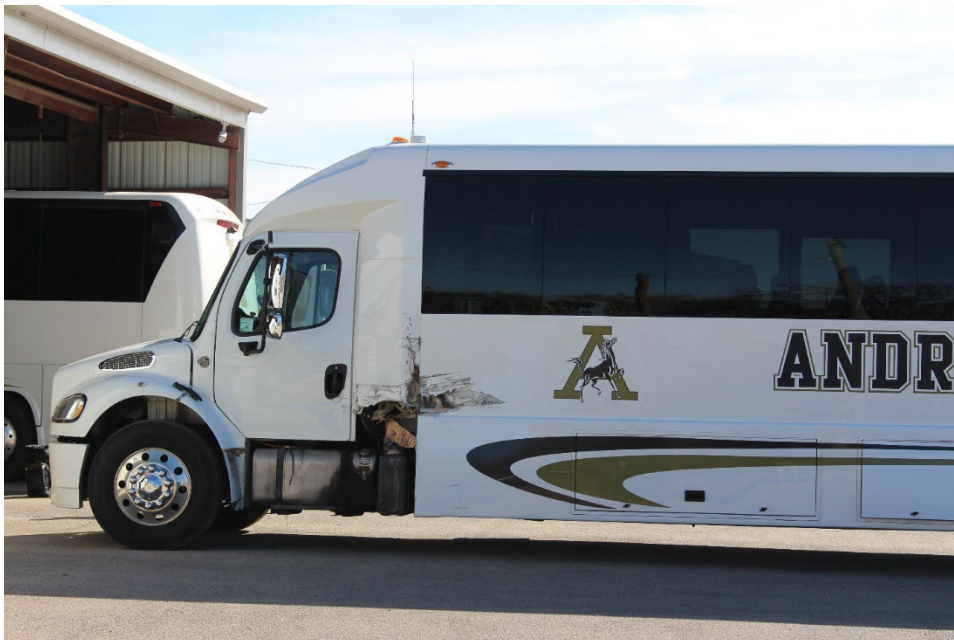
The truck was destroyed by impact and the postcrash fire. The Freightliner bus had sideswipe damage beginning at the front of the bus body and running the length of the bus. See figure 9 and 10 for view of sideswipe damage. See figure 11 for a view of the damage to the truck.

Figure 9. View of damage to left forward edge of the bus body.

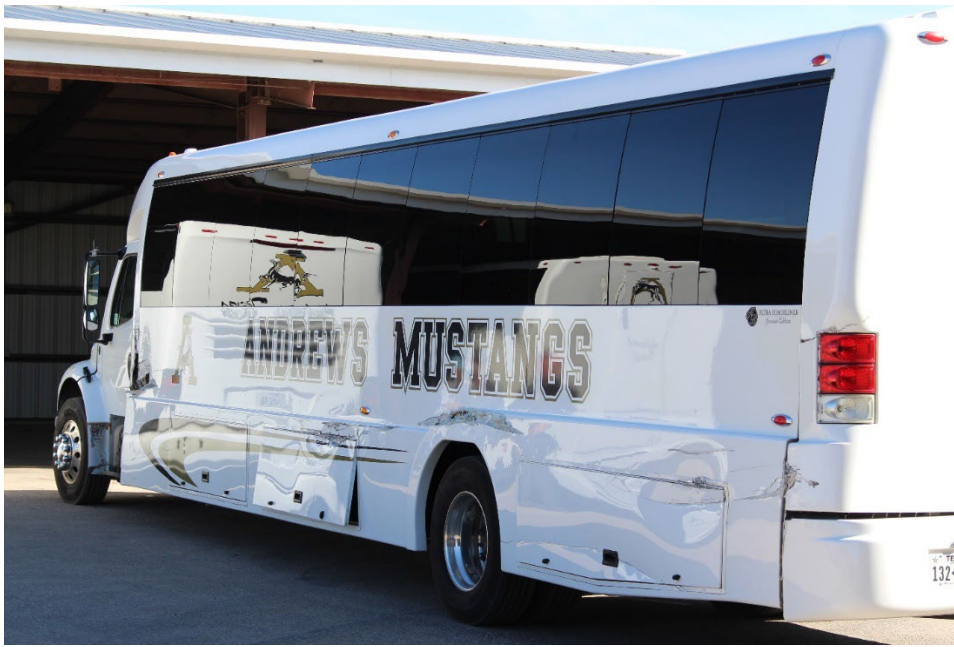
Figure 10. View of sideswiped damage along the left side of the bus body.

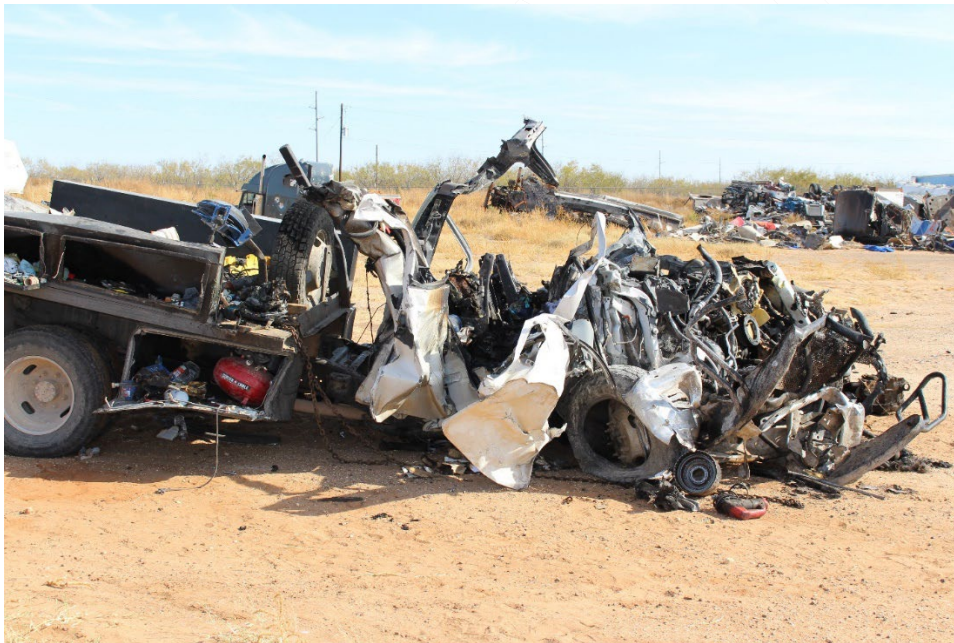
Figure 11. View of damage to the truck.

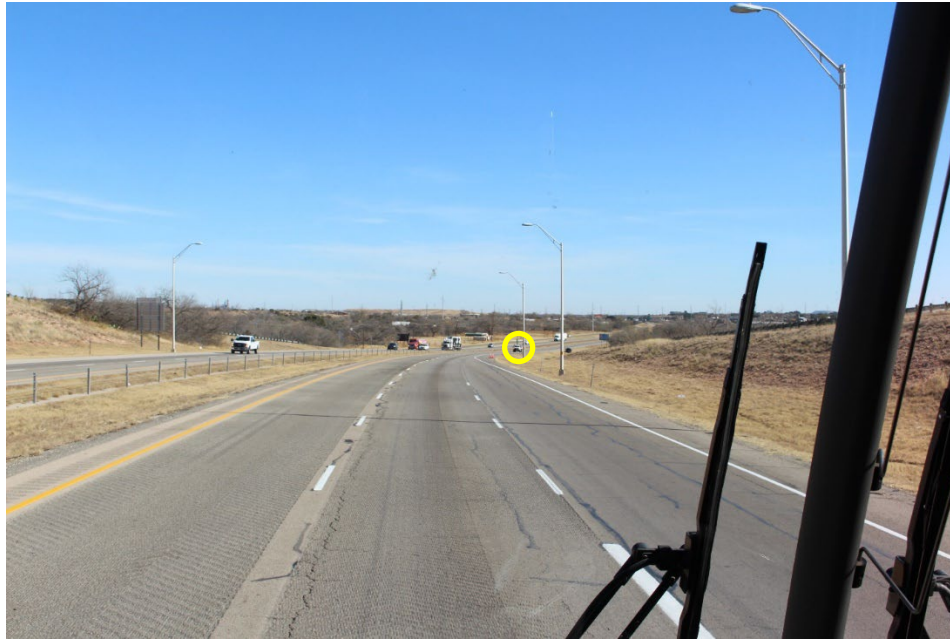
On December 22, 2021, I-20 was closed by TXDOT and TXDPS to conduct sight distance testing with an exemplar motorcoach and an exemplar truck (figure 12). The truck was placed in the eastbound right-hand lane of I-20 facing westbound, approximately 400-feet east of where the impact occurred. The motorcoach was driven east on I-20 until the driver could discern the truck. According to the driver of the exemplar motorcoach, the exemplar truck was clearly visible when he was 1,055-feet from the truck. At these positions, the motorcoach was

655-feet from the point of impact and the truck was 400-feet from the point of impact. The sight distance measured met the minimum requirements established in Table 3-2 of the American Association of State Highway and Transportation Officials (AASHTO) *A Policy on Geometric Design of Highways and Streets*, which indicates that a stopping sight distance of 866-feet should be provided for 75 mph speeds on a three-percent downgrade in new construction projects.²⁴

Figure 12. Exemplar bus driver's view of an exemplar truck located 1,055-feet ahead.

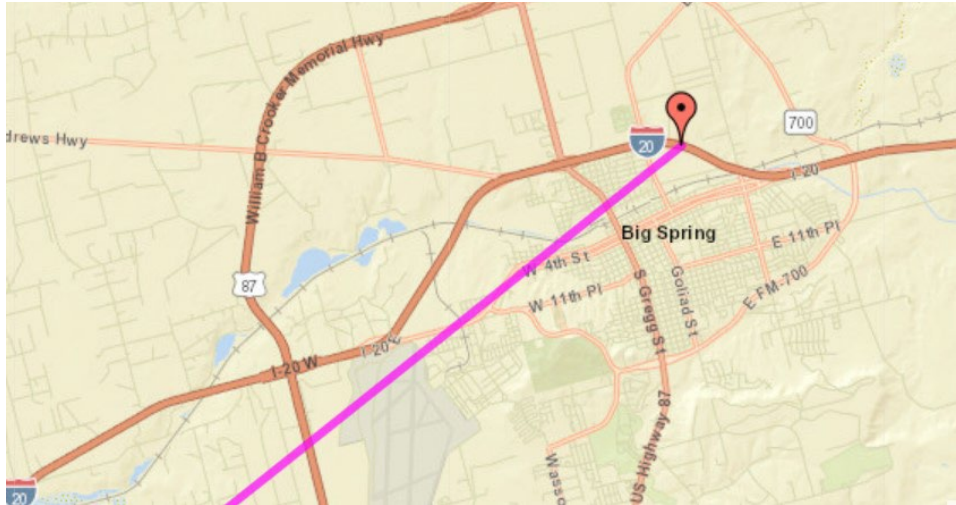
an elevation of 17 degrees (see figure 13). The sun would have been to the left of the truck driver at the time of the crash.

Figure 13. Direction of the sun at the time of the crash.
