1990 85' Russell Portier Custom Commercial Long Line Fishing Vessel
"Blue Dragon"

Report of Marine Survey

April 26, 2022

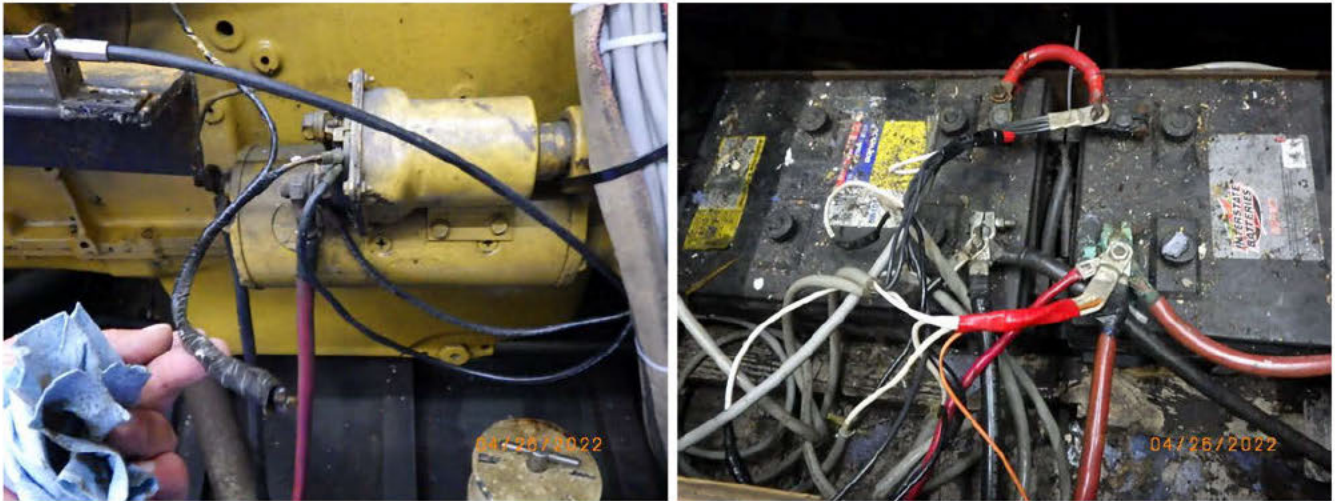
FINDING A-2 DC ELECTRICAL/WIRING COMMENTS (ABYC E-11)

Unterminated wiring noted in the forward engine room at the bulkhead and below the helm (currently being upgraded).

Trace and properly secure & terminate all wiring and electrical components, as necessary.

Replace electrical tape and wire nut connections with Marine Grade insulated butt connections (wire nuts are approved for solid household type wiring only).

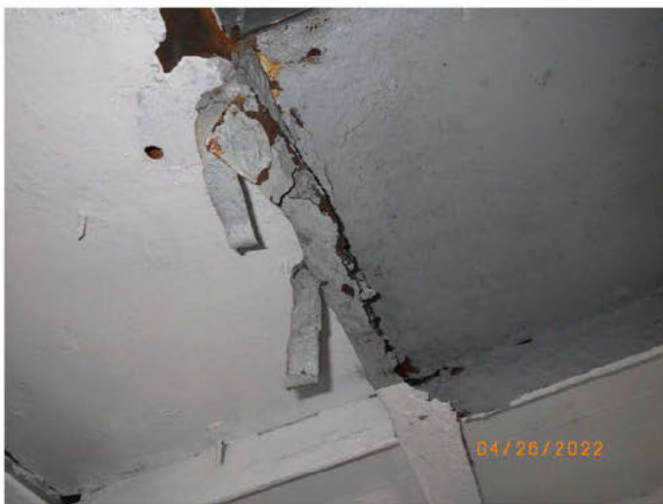
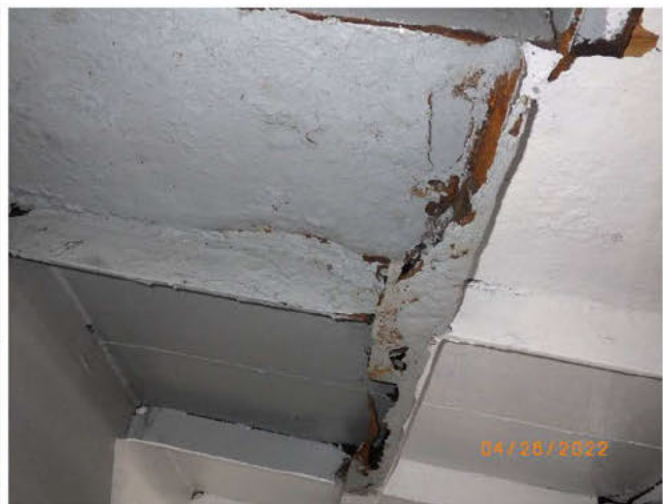
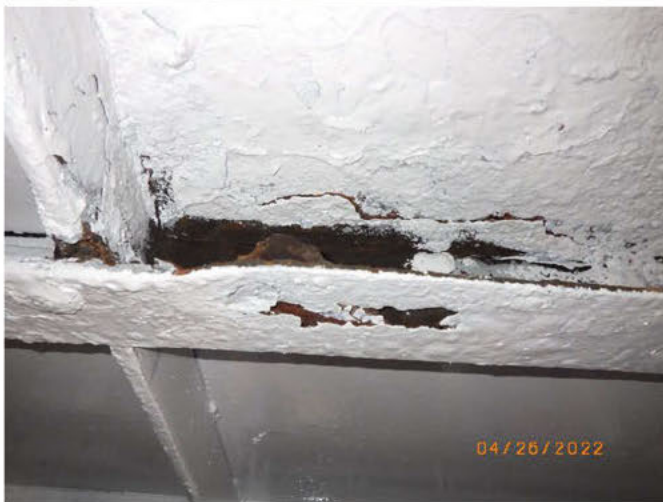
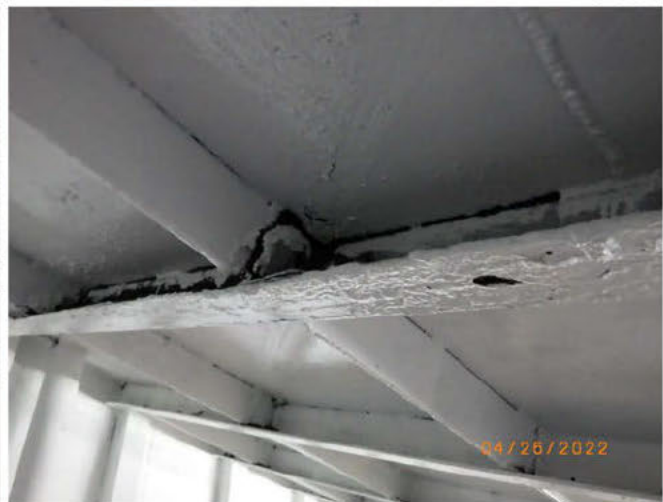
The deck supports in the forepeak below the foredeck hatch are wasted.

The steel deck supports in the forepeak below the foredeck hatch are wasted due to corrosion.

Crop out deteriorated/wasted angle and flat bar and replace in like-kind to original construction. Properly seal foredeck hatch to reduce water entry.

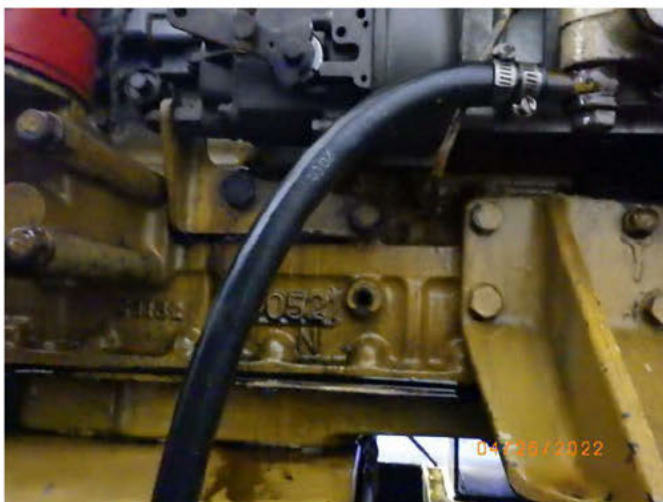
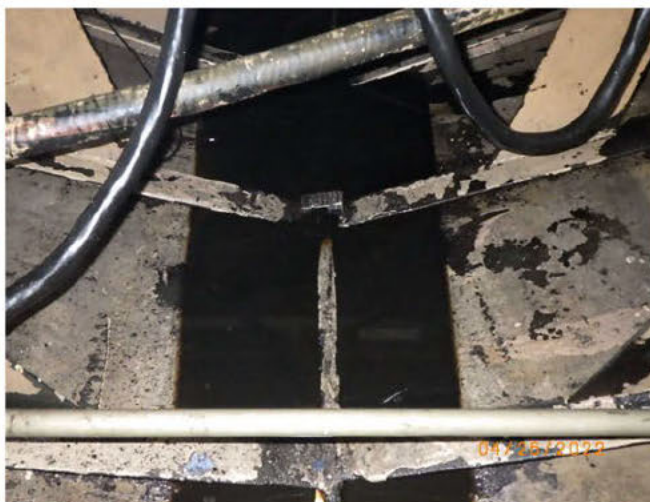
FINDING B-3 GENERATOR MODEL

The starboard engine has a substantial oil leak.

Investigate further, and repair as necessary.

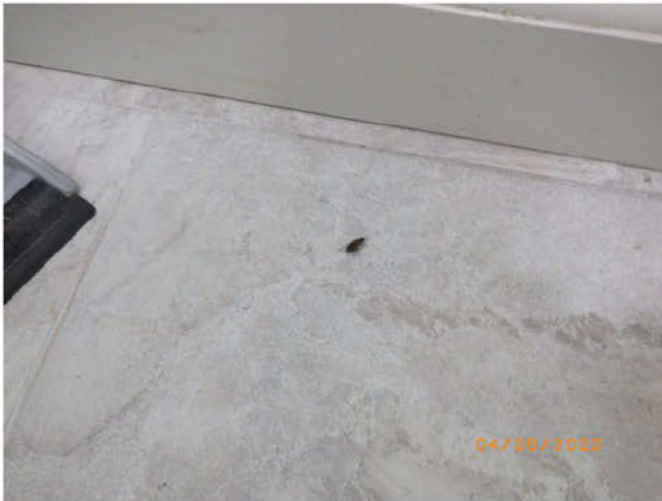
Evidence of cockroaches.

Investigate further, and exterminate as necessary.
