National Transportation Safety Board

Safety Issue #2

- Evaluation of In-Line Inspection Information

Significant Events Timeline for Olympic Pipeline In-Line Inspections

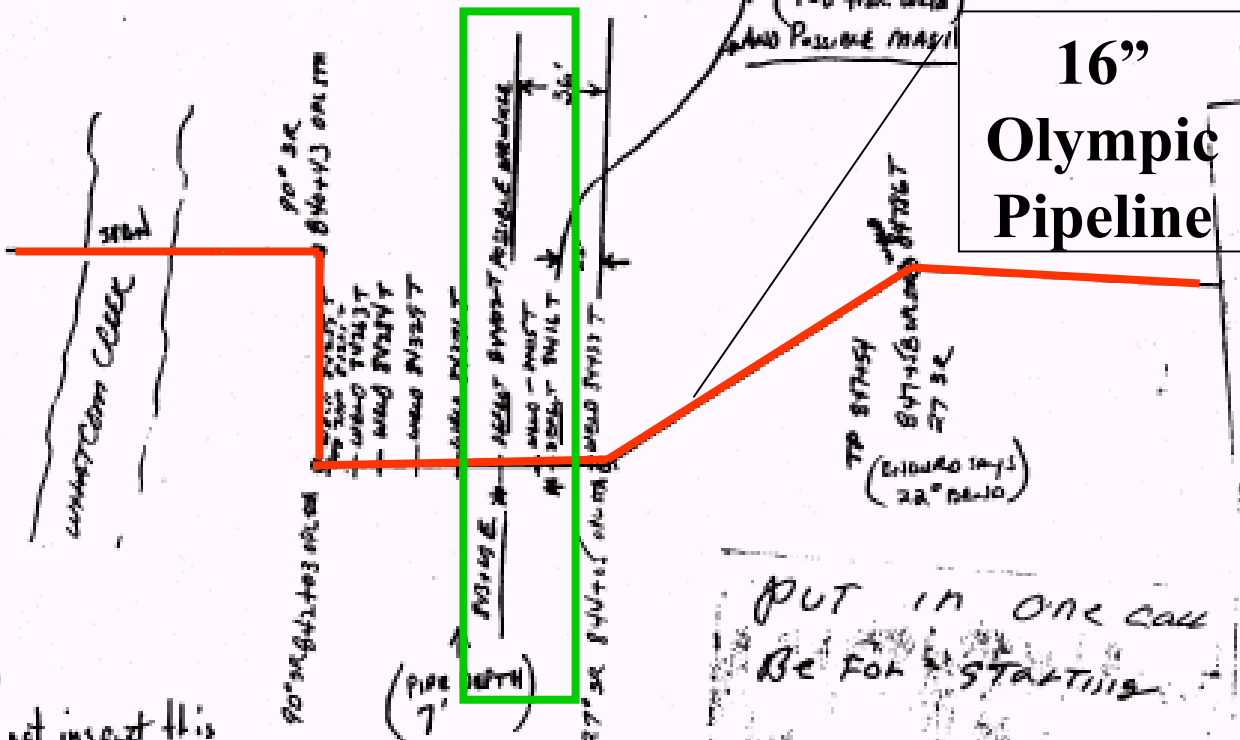
Drawing # FE-1

Defect % 23

Position 1 O'clock

491
Did not inspect this location.
Tubercle possible mill/mach 23% (min)
Endure 45 sharp (less than repairable)

23% wall loss defect

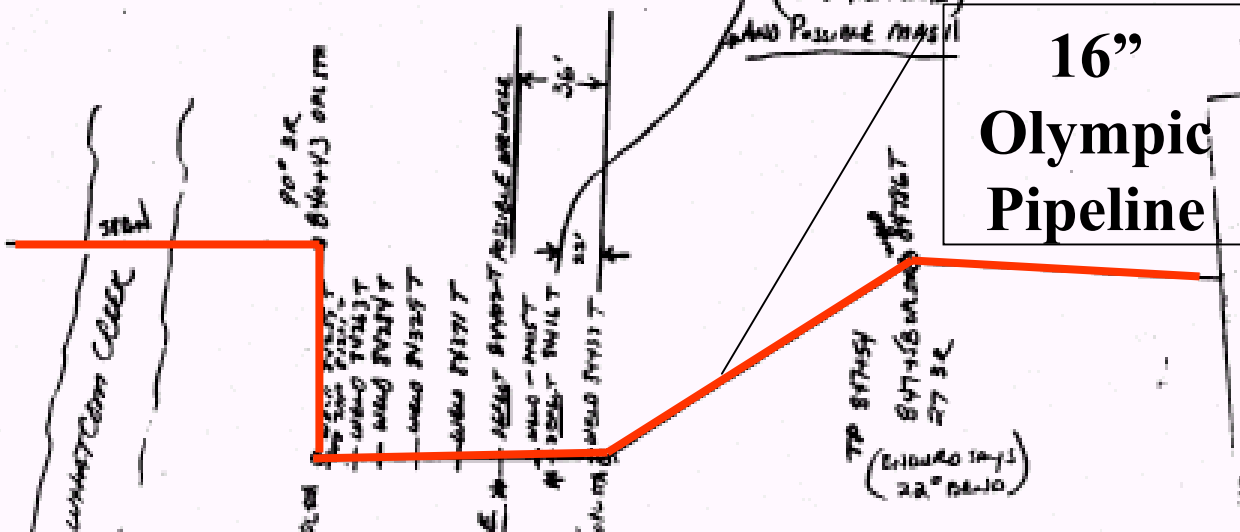
Drawing # FE-1

197
Did not inspect this location.
Tubercle possible mill/mach 23% (min)
Endure 45 sharp (less than repairable)
RIK.
(Differences to notes)
K10marplg/DIG2

- Did not inspect this location;
- Tuboscope [magnetic flux tool company] possible mill/mechanical 23% (**min risk**)
- Enduro [caliper tool company] .45 sharp (**less than repairable**)
- Difficult area to access

In-line pipeline inspection data along with excavation activity that occurred in 1993 and 1994 were sufficient to justify excavation and examination of the pipeline in the area of reported anomalies.
