# Bellingham, Washington June 10, 1999

# **Pipeline Rupture and Subsequent Fire In Bellingham, Washington**

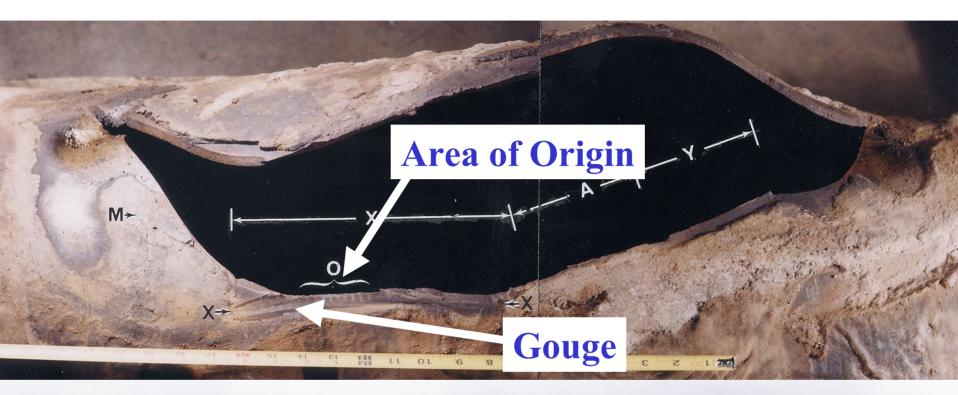
#### **External Gouges on Ruptured Pipeline**

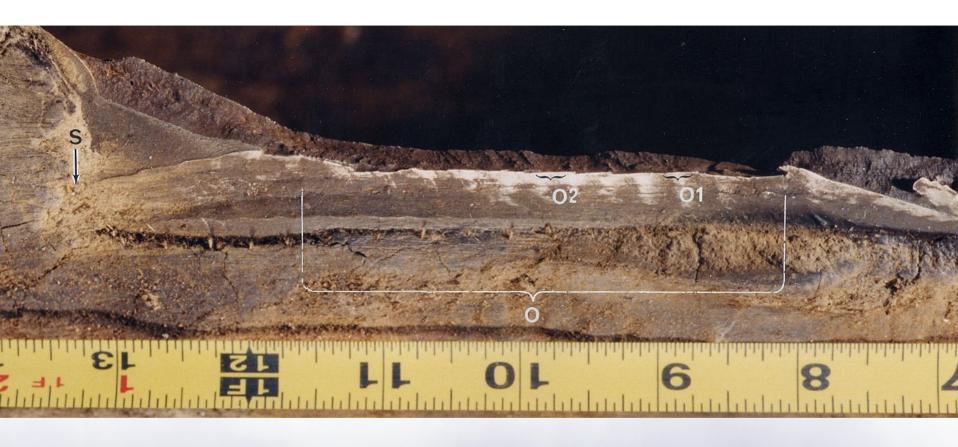
#### **Close-up View of Gouge at Origin**
