National Transportation Safety Board

**IMCO's excavations in the
vicinity of Olympic's pipeline.**

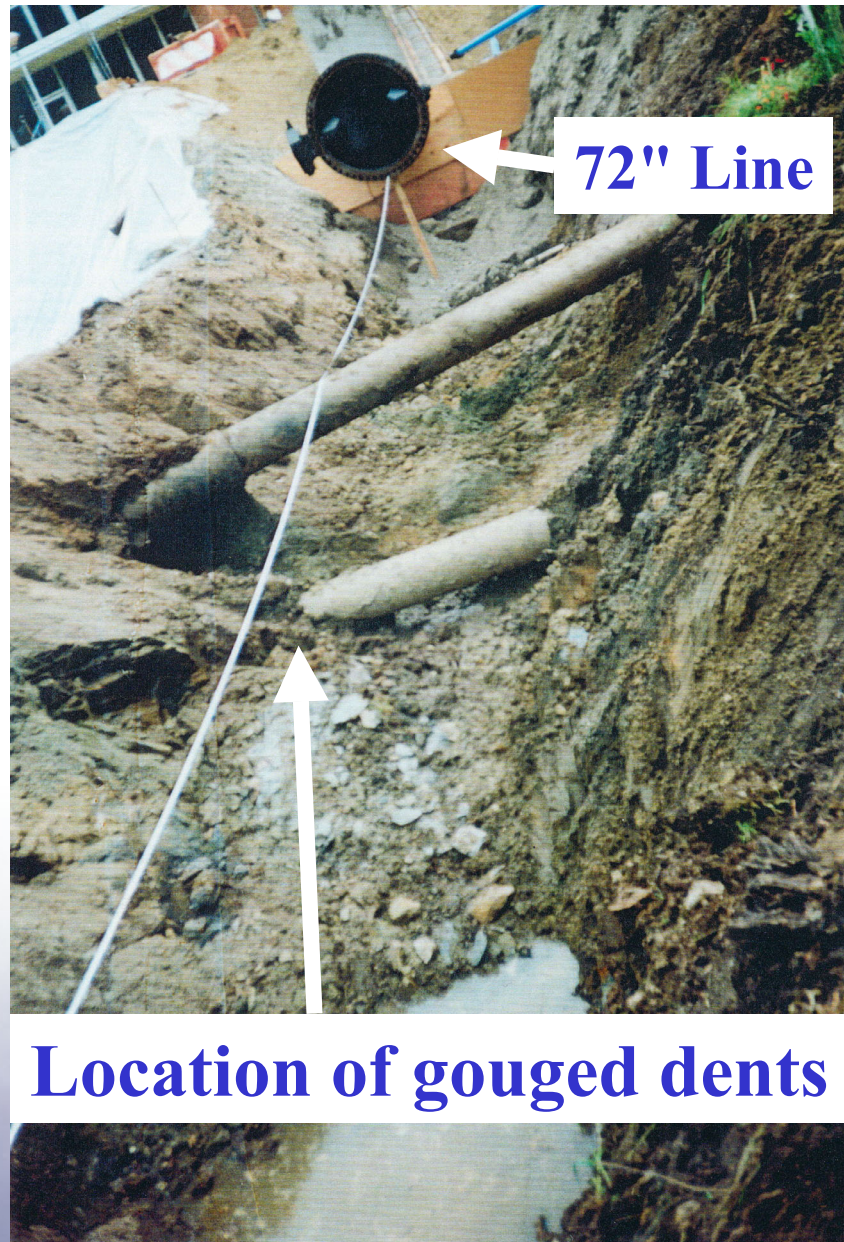
**Olympic
Pipeline
Exposed
During
Water Line
Installation**

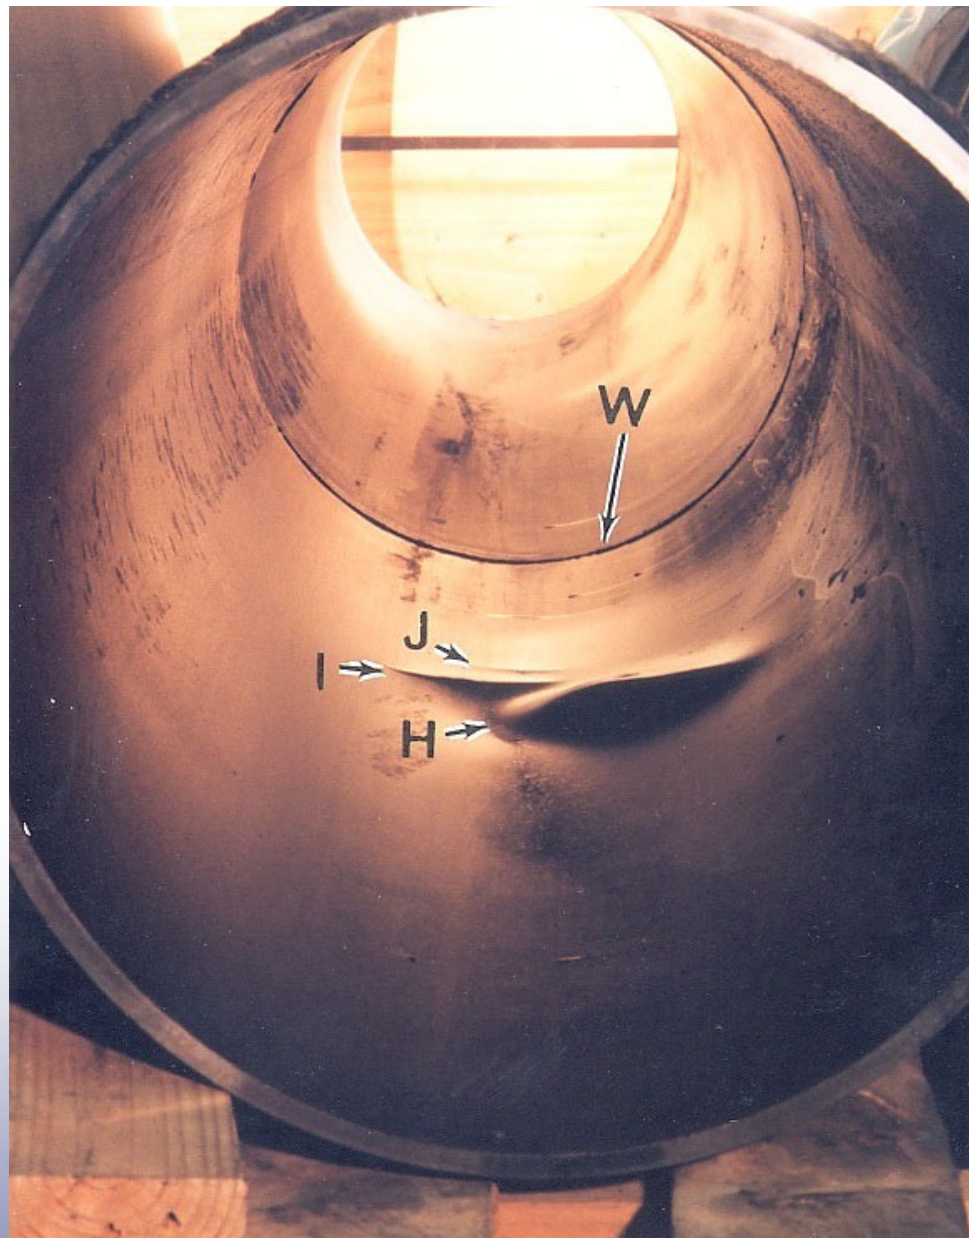
**Gouged Dents
Found Near
Water Line
Crossing**

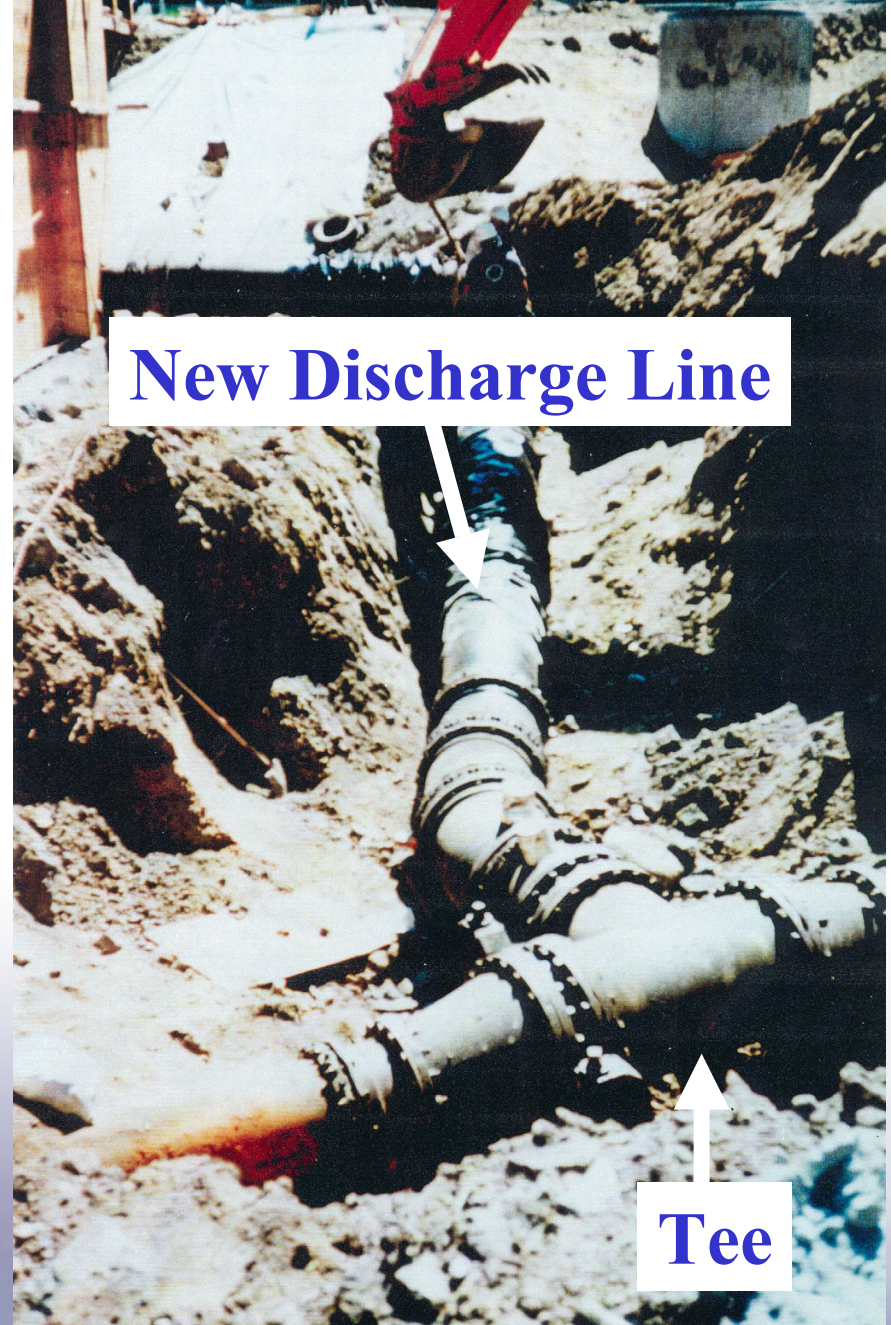
Newly-Installed

Discharge

Water Line

New Discharge Line

Tee

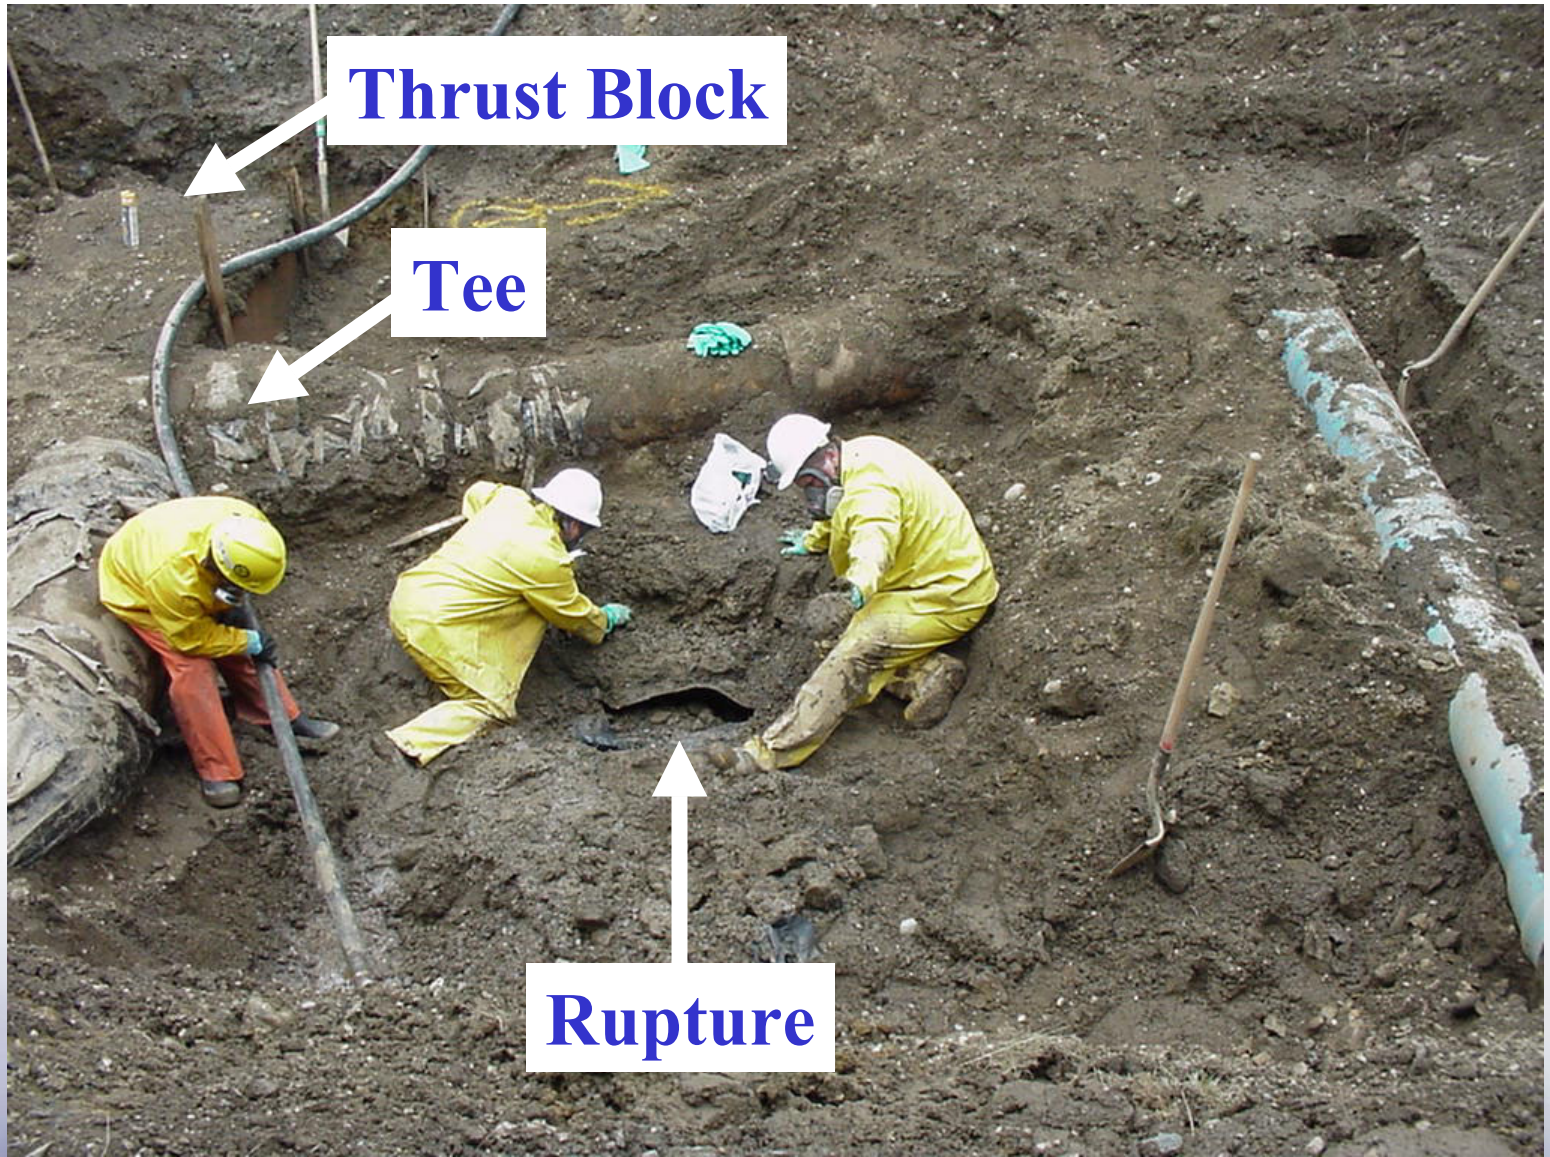
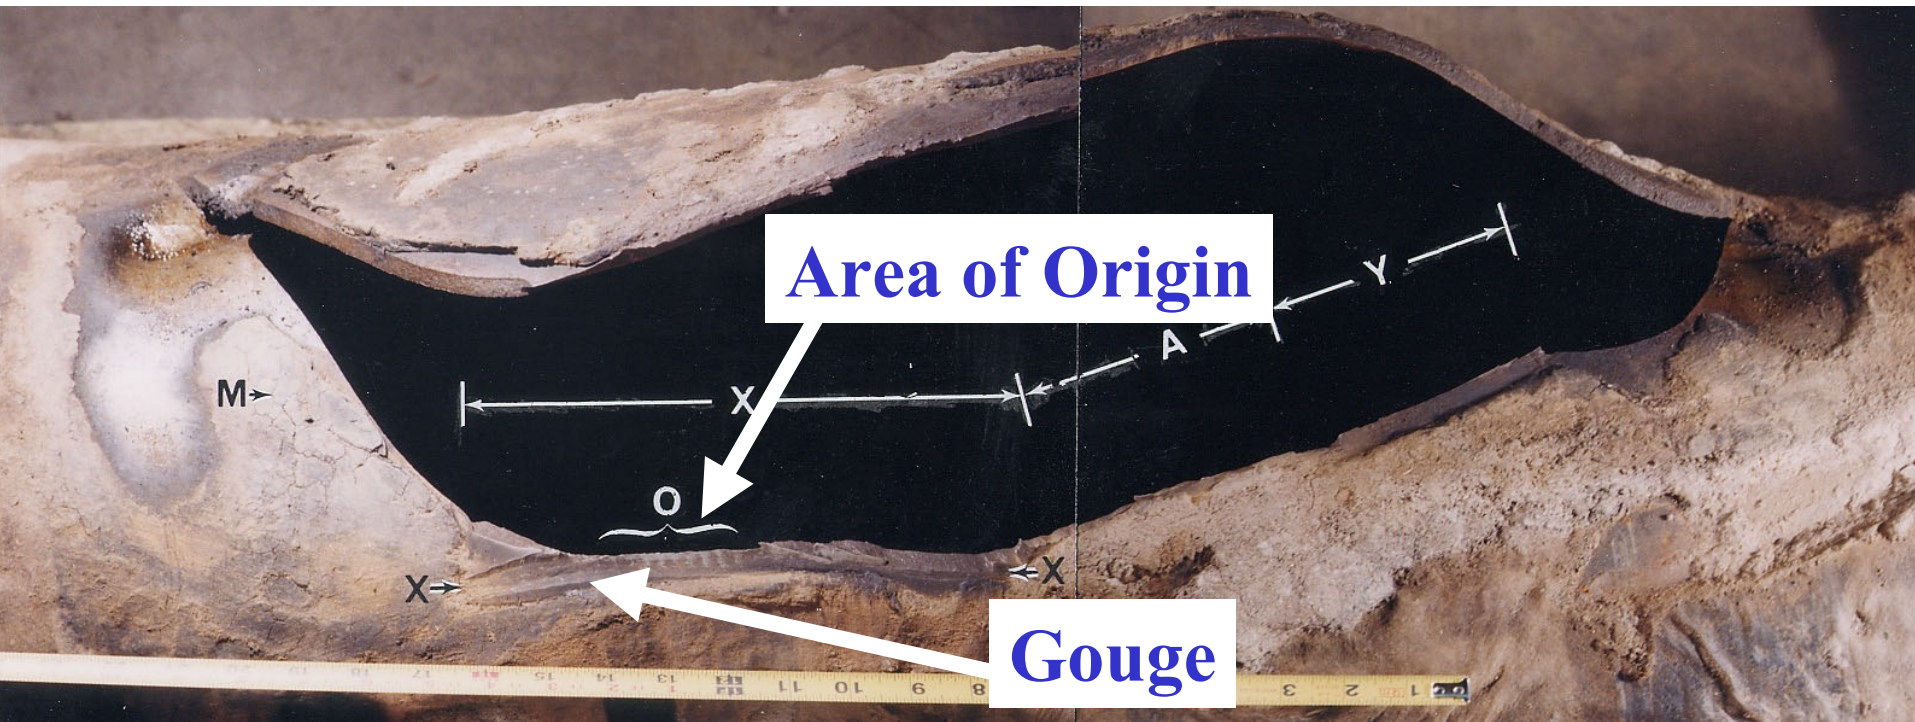
External Gouges on Ruptured Pipeline

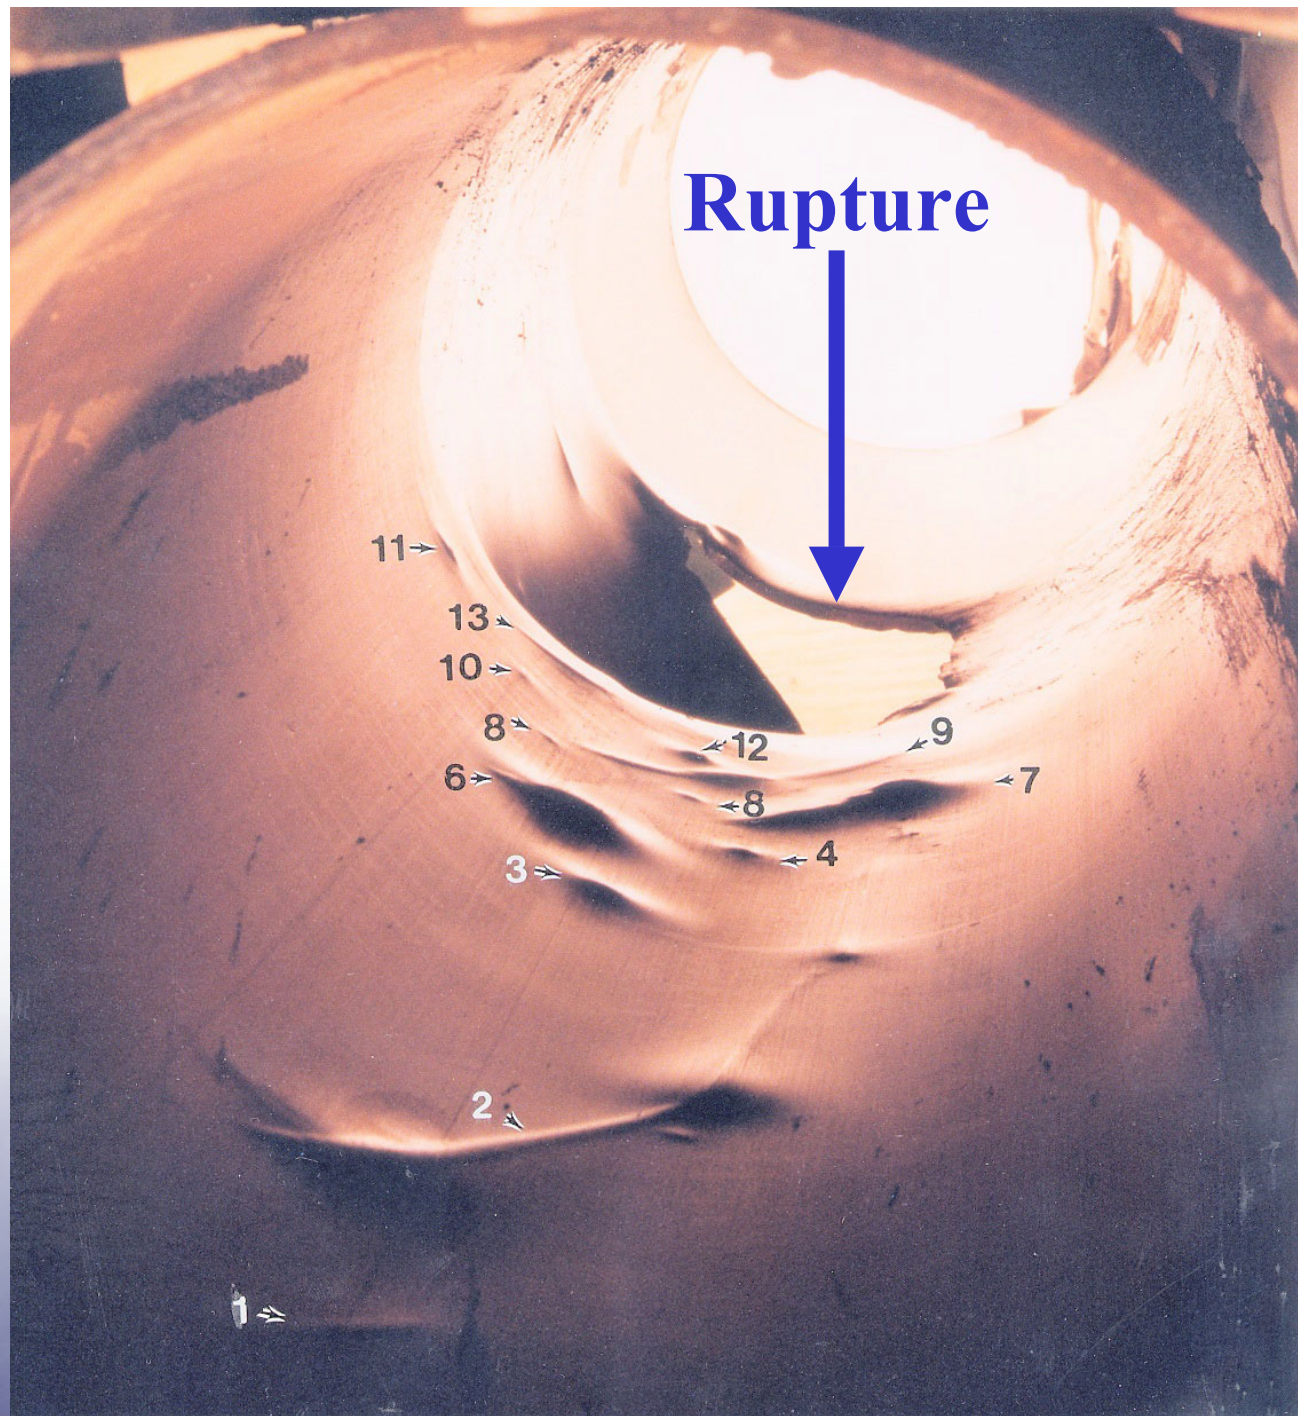
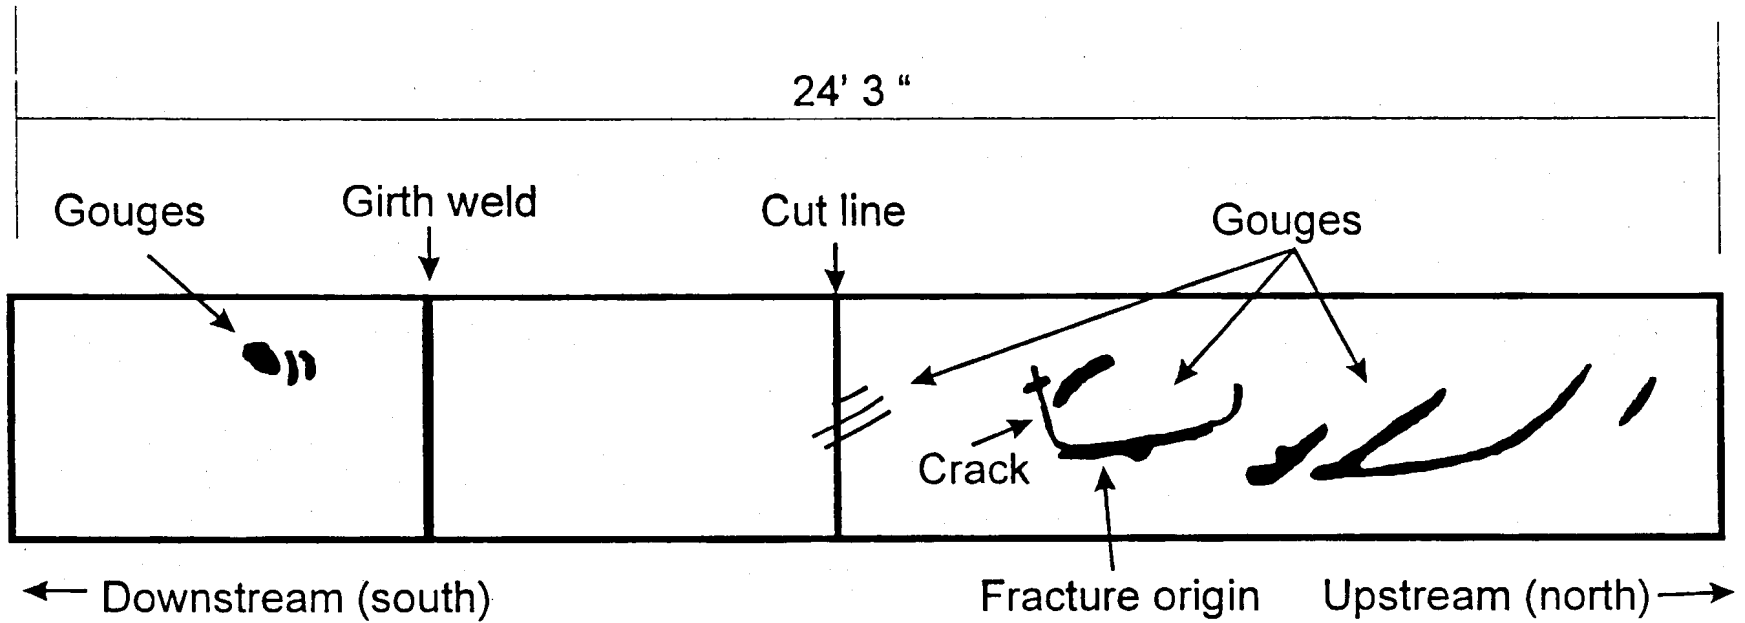
**Damage
Shown on
Internal
Surface**

Extent of Damage to Pipe

**Damage to the Olympic pipeline
probably occurred during IMCO
excavations associated with the water
treatment modification project.**
