Boat fire at a marina dock

Sunday morning, November 5, 2023

This report covers a fire that destroyed one boat and damaged another. The boats were in a marina in Maine. Loss or significant damage to several other boats was averted due to the unusually fast response of the local volunteer fire department. There are several important observations and lessons learned from this incident.

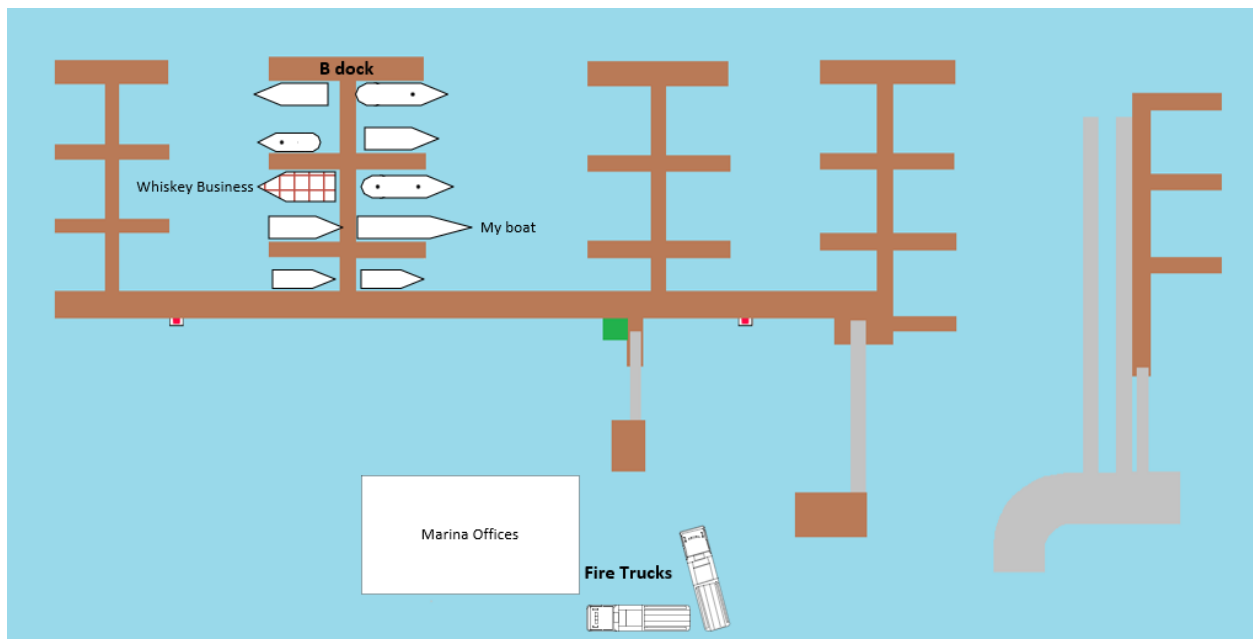
Figure 1 Boats on "B" dock Sunday morning. Fire trucks arrive about 0915.

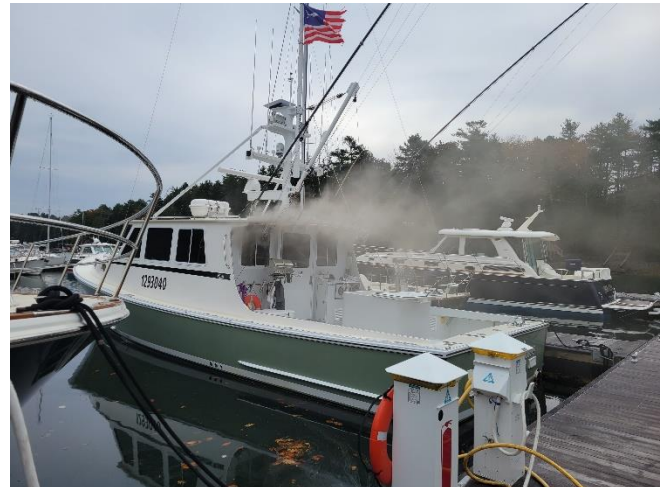
0911: Smoke was streaming from the partially open window (aft port corner of the main cabin) on Whiskey Business. The marina staff member and I discussed how we could move other boats away from Whiskey Business. Most boats were winterized and we could not use their engines. We planned to untie them and push them out into the fairway away from the fire.

Figure 2 Smoke from Whiskey Business at 0911

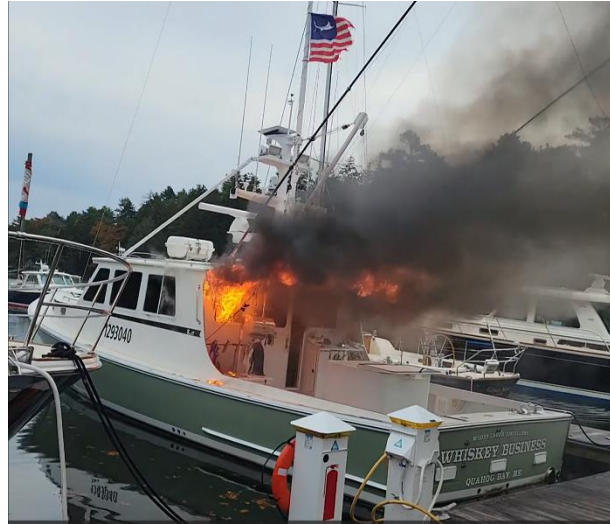
0915 (about): Two fire trucks and crews arrived. Smoke was heavier and streamed across the dock. Flames were now 2 feet high and coming out of the aft windows of the salon that appear to have all shattered. The first fire fighter attempted to deploy a Fire TKO fire suppression tool (FST) in the salon. FST was provided by the marina. The FST did not activate due to operator error (see appendix).

Figure 3 Whiskey Business about 0915

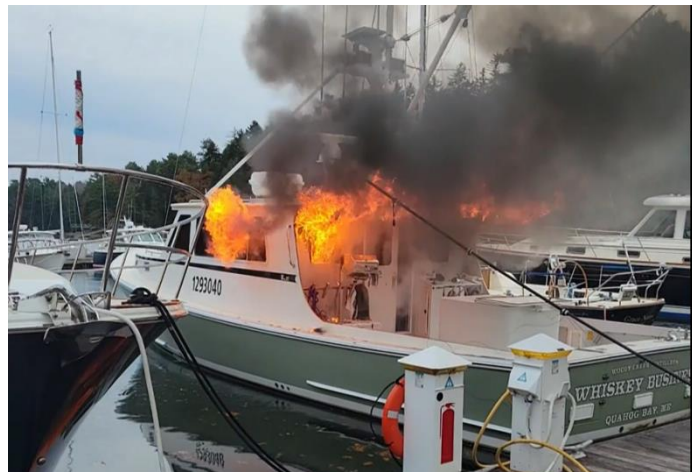
0918: Interior of cabin appeared fully engulfed in flame. Aftermost window on the port side of the salon shattered and flames rose several feet above the roof of the salon. Other windows started to shatter. Fiberglass outrigger fishing poles melted and fell. Flames reached the radar mast. Varnish started to blister on the boat adjacent Whiskey Business on port side. We made preparations to move adjacent boat. Ultimately the adjacent boat was not moved because the fire department arrived, and we decided the adjacent boat was no longer at risk of major damage.

Figure 4 Whiskey Business at 0918

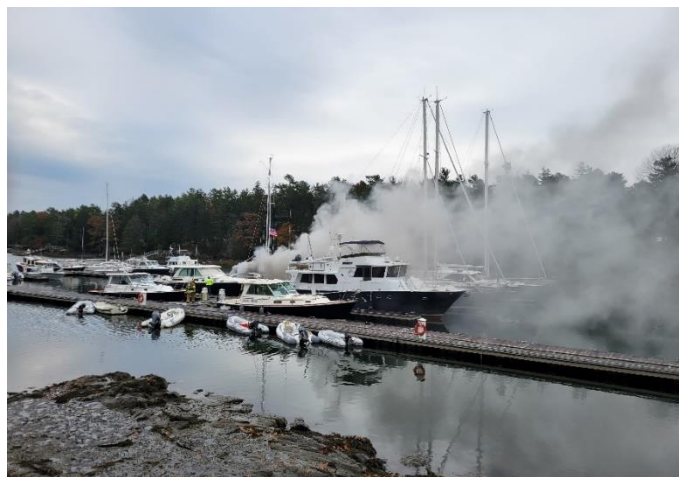
0923 (about): Fire department started fighting the fire with a 2 ½” fire hose that had been run down the docks to the scene. Flames were streaming out of the salon and across the aft deck of Whiskey Business. Most windows had shattered. Heavy smoke had engulfed the 5 boats around Whiskey Business. Only firefighters in protective gear with air tanks could approach Whiskey Business. All others evacuated from the dock.

Figure 5 B dock at 0923. Note fire hose running down the dock.

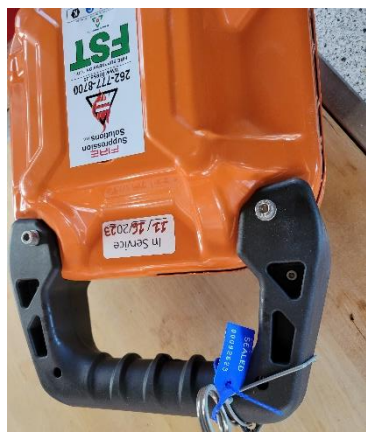
Pin #1 is large and very obvious. In this situation, that pin was pulled. However, pin #2 and its clip was small and the same color as the handle of the device. (Note that the clip for pin #2 is different in the new FST’s shown in the photo and is more obvious than the clip on the older FST’s we used.) It was not obvious that the clip was attached to a pin or that it needed to be pulled to activate the device. Pin #2 was not pulled and thus the device did not activate.

Figure 8 original metal pin #2

I have modified my FST by painting the clip for pin #2 yellow so that it is obvious and hopefully will be more obvious that pin #2 must be also removed to activate the device.

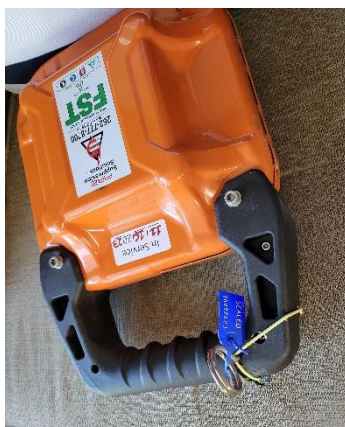
Figure 7 Pin #2 painted yellow
