**Party Submission of
Bobcat Contracting, LLC
To the
National Transportation Safety Board**

**Atmos Energy Corporation
Natural Gas-Fueled Explosion During Routine Maintenance
Farmersville, Texas
June 28, 2021
Investigation No. PLD21FR002**

Submitted March 18, 2022

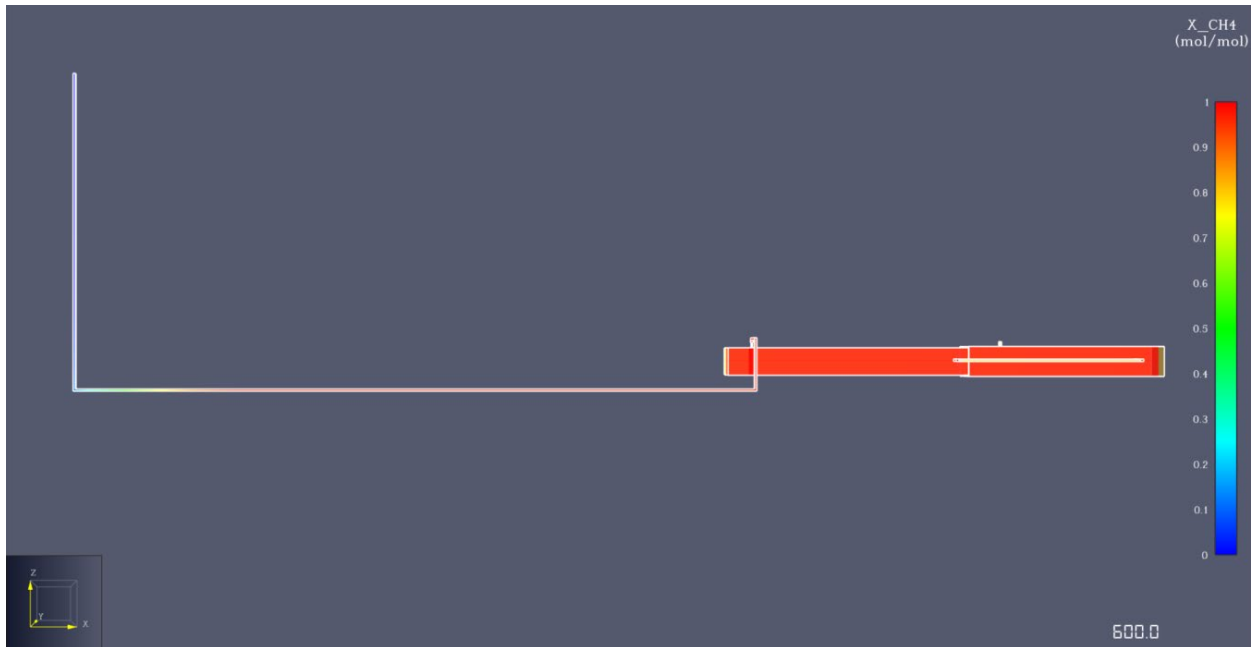
Atmos Sr. FCC A estimated that the time between the launcher door being opened and the accident was approximately 10 minutes.⁸⁰ At 10 minutes into the Scenario 1 simulation, the vertical section of the flare stack piping is filled primarily with air, while the horizontal section of the flare stack piping concentrations of natural gas that range from 100% at the launcher end and something approaching the flammability limits where the vertical and horizontal flare stack pipes come together.⁸¹

Materials Laboratory Study Report 21-098S, Figure 4: Scenario 1 at 600 seconds. (Side view.)

Modeling performed by the NTSB Office of Research and Engineering, Materials Laboratory Division revealed the flammability conditions within the launcher during the flaring, launcher door opening and pig loading processes. Scenario 1 shows that the flaring system used to de-pressurize and burn off escaping natural gas results in a concentration of natural gas within the launcher barrel at or near 100% natural gas at the end of the process. After 10 minutes, the vertical section of the flare stack piping is filled primarily with air, while the horizontal section of the flare stack piping concentrations of natural gas that range from 100% at the launcher end and something approaching the flammability limits where the vertical and horizontal flare stack pipes come together. (See Figure 4 of the Materials Laboratory Factual Report.)

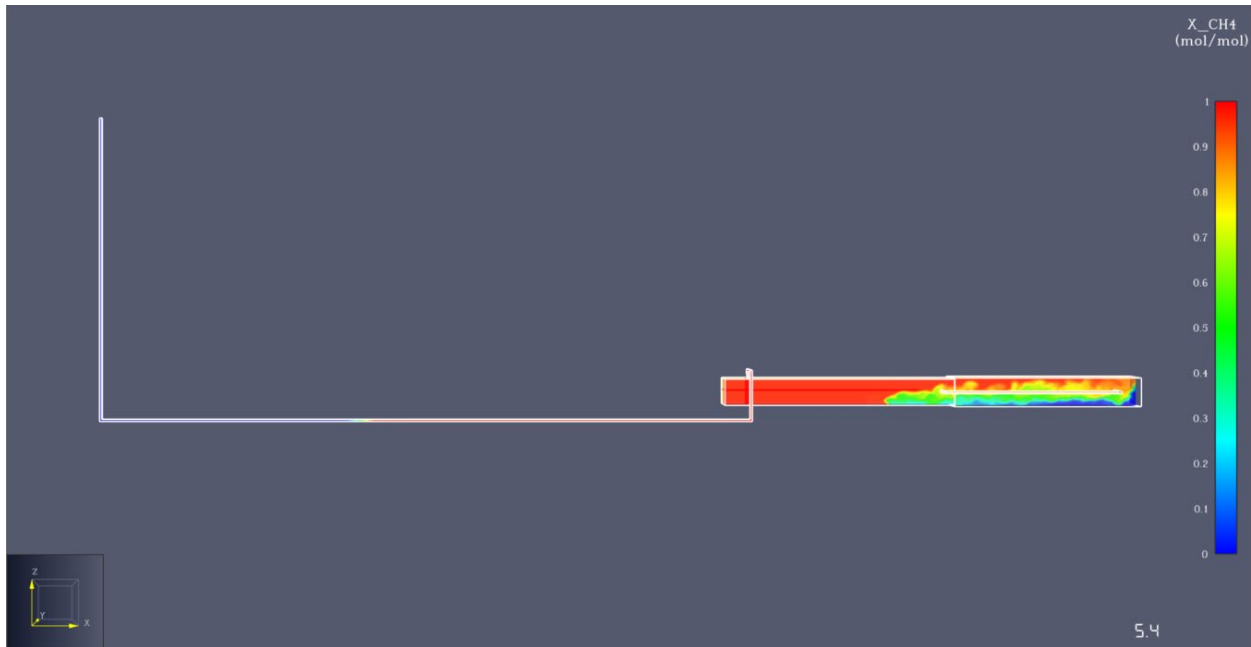
Scenario 5 of the modeling examined the rate of venting when the launcher door is opened.⁸² It assumes a worst-case scenario of the launcher barrel and flare piping being full of natural gas.⁸³ In this scenario, air rapidly enters the barrel along the bottom of the launcher door's cross section while natural gas escapes along the top of the open door's cross section.⁸⁴ Air is also flowing down the flare stack piping and into the launcher barrel.⁸⁵

Materials Laboratory Study Report 21-098S, Figure 7: Scenario 5 at 5.4 seconds after the launcher door was opened. (Side view.)

When the launcher door is opened, Scenario 5 of the modeling shows that air rapidly enters the barrel along the bottom of the launcher door opening while natural gas (which is lighter than air) escapes along the top of the open door opening. After 60 seconds, the concentration of the natural gas in the launcher falls into the flammable limits (5-15%). At 120 seconds, the flammable concentrations of natural gas are limited to areas along the top of the launcher barrel. At 180 seconds, there are no longer any areas of flammable gas concentration in the launcher. (See Figures 7 and 10 of the Materials Laboratory Factual Report.)

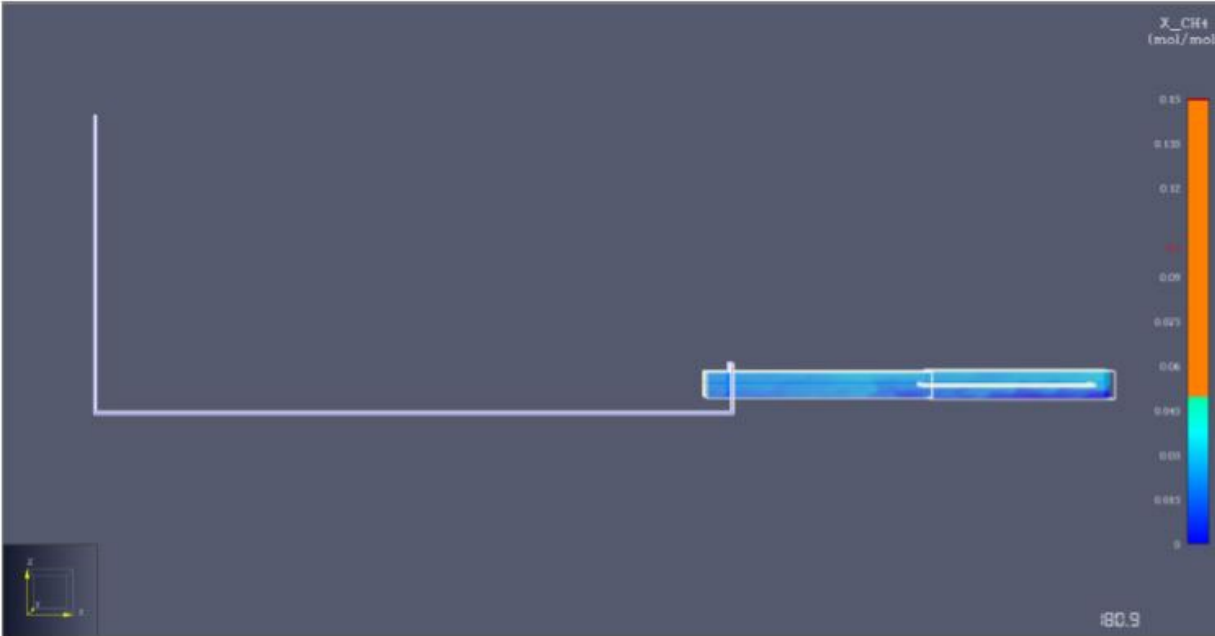
At 60 seconds after door opening, the concentration of the natural gas in the launcher falls into the flammable limits (5-15%).⁸⁶ At 120 seconds, the flammable concentrations of natural gas are limited to areas along the top of the launcher barrel.⁸⁷ At 180 seconds, there are no longer any areas of flammable gas concentration in the launcher.⁸⁸

Materials Laboratory Study Report 21-098S, Figure 10: Scenario 5 at 180 seconds. No more flammable regions exist within the launcher barrel. (Side view.)

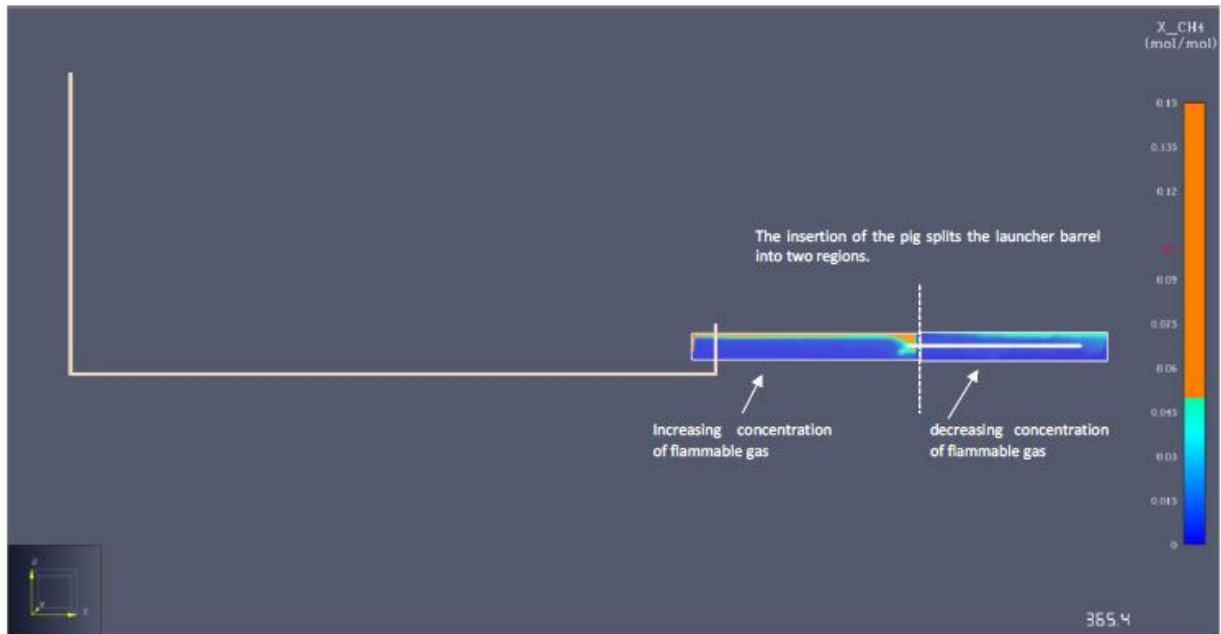
Once the pig was introduced, the concentration of natural gas began to increase substantially within the reduced section of the launcher barrel and decrease (dissipate) substantially in the open section of the launcher barrel.⁹³ At one minute after the insertion of the pig, a large portion of the reduced section was within the flammable range while the open section of the launcher barrel did not contain flammable regions.⁹⁴ At ten minutes, regions along the top of the reduced section and the flare line began to exceed the upper flammable limits.⁹⁵ Examination of the direction of flow of gasses through the equalizer piping indicate that air was traveling from the open end of the launcher barrel towards the reduced section of the launcher barrel.⁹⁶ Examination of the flow of gas through the flare piping indicated that the gas mixture in the reduced section of the launcher barrel was flowing through the flare piping and out to the

Materials Laboratory Study Report 21-098S, Figure 13: Scenario 6 at 365 seconds. The pig has just been introduced effectively splitting the launcher barrel into two regions joined only by the equalizer piping. (Side view.)

As a result of this, the concentration of natural gas increases substantially on the pipeline side when the pig is inserted into the launcher barrel and quickly reaches a flammable level. The concentration of natural gas on the open side of the pig decreases substantially and never reaches a flammable concentration. Significantly, the concentration of natural gas in the flare line also reaches a flammable concentration. (See Figures 12-15 of the Materials Laboratory Factual Report.)

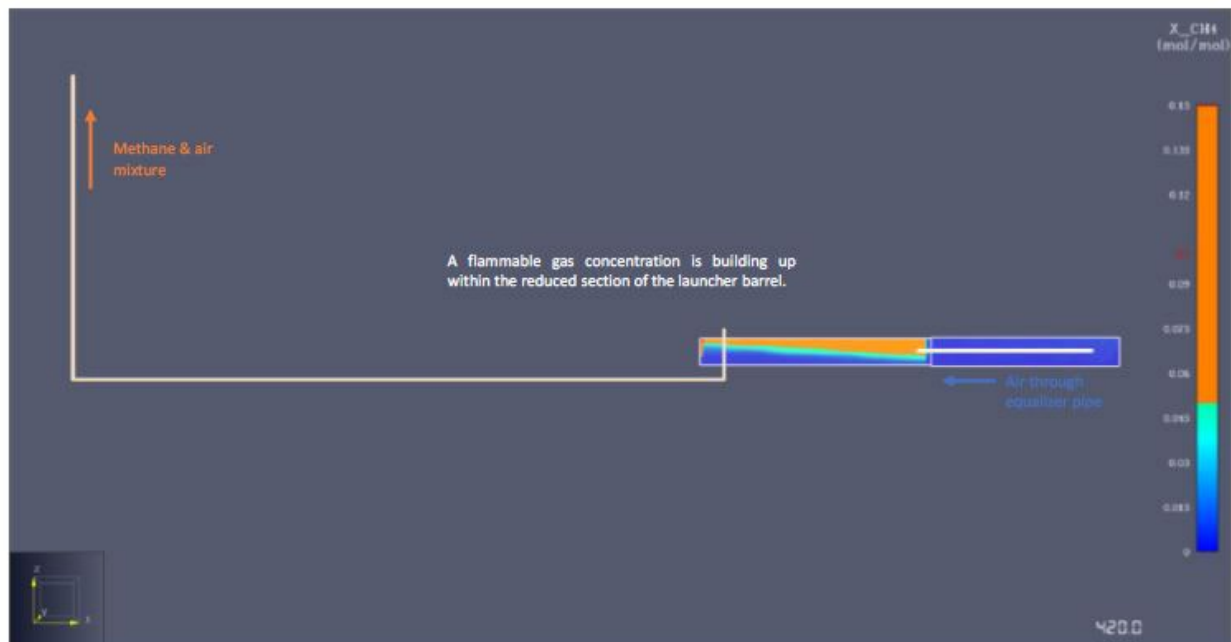
Materials Laboratory Study Report 21-098S, Figure 14: Scenario 6 at 420 seconds. This is 60 seconds after the pig was introduced. (Side view.)

The flare stack piping, on the other hand, would have had a flammable concentration of natural gas at various points between the launcher end of the piping and the flare stack. (See Figures 14-15 of the Materials Laboratory Factual Report.)

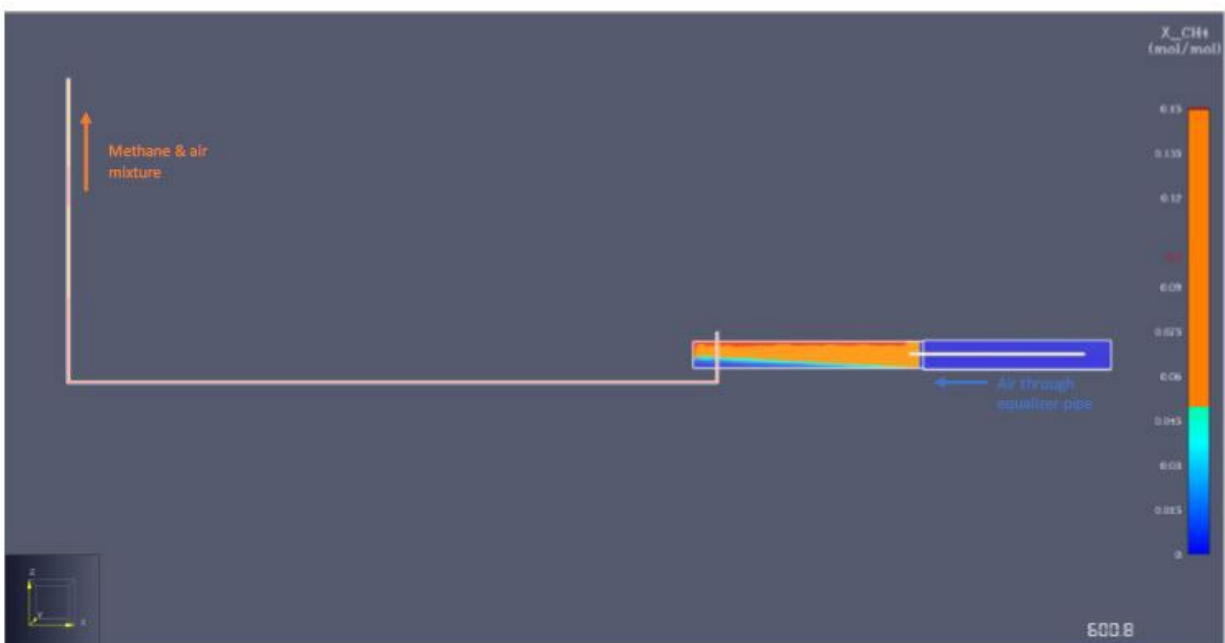
Materials Laboratory Study Report 21-098S, Figure 15: Scenario 6 at 600 seconds. (Side view.)
