## PRELIMINARY REPORT HIGHWAY

### Construction Zone Multivehicle Collision HWY18FH015

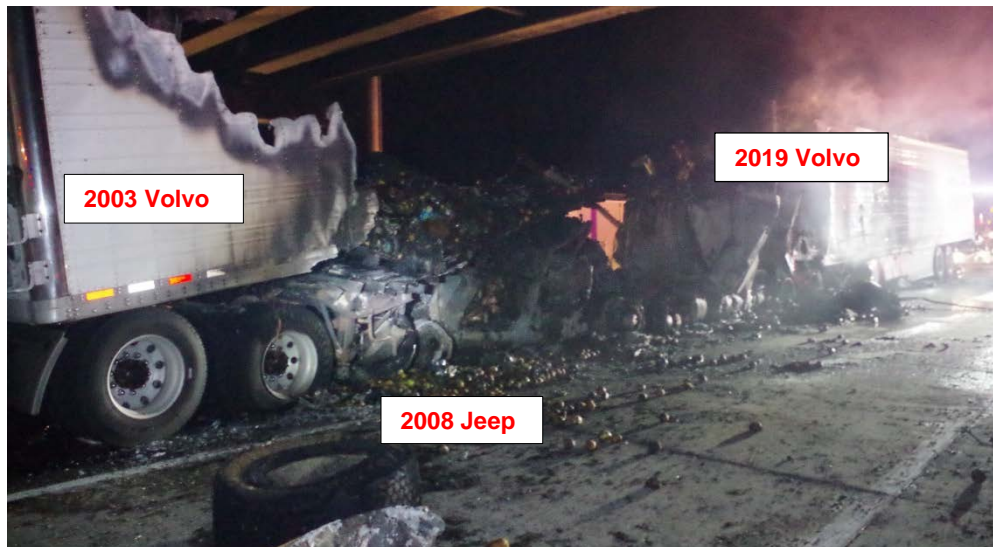
On I-84 east, a traffic queue had formed in the second to the right lane. A 2008 Jeep Wrangler was located at the end of the queue. Meanwhile a 2019 Volvo truck-tractor in combination with a 2015 Great Dane refrigerated semitrailer was approaching the end of the traffic queue from the west. The driver did not react to the stopped traffic in the queue and collided with the rear of the Jeep. As both vehicles moved forward, the Jeep was pushed into the rear of a 2003 Volvo truck-tractor in combination with a 2008 Great Dane refrigerated semitrailer, which was stopped in front of the Jeep. Figure 1 shows the final rest positions of the two combination vehicles and the Jeep.

**Figure 1:** Vehicles at final rest under Cloverdale overpass (Idaho State Police).
