**NATIONAL TRANSPORTATION SAFETY BOARD**  
Office of Research and Engineering  
Washington, D.C. 20594

## **Video Study**

**NTSB Case Number:  
HWY18FH015**

Location: Boise, Idaho  
Date: June 16, 2018  
Time: 11:28 p.m.  
Vehicle No. 1: 2019 Volvo tractor in combination with a 2015 Great Dane trailer  
Vehicle No. 2: 2009 Jeep Wrangler  
Vehicle No. 3: 2003 Volvo tractor in combination with a 2008 Great Dane trailer

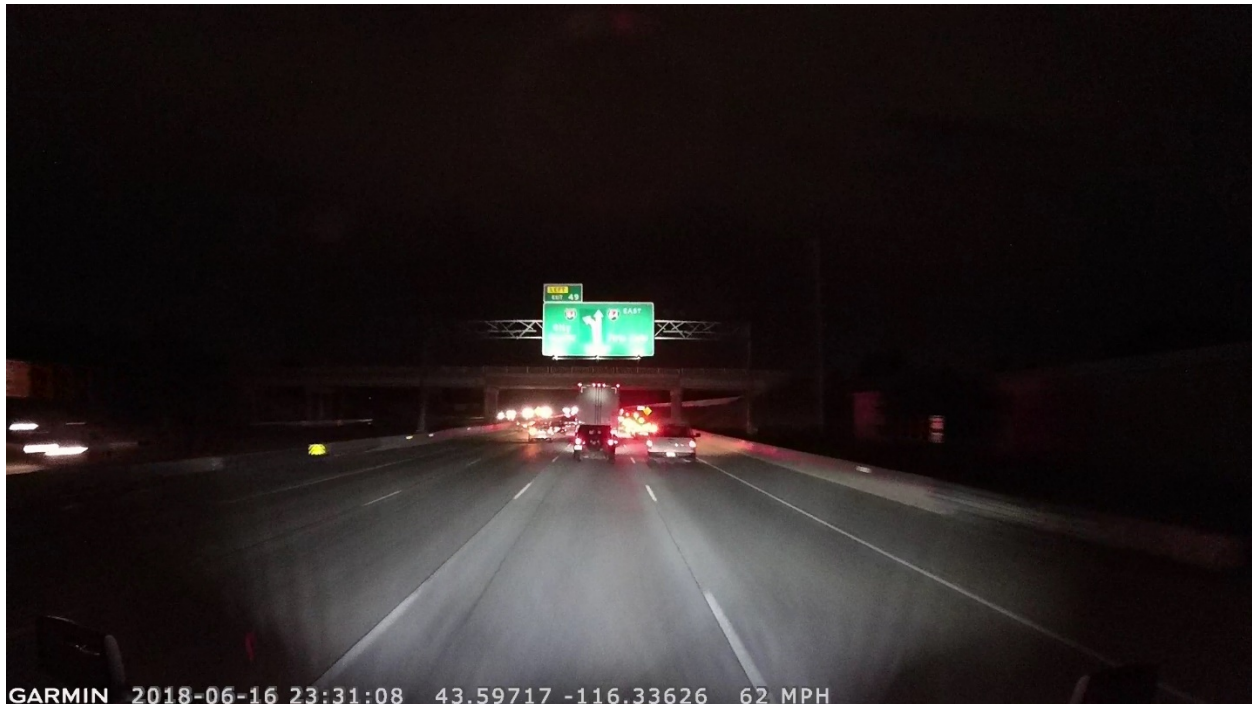
The goal of this study was estimating the speed of the 2019 Volvo tractor before its impact with the Jeep based on a video recorded by a Garmin device installed on the tractor. The video had 1920x1080 resolution and frame rate of 30 fps. In addition to recording the video, the Garmin device also recorded the GPS location of the tractor and the tractor speed it computed based on the GPS locations. The GPS location and the speed were superimposed on the video and were updated once per second. The superimposed GPS-based speed at the time of impact was 62 mph. Figure 1 shows a frame from the video recorded about 1.3 seconds before impact.

**Figure 1. Video Frame Recorded 1.3 Seconds before Impact**
