Dive Survey 31Oct @ Sandfill Dock, St Thomas

Damage observations

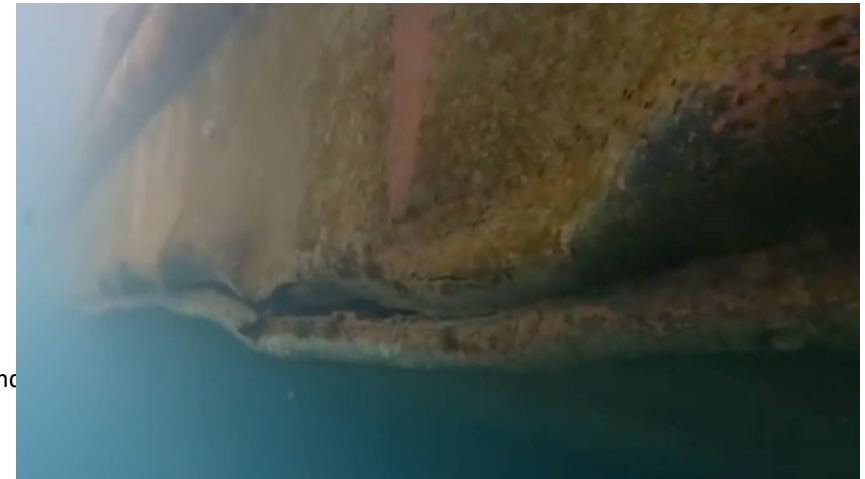
Ref 11. SB Chine is cracked and

8. Crack (#7) is drilled at the end at frame #58-59.
9. Mudtanks #1 SB repaired using epoxy.
10. Indentation on the PS chine
11. Serious indentation up to 8" on the SB chine with a longitudinal crack, length 5ft 8".
12. @ frame 43: 3ft off the side shell, a crack is found.
13. PS rudder has a small bent and one blade on the PS-propellor is bent.

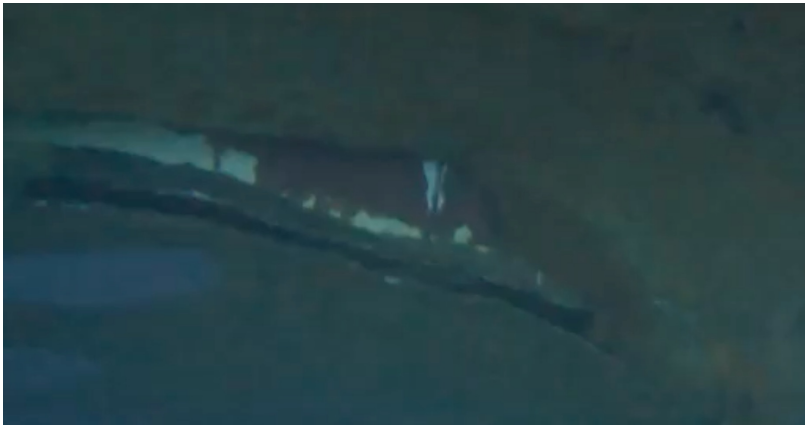
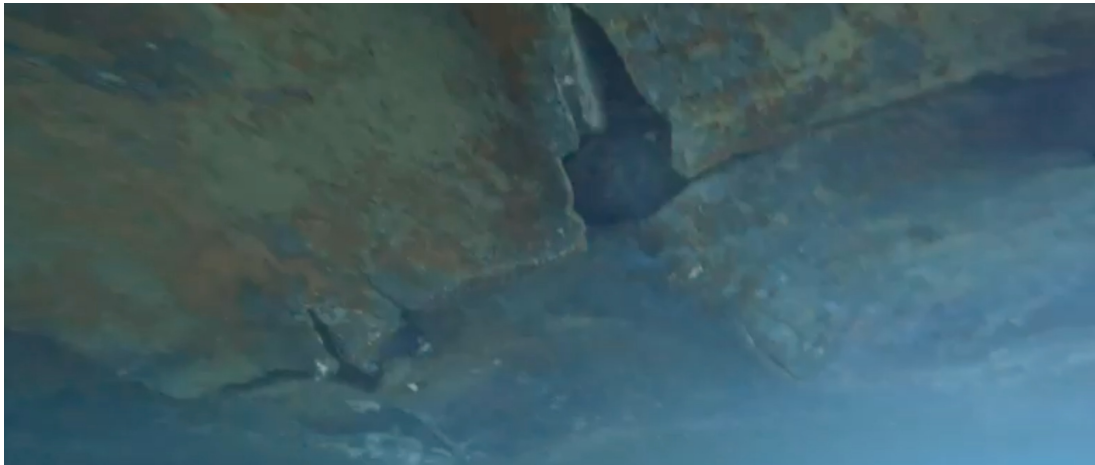
1. Pushed up bottom plating
2. Bottom view with indentation
3. Crack between two longitudinal longer cracks. (around frame 45)

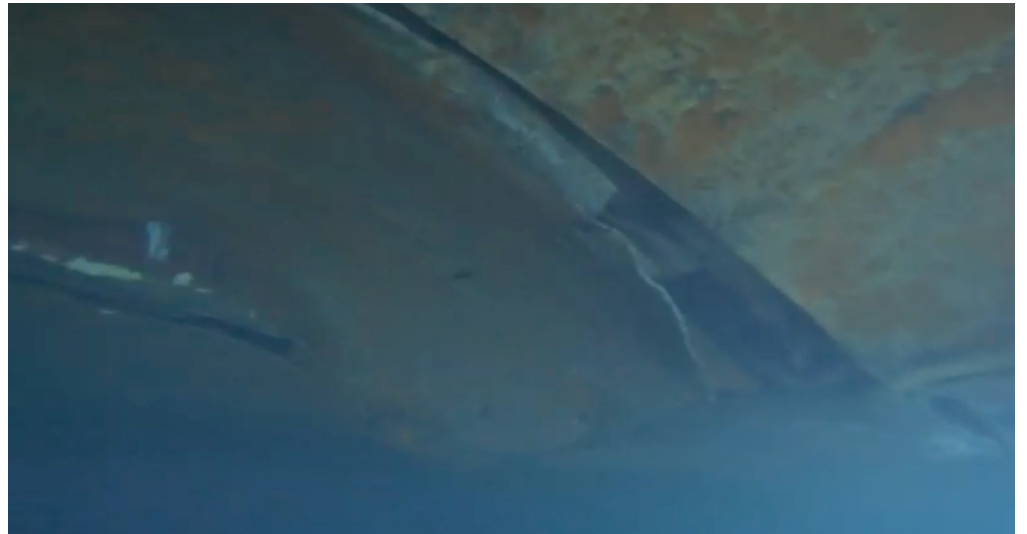
Crack further on SB side (ref 12)

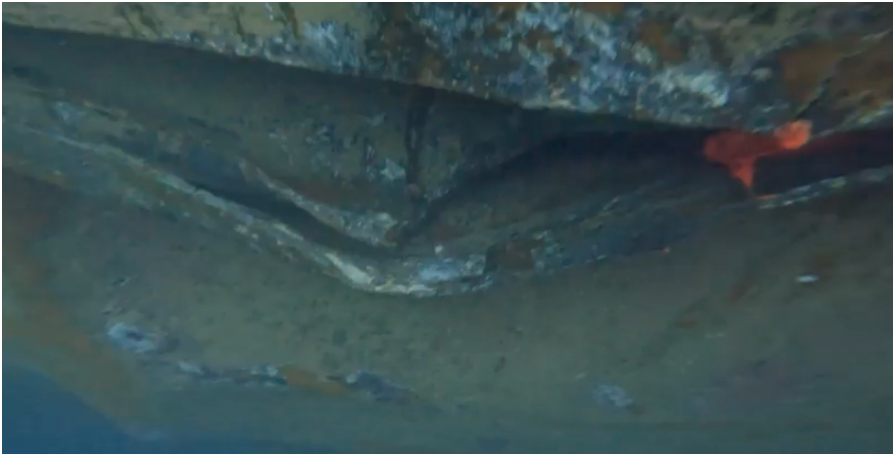
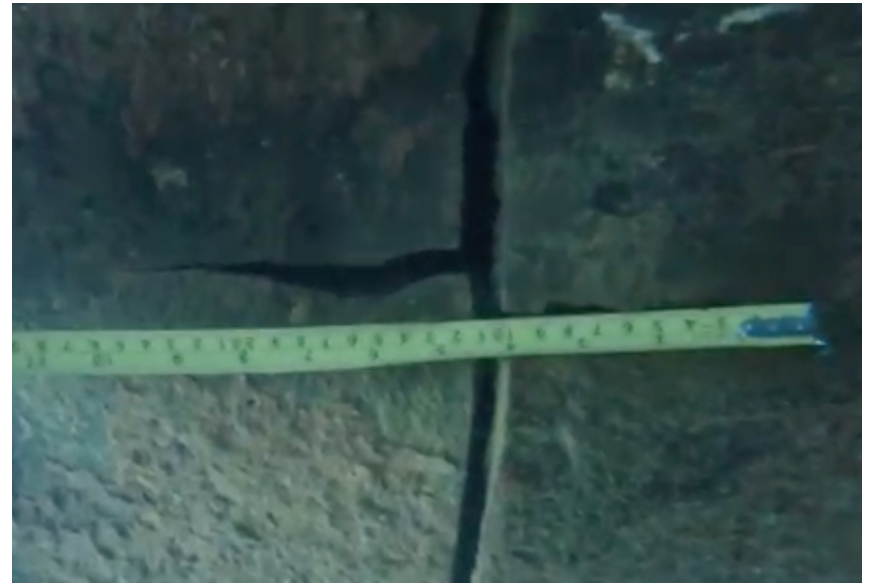
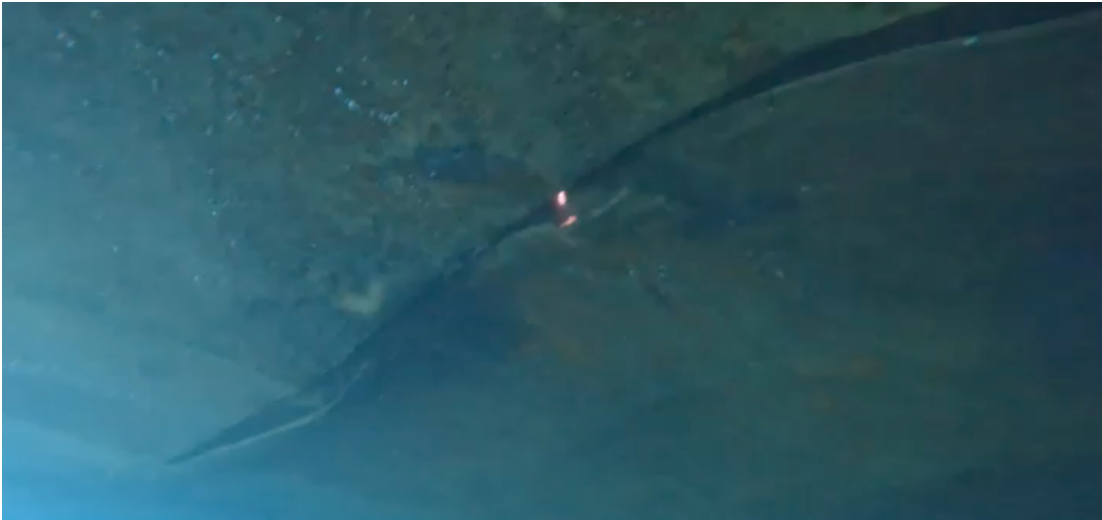
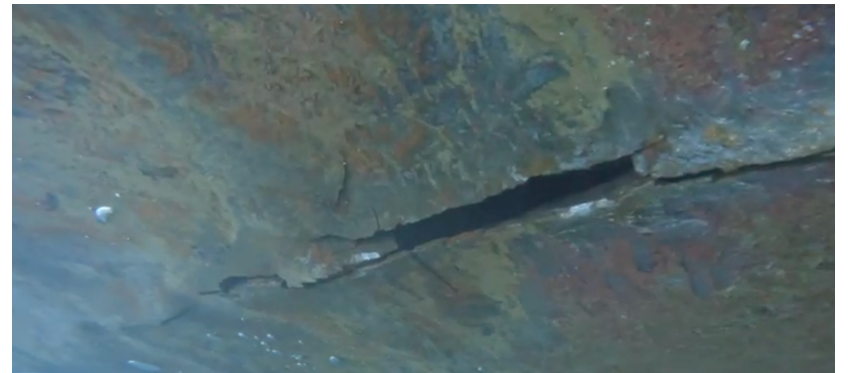
7. @ frame 41-59: Long crack which starts 17" from ER Bulkhead forward, starting as a small crack and opening over the length till a larger opening at frame #40 (6"x6").

Long crack from aft to fwd (ref 7.), where damage opened the plating.

8. Crack (#7) is drilled at the end at frame #58-59.
9. Mudtanks #1 SB repaired using epoxy.
