Bridge Factors Photographs – MCM’s Photo Submission

Miami, FL

HWY18MH009

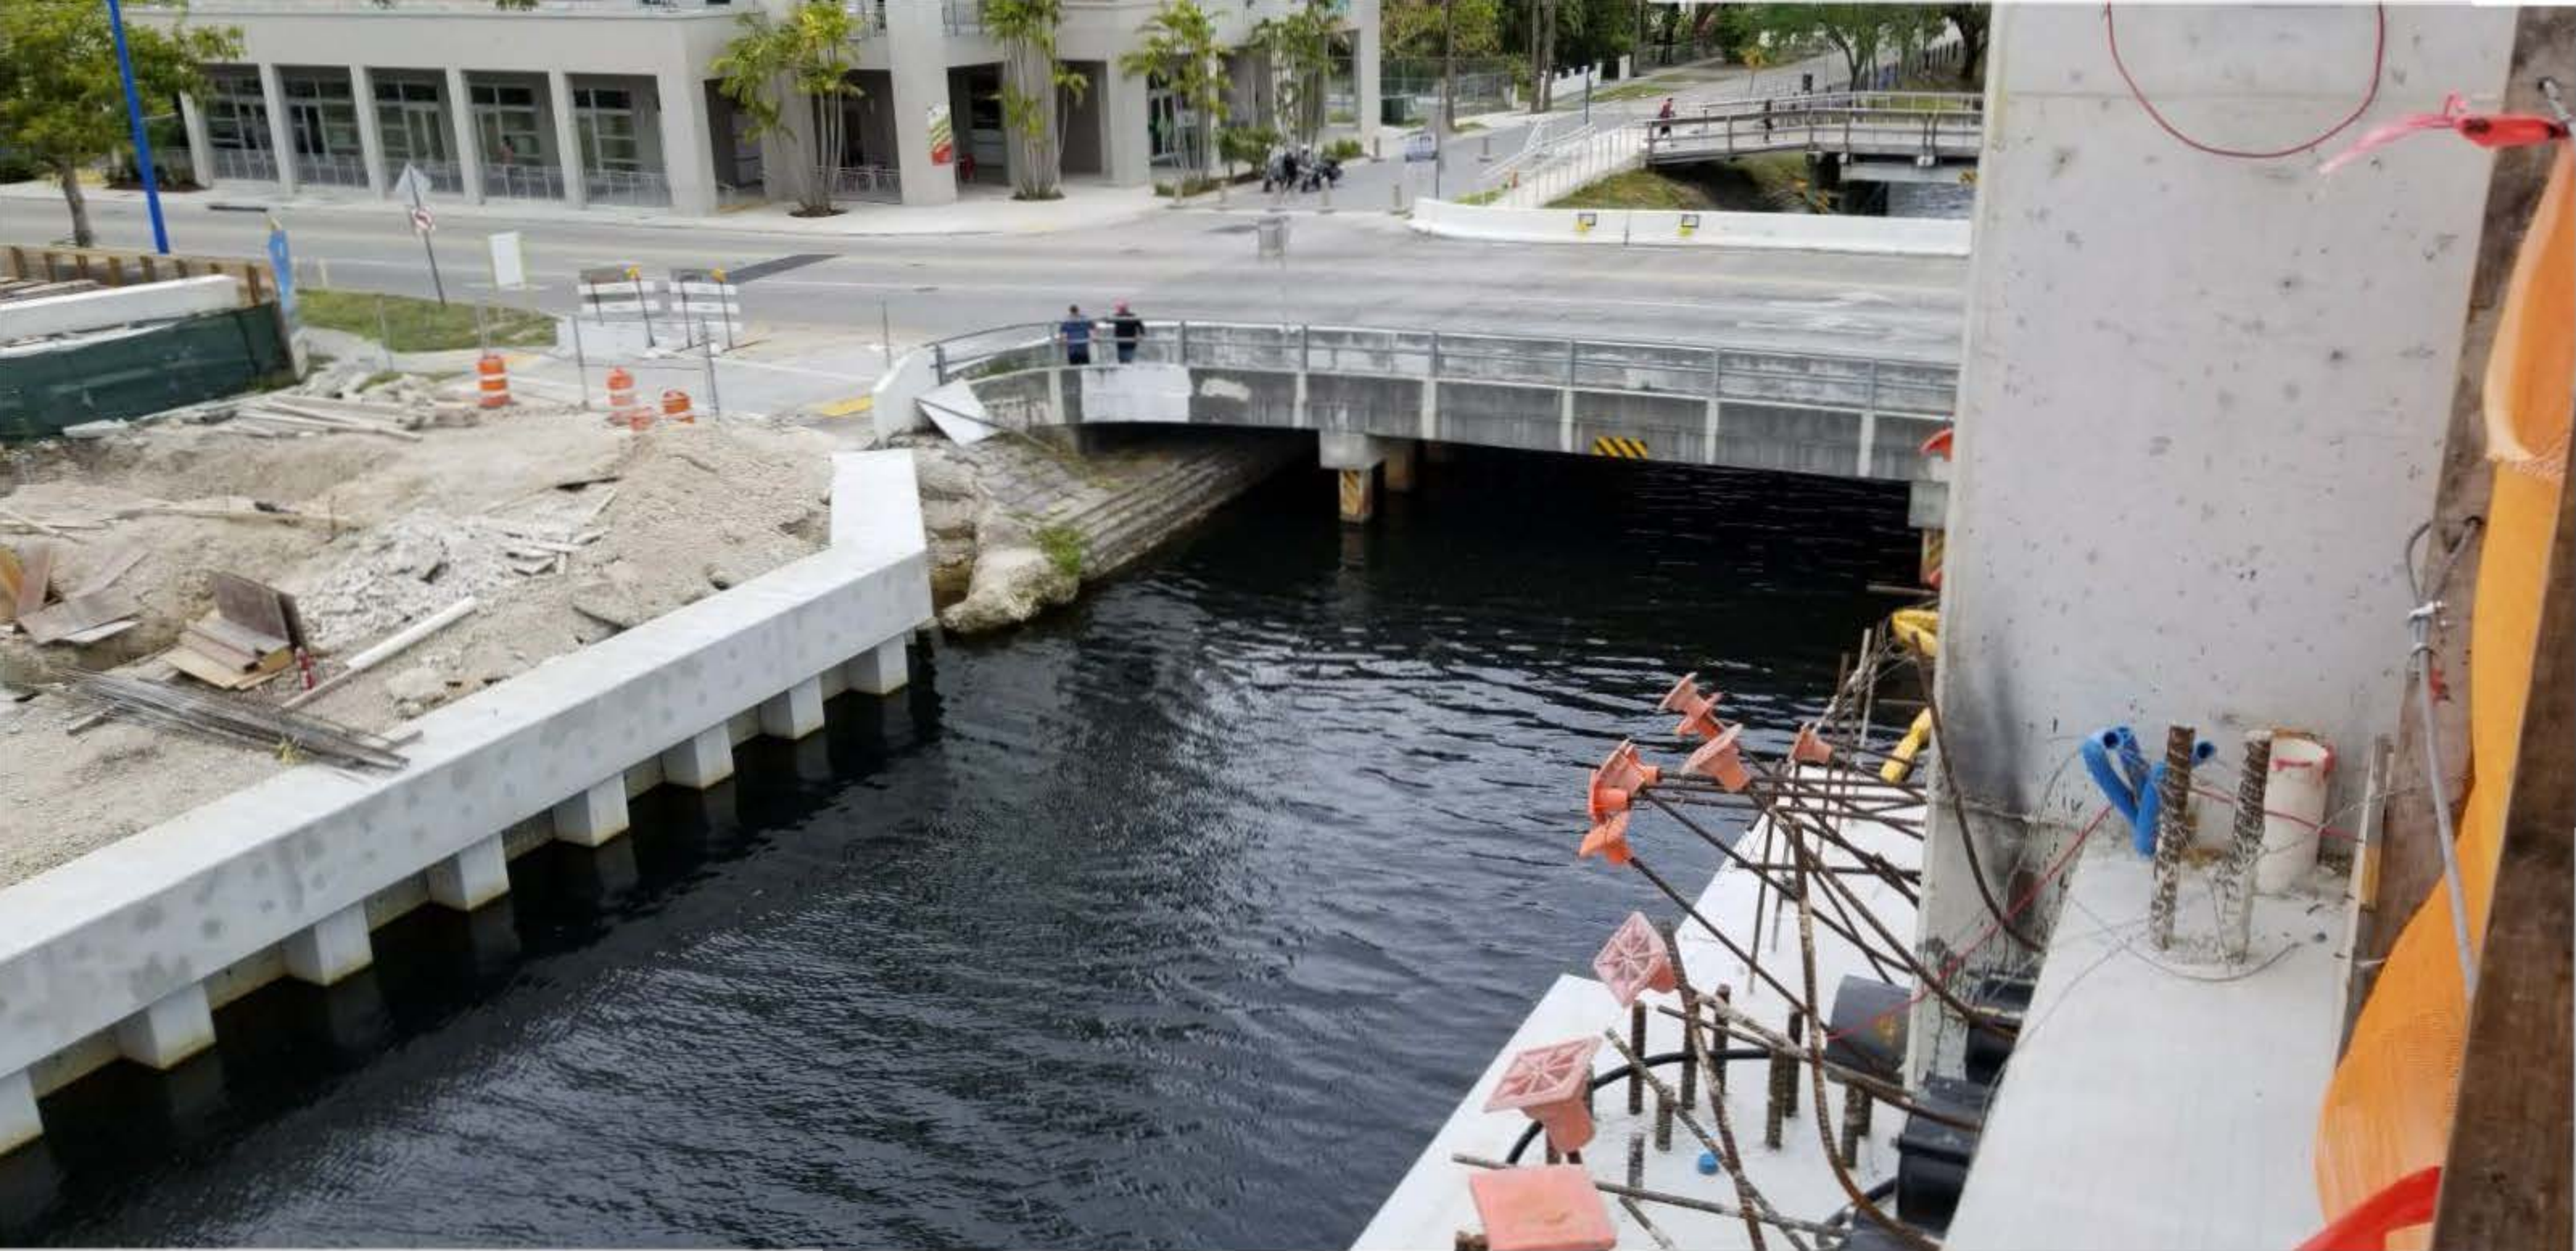
March 10, 2018
Time: Unknown

View along west side of Diaphragm II looking to the east.

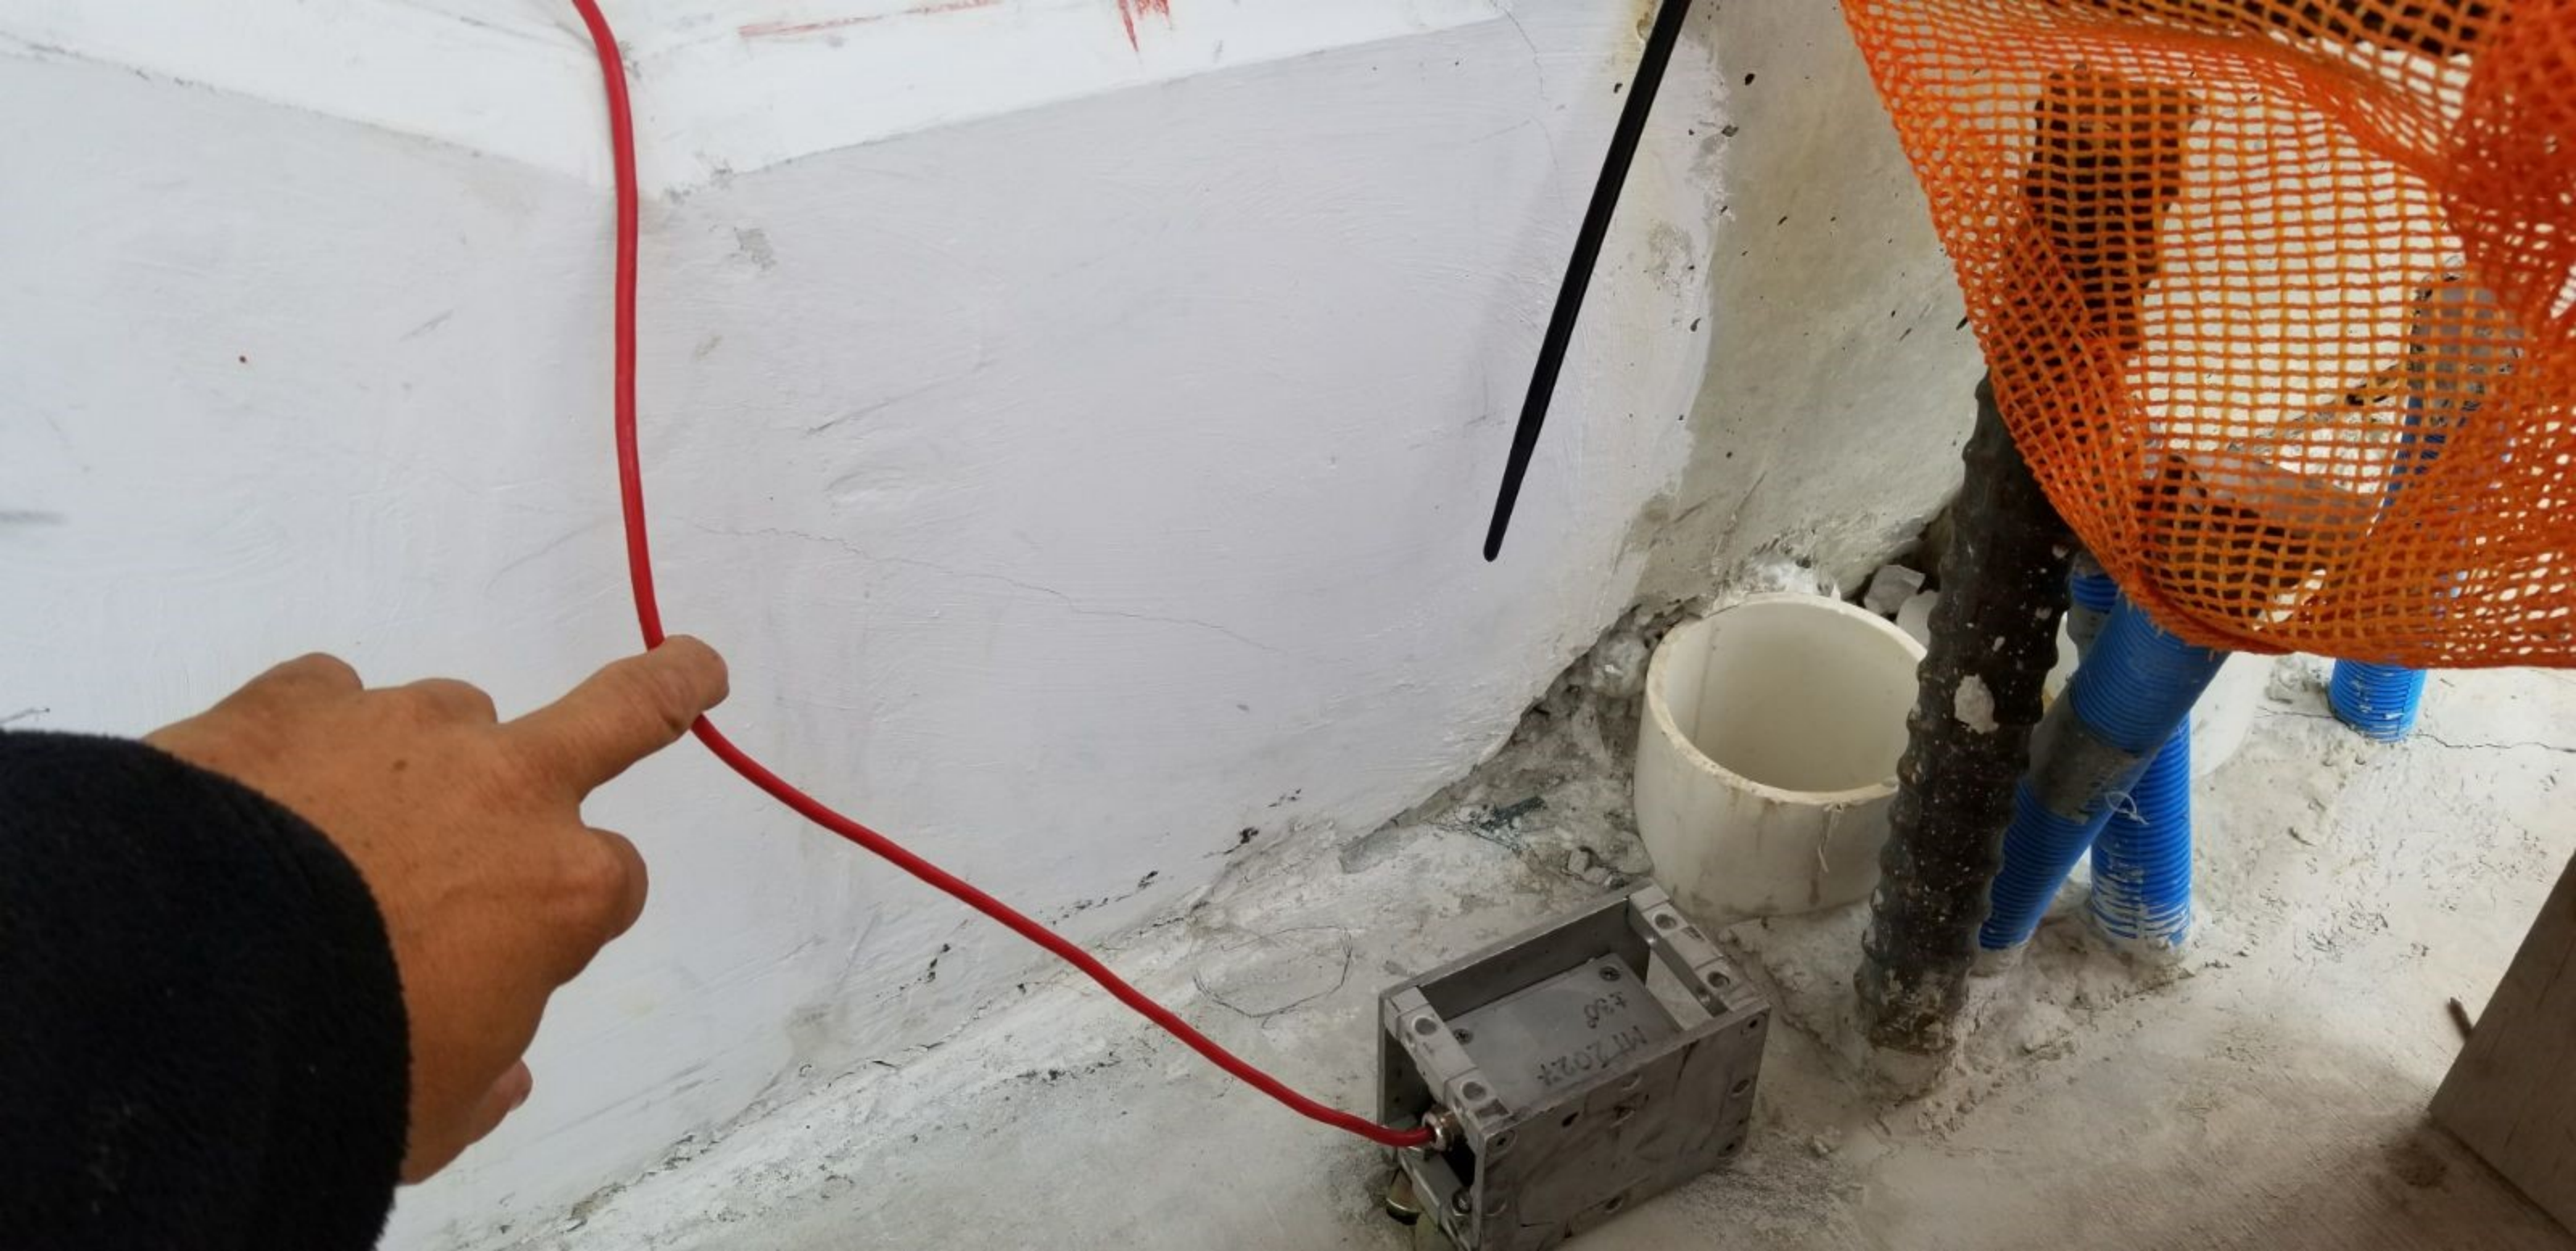
March 10, 2018

View of bottom of diagonal support #11 on east side looking to the west.
