**Bridge Factors Photographs 1 through 111**

**Miami, FL**

**HWY18MH009**

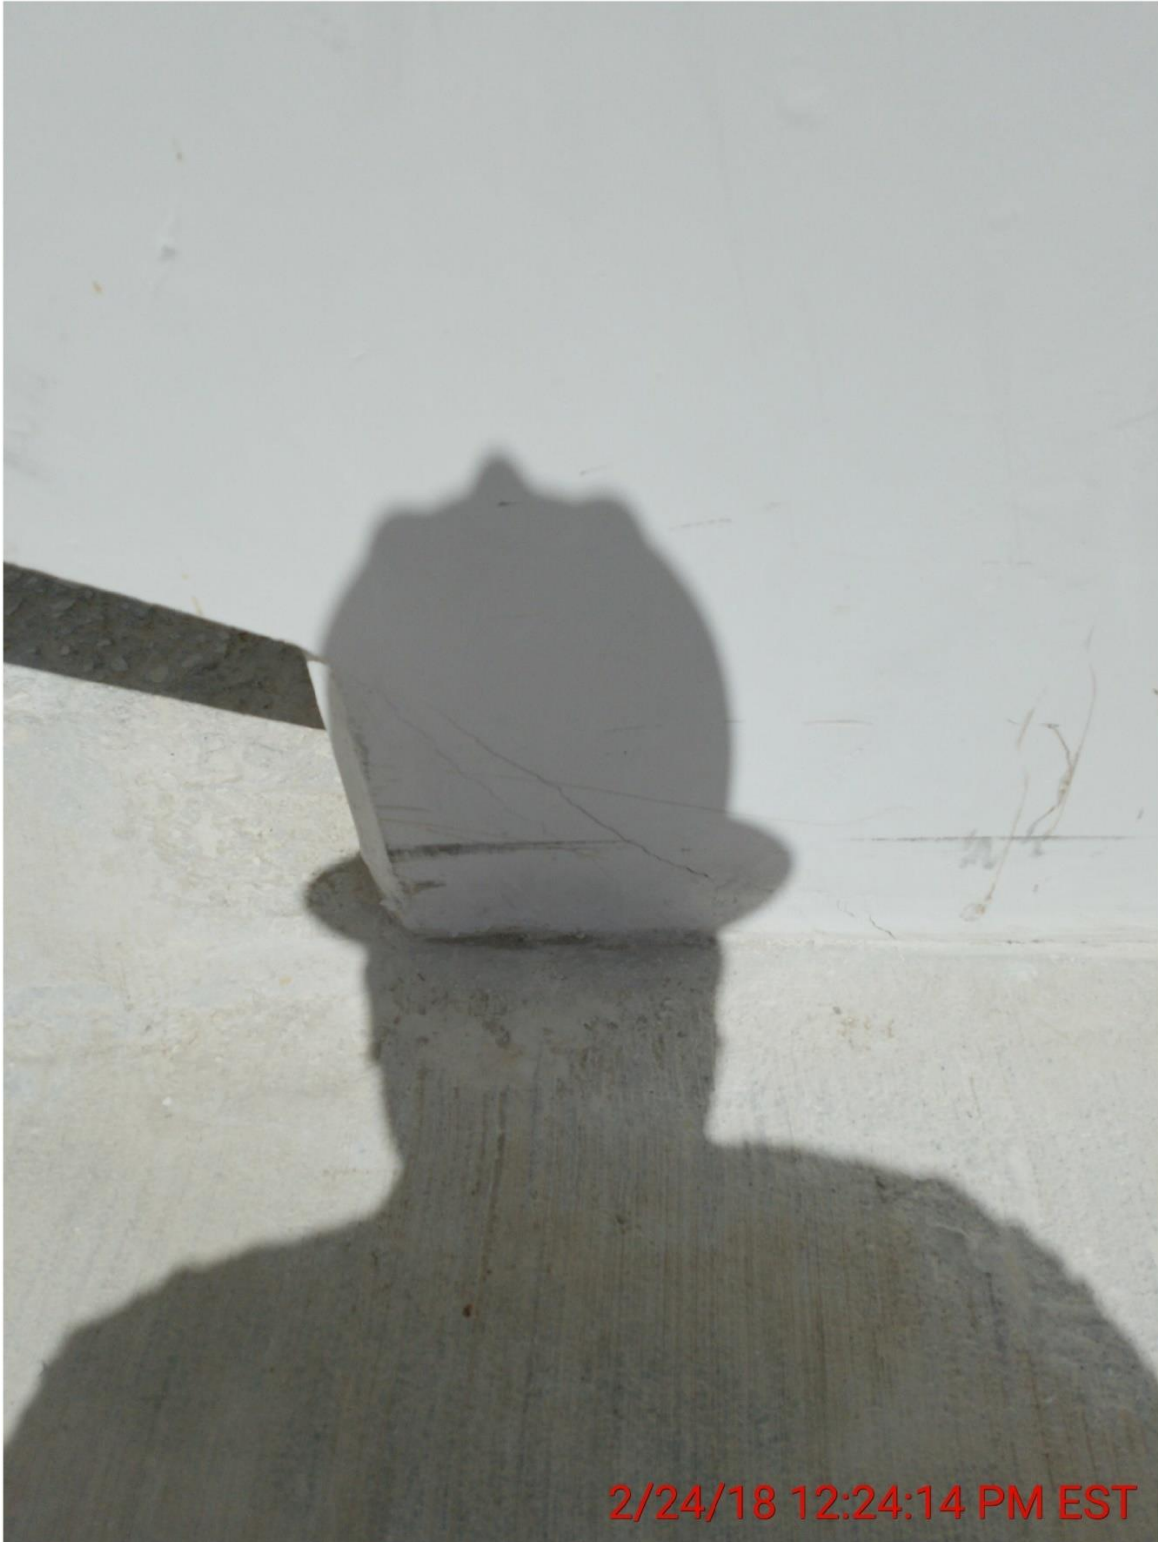
Bridge Factors Photo 37 – View of cracks at the bottom of diagonal support #2 on south side looking to the north in casting yard on 2/24/18 at 12:24:14 p.m. (Source: Munilla Construction Management, MCM)

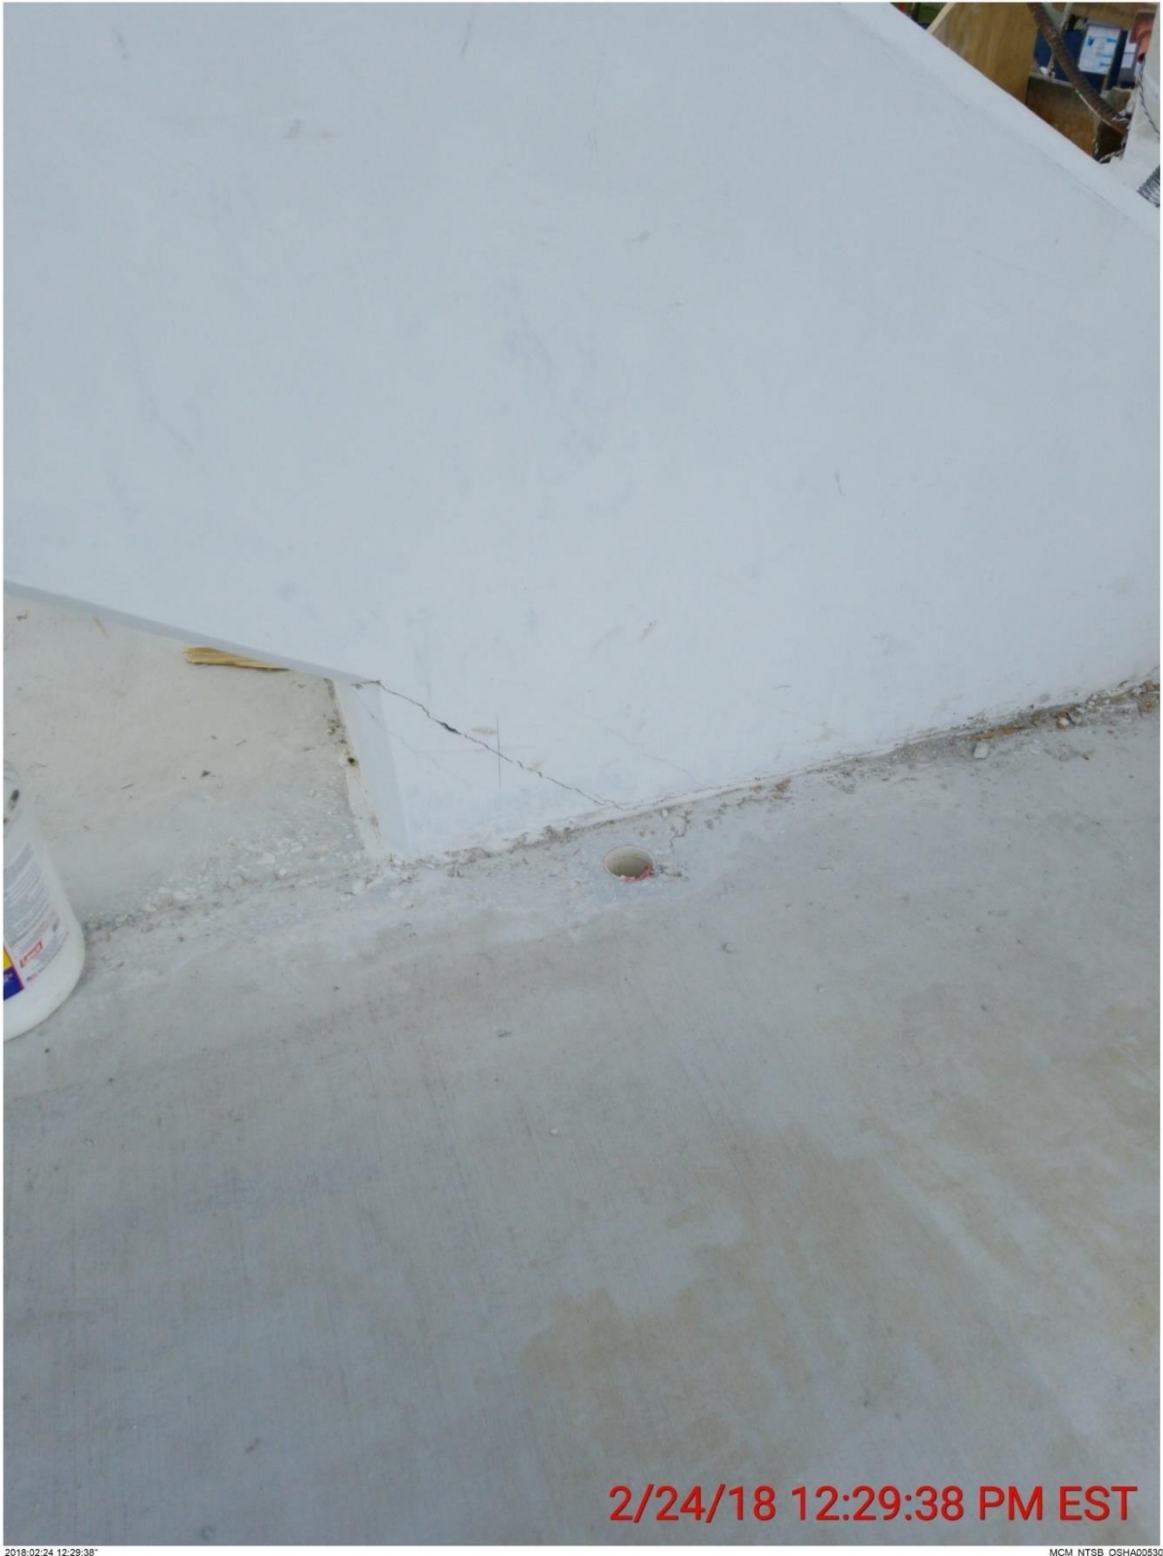
Bridge Factors Photo 38 – View of crack at the bottom of diagonal support #11 on north side looking to the south in casting yard on 2/24/18 at 12:29:38 p.m. (Source: Munilla Construction Management, MCM)

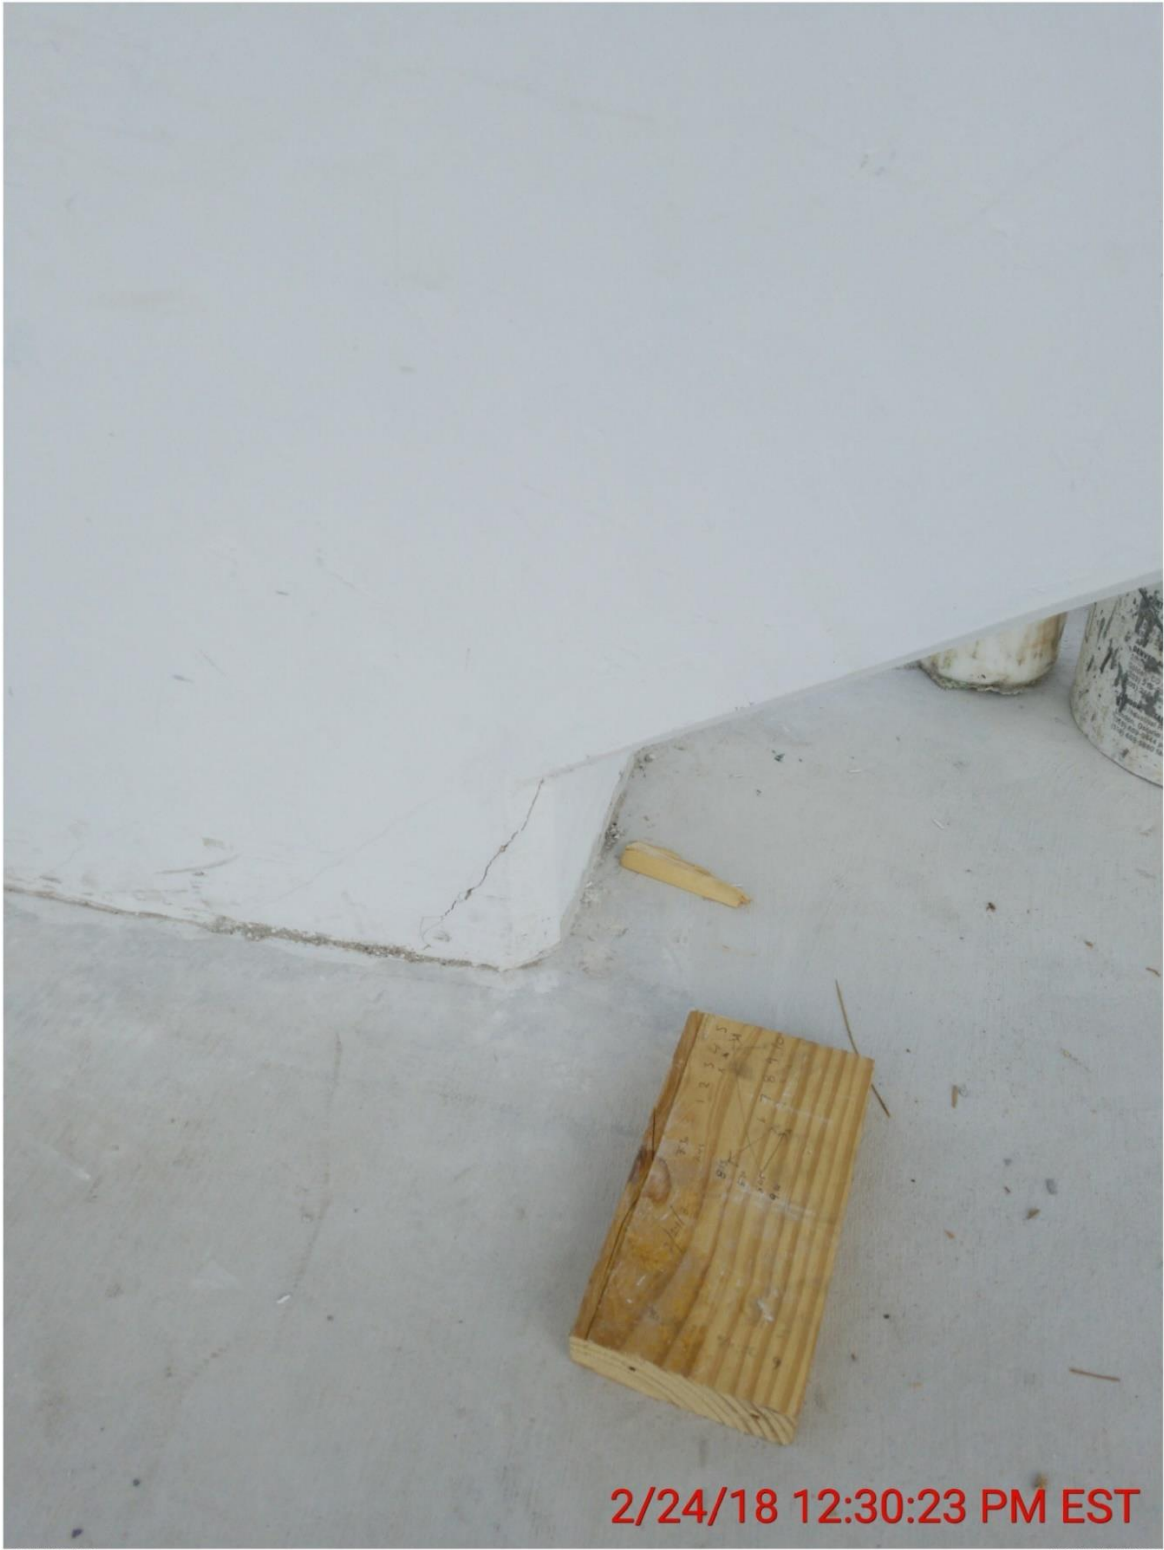
Bridge Factors Photo 39 – View of crack at the bottom of diagonal support #11 on south side looking to the north in casting yard on 2/24/18 at 12:30:23 p.m. (Source: Munilla Construction Management, MCM)

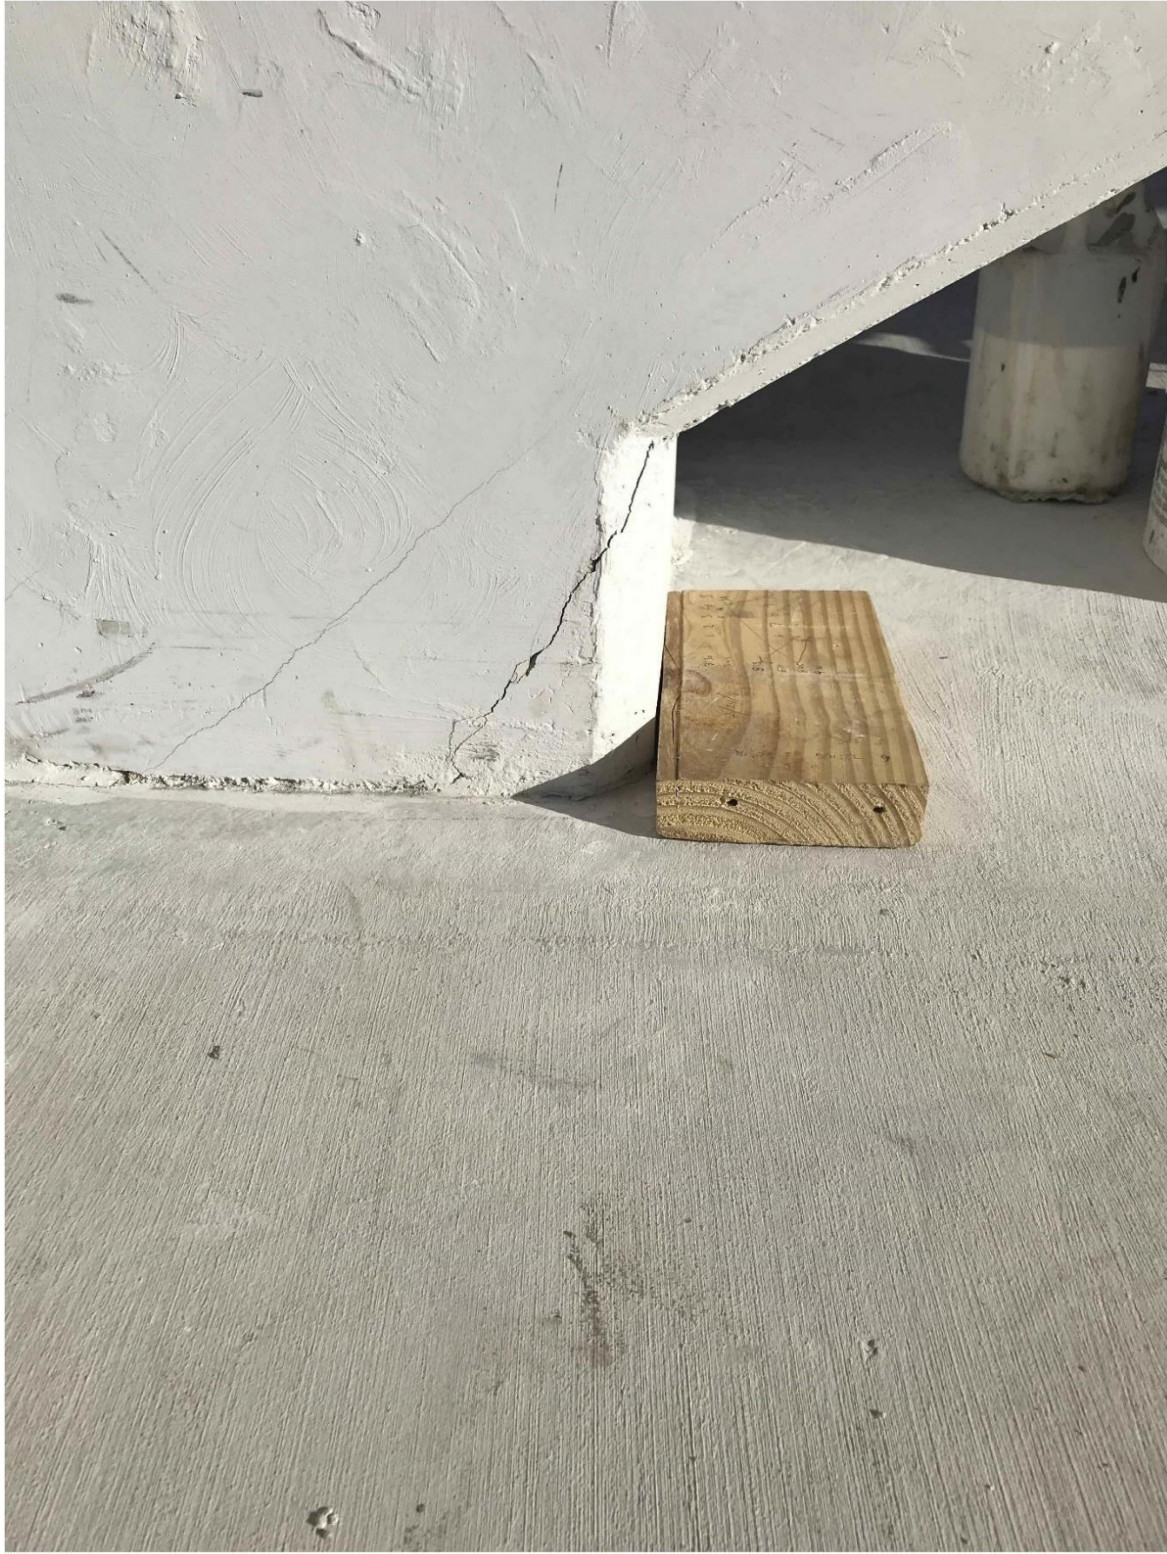
Bridge Factors Photo 43 – View of crack at the bottom of diagonal support #11 on south side looking to the north in casting yard on 2/26/18 at 8:38:58 a.m. (Source: Munilla Construction Management, MCM)

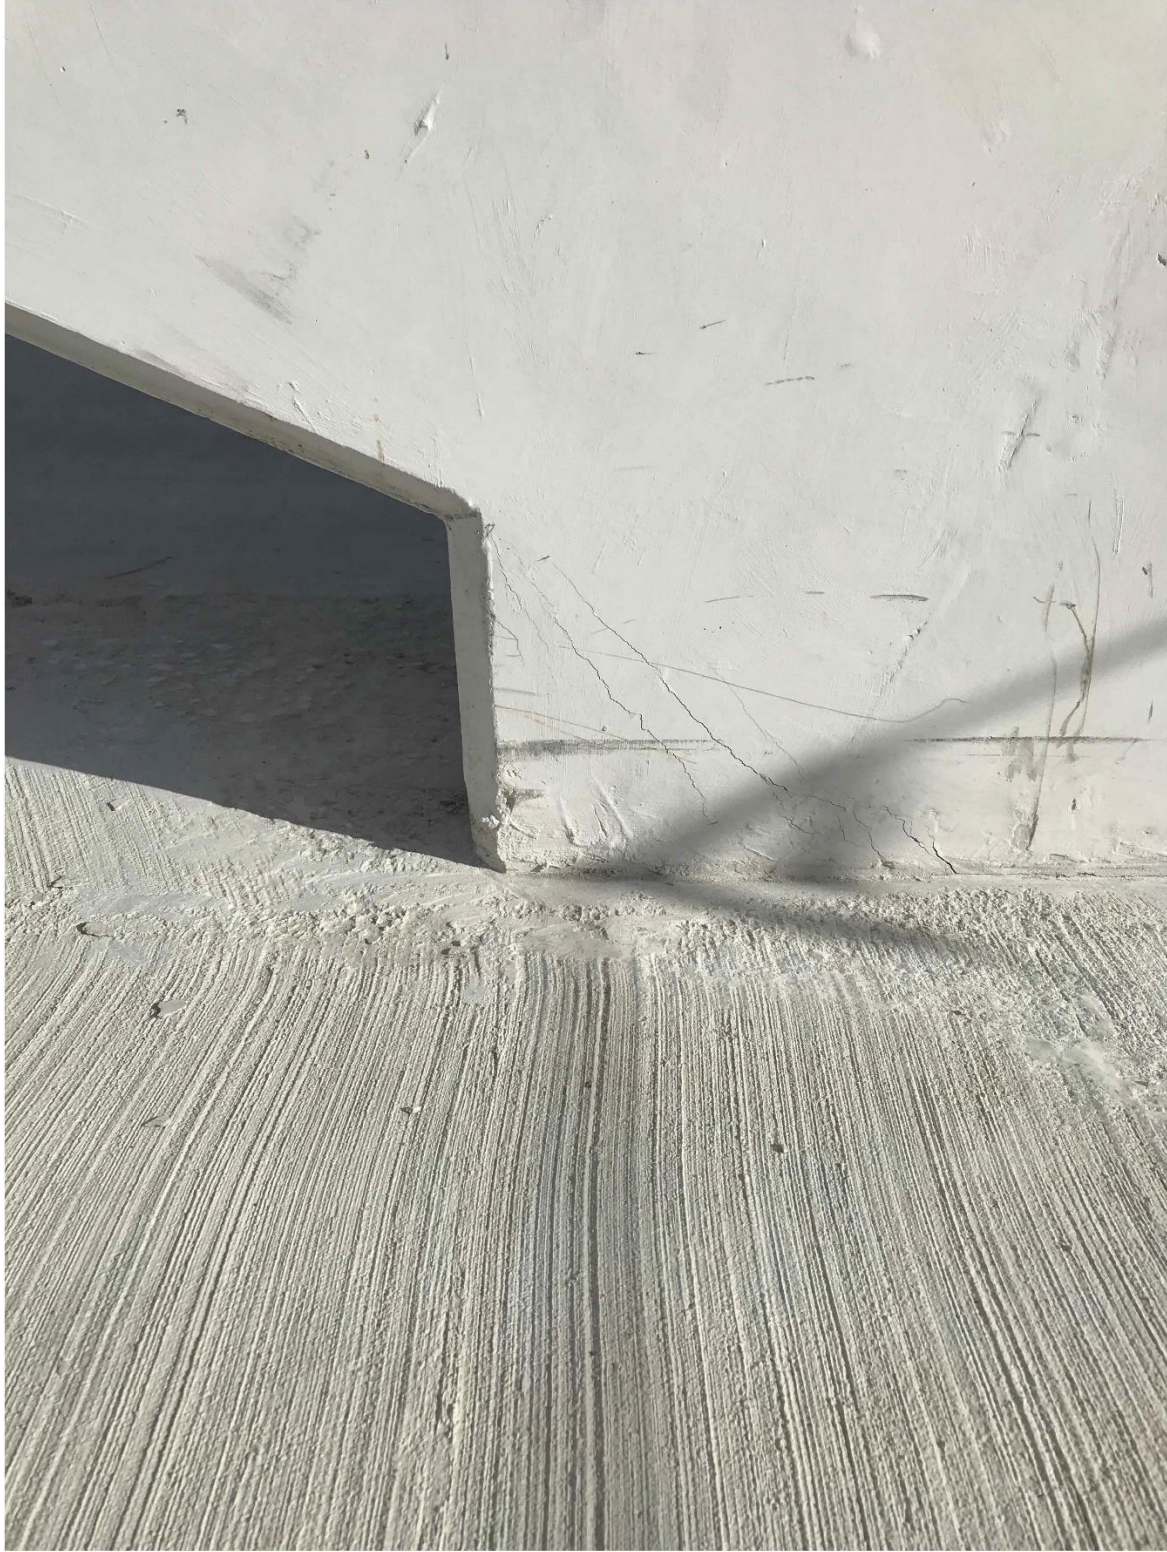
Bridge Factors Photo 44 – View of cracks at the bottom of diagonal support #2 on south side looking to the north in casting yard on 2/26/18 at 8:39:52 a.m. (Source: Munilla Construction Management, MCM)

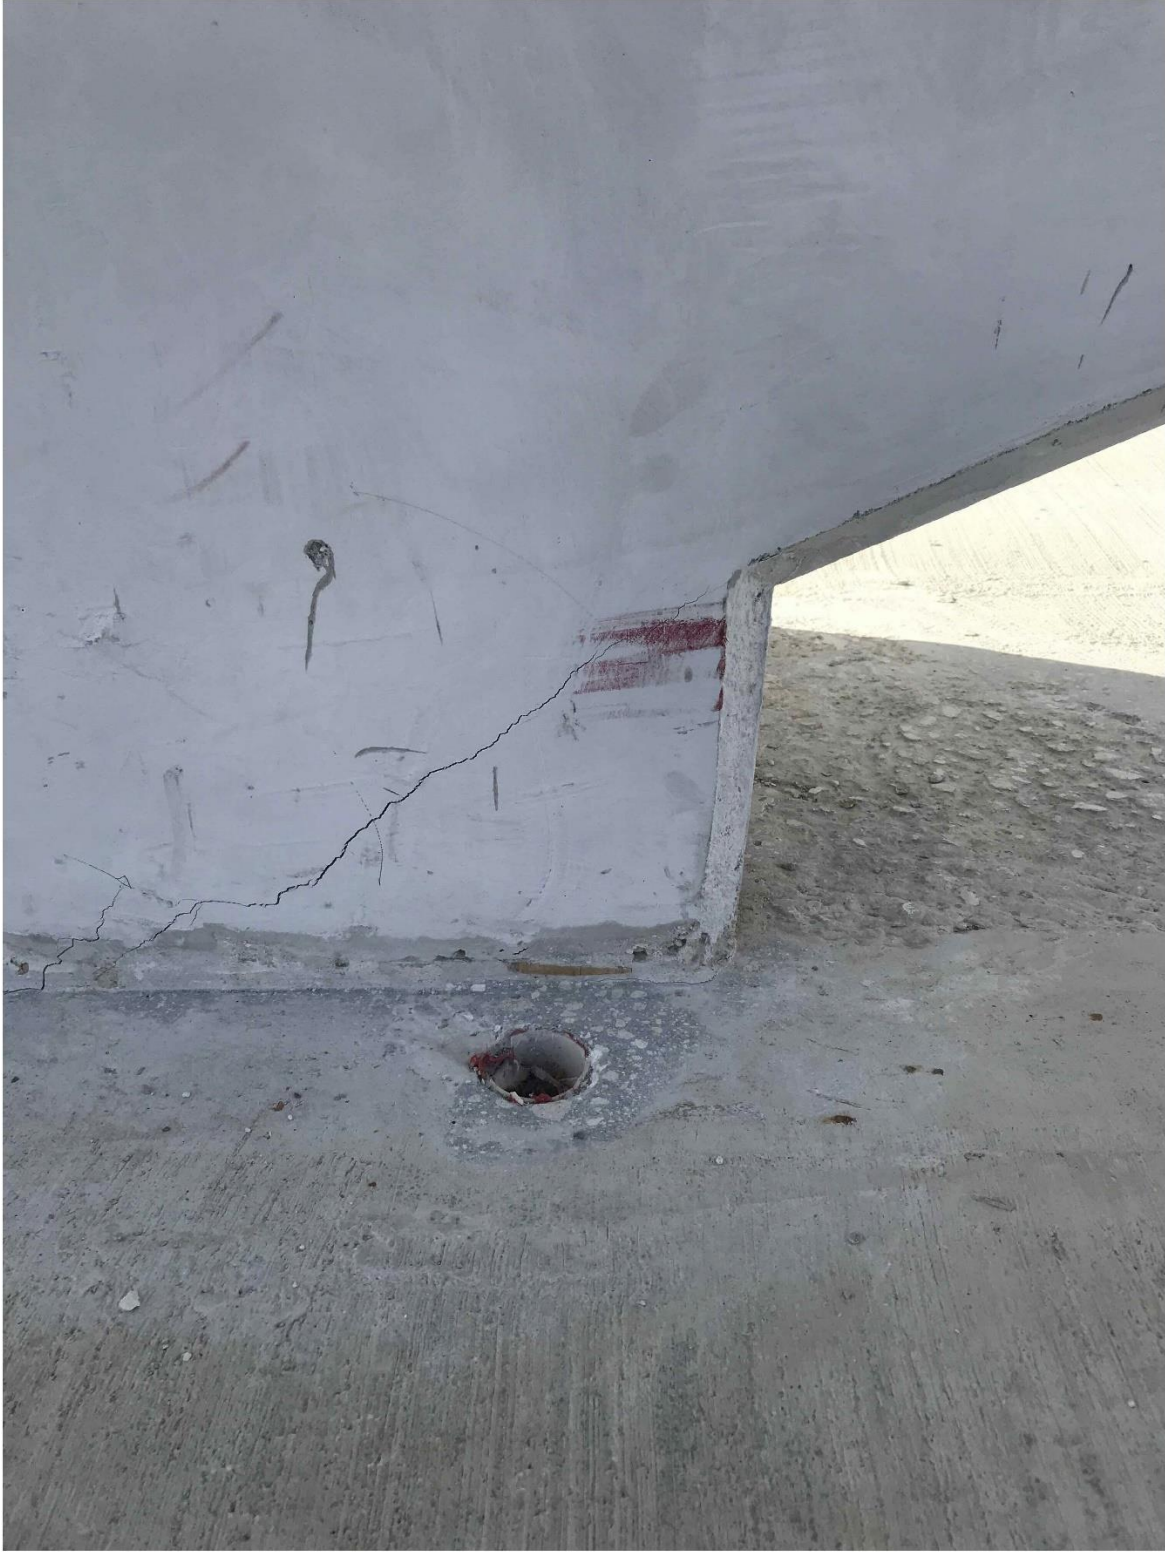
Bridge Factors Photo 45 – View of crack at the bottom of diagonal support #2 on north side looking to the south in casting yard on 2/26/18 at 8:40:08 a.m. (Source: Munilla Construction Management, MCM)

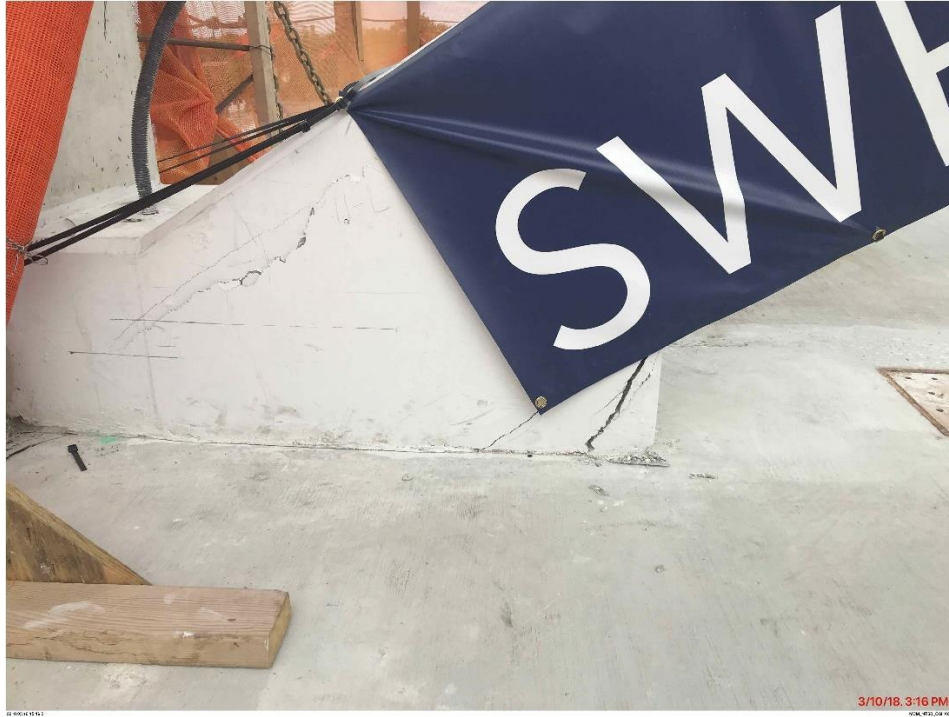
Bridge Factors Photo 62 – View of cracks at the bottom of diagonal support #11 on west side looking to the east on 3/10/18 at 3:16 p.m. (Source: Munilla Construction Management, MCM)

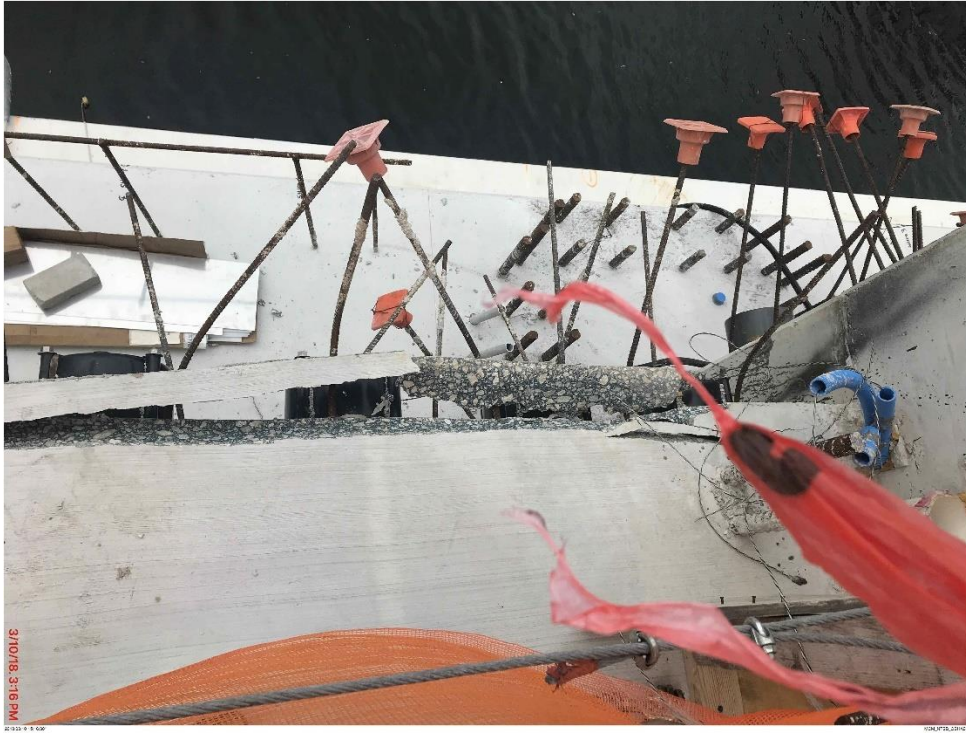
Bridge Factors Photo 63 – Top view of cracks along west side of Diaphragm II on 3/10/18 at 3:16 p.m. (Source: Munilla Construction Management, MCM)

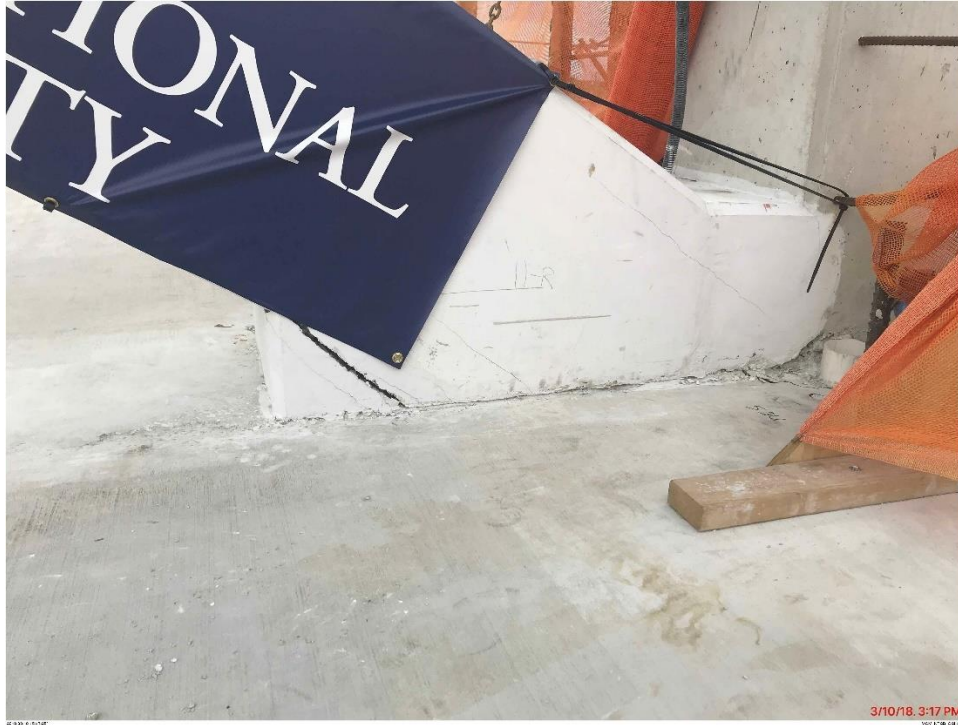
Bridge Factors Photo 64 – View of cracks at the bottom of diagonal support #11 on east side looking to the west on 3/10/18 at 3:17 p.m. (Source: Munilla Construction Management, MCM)

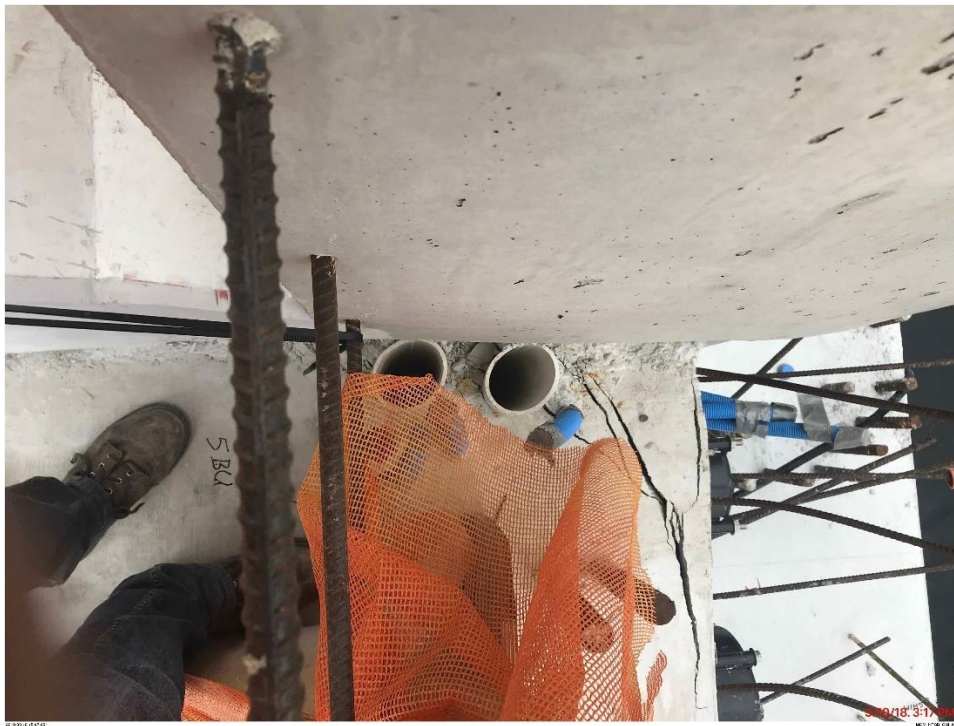
Bridge Factors Photo 65 – Top view of cracks along east side of Diaphragm II on 3/10/18 at 3:17 p.m. (Source: Munilla Construction Management, MCM)

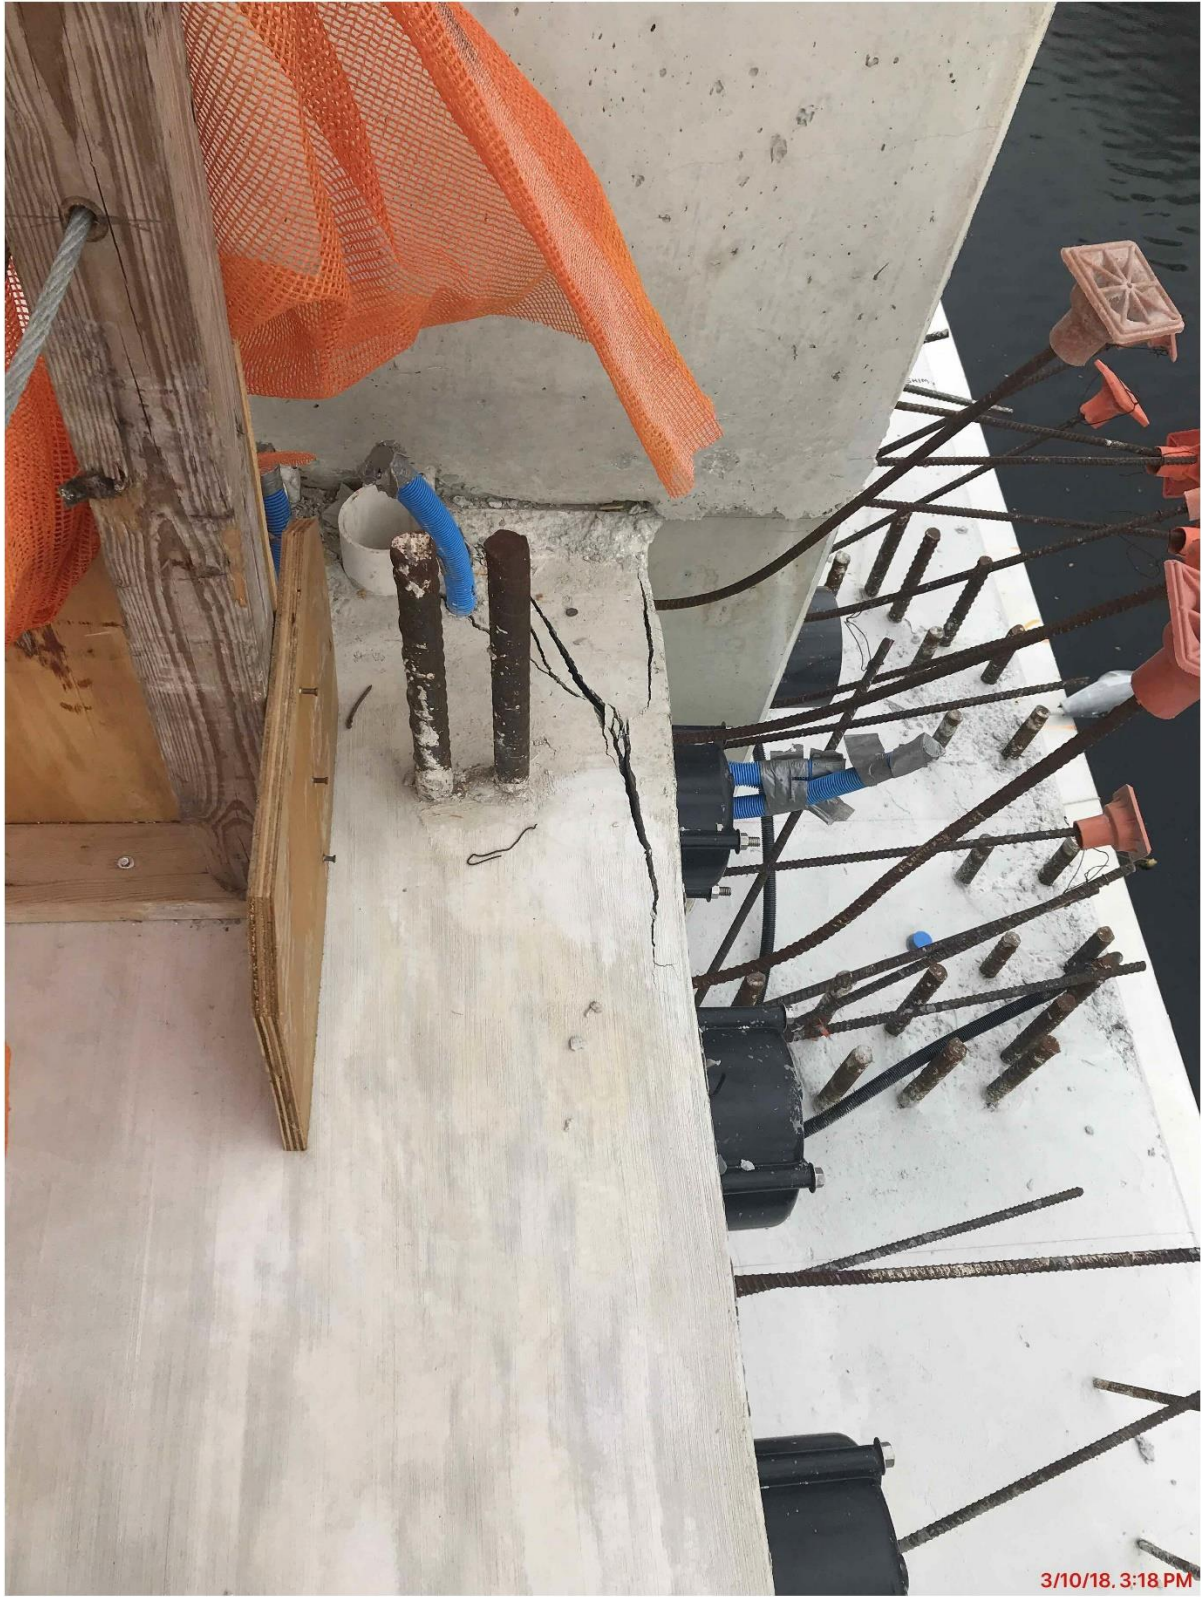
Bridge Factors Photo 66 – Top view of cracks along east side of Diaphragm II on 3/10/18 at 3:18 p.m. (Source: Munilla Construction Management, MCM)

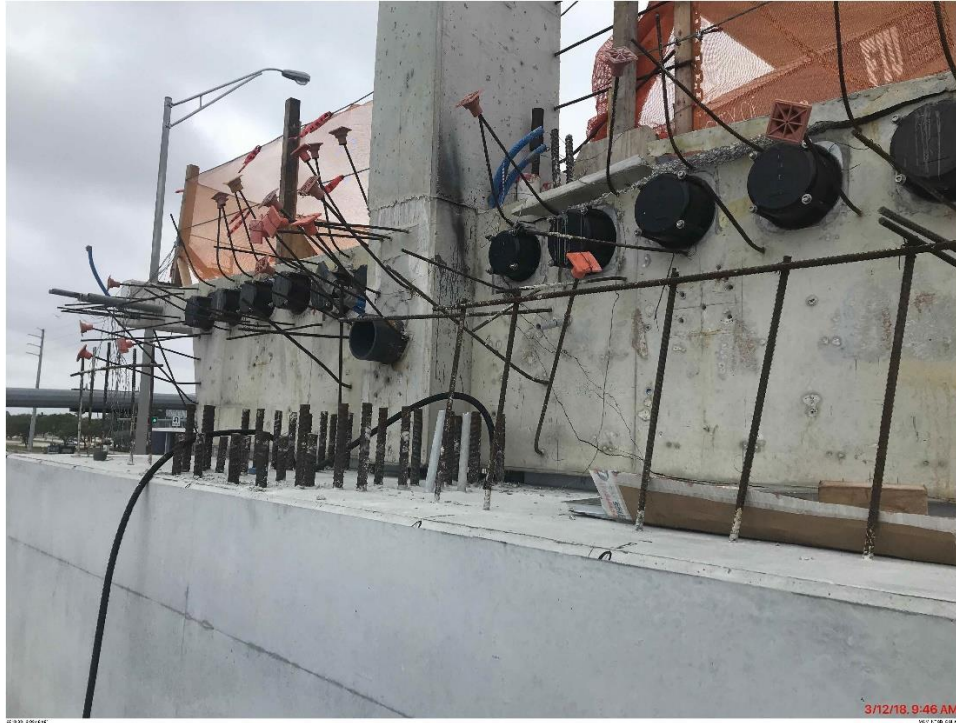
Bridge Factors Photo 67 – View of cracks on north face of Diaphragm II on west side on 3/12/18 at 9:46 a.m. (Source: Munilla Construction Management, MCM)

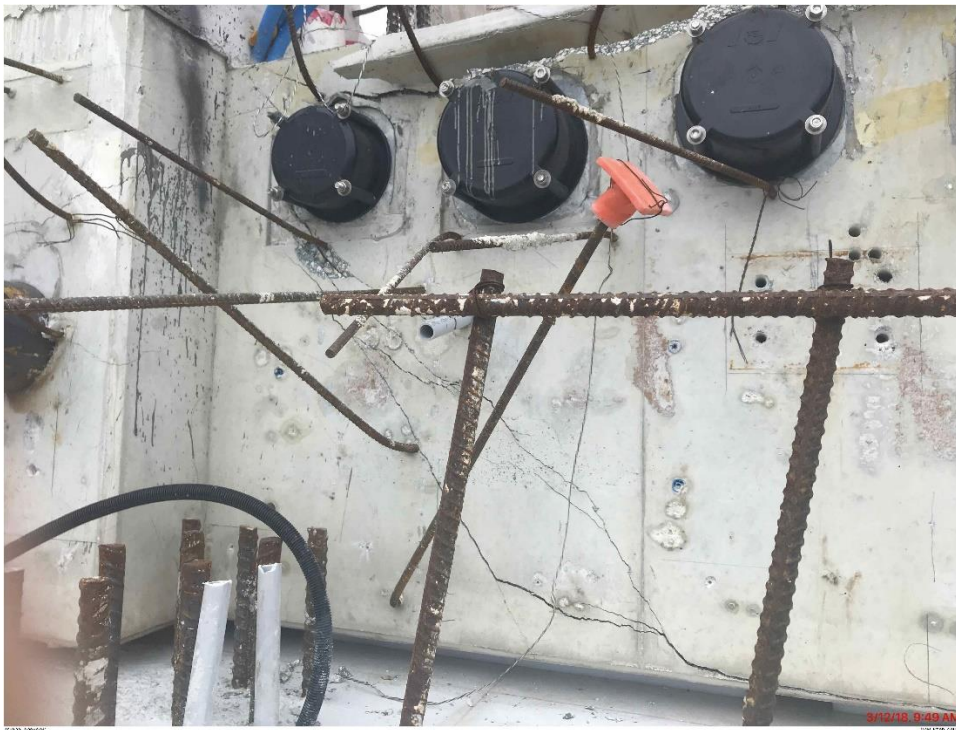
Bridge Factors Photo 68 – View of cracks on north face of Diaphragm II on west side on 3/12/18 at 9:49 a.m. (Source: Munilla Construction Management, MCM)

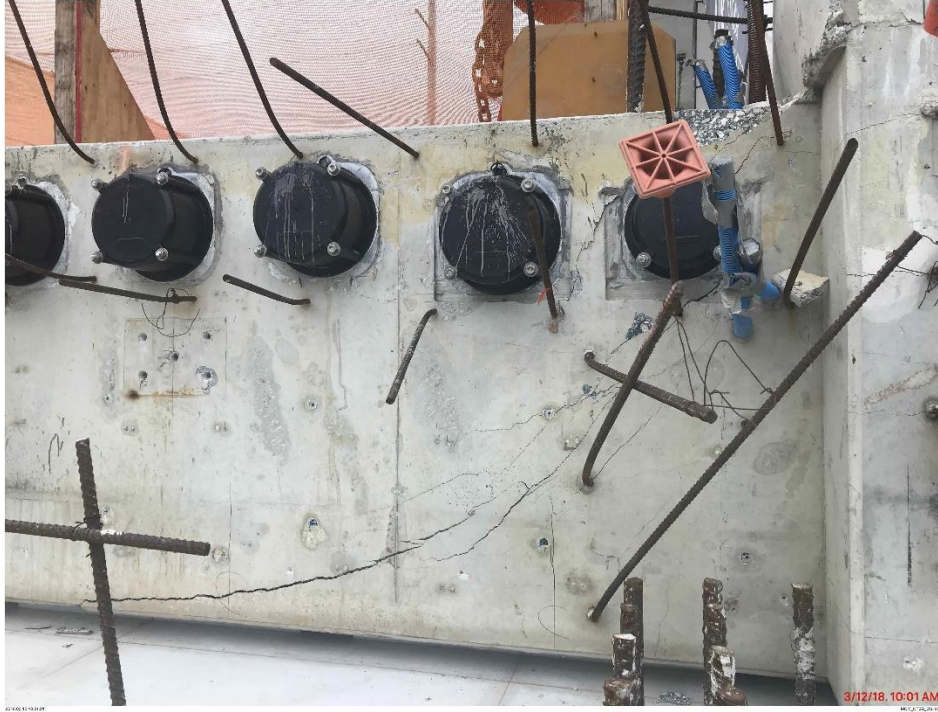
Bridge Factors Photo 69 – View of cracks on north face of Diaphragm II on east side on 3/12/18 at 10:01 a.m. (Source: Munilla Construction Management, MCM)

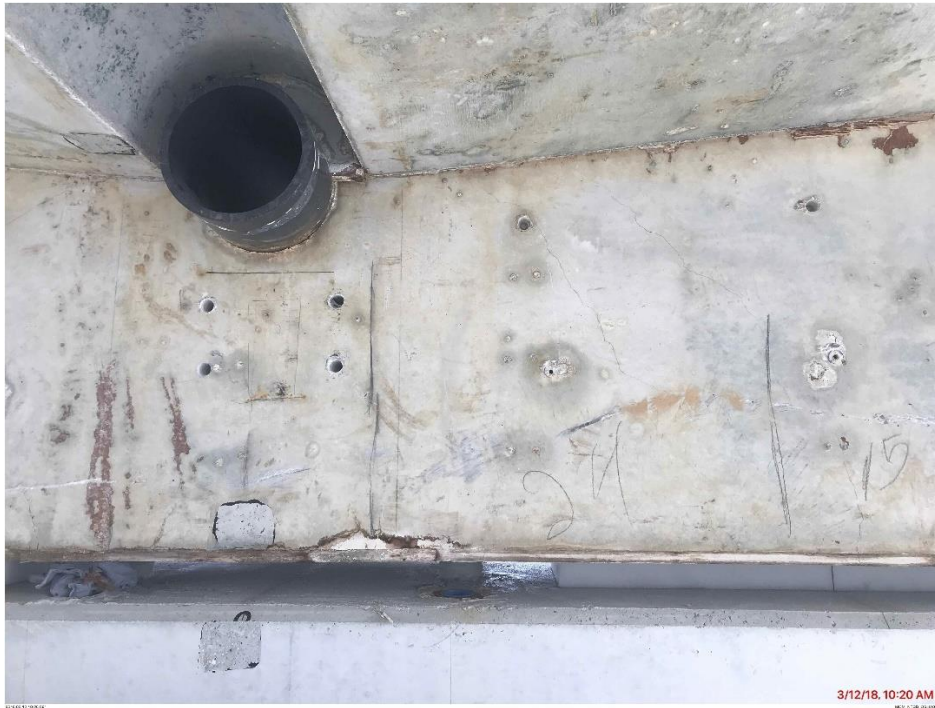
Bridge Factors Photo 70 – View of cracks on south face of Diaphragm II on east side on 3/12/18 at 10:20 a.m. (Source: Munilla Construction Management, MCM)

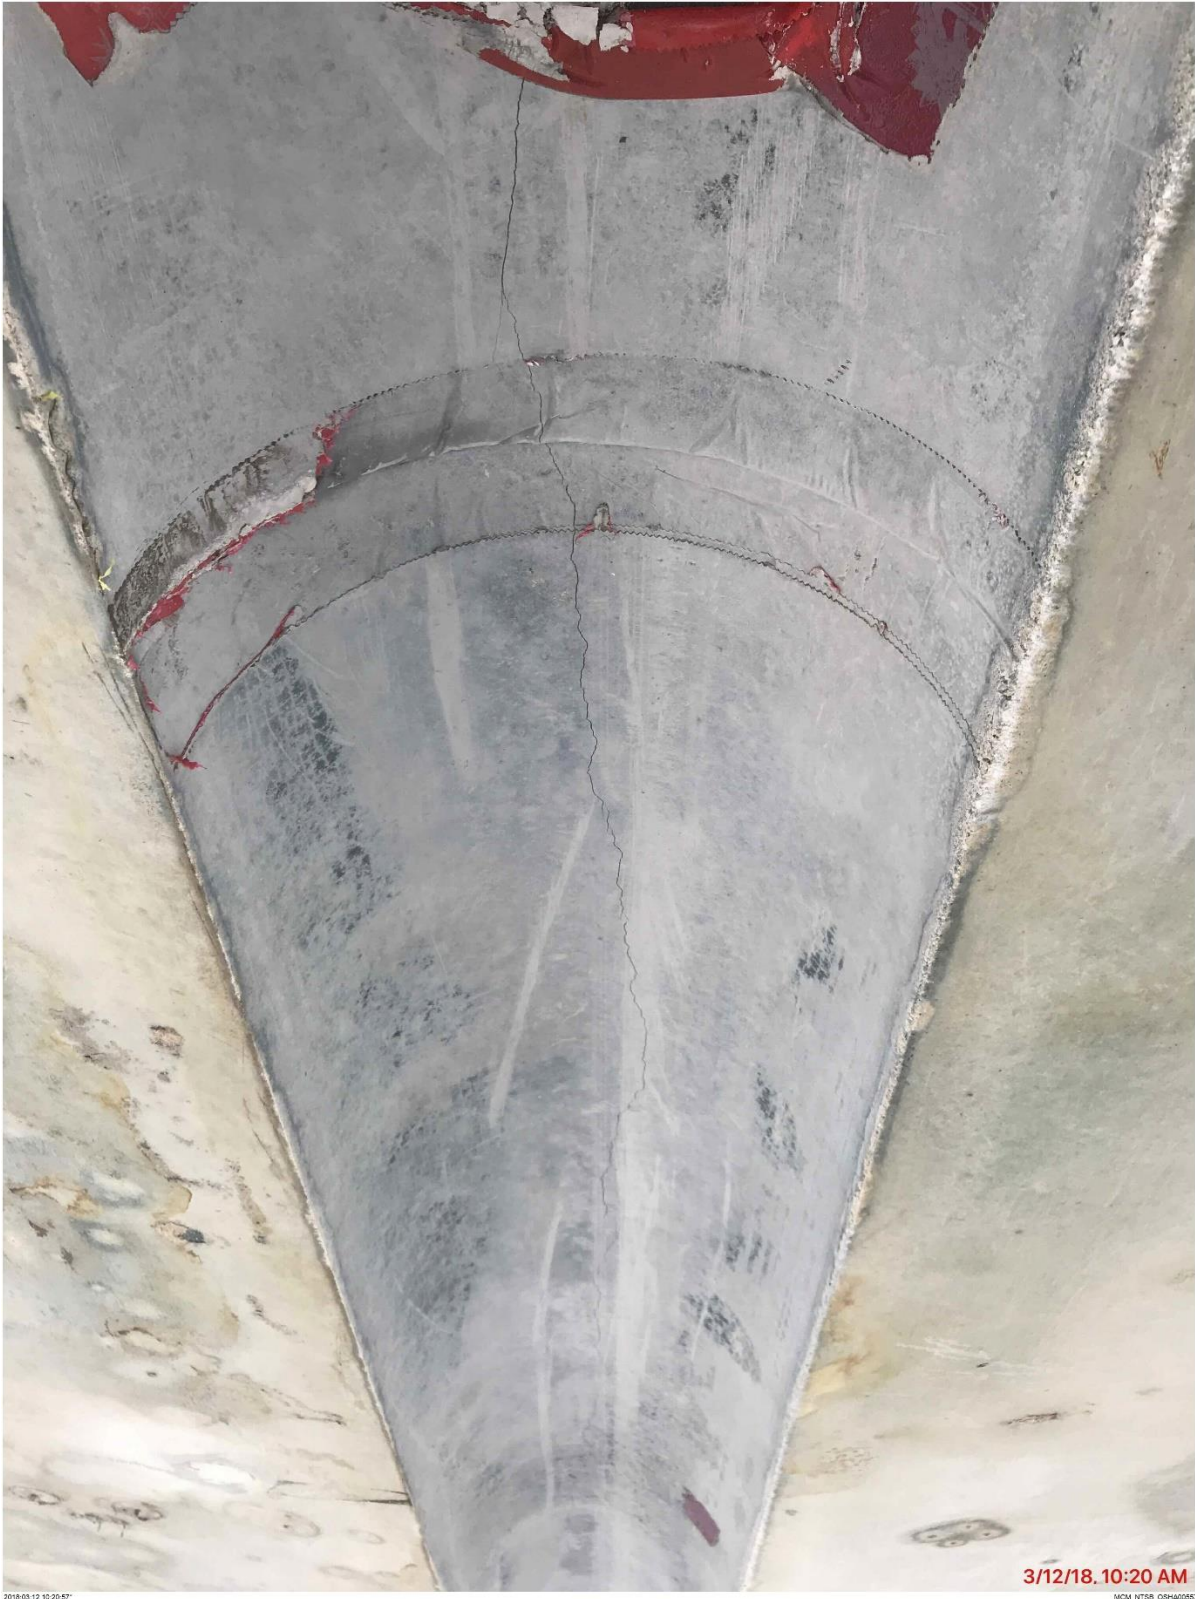
Bridge Factors Photo 71 – View of crack in cut-out for drain pipe under deck on 3/12/18 at 10:20 a.m. (Source: Munilla Construction Management, MCM)

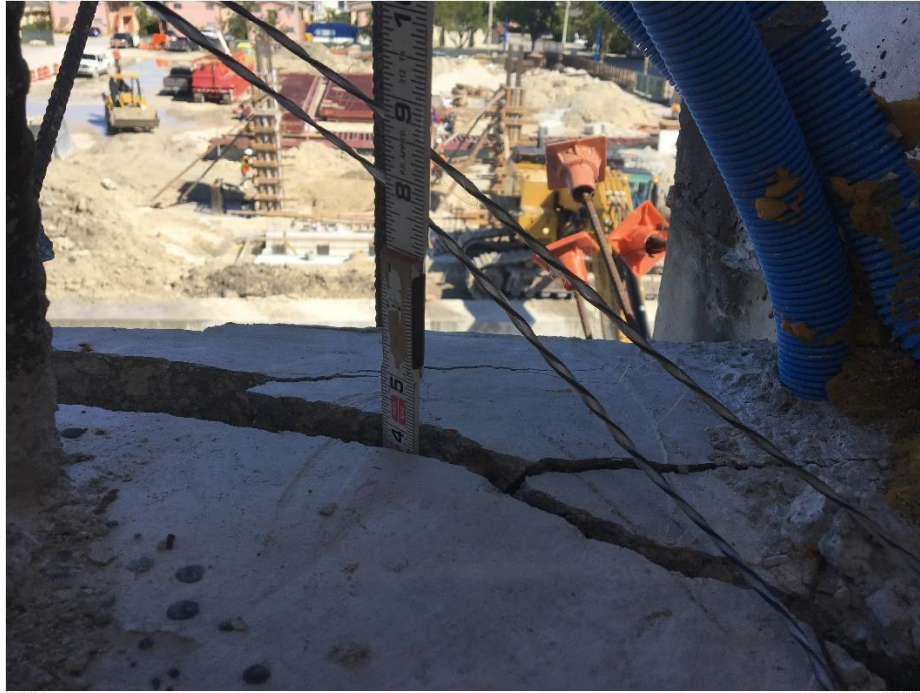
Bridge Factors Photo 74 – View of cracks along west side of Diaphragm II looking to the north showing crack is approximately 4 inches deep on 3/13/18 at 11:16:50 a.m. (Source: Munilla Construction Management, MCM)

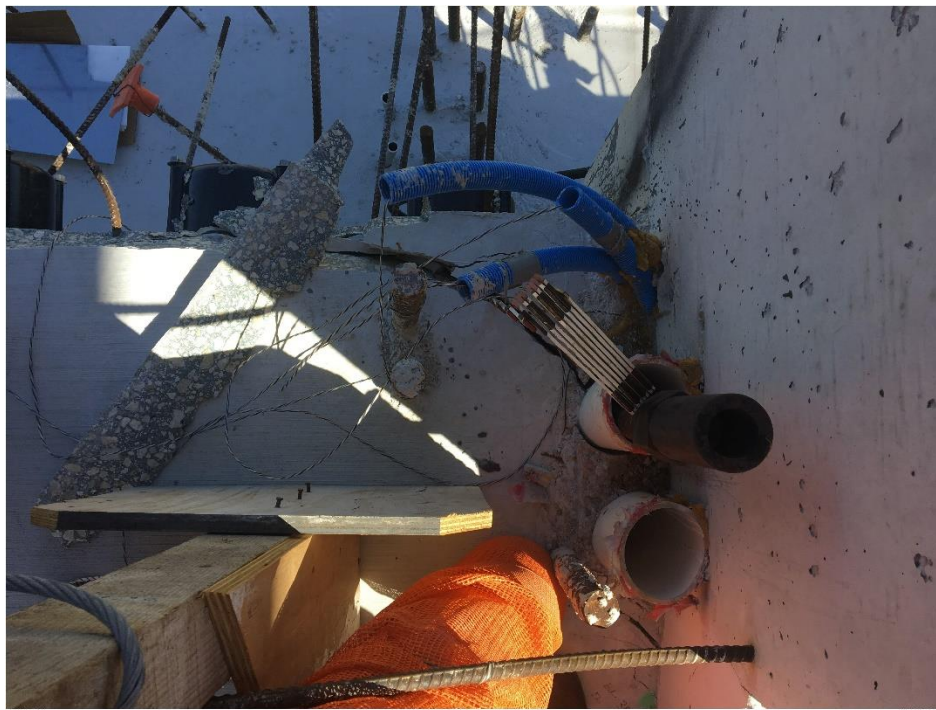
Bridge Factors Photo 75 – Top view of cracks along west side of Diaphragm II on 3/13/18 at 11:17:04 a.m. (Source: Munilla Construction Management, MCM)

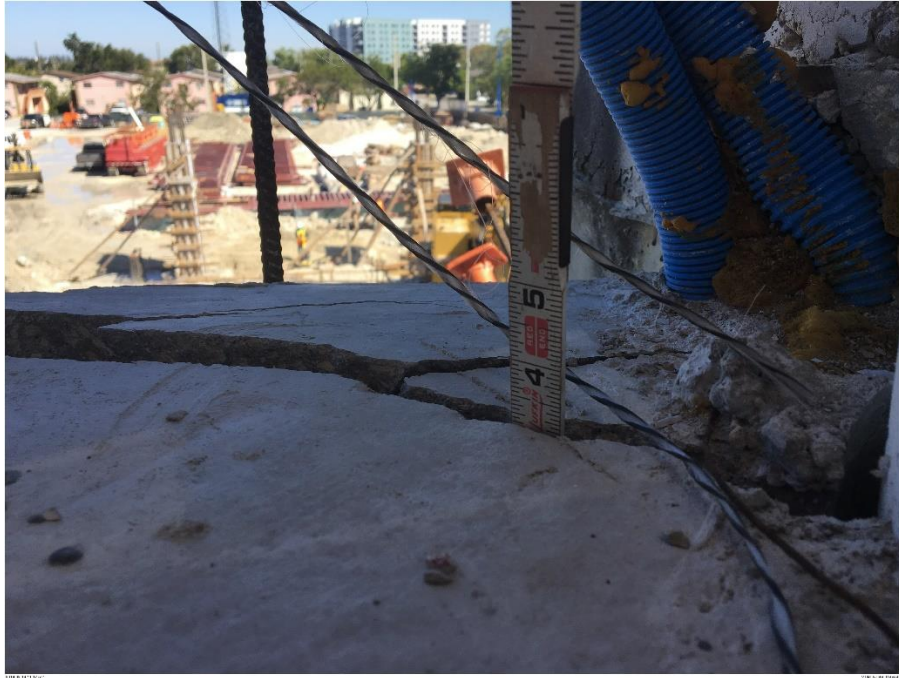
Bridge Factors Photo 76 – View of cracks along west side of Diaphragm II looking to the north showing crack is approximately 3 inches deep on 3/13/18 at 11:17:57 a.m. (Source: Munilla Construction Management, MCM)
