**Bridge Factors Photographs 1 through 111**

**Miami, FL**

**HWY18MH009**

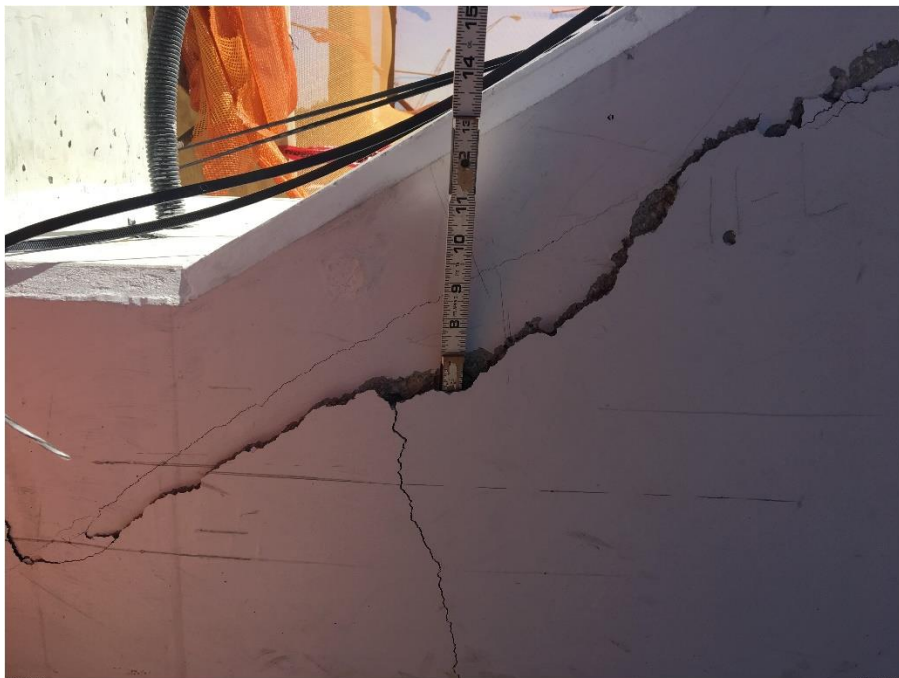
Bridge Factors Photo 77 – View of crack along bottom of diagonal support #11 on west side showing crack is approximately 6 inches deep on 3/13/18 at 11:18:50 a.m. (Source: Munilla Construction Management, MCM)

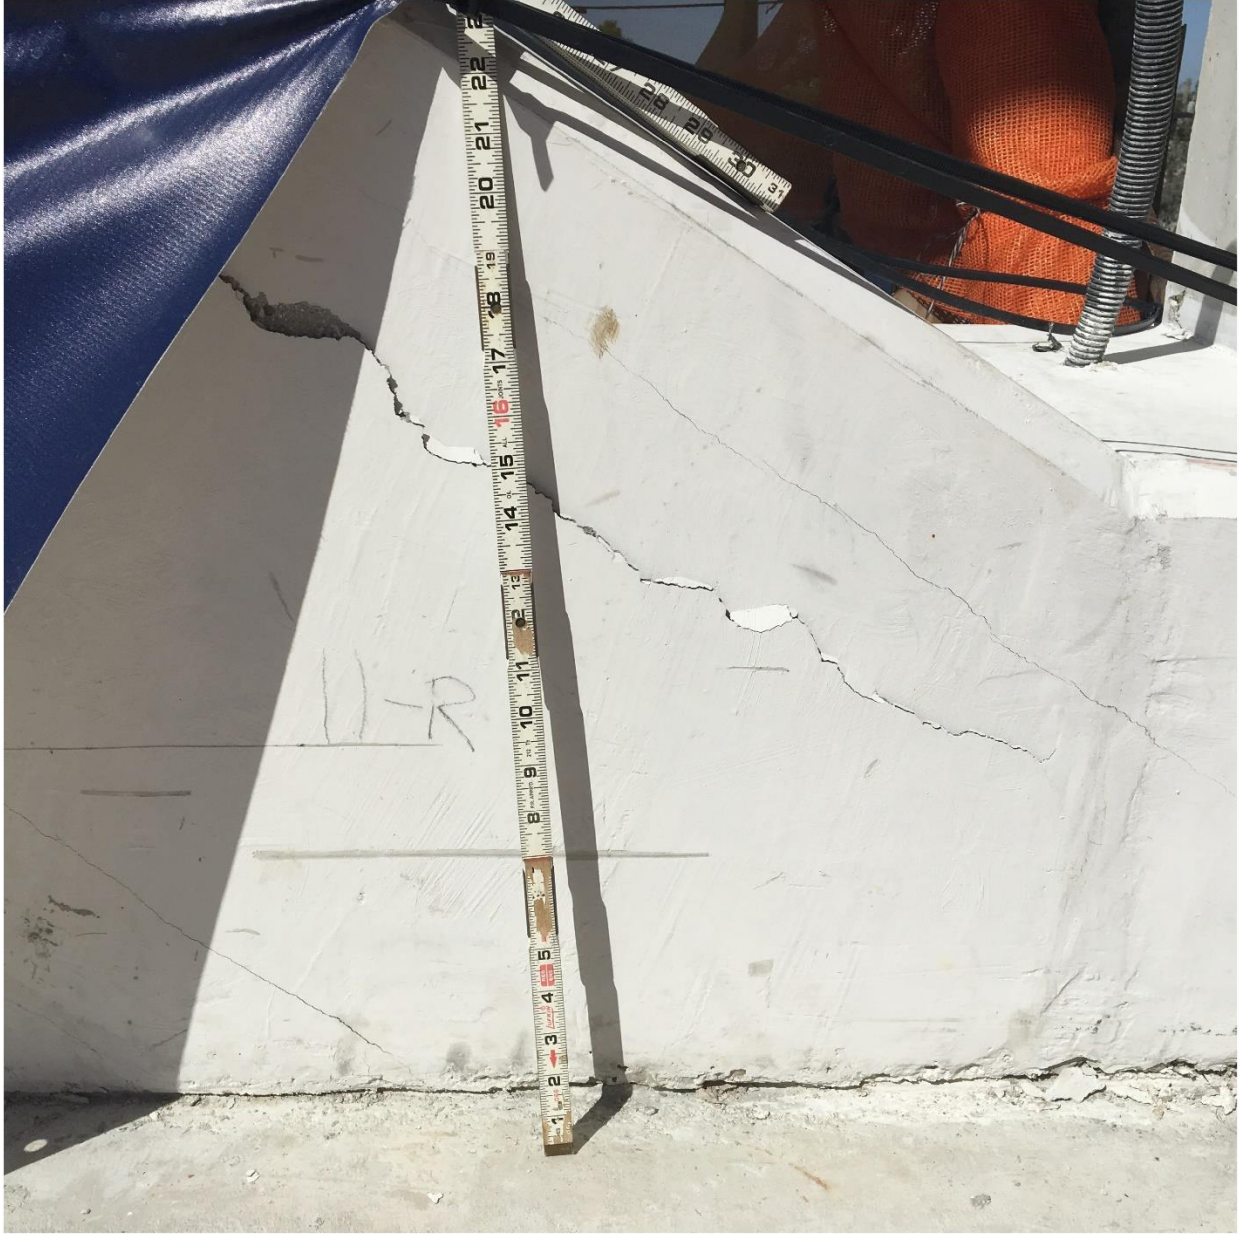
Bridge Factors Photo 78 – View of crack along bottom of diagonal support #11 on east side on 3/13/18 at 11:20:19 a.m. (Source: Munilla Construction Management, MCM)

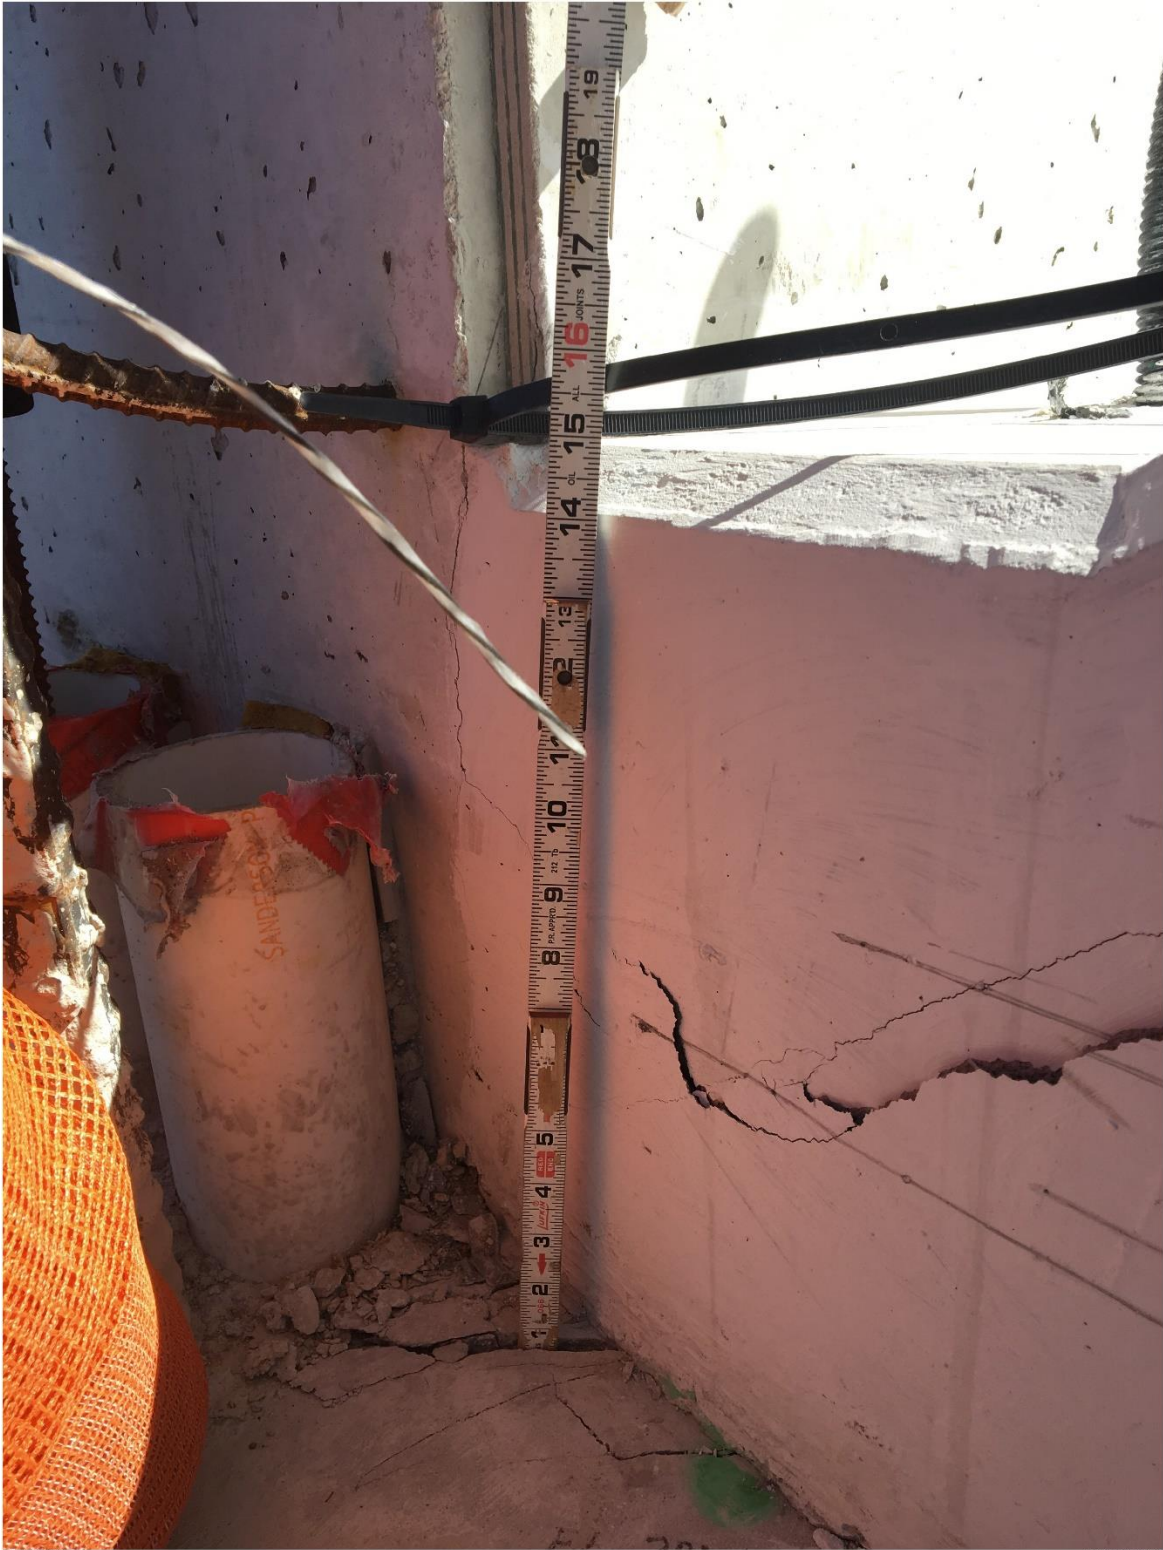
Bridge Factors Photo 79 – View of crack in Node #11/#12 region on west side showing crack is approximately 1 inch deep on 3/13/18 at 11:25:33 a.m. (Source: Munilla Construction Management, MCM)

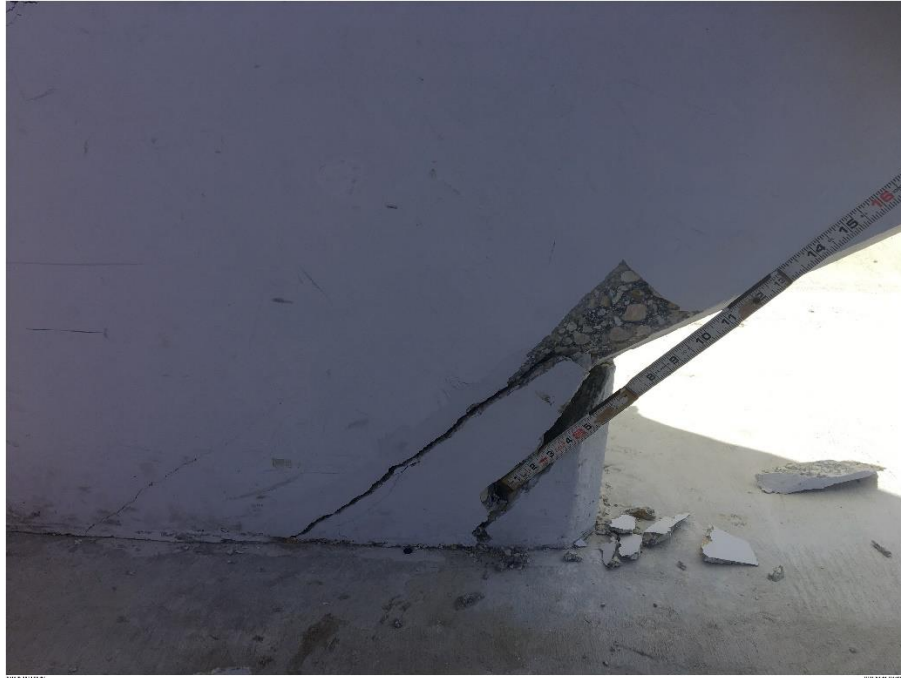
Bridge Factors Photo 80 – View of cracks at the bottom of diagonal support #11 on west side looking to the east showing folding rule inside crack on 3/13/18 at 11:26:36 a.m. (Source: Munilla Construction Management, MCM)

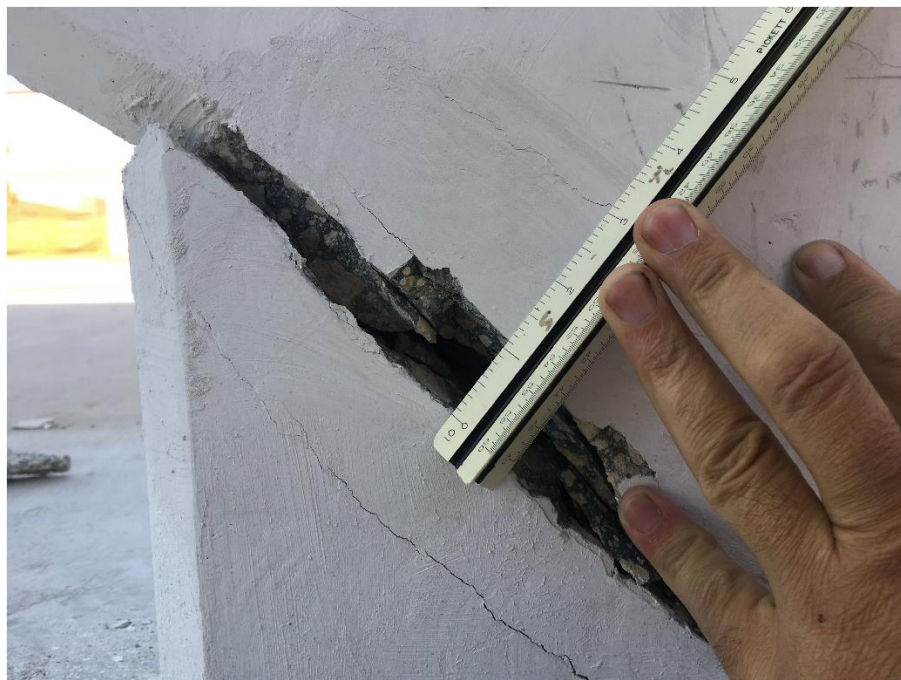
Bridge Factors Photo 81 – View of crack at the bottom of diagonal support #11 on east side looking to the west showing crack is 1 inch wide at one location on 3/13/18 at 1:02:14 p.m. (Source: Munilla Construction Management, MCM)

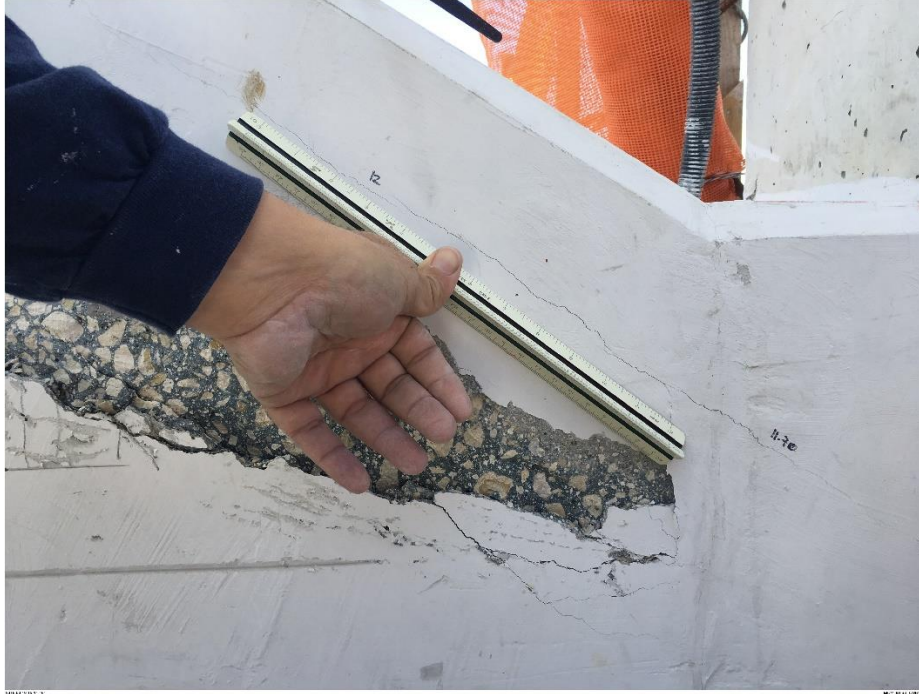
Bridge Factors Photo 82 – View of cracks and delamination at the bottom of diagonal support #11 on east side looking to the west on 3/13/18 at 1:11:16 p.m. (Source: Munilla Construction Management, MCM)

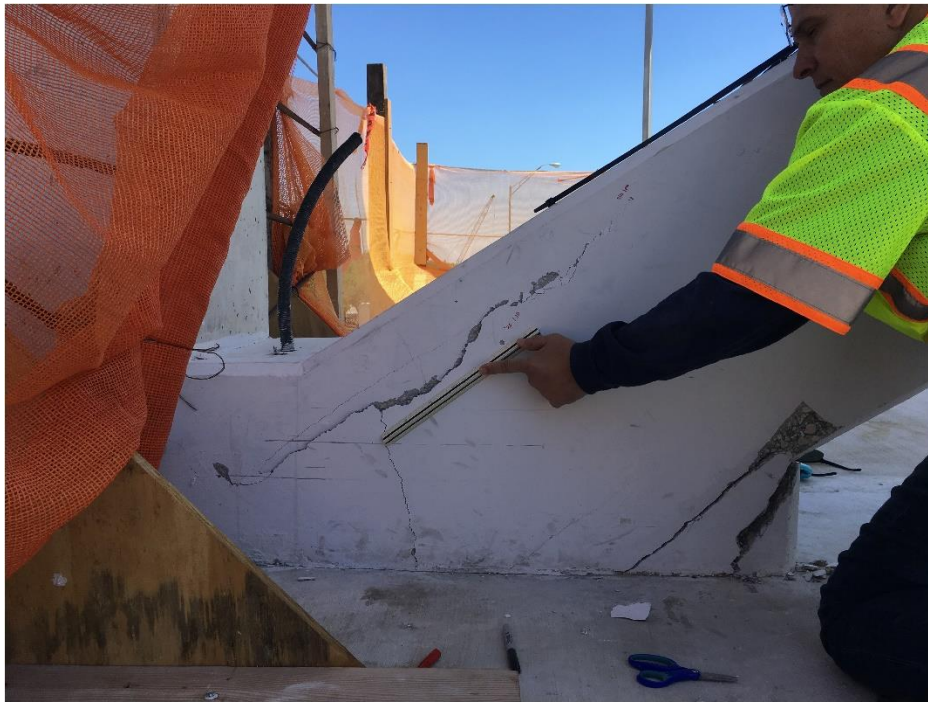
Bridge Factors Photo 83 – View of cracks at the bottom of diagonal support #11 on west side looking to the east on 3/13/18 at 1:17:46 p.m. (Source: Munilla Construction Management, MCM)

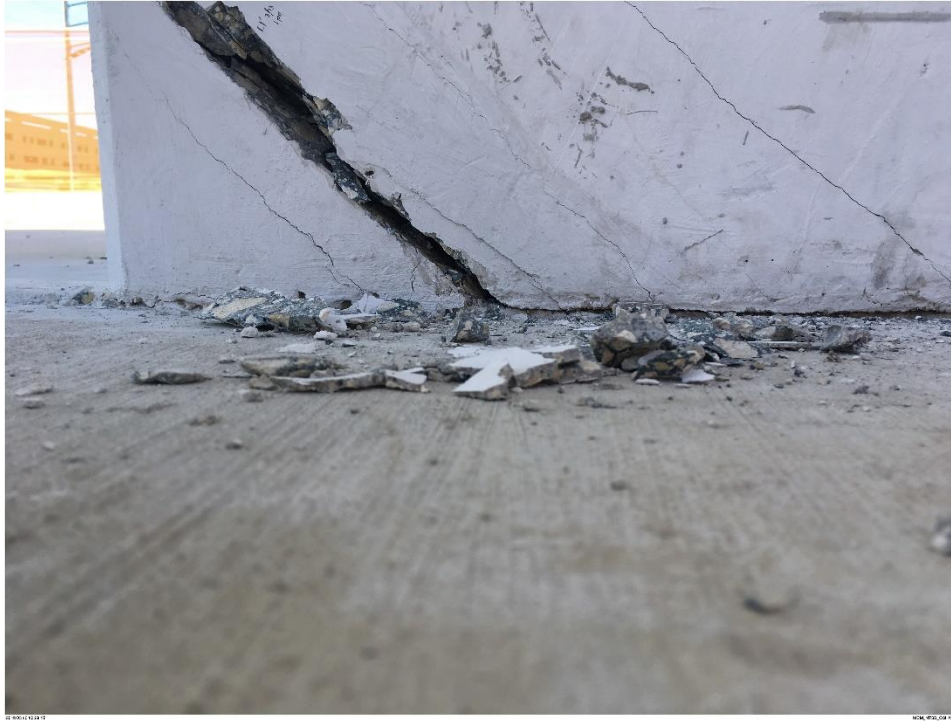
Bridge Factors Photo 84 – View of cracks at the bottom of diagonal support #11 on east side looking to the west on 3/13/18 at 1:29:15 p.m. (Source: Munilla Construction Management, MCM)

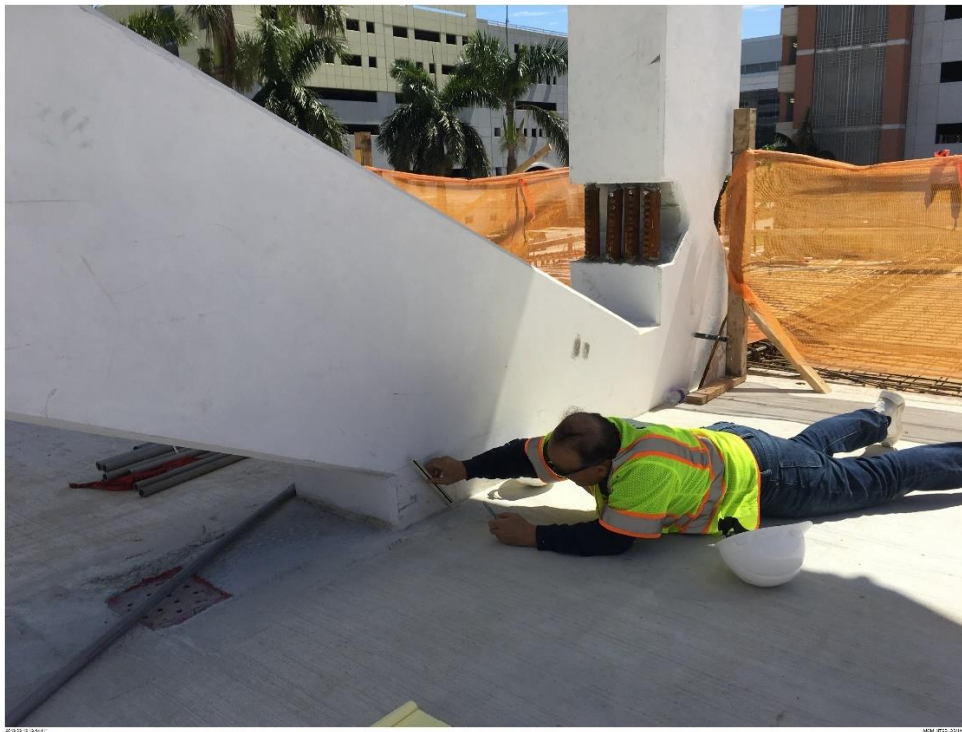
Bridge Factors Photo 85 – View of cracks at the bottom of diagonal support #2 on west side looking to the southeast on 3/13/18 at 1:44:41 p.m. (Source: Munilla Construction Management, MCM)

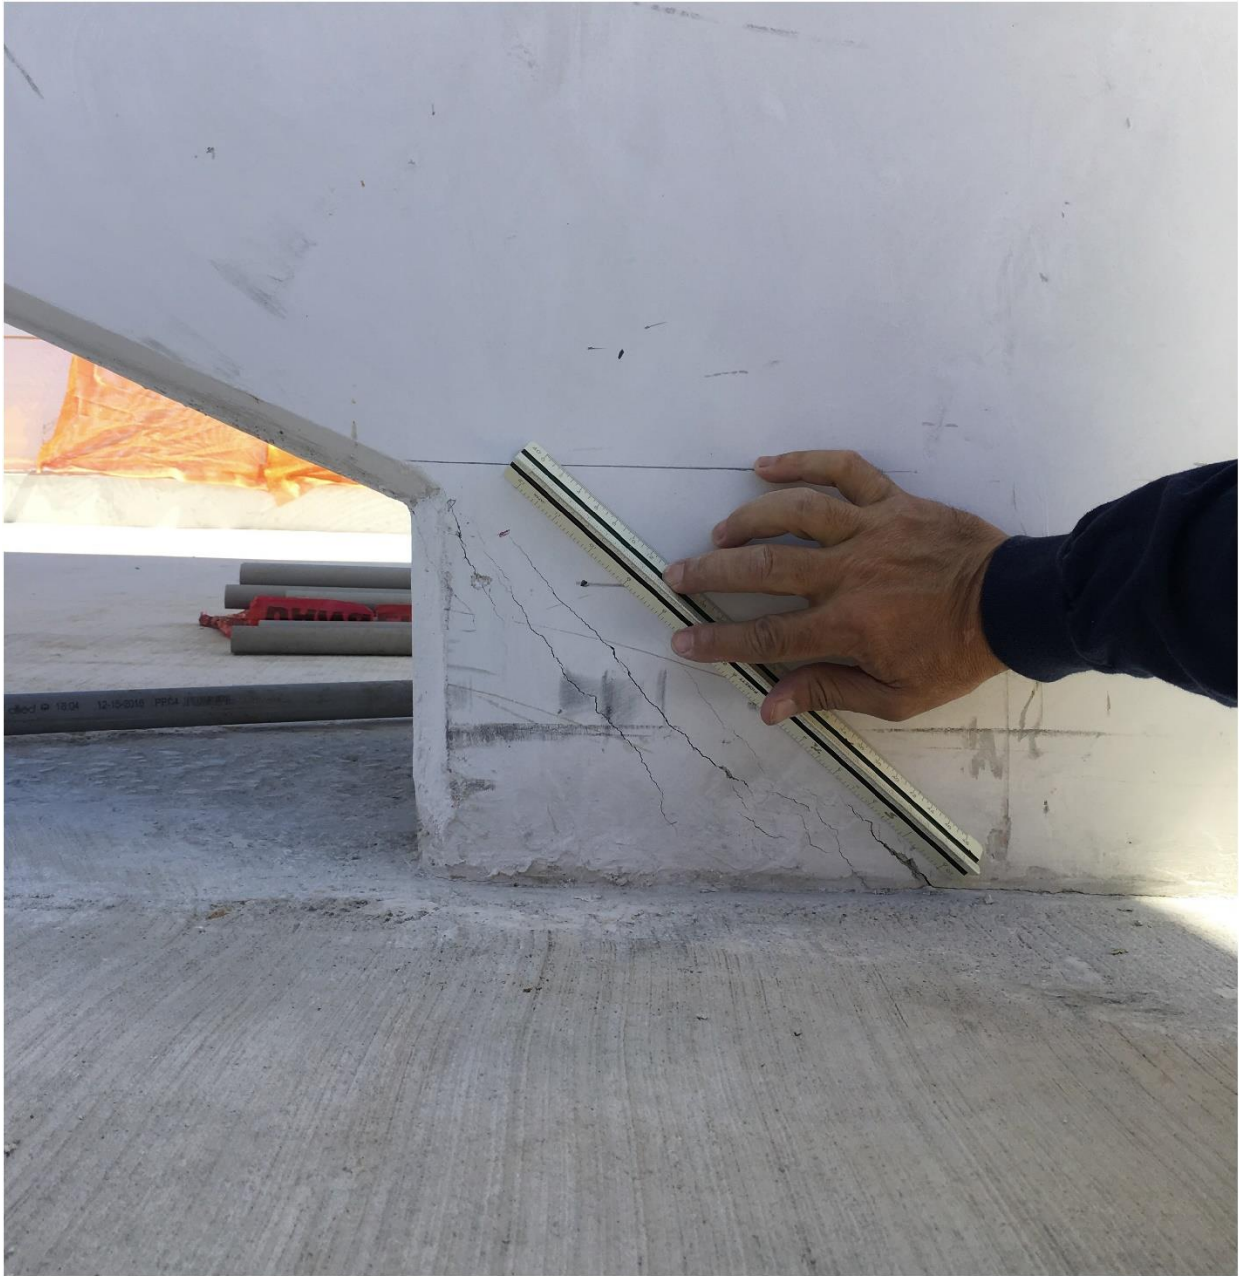
**Bridge Factors Photo 86 – View of cracks at the bottom of diagonal support #2 on west side looking to the east on 3/13/18 at 1:44:53 p.m. (Source: Munilla Construction Management, MCM)**

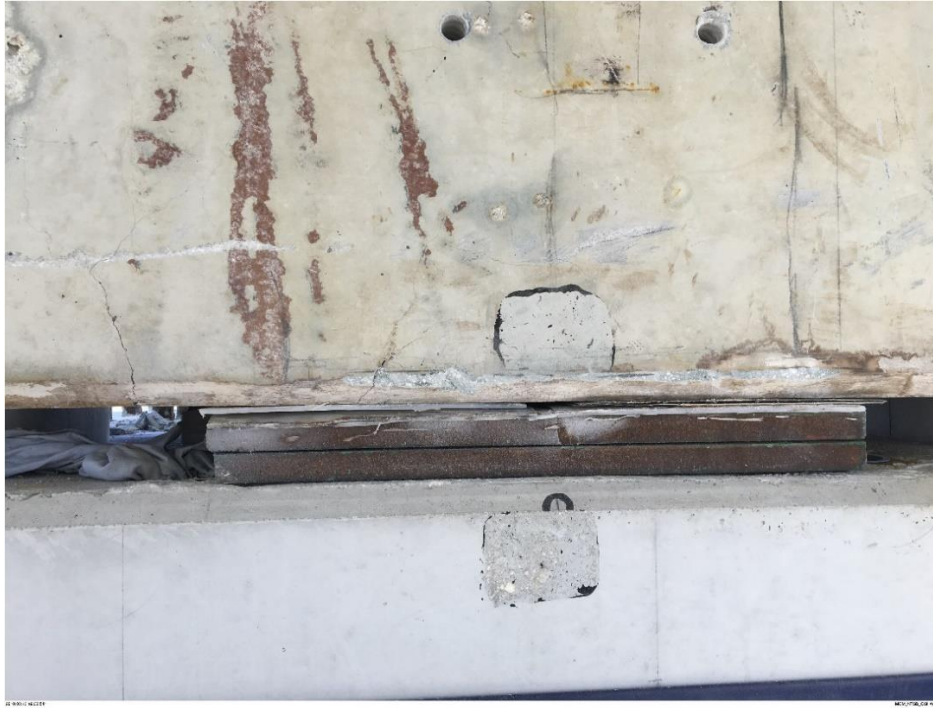
Bridge Factors Photo 87 – View of cracks on south face of Diaphragm II above shim plates on 3/13/18 at 4:32:54 p.m. (Source: Munilla Construction Management, MCM)

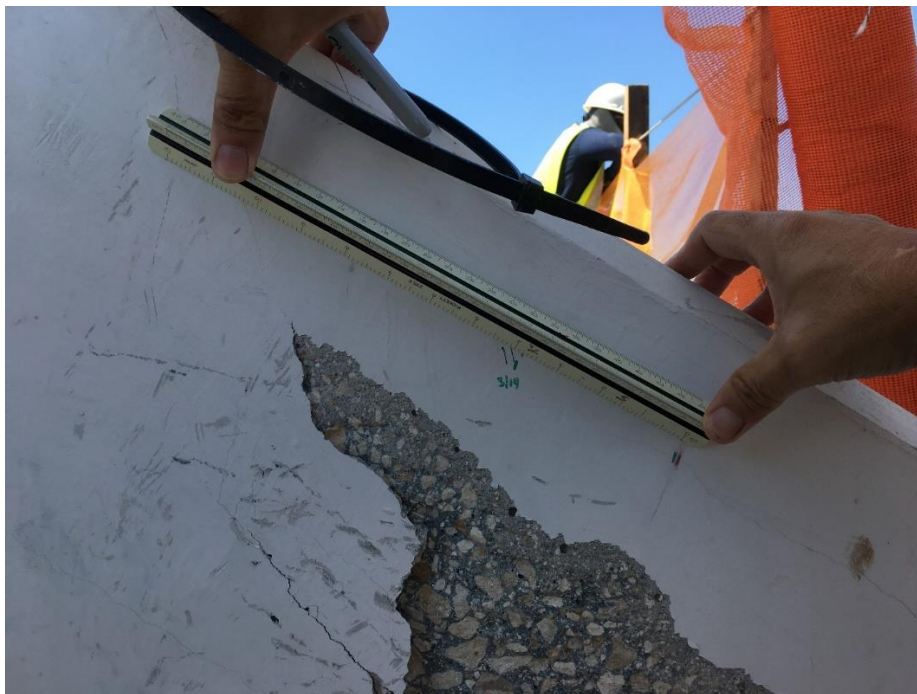
Bridge Factors Photo 88 – View of crack being monitored at the bottom of diagonal support #11 on east side looking to the west on 3/14/18 at 1:42 p.m. (Source: Bolton – Perez and Associates, BPA)

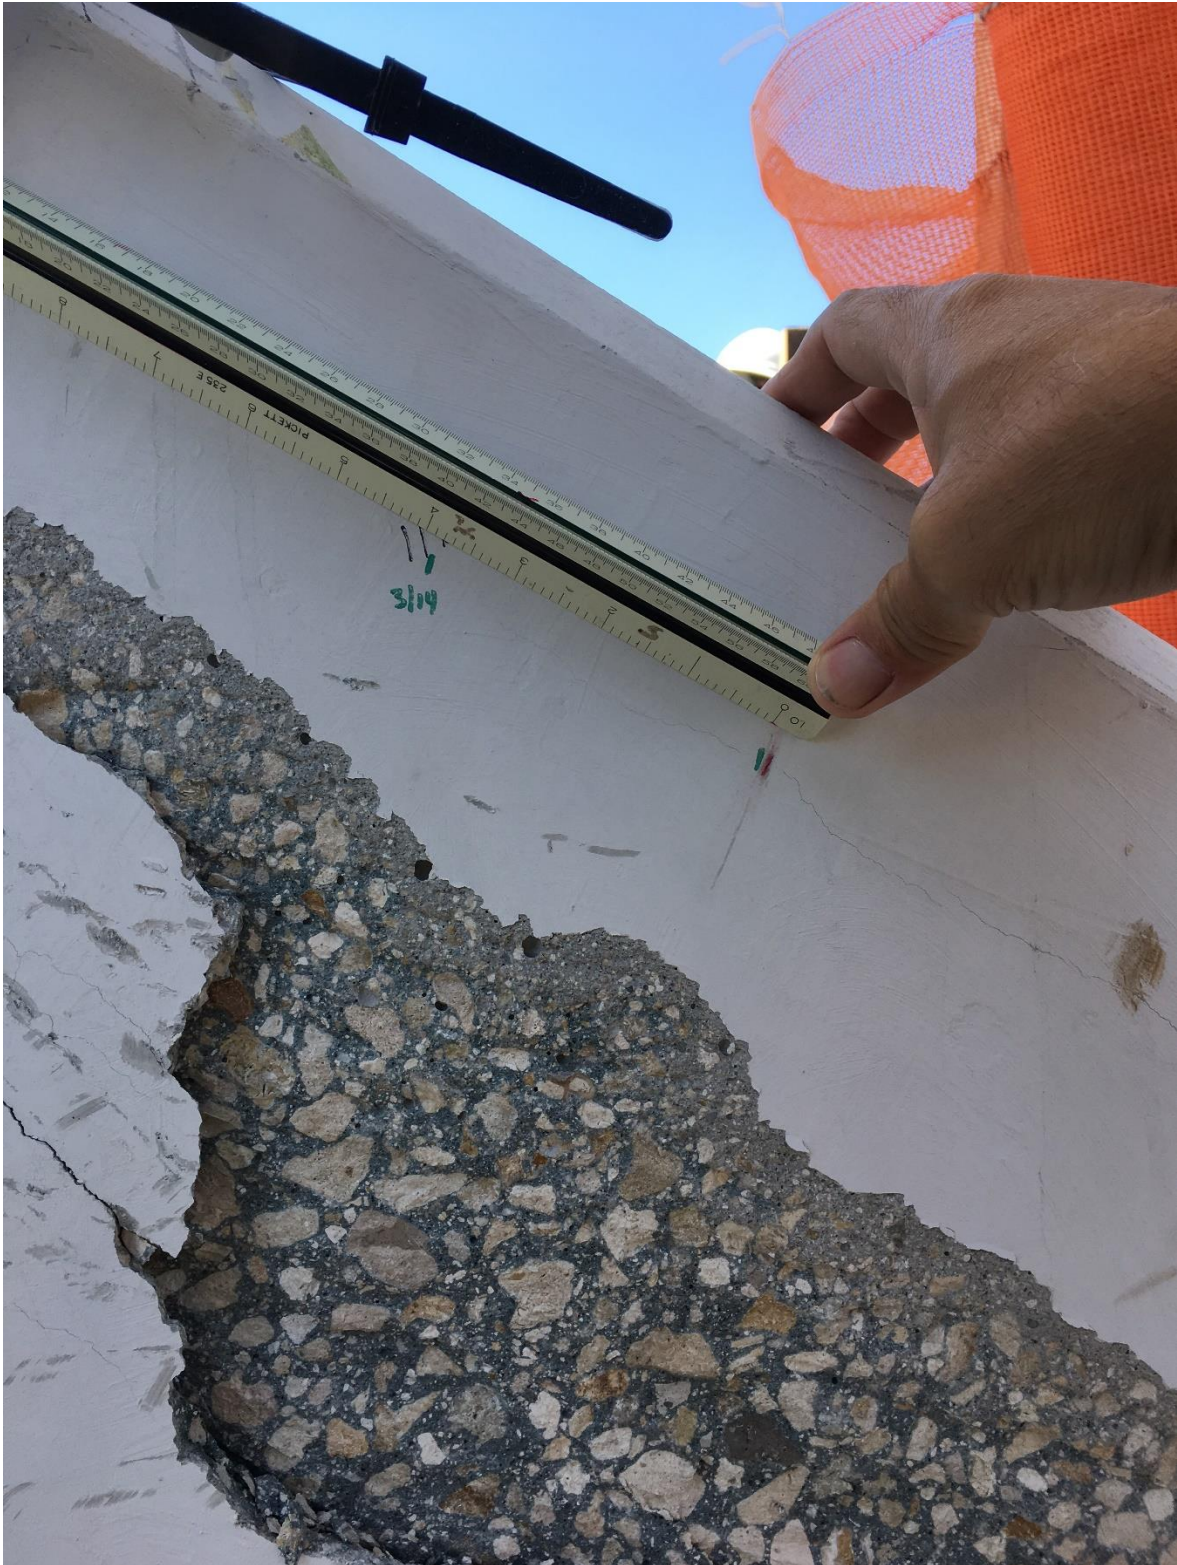
Bridge Factors Photo 89 – View of crack being monitored at the bottom of diagonal support #11 on east side looking to the west on 3/14/18 at 1:42 p.m. (Source: Bolton – Perez and Associates, BPA)

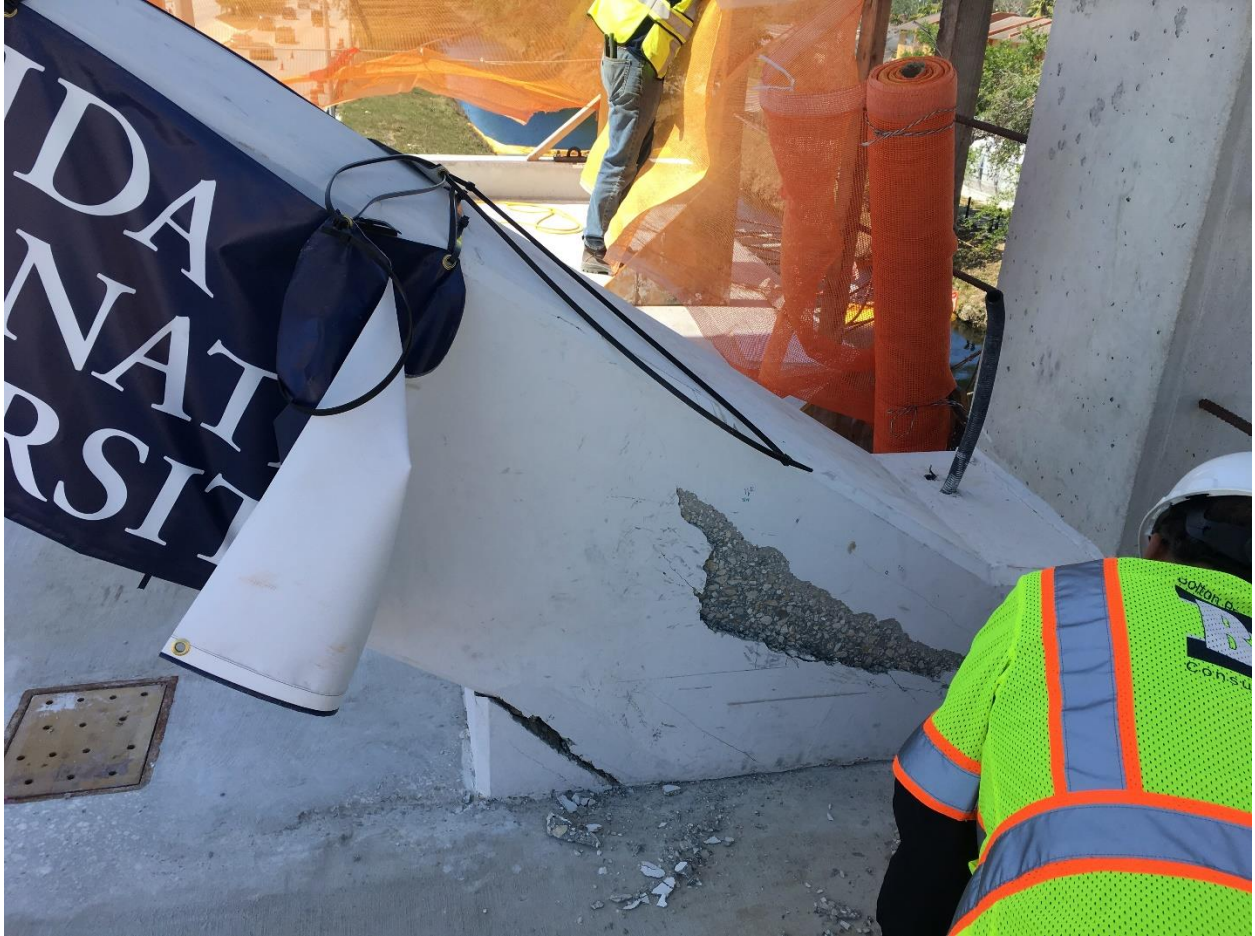
Bridge Factors Photo 90 – View of cracks and delamination at the bottom of diagonal support #11 on east side looking to the west on 3/14/18 at 1:42 p.m. (Source: Bolton – Perez and Associates, BPA)

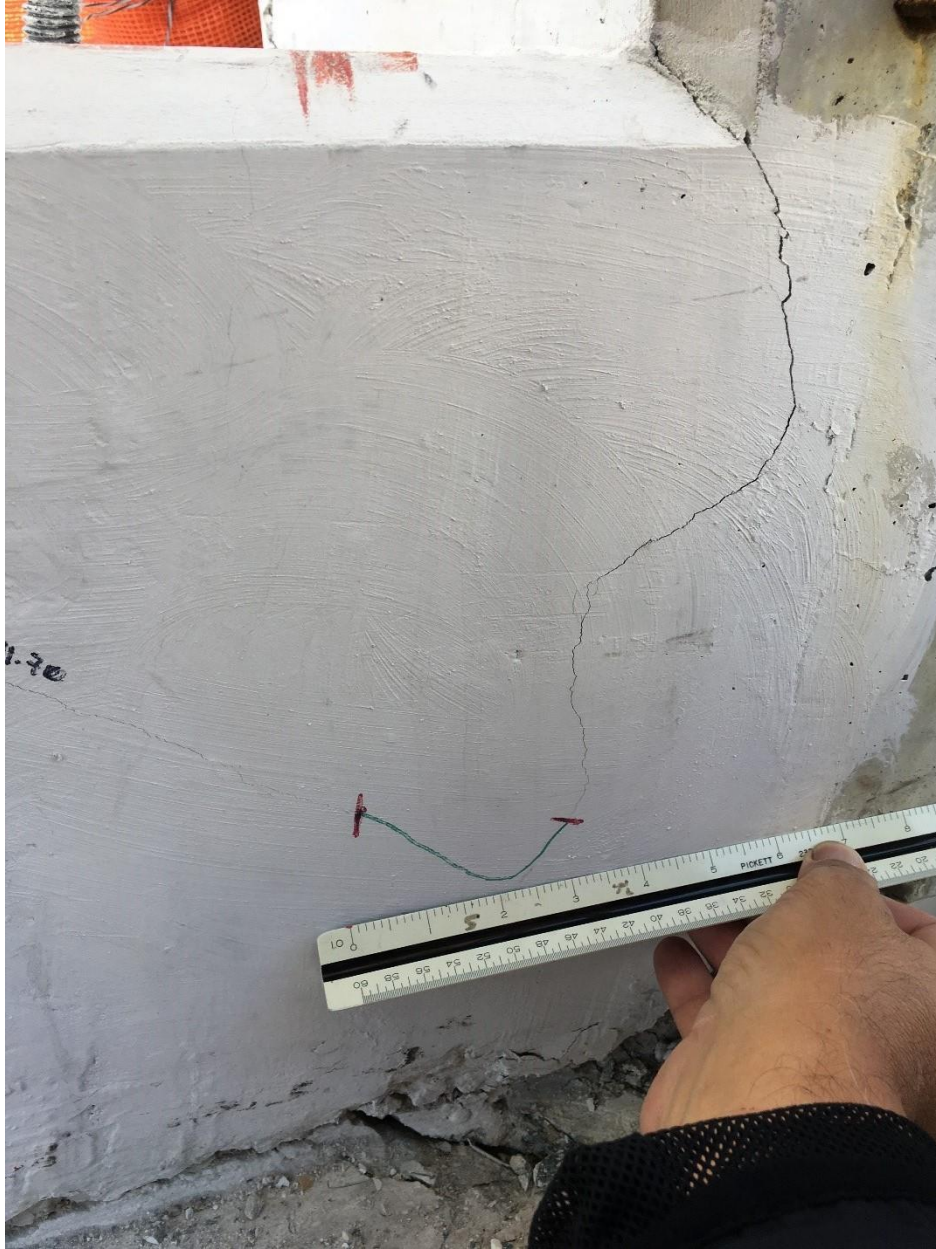
Bridge Factors Photo 91 – View of crack being monitored at the bottom of diagonal support #11 and vertical support #12 on east side looking to the west on 3/14/18 at 1:42 p.m. (Source: Bolton – Perez and Associates, BPA)

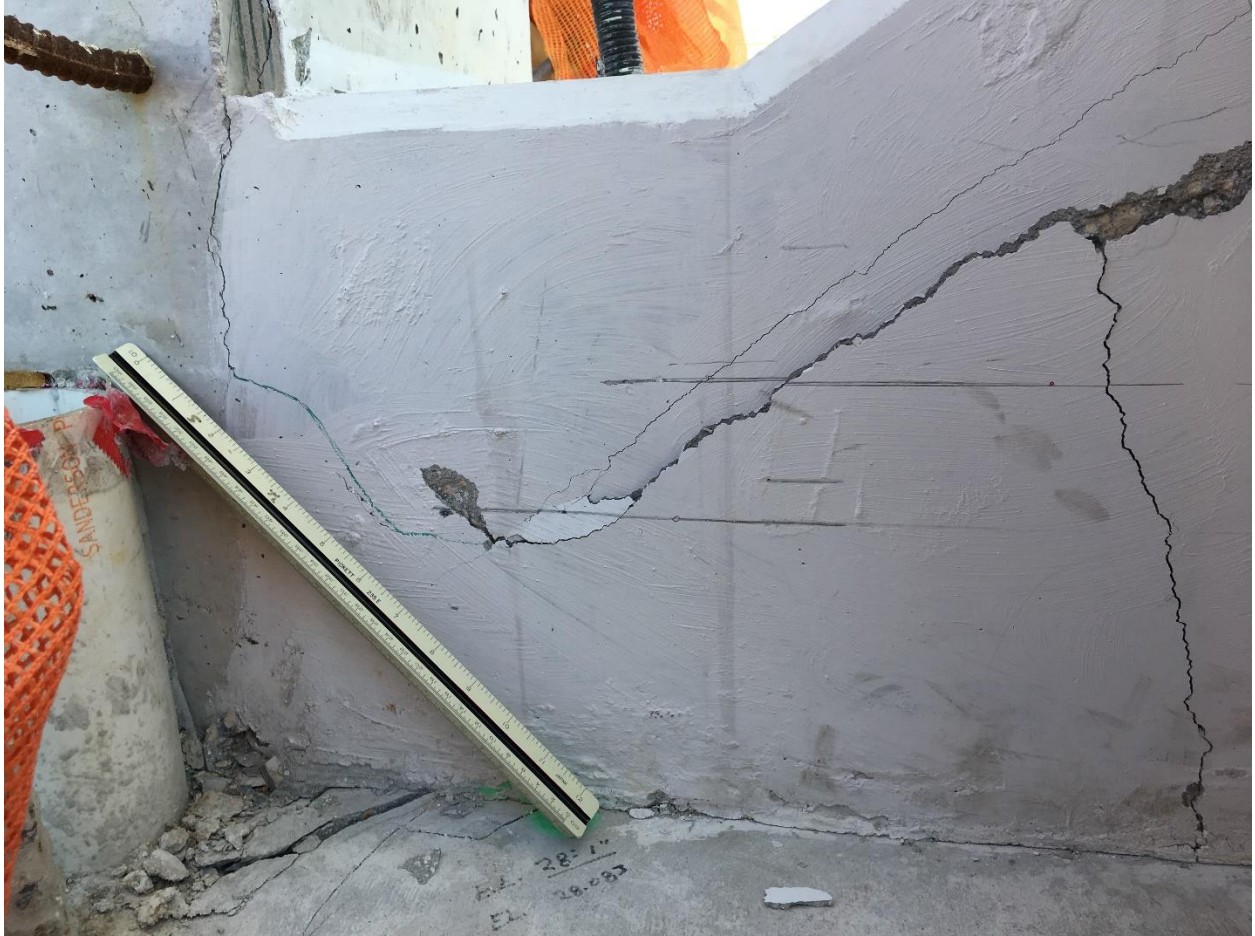
Bridge Factors Photo 92 – View of cracks being monitored at the bottom of diagonal support #11 and vertical support #12 on west side looking to the east on 3/14/18 at 1:45 p.m. (Source: Bolton – Perez and Associates, BPA)

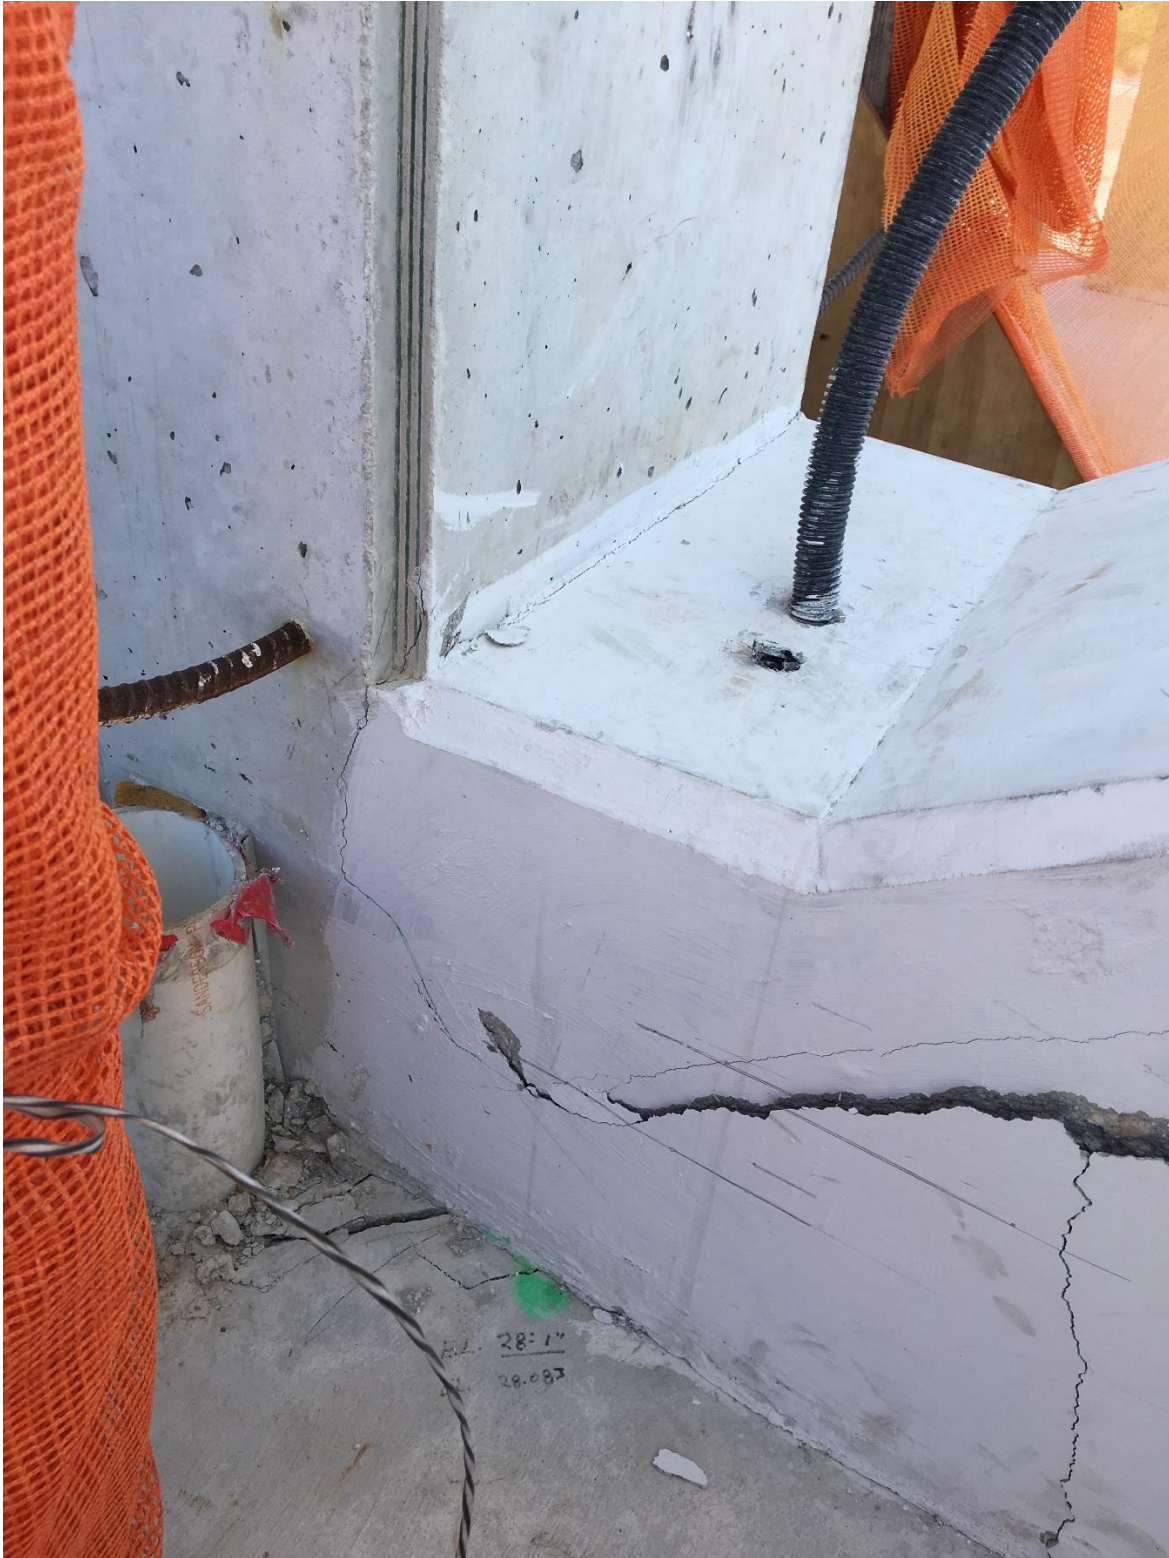
Bridge Factors Photo 93 – View of cracks at the bottom of diagonal support #11 and vertical support #12 on west side looking to the east on 3/14/18 at 1:46 p.m. (Source: Bolton – Perez and Associates, BPA)

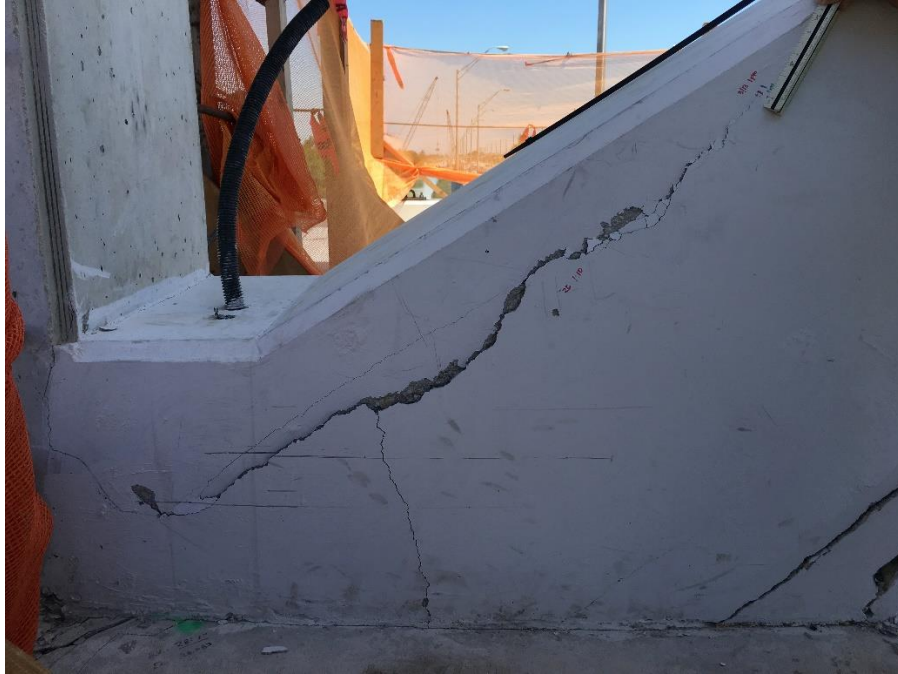
Bridge Factors Photo 94 – View of cracks being monitored at the bottom of diagonal support #11 on west side looking to the east on 3/14/18 at 1:47 p.m. (Source: Bolton – Perez and Associates, BPA)

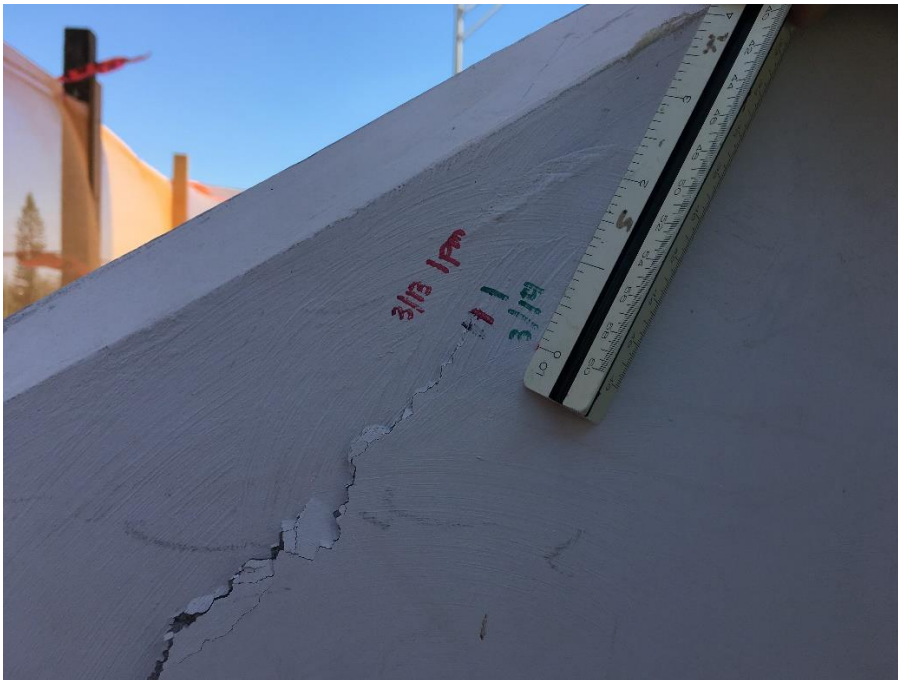
Bridge Factors Photo 95 – View of crack being monitored at the bottom of diagonal support #11 on west side looking to the east on 3/14/18 at 1:47 p.m. (Source: Bolton – Perez and Associates, BPA)

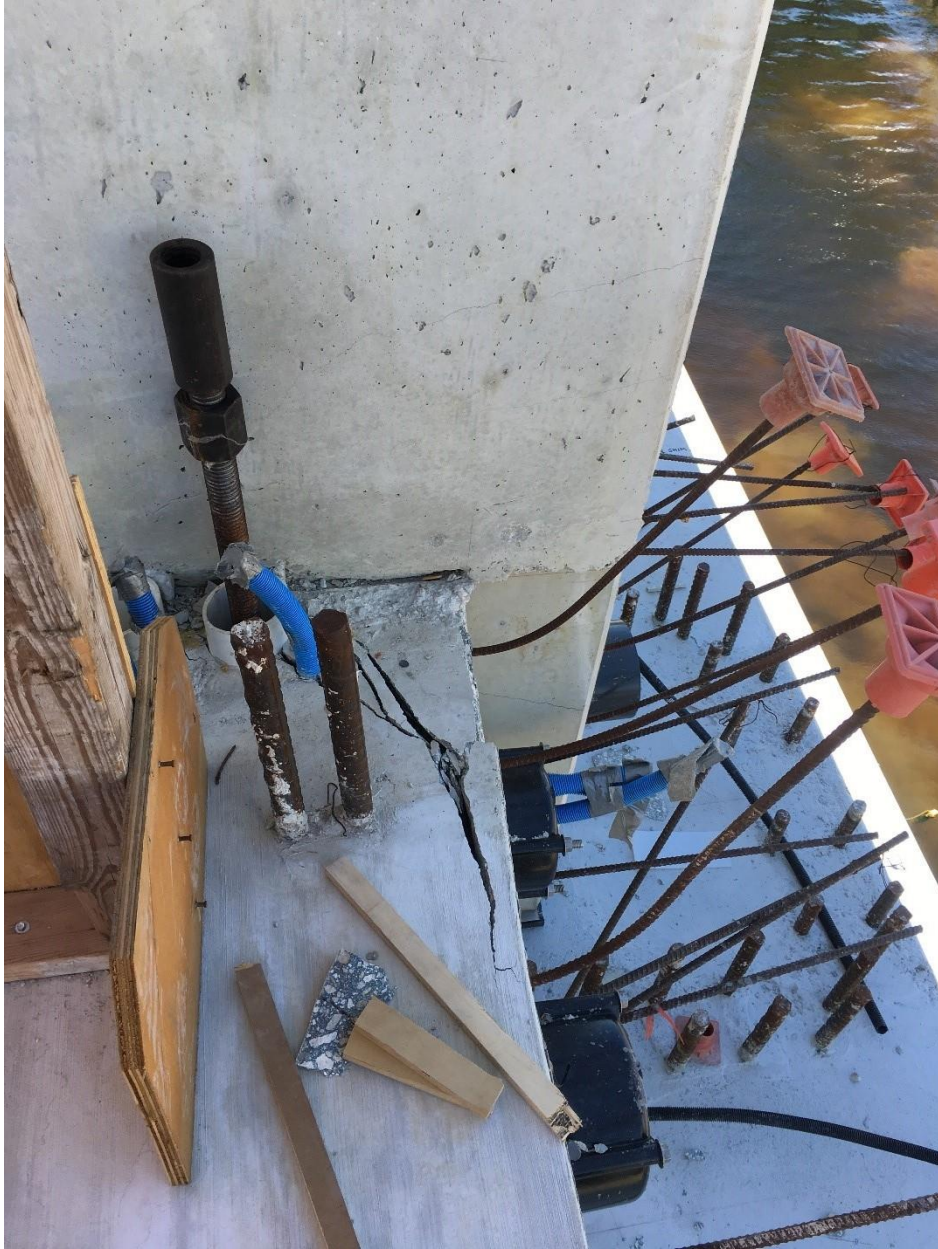
Bridge Factors Photo 96 – Top view of cracks along east side of Diaphragm II on 3/14/18 at 1:50 p.m. (Source: Bolton – Perez and Associates, BPA)
