**Bridge Factors Photographs 1 through 111**

**Miami, FL**

**HWY18MH009**

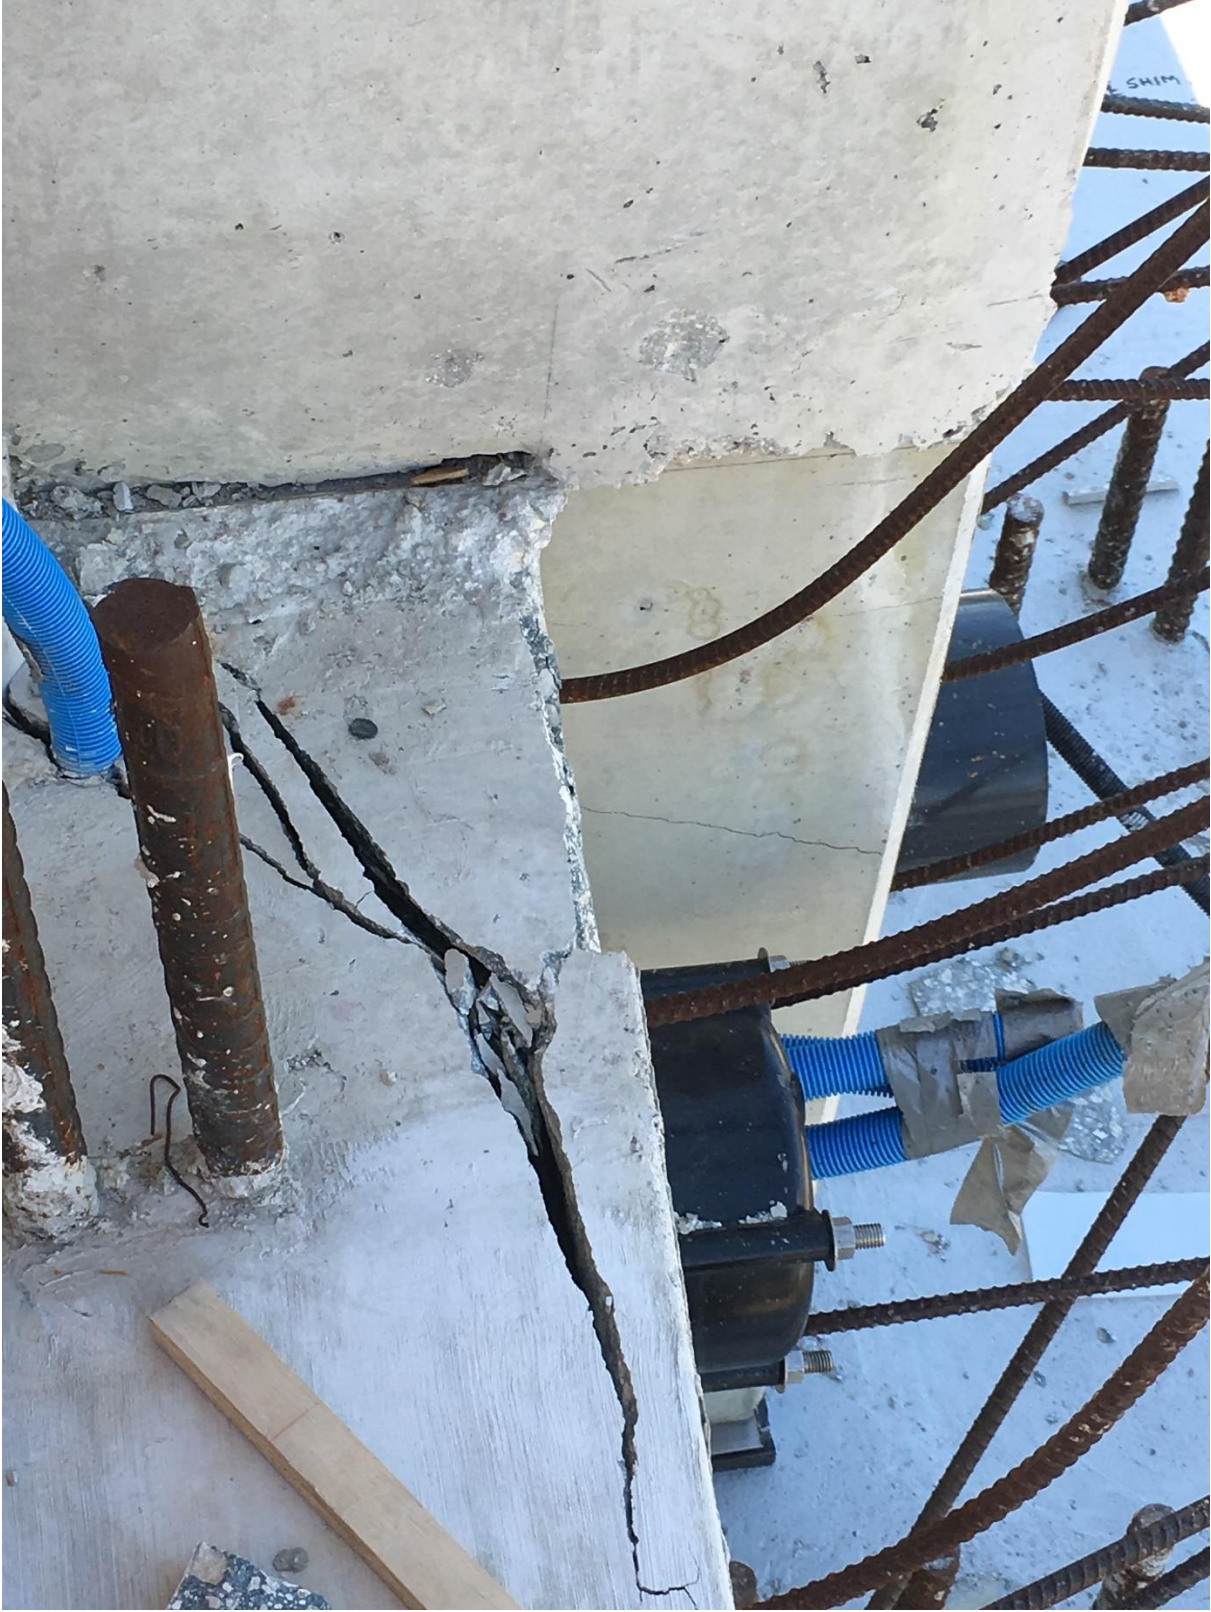
Bridge Factors Photo 97 – Top view of cracks along east side of Diaphragm II on 3/14/18 at 1:50 p.m. (Source: Bolton – Perez and Associates, BPA)

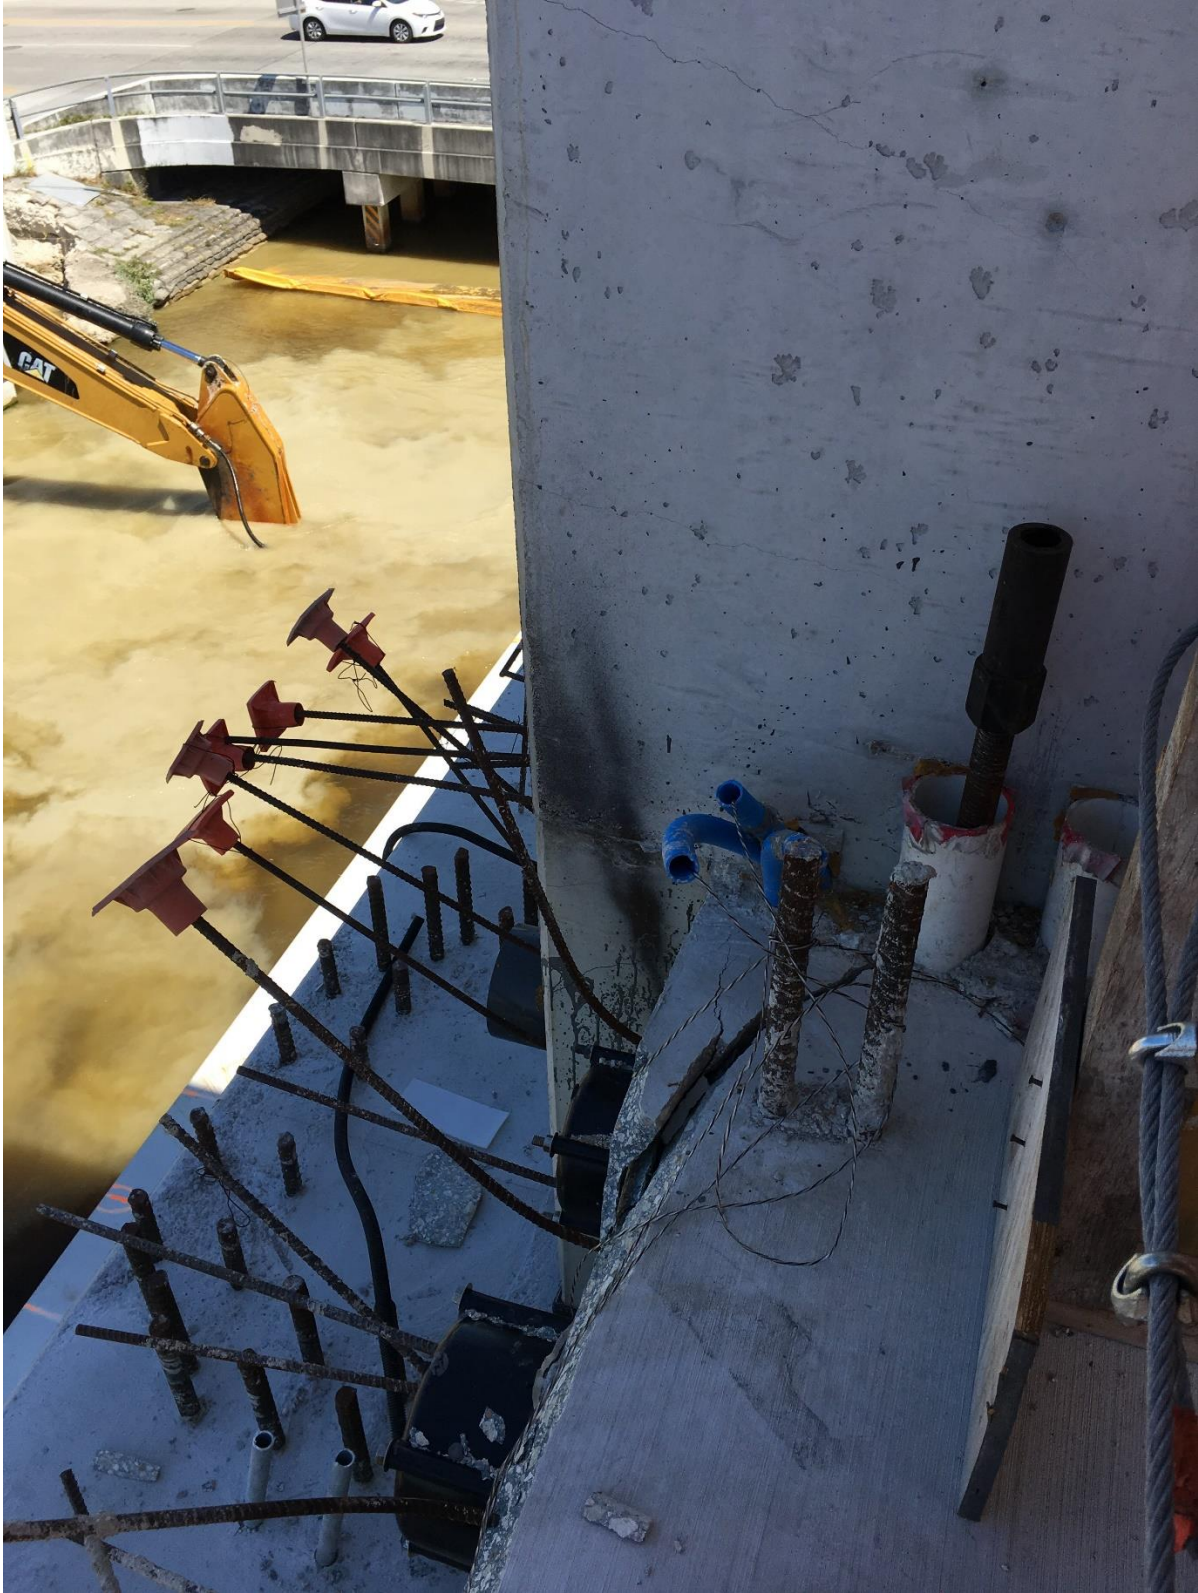
Bridge Factors Photo 98 – Top view of cracks along west side of Diaphragm II on 3/14/18 at 1:51 p.m. (Source: Bolton – Perez and Associates, BPA)

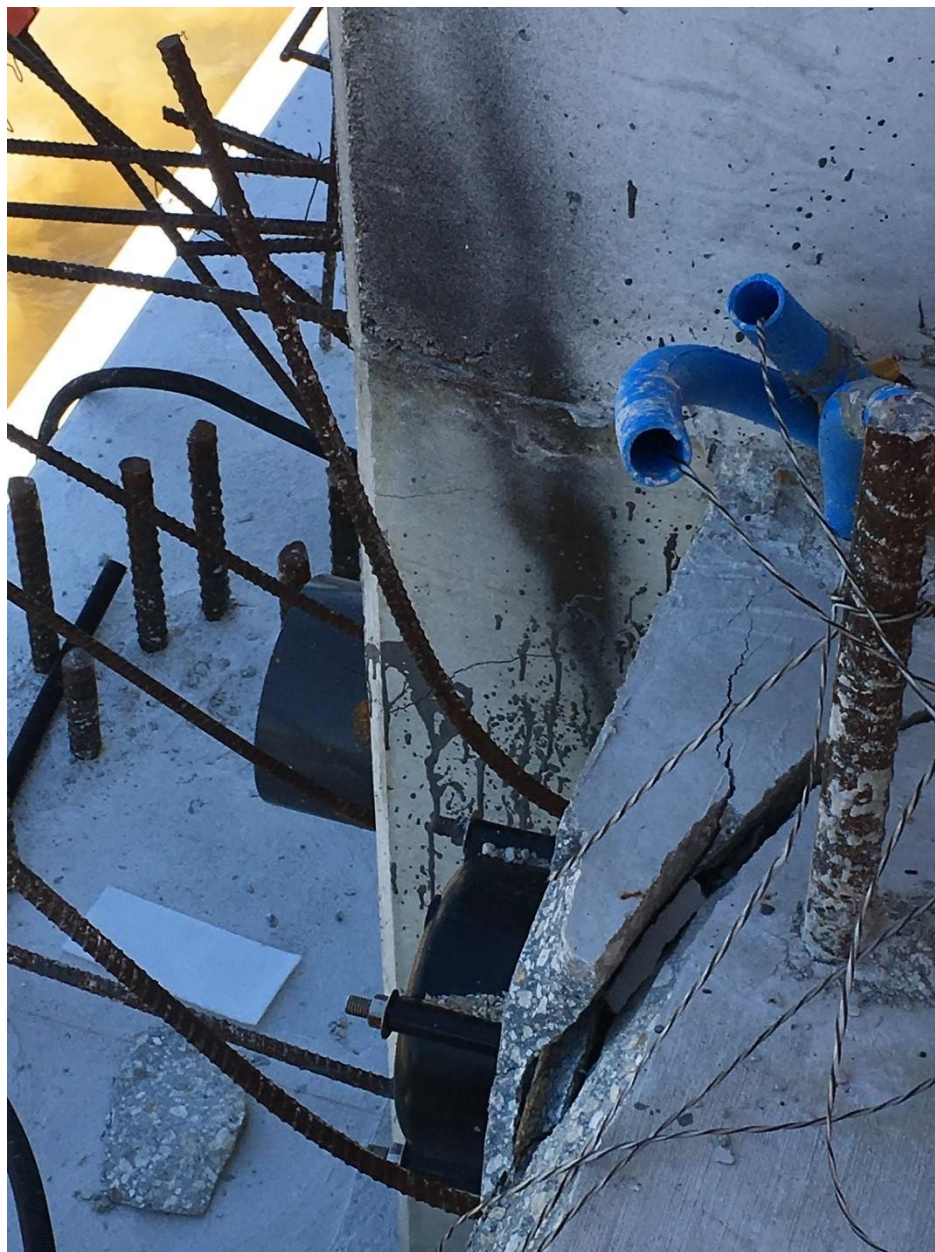
Bridge Factors Photo 99 – Top view of cracks along west side of Diaphragm II on 3/14/18 at 1:51 p.m. (Source: Bolton – Perez and Associates, BPA)

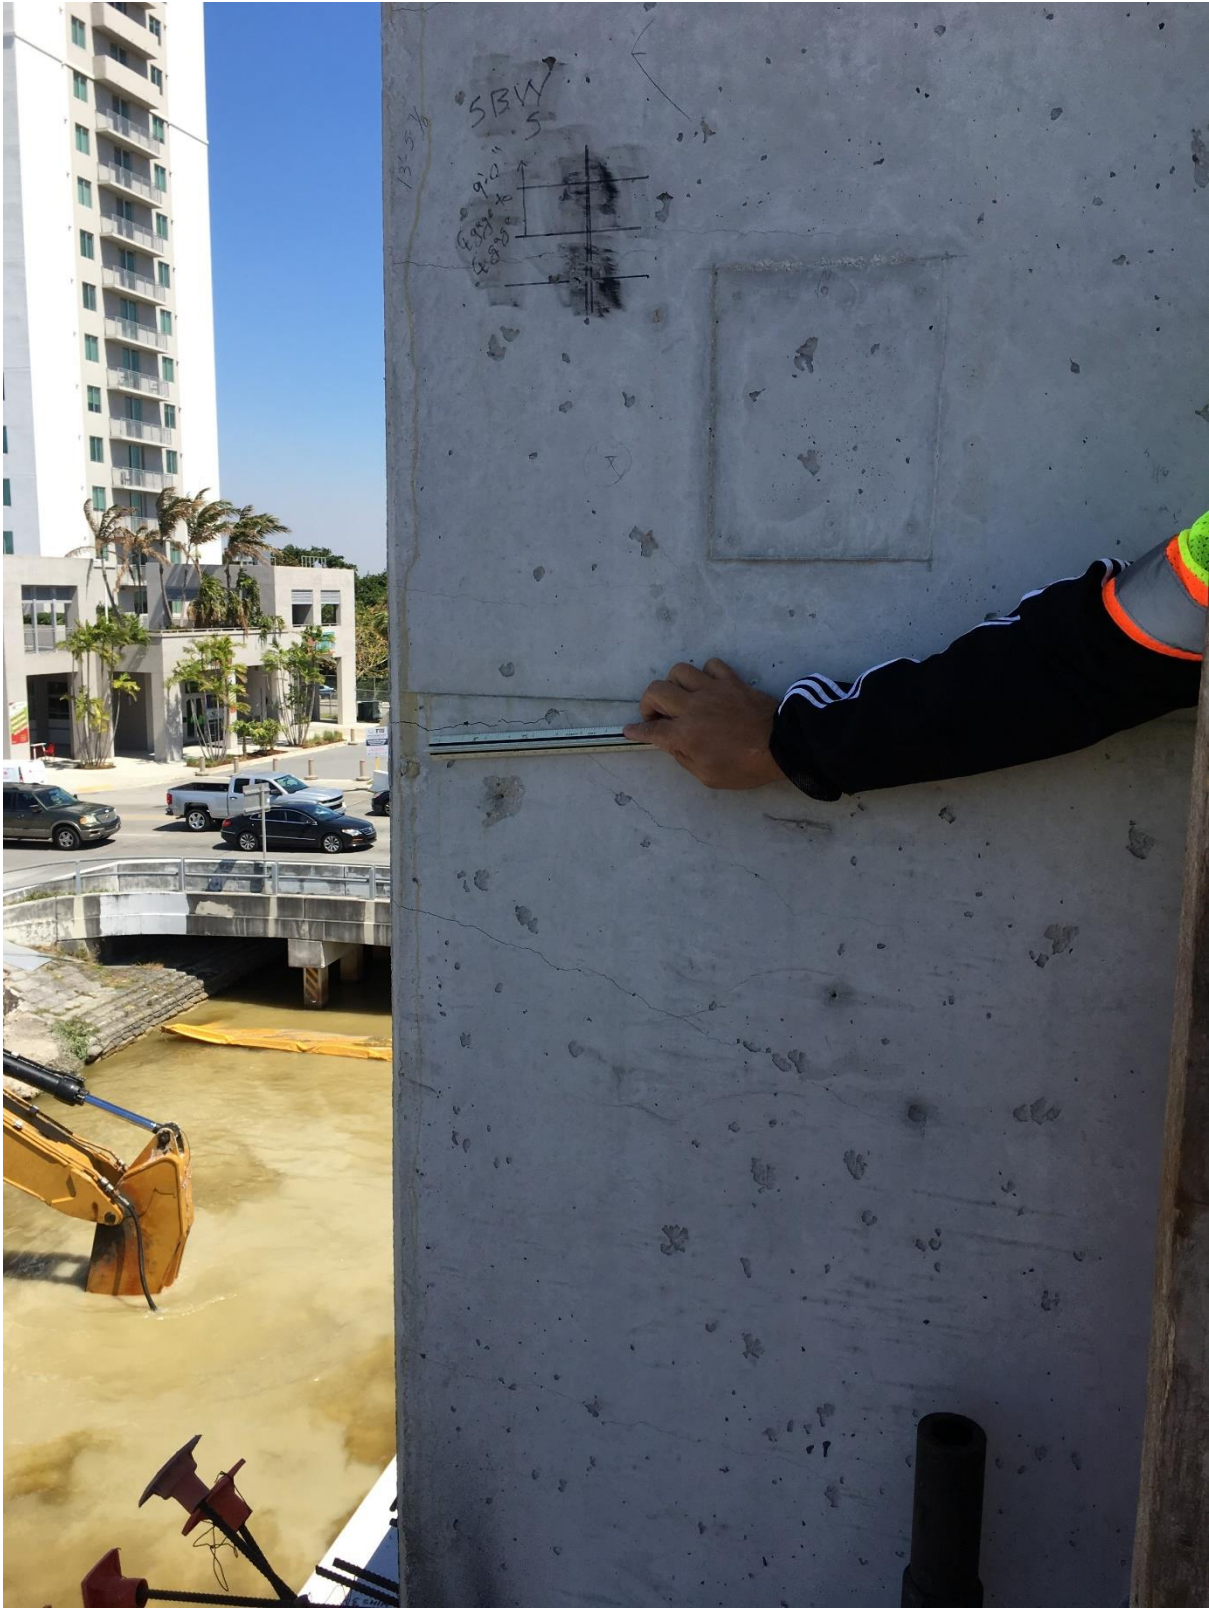
Bridge Factors Photo 100 – View of crack being monitored on the west side of vertical support #12 looking to the east on 3/14/18 at 1:51 p.m. (Source: Bolton – Perez and Associates, BPA)

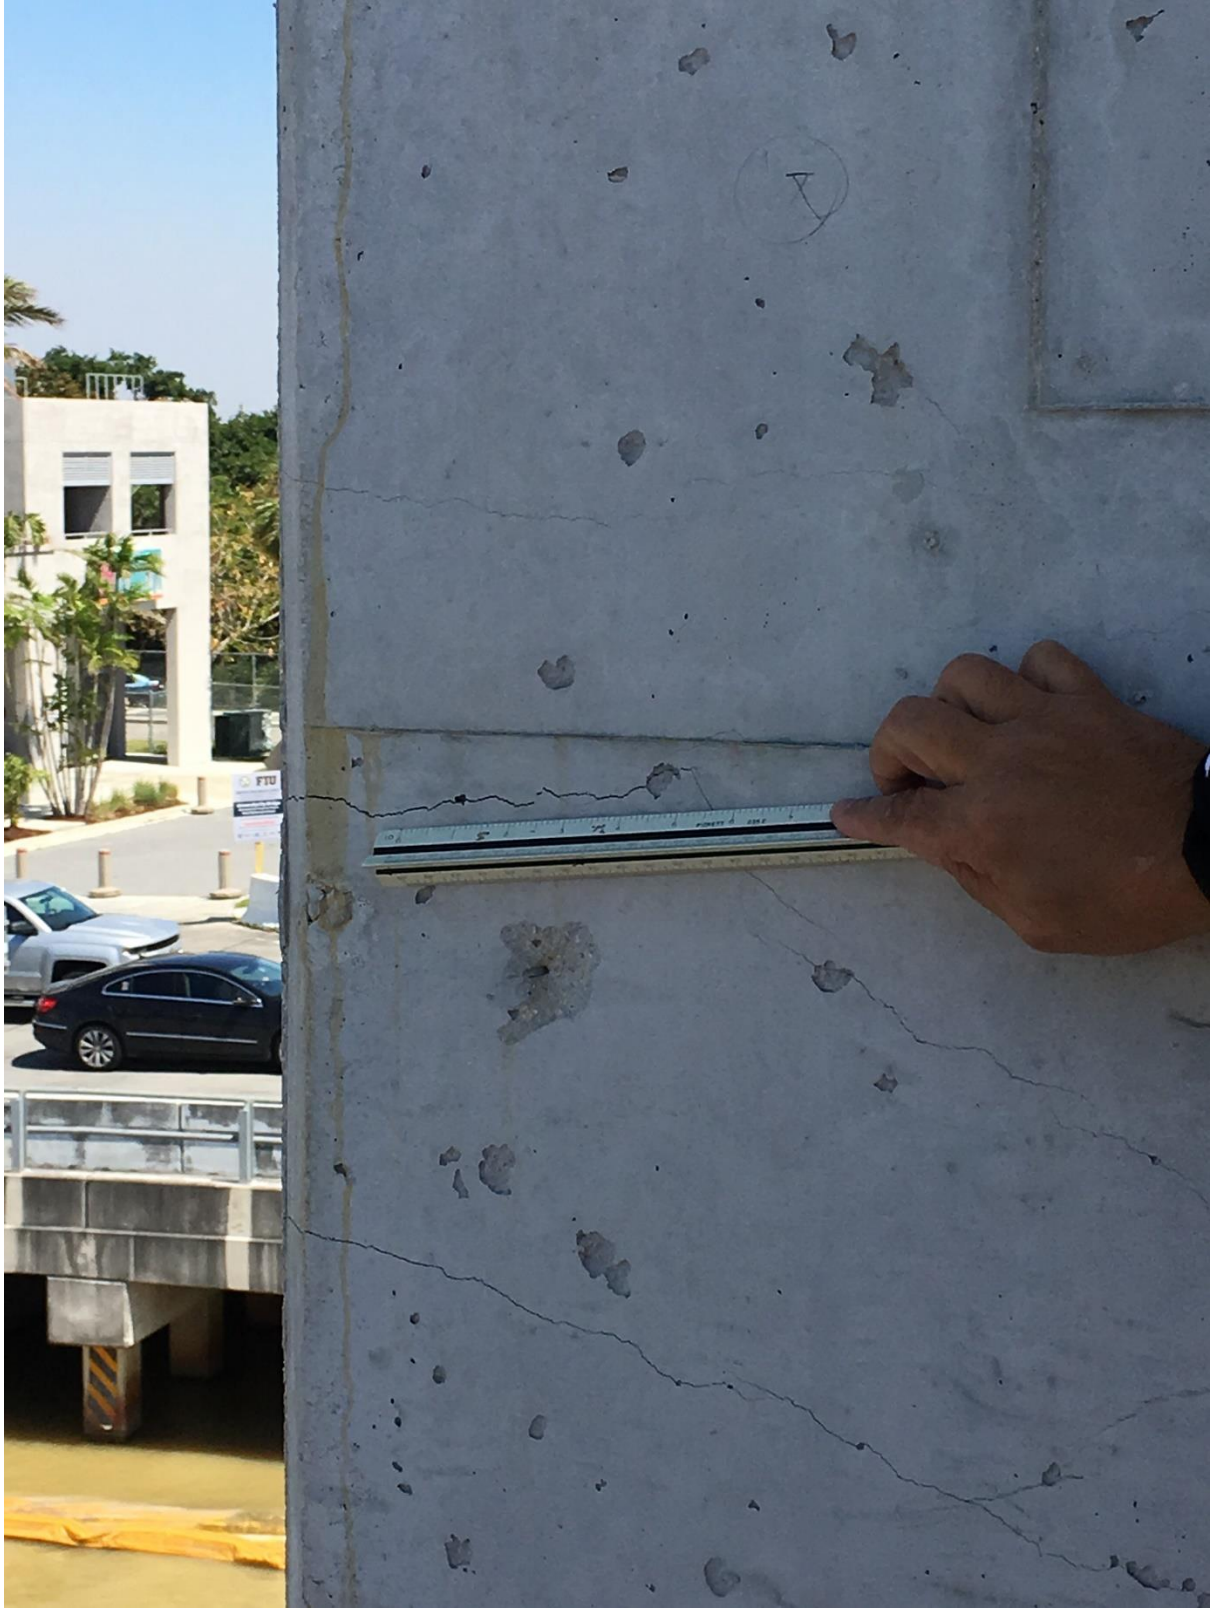
Bridge Factors Photo 101 – View of crack being monitored on the west side of vertical support #12 looking to the east on 3/14/18 at 1:51 p.m. (Source: Bolton – Perez and Associates, BPA)

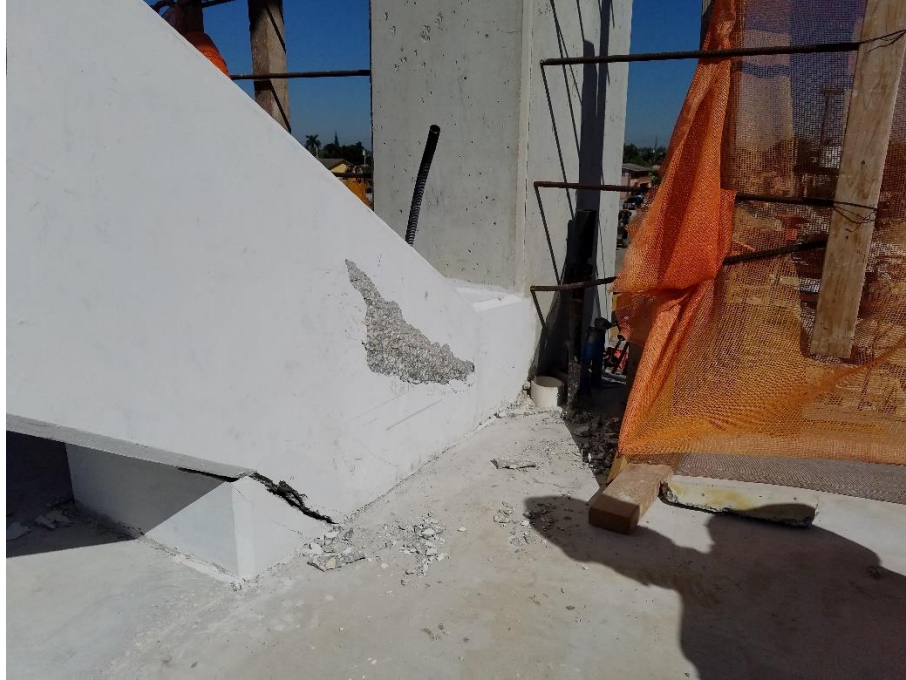
Bridge Factors Photo 102 – View of cracks and delamination at the bottom of diagonal support #11 on east side looking to the northwest on 3/15/18 at 10:53 a.m. (Source: FIU Associate Vice-President of Facilities Management)

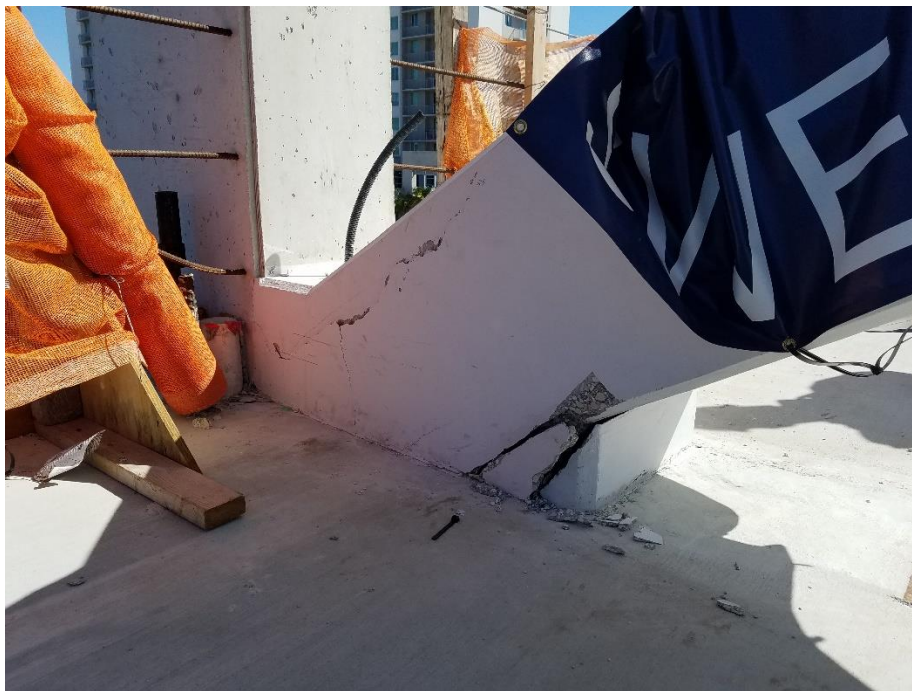
Bridge Factors Photo 103 – View of cracks at the bottom of diagonal support #11 on west side looking to the northeast on 3/15/18 at 10:55 a.m. (Source: FIU Associate Vice-President of Facilities Management)

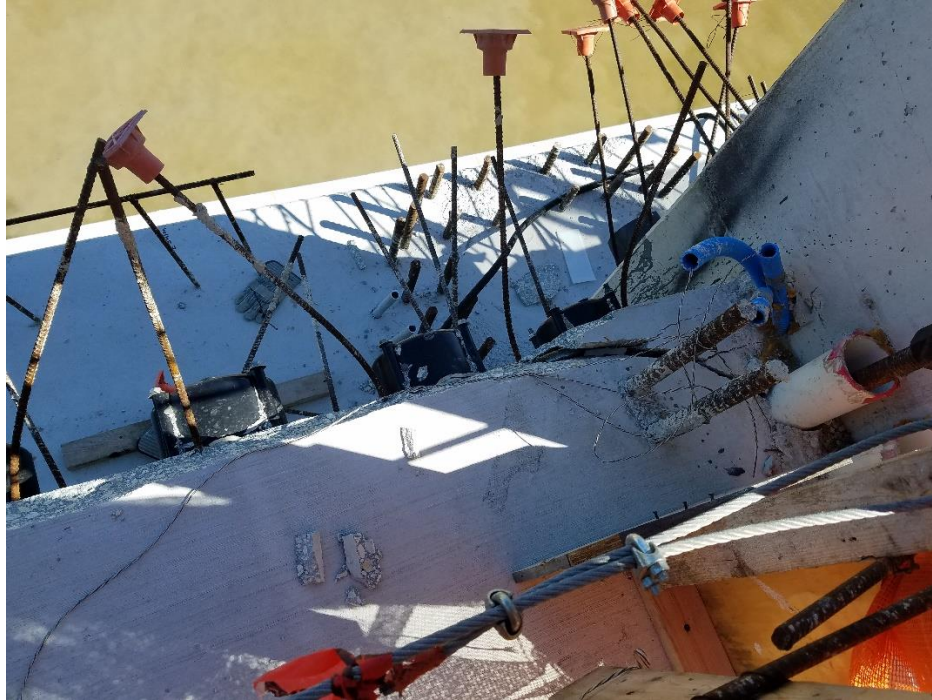
Bridge Factors Photo 104 – Top view of cracks along west side of Diaphragm II on 3/15/18 at 10:55 a.m. (Source: FIU Associate Vice-President of Facilities Management)
