National Transportation Safety Board

DCA24MM031

BRIDGE PROTECTION SYSTEMS

Group Chair's Factual Report

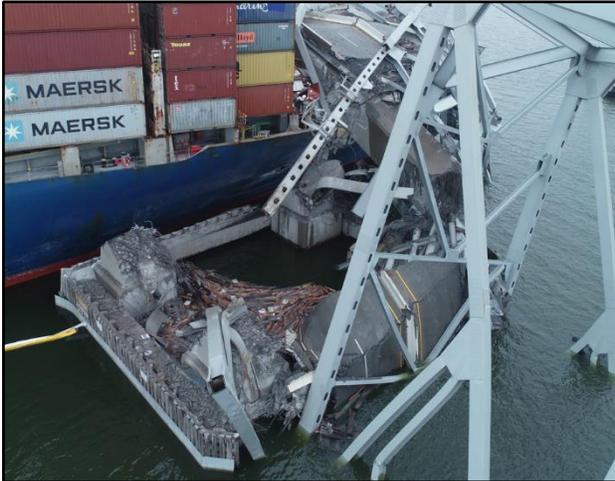
Both fender systems surrounding piers 17 and 18 were damaged during the collision and subsequent collapse of the bridge. The most significant damage to Pier 17 occurred on the opposing side of the channel, while the fender on the channel side remained largely intact (see **Figure 15**). The most significant damage to Pier 18 occurred on the channel side where portions of the fender were no longer present (see **Figure 16**). Components of the truss spans came to rest in the areas of the damaged and missing fender sections.

Figure 15. Post-collapse condition of the fender surrounding Pier 17.

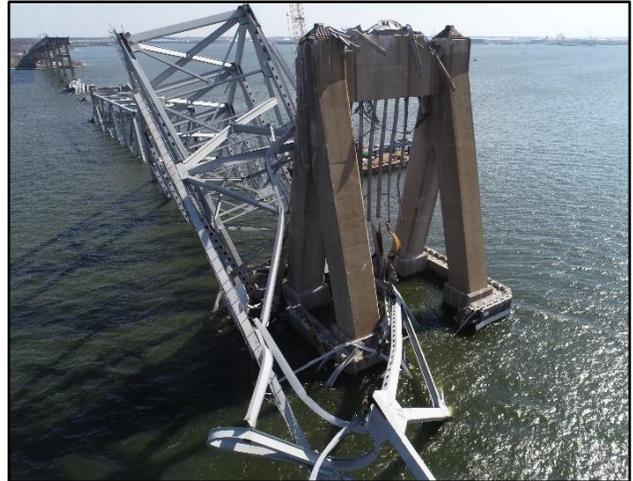
Figure 16. Post-collapse condition of the fender surrounding Pier 18.

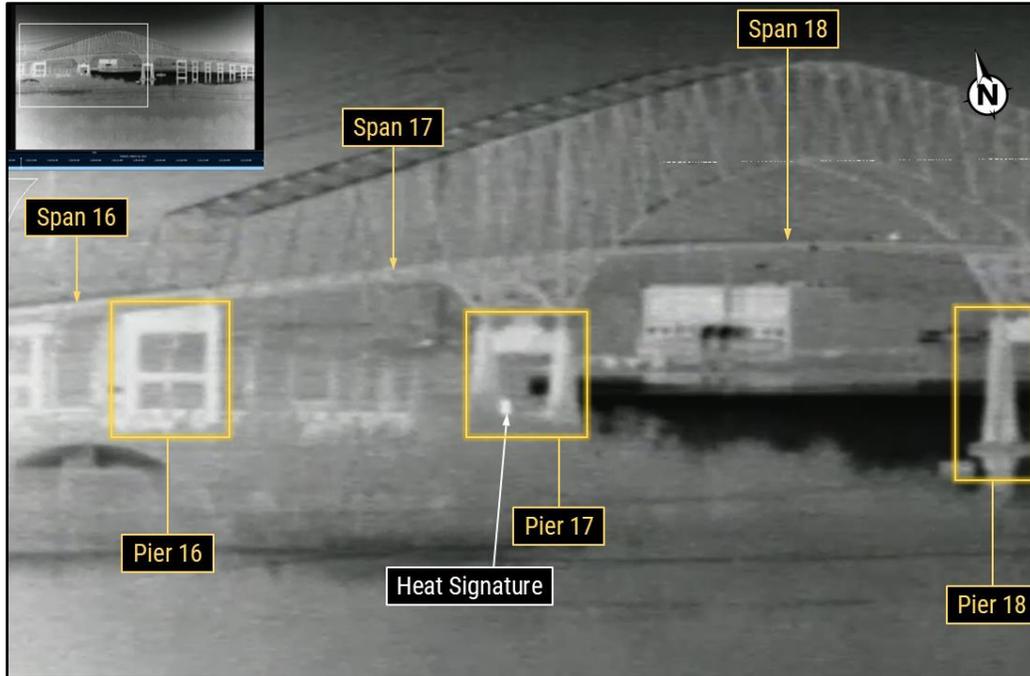
Figure 23 shows that at 1:29:09 AM, a heat signature was visible in the NRP video when the starboard bow of the *Dali* impacted the northwest column of Pier 17 approximately 20 feet above the waterline. A heat signature is the infrared energy emitted by an object. An infrared camera measures the emitted energy and displays warmer objects in white and cooler objects in black.

Figure 23. NRP video (zoomed in) depicting the initial impact to the northwest column of Pier 17.

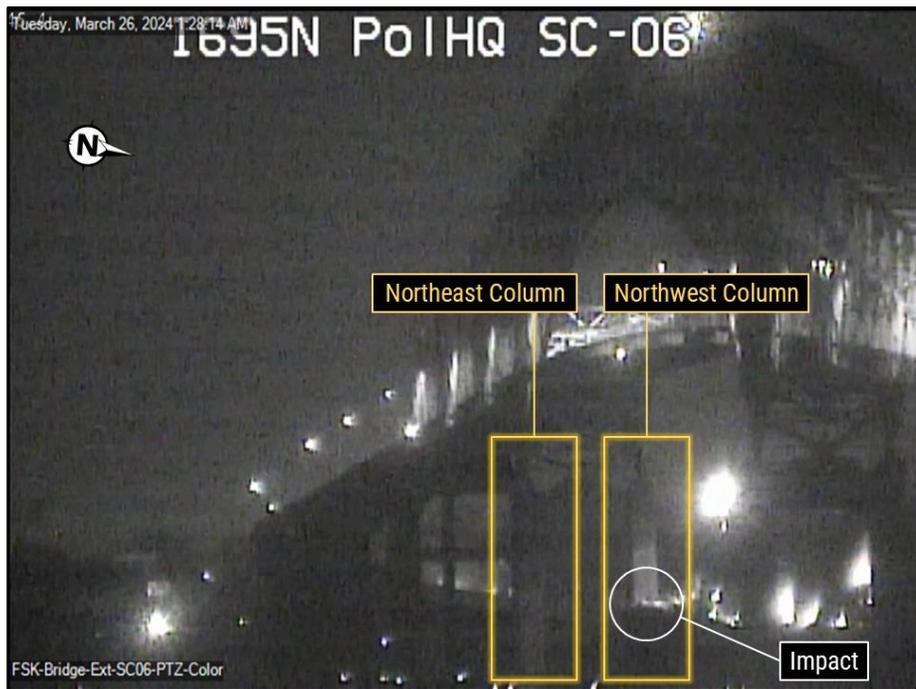
Figure 24. MDTA video depicting the initial impact to Pier 17.

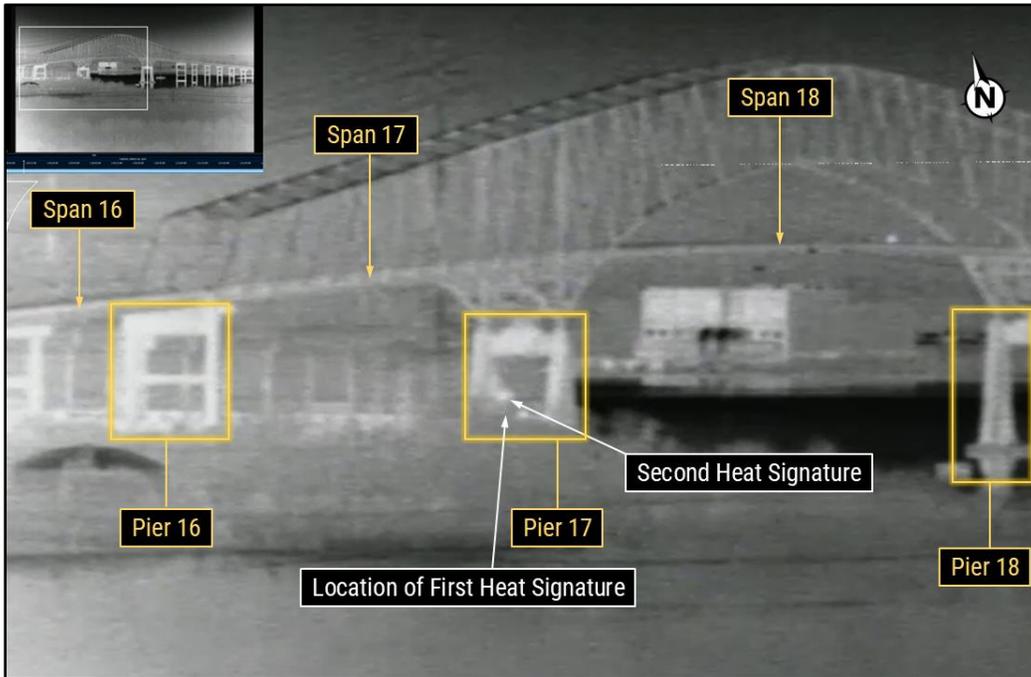
Figure 25 shows that at 1:29:13 AM, a second heat signature, above the heat signature from the initial impact, and displacement of concrete were visible in the NRP video when the northwest column of Pier 17 was likely impacted by container(s) near the starboard bow of the *Dali*.

Figure 25. NRP video depicting a second impact to the northwest column of Pier 17.

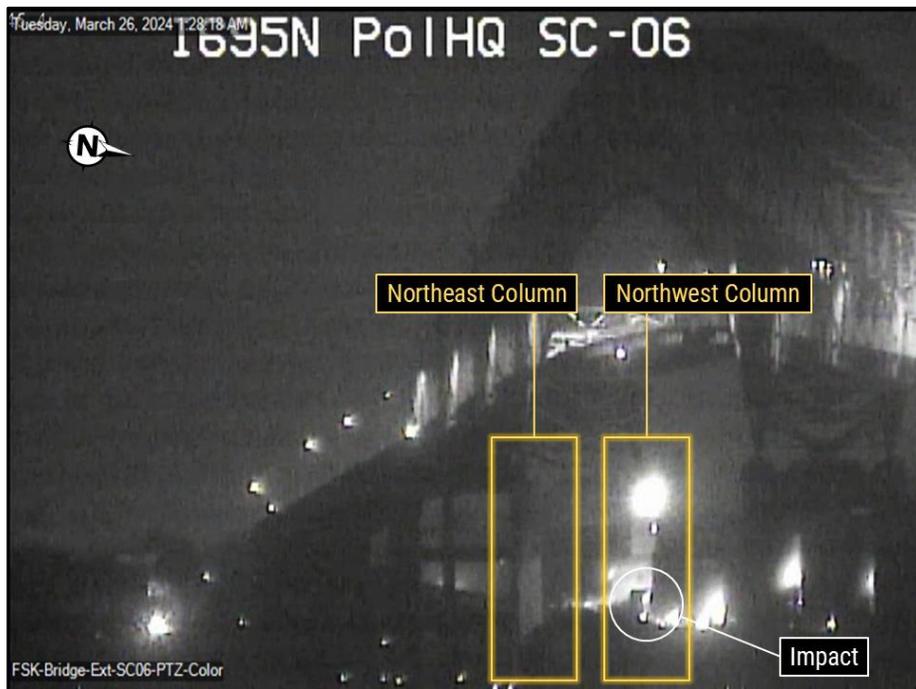
Figure 26. MDTA video depicting the second impact to the northwest column of Pier 17.

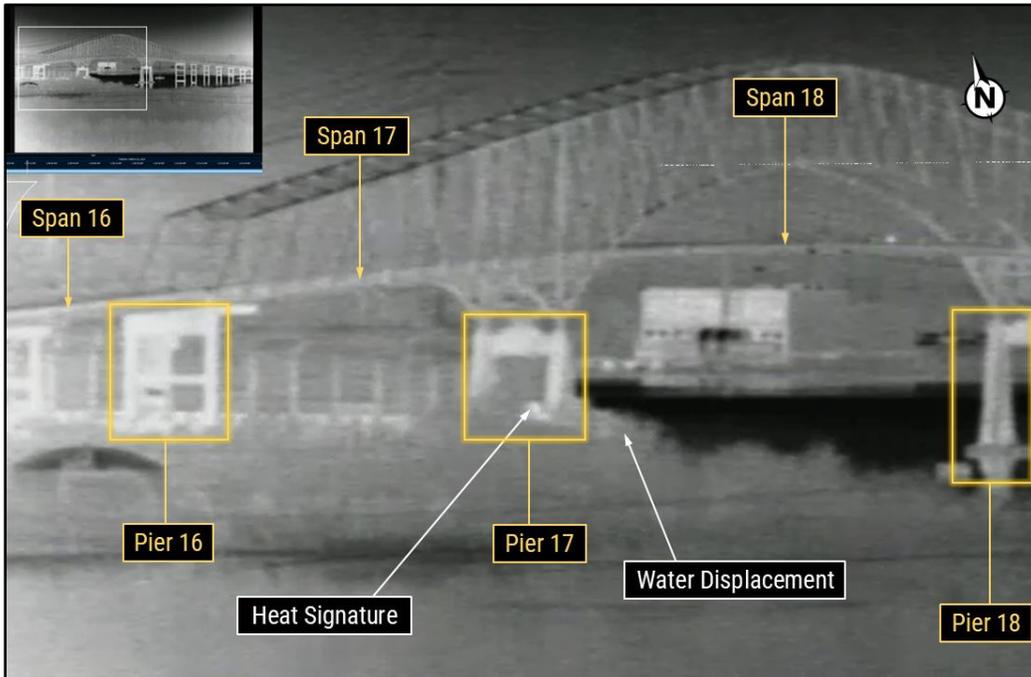
Figure 27 shows that at 1:29:16 AM, there was a heat signature near the northeast column of Pier 17, likely the result of impact(s) by container(s) near the starboard bow of the *Dali*. Displacement of water at the bow of the *Dali* was also observed likely the result of lateral displacement of the bow during impact.

Figure 27. NRP video depicting the initial impact to the northeast column of Pier 17.

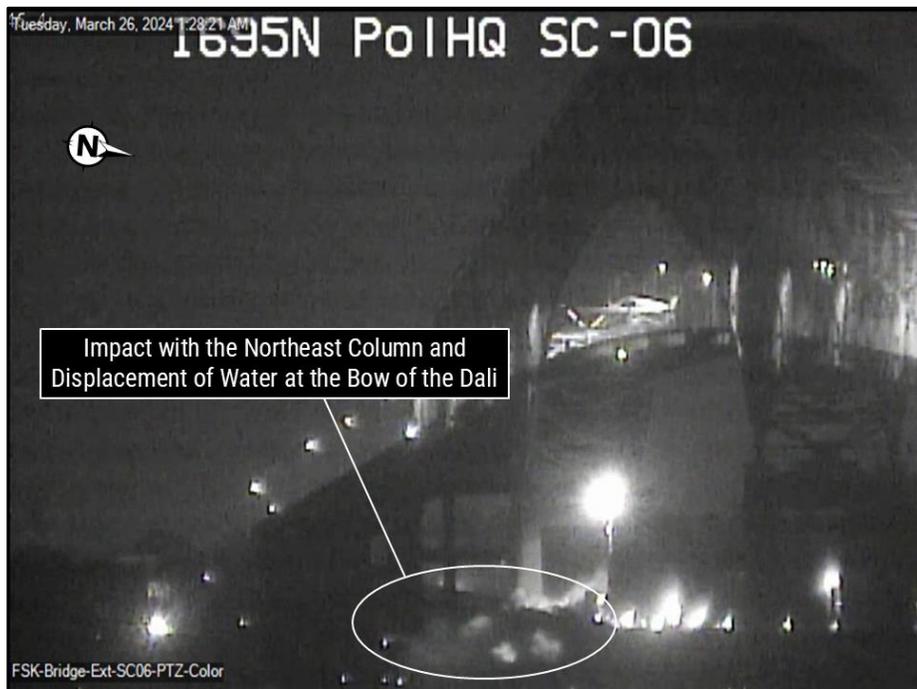
Figure 28. MDTA video depicting the initial impact to the northeast column of Pier 17.

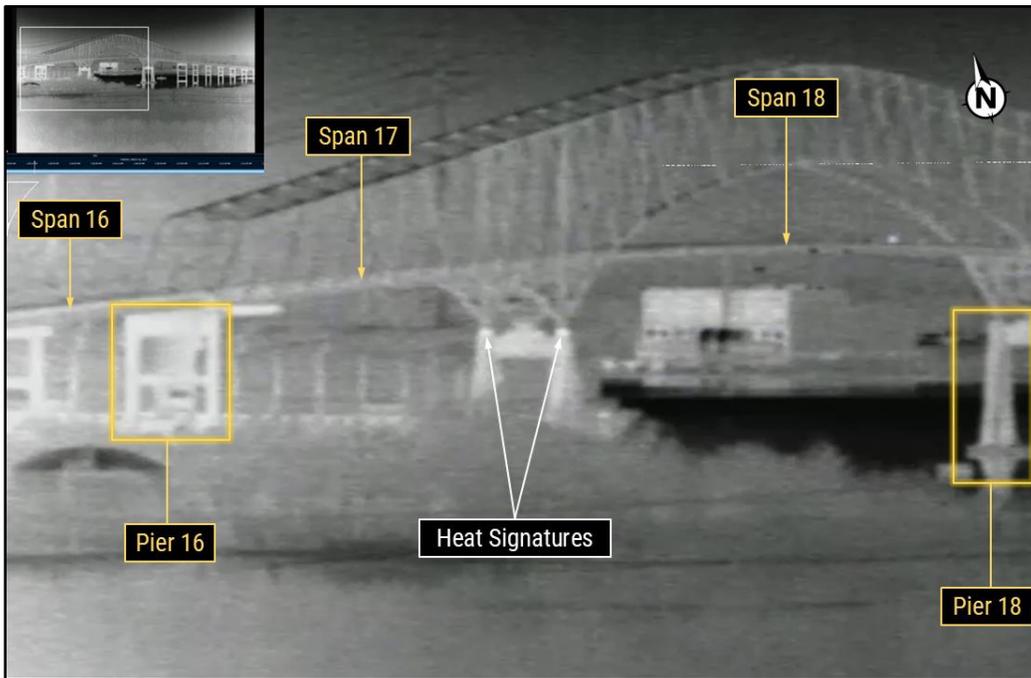
Figure 29 shows that at 1:29:20 AM, heat signatures at both bearings of Pier 17 were visible in the NRP video after the northeast column failed and collapse of the bridge began.

Figure 29. NRP video depicting heat signatures at both bearings of Pier 17.

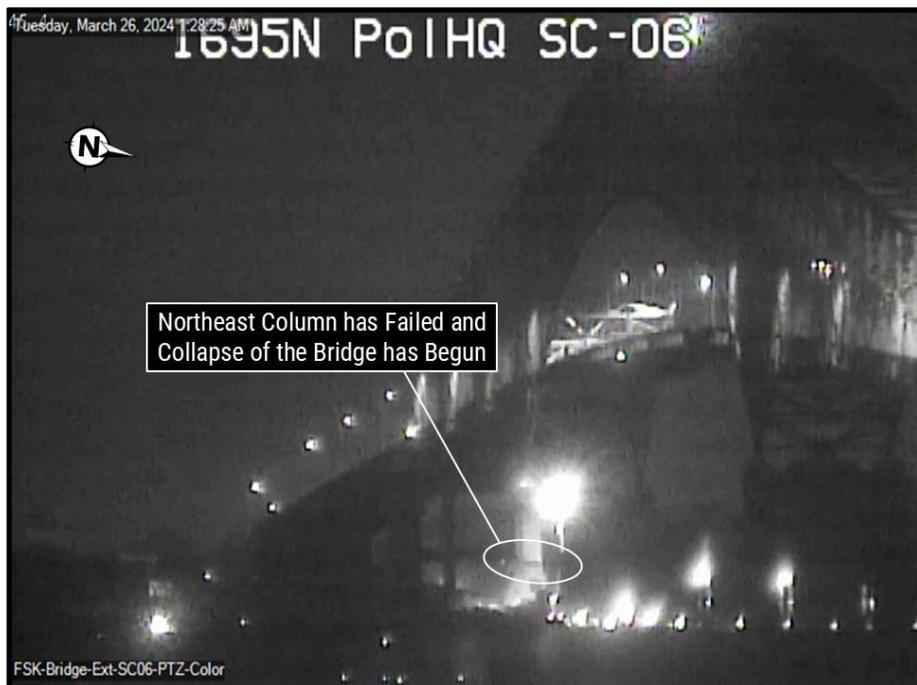
Figure 30. MDTA video depicting the collapse of the northeast column of Pier 17.

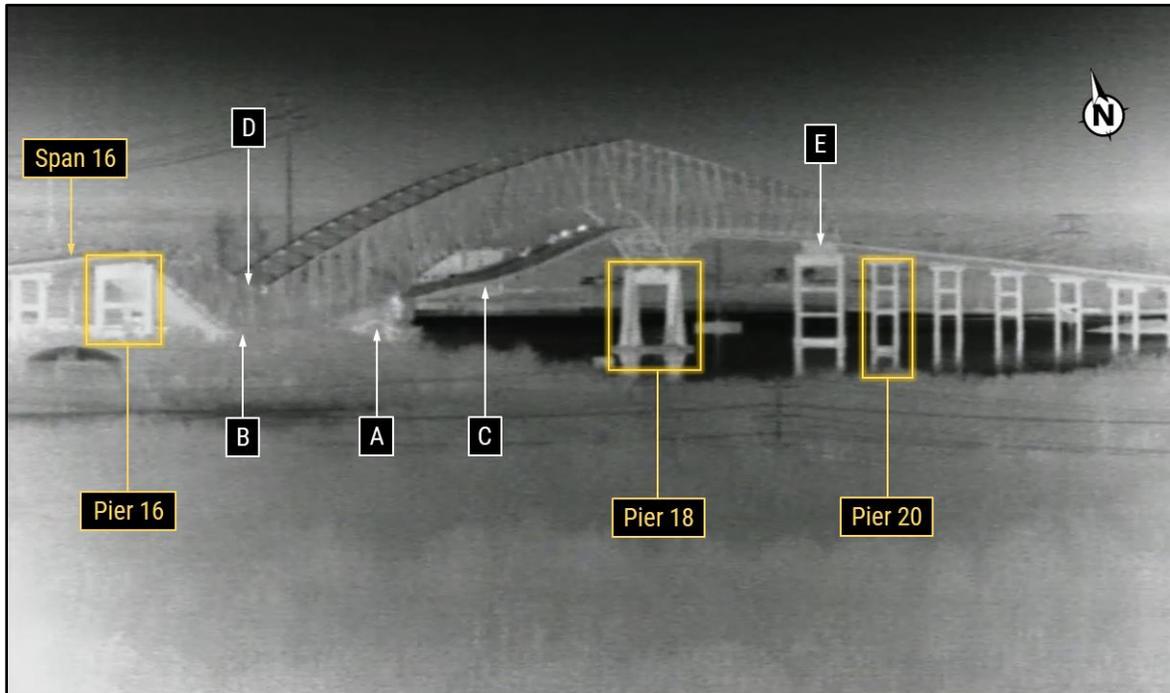
Figure 31 shows that at 1:29:22 AM, Pier 17 has collapsed [A], Span 17 [B] and Span 18 [C] have collapsed, the joints of the upper chord of the steel truss at Span 17 have failed [D], and the north end of the steel truss was displaced upward and off of Pier 19 [E].

Figure 31. NRP video depicting the collapse of Pier 17, Span 17, Span 18, and upward displacement of Span 19 and the north end of the steel truss.

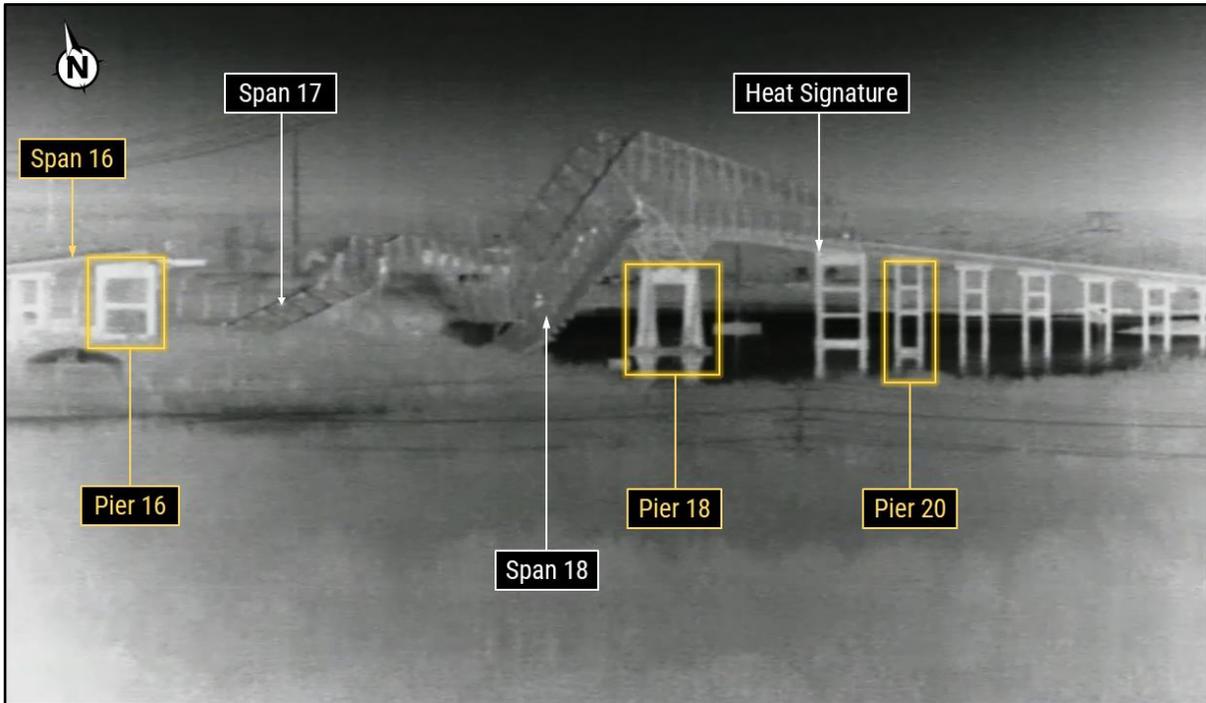
Figure 33 shows that at 1:29:23 AM, a heat signature at the west column of Pier 19 was visible when the north end of the steel truss moved downward from its elevated position and re-contacted the pier.

Figure 33. NRP video depicting a heat signature at the east column of Pier 19.

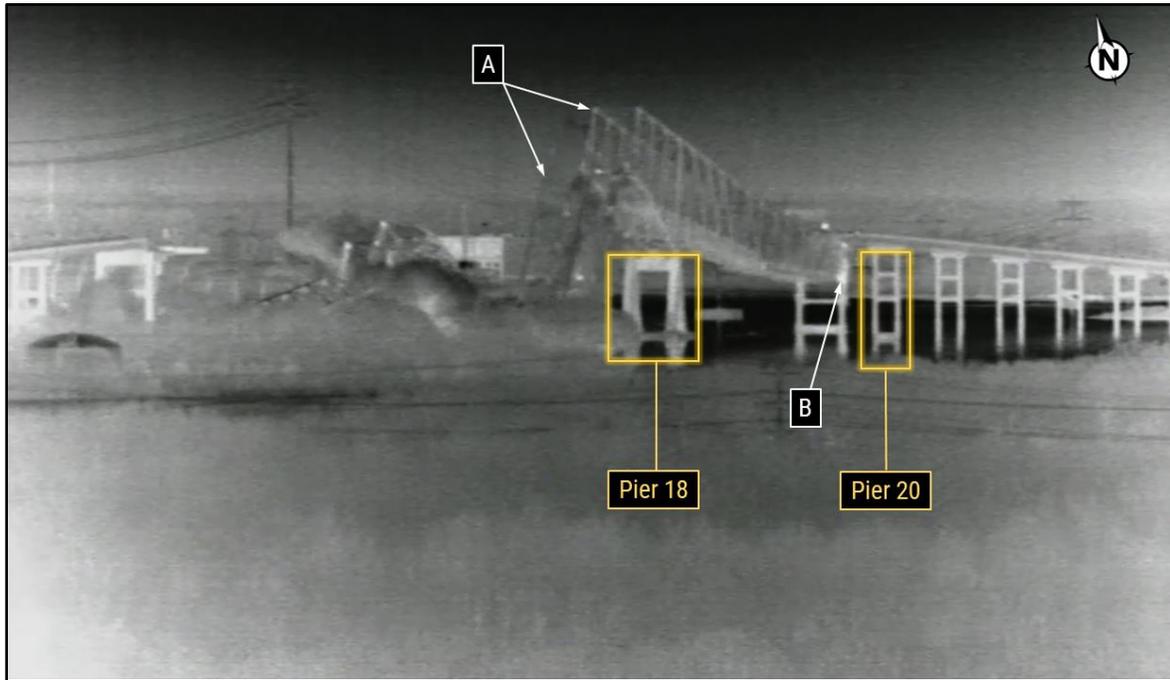
Figure 35 depicts the upper chord of the truss of Span 18 has separated [A] and a heat signature was visible at the east column of Pier 19 as Span 19 contacted the pier as it collapsed [B].

Figure 35. NRP video depicting the collapse of Span 19 and remaining steel truss.

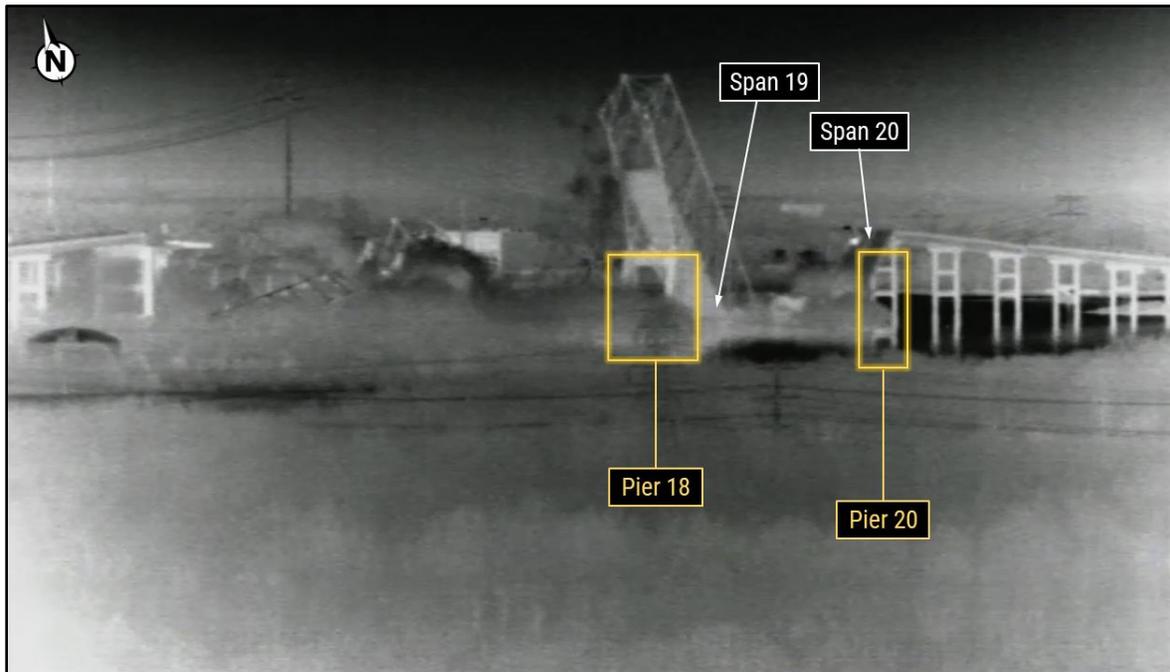
Figure 36 shows the collapse of Span 19 and Span 20

Figure 36. NRP video depicting the collapse of Pier 19 and Span 20.

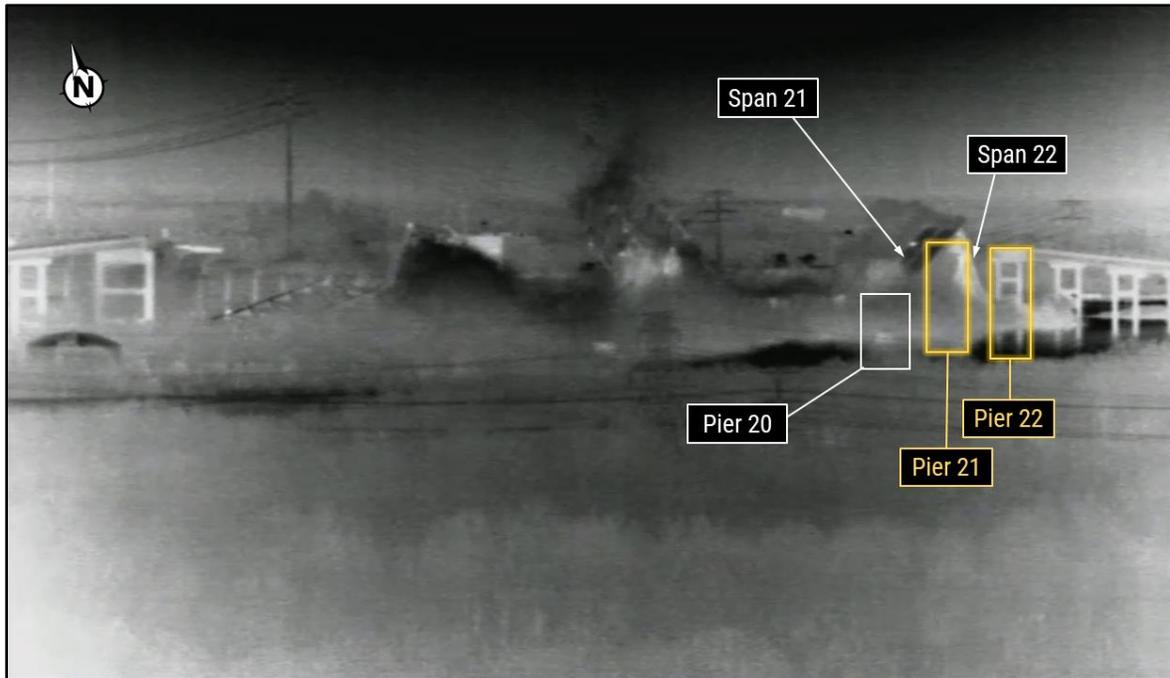
Figure 37 depicts the collapse of Pier 20, Span 21, and Span 22.

Figure 37. NRP video depicting the collapse of Pier 20, Span 21, and Span 22.

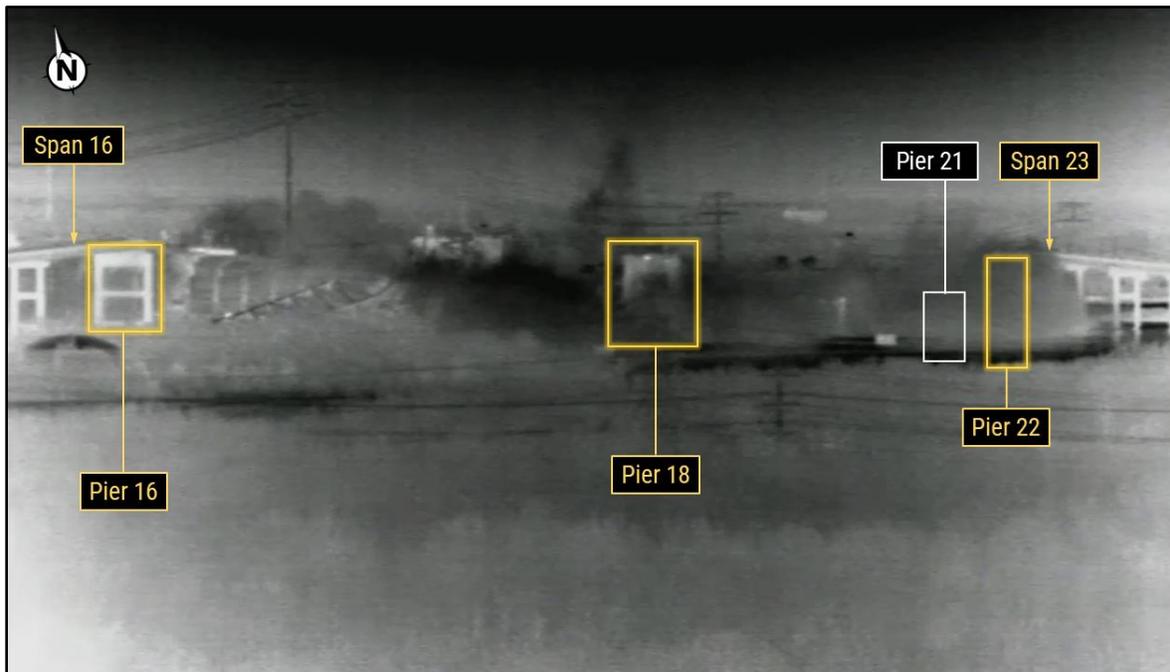
Figure 38 depicts the collapse of Pier 21. Span 16 and Span 23 were the spans that remained at each end of the bridge. Pier 16, Pier 18, and Pier 22 remained after the collapse.

Figure 38. NRP video depicting the collapse of Pier 21.

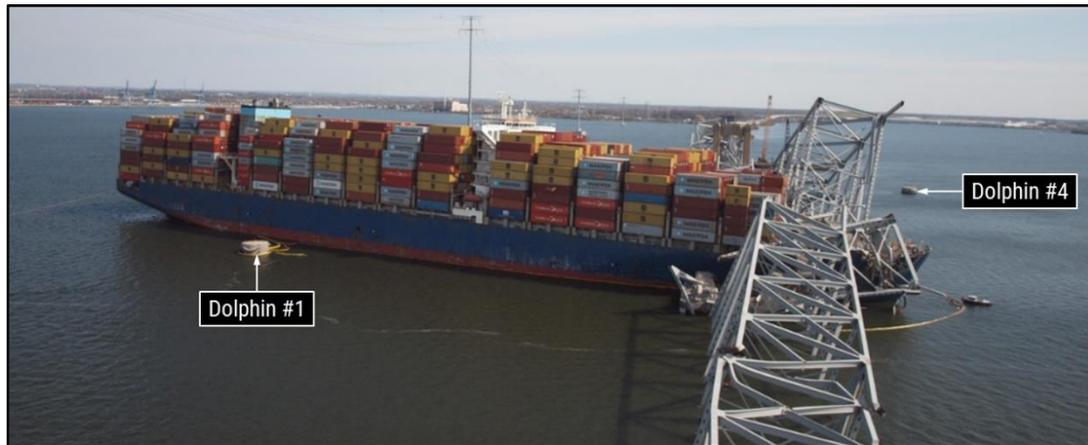
Figure 40 is a view from the edge of Span 16 looking to the north depicting the *Dali* with a portion of the Key Bridge resting on the bow and Dolphin #1 located along the starboard side of the vessel, forward of the stern.

Figure 40. Final rest position of the *Dali*.
