NATIONAL TRANSPORTATION SAFETY BOARD
Office of Aviation Safety
Washington, D.C. 20594

Airworthiness Sub-Group Chairman's Factual Report

DCA21FA085

Operator: United Airlines
Location: Broomfield, CO
Date: February 20, 2021
Time: 1309 mountain standard time (MST)
Airplane: Boeing 777-222, N772UA

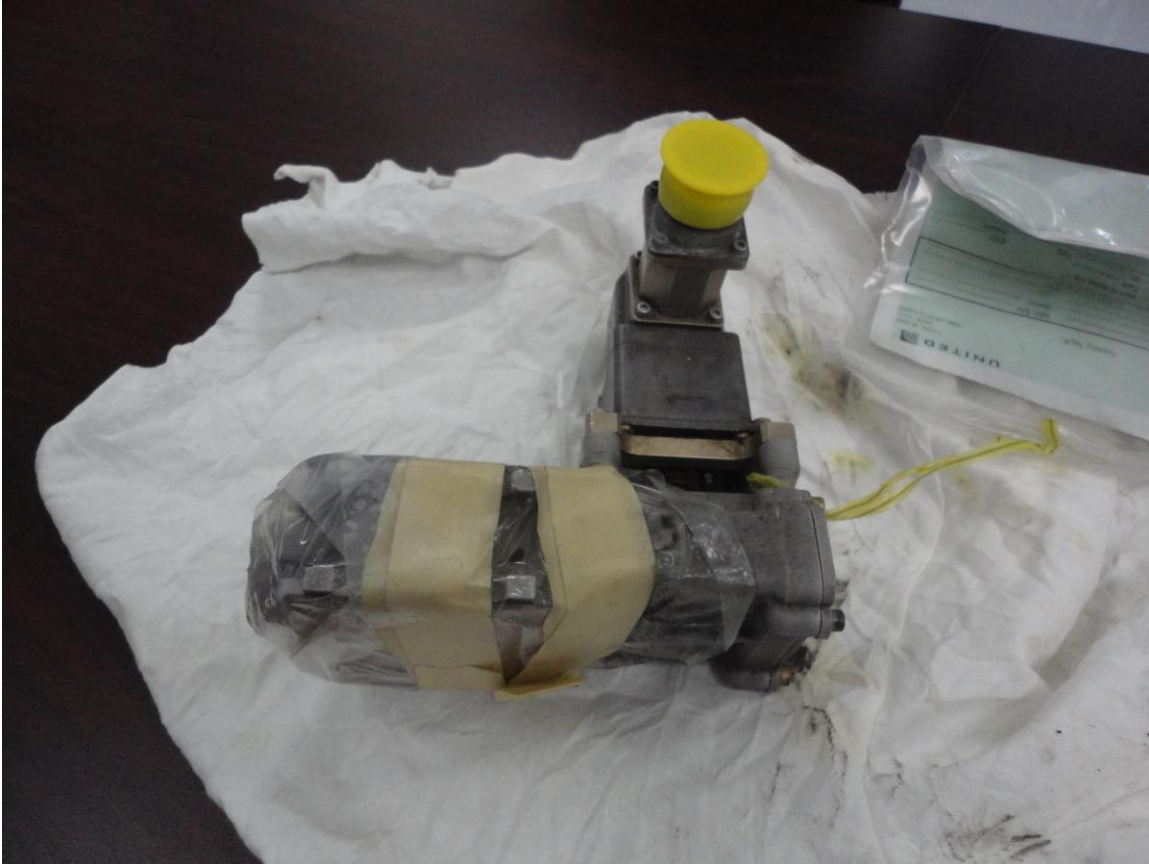
The shipping box containing the valve was retrieved from secure storage, and there was no apparent damage. The valve was removed from the box, and an external examination was conducted with no obvious damage noted (see figure 1). The valve data plate was photographed. The valve pins were photographed – no bent pins or corrosion was noted.

Figure 1
EDP supply shutoff valve – overall view

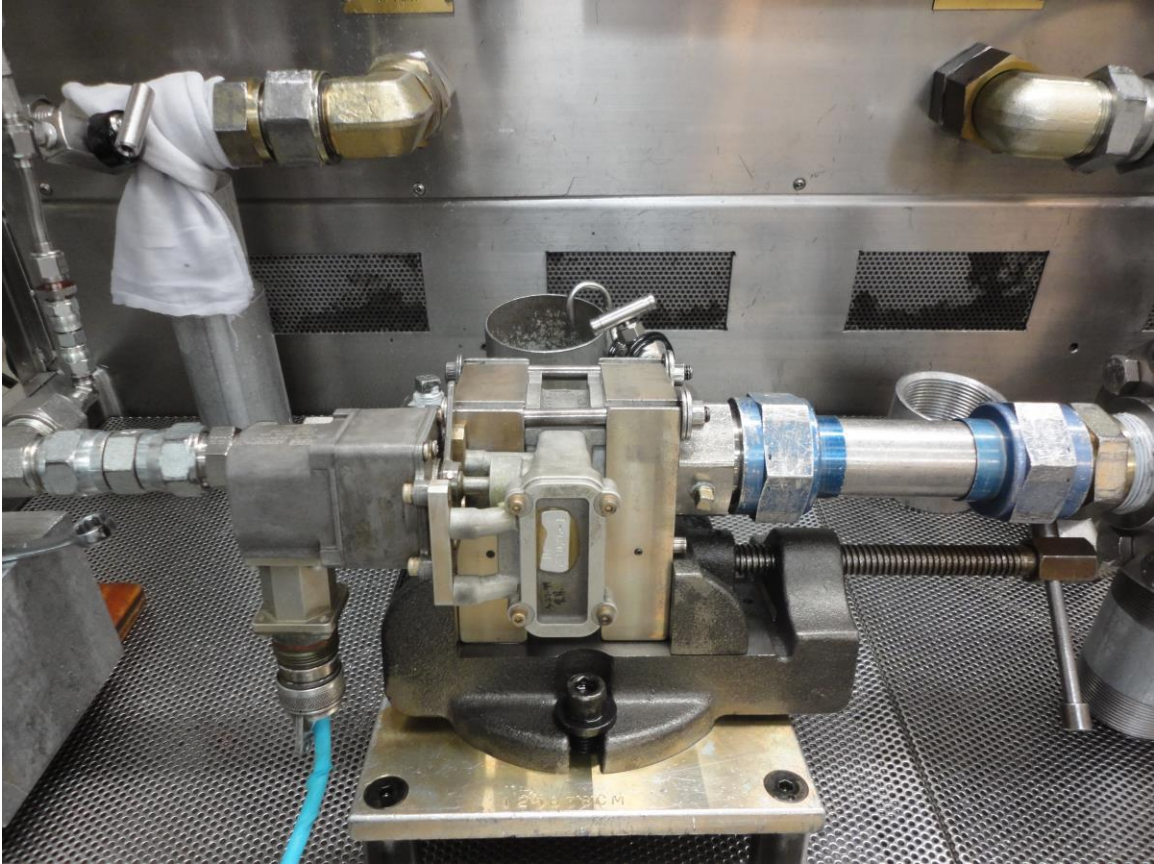
The running current test was attempted. The zip tie restraining the indicator arm was removed, and the valve was installed in the ITT hydraulic flow test bench (see figure 2). The voltage applied to the valve was 18 v, with 100 psig applied, and the valve did not close and there was no current draw noted on the test setup.

Figure 2
Valve installed on test bench

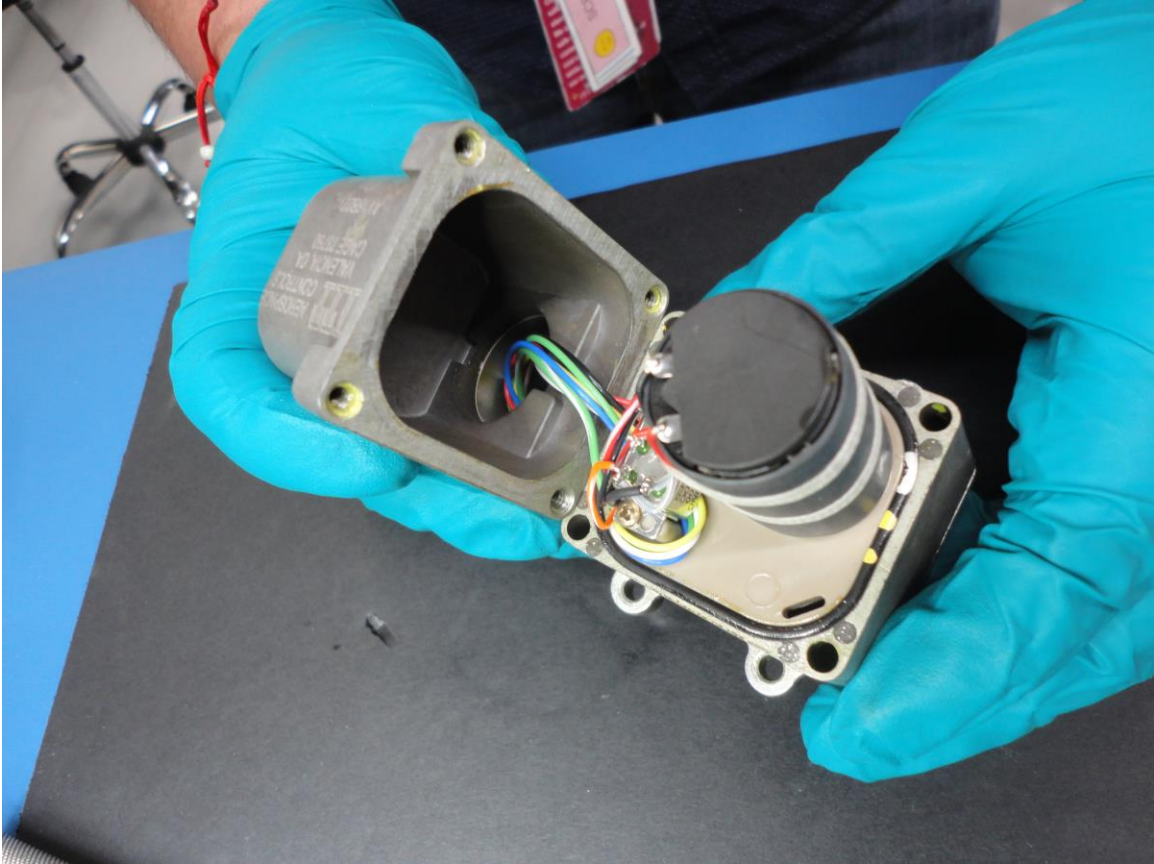
The screws holding the actuator cover to the body were removed, and the cover was removed. No debris, water, corrosion, or streaking was noted inside the actuator body or on the cover (see figure 3).

Figure 3
Actuator cover removed

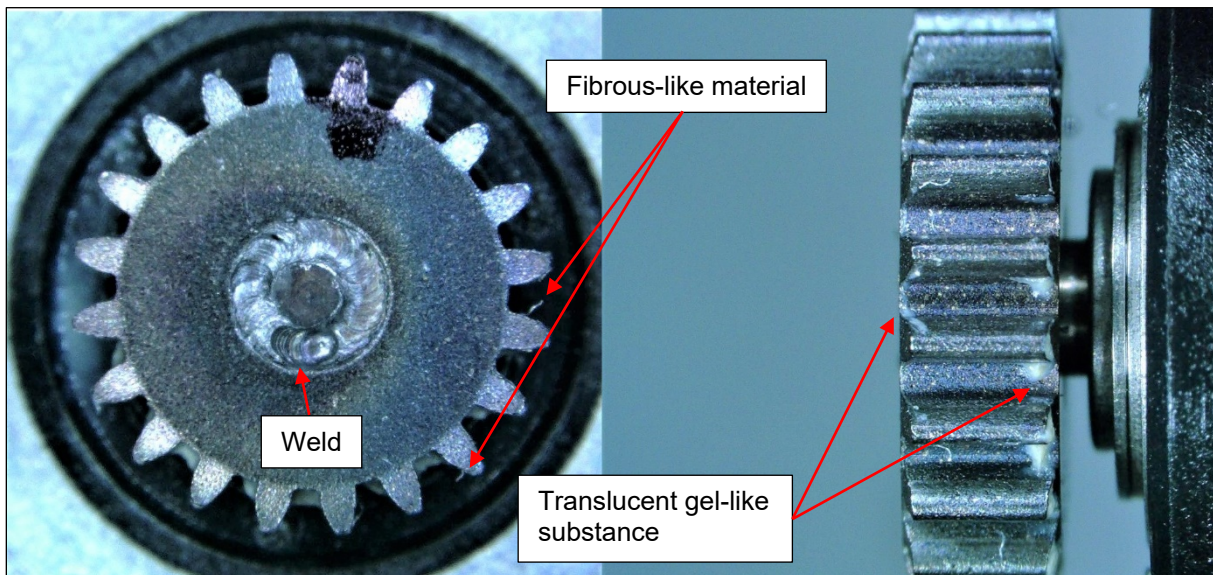
The pinion gear was examined under magnification as shown on Figure 6. Fibrous-like material were observed at random locations and a translucent gel-like substance were present near the edges of the teeth. No deformations were observed on each tooth profile and base. The weld between the shaft and pinion gear appeared consistent and no anomalies observed.

Figure 6: Pinion gear under magnification. Locations of weld, fibrous-like material and translucent gel-like material shown.

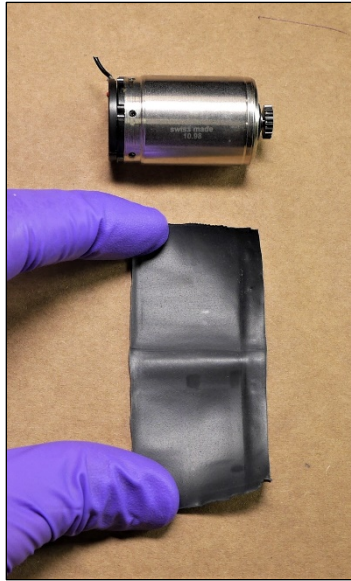
A sharp blade was used to cut the black sleeve open as shown on Figure 7. No visible sign of moisture or any contamination was present on the inner surface of the black sleeve and on the DC motor housing.

Figure 7: Black sleeve removed from the DC motor housing.

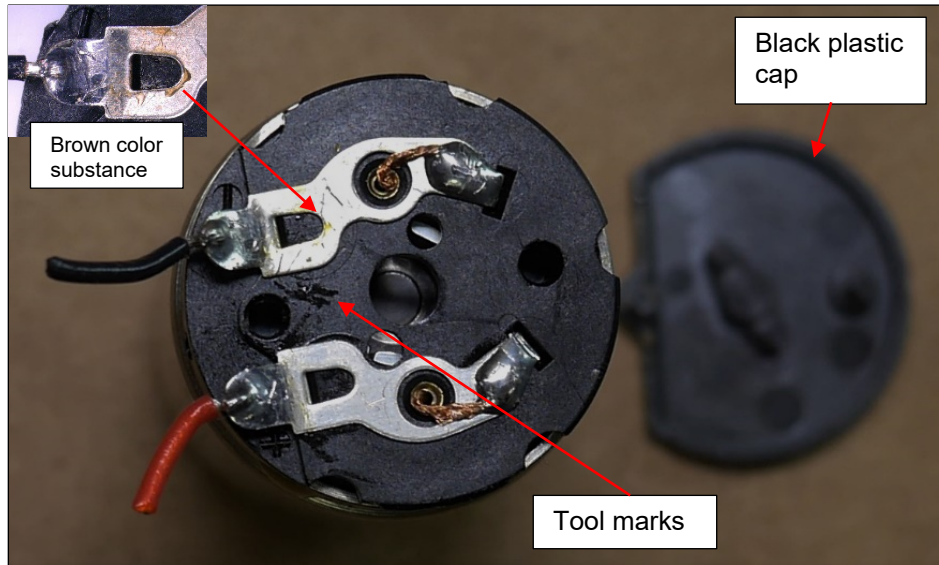
The black plastic cap was removed as shown on Figure 9. A brown colored substance was visible on the black terminal. Solder appeared sufficient and no voids or cracks present. Tool marks were present on the black plastic material. ITT Aerospace Controls had previously removed the plastic cap on an earlier examination. Solder on both terminal wires and brush wires appeared unremarkable.

Figure 9: Black plastic cover removed from the rear section of the DC motor.

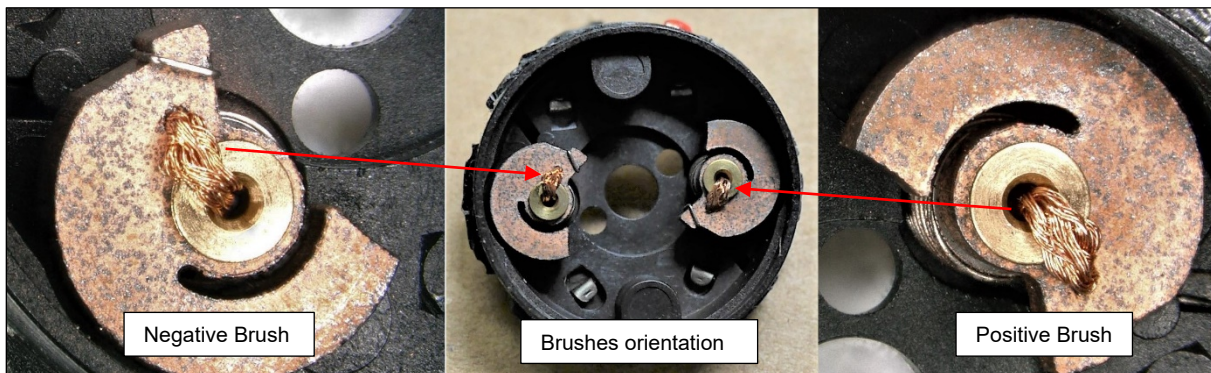
Figure 13 shows the orientation of the brushes after separation from housing. Wire brushes appeared kinked but no visible strands broken.

Figure 13: Orientation of brushes upon separation from DC motor housing. Magnified images of each brush showing wire strands.

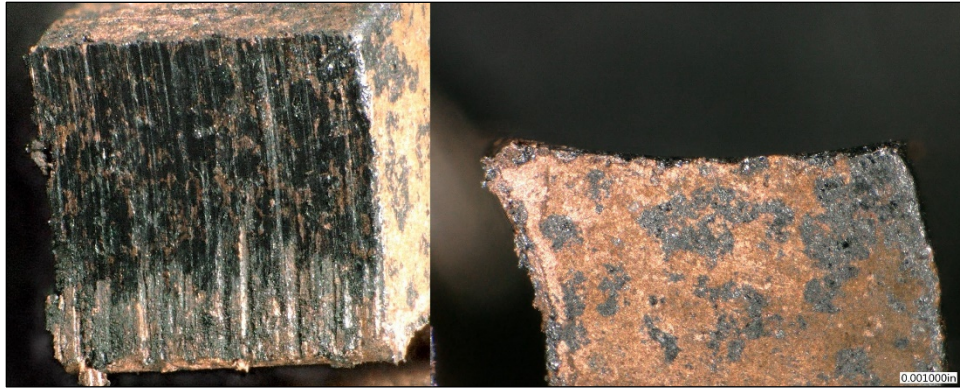
Both brushes were examined under magnification as shown on Figure 15 and 16. Both brushes exhibited deep lines consistent with the commutator surfaces. Side view of both brushes appeared to take the shape of the commutators. A silver colored particle was present at the edge of the negative brush.

Figure 15: Positive brush top surface (left) and side view (right).

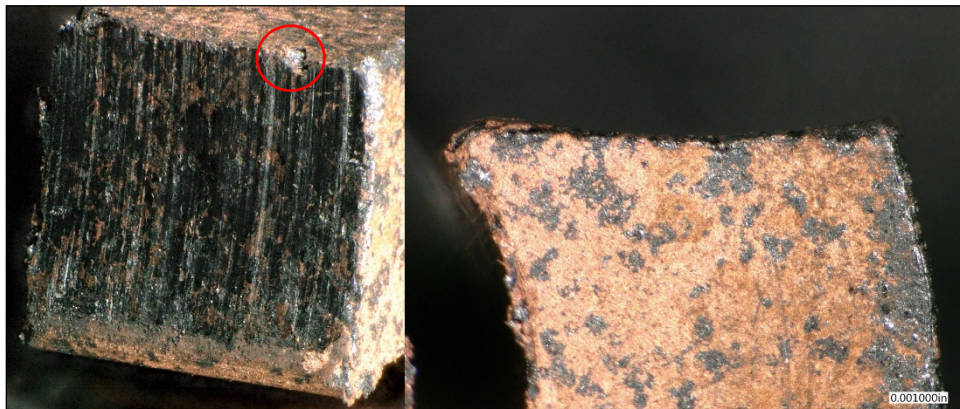
Figure 16: Negative brush top surface (left) and side view (right). Note: Silver colored particle observed circled in red.

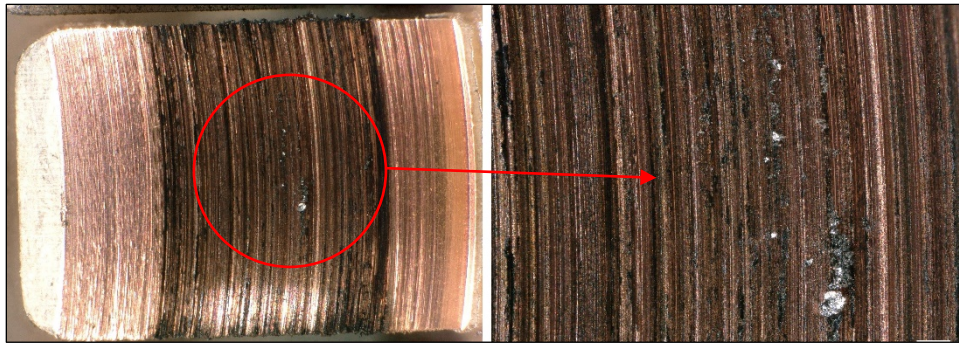
On commutator 7, silver colored particles were observed near the center as shown on Figure 28.

Figure 28: Silver colored particles present on Commutator 7.

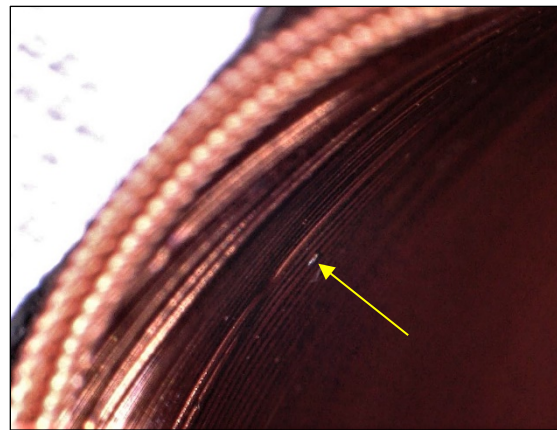
The shaft was pushed out to separate the coil and commutators from the housing (Figure 32). The inner diameter of the coil was inspected under magnification and observed a silver colored particle (Figure 33) measuring 0.006769 inches.

Figure 33: Inner diameter of coil showing location of silver colored particle.

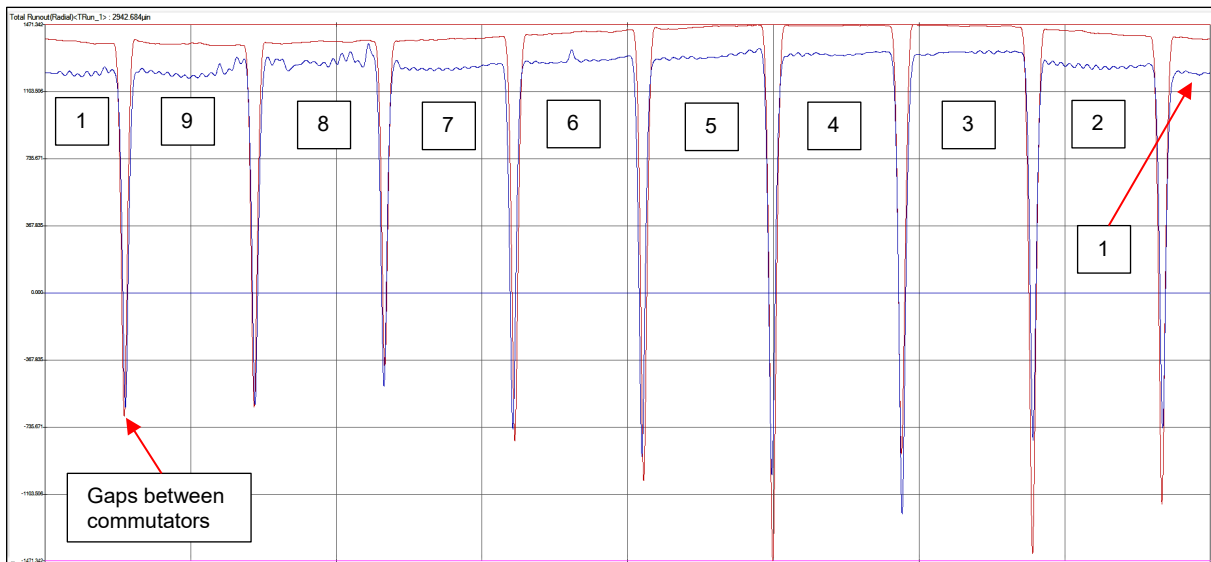
Figure 35 shows a graph of the commutator roundness. Red lines represent the bottom section of the commutators while blue lines represent the top section of the commutators. The numbers represent the location of each commutator. Excluding the gaps between commutators, the lowest and highest point for the top and bottom sections were obtained.

Figure 35: Roundness profile of the commutators.

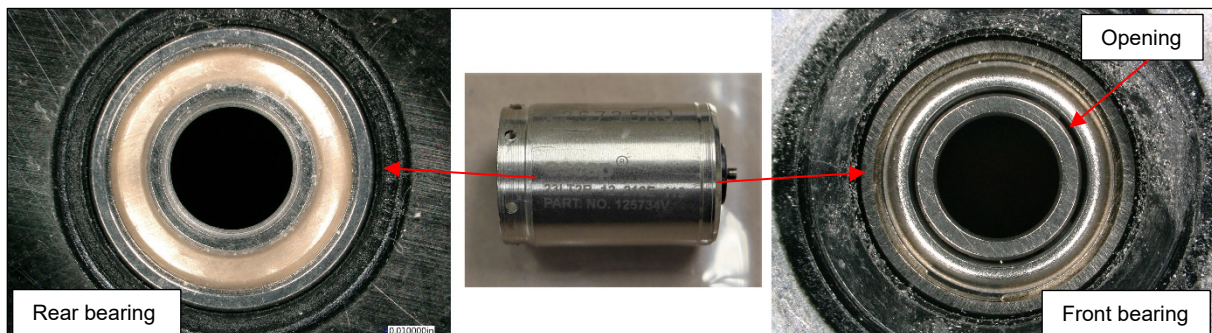
The front and rear bearings were inspected under magnification as shown on Figure 37. The front bearing appeared to show an opening between the inner race and the shield. The shield at the rear bearing appeared flushed at the inner and outer races.

Figure 37: Rear and front bearings shown.

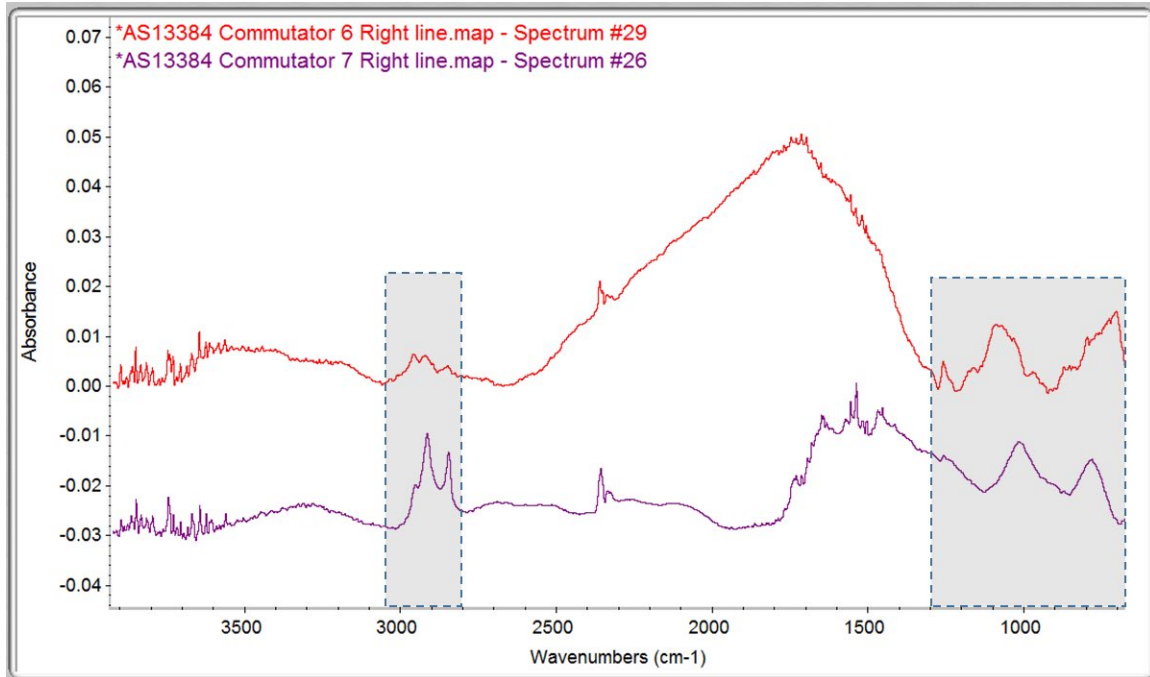
Figure 3. Unusual scans included a large inorganic peak from the dark line at the top of Sample #6, and an organic compound in the light area in the top third of #7. Both spectra also show silicone character.

Sample #7 had another organic residue in addition to silicone. That was observed in the top shiny area. Low signal to noise, and broad inorganic peaks obscure more detailed interpretation of the identity of this "other" organic.

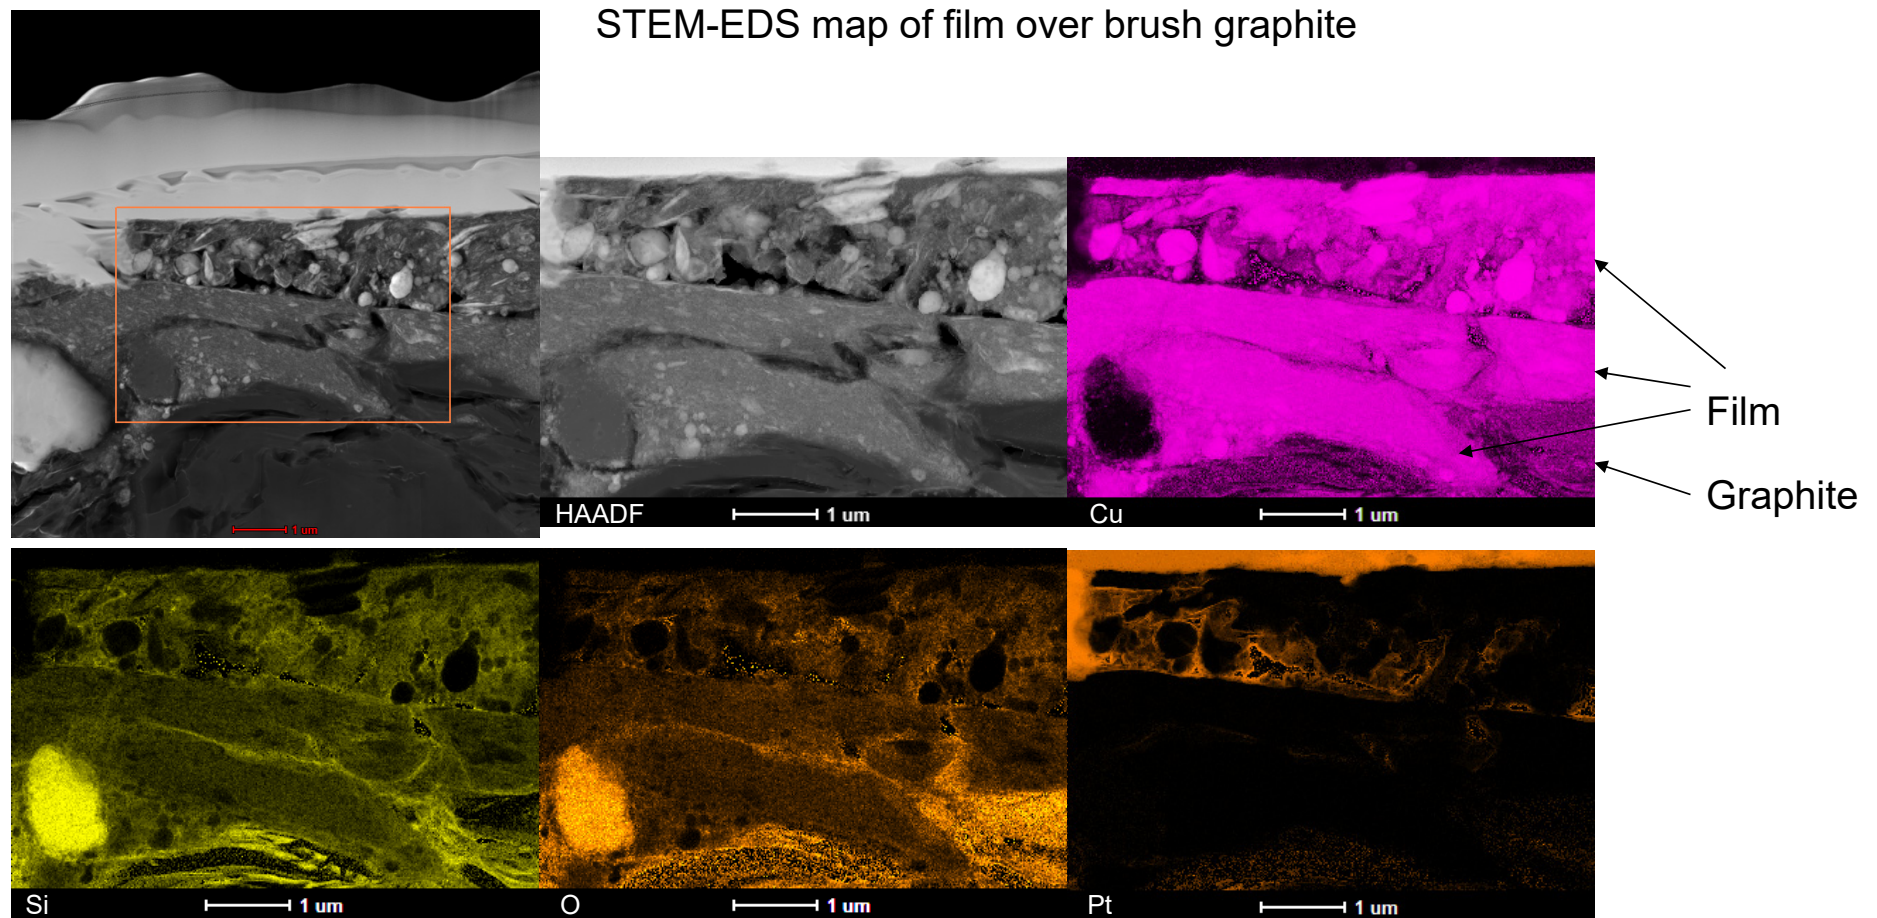
Film Resistance - The silicone was found to be fully dense with copper metal and Cu_2O copper oxide fretting debris, a condition that likely worsened over time and added to film resistance.

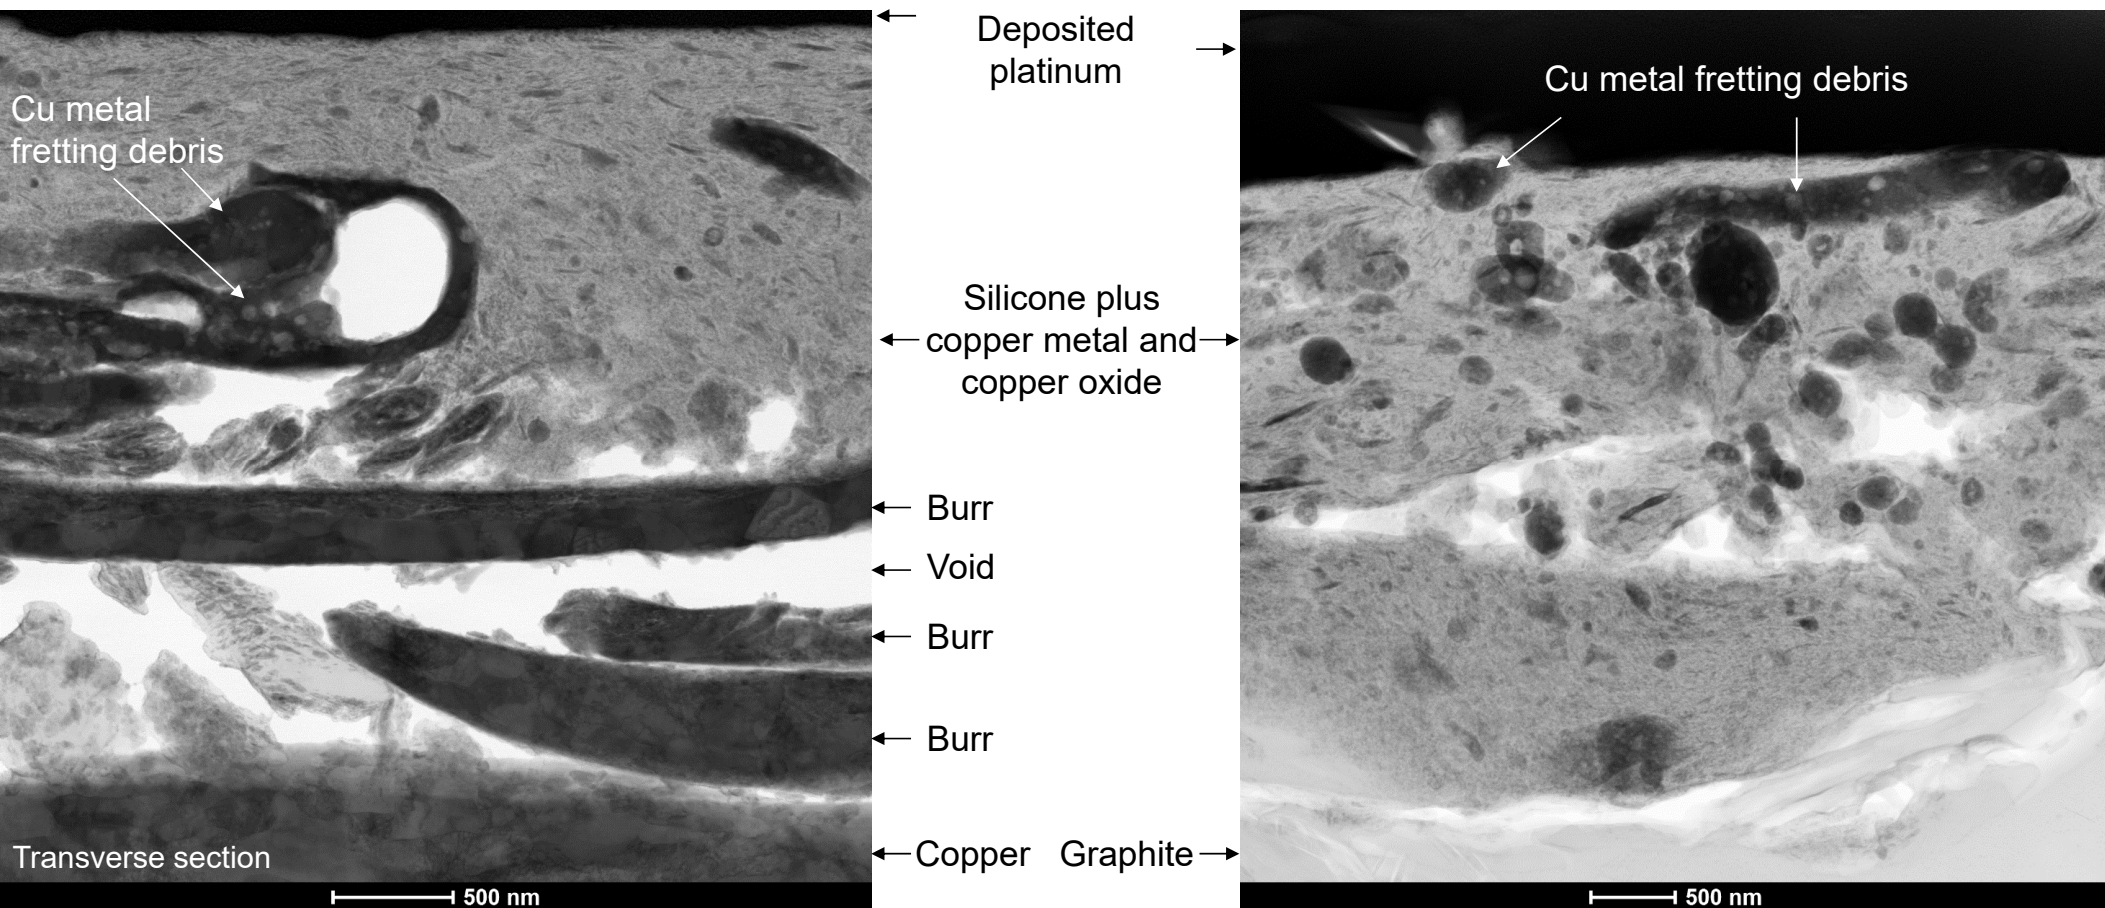
Film Resistance - The silicone was found to be fully dense with copper metal and Cu_2O copper oxide fretting debris, a condition that likely worsened over time and added to film resistance.

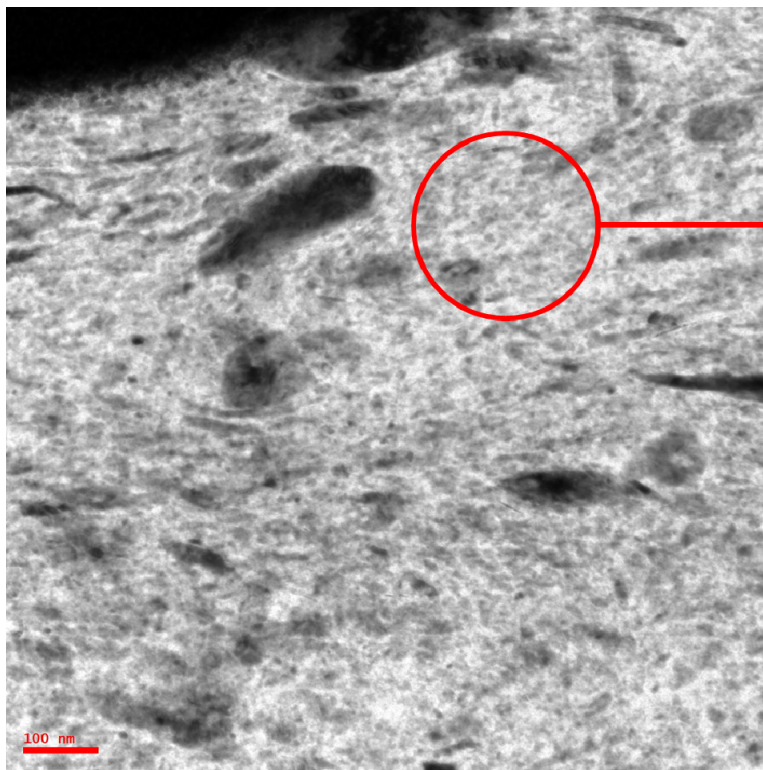
TEM image of the silicone film on the commutator, fully dense with copper oxide.

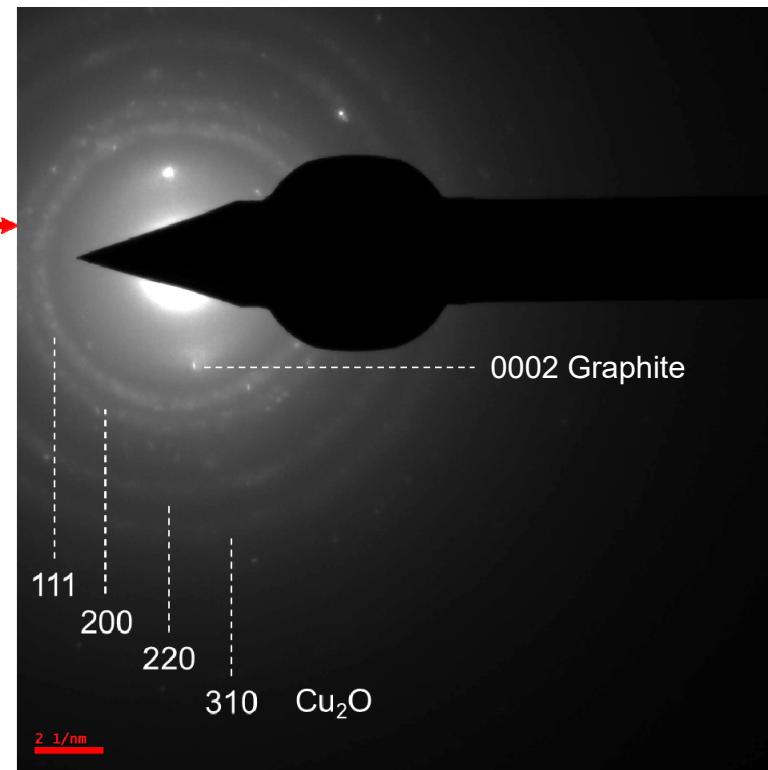
TEM electron diffraction pattern of the silicone film, exhibiting a ring pattern from nanograined Cu_2O .

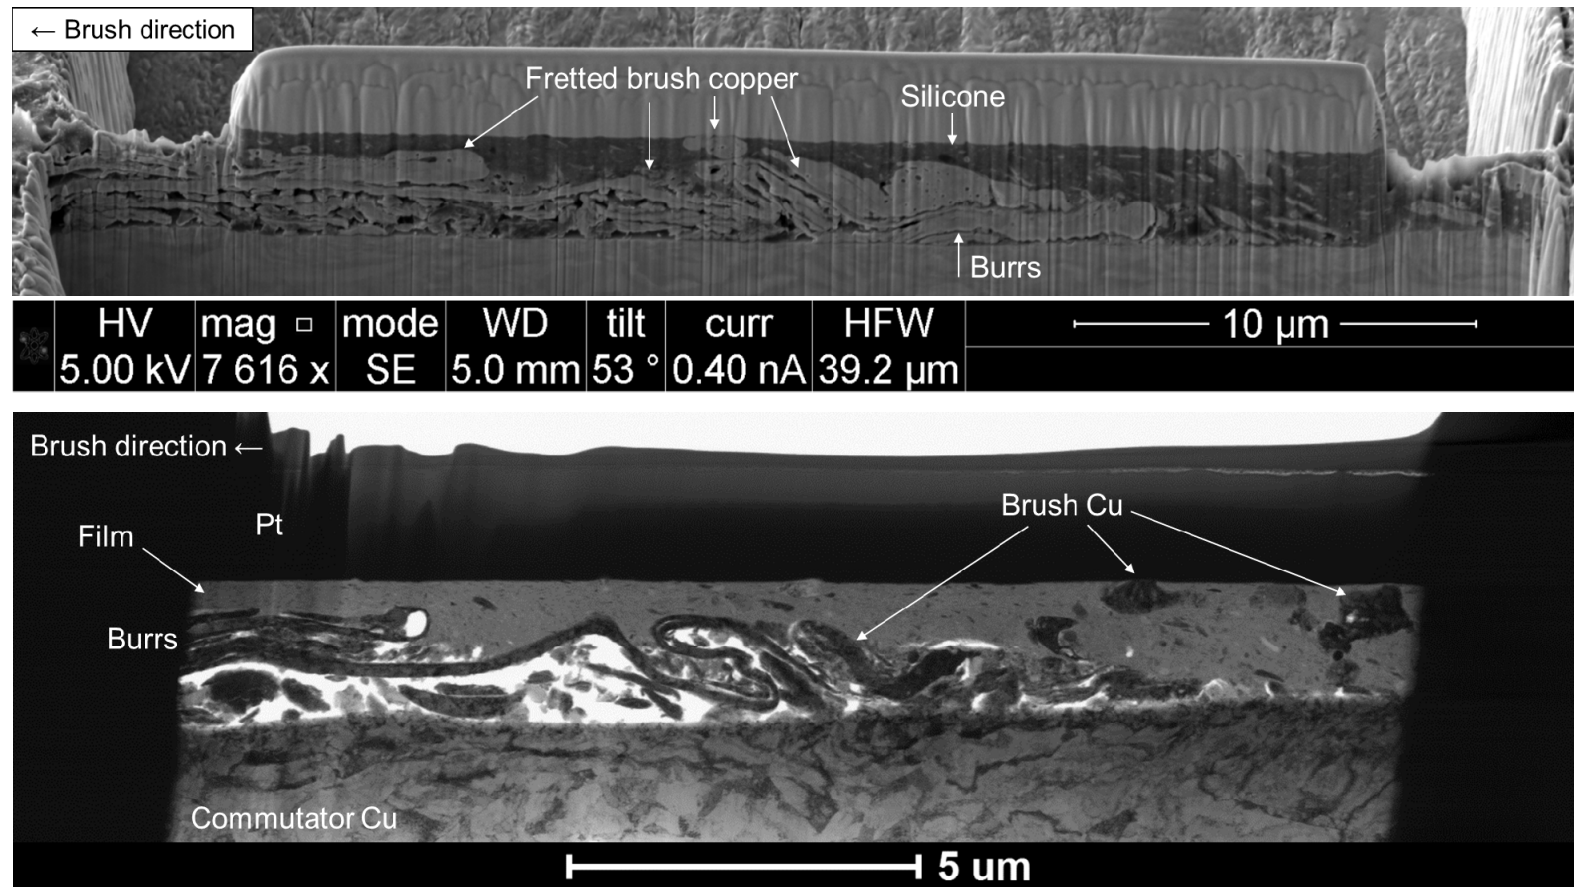
Film Resistance - On the commutator bars, the fretting debris-filled silicone film could potentially grow in thickness sufficient to cover the entirety of the surface at a local level. The film itself had poor contact with the commutator bar.

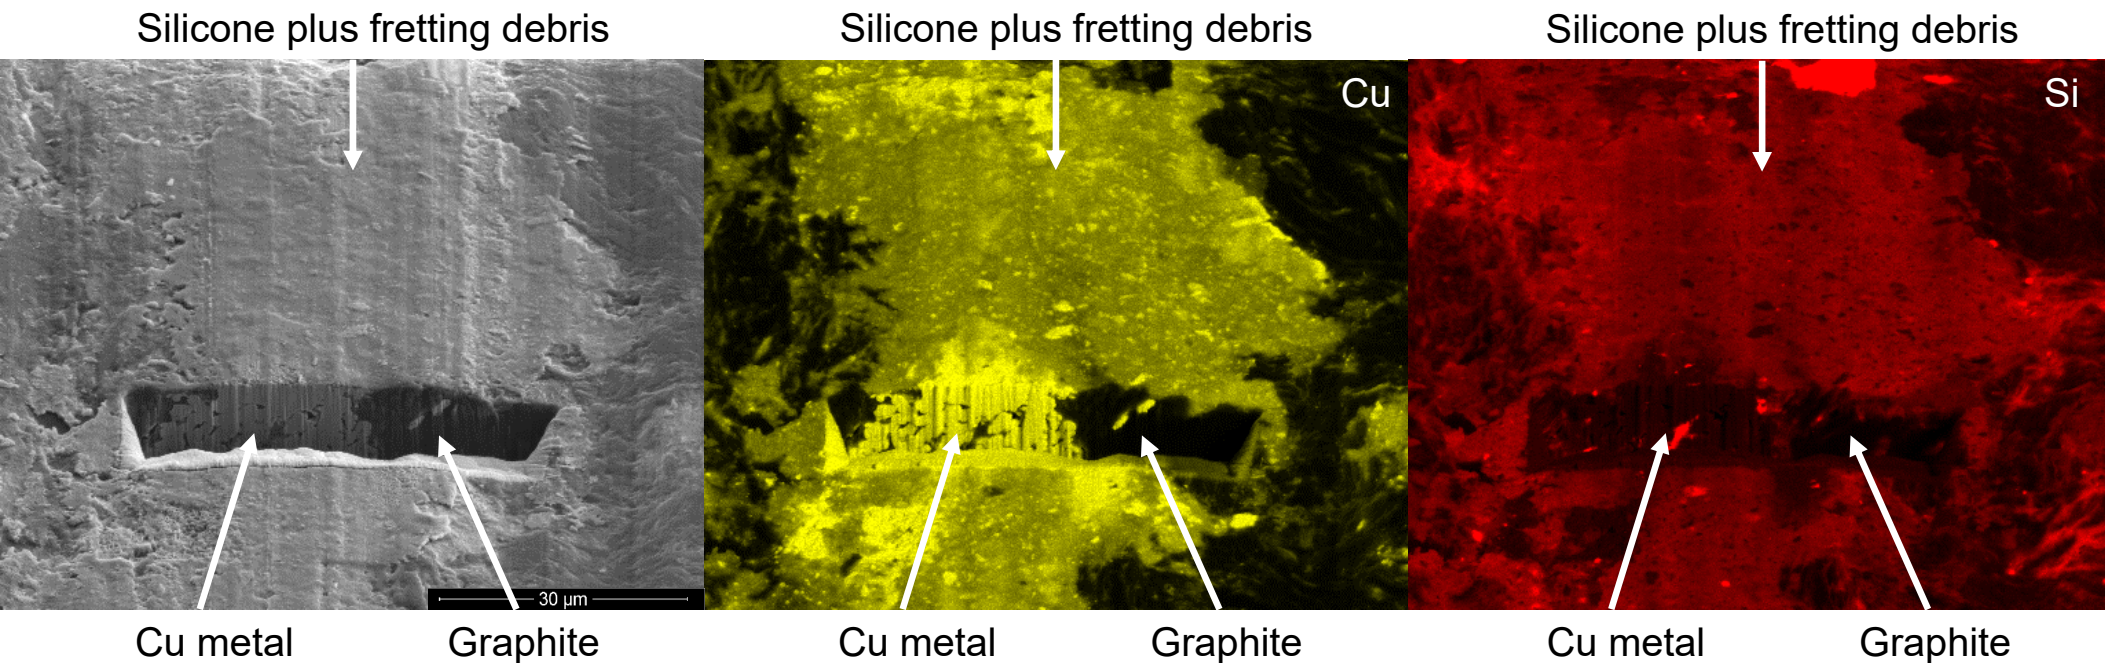
Example 1 – A FIB cross-section of brush shows silicone and fretting debris over copper metal and graphite. The wear direction is vertical in the images.

Film Resistance - On the brushes, the fretting debris-filled silicone built up mostly over the graphite and to a lesser extent the copper metal, likely increasing film resistance of each component over time.

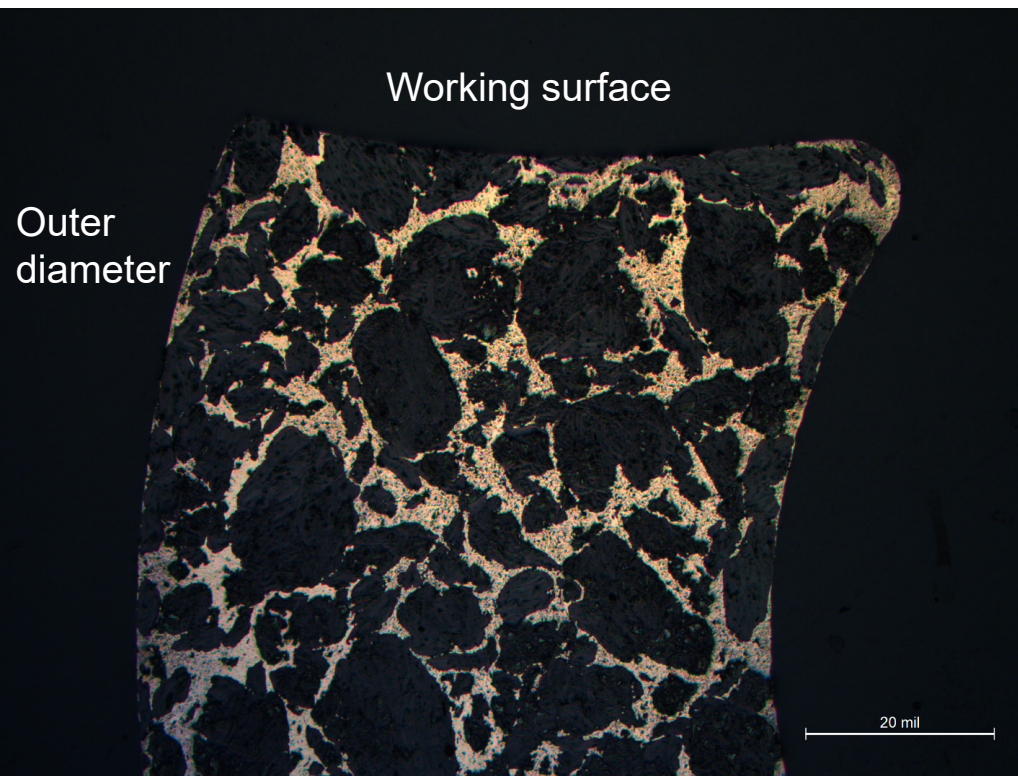
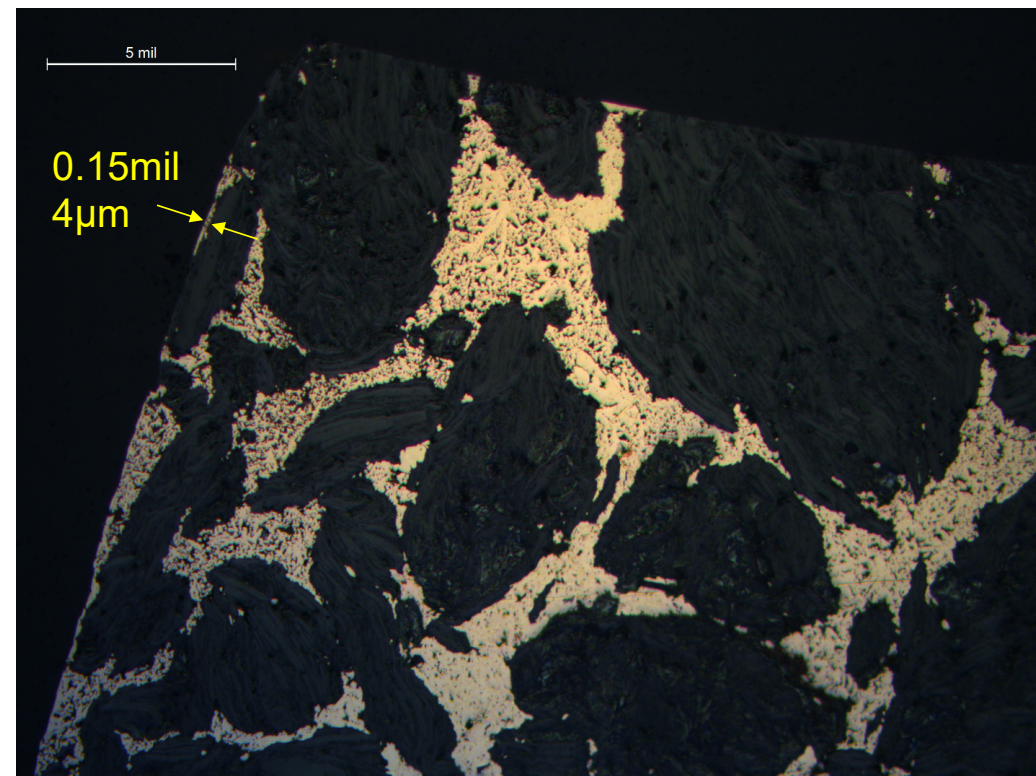
Constriction Resistance - The as-manufactured area percent copper metal on the brush is expected to be around 48-71%. With wear, the surface enrichment of copper metal gave way to the bulk composition of 18% copper metal, increasing constriction resistance.
