**NATIONAL TRANSPORTATION SAFETY BOARD
OFFICE OF HIGHWAY SAFETY
WASHINGTON, D.C.**

**HIGHWAY FACTORS GROUP CHAIRMAN'S
FACTUAL REPORT**

Location: State Route 12 (SR-12) mile marker 10.4, near Bryce Canyon City,
Garfield County, Utah

NTSB #: **HWY19MH012**

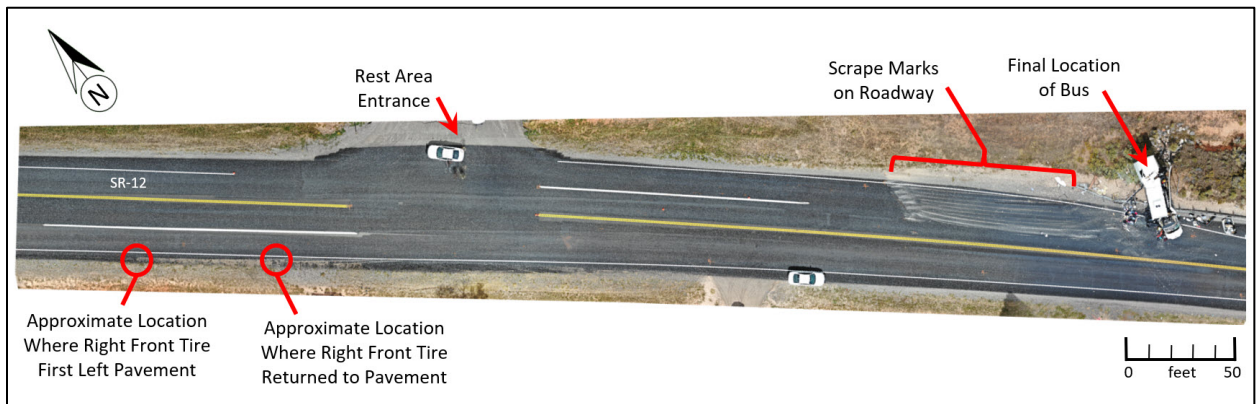
Figure 2: Orthomosaic Aerial Image of Crash Scene (source: Utah Highway Patrol, annotated)

The collision occurred on eastbound State Route 12 (SR-12), at milepost 10.4 in front of the Pines Rest Area near Bryce Canyon City, Garfield County, Utah. The crash location, shown in **Figure 1**, was located approximately 3.5 miles northwest of Bryce Canyon City, Utah. An annotated ortho-mosaic aerial image of the crash scene is shown in **Figure 2**.¹
