Survival Factors Photographs

Bryce Canyon City, Utah

HWY19MH012

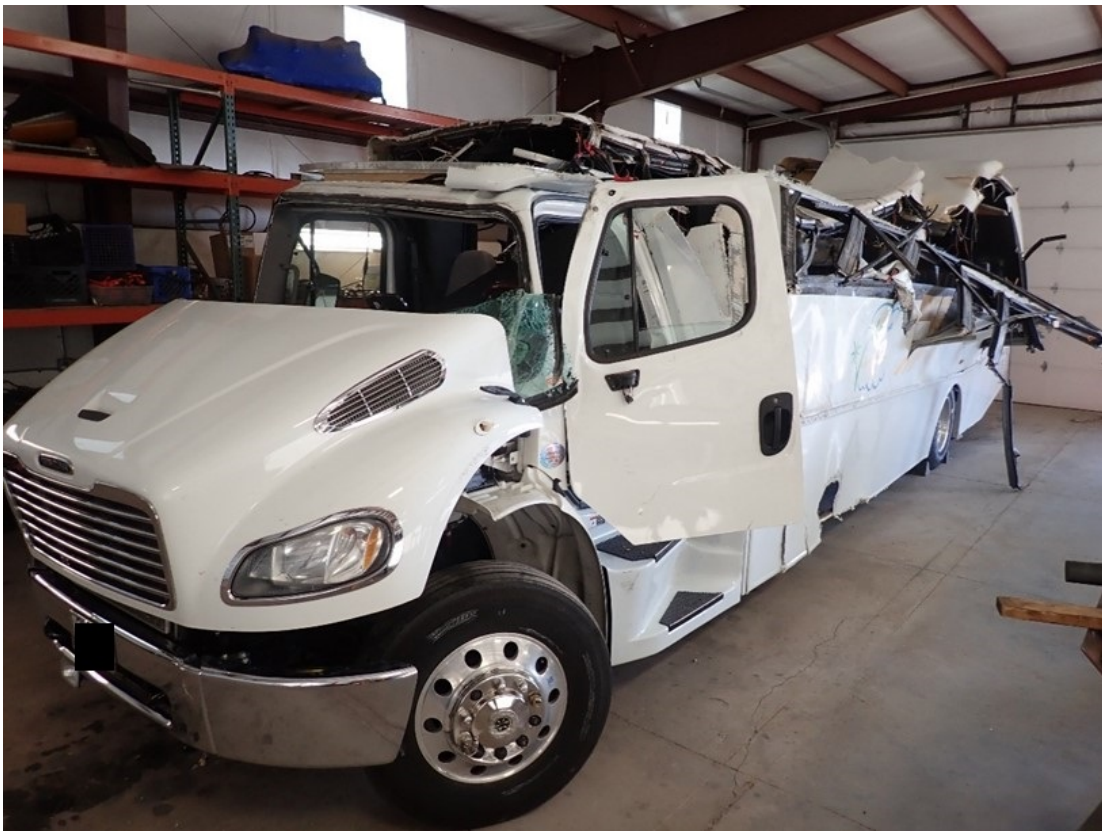
Photo 1 – Front left angle view of deformation to 2017 Freightliner, Embassy bus body.

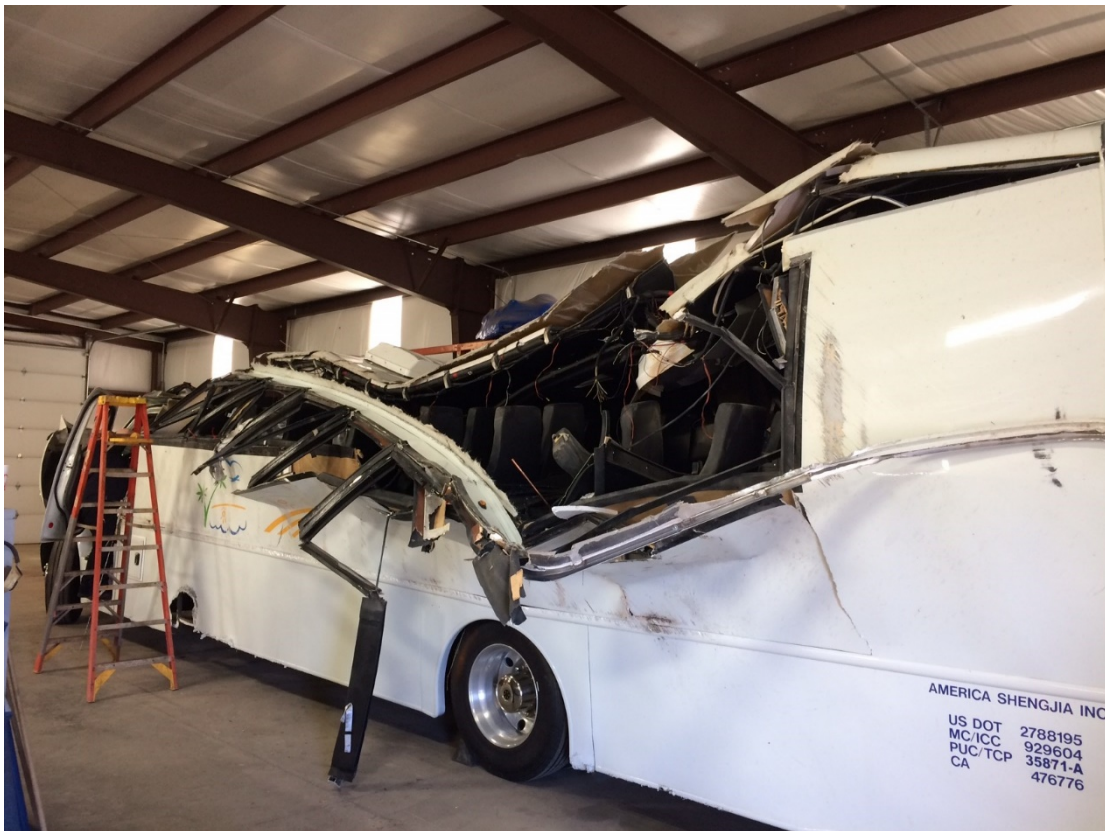
Photo 2 – Rear left angle view of deformation to roof of 2017 Freightliner, Embassy bus body.

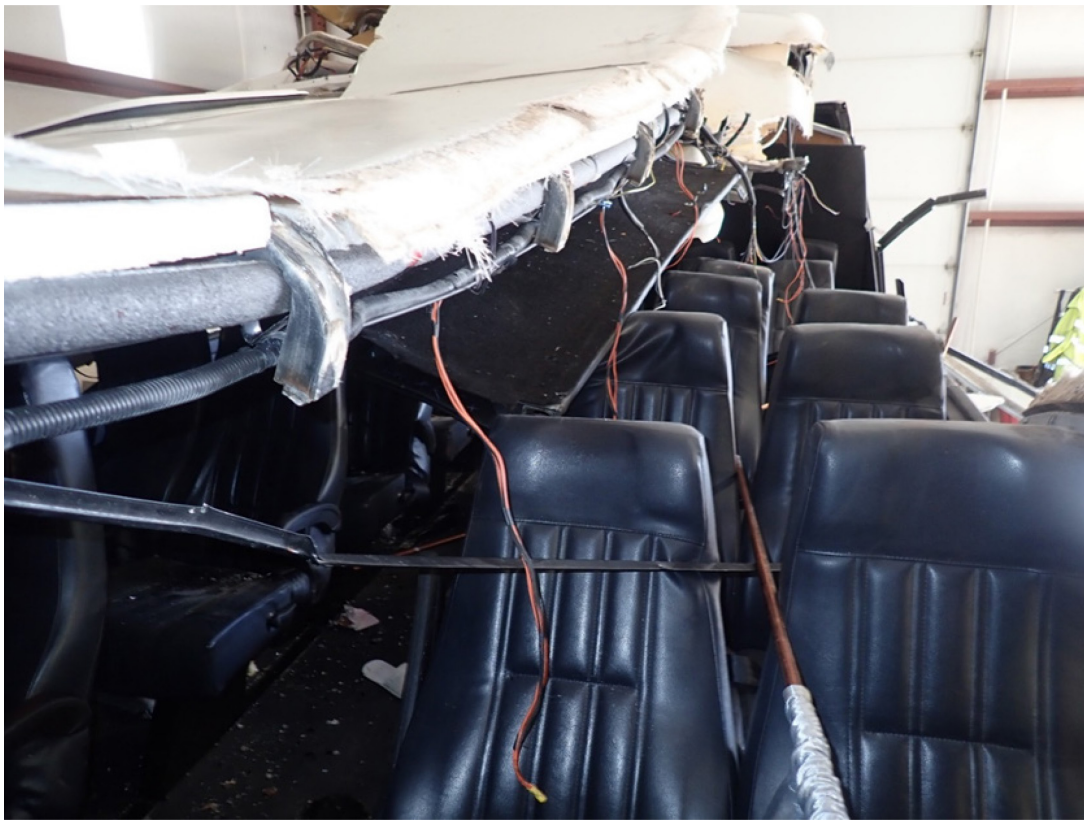
Photo 3 – View looking from front to rear showing roof shift and integrity loss.

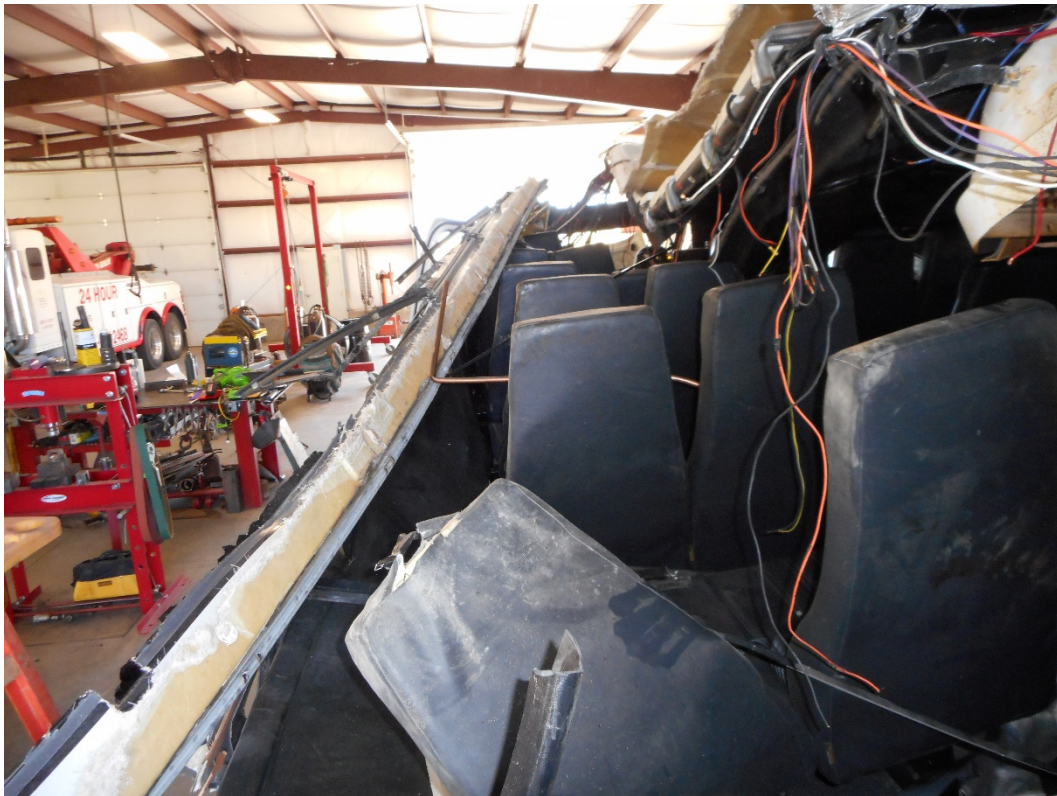
Photo 4 – View looking from rear to front showing roof shift and integrity loss.

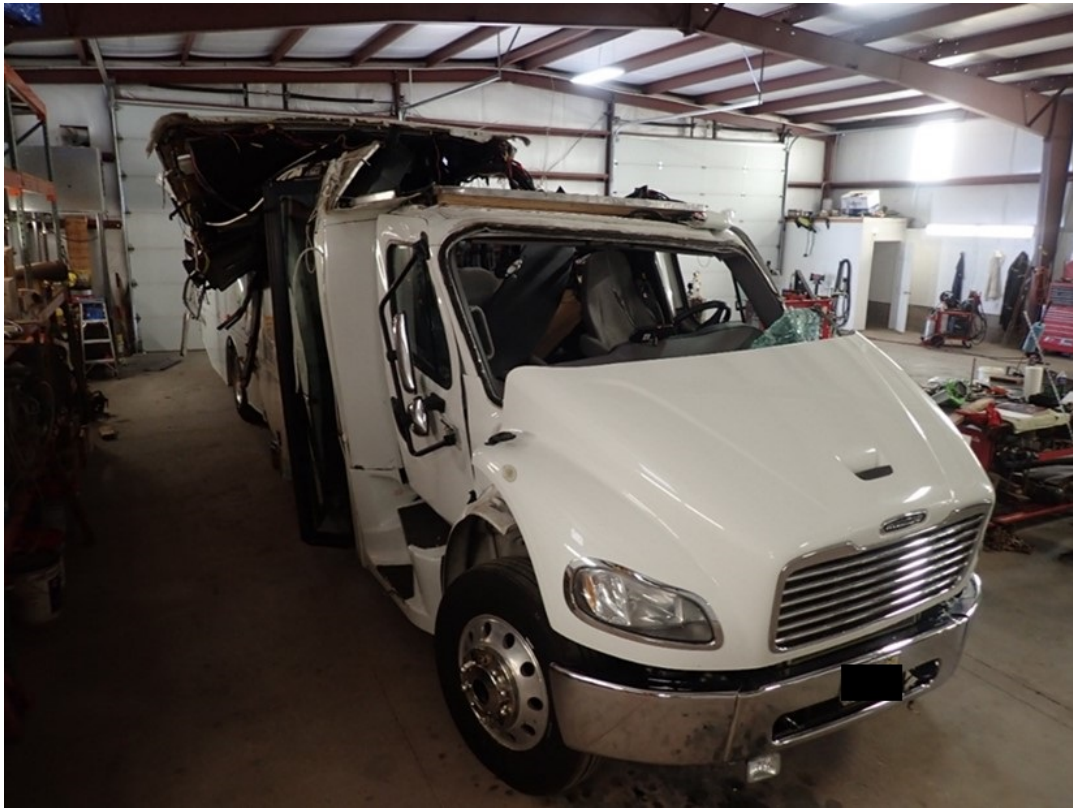
Photo 5 – Front right-angle view of deformation and roof shift to 2017 Freightliner, Embassy bus body.

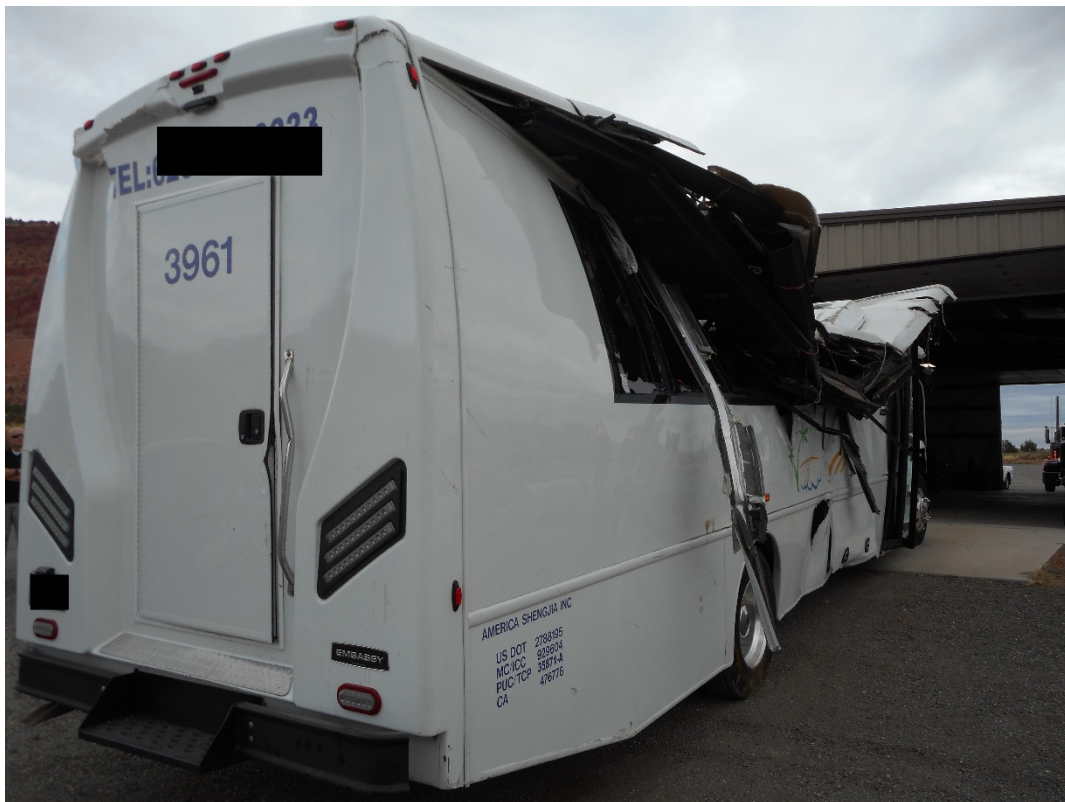
Photo 6 – Rear right angle view of deformation and roof shift to 2017 Freightliner, Embassy bus body.

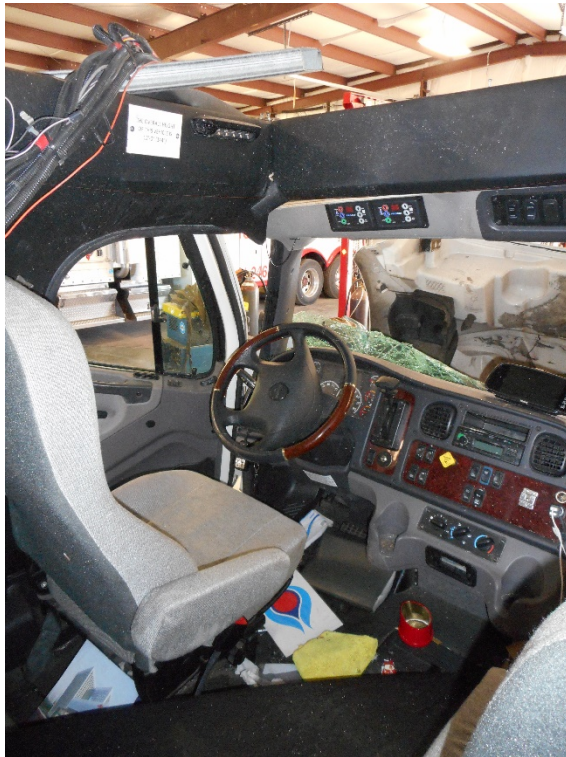
Photo 7 – Interior view looking at undamaged driver seating area. Note: Missing roof structure.

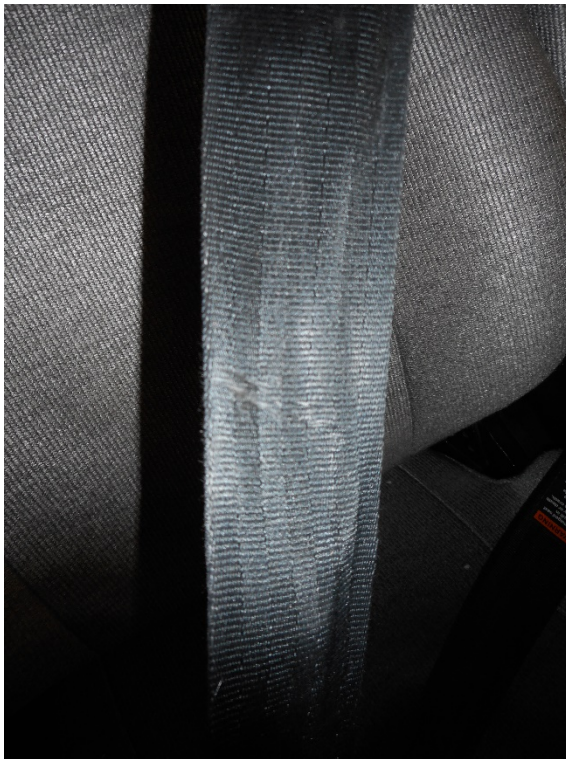
Photo 8 – View of loading evidence on bus driver's shoulder belt webbing.

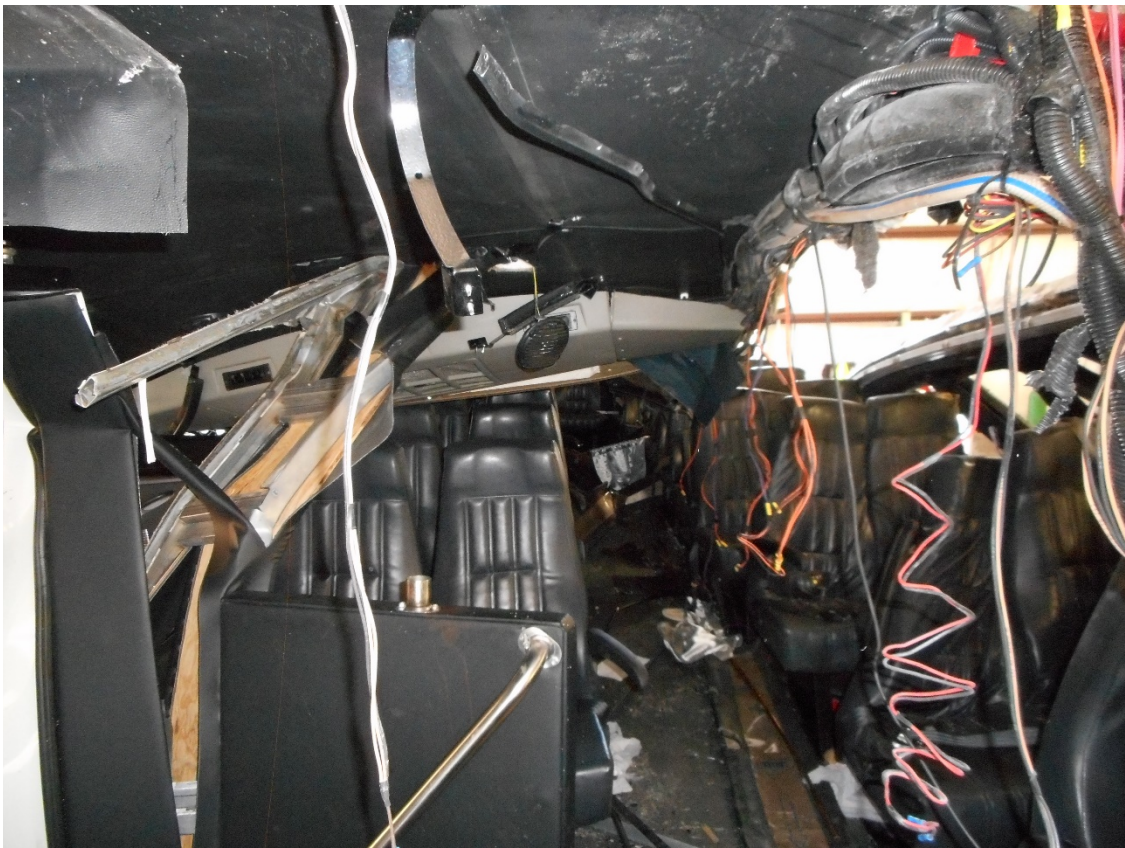
Photo 9 – Interior view of roof collapse looking from front to rear.

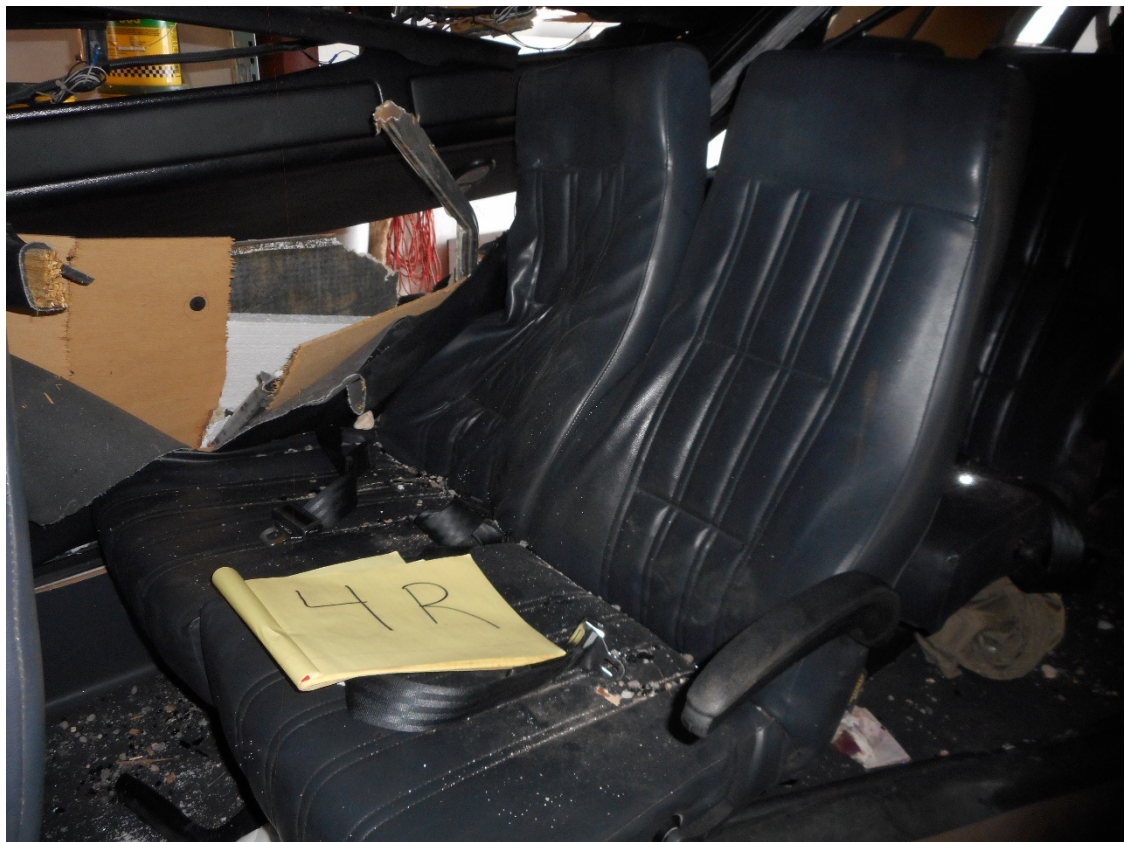
Photo 10 – View of sidewall intrusion to right side row 4.

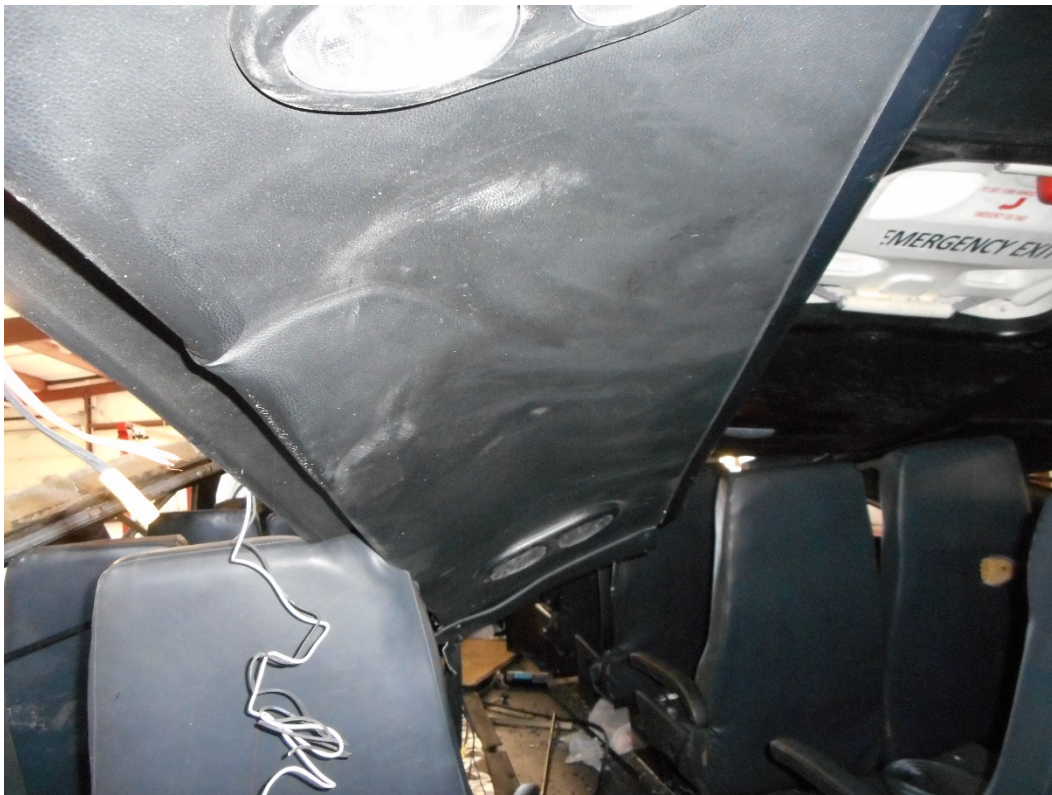
Photo 11 – View of roof collapse on top of Row 7 left side seatbacks.

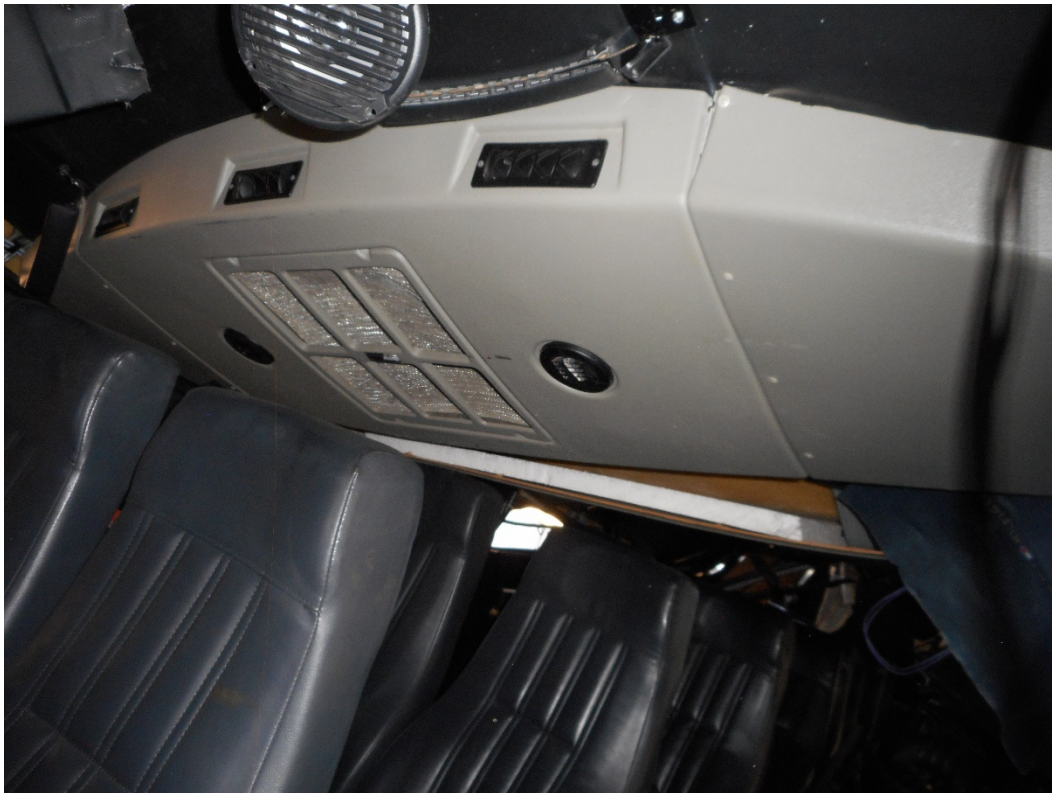
Photo 12 – View of roof collapsed on top of Row 3 left side seatbacks.

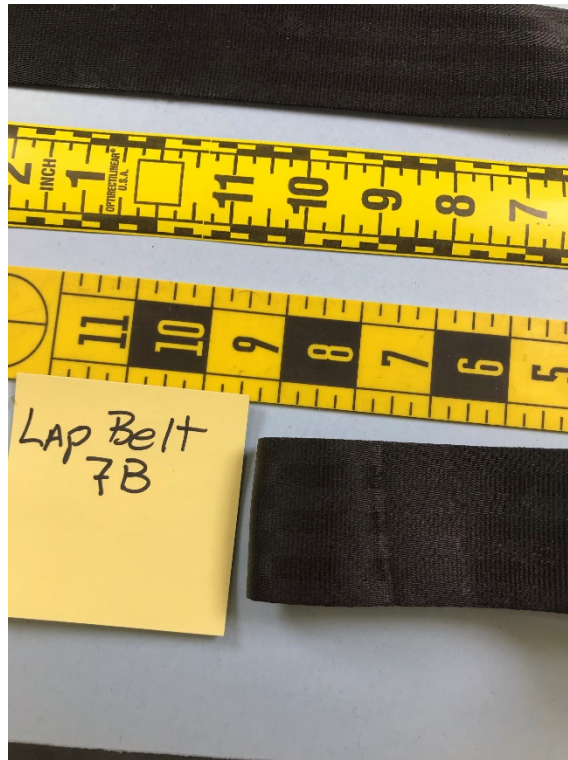
Figure 13. Close-up view of loading evidence to 7B lap belt webbing.

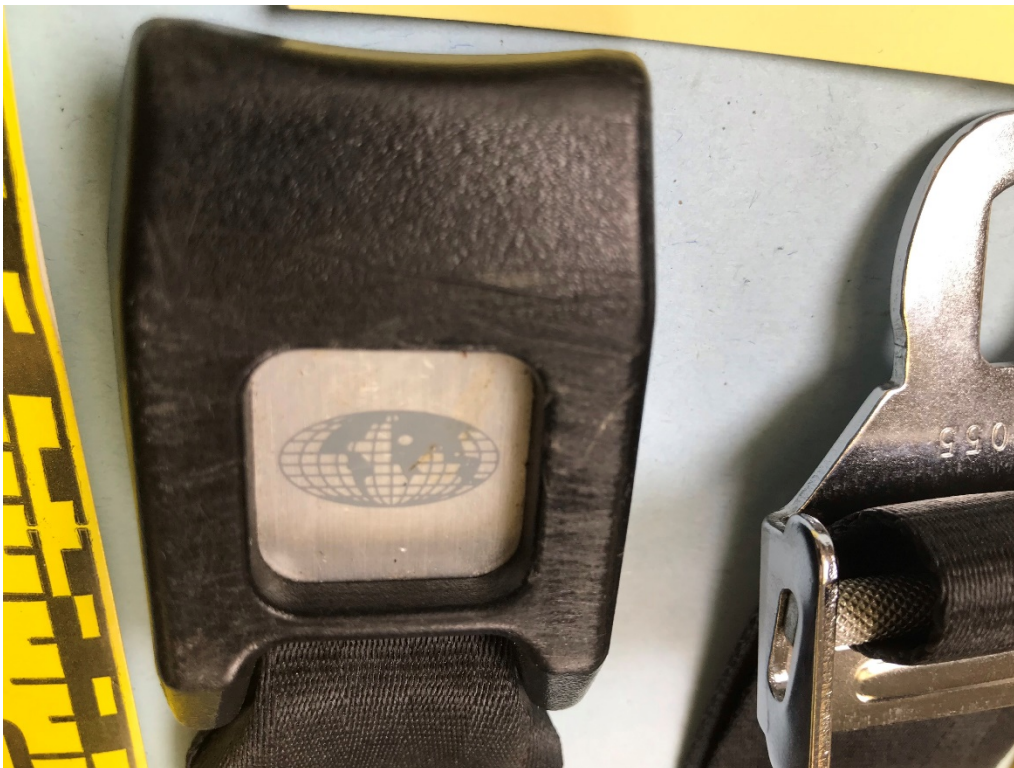
Figure 14. Close-up of 7B lap belt buckle showing evidence of roadway contact to top of plastic housing and latch plate cover broken off.

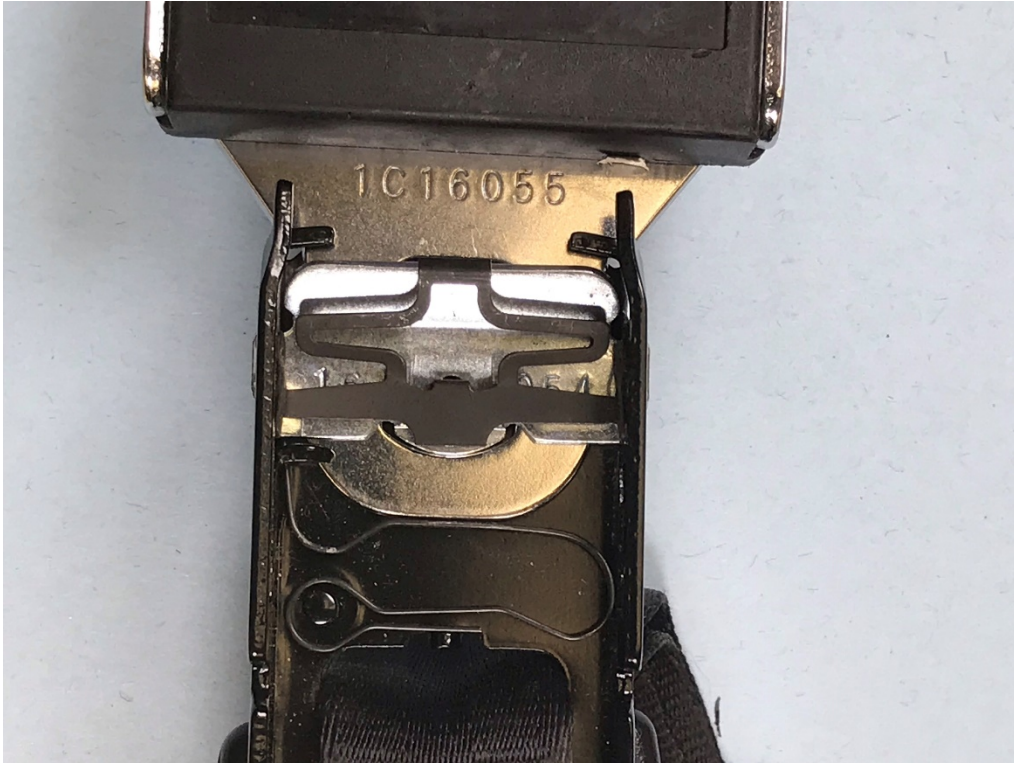
Figure 15. View inside lap belt buckle 7A prior to removal of interior components.

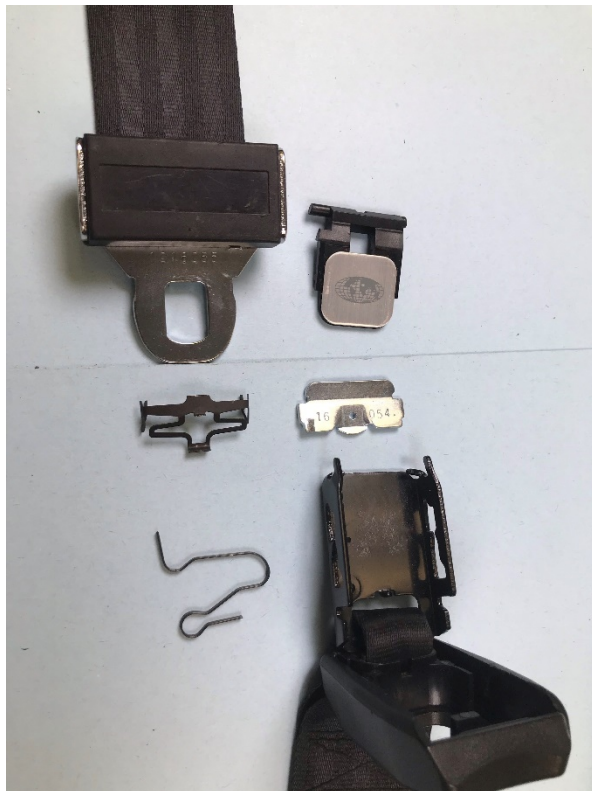
Figure 16. View of undamaged lap belt components removed and examined.
