## PRELIMINARY REPORT

### HIGHWAY

#### HWY19MH012

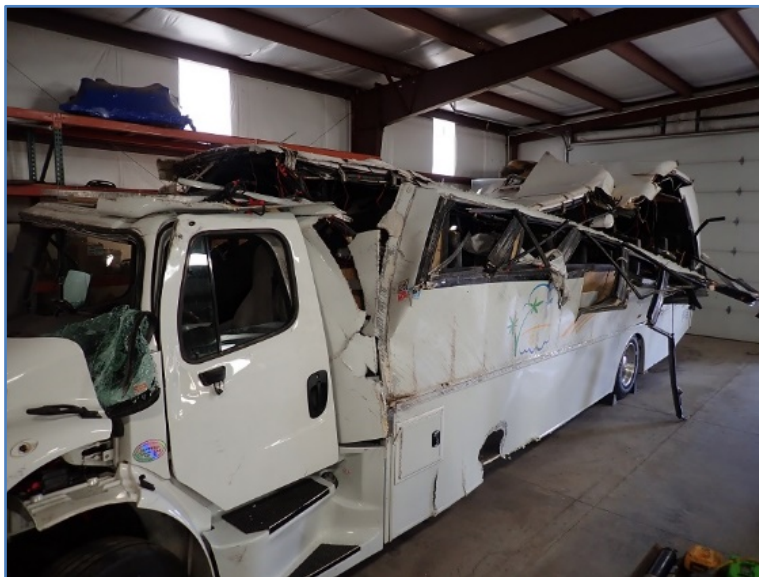
For unknown reasons, the bus went off the right side of the roadway. When the driver steered left to return the vehicle to the roadway, the bus began to cross into the westbound lane. The driver then steered sharply back to the right. The bus began to roll left. As it rolled over, the bus's roof struck the guardrail next to the westbound lane, significantly crushing the roof (figure 1). The bus rolled one complete revolution before coming to rest on its wheels.

**Figure 1.** View of bus's left side showing roof damage.

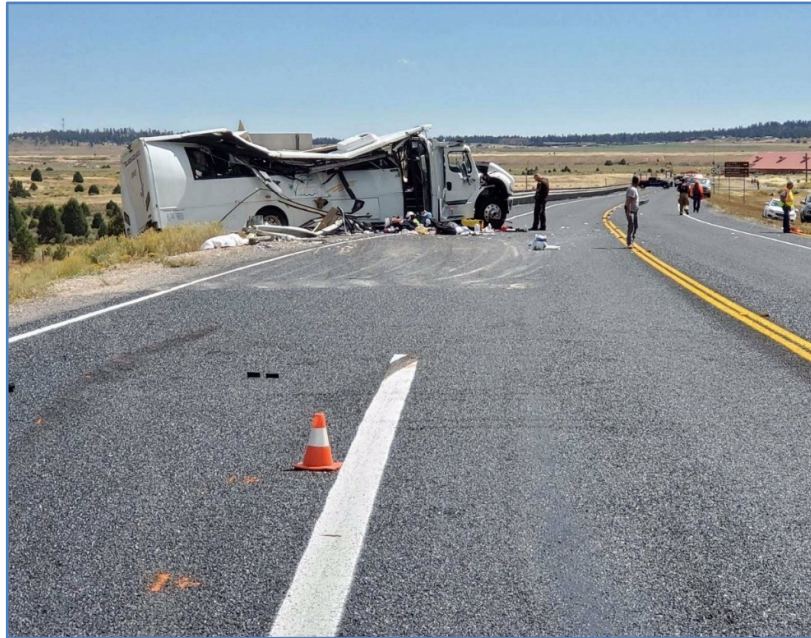
At its final rest, the bus straddled the damaged guardrail, with its front partially blocking the westbound traffic lane of SR-12 (figure 2). According to preliminary information, 11 passengers were completely ejected and 2 passengers were partially ejected during the rollover. Four passengers sustained fatal injuries, 15 passengers suffered serious injuries, and 11 passengers and the bus driver received minor injuries.

**Figure 2.** Postcrash scene. (Source: Utah Highway Patrol)
