**NATIONAL TRANSPORTATION SAFETY BOARD
OFFICE OF HIGHWAY SAFETY
WASHINGTON, D.C.**

**SURVIVAL FACTORS GROUP CHAIRMAN'S
FACTUAL REPORT**

Location: State Route 12 (SR-12) mile marker 10.4 near Bryce Canyon City,
Garfield County, Utah

NTSB #: **HWY19MH012**

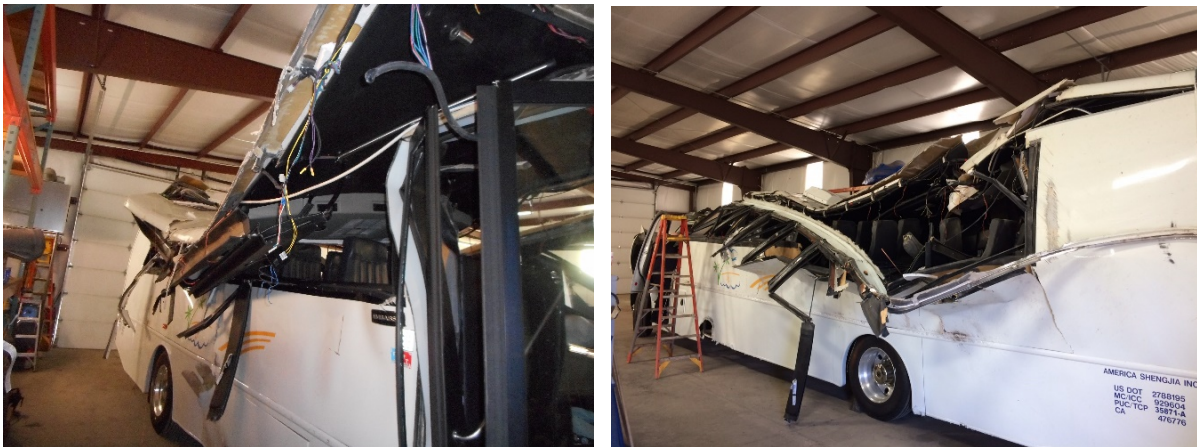
The bus sustained extensive roof damage with significant downward vertical intrusion. The top fiberglass portion of the driver compartment roof was torn off the bus. The bus roof was displaced and shifted to the right side approximately 31 inches as shown in **Figures 1 and 2**. Additionally, the roof on the left side was crushed downward and shifted approximately 47 inches rightward, exposing the two passenger seats adjacent to the sidewall on the left side as shown in **Figures 3 and 4**. The left side window post showed signs of having been in contact with pavement, with portions worn through and asphalt debris present.

Figure 1. Right side view of roof crush and rollover damage. **Figure 2.** Left side view of damage to roof.

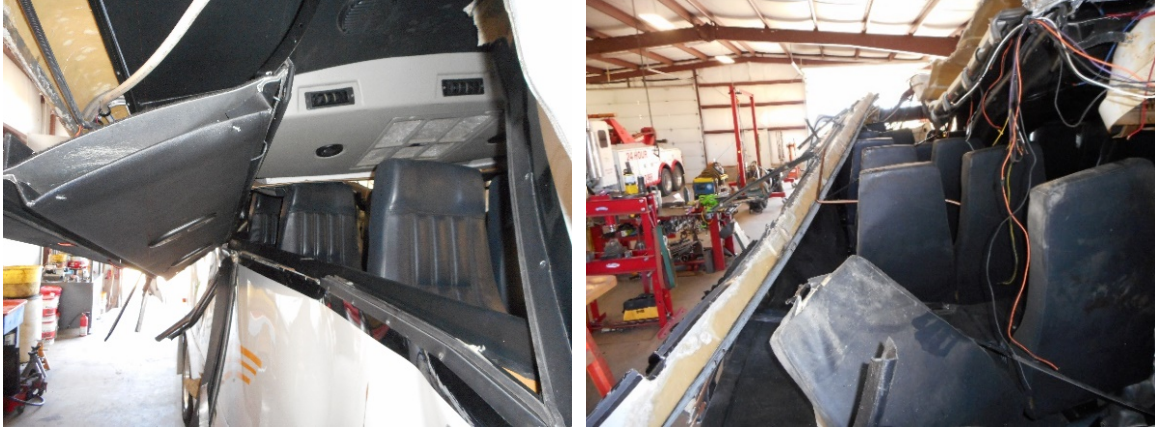
The driver's door was ajar and unable to close due to the frame being deformed with the front passenger door (chassis cab) being operational. The windshield was totally displaced and laid out in the engine compartment. The bus was equipped with 8 windows on the left side and 7 windows on the right side. There were 6 emergency exit windows (#3, #5, and #7 on the left side and #2, #4, and #6 on the right side) and an emergency roof hatch. Due to the deformation to the roof structure, most of the window frames along both sides were displaced. At the time of inspection, the Transpec roof hatch located above the center aisle near rows 6-7 was found closed and damaged (exterior road rash) and was not fully operable. The passenger loading bi-fold door was damaged and was stuck partially open. The aft window of the passenger loading bi-fold door was broken out while the forward window remained intact. For detailed exterior examination description, *Refer to the Vehicle Factors Factual Report of the Investigation* in the docket.

Figure 3. View looking aft at lateral roof shift on right side. **Figure 4.** View of lateral roof shift on left side.

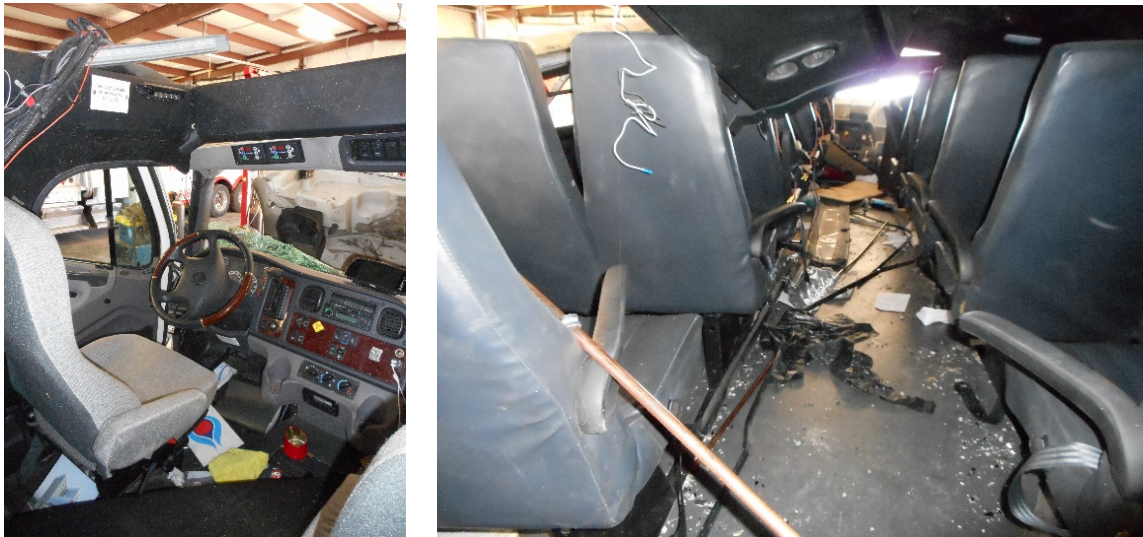
The bus sustained severe vertical intrusion from the roof collapse in addition to right sidewall intrusion towards the middle portion of bus. As noted in section 1.1, the driver and front right seating area remained undamaged except for the fiberglass roof above this section which was entirely displaced as shown in **Figure 5**. The modesty panels along both sides of the loading stairwell were displaced from their original attachment points.

Figure 5. Interior view of missing roof above driver seating. **Figure 6.** View looking forward of roof collapse.
