**NATIONAL TRANSPORTATION SAFETY BOARD
OFFICE OF HIGHWAY SAFETY
WASHINGTON, D.C.**

**VEHICLE FACTORS GROUP CHAIRMAN'S
FACTUAL REPORT**

Vehicle 1: 2017 Freightliner, Embassy body 37- passenger medium-size bus

NTSB #: **HWY19MH012**

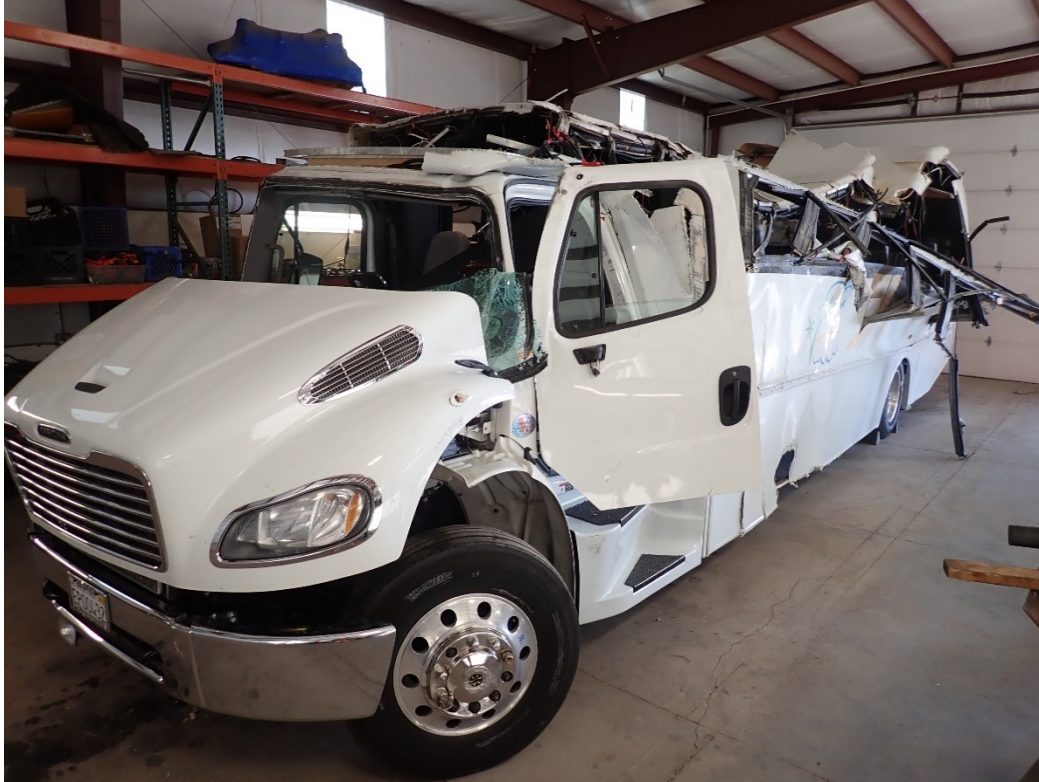
The front of the Freightliner had minor damage. The left fog lamp was torn from its mount and missing the lens, but the bulb was intact.⁵ The hood was undamaged. The windshield was shattered and displaced from the frame and was laying in the engine compartment. The top of the cab was shifted to the right and downward approximately 1 foot. The roof of the cab was torn away and displaced rearward.

The driver's door was ajar and unable to close due to the frame being deformed. There were abrasions to the left fender and it was missing the side marker light. The driver's side mirror was missing and torn from its mount. The top of the rear bus body was displaced rearward away from the cab of the Freightliner.

The fiberglass panels on the left side just behind the cab were damaged and torn away from the body exposing the metal frame and Styrofoam insulation beneath. All damage was measured longitudinally from the front bumper of the Freightliner rearward and all height measurements were from the ground up. Between 144-inches and 168-inches on the left side was a hole in the lower fiberglass panel extending from 12-inches to 26-inches high. The 2.25-inch wide metal transition strip between the upper and lower fiberglass panels had abrasions on it extending from 96-inches to 372-inches. There were tears in the top of the fiberglass side panels at 216-inches, 324-inches, 348-inches, and 396-inches. Tears were also present on the bottom of the side left side fiberglass panels at 120-inches and 138-inches. At 441-inches rearward was an 8-inch tear in the panels approximately 60-inches high.

All left side windows were missing, and the window frames were deformed rearward. Between 96-inches and 252-inches rearward, the frames were pushed inward toward the interior. Between 252-inches and 396-inches the frames were displaced outward away from the bus. The rear window frame and roof support structure extended outward approximately 48-inches from the side of the bus. The seventh row left outside seat back and headrest were deformed and protruding from the window area. The marker light above axle #2 was missing. **Figure 1** shows the damage to the left side of the Freightliner as seen from the left front corner.

Figure 1: View of damage to Freightliner from left front corner

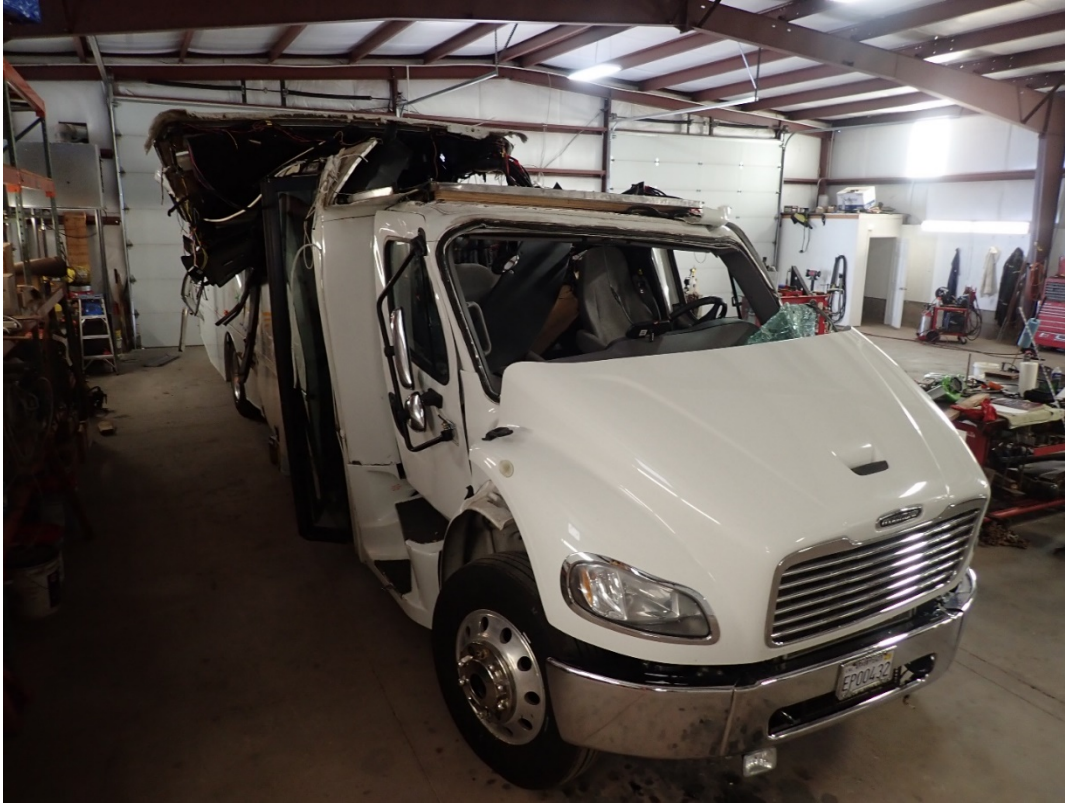
Damage to the right side of the bus included the right-side mirror, which was displaced inward to the door, but still attached. The passenger side door was deformed causing the door to open and close with difficulty. The right-side step fairing had abrasions to the fiberglass and the panel was damaged at 108-inches rearward from the front bumper. The boarding door frame at 114-inches was damaged and the glass on the left side of the bi-fold door was missing. The left side boarding door mount was shifted rearward. There was damage to the bottom of the fiberglass panels between 156-inches and 168-inches. The metal structural frame securing the bottom of the fiberglass panel was displaced upward and inward between 216-inches and 228-inches. At 252-inches the metal frame was displaced upward. This displacement ended at the 264-inch mark. There was a wood 6-inch by 8-inch guardrail post embedded in the right side of the bus between 288-inches and 264-inches to the rear of the front bumper. The bottom of the fiberglass panel was damaged again between 390-inches and 417-inches. The fiberglass panels were warped between 156-inches and 192-inches. The panels were torn at the 246-inch, 264-inch, and 282-inch locations. **Figure 2** shows the damage to the right side of the Freightliner as seen from the right front corner looking rearward.

Figure 2: View of the damage and roof shift to the right side of the Freightliner

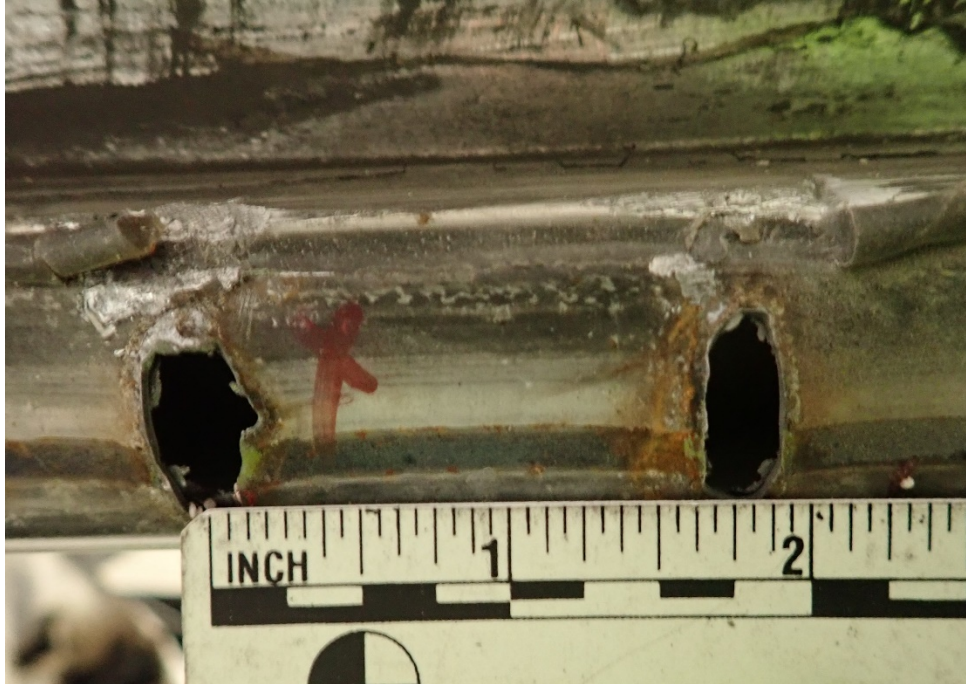
The roof structure and window frames were shifted out, away from the side to the left beginning at the rear of the cab, extending to the rear of the bus with the exception of the last three window frames which were shifted inward. The fiberglass roof and structural metal bows were torn away from the metal sidewall frame mounts on both the left and the right side. The left side of these bows showed signs of having been in contact with pavement, with portions worn through and asphalt debris present. The roof frame bows were approximately 1-inch by 1 ½ -inch galvanized metal tubes and were spaced 24-inches apart on center. During the bus body's fabrication, the roof bows were welded to the bus's sidewall frame near the top of the windows. Post-crash, all roof bows on the left side were separated at the weld joint with the sidewall frame. Investigators removed two of these joint sections for analysis in the NTSB Materials Lab. Visual inspection concluded that there was sufficient fusion along the entire length of the welds, but the base metal of the sidewall frame had torn away at the weld during the overturn. **Figures 3 and 4** show the separated roof bow and frame welds.

Figure 3: Location on sidewall frame where roof bow connects.

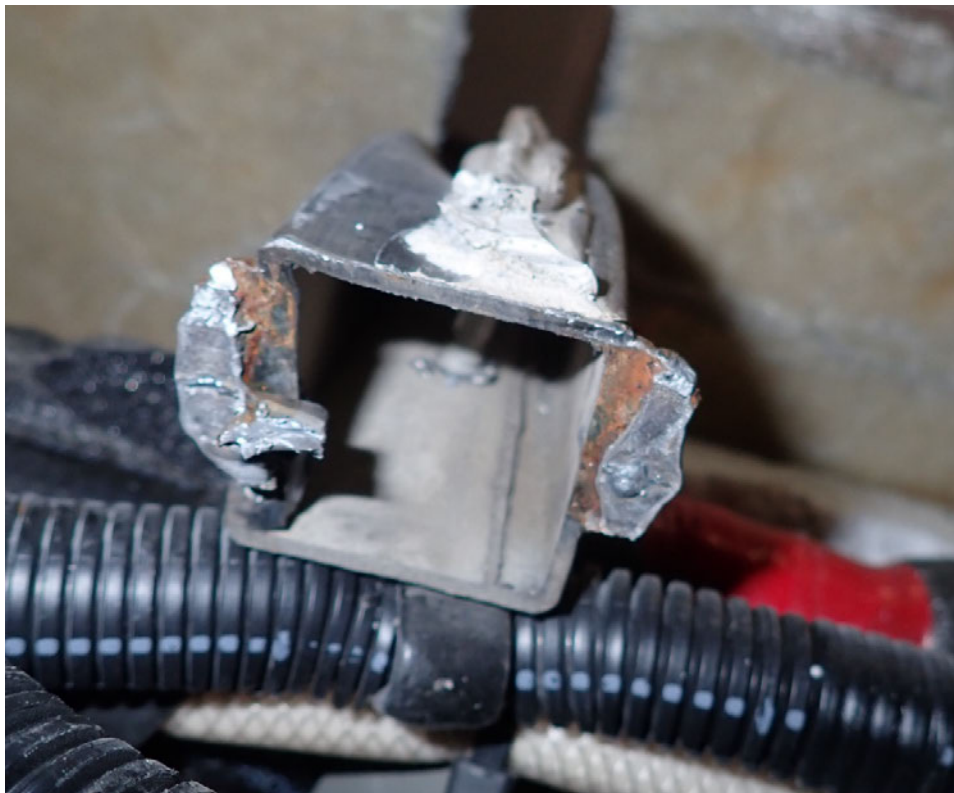
Figure 4: Separated roof bow with attached weld material.

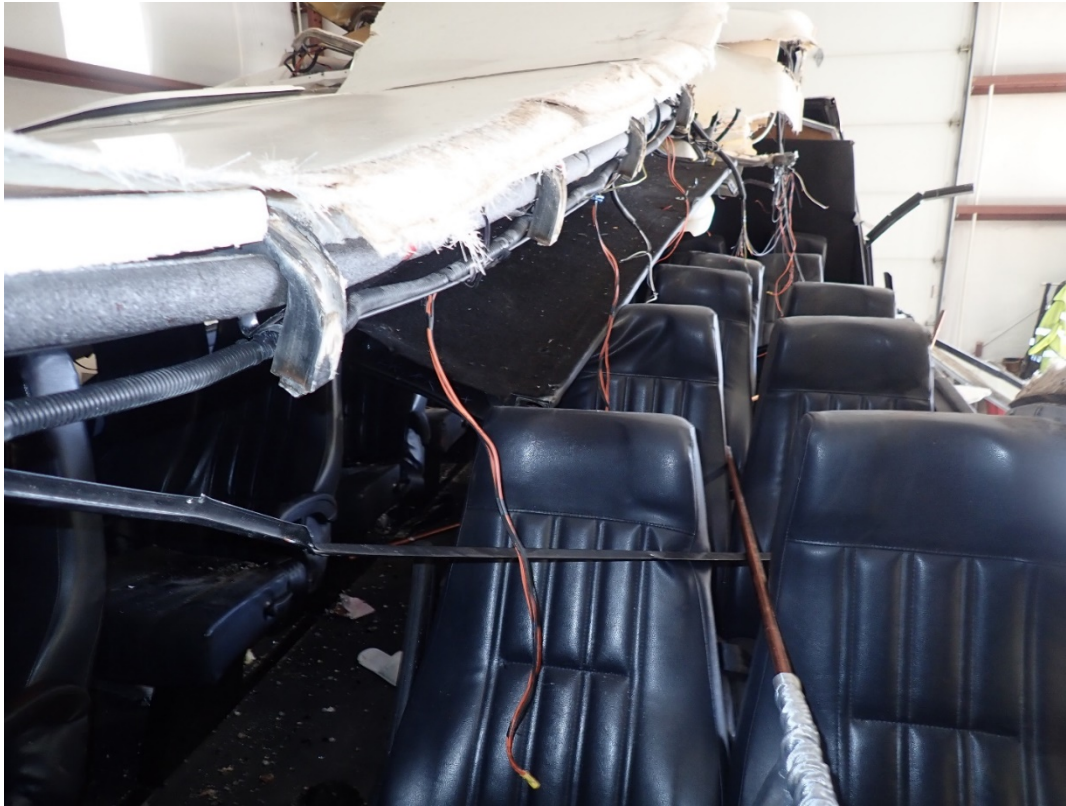
During the rollover, the roof had collapsed downward and to the right onto the tops of the right-side seats. The left side seats were exposed with no roof above. The roof of the cab was also

missing, having shifted to the rear. **Figure 5** shows the damage to the roof structure as seen from the cab facing rearward.

Figure 5: View of the damage and integrity loss to the roof structure of the Freightliner
