**GROUP CHAIRMAN'S FACTUAL REPORT OF  
INVESTIGATION**

**HWY22MH003**

## Bus Surveillance Videos

Location: Pittsburgh, Pennsylvania  
Date: January 28, 2022  
Bridge: Fern Hollow Bridge  
NTSB Number: HWY22MH003

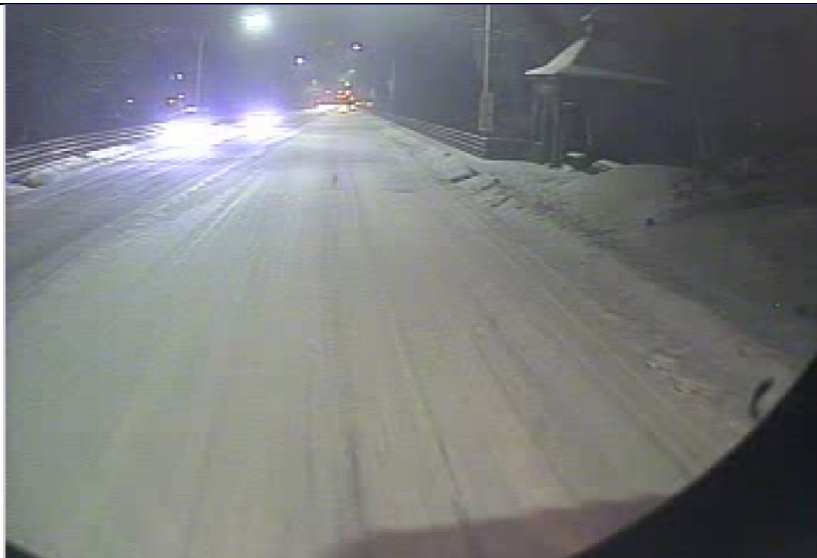
<p>Curbside/6:29:03.700</p>	<p>The stone house at the entrance of the bridge was first visible on the Curbside camera.</p>	  A night-time curbside camera view showing a snow-covered road. The road is illuminated by streetlights, and a stone house is visible in the distance at the entrance of a bridge. The surrounding area is dark with some trees and bushes.
<p>Forward-facing/6:29:03.866</p>	<p>The front of the bus crossed the expansion joint.</p>

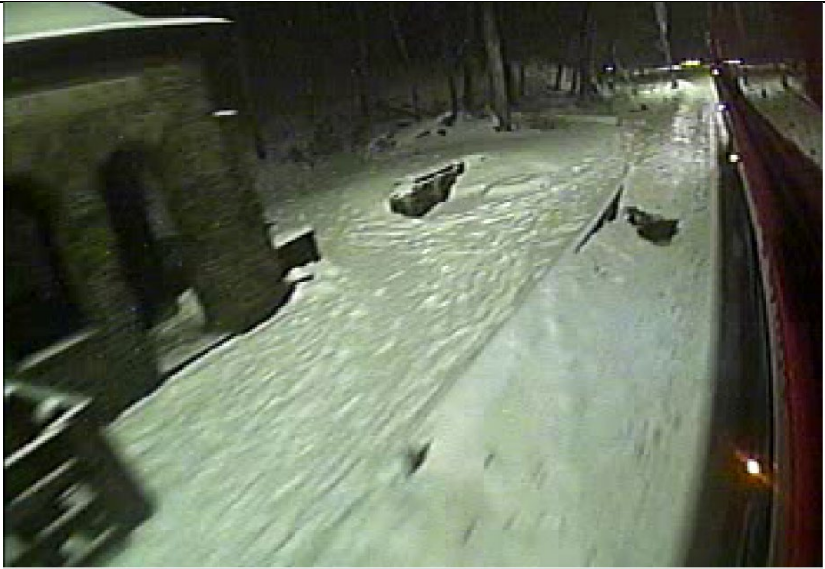
<p>Curbside/6:29:03.966</p>	<p>The bridge's south railing was first visible. Lights visible behind the bus were the taillights of a westbound vehicle.</p>

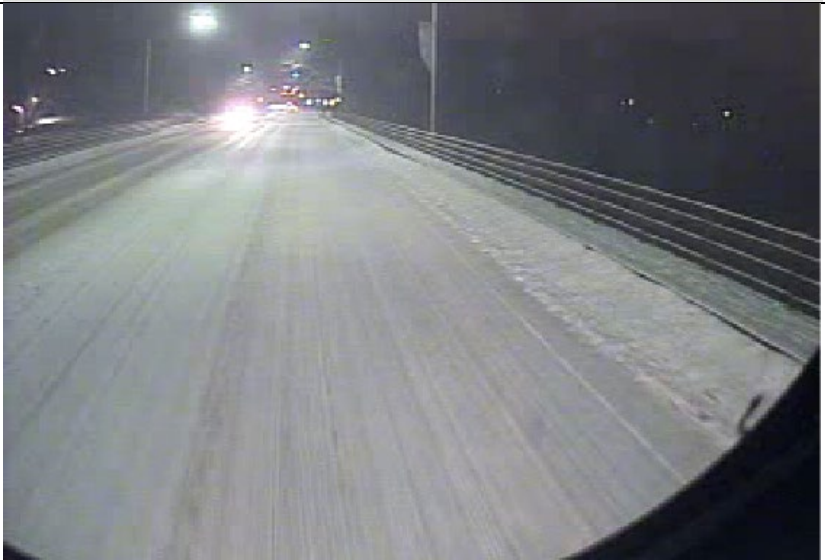
<p>Forward-facing/6:29:07.866</p>	<p>A westbound pick-up truck crossed onto the bridge. This was the only westbound vehicle observed on the bridge before the event occurred.</p>

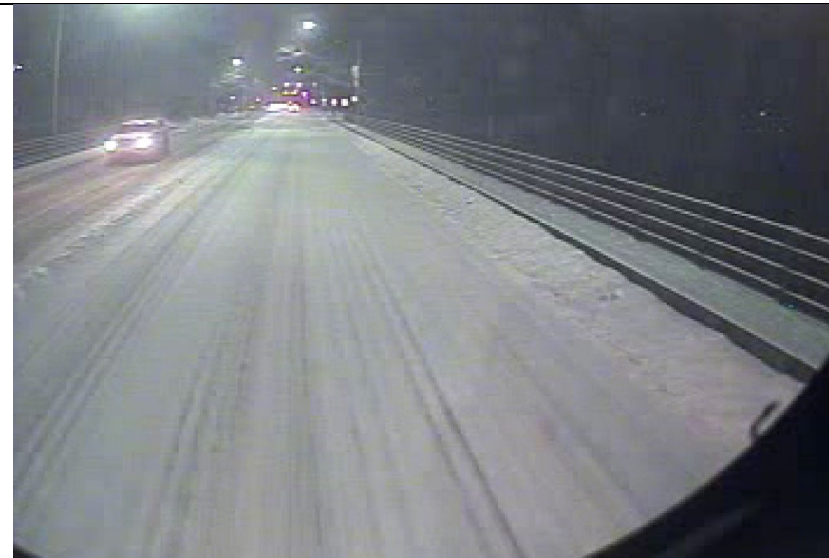
<p>Forward-facing/6:29:10.666</p>	<p>The front of the bus passed the light pole located in the middle of the bridge's south side. There were two other light poles located at each end of the bridge's south side.</p>

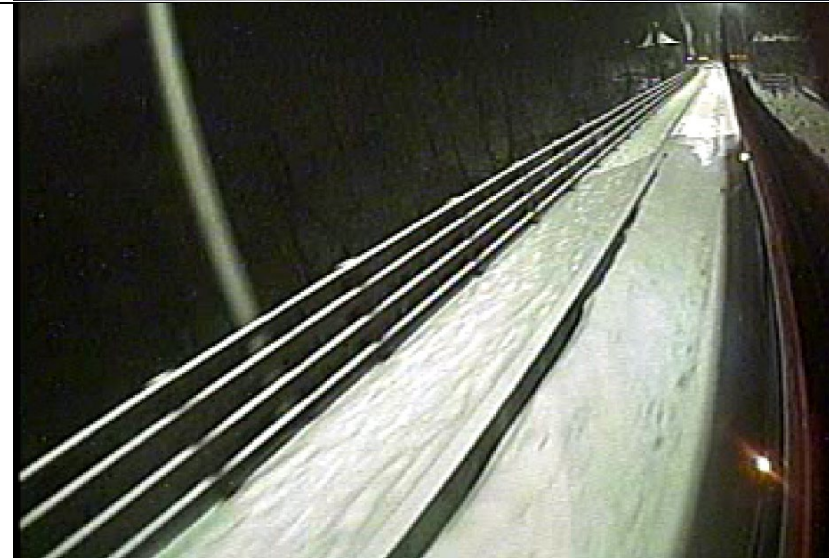
<p>Curbside/6:29:11.433</p>	<p>The light pole located in the middle of the bridge's south side was first visible on the Curbside camera.</p>

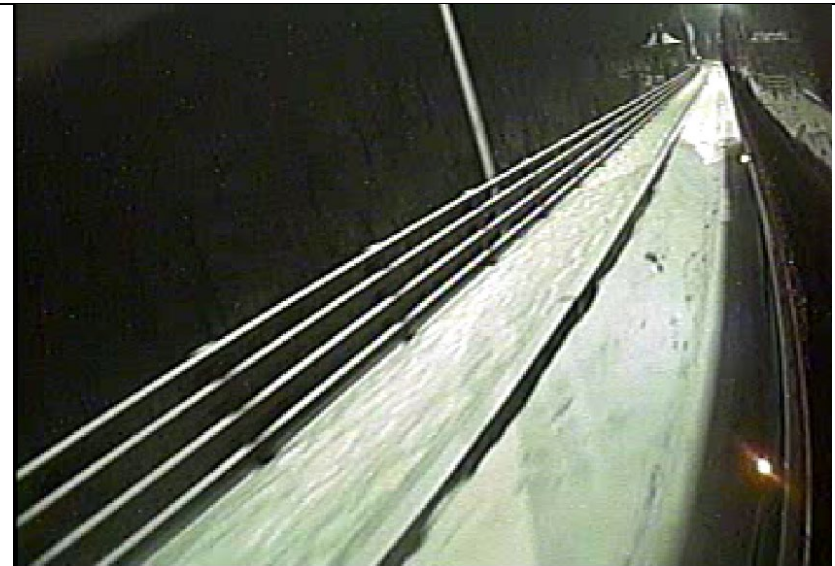
Curbside/6:29:11.966	Observation of the bridge's south railing indicated the first visible vertical drop in the bridge. There are 3.5 post-spacings visible from the left extent of the image to the center light pole.

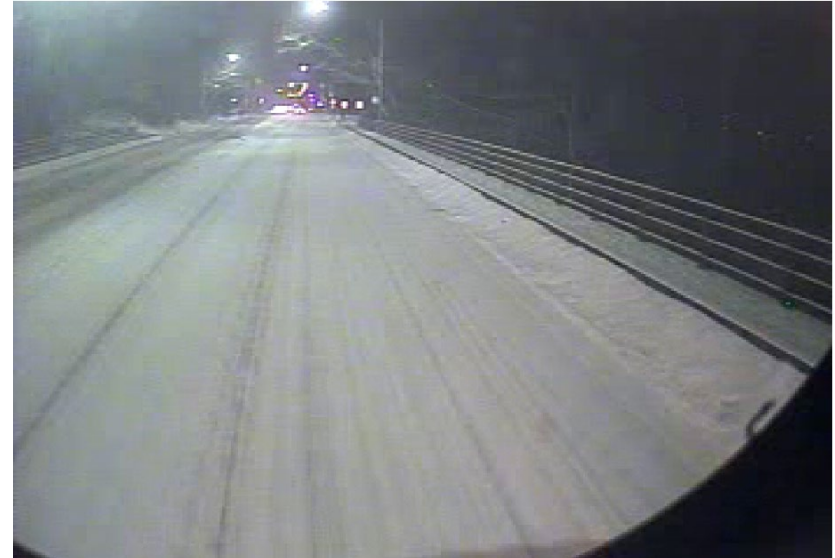
A night-time photograph showing a close-up view of the bridge's south railing. The railing consists of several parallel metal cables or rods that run diagonally across the frame from the bottom left towards the top right. The background is dark, suggesting a nighttime setting.
Forward-facing/6:29:12.366	The camera view started to pitch up (corresponds to vertical drop of the bridge observed on the Curbside camera at 6:29:11.966).

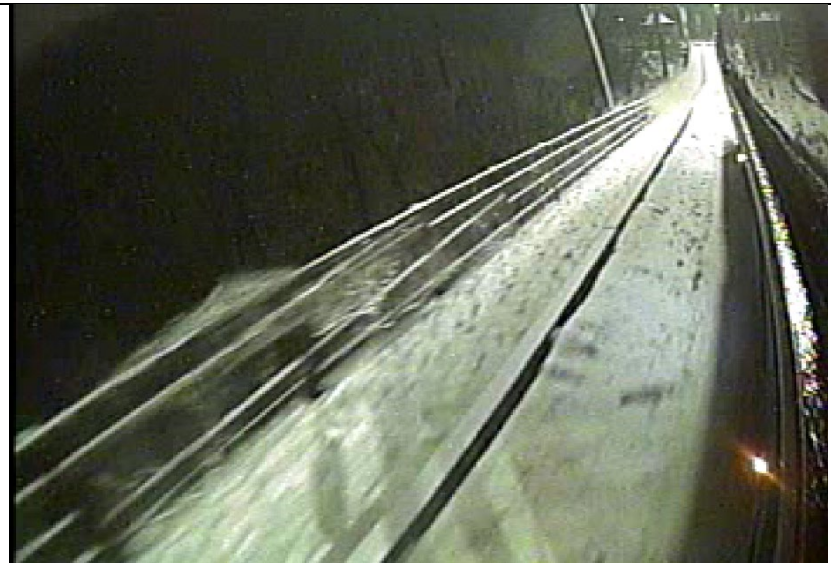
Curbside/6:29:13.033	In addition to vertical displacement, there appeared to be lateral displacement towards the north at bent 1. The railing in the foreground near bent 2 had started to break.

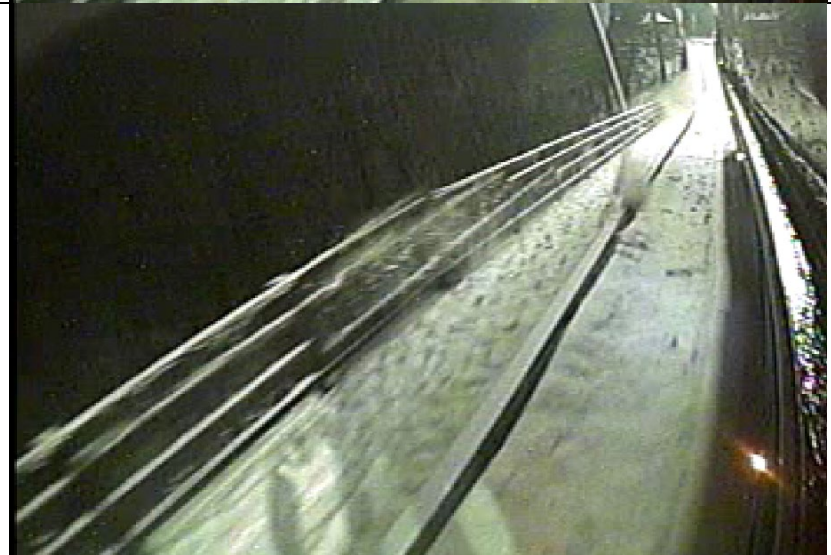
Curbside/6:29:13.300	A puff of material along the curb line was observed which indicated that a hinge was forming in the deck. The railing had continued to break.

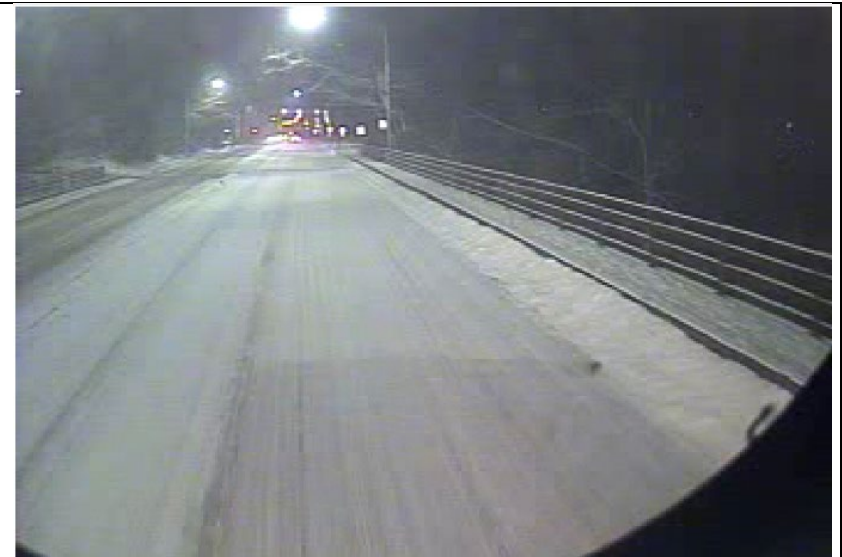
<p>Forward-facing/6:29:13.466</p>	<p>The Forward-facing camera view reached maximum vertical displacement comparing frame to frame starting at 6:29:12.366.</p>

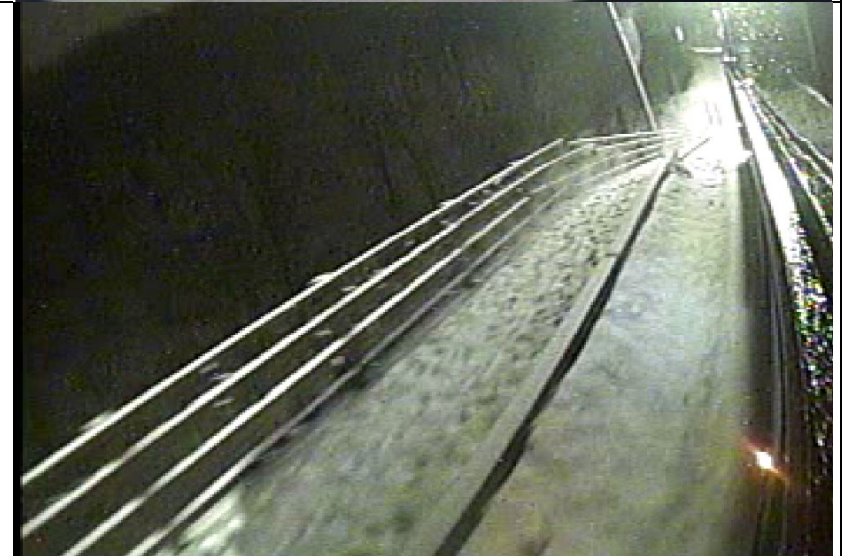
<p>A forward-facing camera view of a bridge at night. The bridge deck is illuminated by streetlights, and the road surface shows lane markings. The bridge railing is visible on the right side. In the distance, there are some lights and structures, possibly a building or another part of the bridge.</p>
<p>Curbside/6:29:13.833</p>	<p>The west end of the bridge had visibly fallen off of the abutment.</p>

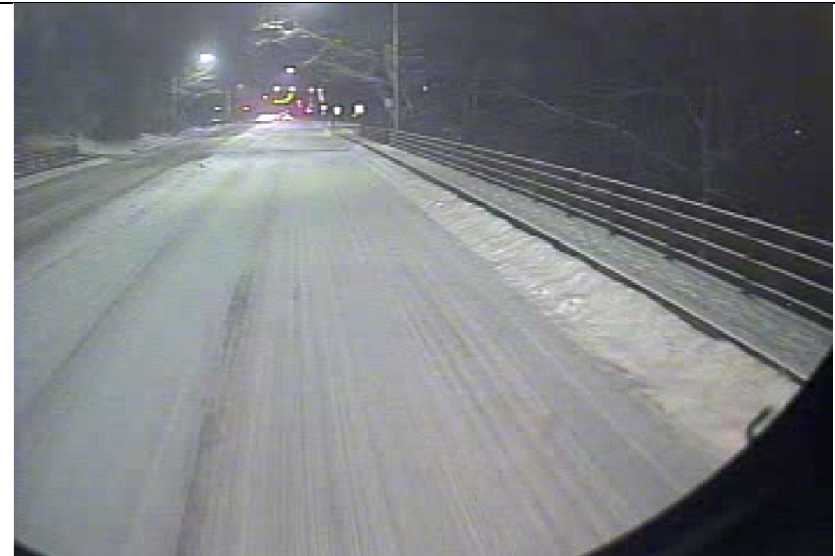
<p>Forward-facing/6:29:14.066</p>	<p>The east expansion joint had visibly separated.</p>

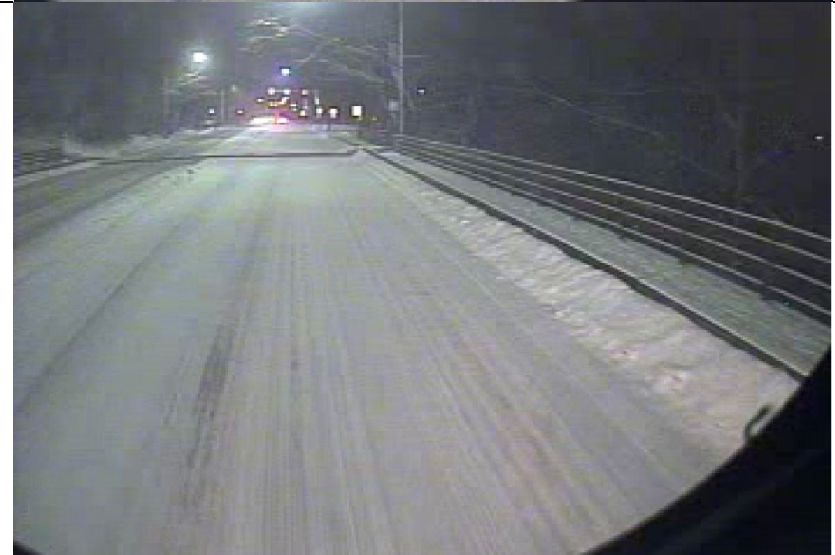
<p>Forward-facing/6:29:14.366</p>	<p>Changes in the top railing observed provided the first indication of vertical displacement at the east abutment of the bridge.</p>

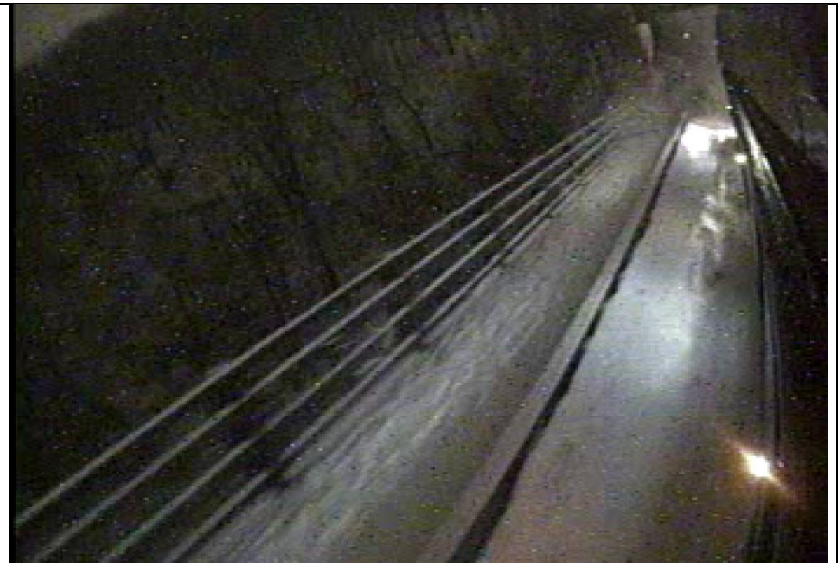
Curbside/6:29:14.633	The center light pole went dark on the Curbside camera.

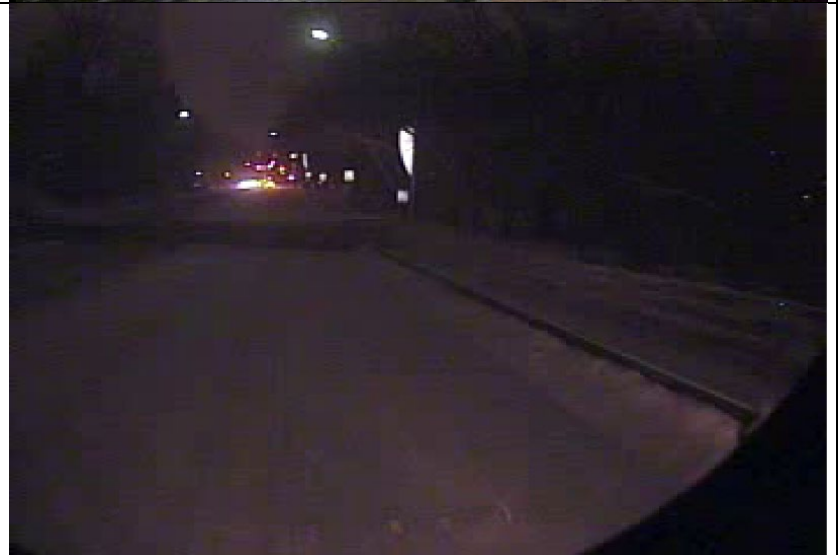
A night-time view from a curbside camera looking down a bridge. The bridge deck is illuminated by streetlights, and several support cables are visible on the left side. The background shows dark trees.
Forward-facing/6:29:14.866	The light poles at the east end of the bridge went dark on the Forward-facing camera. The south side of the bridge had dropped more than the north side.

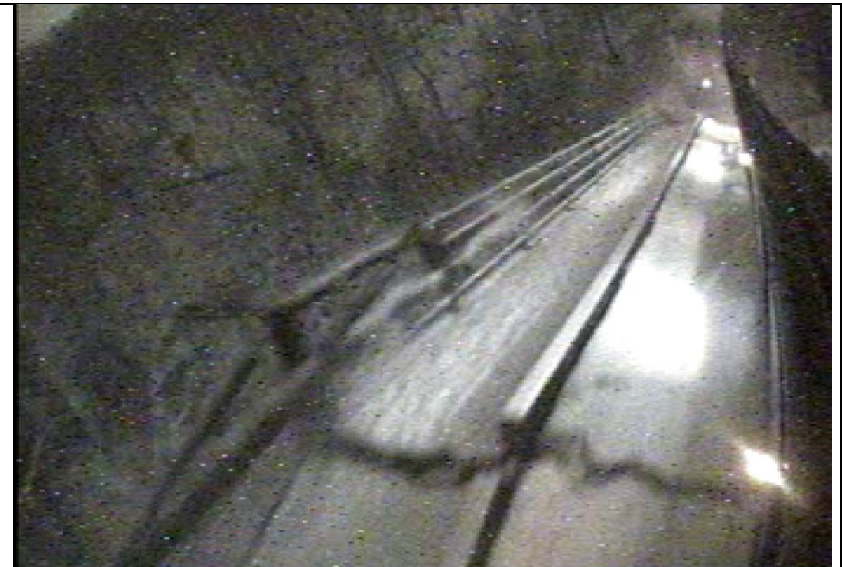
Curbside/6:29:15.166	Another fracture of the deck was observed on the Curbside camera.

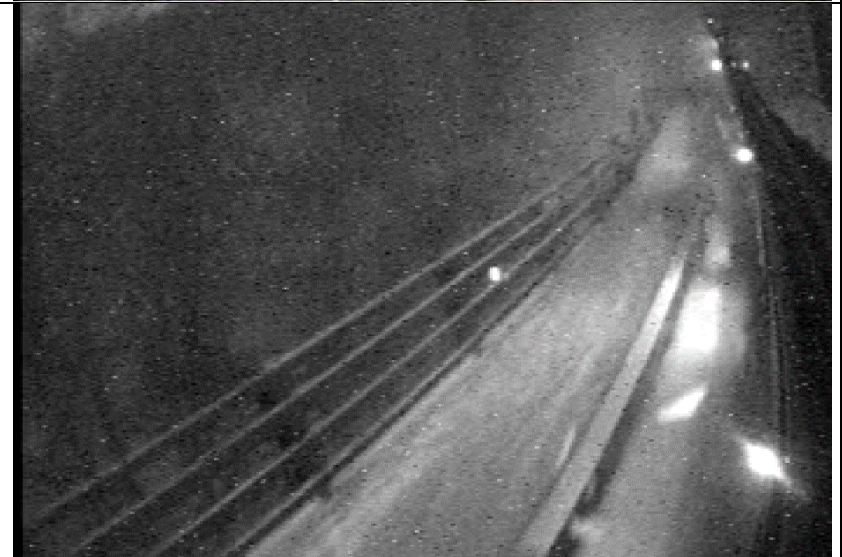
Curbside/6:29:17.066	Another fracture of the deck occurred based on a debris cloud formed along the rail and the curb near the mid-length of the bus.
