NATIONAL TRANSPORTATION SAFETY BOARD
Vehicle Recorder Division
Washington, DC 20594

Bystander Video

Specialist's Factual Report
By Tom Barth, Office of Highway Safety and
Charles Cates, Office of Research and Engineering

Location: West Hollywood, California
Date: June 15, 2018
Vehicle: Tesla Model S
NTSB Number: HWY18FH014

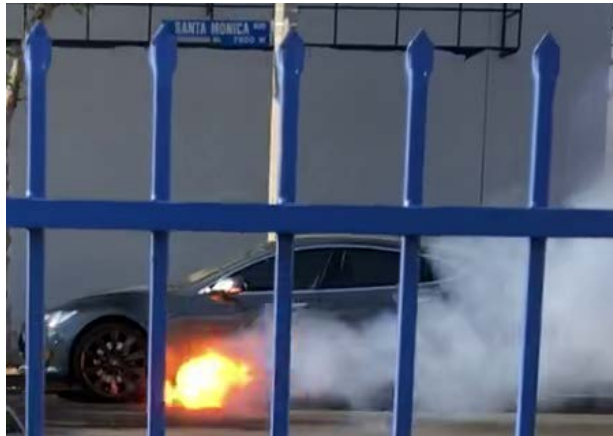
Figure 1. Image from Bystander Recording One at four seconds.

Time (mm:ss)	Observations
00:01 to 00:05	Two uniformed officers walked from the west to the east of the vehicle.
00:04	The driver side of the Tesla was visible with orange/yellow flames emerging from the rocker panel just aft of the left front wheel. The flames covered the area approximately in the front half and lower half of the driver door. A cloud of white and light grey smoke was blowing to the east (towards the back) of the vehicle. See figure 1.

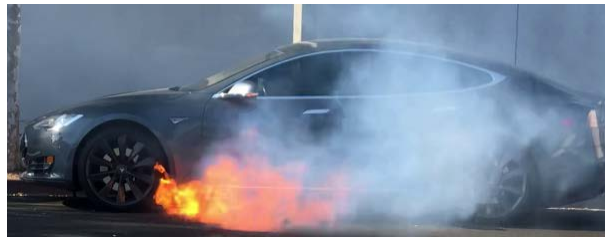
Figure 2. Image from Bystander Recording One at 19 seconds.

00:19	The bystander zoomed the recording to show a close up view of the vehicle. The flames were shooting laterally from the vehicle. The smoke emitted at this time was less dense, and the force of the flames and density of the smoke was variable. See figure 2.

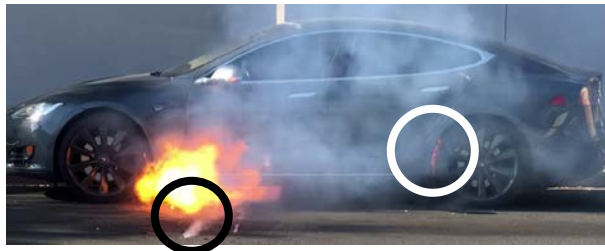
Figure 3. Image from Bystander Recording One at 26 seconds with annotations.

00:26	A close up of the vehicle showed flames continuing to emanate from the left front wheel as previously observed, and additional flames visible at the forward portion of the left rear wheel well (see white circle in figure 3). A small piece of material was ejected laterally out of the front wheel well area of the vehicle, landed on the street, and emanated smoke. See black circle in figure 3.

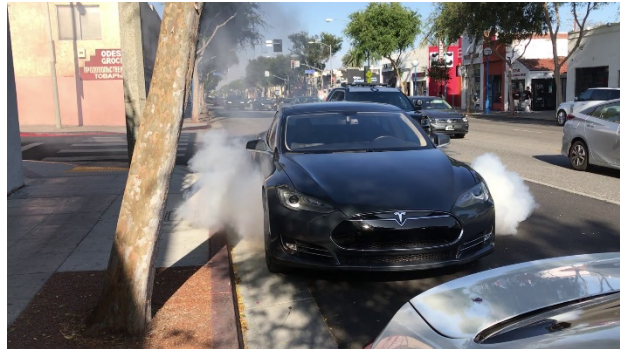
Figure 4. Image from Driver Video at 9 seconds.

00:09	The density and force of the smoke thrusting laterally from the vehicle intensified and a hissing sound became audible. See figure 4.
00:14	The density of the smoke and the sound of the hissing intensified. The smoke was mostly visible on the left side of the Tesla. Smoke was venting approximately 10 ft laterally from the vehicle.

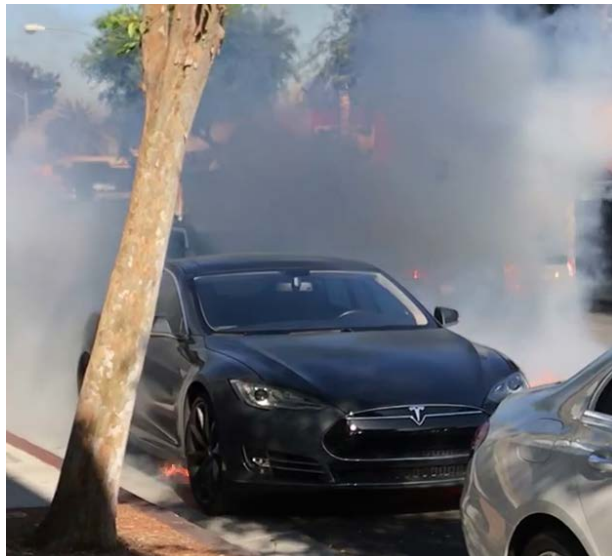
Figure 5. Image from Driver Video at 35 seconds.

00:32	The density of the smoke reduced and red and orange flames became visible on the left side of the visible.
00:35	Flames became visible on the right side of the vehicle. See figure 5.

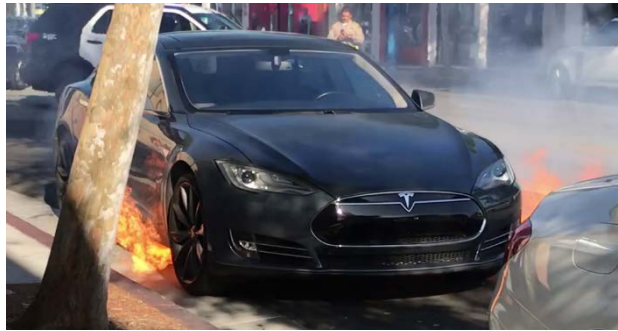
Figure 6. Image from Driver Video at 01:11.

01:11	The smoke reduced and the flames shot laterally with more force from the left side. The flames grew larger on the right side, but do not have as much lateral thrust as the flames on the left. See figure 6.

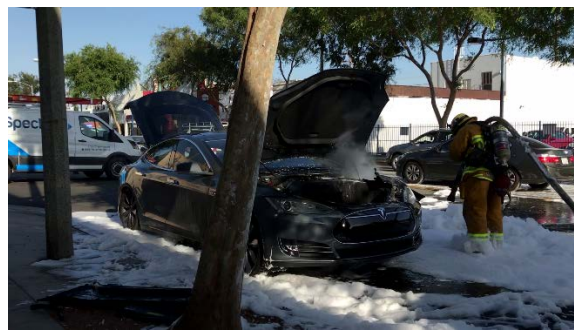
Figure 7. Image from Driver Video at 14:34.

Time (mm:ss)	Observations
13:49	The driver pointed the camera back to the Tesla and FF were continuing to remove portions of the fender and apply streams of water and foam. Wisps of smoke continued to emanate through the end of the video.
14:34	The video recording ended. See figure 7.
