# ENGINE EXAMINATION REPORT

<b>ENGINE MODEL</b>	O-300-D (6B)
<b>ENGINE SERIAL NUMBER</b>	27160-D-2-D
<b>AIRCRAFT MAKE &amp; MODEL</b>	1958 Cessna 172
<b>AIRCRAFT SERIAL NUMBER</b>	36320
<b>AIRCRAFT REGISTRATION</b>	N8620B
<b>FILE NUMBER</b>	18-370

EXAMINATION		ACCIDENT DATA	
<b>DATE</b>	6-17-2019	<b>NTSB ACCIDENT #</b>	CEN19FA099
<b>FACILITY</b>	Continental Aerospace Technologies-Analytical	<b>NTSB INVESTIGATOR</b>	Michael Hodges, IIC Central Region
<b>ADDRESS</b>	2039 South Broad Street Mobile, Alabama	<b>FAA INVESTIGATOR</b>	NA
		<b>ACCIDENT DATE</b>	3-14-2019
		<b>ACCIDENT LOCATION</b>	Lakeway, TX

The engine was disassembled and inspected under the supervision of the NTSB IIC. This inspection did not reveal any pre-impact anomalies that would have prevented its ability to produce rated horsepower.

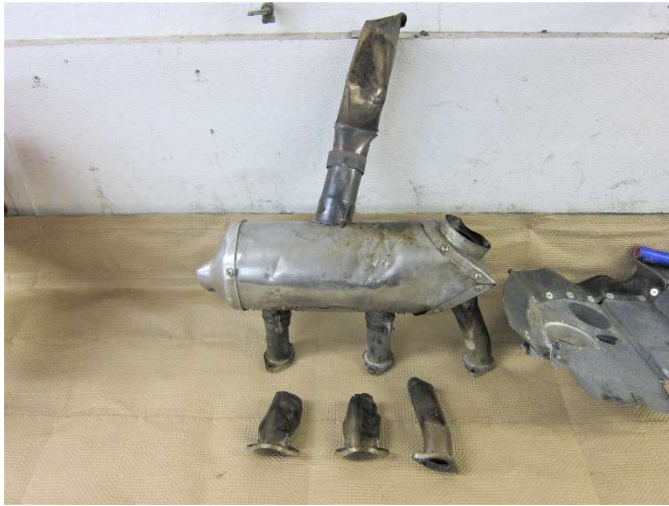
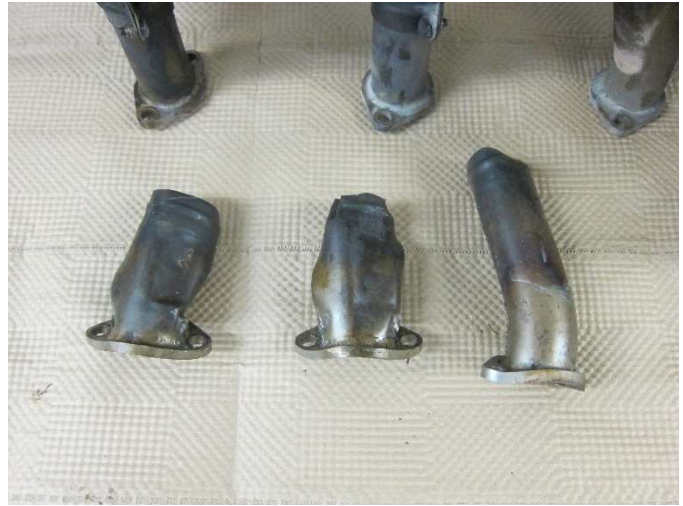
### EXHAUST SYSTEM

The exhaust system components were impact damaged. The muffler/heat exchanger was impact damaged. Left muffler assembly not shipped with engine.

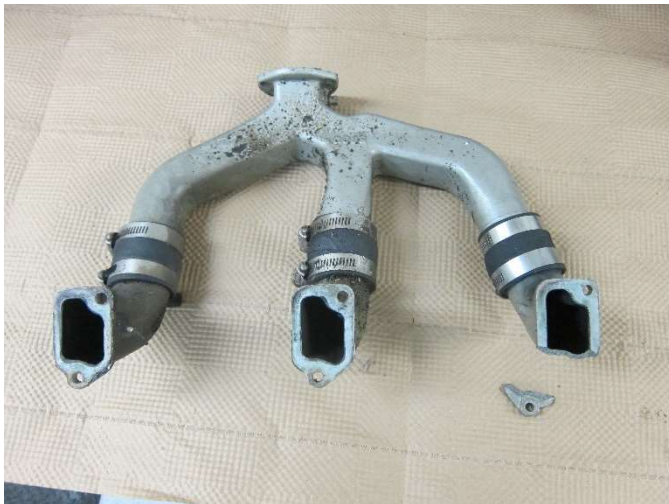
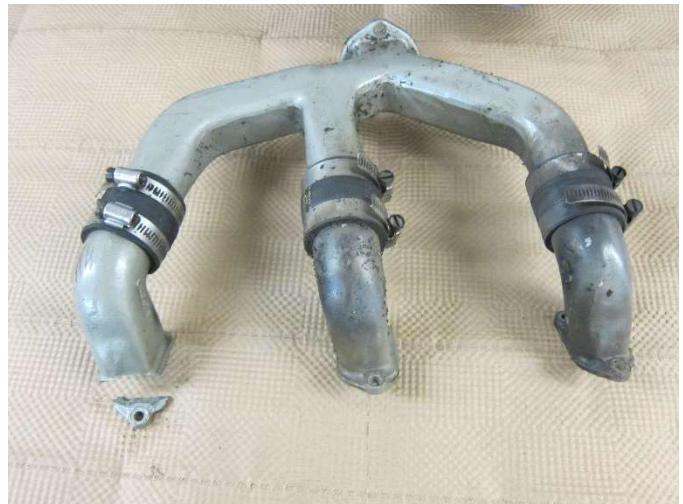
### INDUCTION SYSTEM

The left induction manifold was impact separated and not returned with the engine. The right induction manifold was intact except damage to the mounting flange.

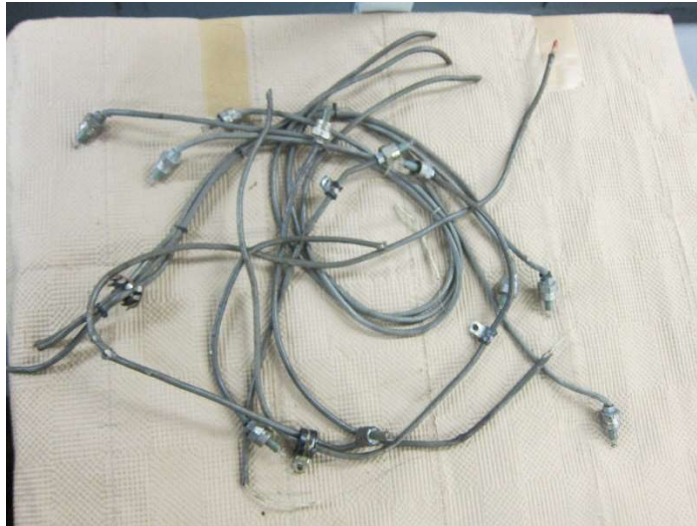
<b>MAGNETO-TO-ENGINE TIMING</b>	Specification: Rt. 26° BTDC Lt. 28°	L/H Magneto: NA	R/H Magneto: NA
Ignition timing could not be determined. The magnetos had been removed during the recovery examination.			
<b>IGNITION HARNESS</b>	Manufacturer: Slick-Unison	P/N: M-2930 (L) M-2931 (R)	S/N: Undetermined
Condition:	The ignition harness was impact damaged

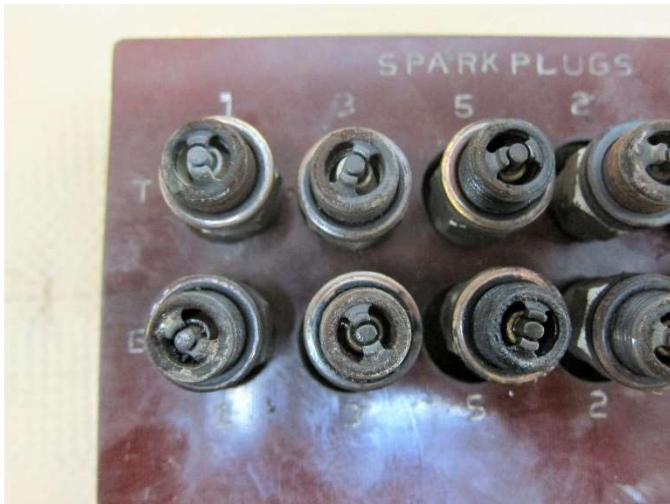
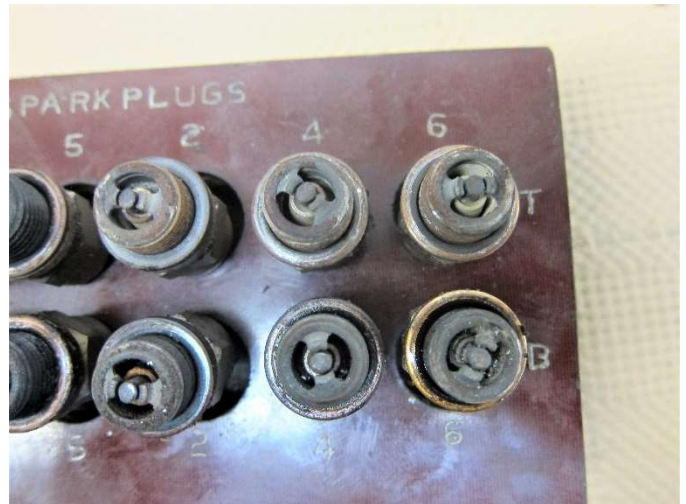
<b>SPARK PLUGS</b>	Manufacturer: Tempest	P/N: UREM40E
Condition:	When compared to a Champion Spark Plug "Check-A-Plug" chart, the sparkplugs appear to be in <i>worn out normal</i> condition.

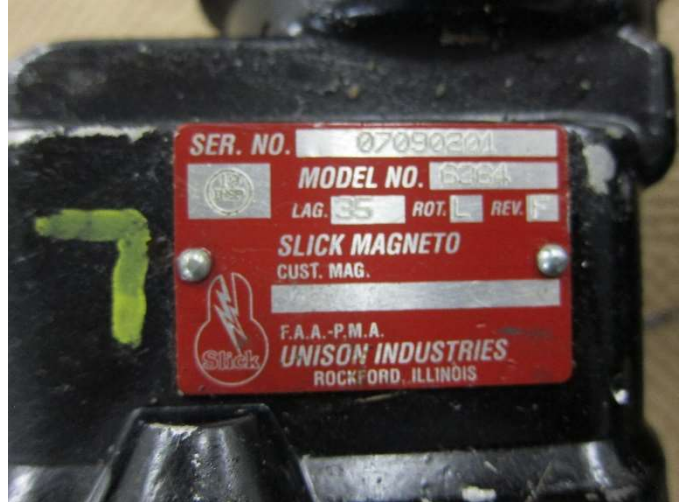
<b>LEFT MAGNETO</b>	Manufacturer: Slick-Unison Industries	M/N: 6364	S/N: 07090201
Condition:	The magneto had been removed during the initial recovery examination. The magneto and tested by manually rotating the drive and noting spark at all six ignition leads. The magneto was shipped loose in the shipping container. The magneto was bench tested and functioned normally.

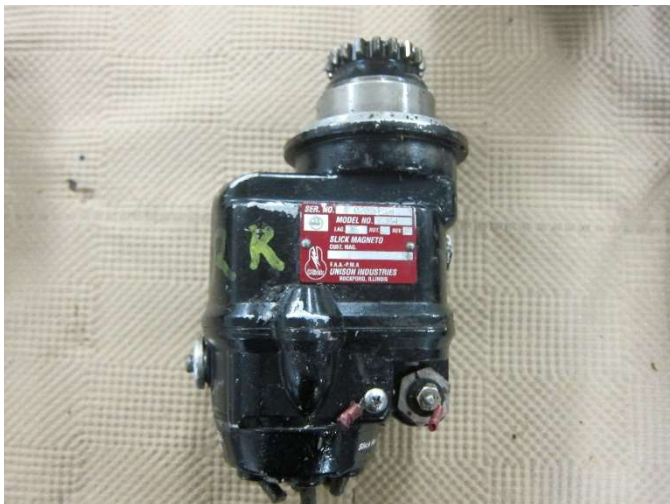
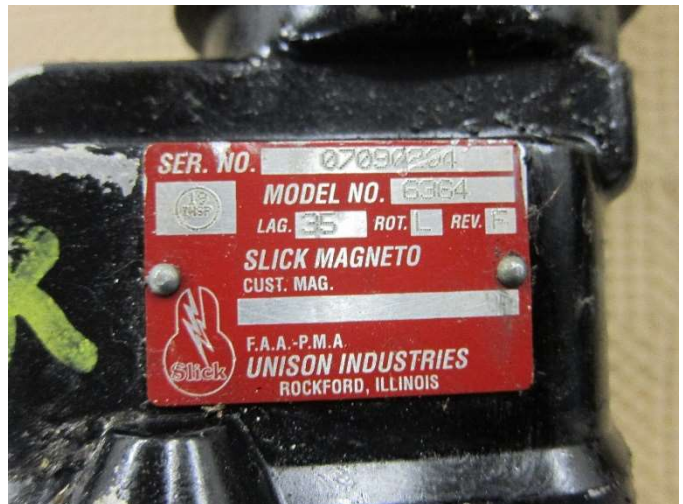
<b>RIGHT MAGNETO</b>	Manufacturer: Slick-Unison Industries	M/N: 6364	S/N: 07090204
Condition:	The magneto had been removed during the initial recovery examination. The magneto and tested by manually rotating the drive and noting spark at four of the six ignition leads. The magneto was shipped loose in the shipping container. The magneto was bench tested and functioned normally.

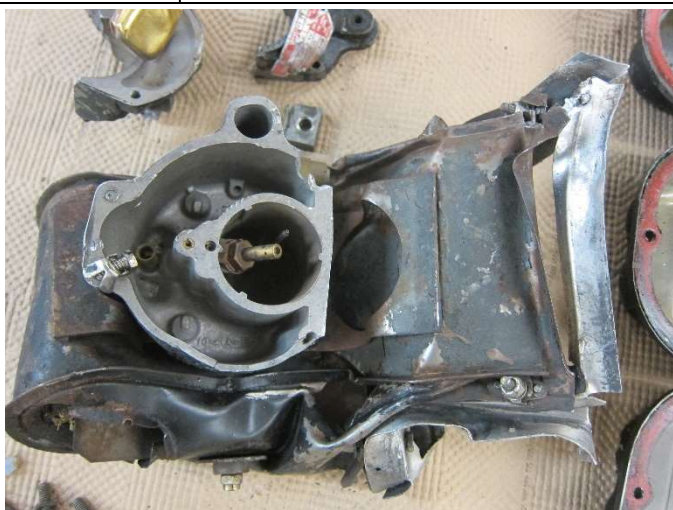
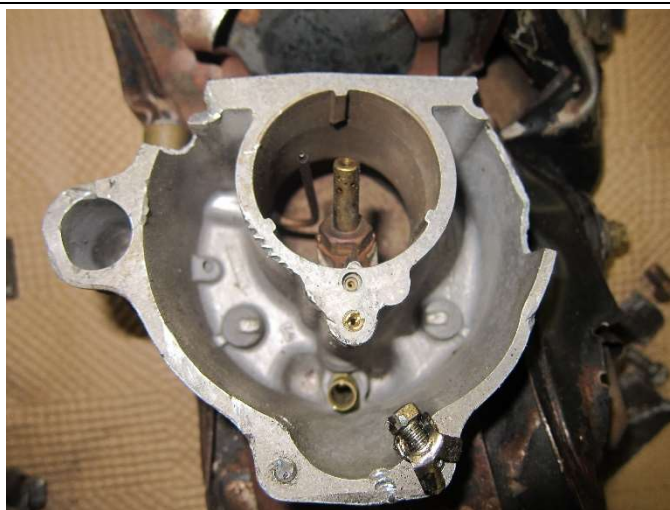
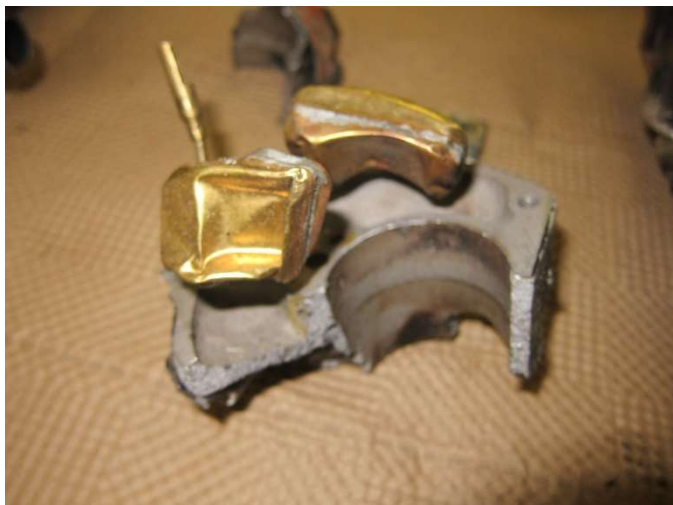
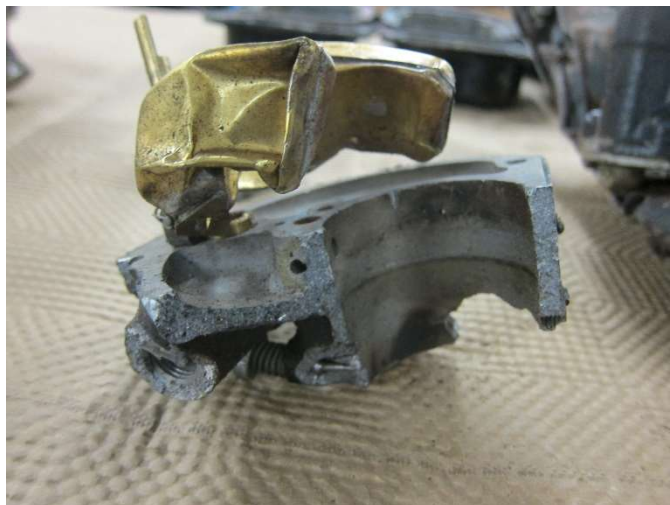
### CARBURETOR

The airframe airbox and carburetor were impact separated at impact. The carburetor was destroyed by impact forces. Metal floats exhibited "hydraulic" damage consistent with fuel in the carburetor bowl at impact.

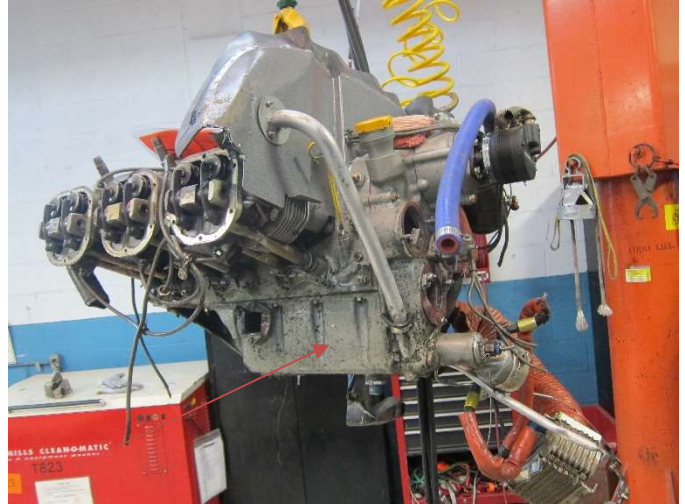
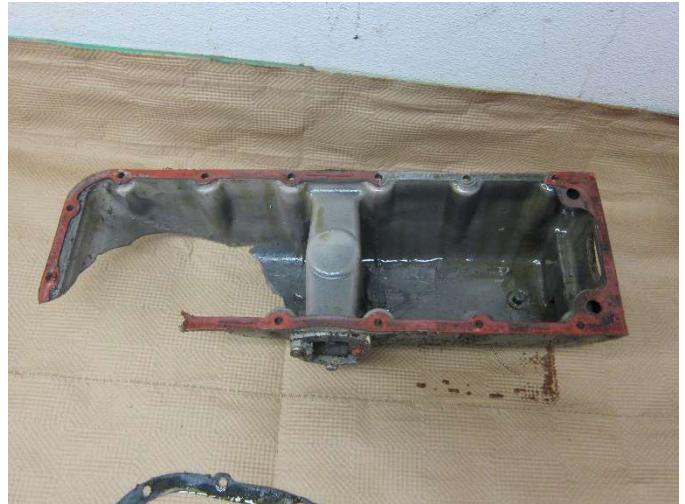
### OIL SUMP

The oil sump was impact damaged. The left-forward section impact separated.

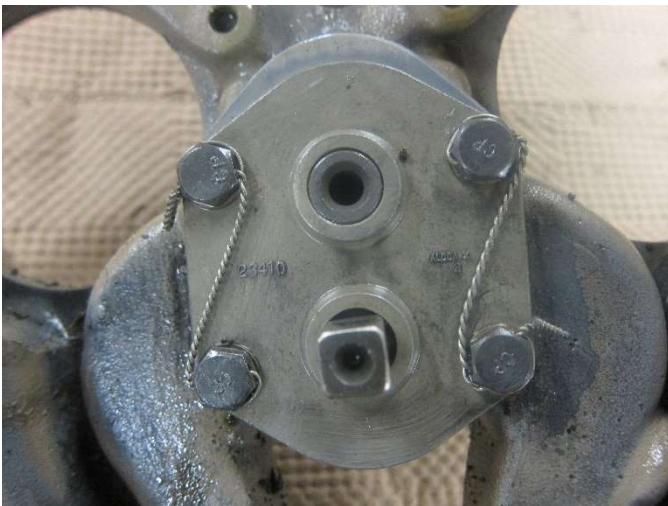
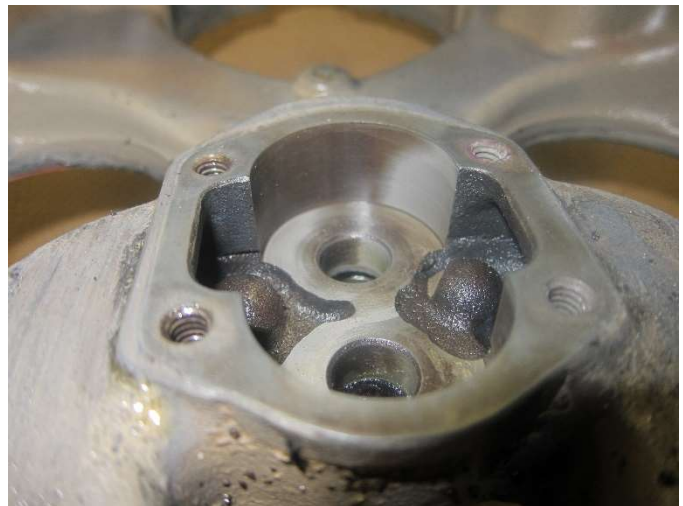
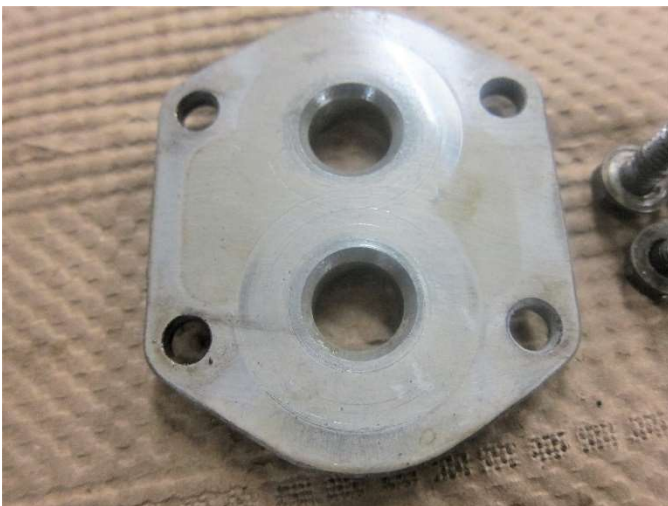
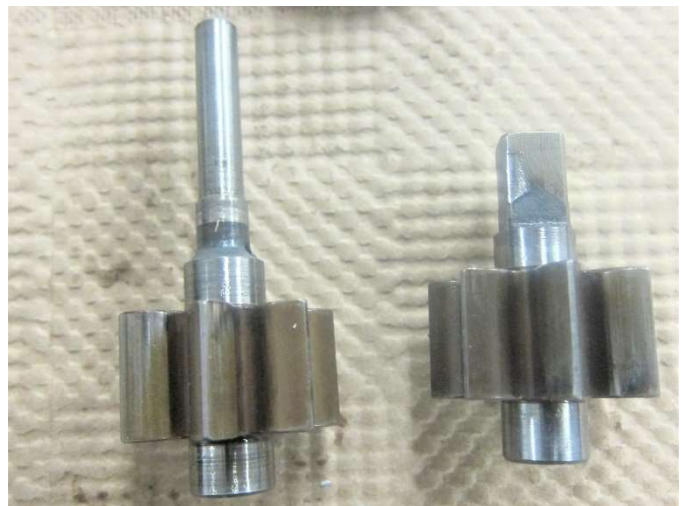
**Condition:** The oil pick-up screen was uncontaminated.

**Condition:** The oil pump rotated normally with no binding or internal damage due to hard particle passage.

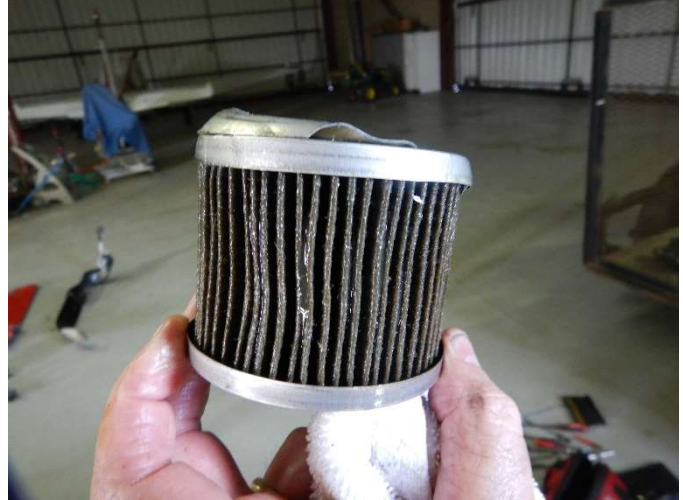
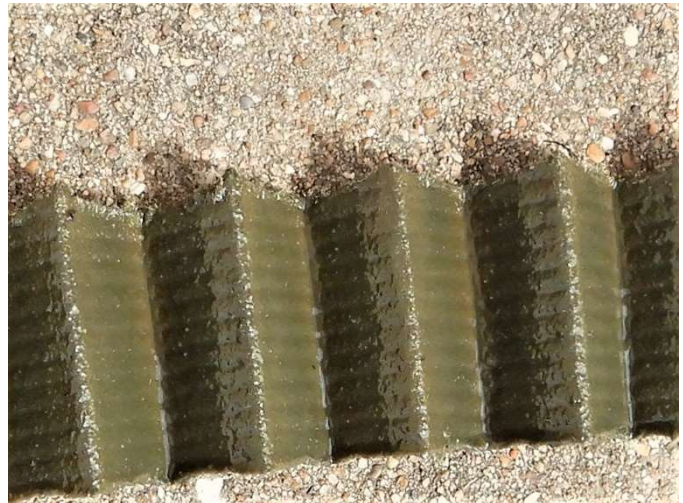
## OIL FILTER

The spin-on oil filter had been previously removed at the recovery inspection and cut open for inspection. There was no metal contamination noted. Four photos below were taken at the recovery examination.

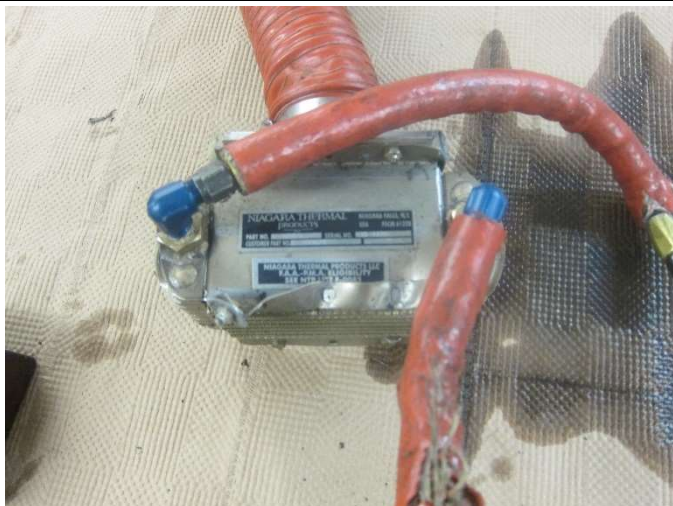
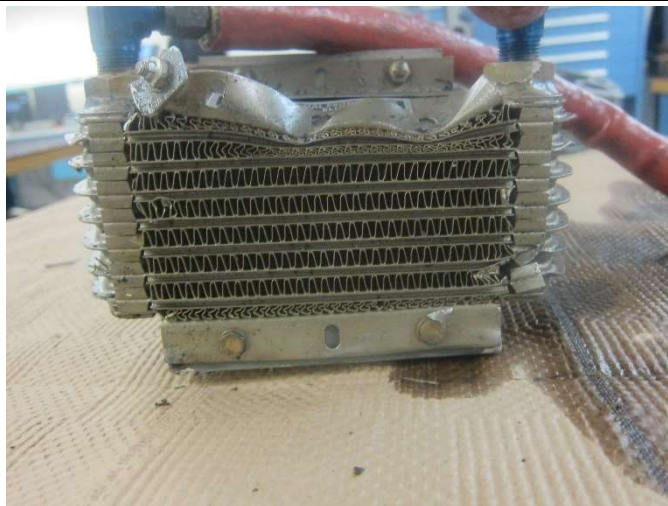
<b>OIL COOLER</b>	Manufacturer: Niagara Thermal Products, Inc	P/N: 20002A	S/N: E15-12882-19
Condition:	The oil cooler exhibited impact damage

The current Continental Aerospace Technologies Illustrated Parts Catalog for this engine does not indicate that an oil cooler was included during the manufacturing of model O-300-D (6B) engines.

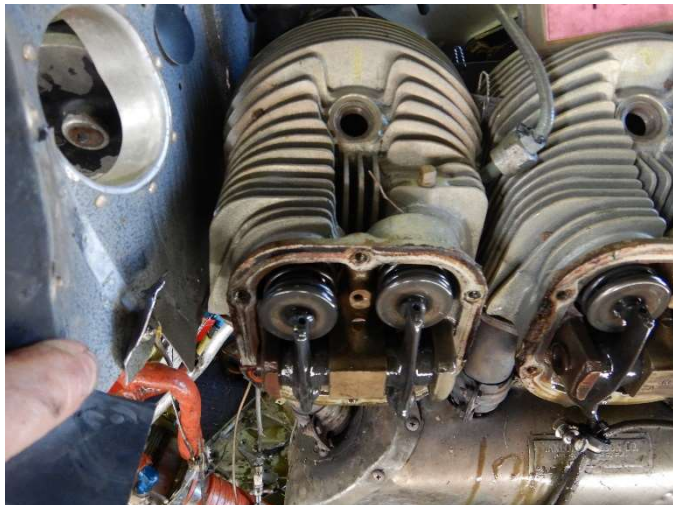
<b>CYLINDER #1</b>	P/N: SA 10200-A1	S/N:20-C15-41895	Head Date: Undetermined
Work Orders:	B-03309		
Condition:	No damage was noted.

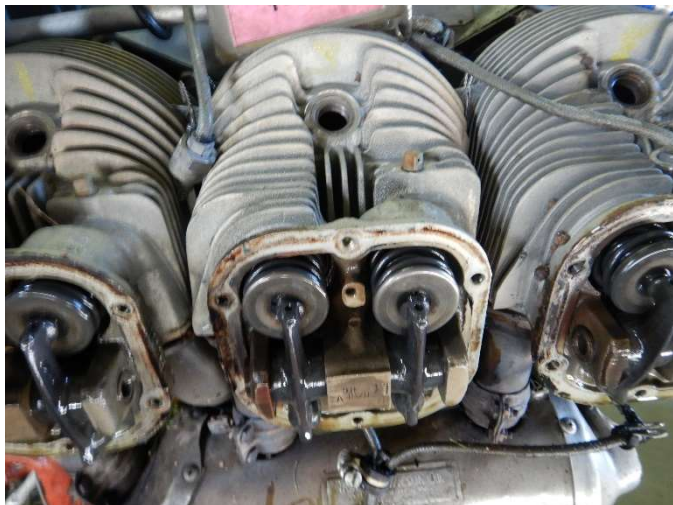
<b>CYLINDER #3</b>	P/N: SA 10200-A1	S/N:20-C15-41893	Head Date: Undetermined
Work Orders:	B-03291		
Condition:	Intake and exhaust push rods and push rod tubes were impact damaged.

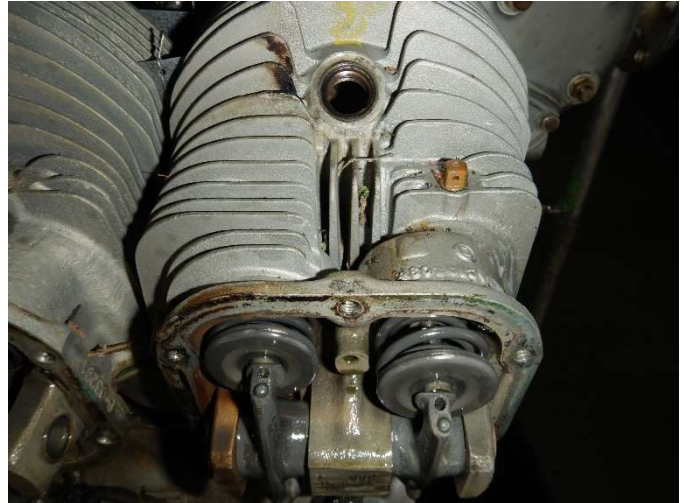
**CYLINDER #5**

No damage was noted

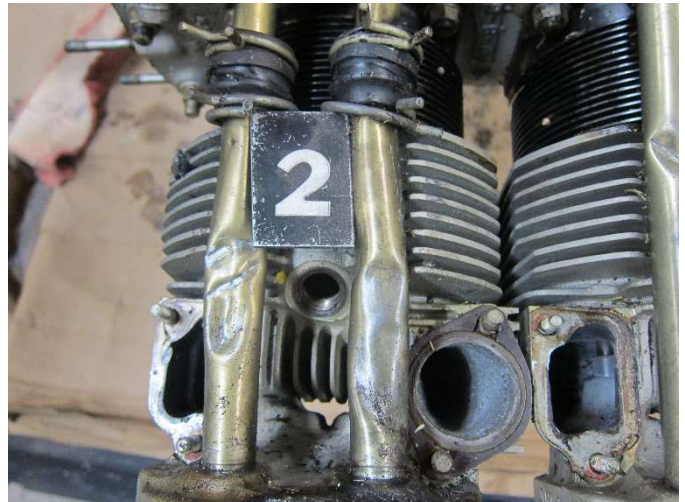
**CYLINDER #2**

No damage was noted except impact damage to pushrod tubes and pushrods

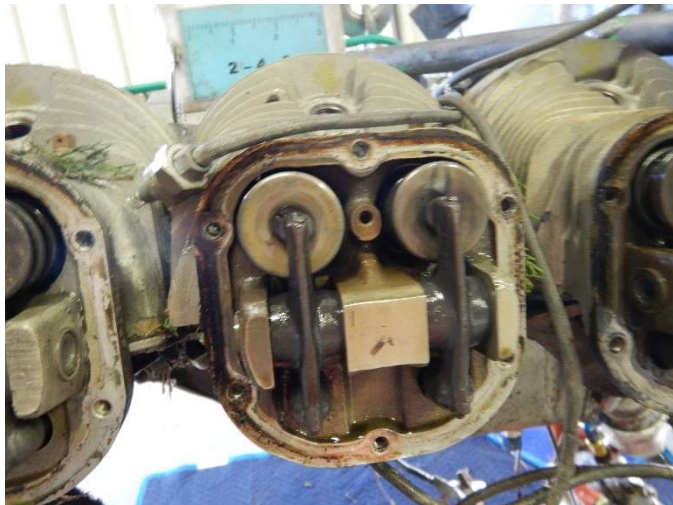
**CYLINDER #4**

No damage was noted

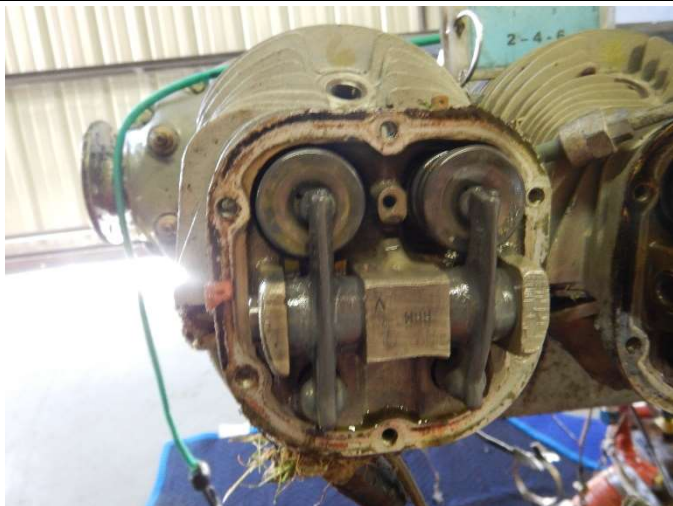
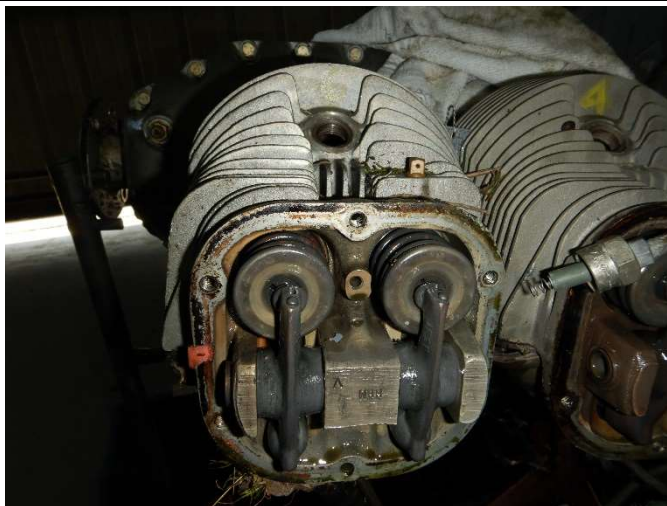
**CYLINDER #6**

No damage was noted

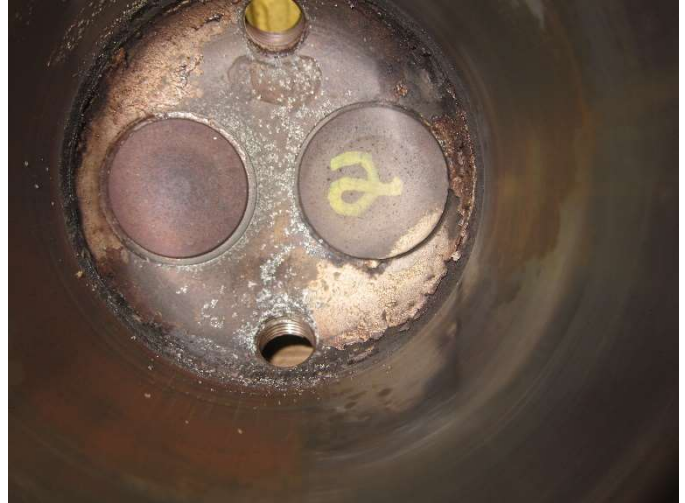
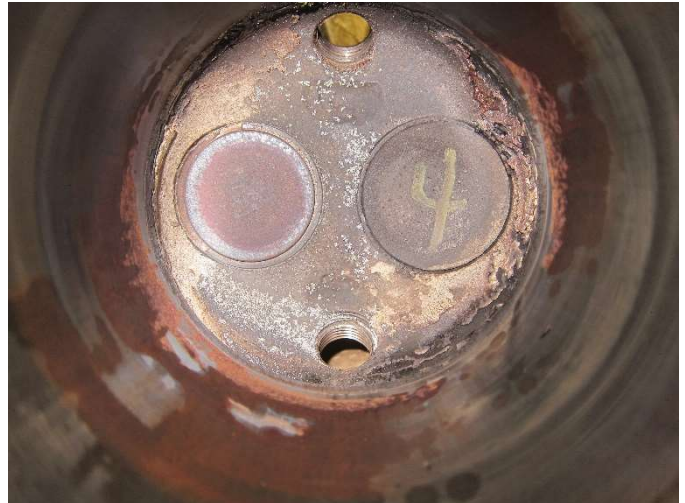
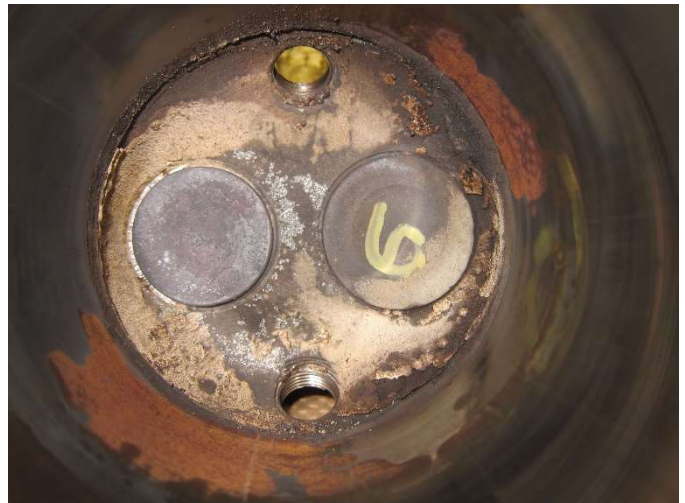
**VALVES AND GUIDES**

All intake and exhaust valves were intact and exhibited normal combustion signatures.

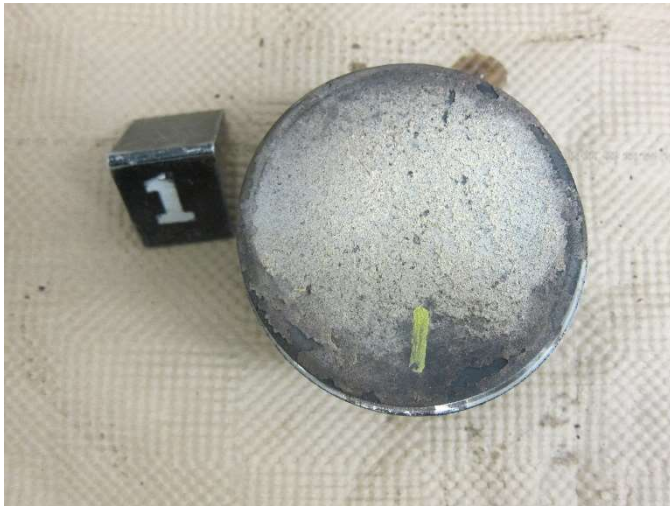
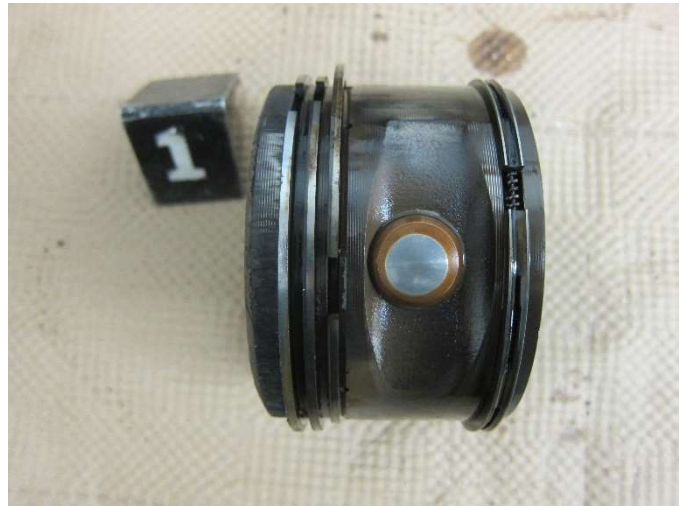
**#1 PISTON,  
RINGS AND PIN**

Normal combustion signatures and wear patterns

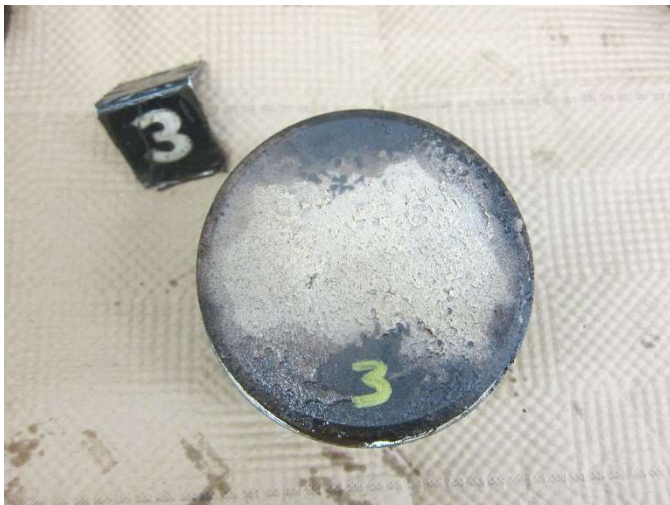
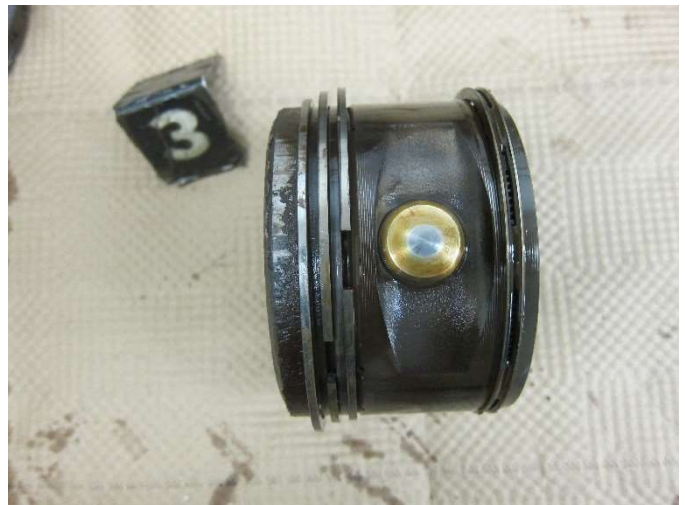
**#3 PISTON,  
RINGS AND PIN**

Normal combustion signatures and wear patterns

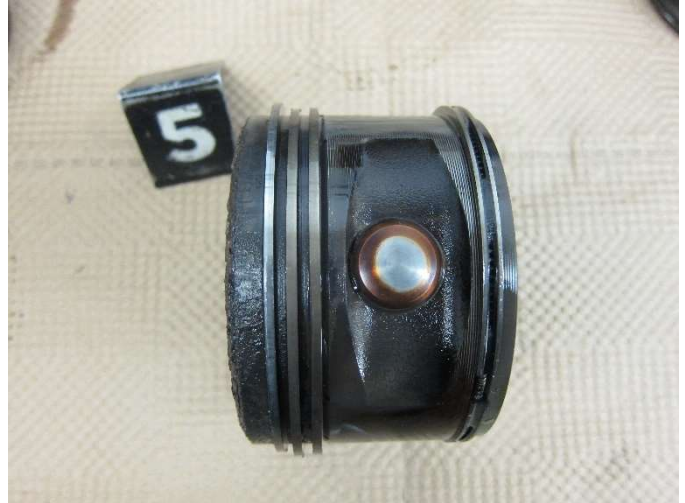
**#5 PISTON,  
RINGS AND PIN**

Normal combustion signatures and wear patterns

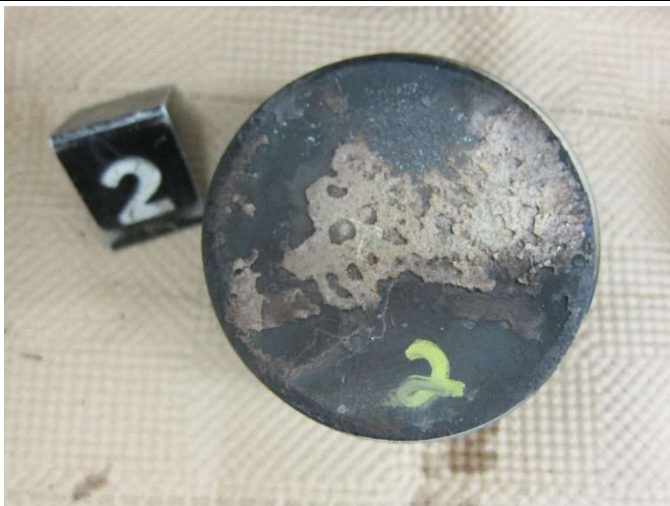
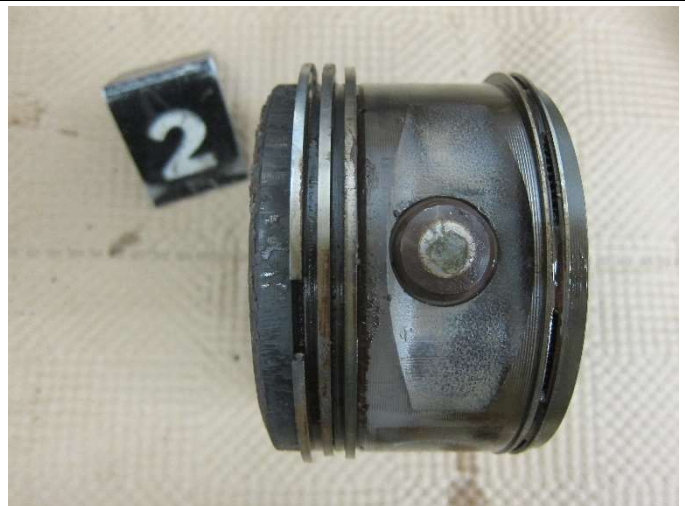
**#2 PISTON,  
RINGS AND PIN**

Normal combustion signatures and wear patterns

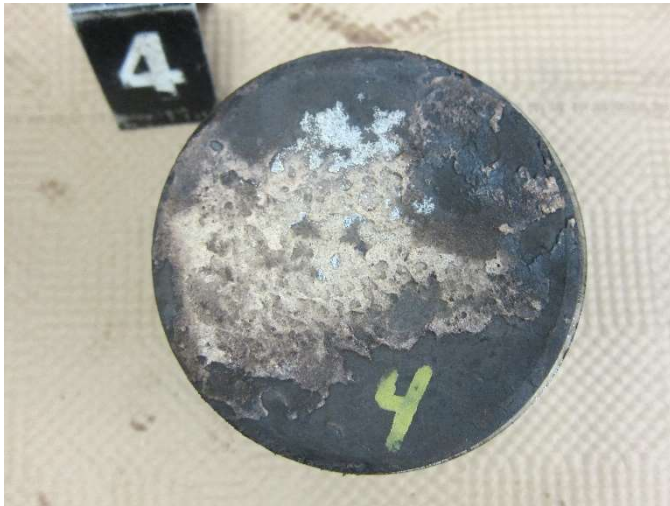
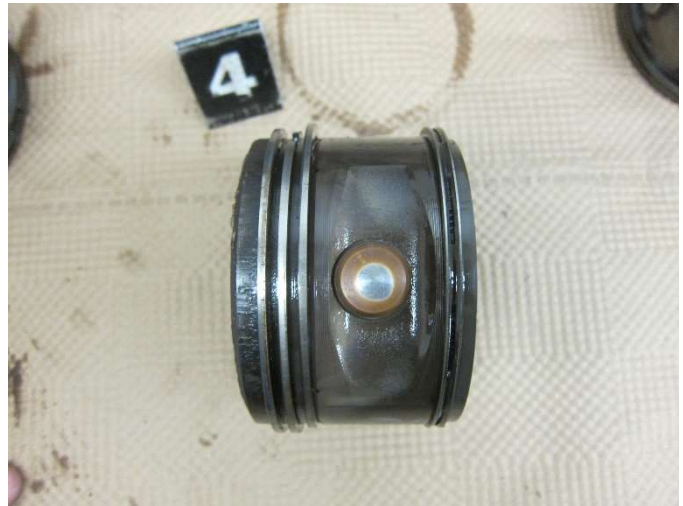
**#4 PISTON,  
RINGS AND PIN**

Normal combustion signatures and wear patterns

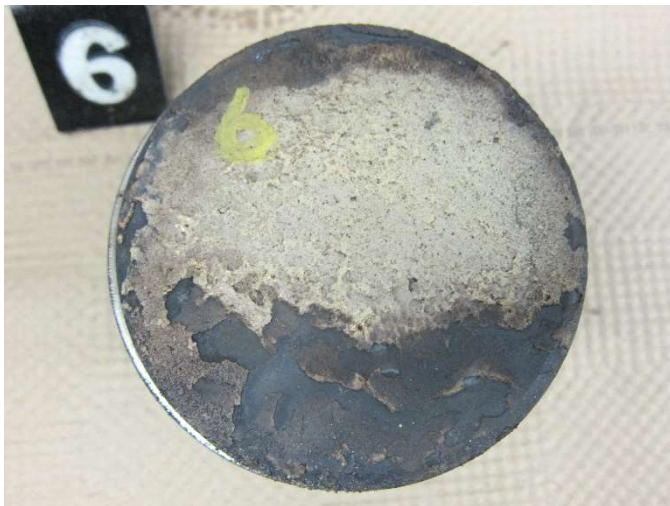
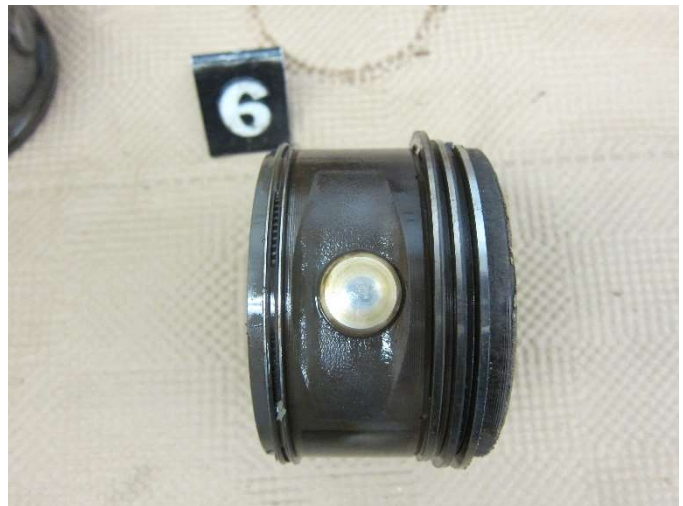
**#6 PISTON,  
RINGS AND PIN**

Normal combustion signatures and wear patterns

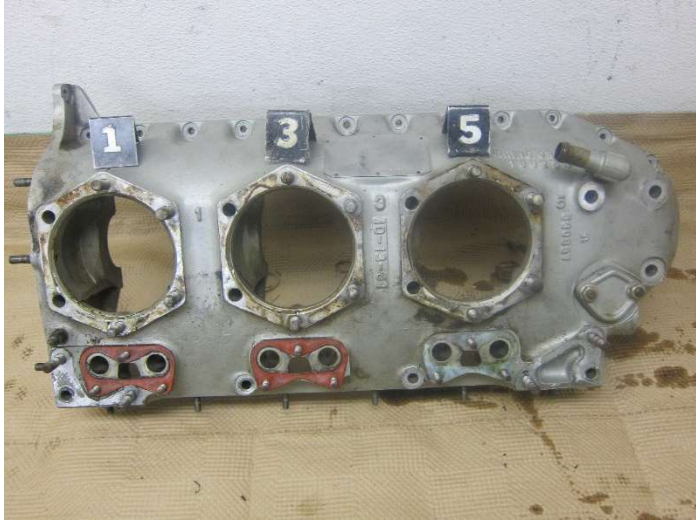
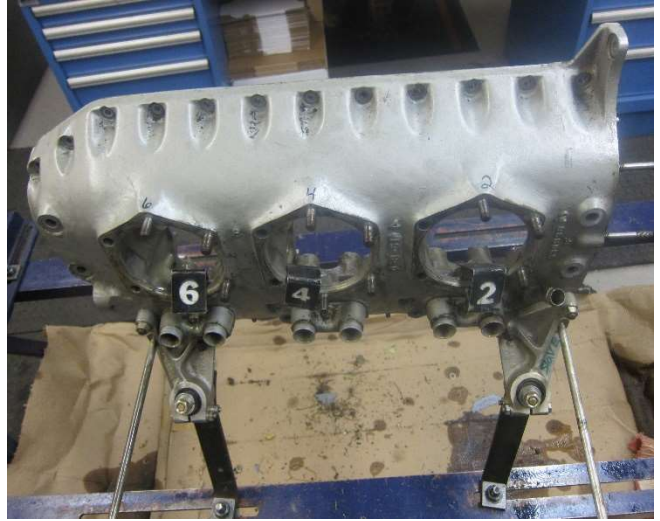
<b>CRANKCASE</b>	Casting Number:	1-3-5: 530836	2-4-6: 530837	S/N: 51157-103
Condition:	Exhibited normal operating signatures

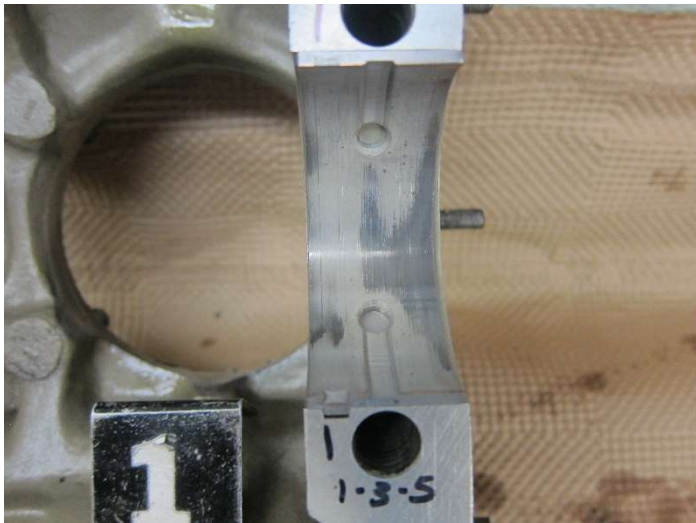
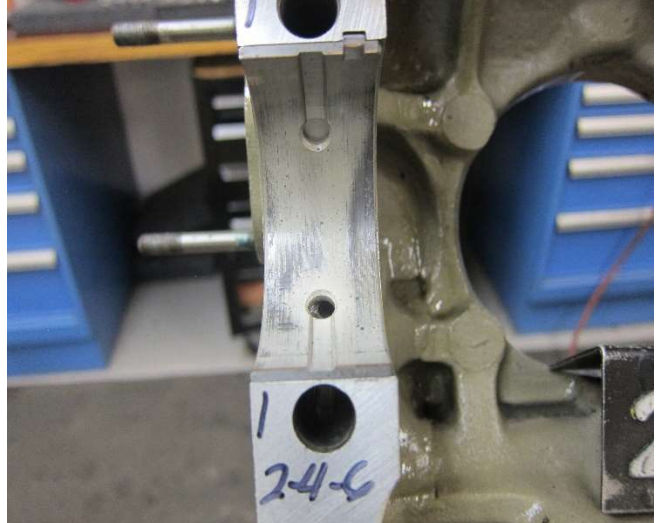
<b>#1 MAIN BEARINGS</b>	P/N: 626230-M010	Date Code: 06/13
Condition:	Exhibited normal operating signatures

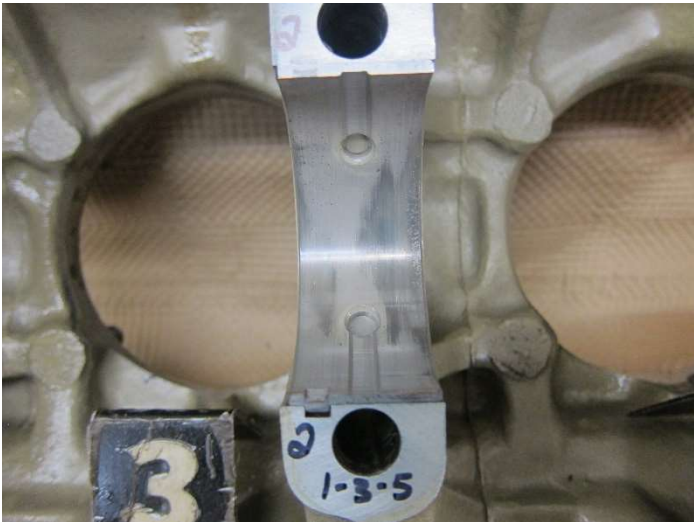
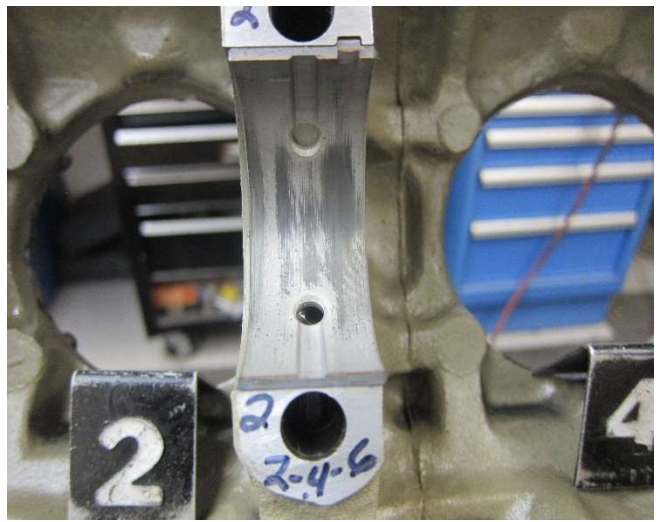
**#2 MAIN BEARINGS**

Condition: Exhibited normal operating signatures

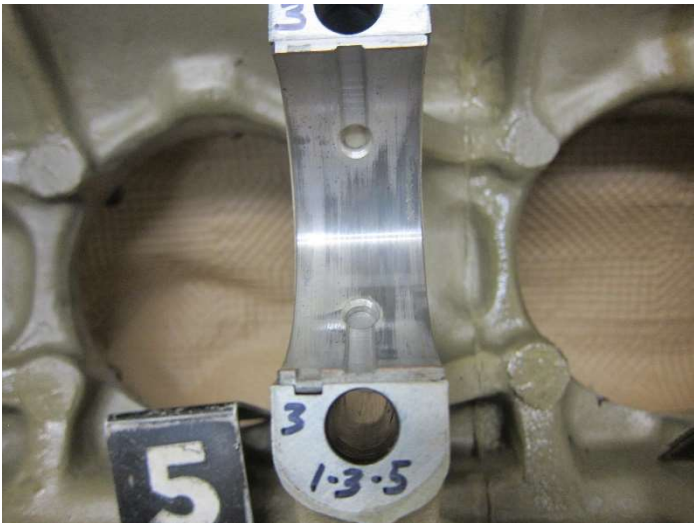
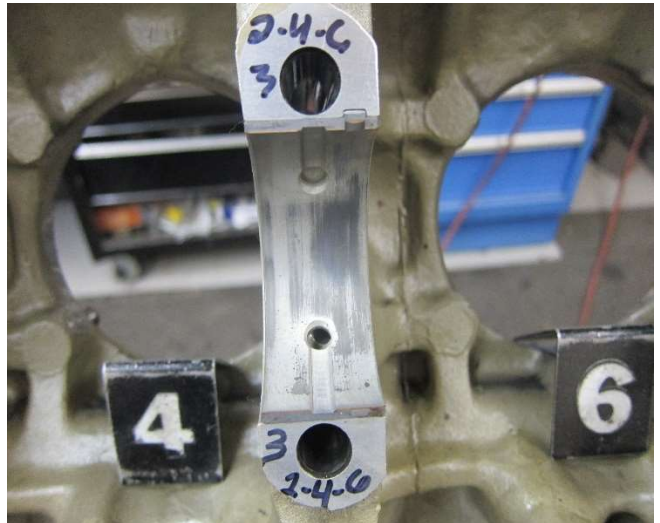
**#3 MAIN BEARINGS**

Condition: Exhibited normal operating signatures

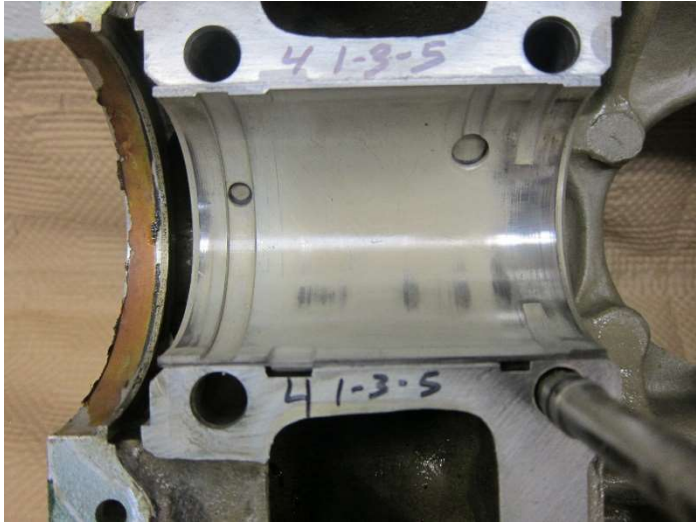
#4 MAIN BEARINGS

Exhibited normal operating signatures

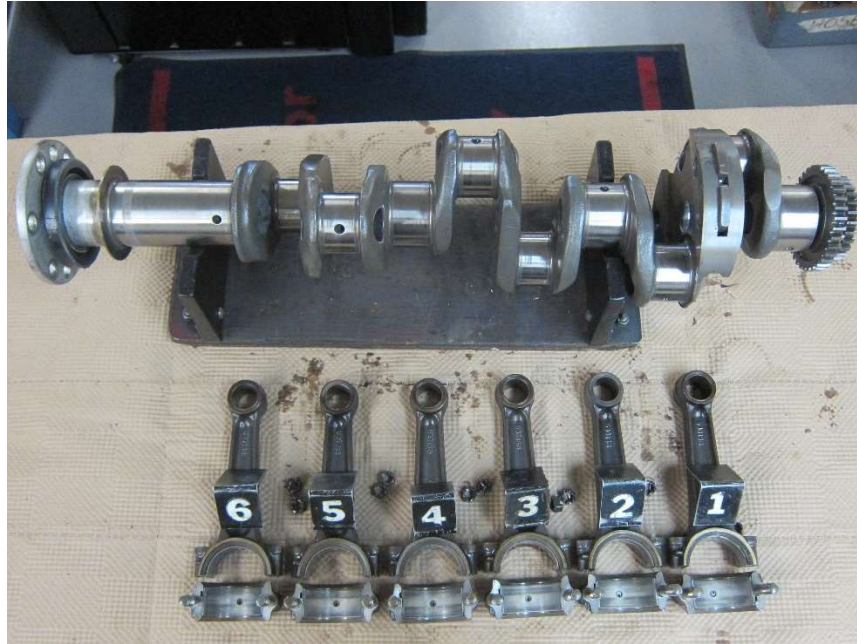
CRANKSHAFT

Exhibited normal operating signatures

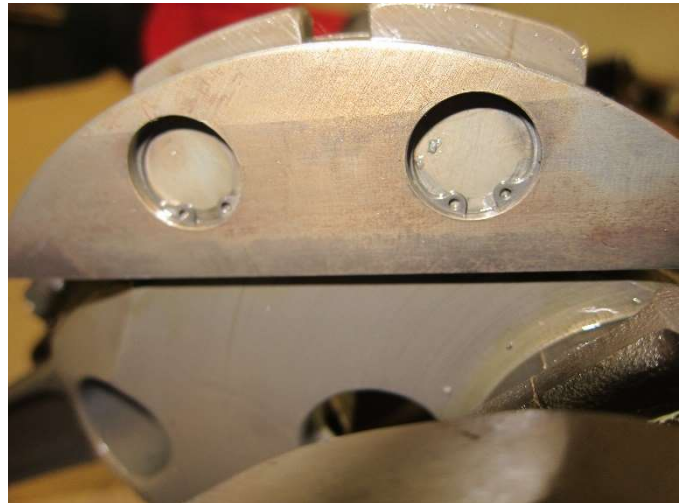
COUNTERWEIGHTS

Dampers were free to move on pins. All plates and snap-rings were intact.

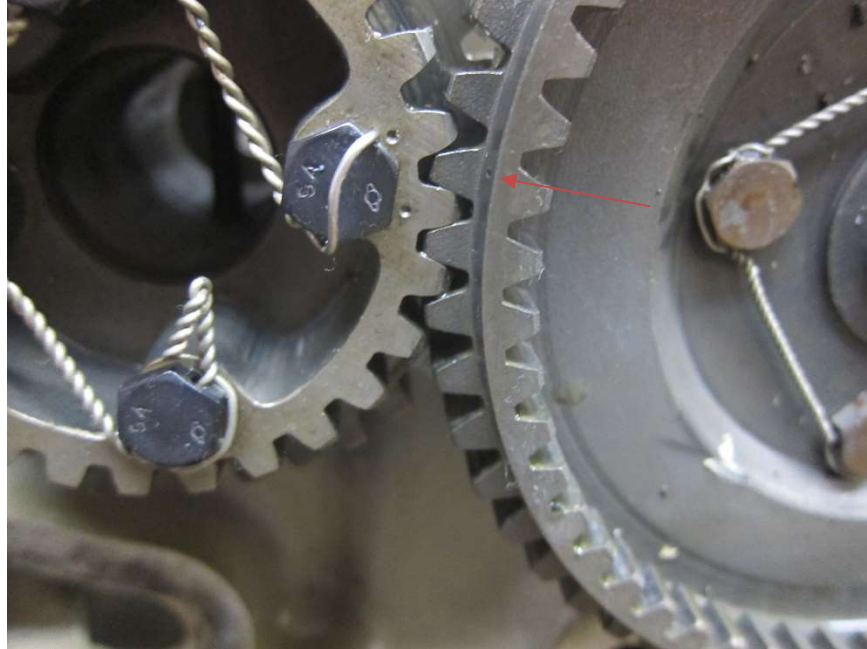
**INTERNAL  
TIMING**

Correct internal timing was confirmed. Red arrow points to timing mark on camshaft gear.

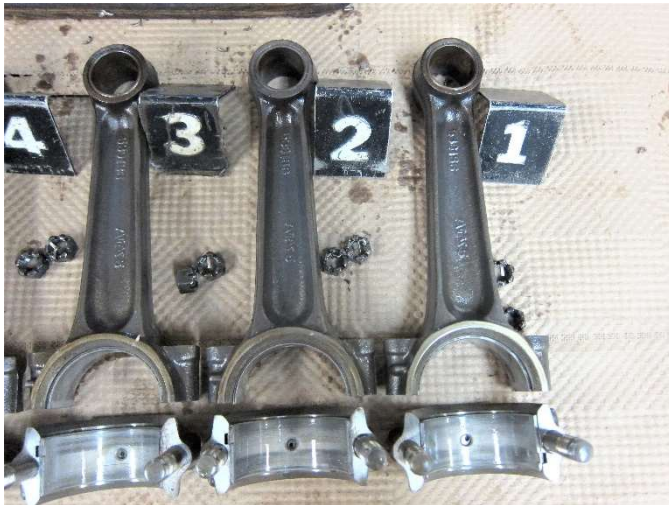
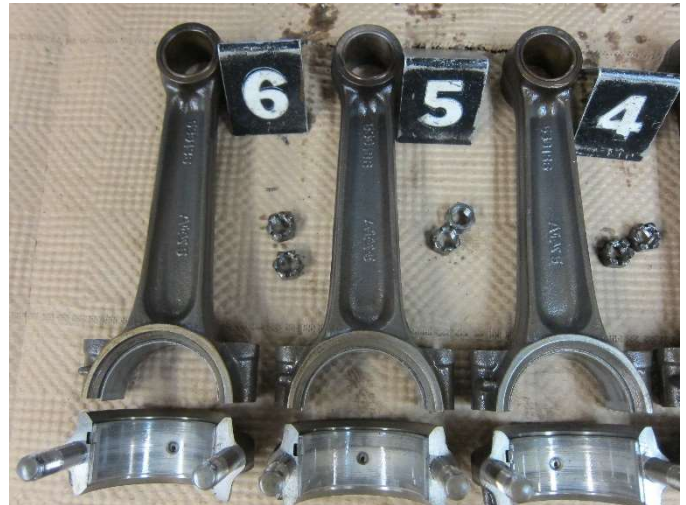
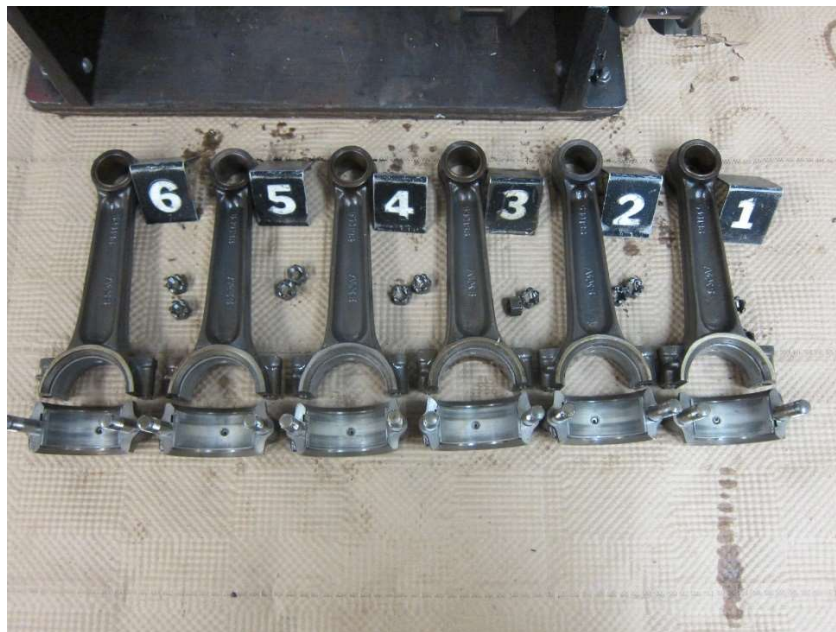
Condition: Exhibited normal operating signatures
