# ENGINE EXAMINATION REPORT

<b>ENGINE MODEL</b>	O-300-D (6B)
<b>ENGINE SERIAL NUMBER</b>	27160-D-2-D
<b>AIRCRAFT MAKE &amp; MODEL</b>	1958 Cessna 172
<b>AIRCRAFT SERIAL NUMBER</b>	36320
<b>AIRCRAFT REGISTRATION</b>	N8620B
<b>FILE NUMBER</b>	18-370

EXAMINATION		ACCIDENT DATA	
<b>DATE</b>	6-17-2019	<b>NTSB ACCIDENT #</b>	CEN19FA099
<b>FACILITY</b>	Continental Aerospace Technologies-Analytical	<b>NTSB INVESTIGATOR</b>	Michael Hodges, IIC Central Region
<b>ADDRESS</b>	2039 South Broad Street Mobile, Alabama	<b>FAA INVESTIGATOR</b>	NA
		<b>ACCIDENT DATE</b>	3-14-2019
		<b>ACCIDENT LOCATION</b>	Lakeway, TX

The engine was disassembled and inspected under the supervision of the NTSB IIC. This inspection did not reveal any pre-impact anomalies that would have prevented its ability to produce rated horsepower.

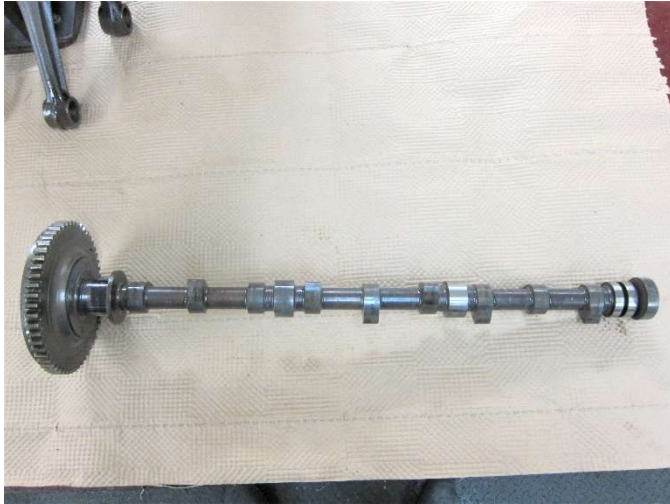
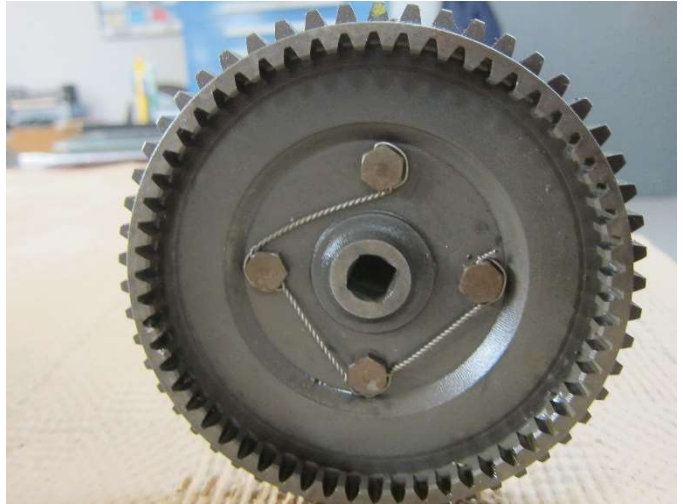
**CAMSHAFT**

Exhibited normal operating signatures

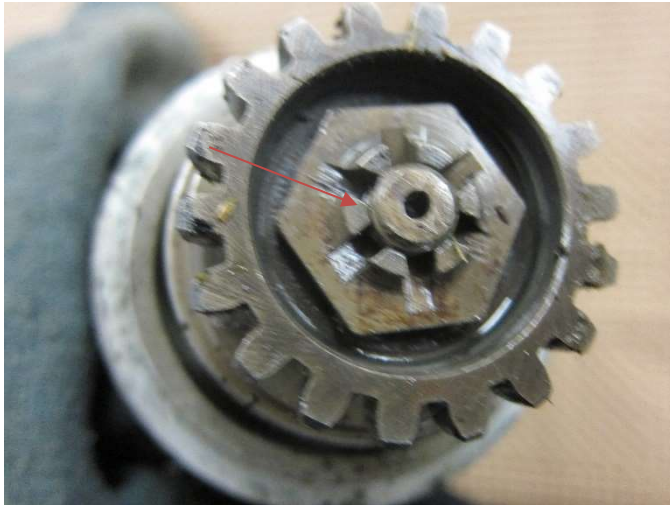
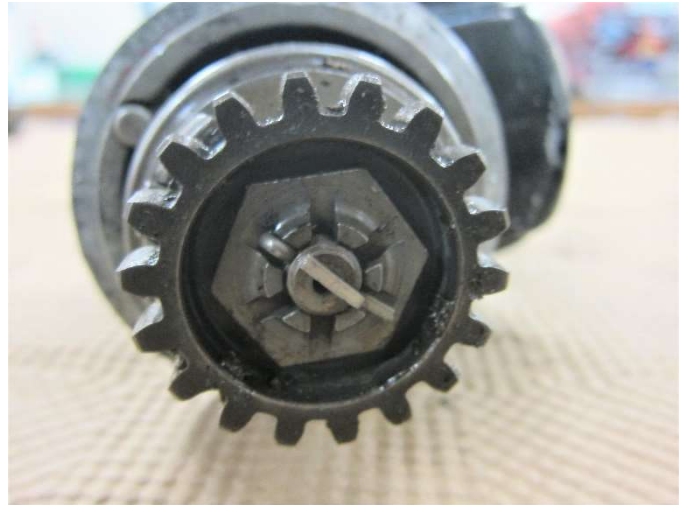
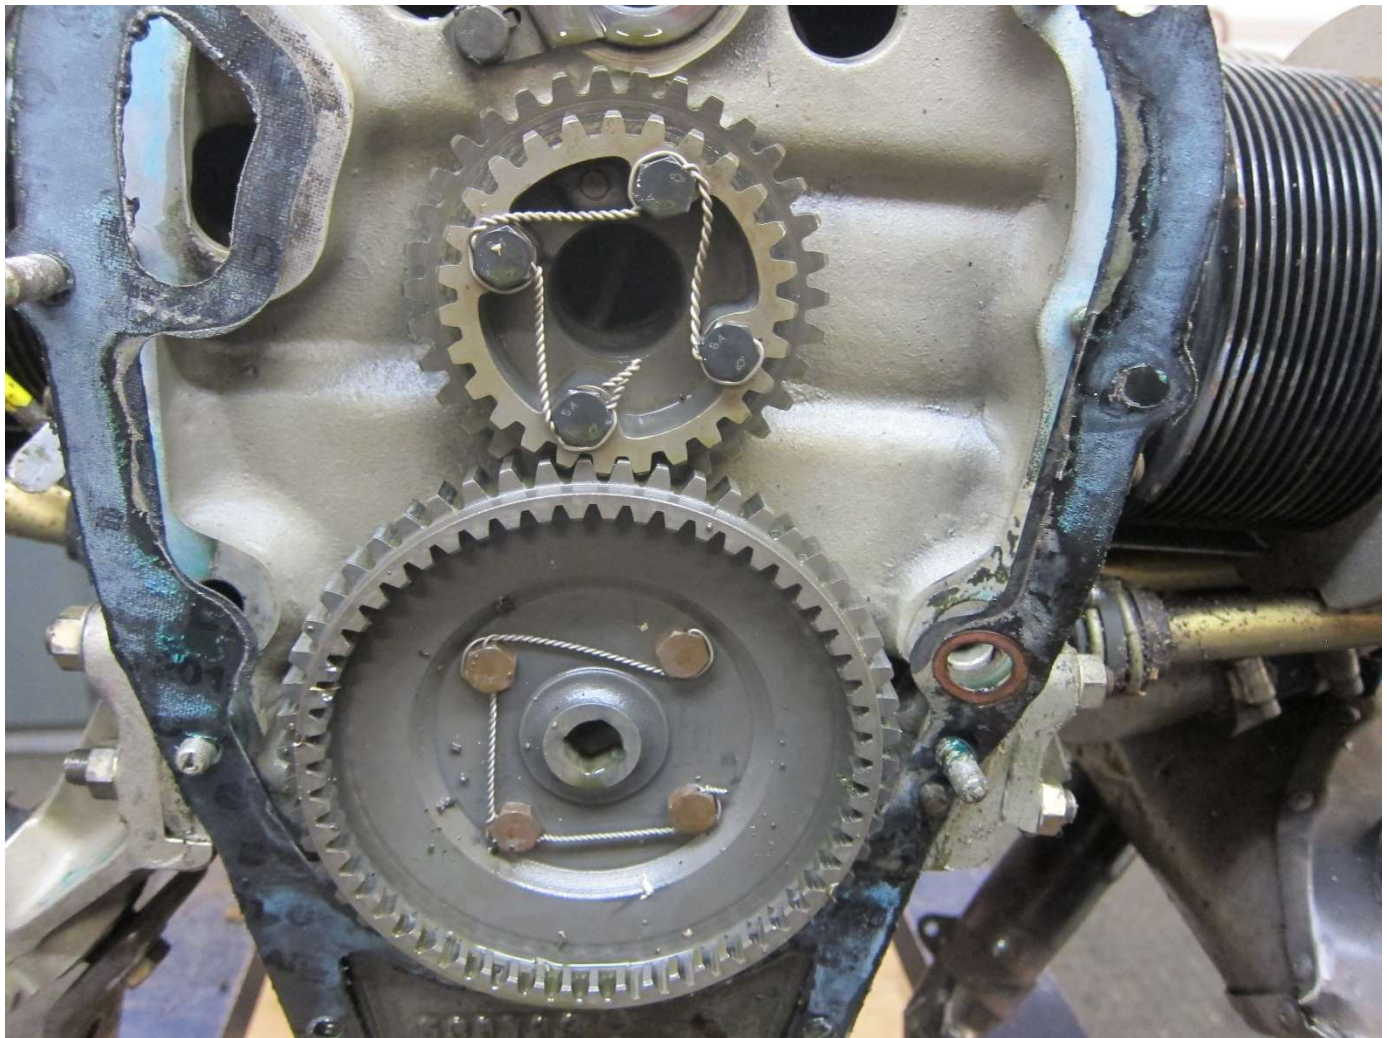
## ACCESSORY GEARS

The accessory gears were intact with no damage noted. Red arrow indicates cotter pin missing but it had been removed at the recovery examination.

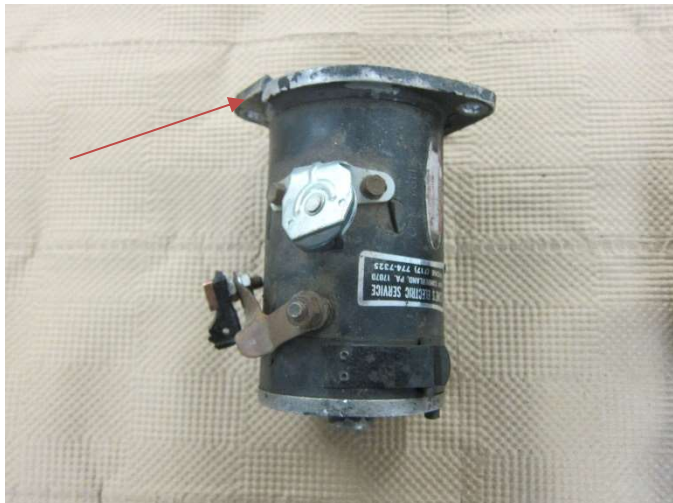
Condition:	The starter motor mounting collar was impact damaged.
------------	---

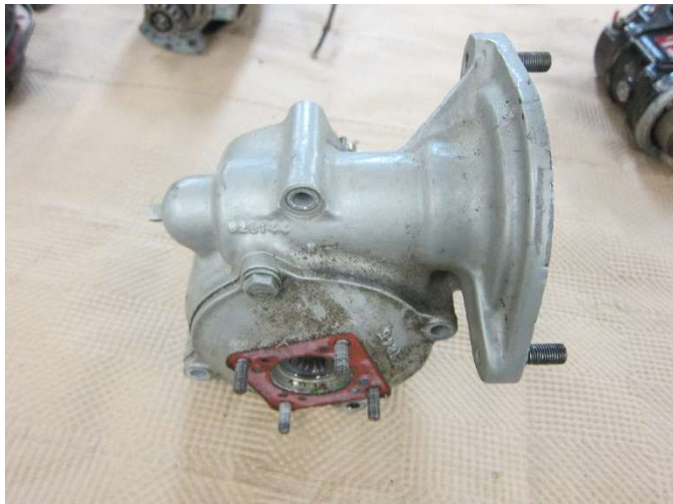
Condition:	The starter adapter was undamaged and rotated normally.
------------	---

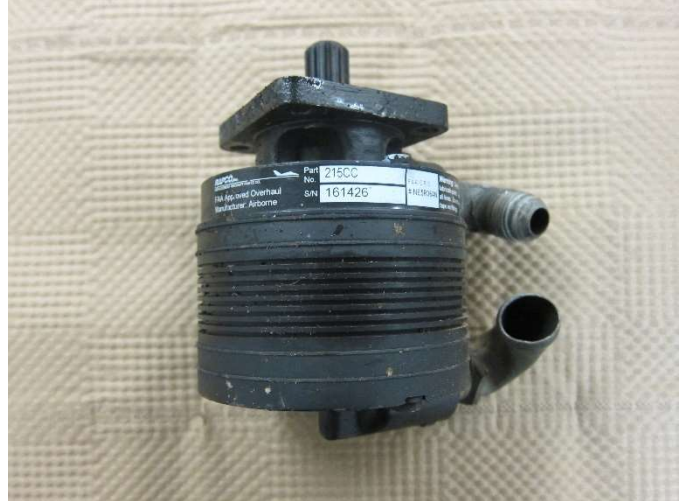
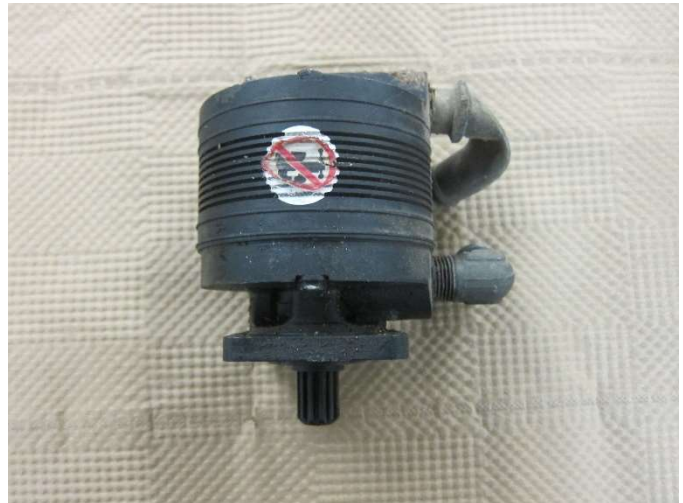
## VACUUM PUMP

The instrument air pump was rotated by hand. The pump rotated smoothly thumb suction was achieved. The plastic drive coupling was intact.
