**NATIONAL TRANSPORTATION SAFETY BOARD
Office of Research and Engineering
Vehicle Recorder Division
Washington, D.C. 20594**

GROUP CHAIRMAN'S FACTUAL REPORT OF INVESTIGATION

CEN18FA391

Location: Gustavus, Alaska
Date: September 28, 2018
Aircraft: Airbus Helicopters AS350-B3e, N907PL
Operator: Private
NTSB Number: CEN18FA391

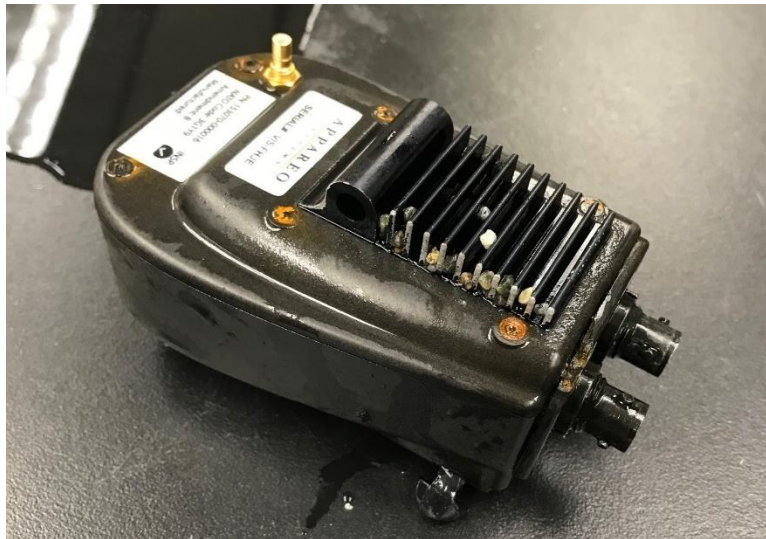
Upon arrival at the NTSB Vehicle Recorder Division, it was evident that the Appareo Vision 1000 had water damage. In accordance with NTSB procedures for electronic devices recovered from water, the device was shipped to the laboratory in fresh water. The unit showed signs of the start of corrosion to some internal parts, but was otherwise undamaged. Figure 1 is an image of the Appareo Vision 1000 as received, after being removed from a container of fresh water.

Figure 1. The Appareo Vision 1000 and SD card.

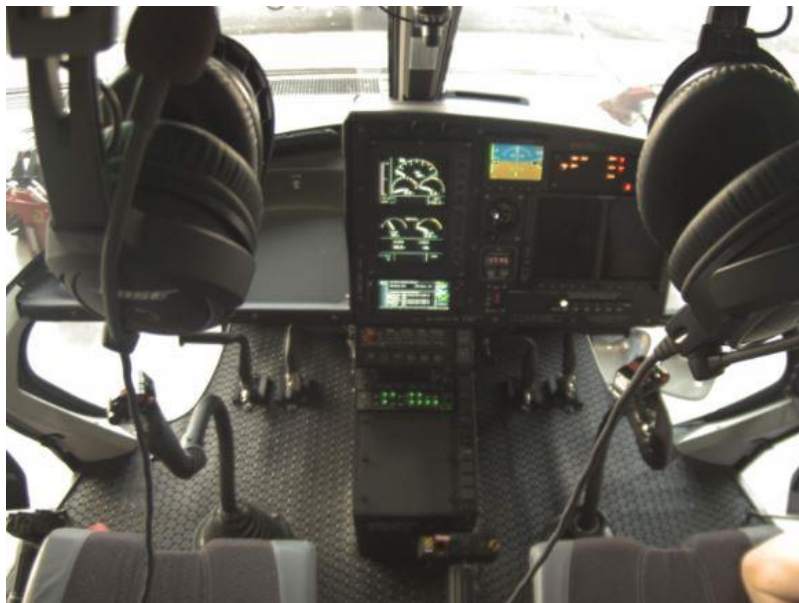
Figure 2 is a copy of the calibration image at the Airbus Helicopter's facility prior to delivery. It shows the Appareo V1000's field of view during the accident flight. The camera position remained in a similar position for the accident flight.

Figure 2. A capture from the Appareo image recorder, serial number VIS-FHJE installed on N907PL, prior to delivery to the owner.

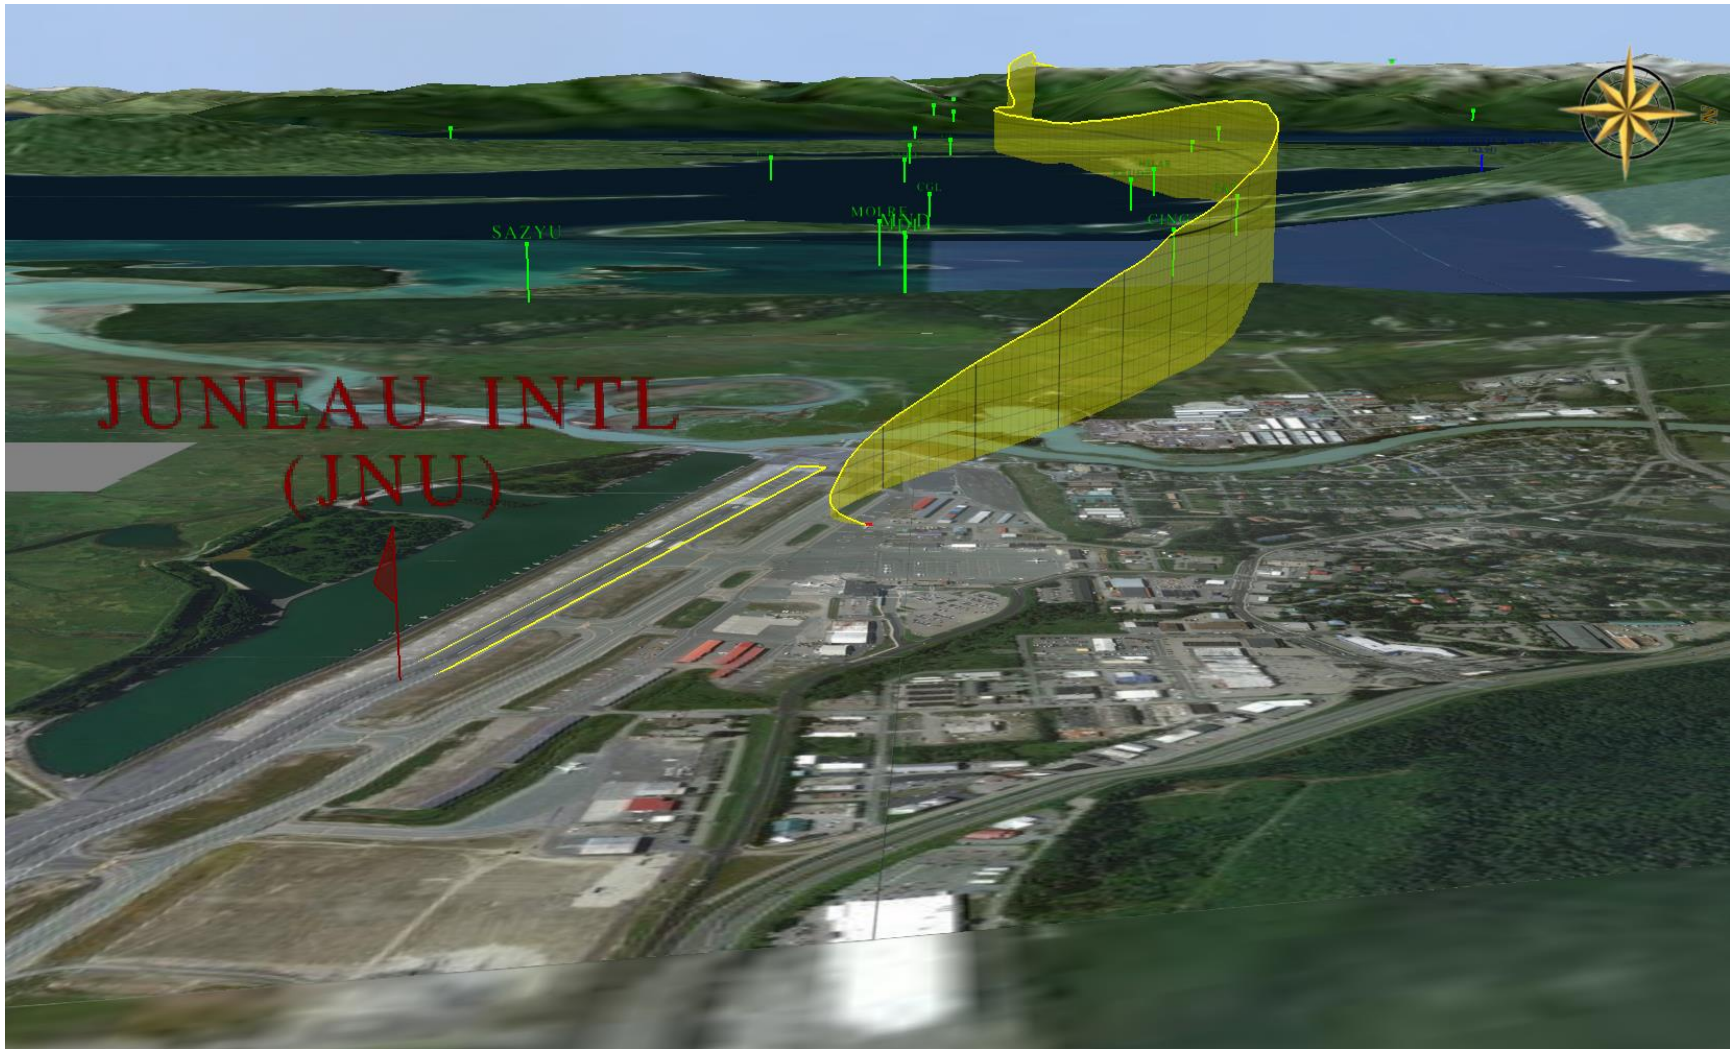
Figure 3 is a screenshot of an exported GPS overlay showing the helicopter's departure from PJNU.

Figure 3. The helicopter's departure from PJNU.

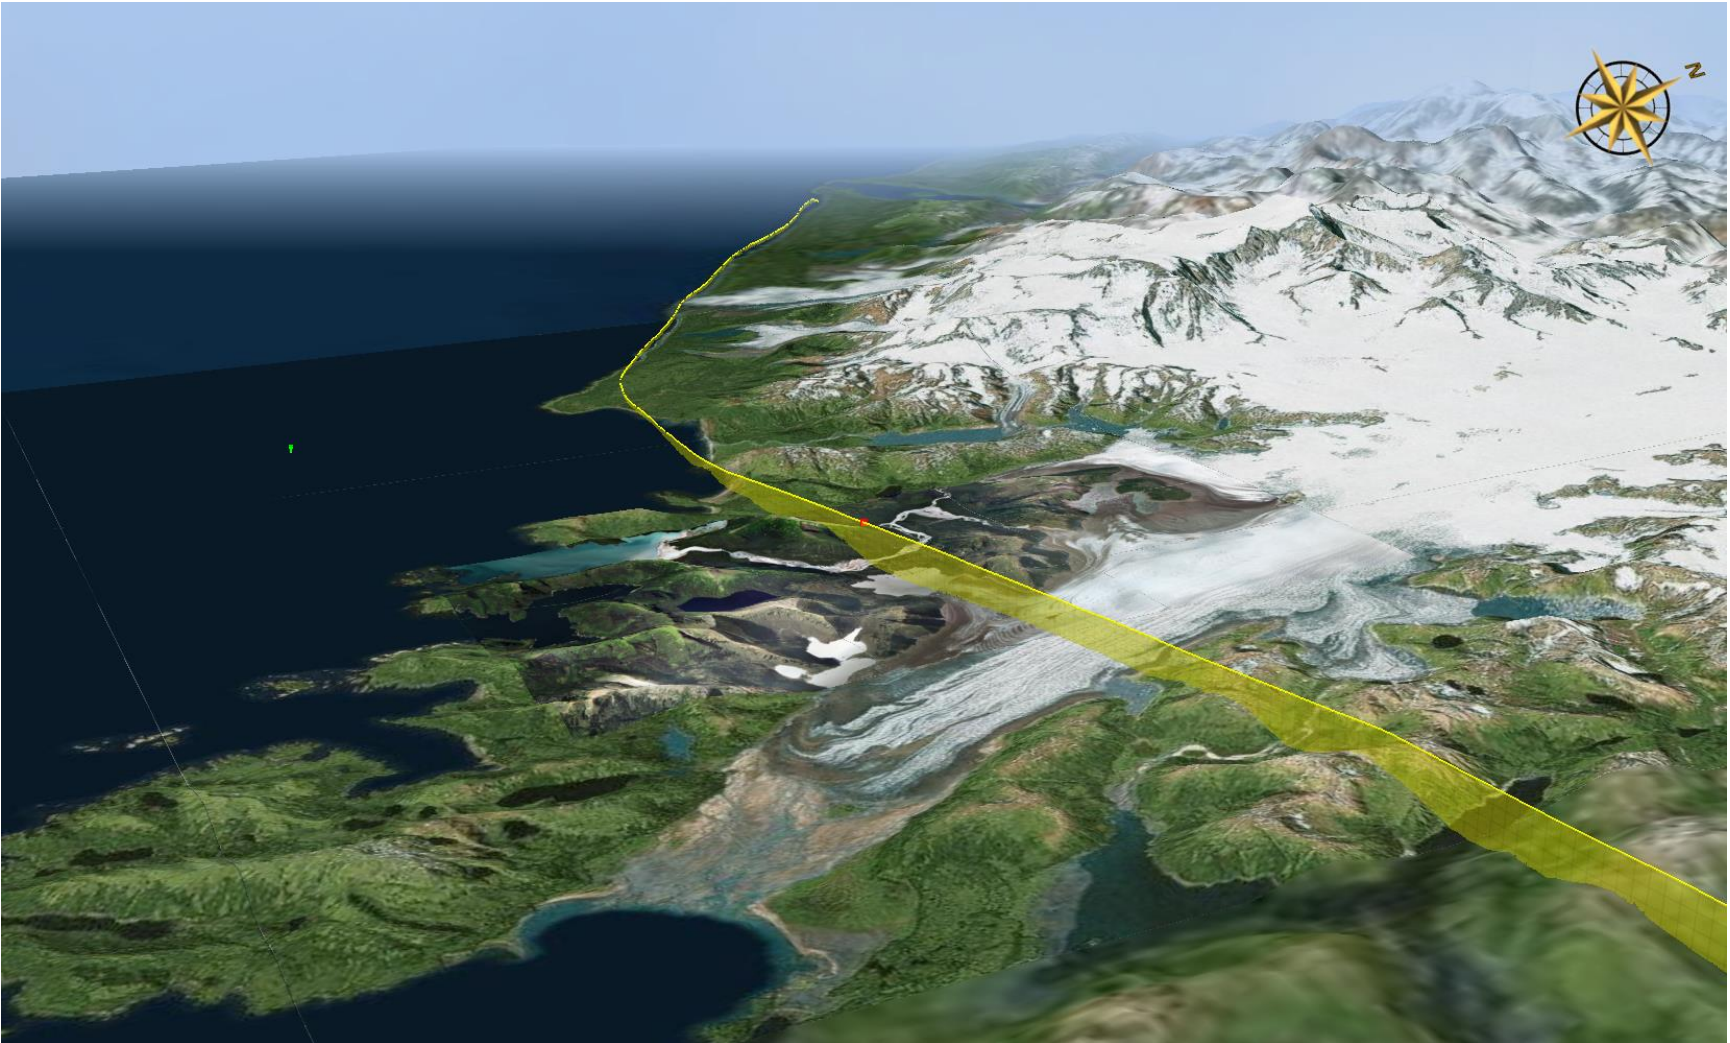
Figure 4 is a screenshot of an exported GPS overlay around 18:40 UTC when the helicopter entered a descent and began a turn to the northwest along the coastline.

Figure 4. The helicopter's flight path around 18:40 UTC. The route of the helicopter's flight was to the northeast (bottom right of page to top left of page).

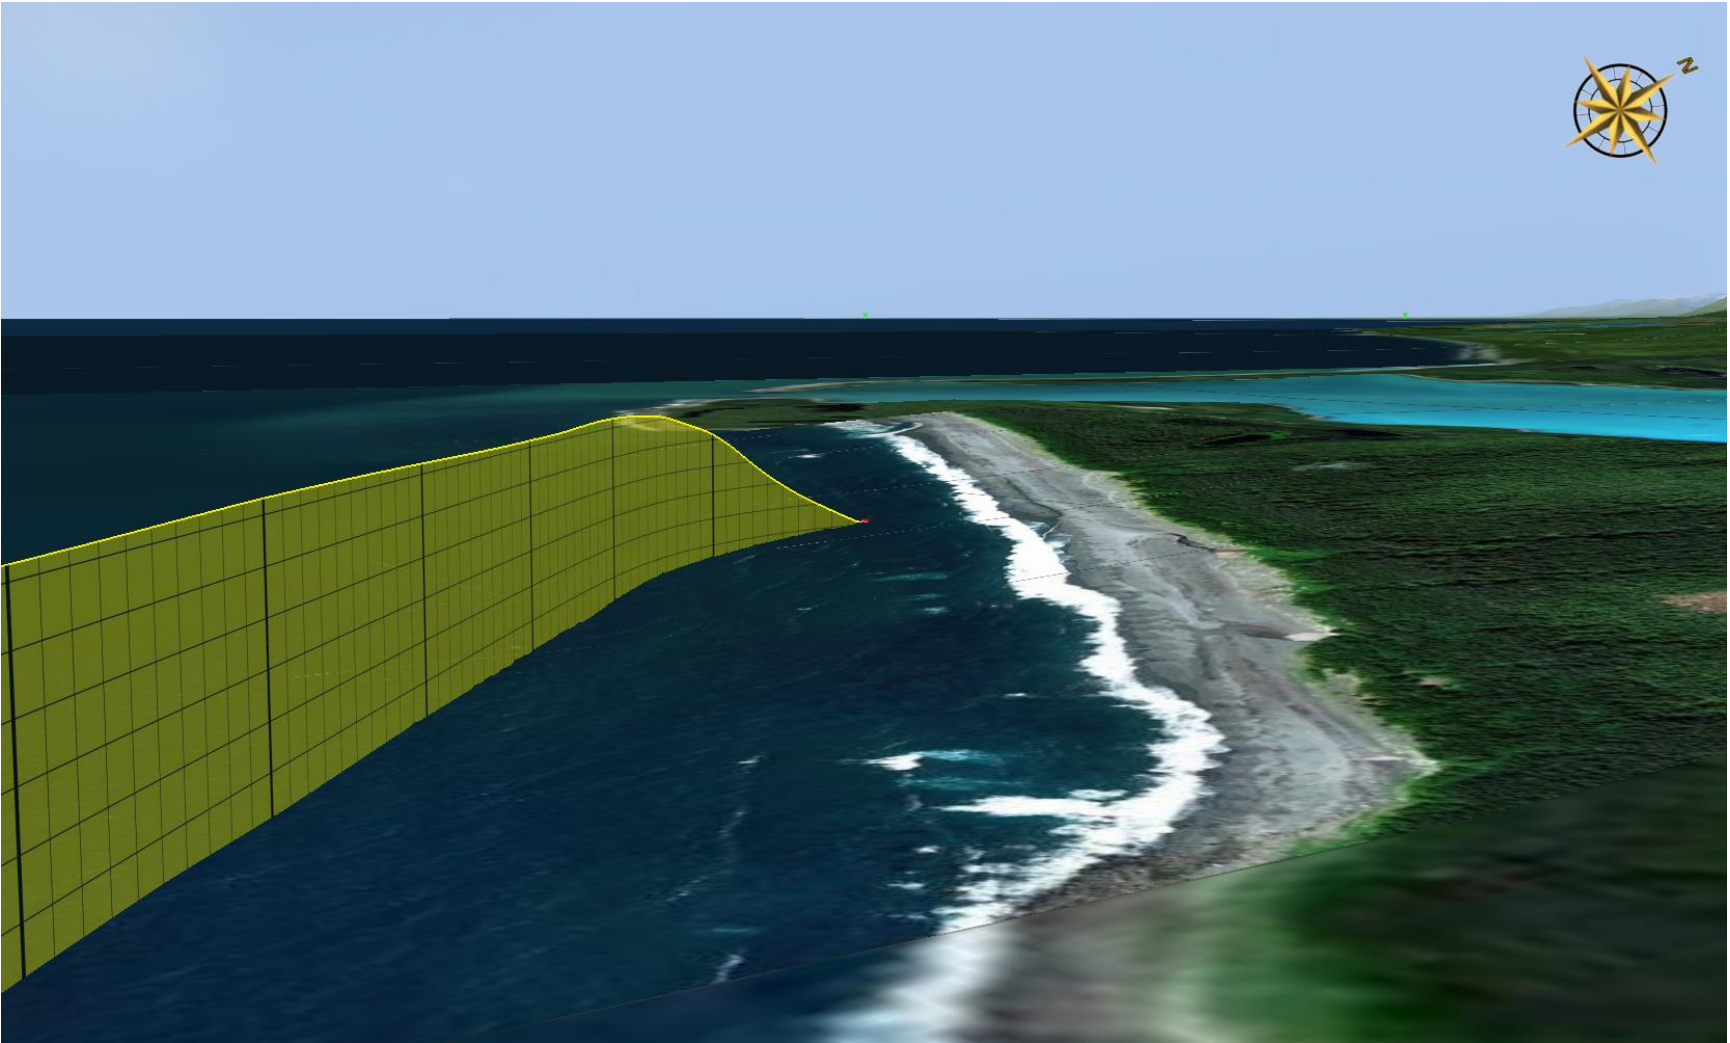
Figure 5 is a GPS overlay showing the final moments of the helicopter's flight.

Figure 5. The helicopter's flight path at the final portion of flight.

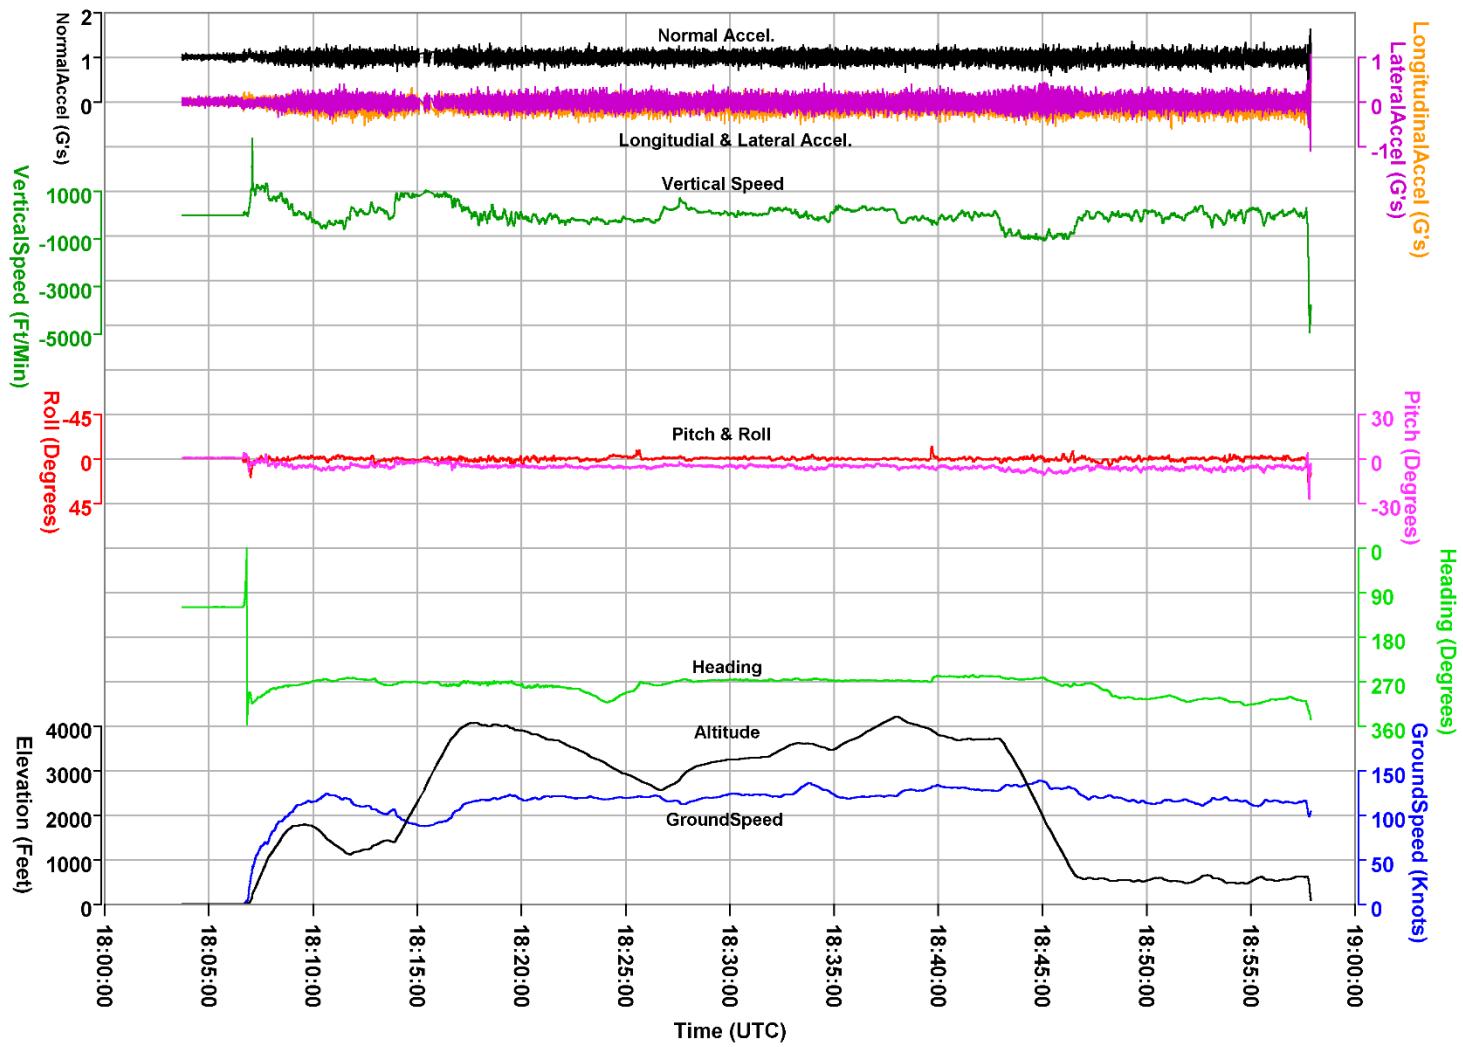
Figure 6 is a strip chart showing recorded parameters for the entire flight.

Figure 6. A plot of recorded parameters for the entire flight.

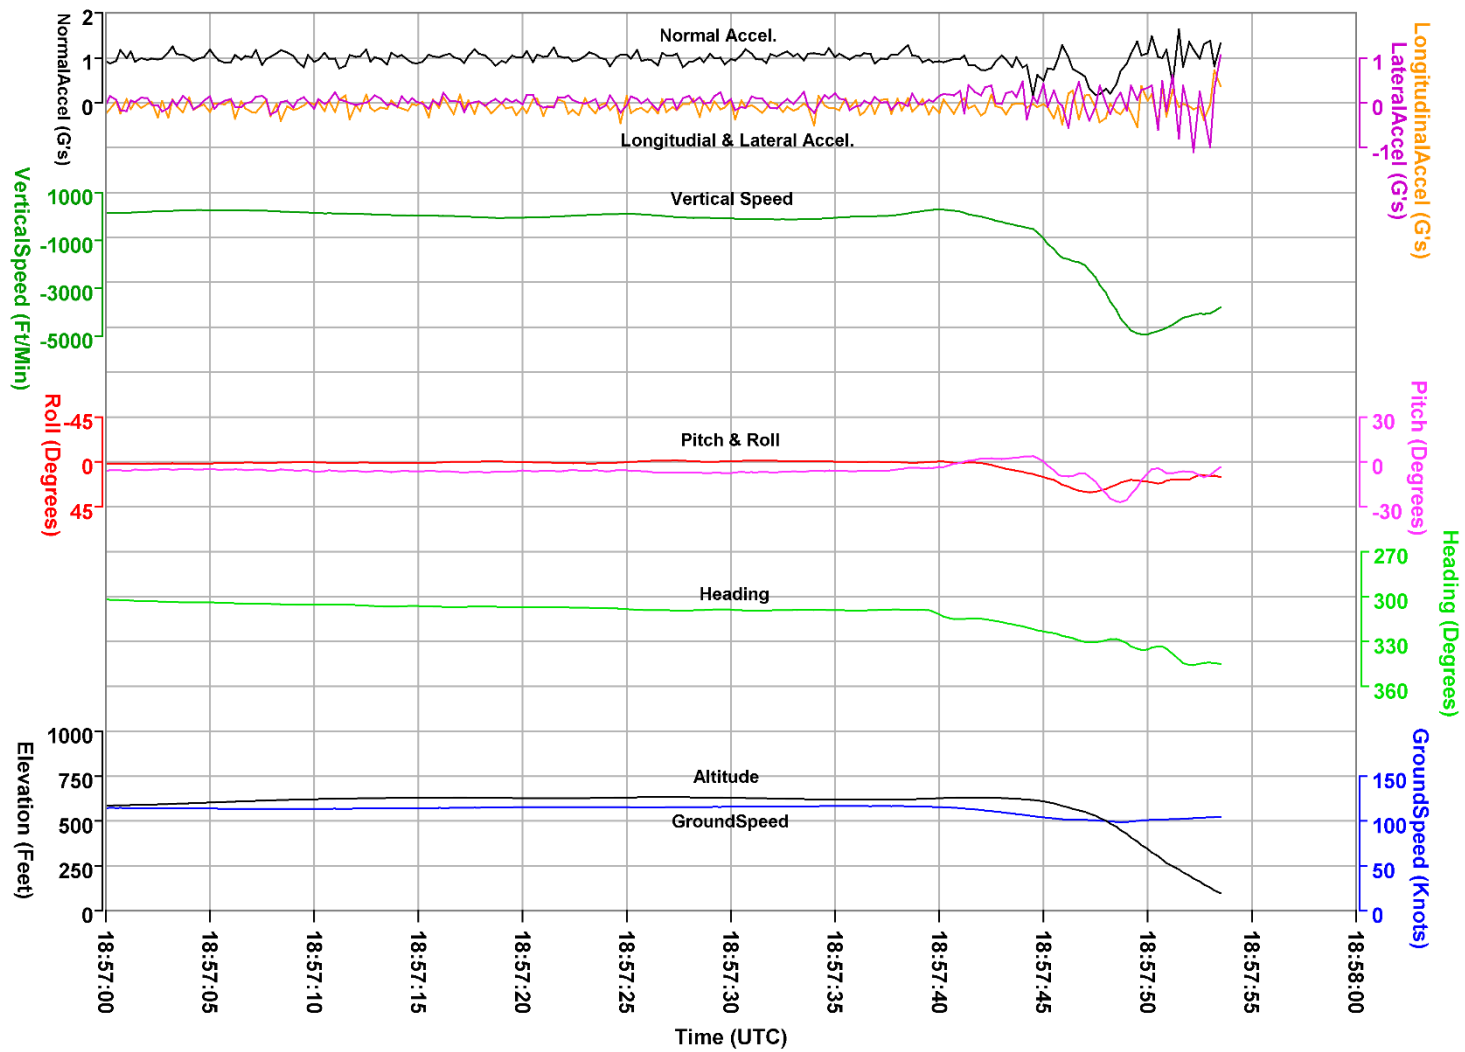
Figure 7 is a strip chart showing recorded parameters for the end of flight.

Figure 7. A plot of recorded parameters for the end of flight.
