Tamarack Aerospace Group Submission to the National Transportation Safety Board

**Collision of Cessna 525A (N525EG) With Terrain Near  
Memphis, IN, November 30, 2018**

**CEN19FA036**

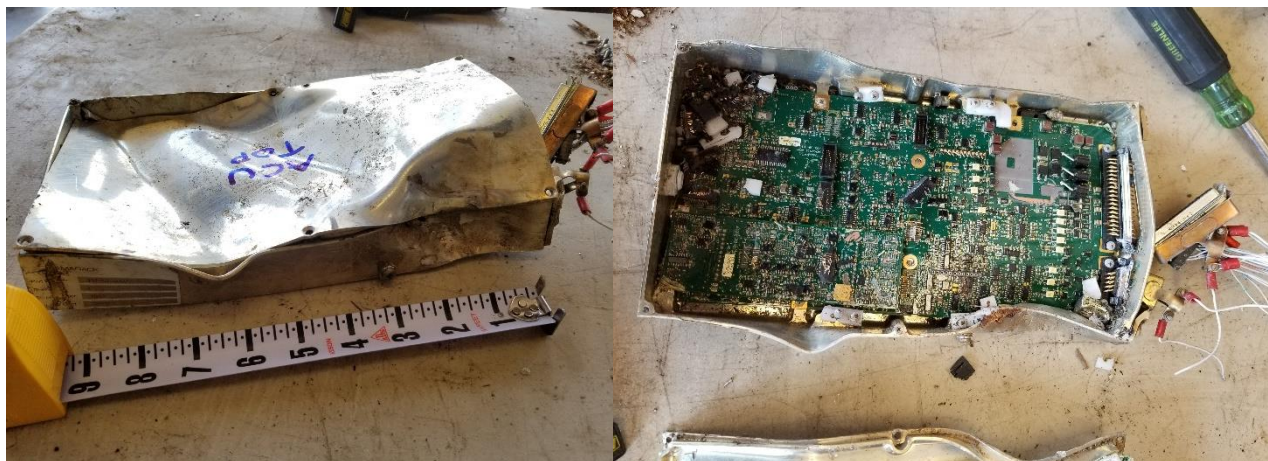
Figure 2-1 ACU as-found condition (external view left, internal view right)

The ACU was found in a severely damaged state, visible in Figure 2-1.

The state of the ACU and the extent of the damage prevented further testing of the unit. The ACU does not have non-volatile memory. The type and extent of the damage is consistent with a severe impact event. The amount of post-impact damage prevents further meaningful investigation into the possibility of in-flight ACU failures. To date, Tamarack has not received any reports of in-flight ACU failures.

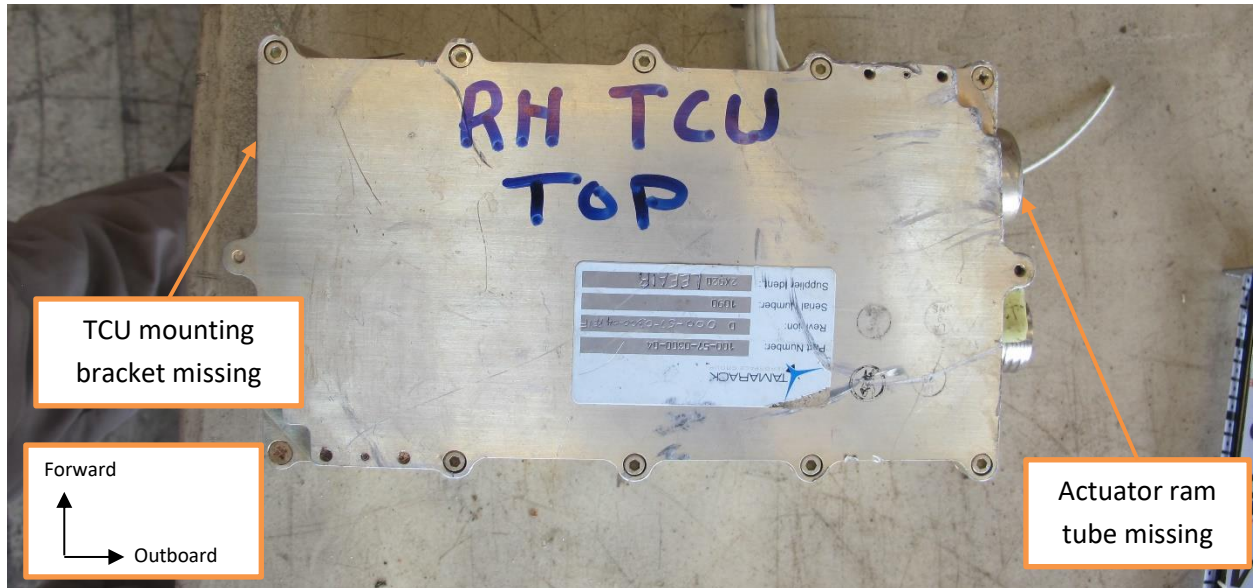
Figure 2-2 RH TCU as-found state (top-down view)

The right hand TCU was found with extensive external and internal damage, similar to the ACU.

A preliminary external examination of the RH TCU found that the actuator ram tube, which ordinarily connects to the TACS deployment linkages via a self-aligning bearing rod end, was broken off from the

actuator. A mounting bracket normally installed on the aft end of the TCU box had been broken off as well. The TCU case was also breached, with leaves and other debris found inside the normally sealed box.

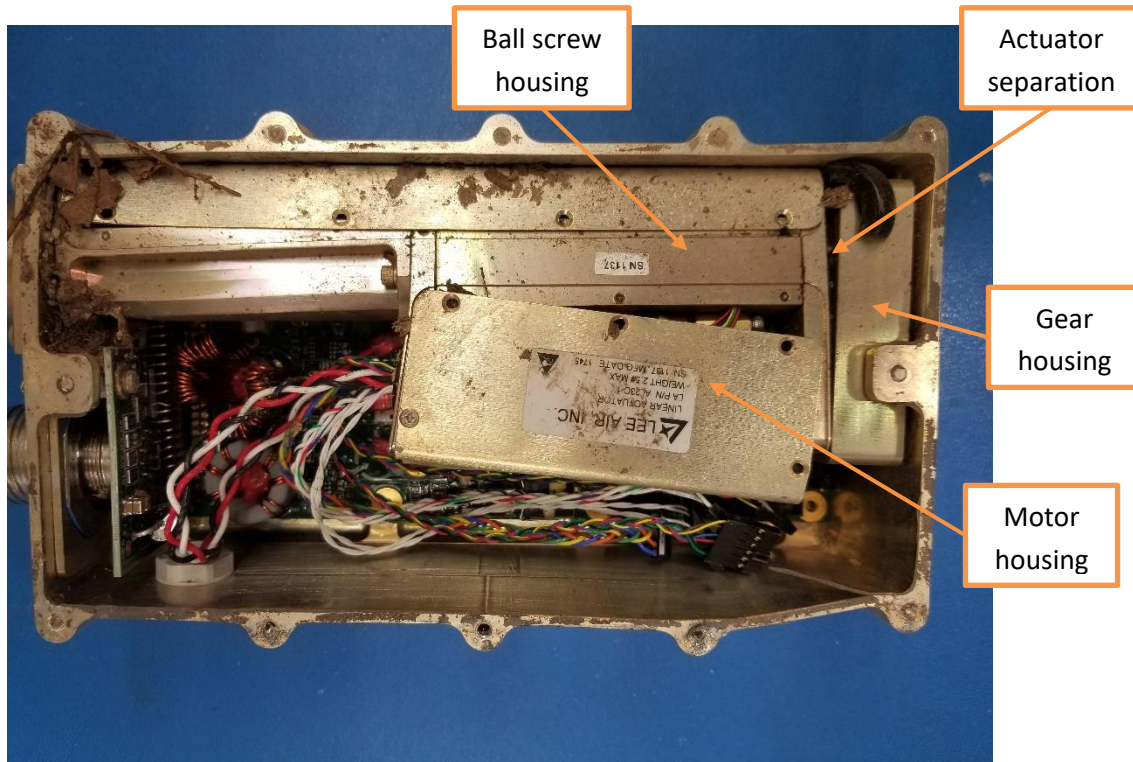
Figure 2-4 RH TCU as-found condition (internal view)

A preliminary internal examination of the RH TCU found that the actuator itself had failed structurally, visible in Figure 2-4 as a separation of the gear housing from the motor and ball screw housings. The gear housing is attached to the motor and ball screw housings by six screws, which were found failed on further inspection. The type of failure was consistent with a tensile overload of the screws. Tamarack notes that the actuator is not capable of developing the static force required to fail these screws in tension, and the separation is thus most likely due to the high energy impact.

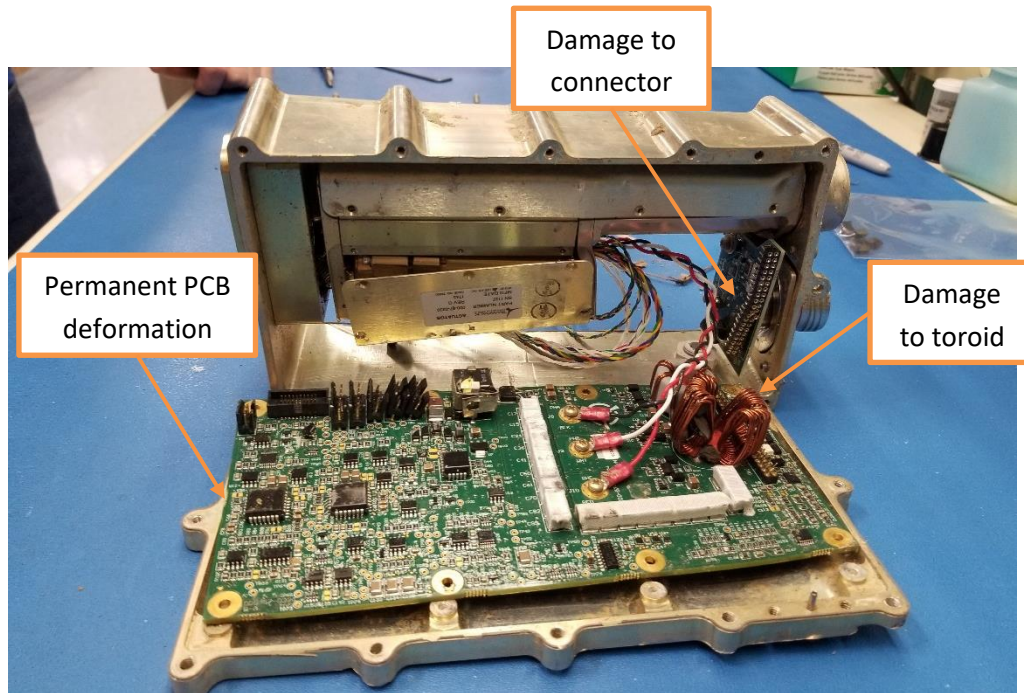
Figure 2-5 RH TCU as-found condition (PCB view)

Extensive damage to the TCU PCB assembly prevented any electrical testing.

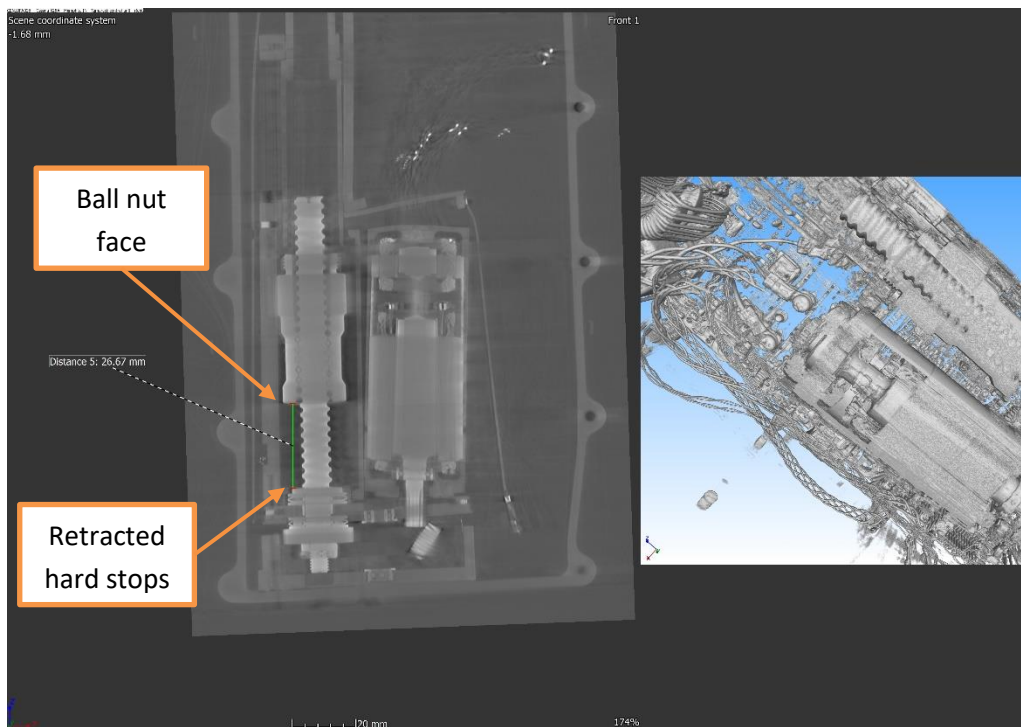
Figure 2-6 RH TCU CT scan results, showing as-found position of ball screw

The CT revealed that the distance from the retracted hard stop of the actuator to the ball screw face was approximately 26.7 mm (1.05 in). When the actuator is in its neutral position (*i.e.*, the TCU is not responding to any gust), the distance between these two faces would nominally be approximately 0.5 in. The distance would be slightly greater than 1.5 in if the actuator were fully extended.

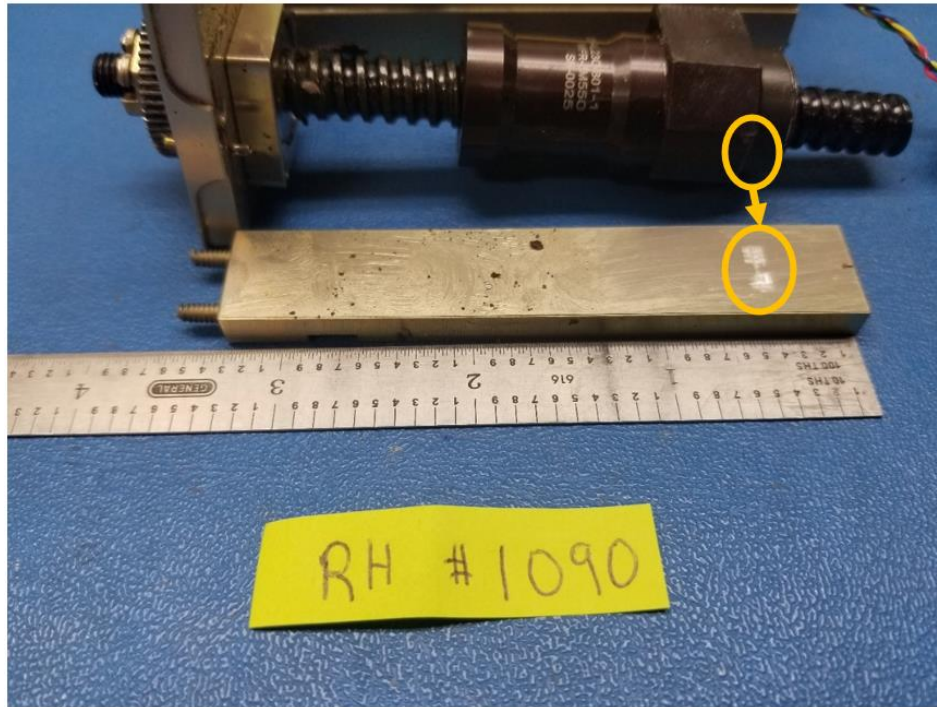
Figure 2-8 RH TCU actuator ball nut lower guide witness marks (excerpt from [3])

Further teardown of the actuator found witness marks on the upper and lower ball screw guides within the actuator, corresponding to the ball screw position recorded by the CT scan.

It is worth noting that the clearance between the ball nut lower guide and the ball nut is nominally 0.025in, and the travel of the ball nut along the axis of the ball screw does not allow the two components to come into contact. The witness marks observed in this TCU (and in the LH TCU as described later) have not been observed in any other actuator teardown by the manufacturer. Therefore, it is likely that these witness marks were caused by deflection of the ball nut under impact loads, rather than normal operation.

The as-found position of the ball nut after the actuator ram tube was sheared off and the witness marks on the lower ball nut guide strongly suggest that the actuator was in this position, deploying the TACS approximately 10° trailing edge up, at the time of impact. A deployment of this type would be expected during an attempted recovery from a dive, as the airplane would experience elevated positive load factor and thus would cause ATLAS to deploy TACS to alleviate resulting aerodynamic loads.

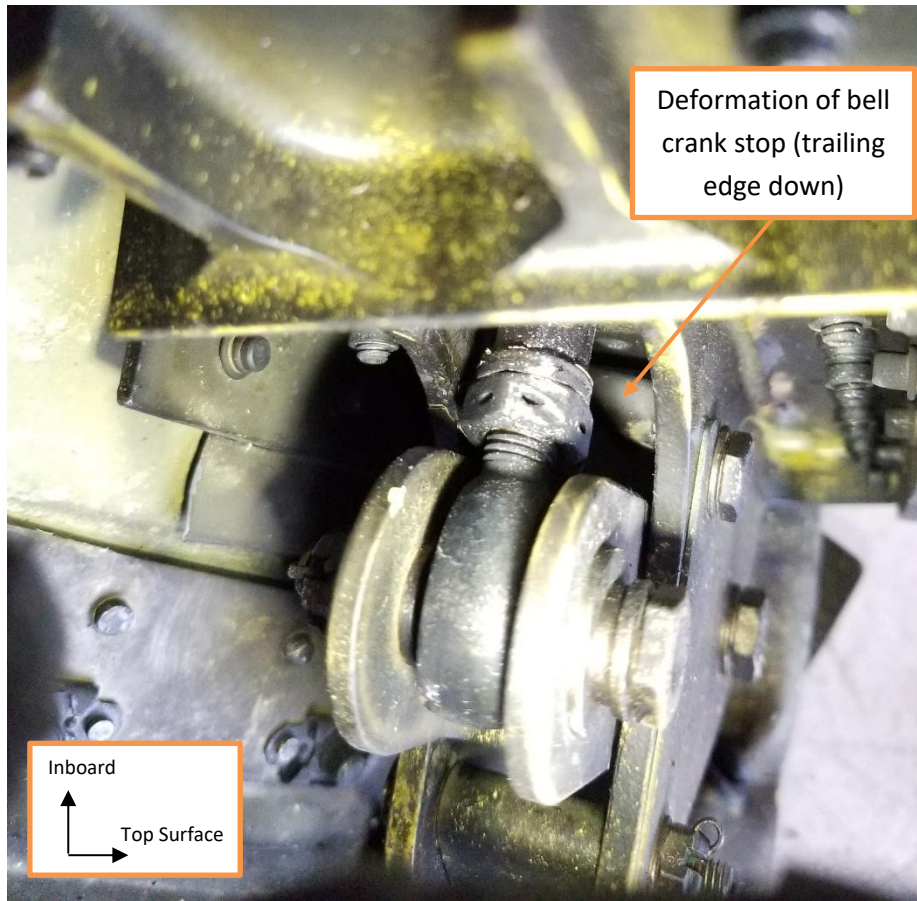
Figure 2-9 RH wing extension bell crank damage

Deformation of bell crank stop (trailing edge down)

Damage to the right wing extension, specifically the bell crank and the hinge bracket, presents a disparity between the witness marks within the actuator and witness marks on the hinge hardware. The bell crank

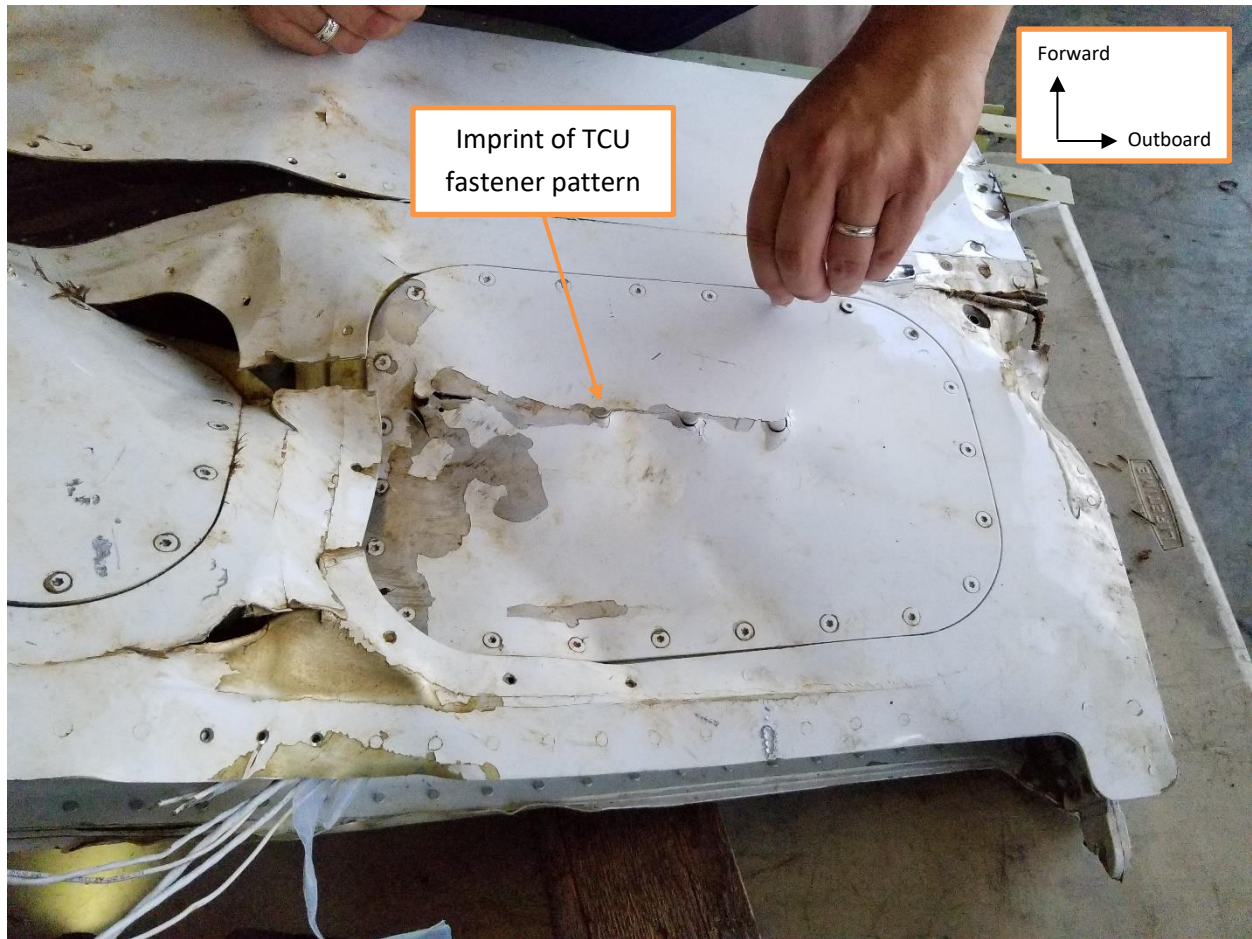
Figure 2-12 LH wing extension (lower surface shown) showing imprint of TCU

The left hand TCU was recovered installed in a mostly intact section of the outboard wing, and the external damage to the unit was less severe than that of the RH TCU, but was still significant. The wing section in which the LH TCU was mounted had sustained significant impact damage, specifically such that the TCU imprinted itself in the access panel below its installed position.

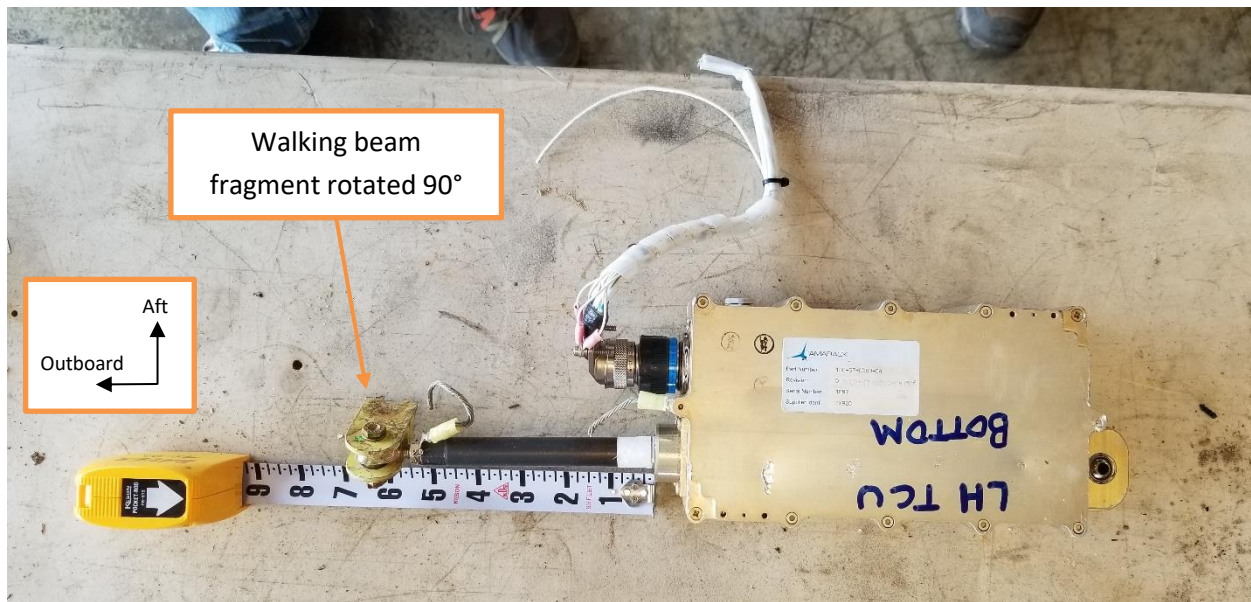
Figure 2-13 LH TCU as-found condition (external view)

The LH TCU case was not breached, as the RH TCU was, and the ram tube was present in the actuator as found. However, the rod end was found rotated 90° from nominal with the safety wire still in place, suggesting the possibility of internal damage to the actuator. This is visible in Figure 2-13.

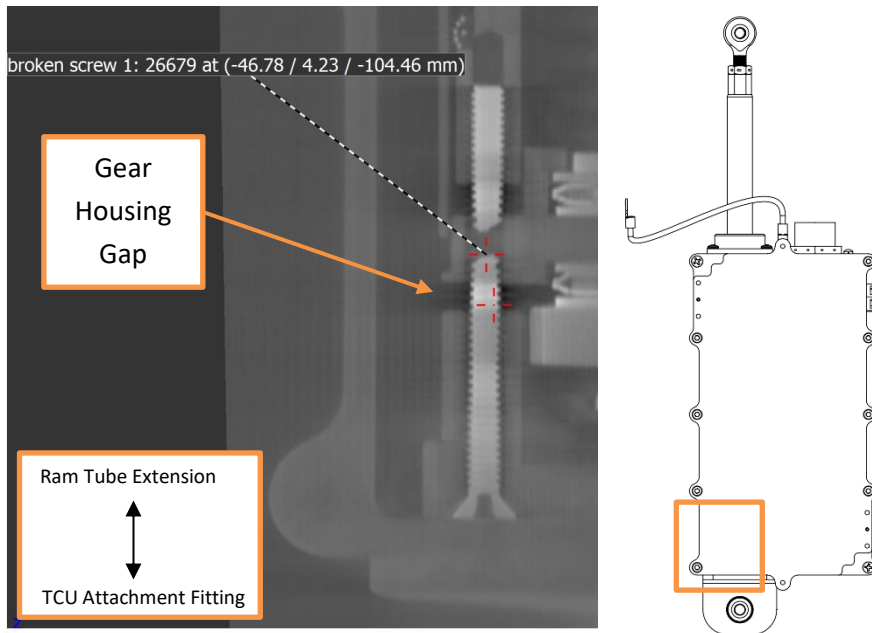
Figure 2-14 LH TCU actuator as-found condition showing broken screws (view from bottom)

CT scanning confirmed this, revealing broken screws between the motor and gear housing, similar to the type of damage found in the actuator of the RH TCU.

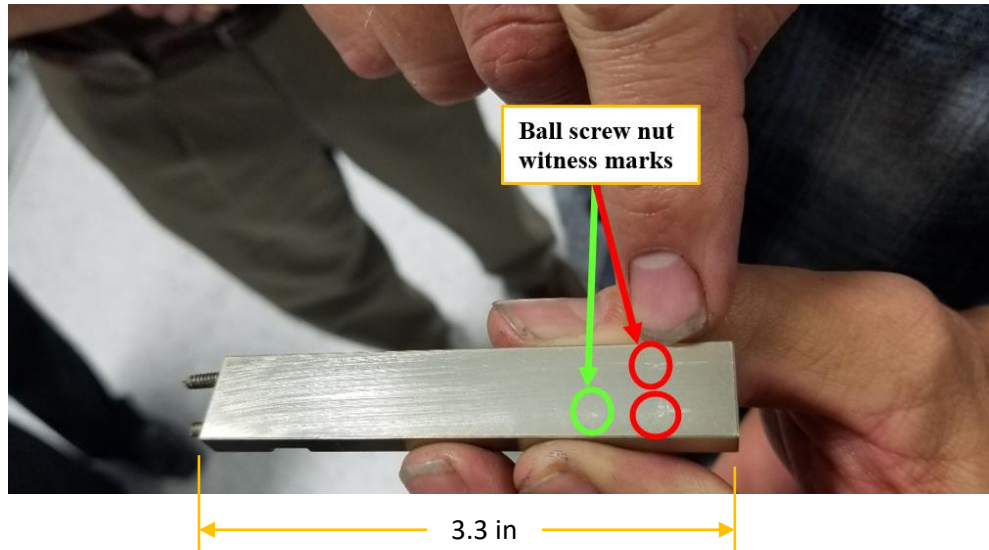
Figure 2-15 LH TCU actuator lower ball nut guide witness marks (excerpt from [3])

Teardown of the actuator also revealed witness marks on the lower ball nut guide similar to those found in the RH TCU actuator. An image of these witness marks is provided below, excerpted from the Systems Group Chairman's Report [3]. Note that the colors only indicate that there are two sets of marks.

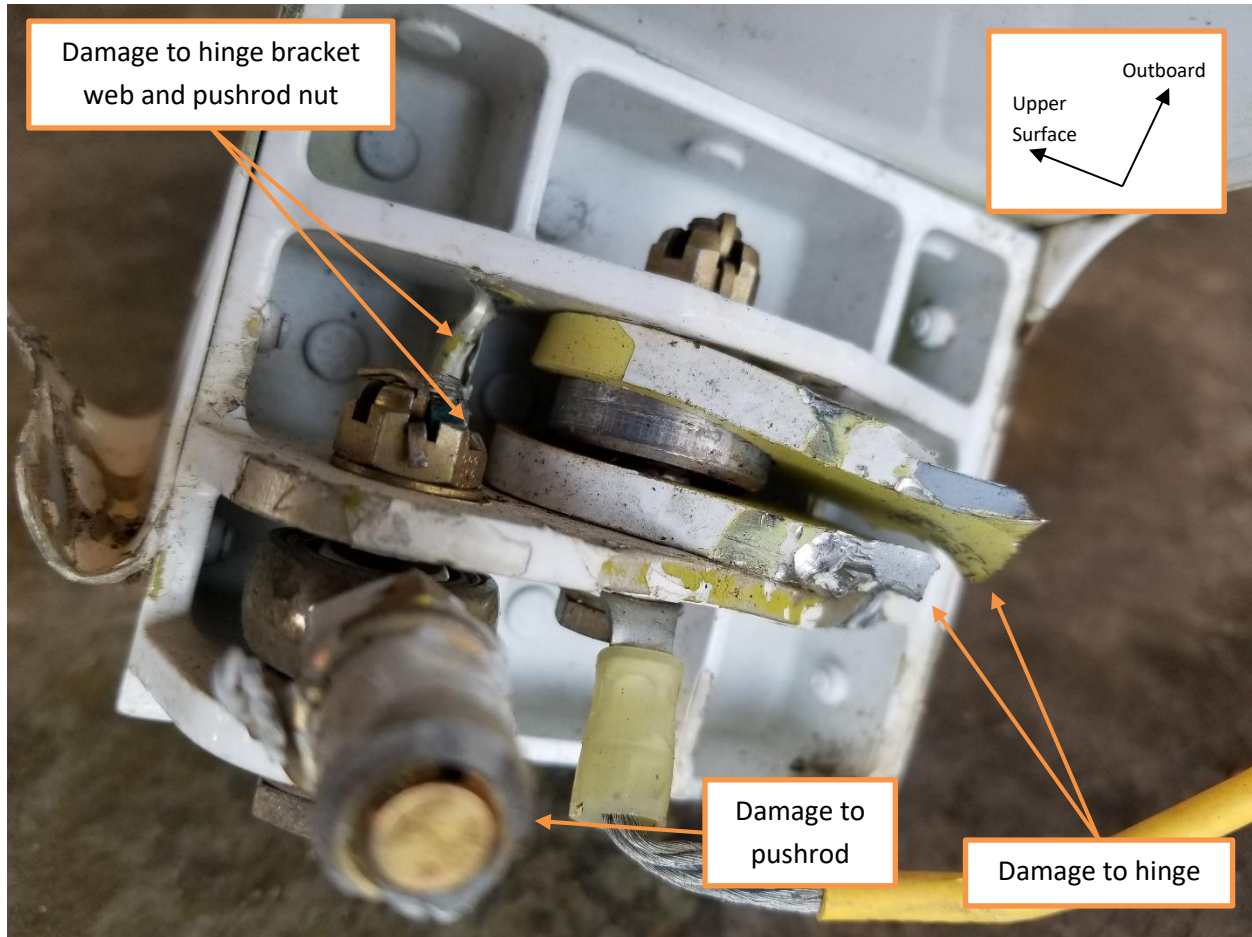
Figure 2-16 LH inboard TACS hinge bracket (view looking aft)

The left hand TACS inboard hinge bracket demonstrated evidence of overdeployment of the surface, trailing edge up. This was in the form of damage to a web in the bracket itself, most likely caused by contact with the TACS hinge itself. See Figure 2-16 for reference. The TACS pushrod rod end was found still

installed on the TACS hinge, but the rod itself was sheared off approximately at the threads of the rod end.

The TACS deployment angle required to cause this type of deformation is approximately 55°, more than twice the maximum angle permitted by either the hard stops internal to the actuator or the stops installed in the bell crank.

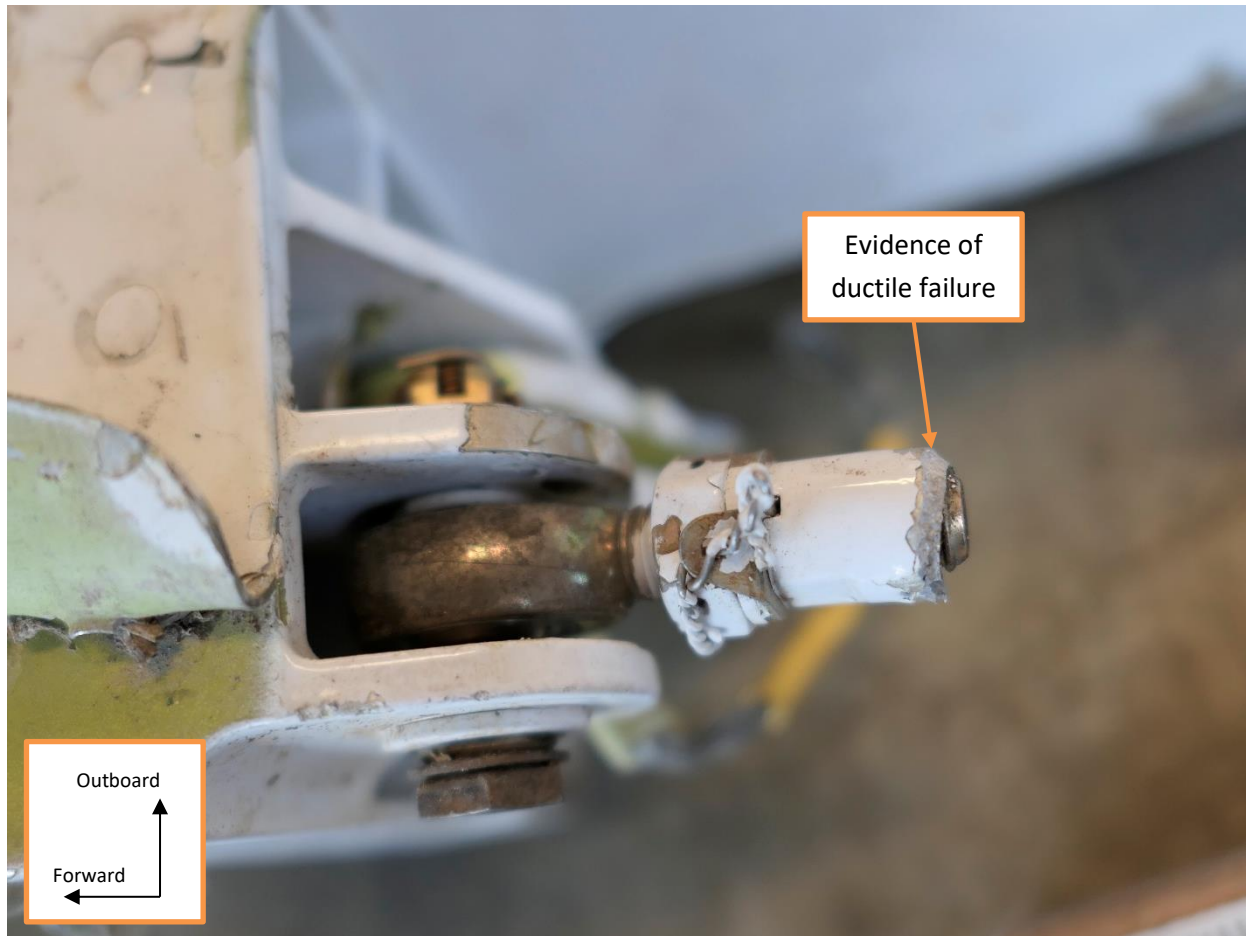
Figure 2-17 LH TACS pushrod failure

The pushrod exhibits the cup-and-cone shape consistent with ductile failure, without evidence of fatigue areas. A slight lateral deformation of the failure area indicates an eccentric tensile load, likely caused as the hinge failed and the TACS separated from the wing extension.

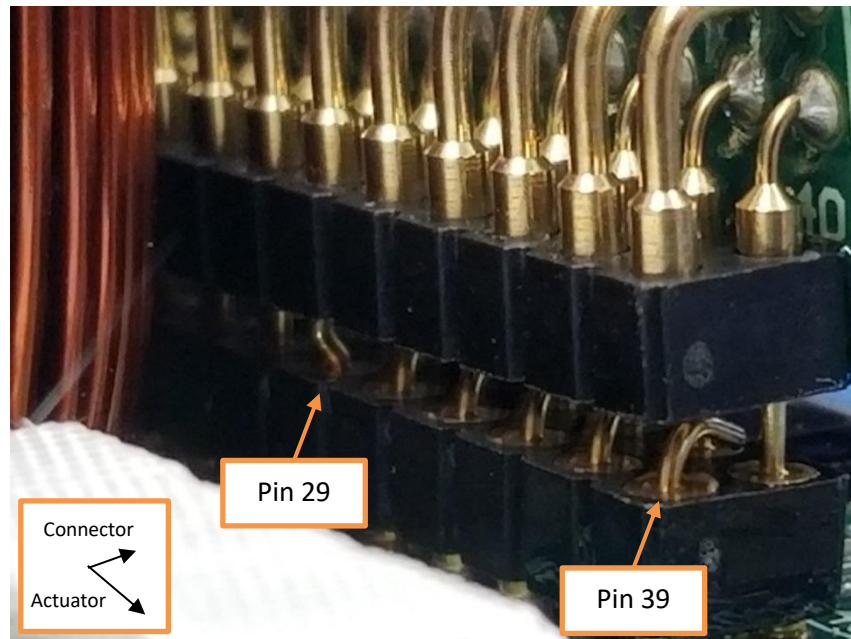
Figure 2-18 LH TCU bent connector pins

An inspection of the LH TCU PCBA found several key indications of damage. Most noticeably, six pins on a 40-pin connector between the main TCU control board and a smaller board providing an external connector interface were found bent and not seated as expected. Pins 29, 31, 33, 35, 37, and 39 were

affected. The bent pins are visible in Figure 2-18, with the start and end range of the affected pins noted in the image.

Initial electrical testing of the LH TCU found that pins 33 and 35 were open. Pin 33 connects to pin A of the external connector, carrying a discrete enable signal from the ACU. Pin 35 connects to pin D of the external connector, carrying the analog actuator command signal.

Tamarack notes that the signals affected by the bent pins (enable and command voltage) are critical to the proper function and powerup of the TCU. This type of extensive damage to those pins, if it had been caused during manufacturing or handling, would most likely have been indicated by faulting or system unavailability on flights prior to the accident flight, especially since the LH TCU was found with fully open circuits on these two signals. Tamarack has no such reports of nuisance failures on this airplane prior to the accident.

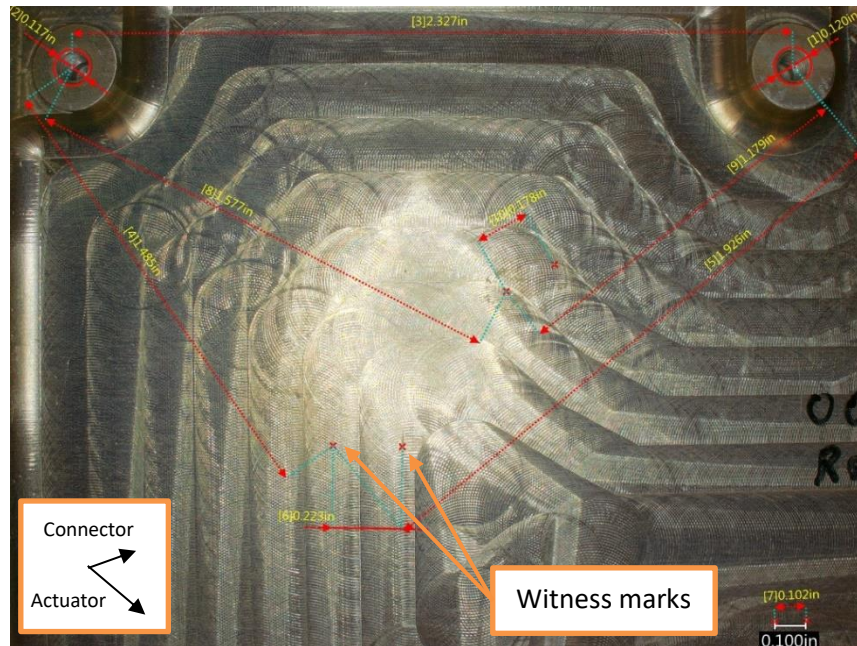
Figure 2-20 Witness marks below PCBA on TCU lower case

There is evidence to suggest that the pins were bent by a substantial flexure of the PCBA during the impact event. The lower surface of the PCBA is populated in part with two rows of capacitors, visible in

Figure 2-19. Witness marks were discovered on the interior of the lower TCU housing, corresponding to the positions of the capacitors installed on the PCBA. These witness marks are visible in Figure 2-20.

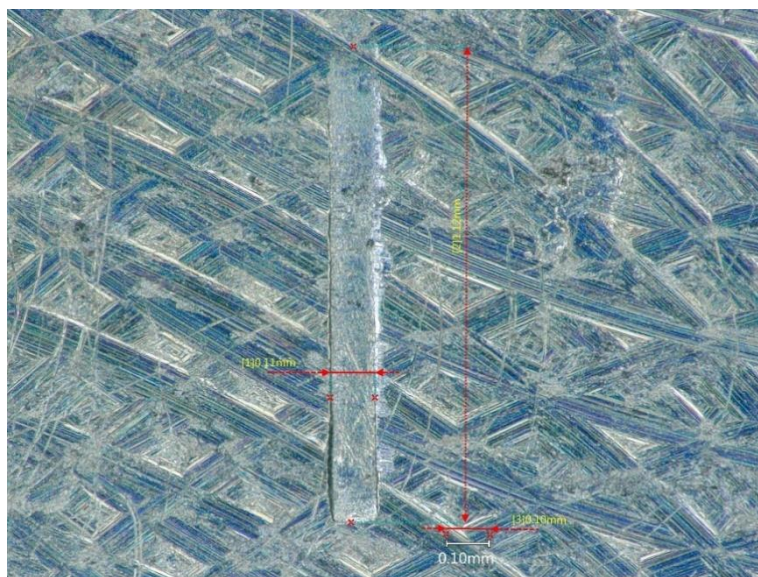
Figure 2-21 Detail view of witness mark on TCU lower case

A detail view of one of the marks in Figure 2-21 shows that it is an impact mark caused by an object with a thin, rectangular cross section. The capacitor bank above the marks in the lower case is populated by capacitors assembled from two smaller capacitors, joined on each end by a small metal plate, which is soldered to the board's solder pads. The plate has a thin, rectangular cross section.

It is likely that during the impact, extreme impact forces on the TCU caused the control PCBA to flex downward, contacting the interior face of the TCU housing below the PCBA and causing the witness marks described above. This partially disconnected the 40-pin connector between the control PCBA and the smaller connector PCBA. As the control PCBA returned to normal position, six of the pins failed to re-seat properly and were bent to the positions in which they were found.

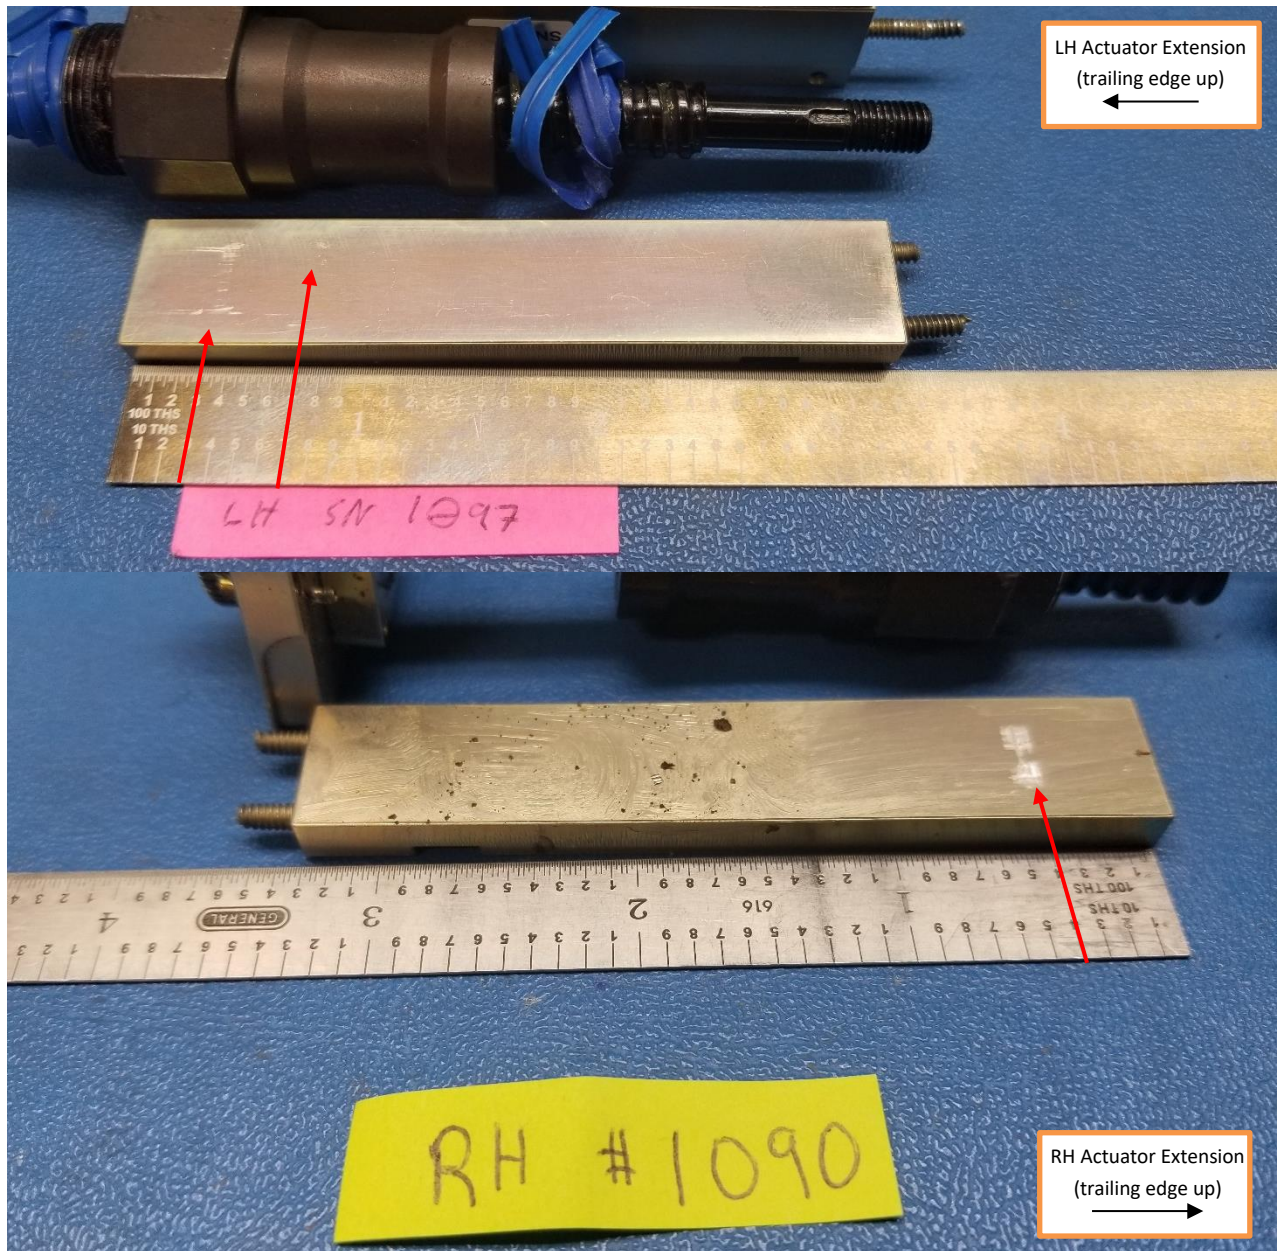
Figure 2-22 LH and RH actuator witness marks comparison

Tamarack concludes that the witness marks left on the upper and lower ram guides in the TCUs were caused by the large impulse force of the impact acting normally to the axis of the ball screw, causing the

ball screw to deflect enough to allow the ball nut to contact the ram guides. Images of the two components are presented below in Figure 2-22 for comparison.

The witness marks in the actuators are important to understanding the most likely state of the system at the moment of impact. The short time scale of the impact event makes it likely that the witness marks were left by the actuator ball nuts in or near the positions they were in at the time of impact. The LH TCU shows evidence of the ball nut dragging for a short distance along the lower ram guide. This is consistent with evidence that the TACS trailing edge was displaced upward on the left wing, as the scratch marks appear to be moving in the direction of an actuator extension. Note that the presence of scratch marks in the LH TCU suggests that there would be evidence if the ball nut position had changed dramatically during the impact. The length of the markings indicates that the ball nut was positioned consistently with an approximately half-scale extension of the actuator.
