National Transportation Safety Board

Errata to Performance Study

Specialist Report

Location: Memphis, Indiana
Date: November 30, 2018
Time: 10:28 eastern standard time (EST)
Airplane: Cessna 525, N525EG
NTSB Number: CEN19FA036

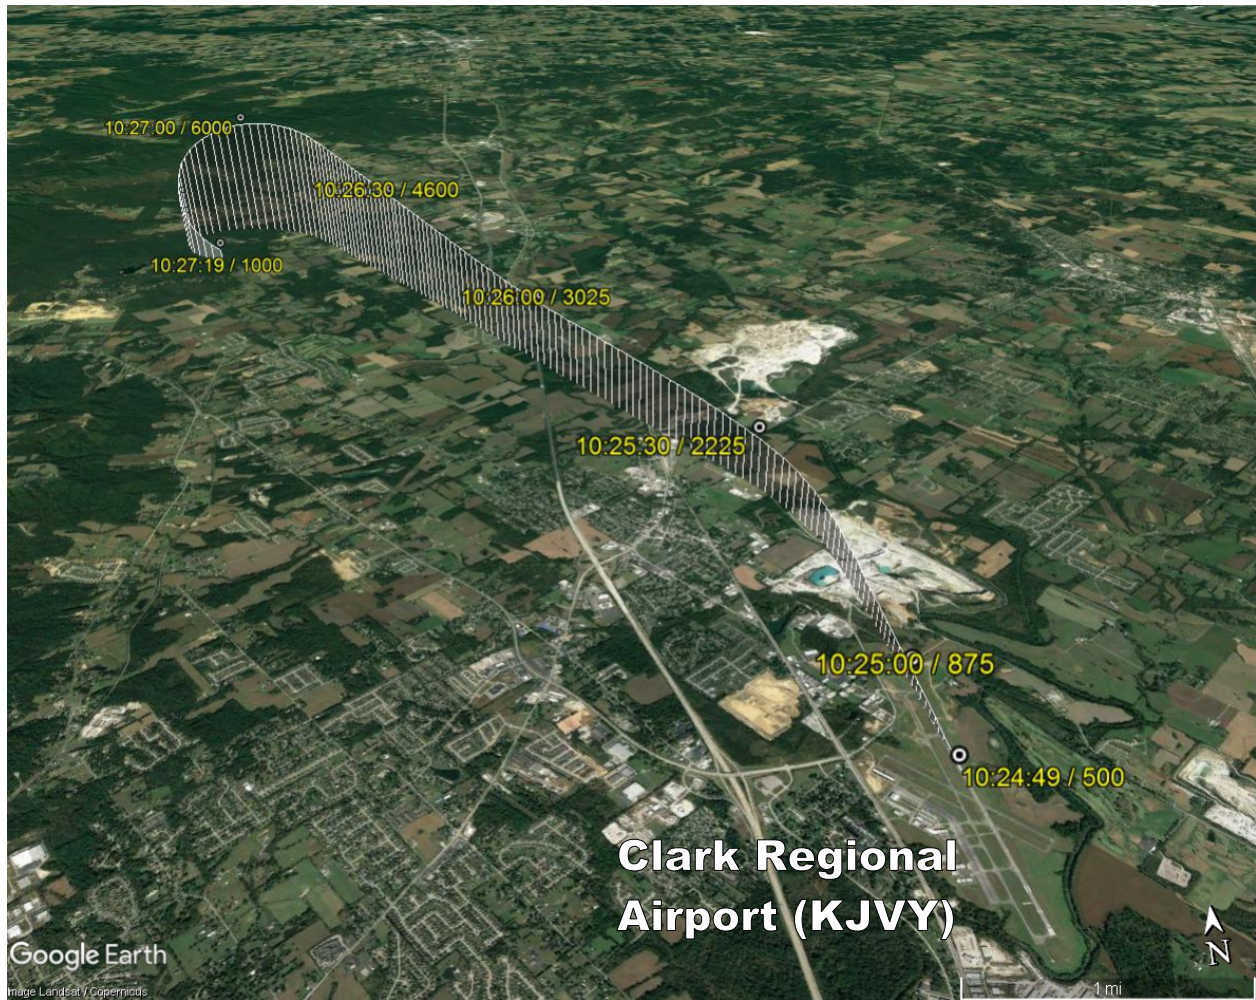
Figure 1 shows the accident flight path. The flight path was approximately 7.5 NM long and the flight lasted about 2 minutes and 30 seconds. Figure 2 shows the altitude profile, calculated groundspeed, airspeed, roll, and roll rate of the flight. The airplane took off from runway 36 (elevation 476 ft) and climbed to about 1,400 ft MSL¹ before turning left onto a track of 330° and continuing to climb. The airplane likely entered the clouds between about 1,000 and 1,500 ft MSL, per the cloud ceiling information in the Weather Observations section. The airplane's autopilot was turned on at approximately 10:25:23. Selected altitude, initially set to 3,000 ft, was changed to 10,000 ft at 10:25:50, consistent with ATC instructions [3]. Once passing 3,000 ft at 10:26, the airplane's airspeed leveled out between 230 and 240 kts and the airplane continued to climb steadily.

Figure 1. Accident flight with select times and altitudes annotated in yellow.

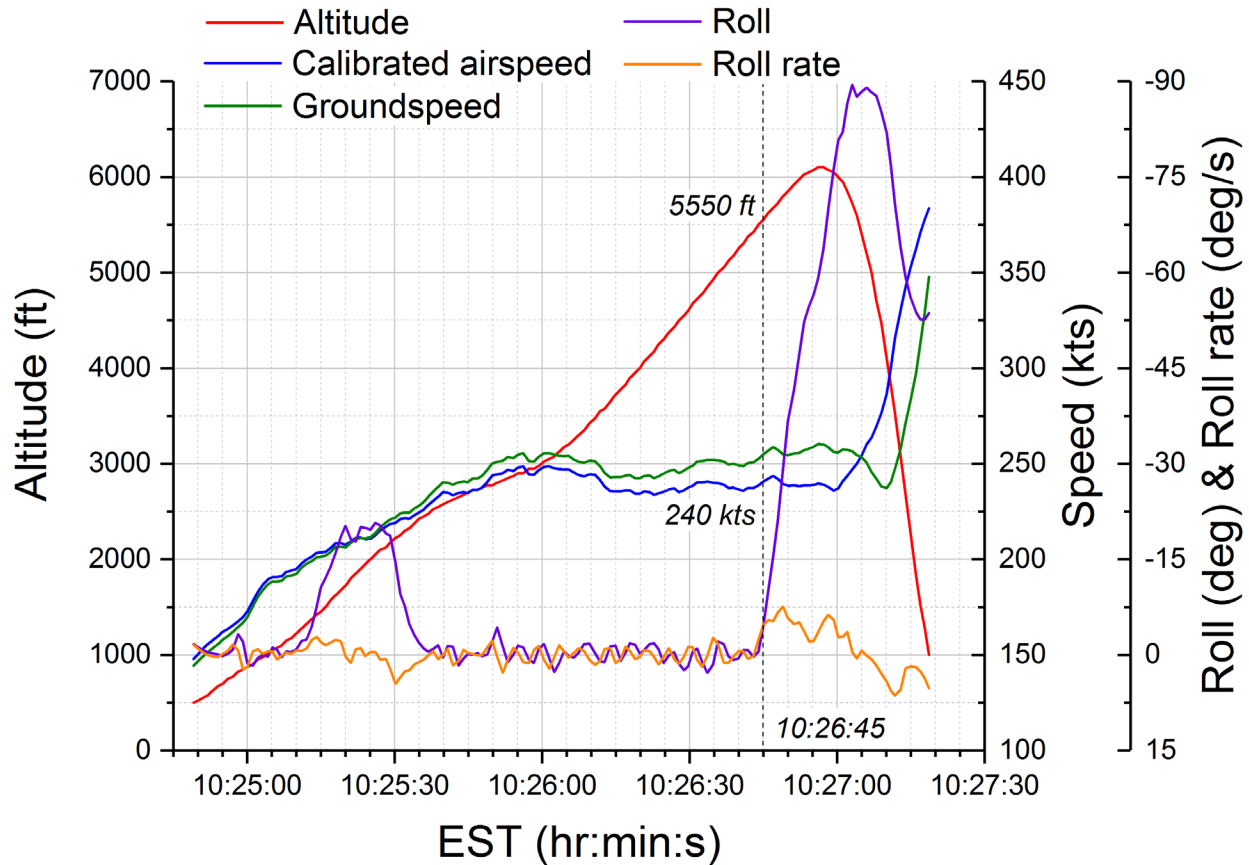
Figure 2. Accident flight altitude, calculated ground and airspeeds, and roll and roll rate.

Then, at 10:26:45 the airplane began to bank to the left at a rate of about $5^\circ/\text{s}$ so that by 10:27:05 the airplane was near 90° left wing down. After the onset of the roll, the airplane maintained airspeed while continuing to climb for 12 seconds, indicating that engine power was not reduced in response to the roll onset. At 10:26:57, the airplane reached its maximum altitude of 6,100 ft and began to descend rapidly, reaching a final recorded altitude of 1,000 ft by 10:27:18.7.

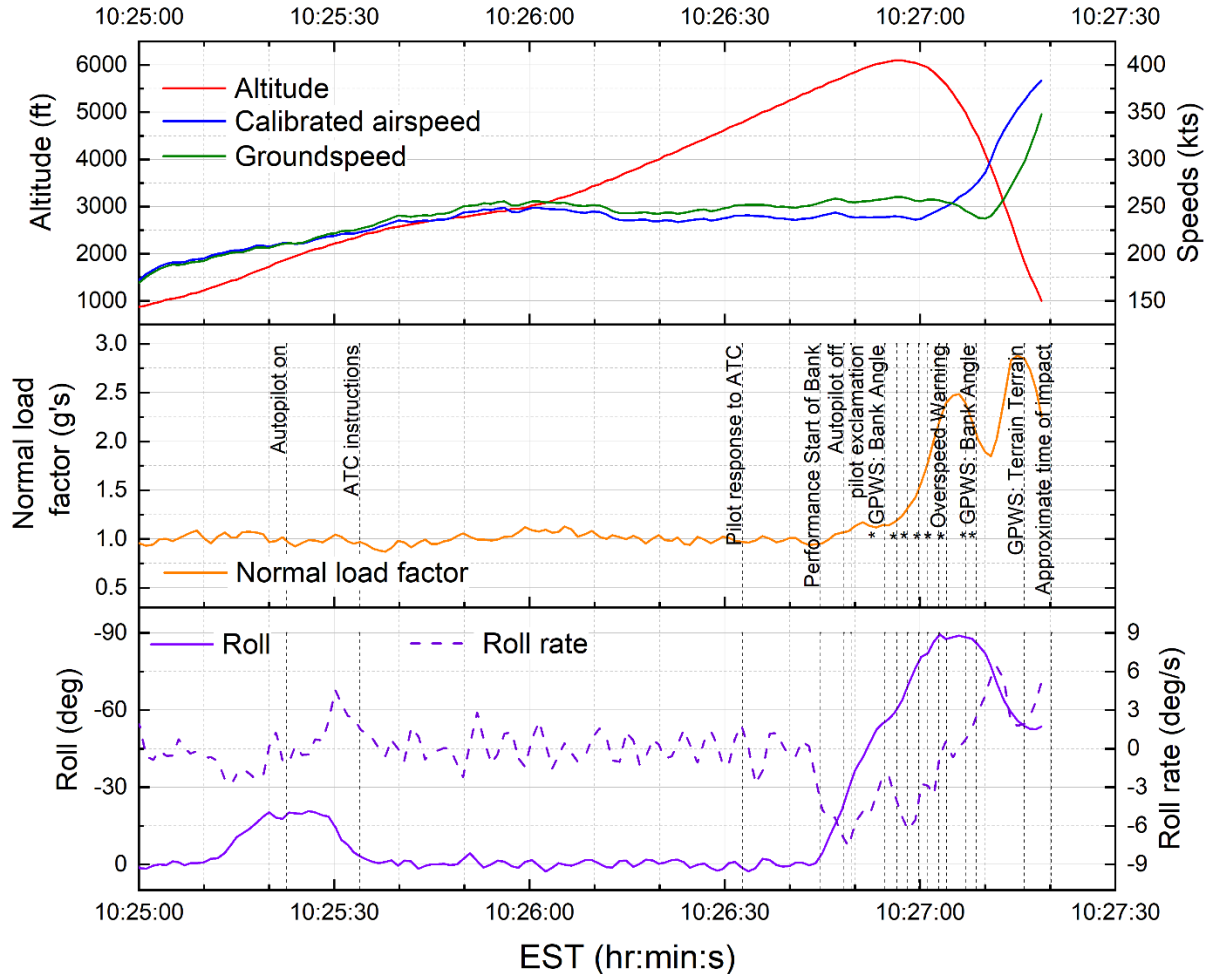
Figure 3 shows the flight altitude, speeds, cockpit annunciations, ATC communications, calculated normal load factor, roll, and roll rates. About three seconds after the start of the left bank, as the bank angle reached about -30° left wing down, the autopilot disconnected. One second later the pilot made an exclamation. At 10:26:54.6, when the bank angle was calculated to be about -55° left wing down, the GPWS began to annunciate “Bank Angle”. The GPWS annunciated “Bank Angle” six times until at 10:27:04 it said “Overspeed Warning” as the airplane passed 250 kts of calibrated airspeed and an altitude of 5,600 ft. The GPWS annunciated “Bank Angle” two more times. The final “Bank Angle” warning was at 10:27:08. ADS-B data ended at 10:27:18. The final recorded altitude was 1,000 ft and the airplane’s calculated airspeed was 380 kts and final bank angle was -53° left wing down. At 10:27:16, the CVR recorded the GPWS annunciating “Terrain Terrain” and the approximate time of impact was 10:27:20. The impact point was 800 ft

of ground distance from the last ADS-B point and at an elevation of about 550 ft. Total time from beginning of left roll to the sound of impact was about 35 seconds.

Figure 3. Accident flight including annunciations and ATC conversation. The multiple GPWS Bank Angle annunciations are indicated by the asterisks.
