# National Transportation Safety Board

## Performance Study

### Specialist Report

Location: Plain City, Ohio  
Date: March 17, 2019  
Time: 17:45 EDT  
Airplane: Cessna 421B, N424TW  
NTSB Number: CEN19FA100

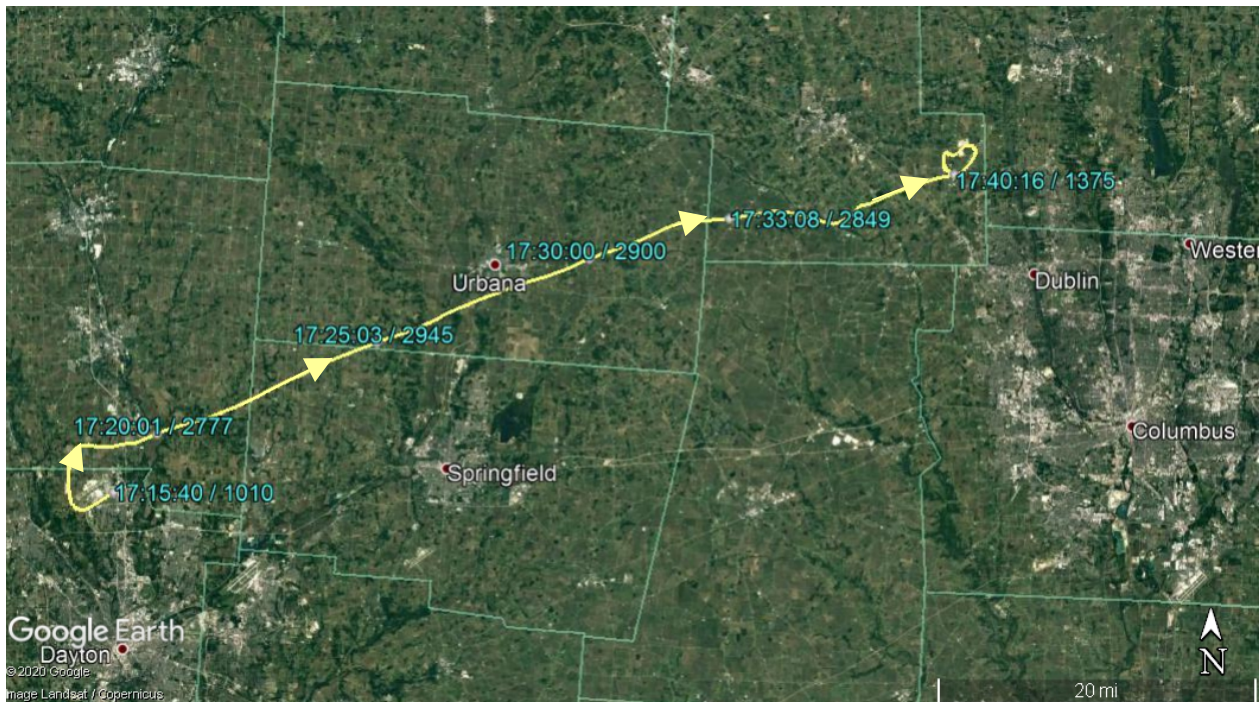
Figure 1 shows the accident flight path. The airplane left Dayton (elevation 1,009 ft) about 17:15:40 from runway 24. The airplane climbed and turned to a ground track of about 70° at an altitude near 3,000 ft mean sea level (msl). Altitudes for the airplane will be reported in msl. The reported overcast cloud ceiling was between 2,100 and 2,600 ft msl.

**Figure 1.** Accident flight in yellow with select times and altitudes annotated in blue.

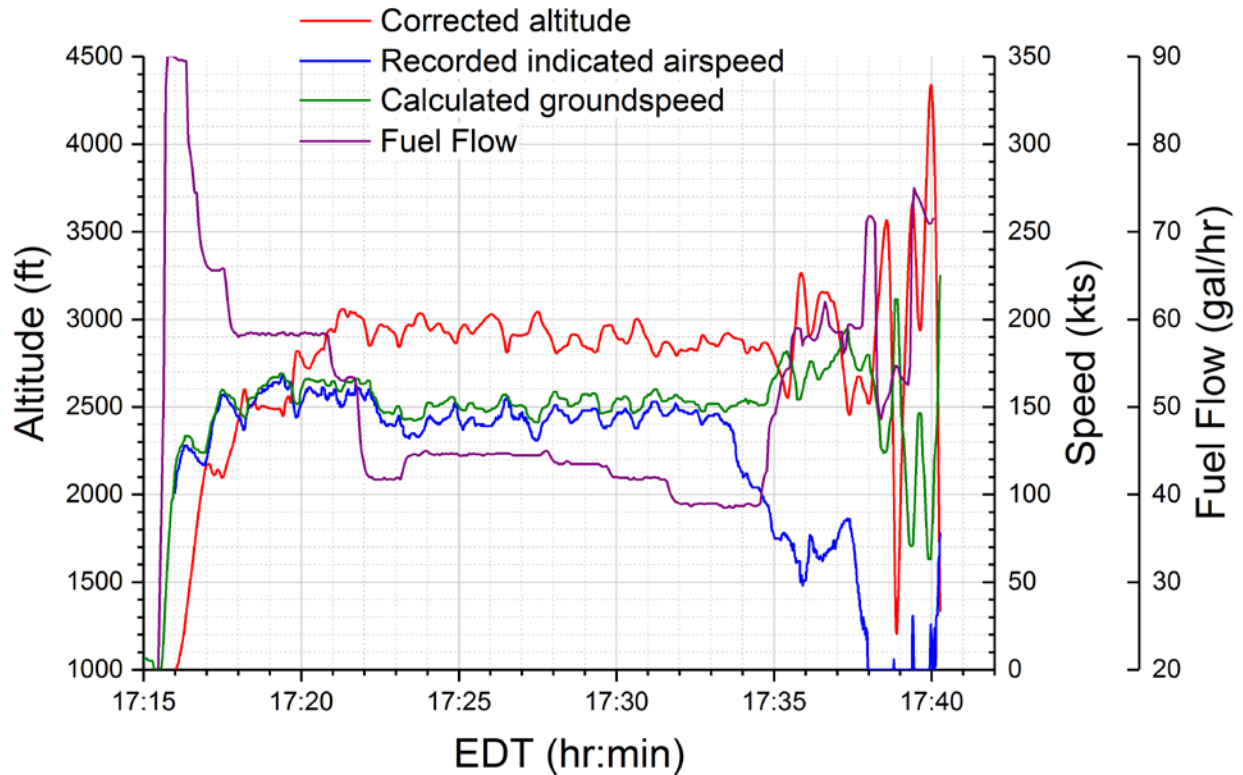
Figure 2 shows the recorded altitude, airspeed, and fuel flow from the airplane and groundspeed calculated from the recorded latitude and longitude. From 17:21 to 17:33, the airplane's altitude varied between 2,800 and 3,000 ft while the airspeed was between 130 and 150 kts. The calculated groundspeed was about 10 kts greater than the measured airspeed for this portion of the flight. After 17:33, the indicated airspeed dropped and diverged from the groundspeed and by 17:38 it had gone to zero. The calculated groundspeed from position data shows that the airspeed after 17:33 was inaccurate. As discussed in the weather section, icing was possible in the area, which may have impeded the pitot tube and resulted in an inaccurate airspeed reading.

**Figure 2.** Accident recorded altitude (red), recorded indicated airspeed (blue), calculated groundspeed (green) calculated from latitude and longitude, and recorded fuel flow (purple).

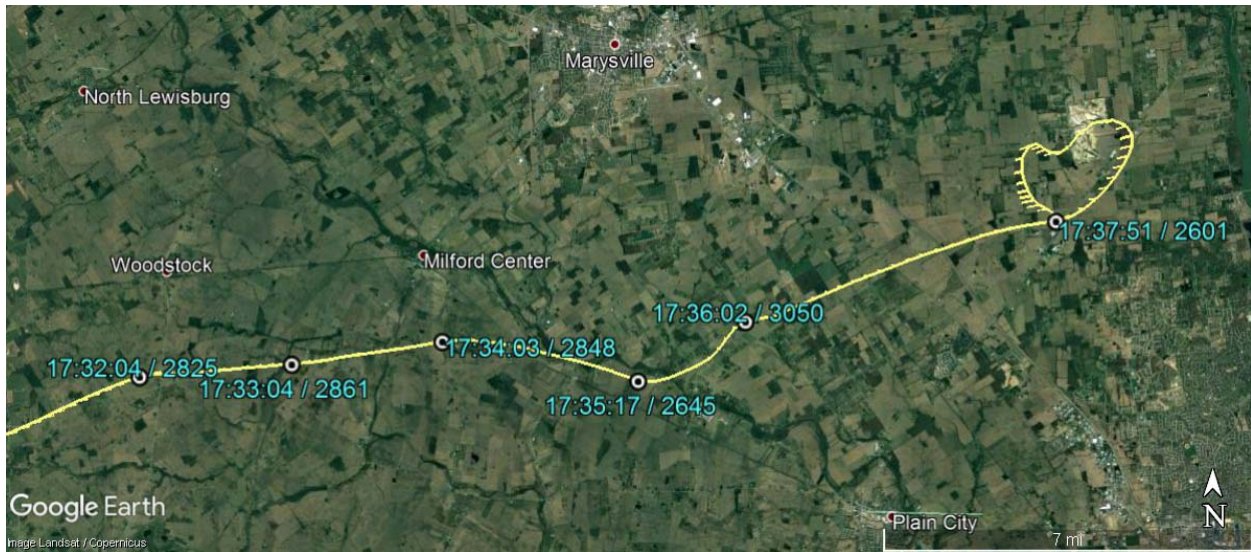
Navigation changes were recorded at 17:33:48 and 17:33:55 as the pilot updated navigation to KDLZ. Then, at 17:34:30, fuel flow increased to near 60 gal/hr, indicating the pilot increased power, likely in response to the drop in displayed airspeed. At this point the measured airspeed had dropped to 100 kts, while the groundspeed had remained a consistent 150 kts. Calculated groundspeed increased above 150 kts with the increase in fuel flow and the airplane began a series of climbs and descents that continued until the end of flight. The airplane's maneuvering speed,  $V_A$ , is 150 kts of airspeed and its maximum structural cruising speed,  $V_{NO}$ , is 200 kts [2]. Airspeed was about 10 kts lower than groundspeed for the flight, so airspeed also exceeded  $V_A$  near the end of flight.

**Figure 3.** Accident flight in yellow with select times and altitudes annotated in blue.

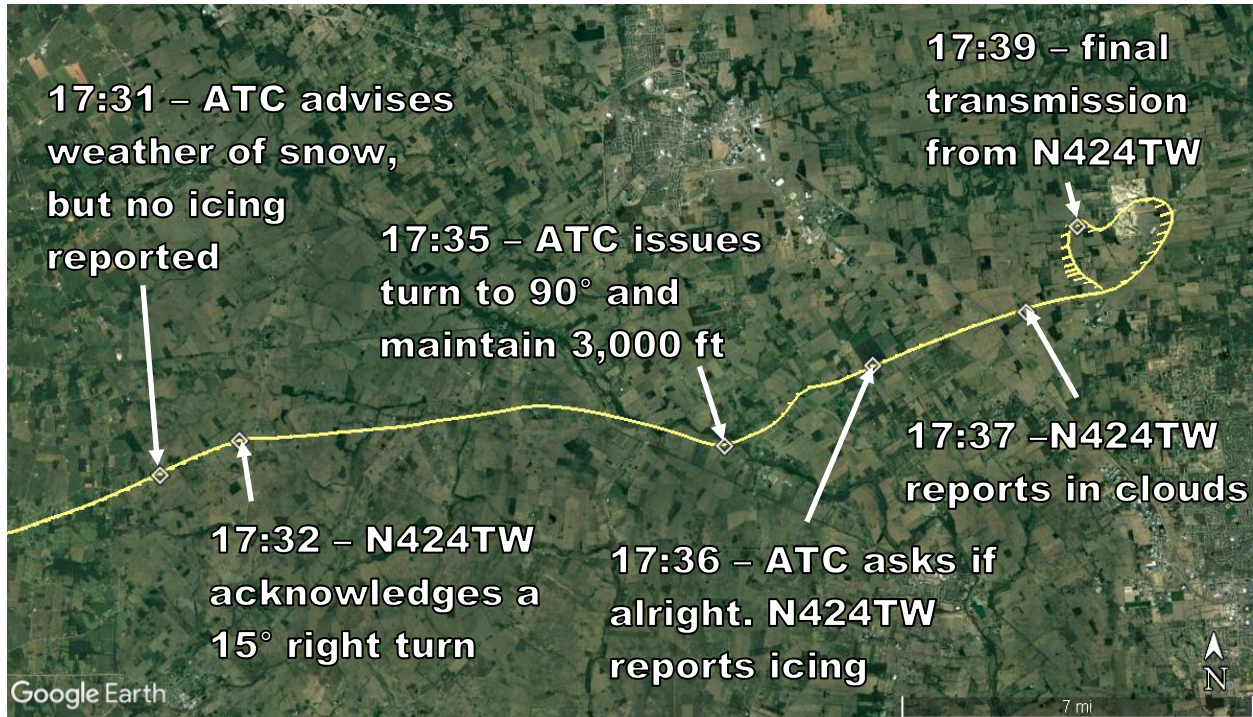
Figure 4 shows six of these communications on the flight path. Again, the timing of the communications was rounded to the nearest minute. ATC communications explain the track changes at 17:32 and 17:35.

**Figure 4.** End of accident flight path with ATC communication annotated.

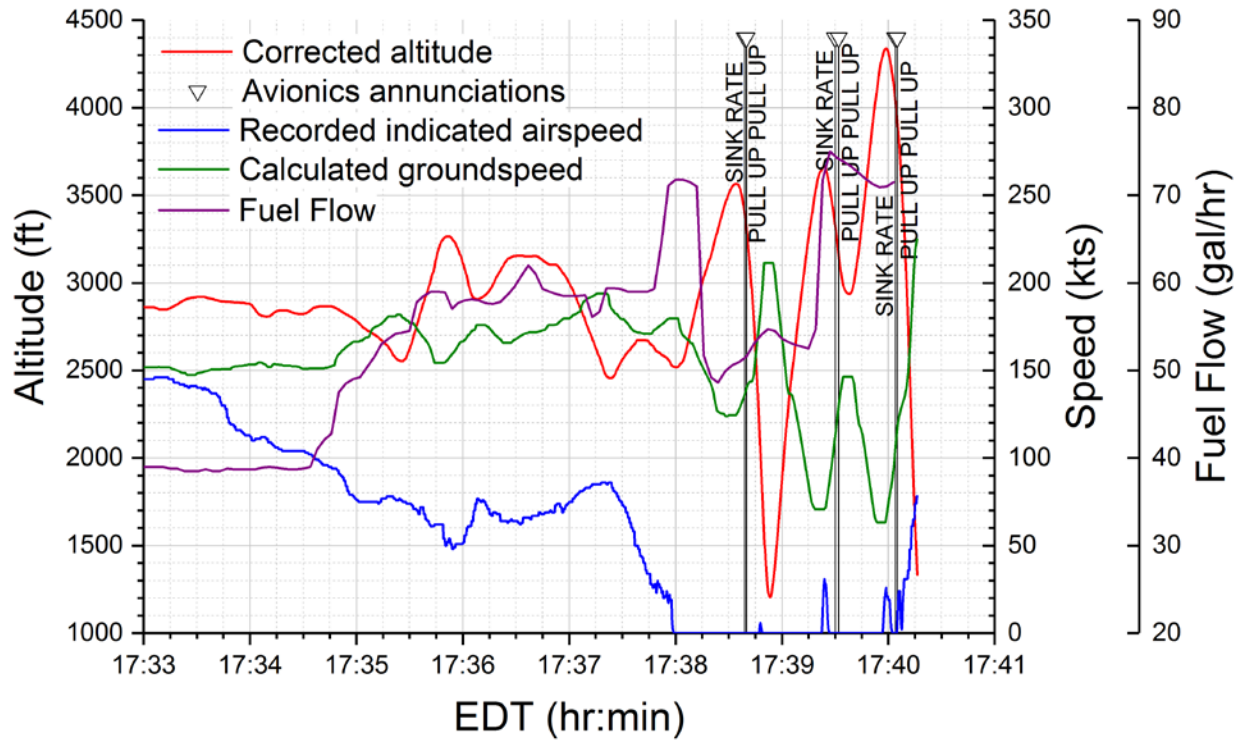
Figure 5 shows the altitude, speed, and fuel flow for the of the end flight with avionics annunciators (recorded by the Avidyne IFD) and Figure 6 shows the flight path. After 17:37, the airplane descended to 2,500 ft, consistent with the request to ATC. For the final two and a half minutes of flight the airplane was in a mostly left-hand turn. ATC had given clearance to climb and make right or left turns as needed to get out of the clouds. At about 17:38:50, fuel flow increased again to over 70 gal/hr. The airplane entered a 1,000 ft climb as fuel flow was then quickly cut back to 50 gal/hr. Just above 3,500 ft the airplane began descending rapidly at more than 5,000 ft/min. The avionics in the cockpit then annunciated “SINK RATE” and “PULL UP PULL UP”. The airplane’s descent was arrested about 300 ft above the ground and it climbed rapidly as fuel flow went to 75 gal/hr. Twice more the airplane climbed and descended as the avionics annunciated “SINK RATE” and “PULL UP PULL UP”. In all, the pilot twice responded to the avionics sink rate and pull up annunciations, but the third time the airplane did not recover from the descent.

During this time, the airplane’s groundspeed (and likely its airspeed) exceeded  $V_A$  (150 kts) and during the first and final “SINK RATE” descents, groundspeed exceeded  $V_{NO}$  (200 kts). The airplane at the time was performing large maneuvers as it climbed and descended while turning left and right. It is possible the airplane experienced loads greater than its structural limitations.

**Figure 5.** End of accident recorded altitude (red), recorded indicated airspeed (blue), calculated groundspeed (green) calculated from latitude and longitude, and recorded fuel flow (purple).

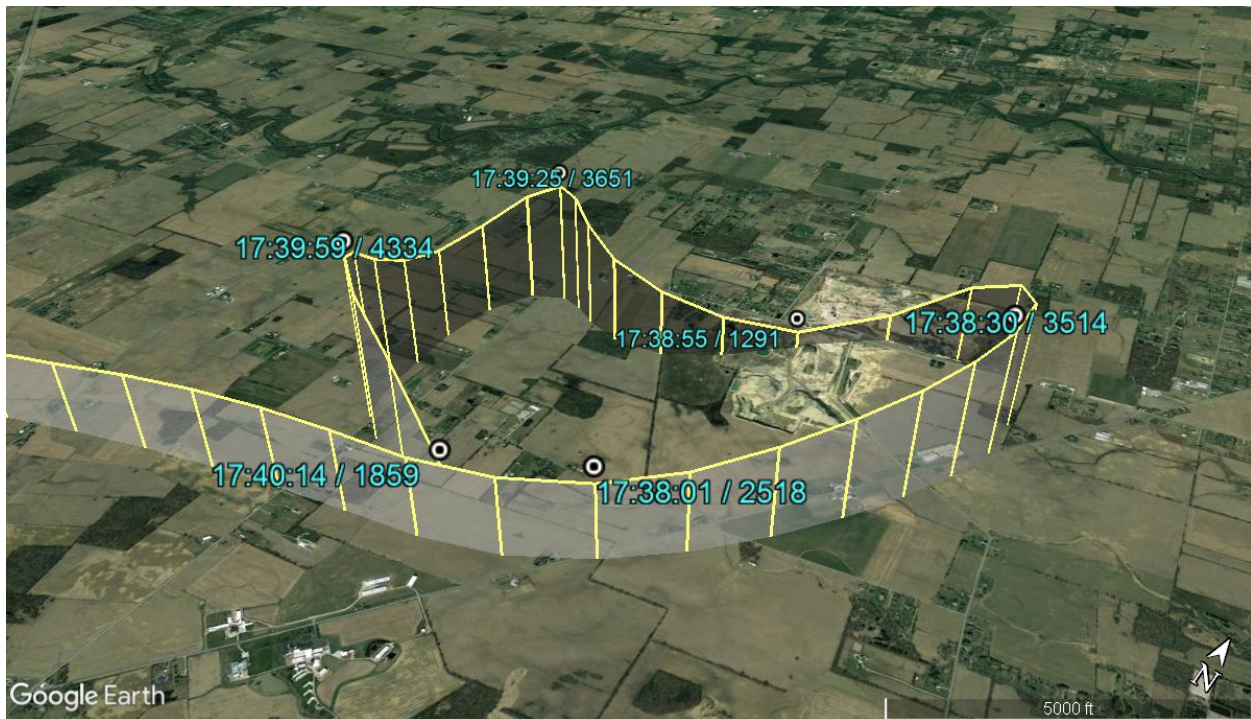
**Figure 6.** End of accident flight path with selected times and altitudes annotated.

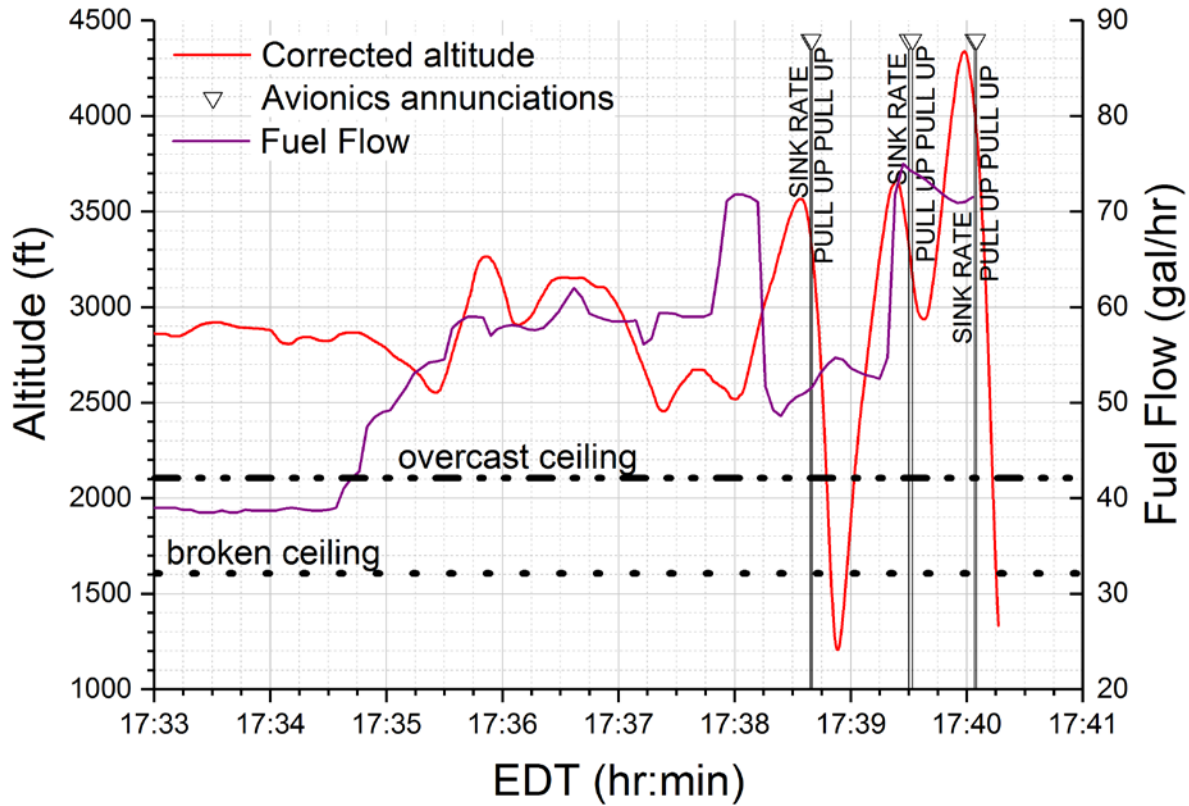
As discussed in the weather section, at 600 ft agl was a broken cloud layer and at 1,100 ft agl it was overcast. Elevation in the area was between 960 ft and 980 ft. Figure 7 shows the altitude and fuel flow with avionics annunciations from Figure 5 with the cloud ceilings noted. This is consistent with the pilot's report to ATC that he was in the clouds.

**Figure 7.** Altitude and fuel flow at end of flight with overcast and broken ceiling heights noted.
