**Specialist's Factual Report – Attachment 3**

**Flight Track Graphics**

**AIR TRAFFIC CONTROL**

CEN19FA161

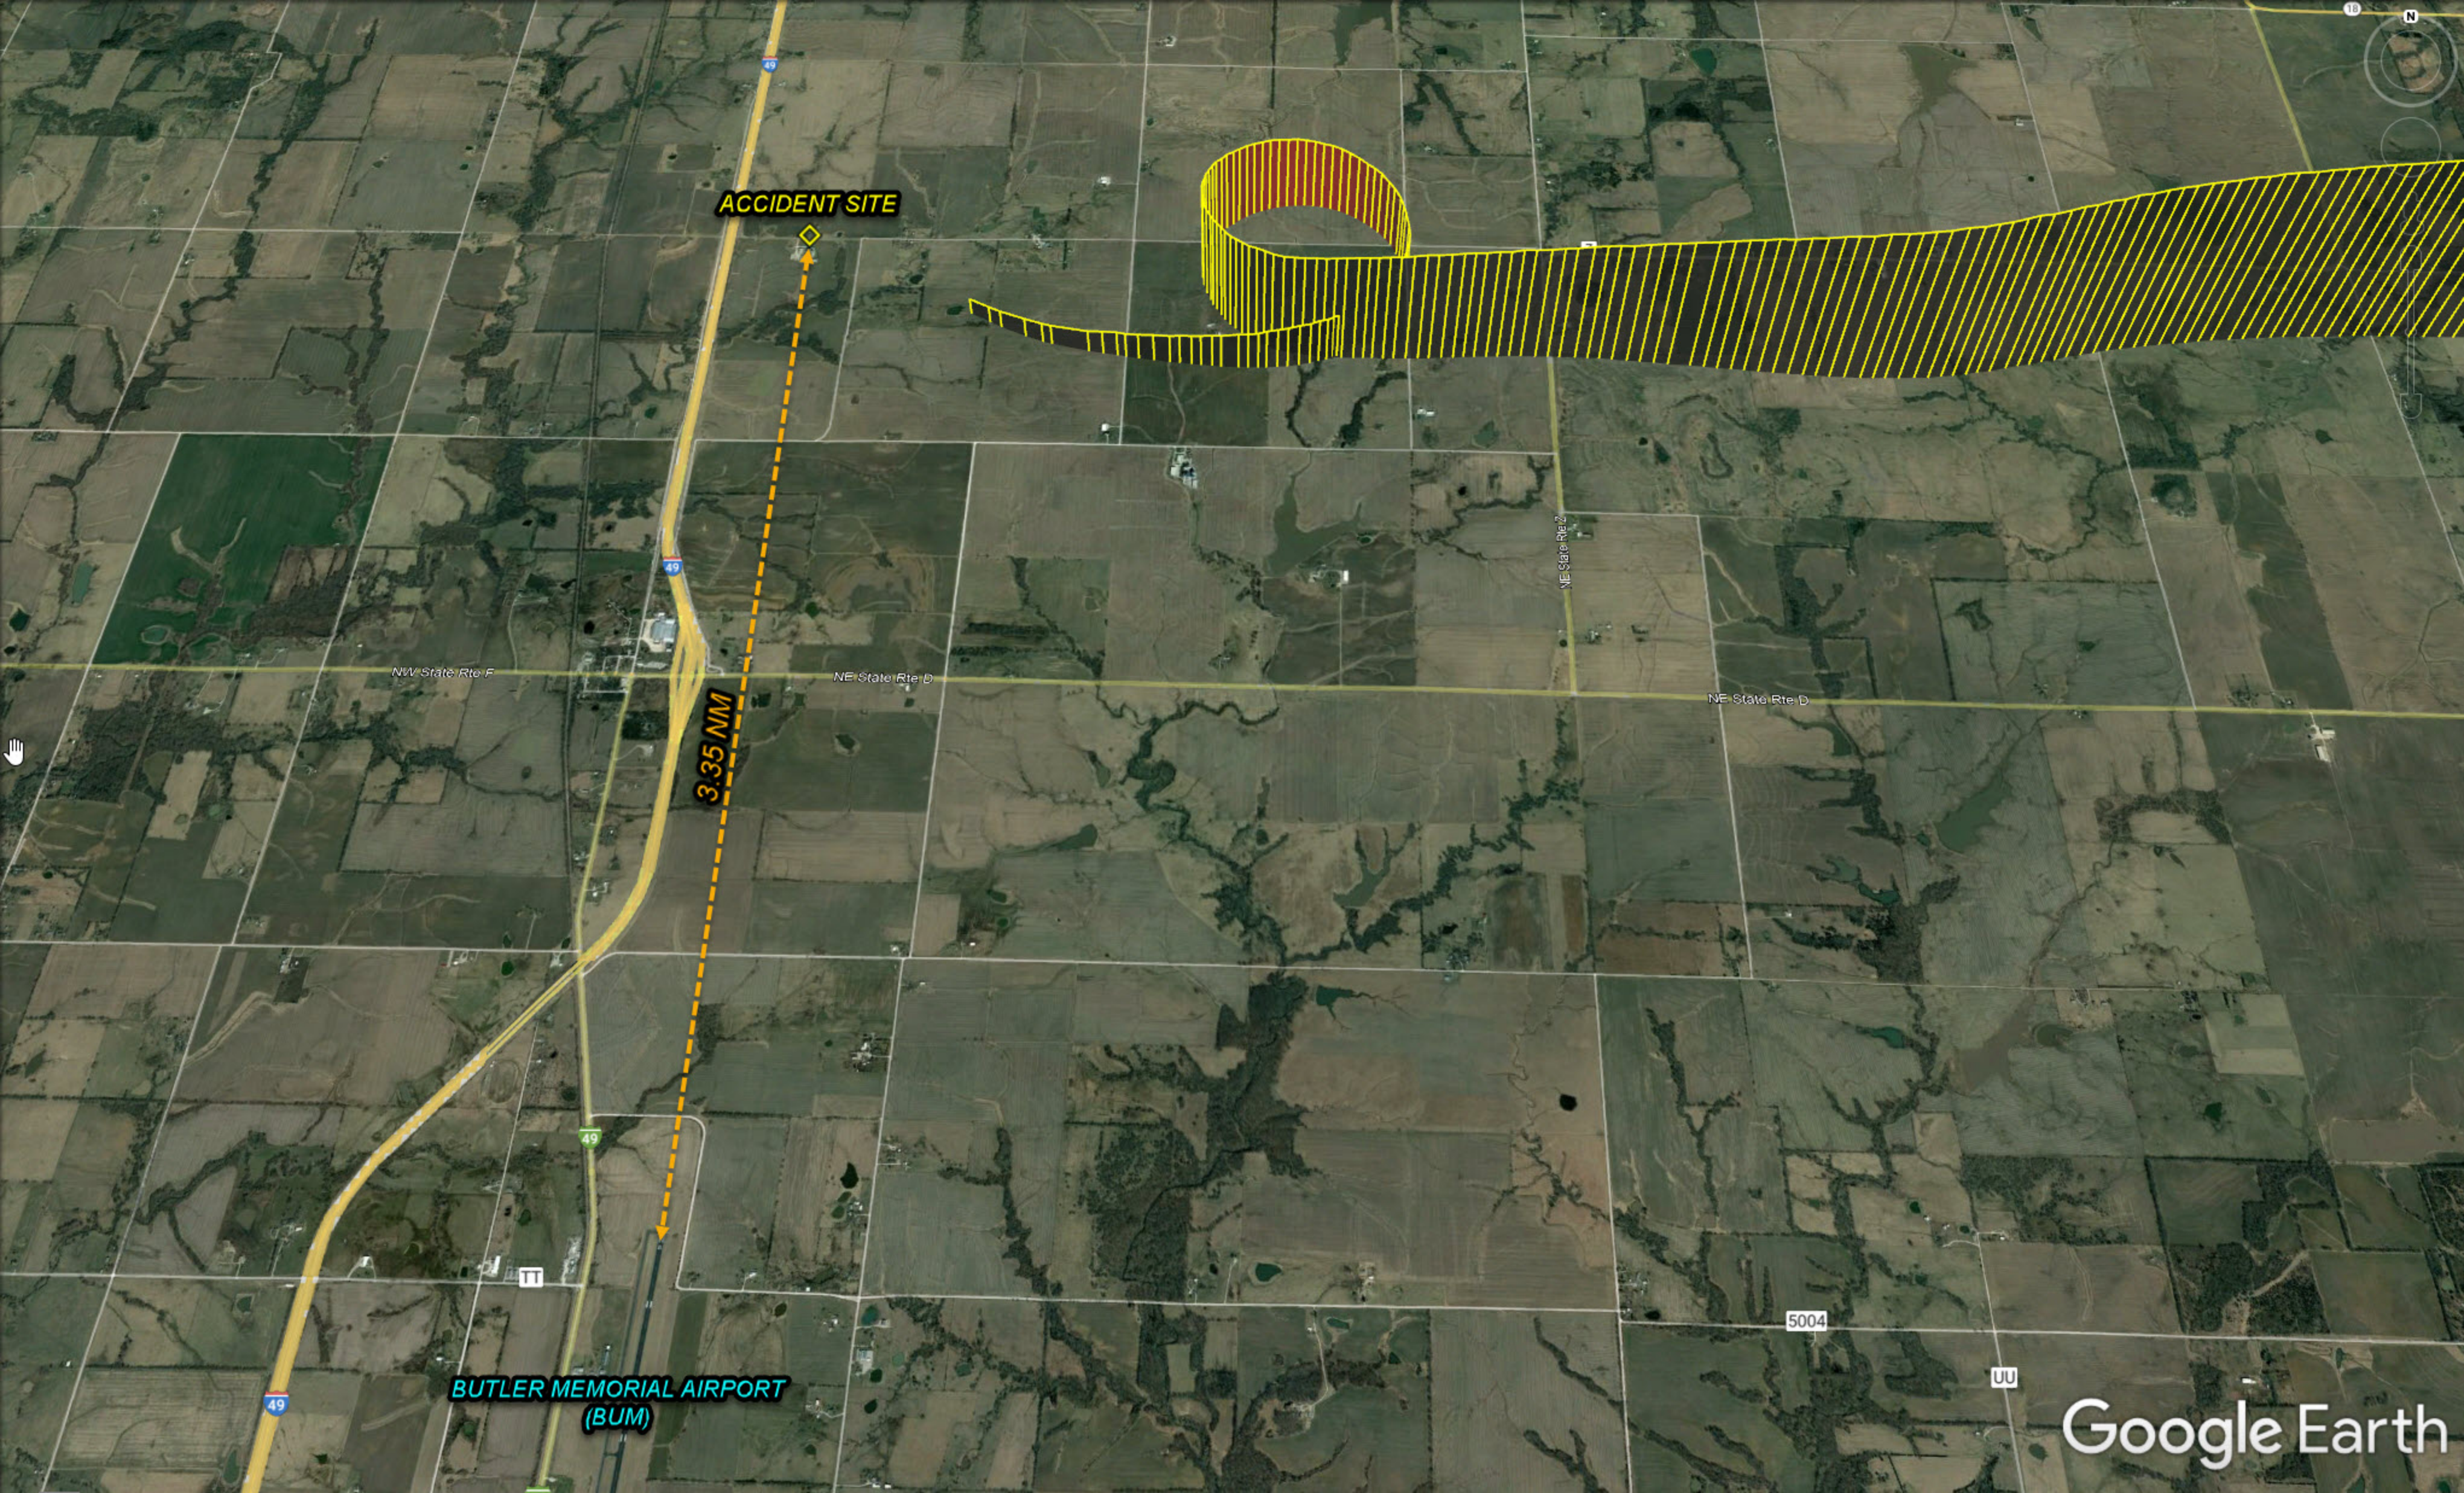
ACCIDENT SITE

3.35 NM

BUTLER MEMORIAL AIRPORT  
(BUM)

- 1 1009 CDT - PILOT REPORTED HE WOULD HAVE TO SHUT ENGINE DOWN AT FULL POWER
- 2 1012 CDT - PILOT REPORTED HE WAS FLYING ON ONE ENGINE
- 3 1014 CDT - PILOT REQUESTED NEAREST AIRPORT AND WAS PROVIDED BUTLER MEMORIAL AIRPORT (BUM)
- 4 1016 CDT - PILOT ADVISED HE WOULD NEED TO LAND RUNWAY 18 AND REPORTED AIRPORT IN SIGHT
- 5 1018 CDT - PILOT ADVISED HE WAS TRYING TO GET AIRPLANE UNDER CONTROL AND WAS CLEARED VISUAL APPROACH
- 6 1019 CDT - PILOT ADVISED THE AIRCRAFT WAS GOING DOWN
