NATIONAL TRANSPORTATION SAFETY BOARD
Office of Aviation Safety
Washington, D.C. 20594

UAS Aerial Imagery Factual Report

A. ACCIDENT **CEN19MA190**

Location: Addison, Tx
Date: June 30, 2019
Time: 0911 Local Time (CDT)
Event: Collision with hangar, N534FF, B300

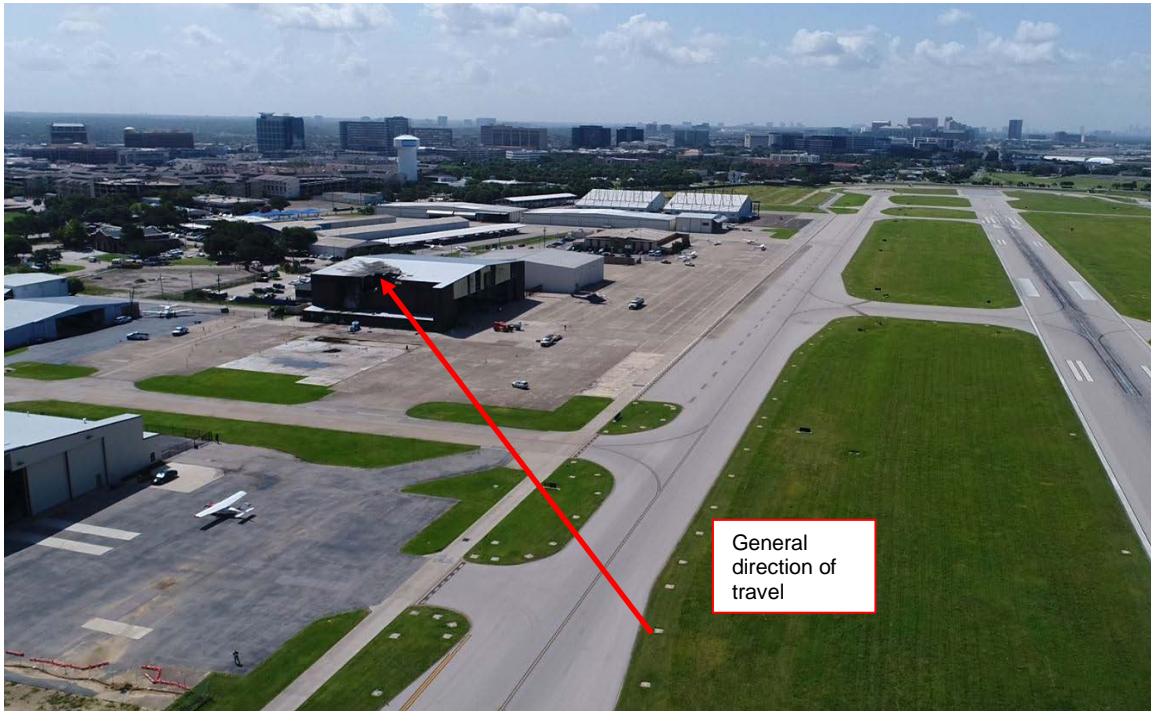
A still frame from the video approximating the flight path of the aircraft is shown in Figure 1. The drone flight and camera orientation only follow the path as shown from ADS-B data obtained by the NTSB ATC investigator. The video flight did not attempt to recreate the attitude of the airplane. The video is included in the docket.

Figure 1 – Still shot from video approximating flight path

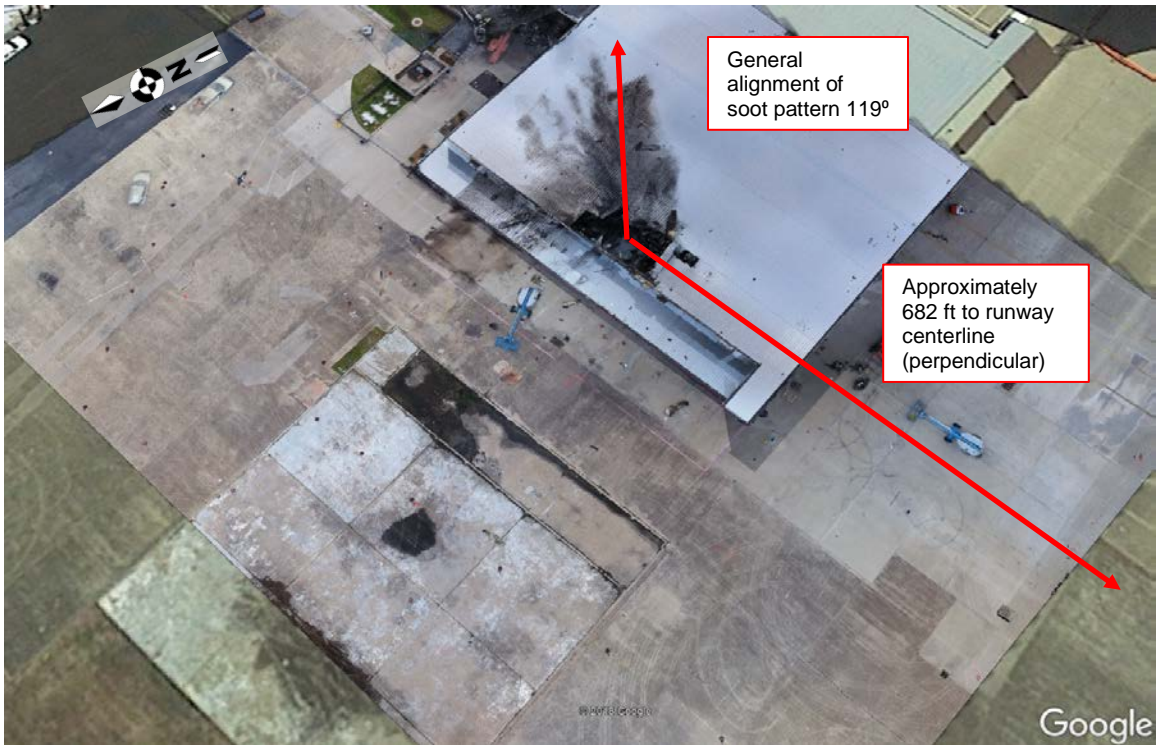
Figure 2 depicts the overall accident area orthomosaic overlaid on a Google Earth base map, with select measurements.

Figure 2 – Orthomosaic overlaid on Google Earth

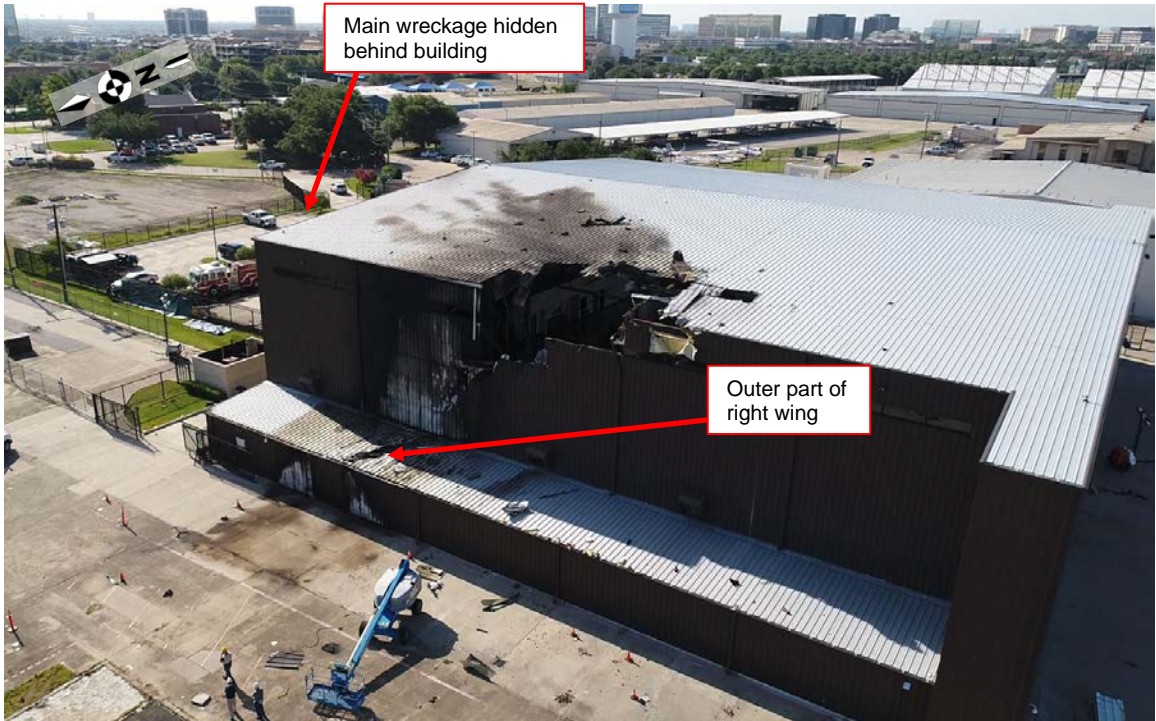
Figures 3 and 4 are overview photographs of the hangar with select wreckage indicated.

Figure 3 – Aerial photo over main impact site looking to the southeast

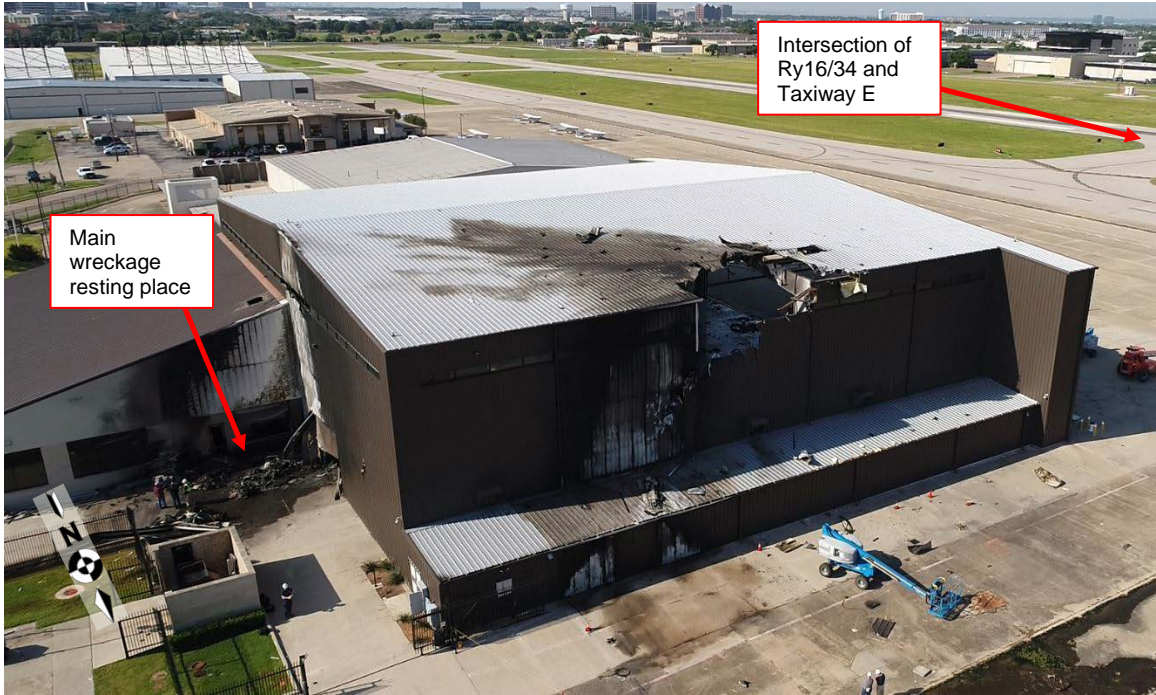
Figure 4 – Aerial photo of accident site looking southwest

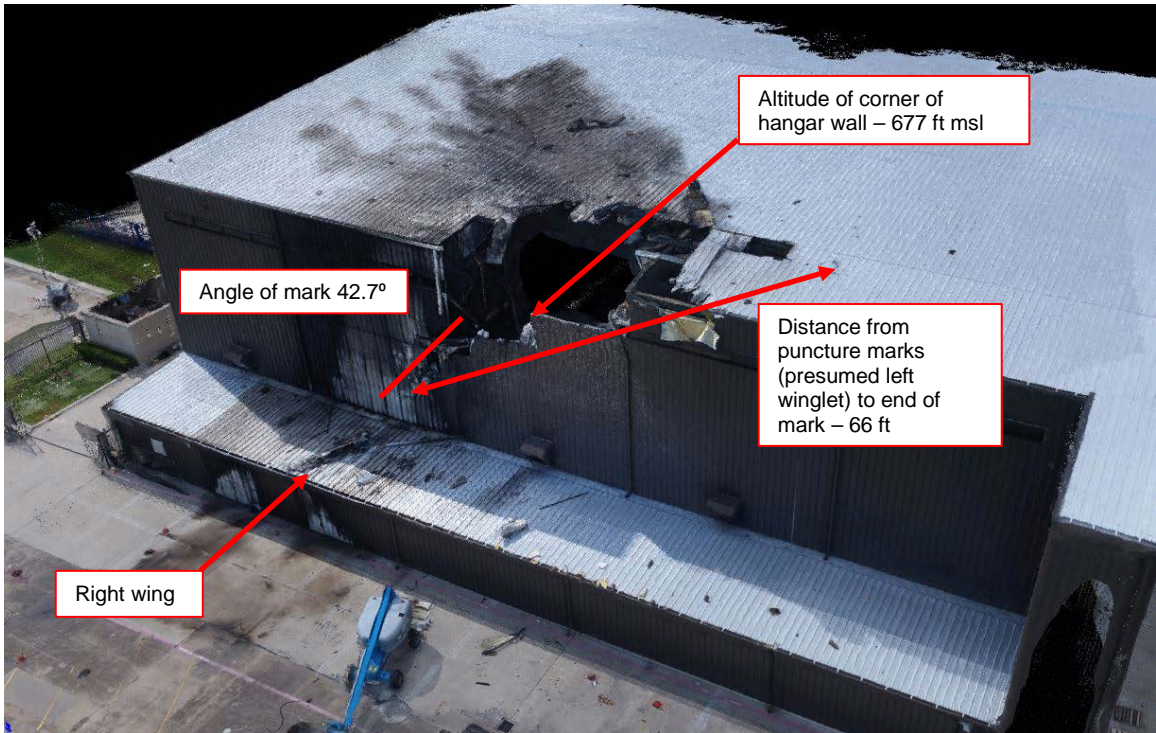
Figure 5 – Select exterior measurements

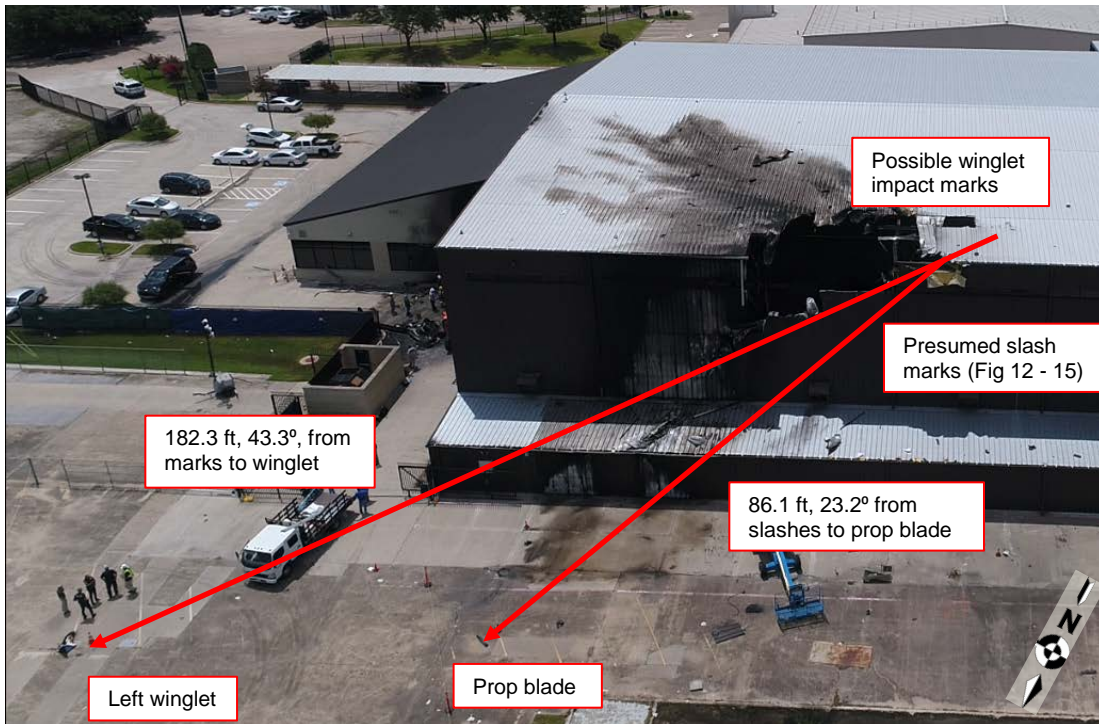
Figure 6 – Location of left winglet and prop blade

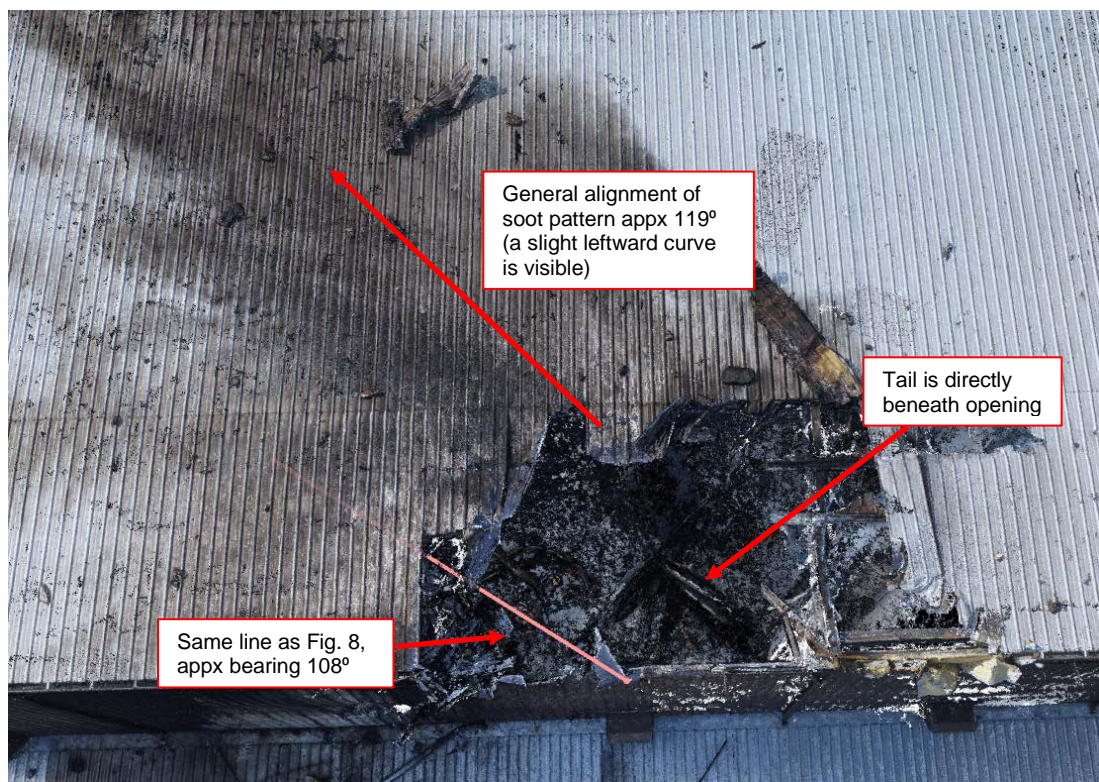
Figure 7 is a zoomed in portion of the combined exterior and interior point clouds, showing the location of the tail inside the hangar, and an indication of the 3D direction between the presumed center fuselage impact on the roof, and a large gouge in the floor.

Figure 7 – Point cloud snapshot of impact area, angle to gouge, tail, and soot pattern.

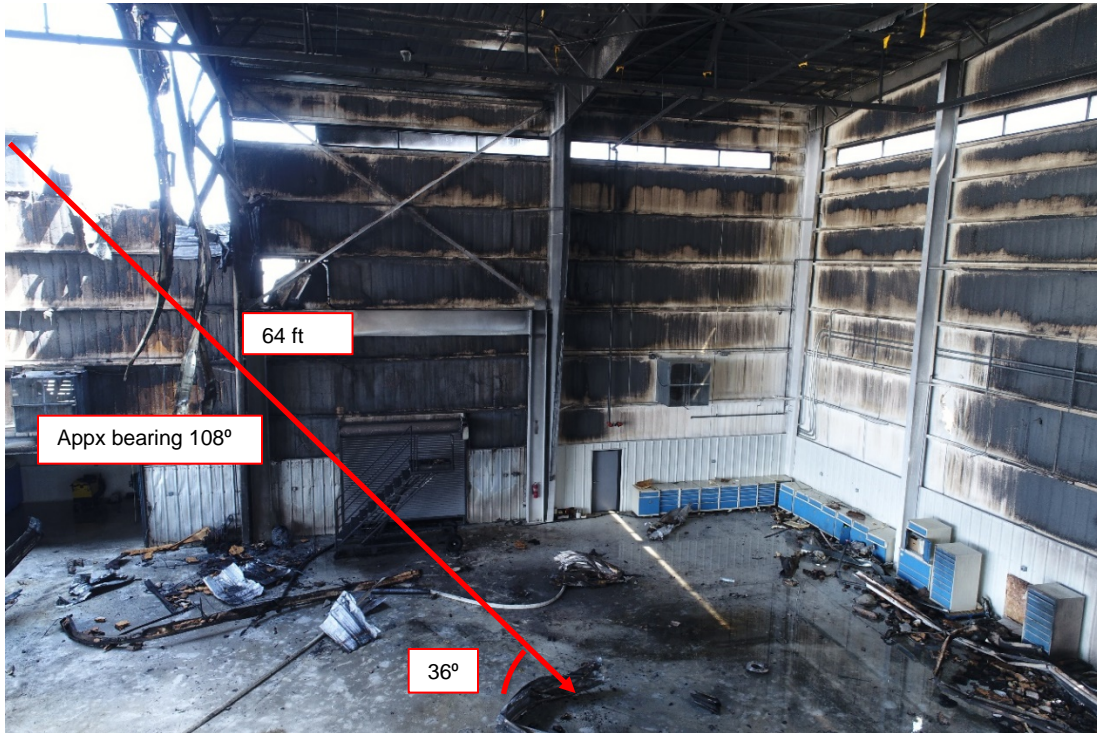
Figure 8 – Angle from approximate center of impact to first significant gouge

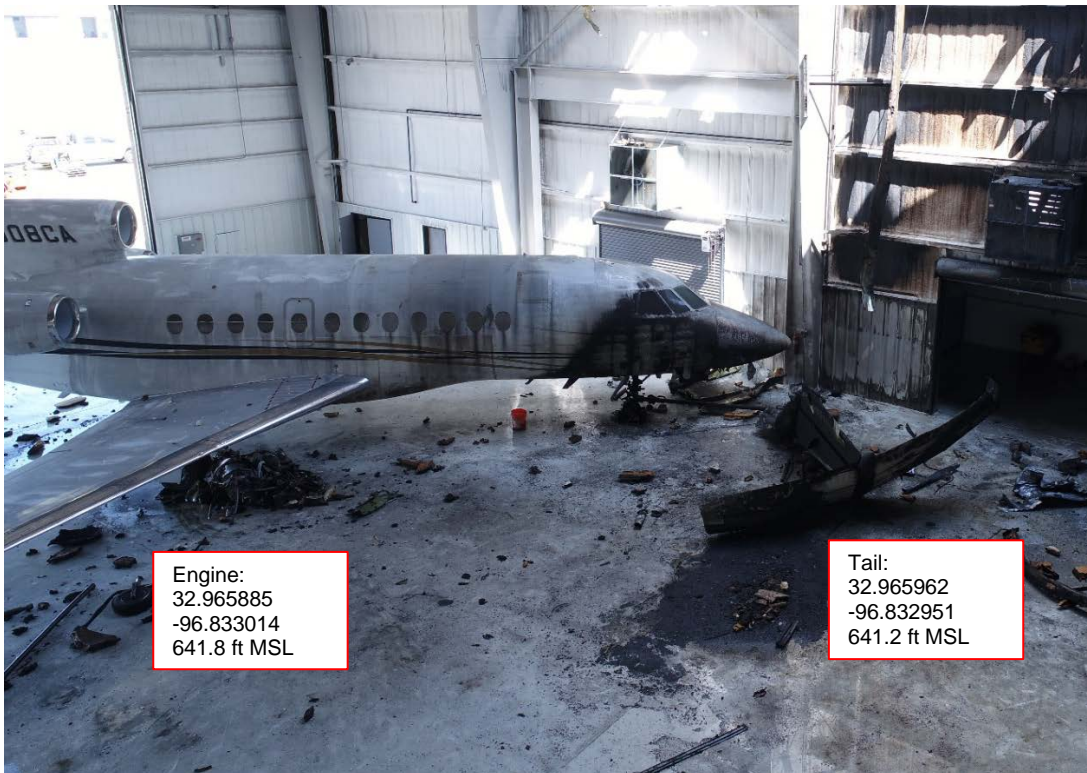
Engine:
32.965885
-96.833014
641.8 ft MSL

Tail:
32.965962
-96.832951
641.2 ft MSL

Figure 9 – Position of engine and tail

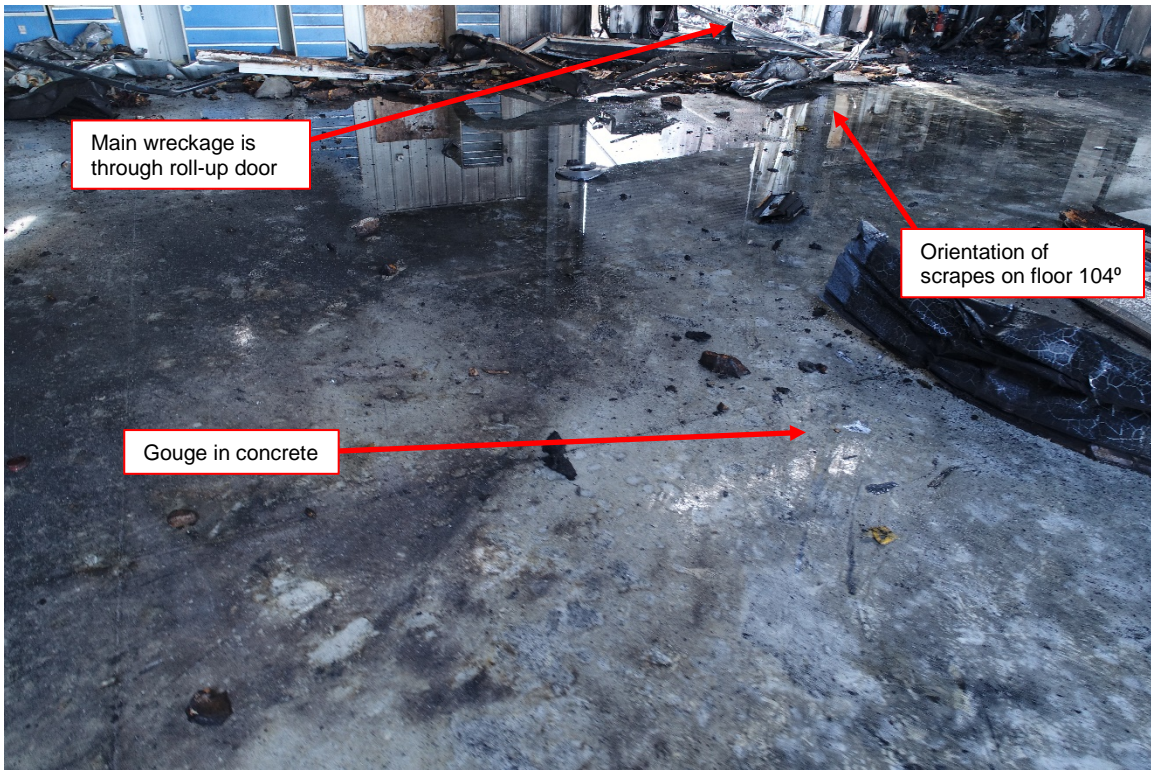
Figure 10 – Orientation of marks on hangar floor

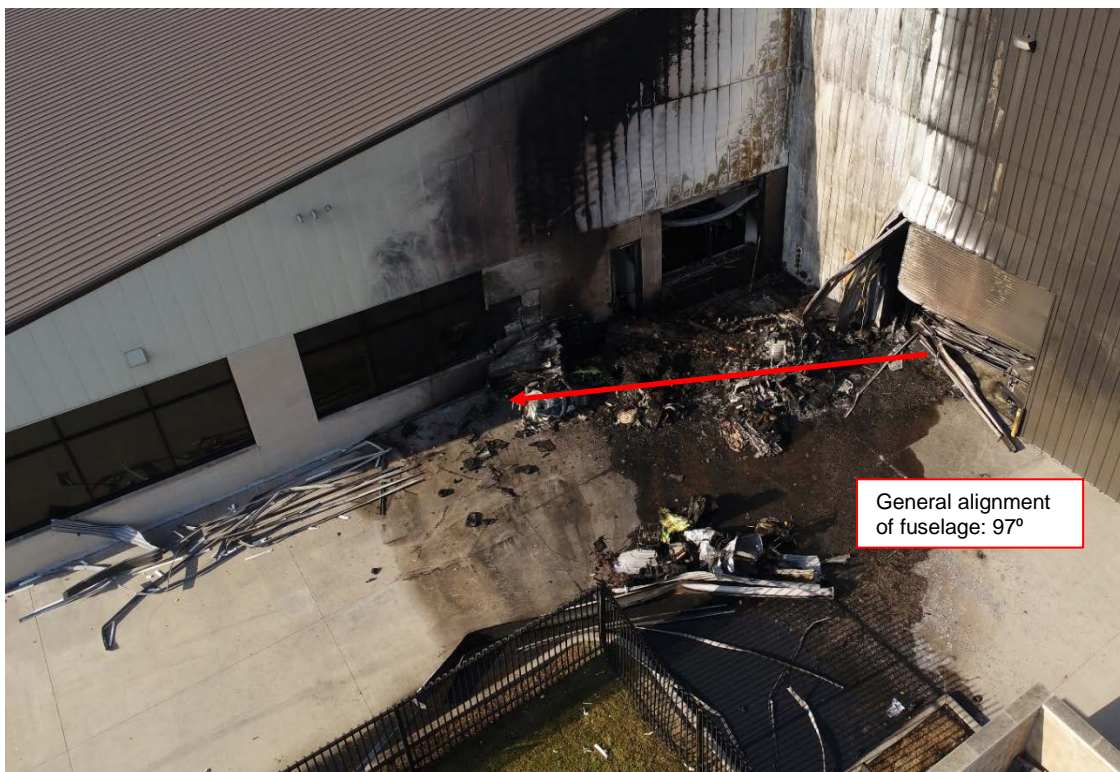
The fuselage and right engine were located outside a roll-up door on the eastern wall of the hangar and adjacent to a cinder block wall of an office area.

Figure 11 – Orientation and location of main wreckage area

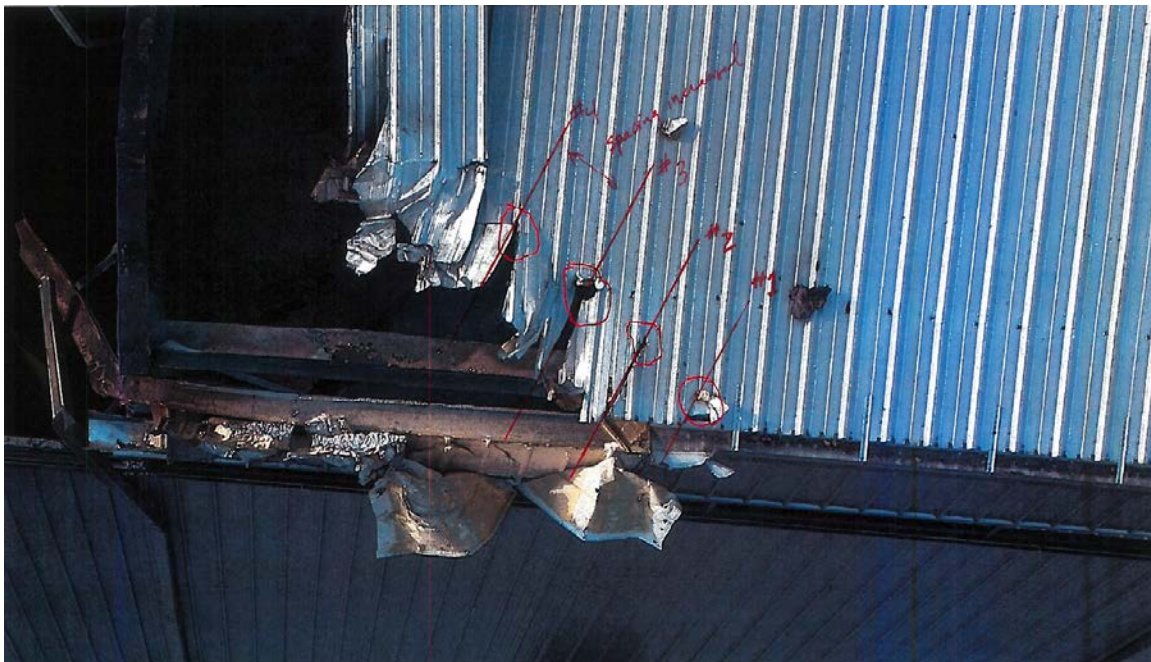
At the request of the Powerplants Group, further measurements between witness marks on the roof hanger were obtained. The Powerplants group provided a marked up photo (figure 12) indicating the points of interest presumed to be propeller strike marks from the airplane left engine. The slash marks were located within the 3D point cloud from various angles to ensure maximum confidence in the measurement. Measurements were taken from the points as closely corresponding to the propeller tips as could be determined, however, the bending and distortion of the damaged roof material added a level of uncertainty as to where exactly to mark. Polylines within the point cloud result in a 3D distance between the witness marks, thereby accounting for the pitch attitude of the airplane, and the slope of the roof.

Figure 12 – Marked up photo from Powerplants Group

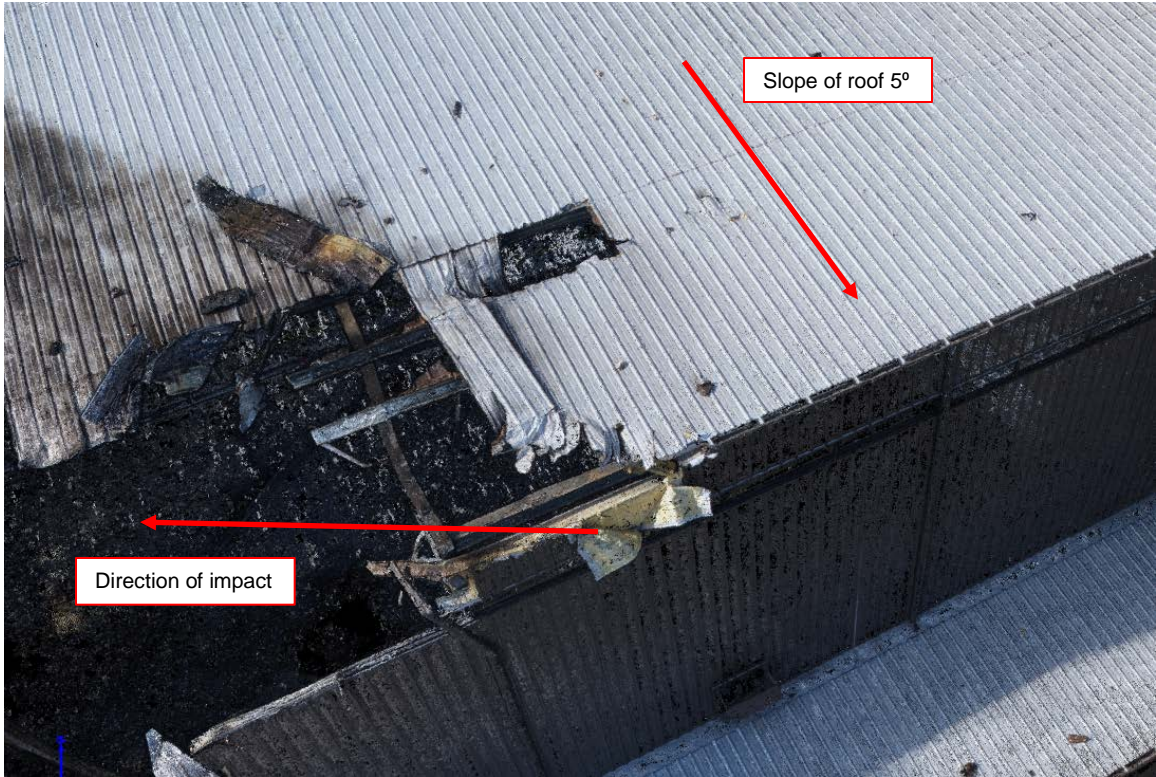
Figure 13 – View of entire point cloud looking approximately perpendicular to airplane path

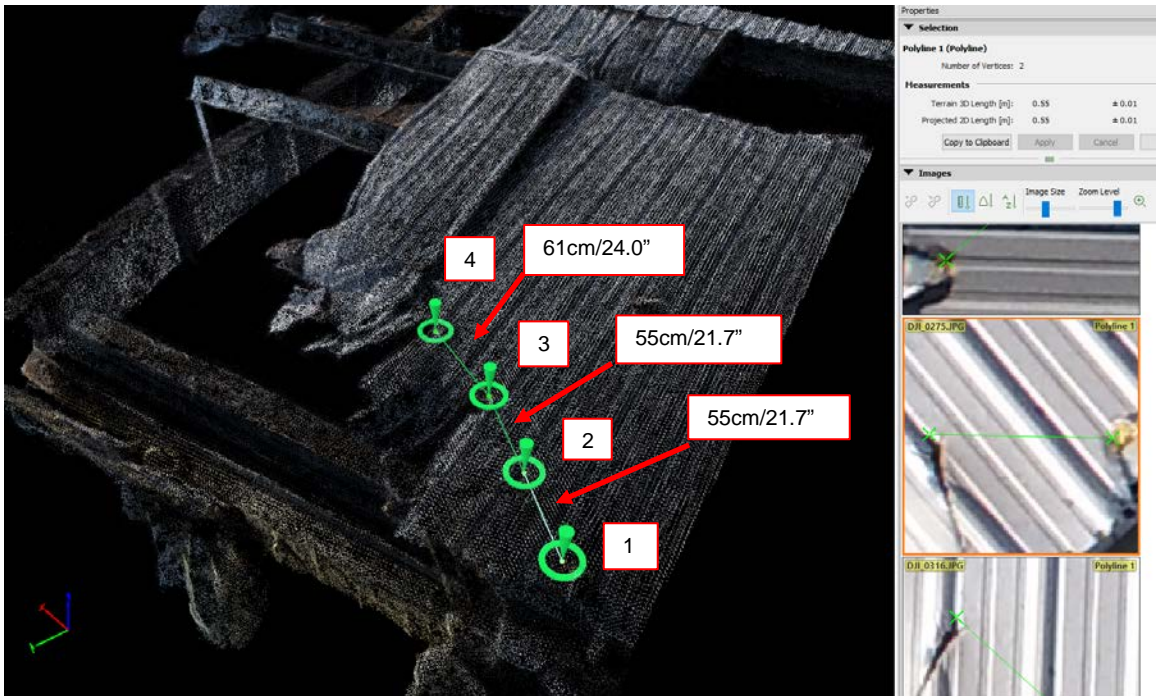
Figure 14 – Point cloud with polyline measurements. Portions of the hangar point cloud not relevant to the measurements are masked for ease of visualization.

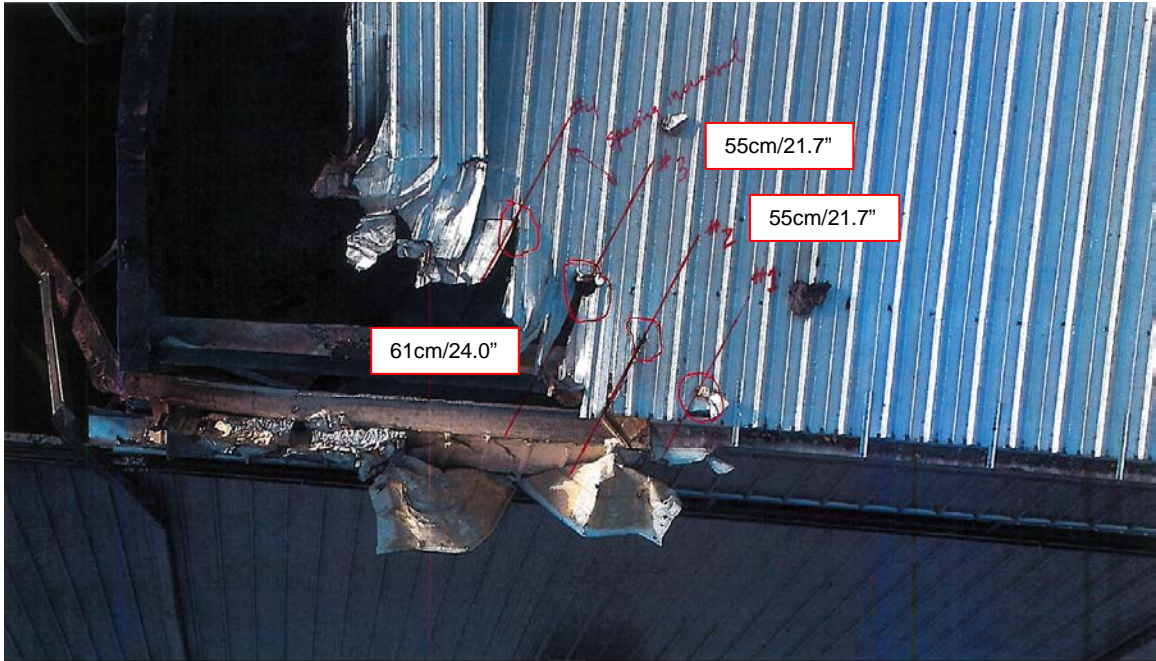
Figure 15 – Markup photo with measurements added

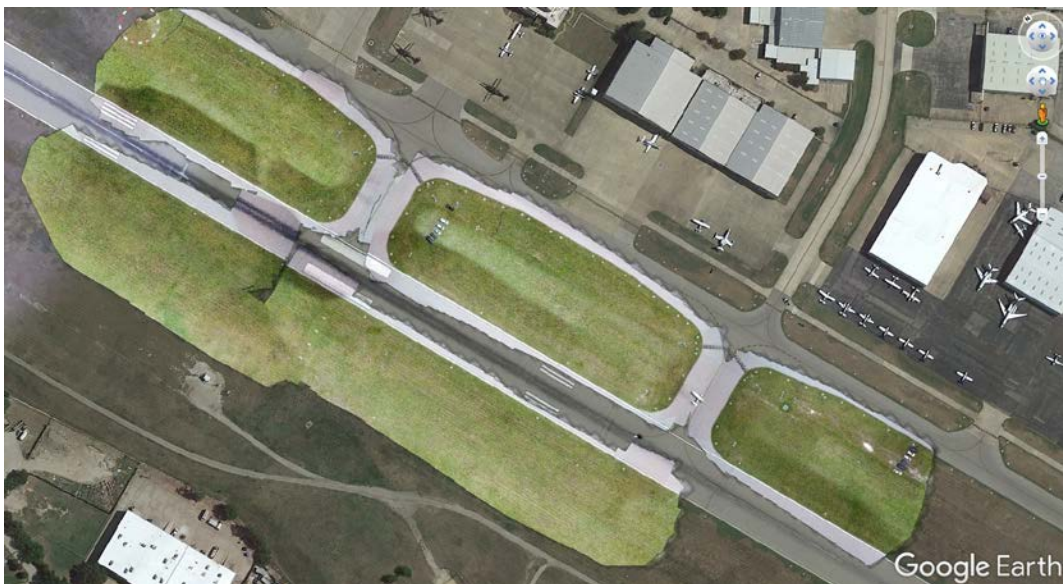
The systems group chairman organized a walk of the runway infield area to search for any potential components which may have departed the airplane during the takeoff roll. Although no parts were found, the exercise allowed for a comparison between drone photography and manual search. Drone flights took less than 20% of the time to cover the desired areas of approximately 1,850 ft by 550 ft. Figures 16 and 17 depict the orthomosaic ability to see small objects.

Figure 16 – FOD-walk Orthomosaic

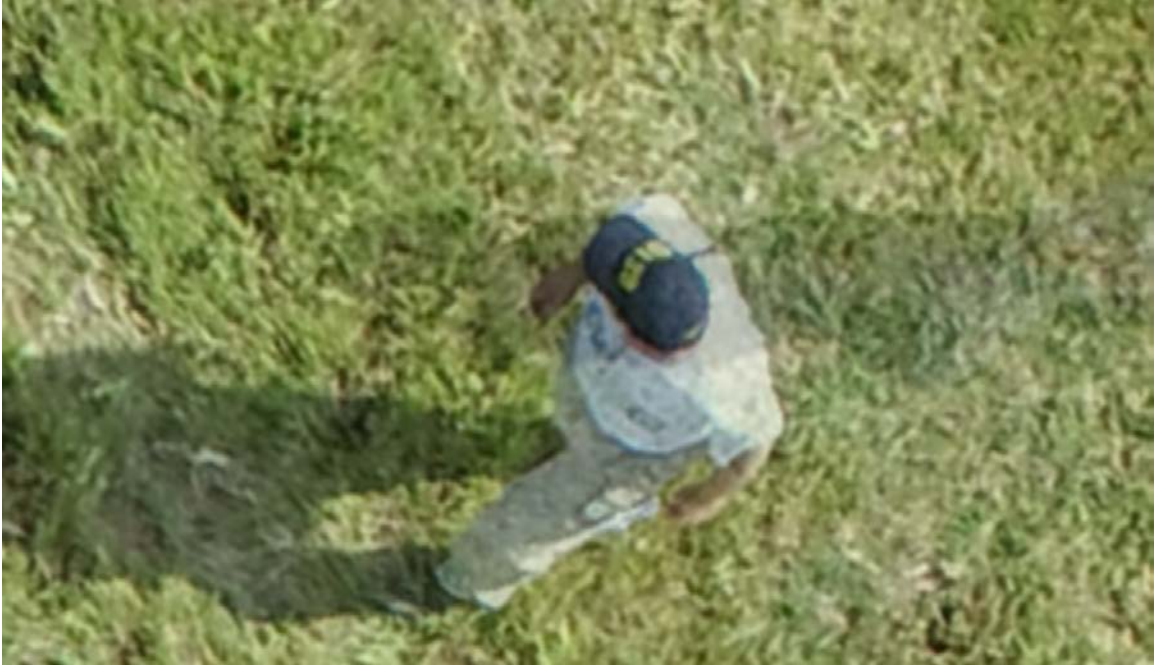
Figure 17 – Sample zoom in to orthomosaic (not photograph), showing capable detail
