**NATIONAL TRANSPORTATION SAFETY BOARD
Office of Research and Engineering
Vehicle Recorder Division
Washington, D.C. 20594**

GROUP CHAIRMAN'S SOUND SPECTRUM STUDY REPORT

CEN19MA190

Location: Addison, Texas
Date: June 30, 2019
Aircraft: Textron Aviation B300, Registration N534FF
Operator: S&H Aircraft
NTSB Number: CEN19MA190

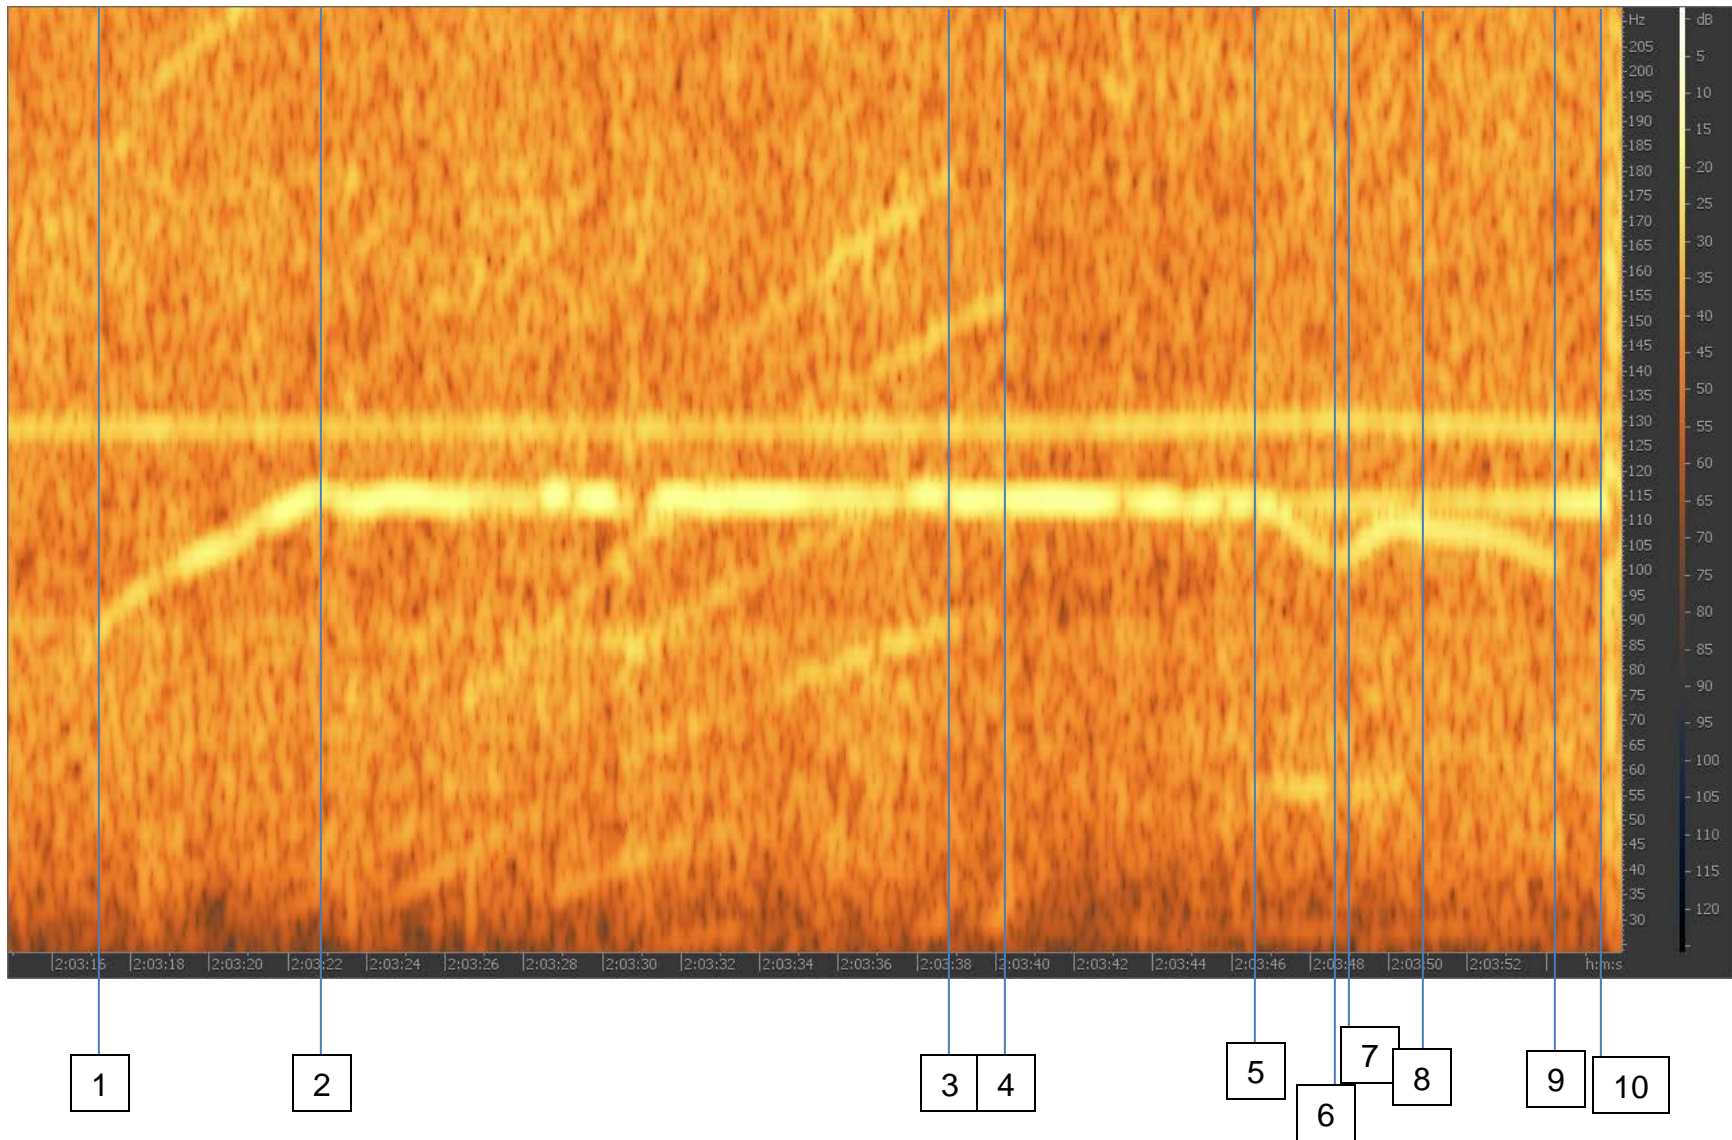
At 2:03:17.2 in the CAM channel (9:10:12.4 CDT), a sound consistent with the engines advancing in power was recorded. During this time, a signal increasing in frequency and stabilizing was present in the sound spectrum. This signal was identified as the blade pass frequency of the propellers. At 2:03:40.1 (9:10:45.3 CDT), a reduction in broadband noise represented in the spectrum as a slight decrease in overall sound energy consistent with the aircraft taking off was audible. Between these two events, a series of multiple signals increasing in frequency with time and abruptly ceasing was present in the sound spectrum. Aircraft ground speed would have been too low for the CVR to capture the fundamental frequency of the landing gear tires, which would have been in the range of 0-30 Hz. Therefore, these signals were identified as harmonics of the fundamental frequency of the landing gear tires rolling on the runway. There was also a constant signal at 129 Hz that was identified as being consistent with avionics fan noise.

After taking off, the signal identified as the propeller blade pass frequency of the two four-bladed propellers was one tone. This is consistent with both propellers turning at approximately the same speed. About five seconds later, the sound of a click was recorded (not visible in figure 1)¹ and the tone then diverged in to two tones, consistent with one propeller turning slower than the other². Stall warning tones were recorded from 2:03:46.5 (9:10:41.7 CDT) to 2:03:49.0 (9:10:44.2 CDT) and again from 2:03:50.9 (9:10:46.1 CDT) to the end of the recording that are visible in figure 2 and are referenced in the points of interest. At 2:03:54.2 (9:10:49.4 CDT), the lower propeller tone abruptly ceased to be visible in the spectrum, however, the first harmonic of that propeller tone was still visible until the point of impact, allowing for continued propeller speed calculations to be made.

sound spectrum for the time period of interest with ten sections annotated that were of interest to the study. A fast Fourier transform (FFT³) analysis was performed at each section to determine frequency components of the signals and calculate the speeds of interest. Relevant FFT parameters including FFT size, window type, and window overlap are included for each of the data points in Section 4.

Figure 1. Image of CAM channel sound spectrum from 25-210 Hz of time period from engines advancing to takeoff power to end of recording, annotated with data point times of interest to the analysis.

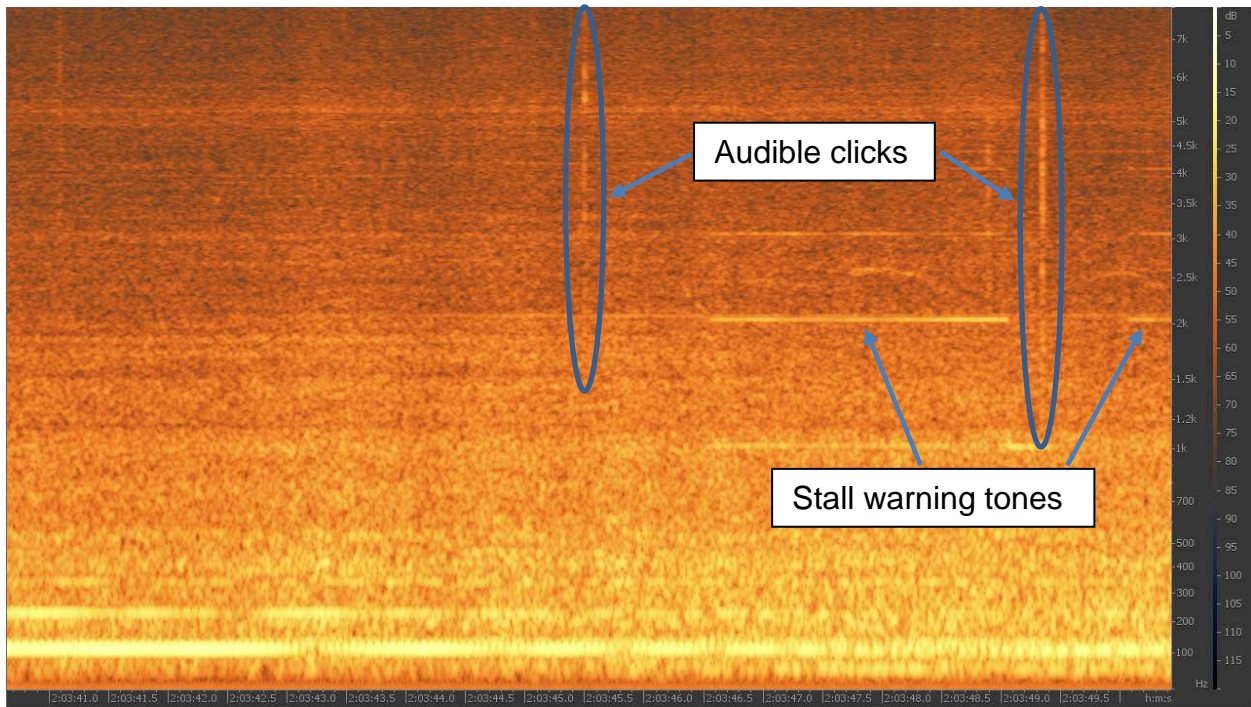
The sound of a click was recorded two times during the accident flight, once at 2:03:40.7 in the CAM channel recording (9:10:41.0 CDT) and again at 2:03:49.3 (9:10:44.5 CDT). The first click occurred about one second prior to the first aircraft stall warning, which is shown in spectrum data as a tone at around 2k Hz starting at 2:03:46.5 (9:10:41.7 CDT)), and the second click occurred between the end of the first stall warning and the beginning of the second stall warning at 2:03:50.9 (9:10:46.1 CDT). Both clicks were broadband in nature, with sound energy captured from about 1.5k-8k Hz. Figure 2 shows this period of the spectrum. The clicks are represented as short duration (vertical) peaks in broadband energy intensity.

The accident recording was filtered to reduce the noise level and a comparison was made of the sound energy between the clicks heard on the accident flight and the clicks recorded in the ground test. It is possible that the background noise on the accident flight may have masked frequencies of the events in question, and therefore there is a high degree of uncertainty surrounding the comparisons. However, adjusted energy levels from the first click recorded during the accident flight sequence exhibited similar characteristics to the click recorded when the throttle contacted the idle stop in the test. Elevated sound energy was noted in frequencies ranging from about 3k-8k Hz, with peaks at about 5.5k and 6k Hz.

Adjusted energy levels from the second click recorded during the accident flight sequence exhibited similar characteristics to the click recorded upon actuation of a flight deck switch. Elevated sound energy was noted in frequencies ranging from about 1.5k to about 8k, with a concentration of energy between 3.5k and 5.5k Hz. Again, due to the background noise level differences there is a high degree of uncertainty in this spectral comparison.

Figure 2. Sound spectrum from accident CAM recording showing two audible clicks under investigation.

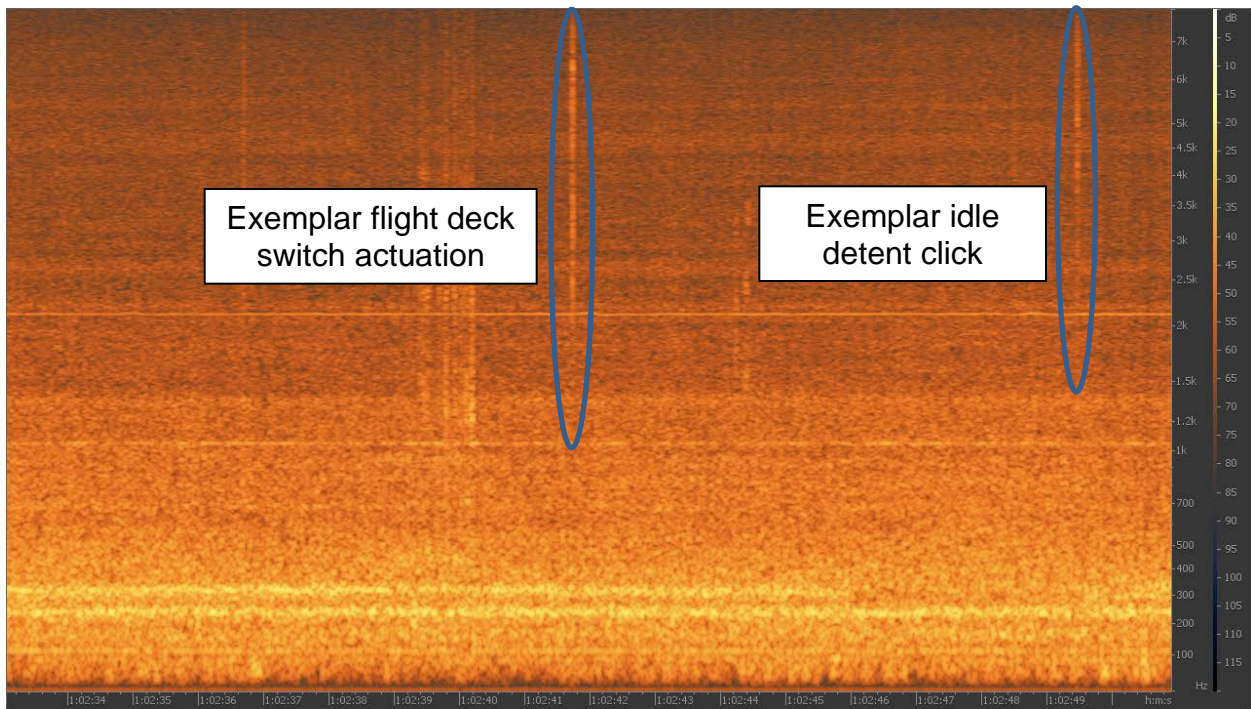
A test was conducted in an exemplar B300 cockpit to see if the throttle movement could produce a similar click. The spectrum in figure 3 shows two clicks, the first from an unidentified flight deck switch being actuated at 1:02:41 in the recording from the exemplar aircraft, and the second from the throttle contacting the idle detent at 1:02:49. The switch panel is located on the lower portion of the panel near the throttle quadrant in the cockpit of the B300.

The test on the aircraft was conducted while on the ground with the avionics on and the engines not running, therefore the background noise environment was quieter on the test aircraft than the accident aircraft. The sound of the switch produced a larger range of frequencies than the sound of the throttle contacting the idle stop. The switch being actuated produced sound energy in frequencies ranging from about 2k-8k Hz, while the throttle contacting the idle stop produced sound energy in frequencies ranging from about 3.5k-8k Hz.

Figure 3. Sound spectrum from exemplar BE-300 aircraft CAM recording showing two audible clicks.

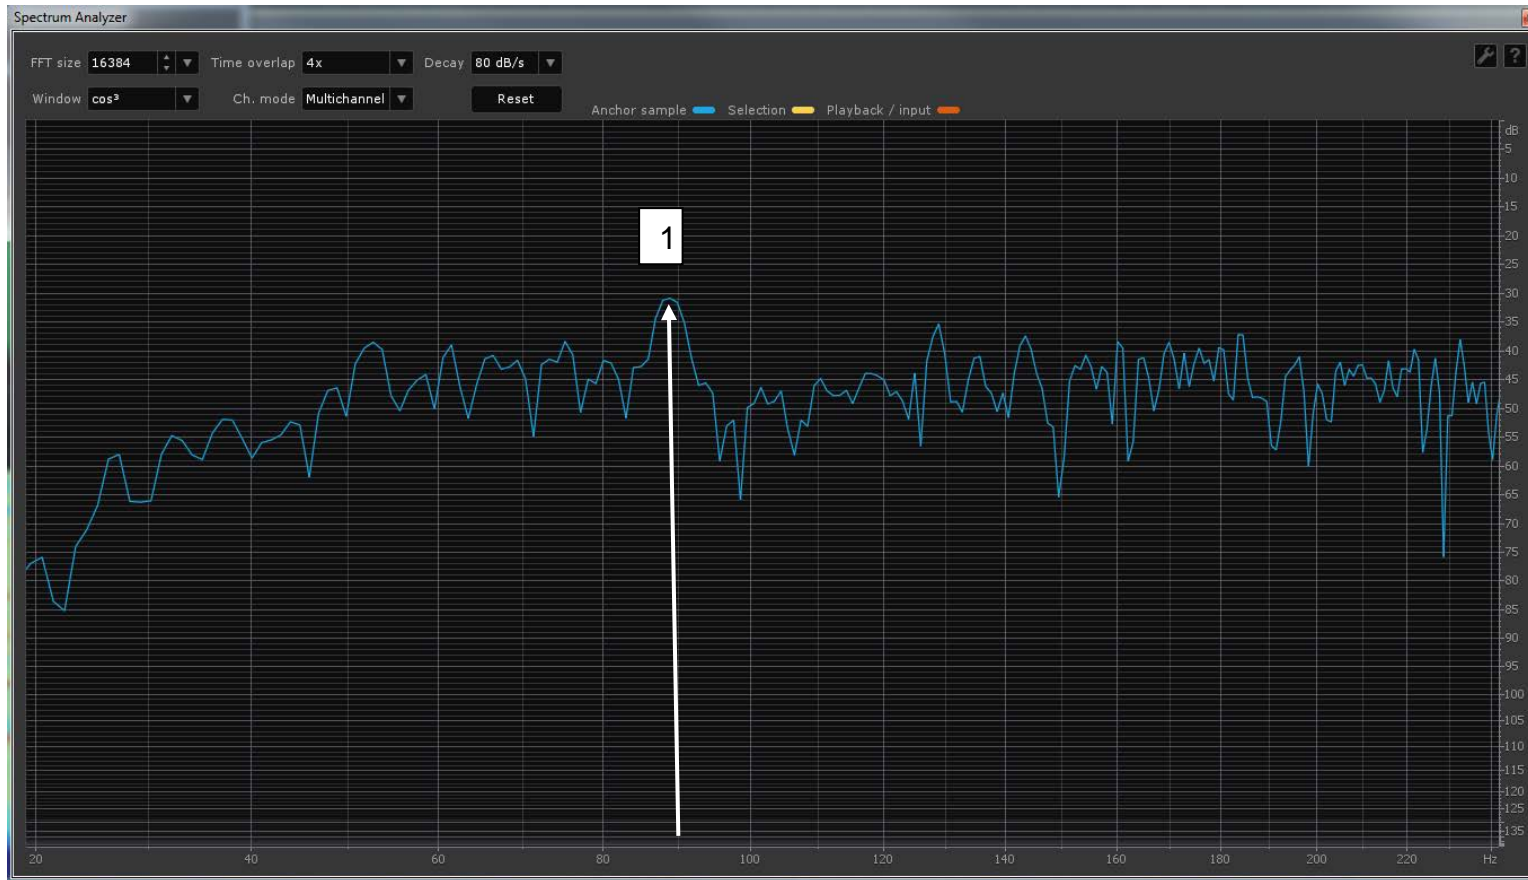
4.1 Data Point 1

Peak 1 : 88.9 Hz, identified as Np

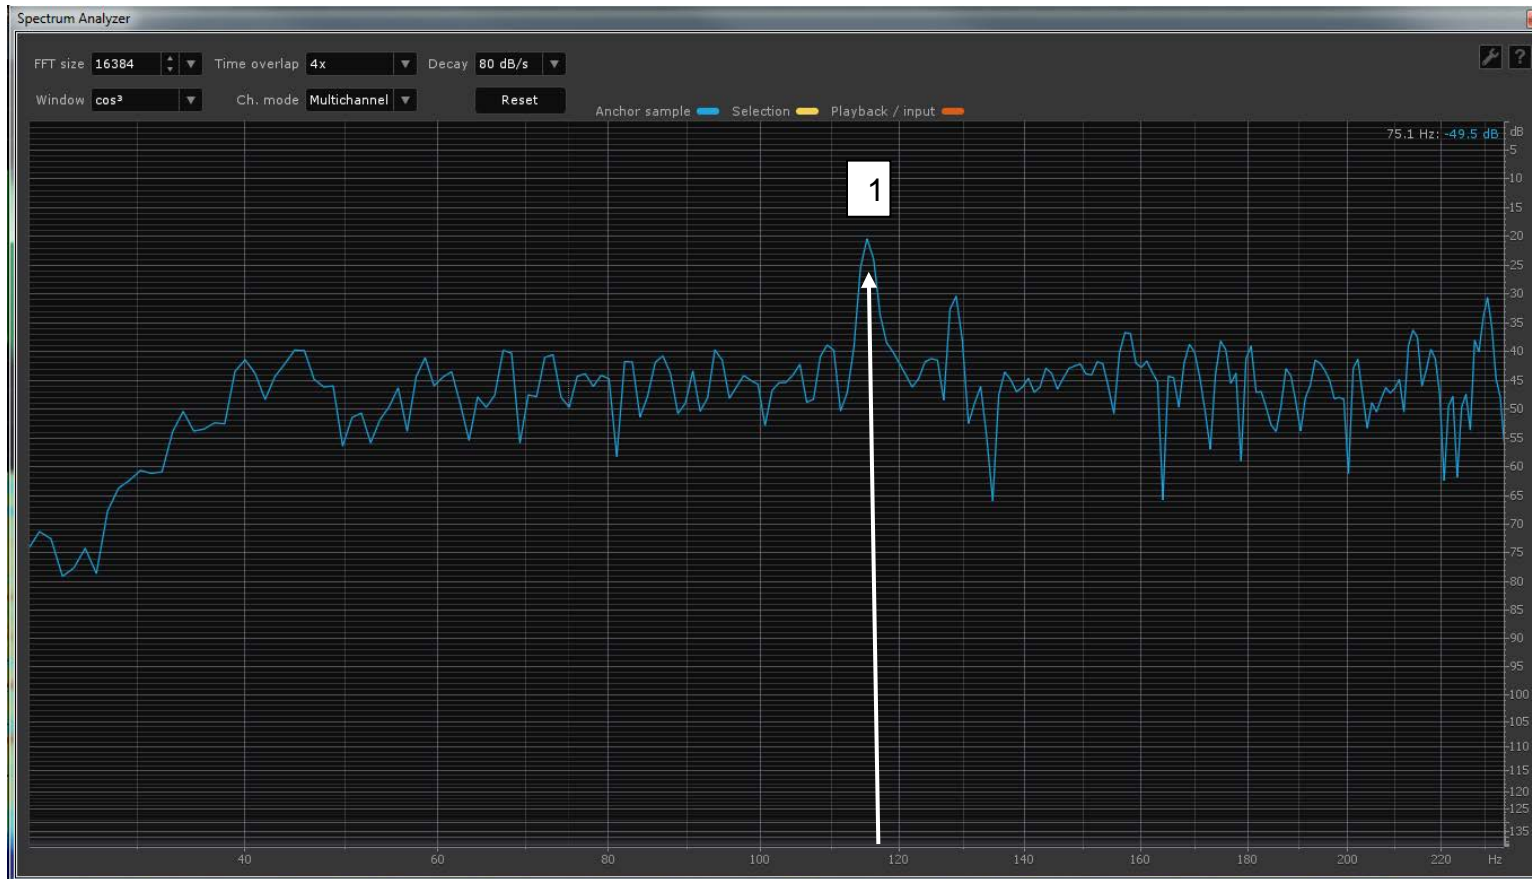
4.2 Data Point 2

Peak 1 : 115.26 Hz, identified as Np

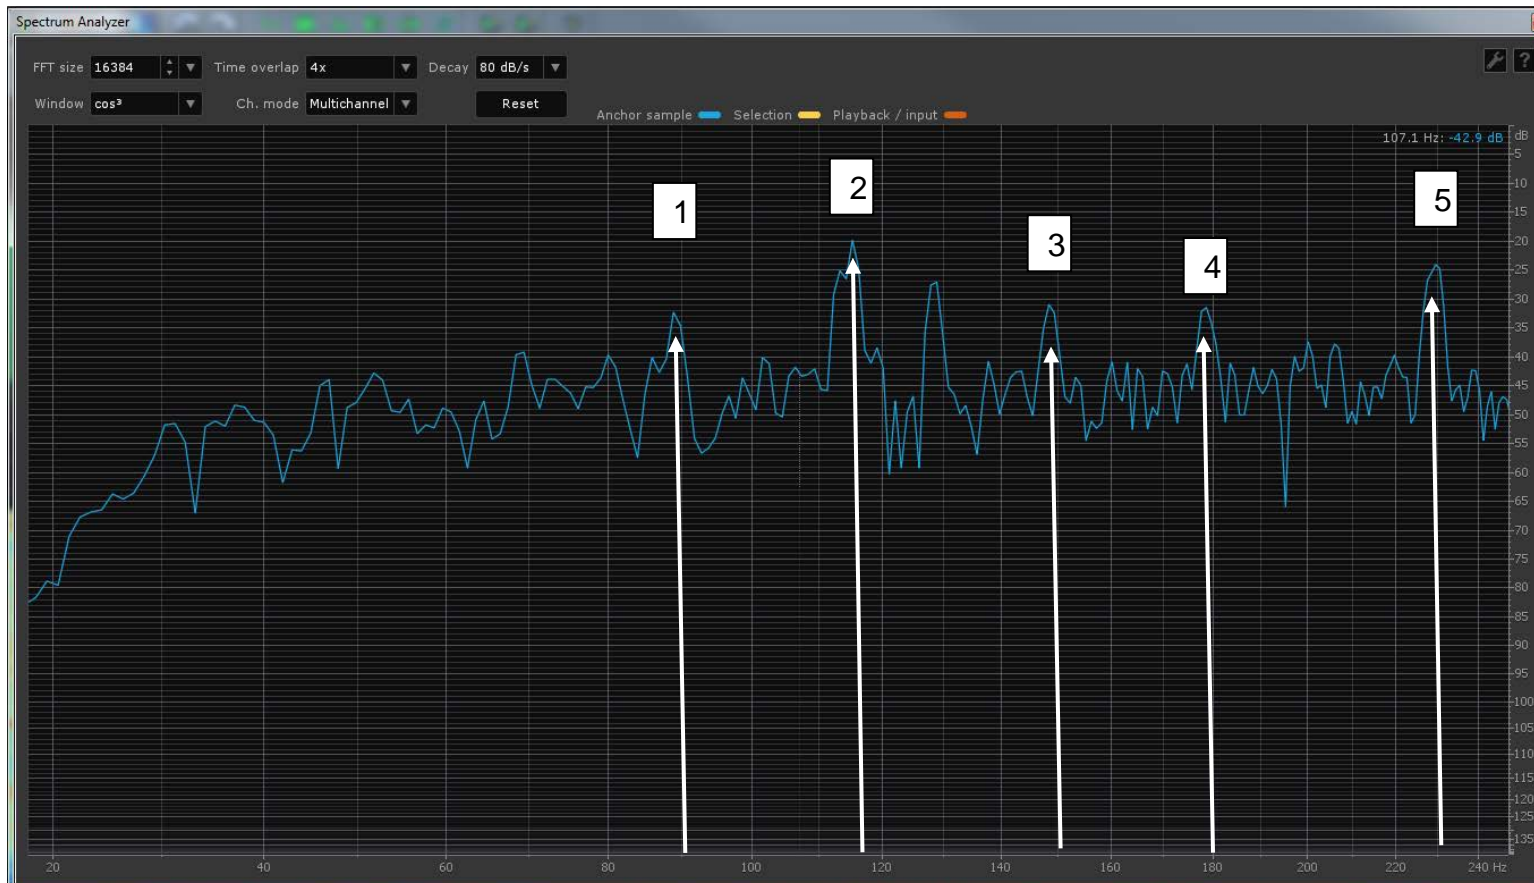
4.3 Data Point 3

- Peak 1: 89 Hz, identified as tire overtone
- Peak 2: 115.22 Hz, identified as Np
- Peak 3: 148.6 Hz, identified as tire overtone
- Peak 4: 178.6 Hz, identified as tire overtone
- Peak 5: 230 Hz, identified as Np overtone

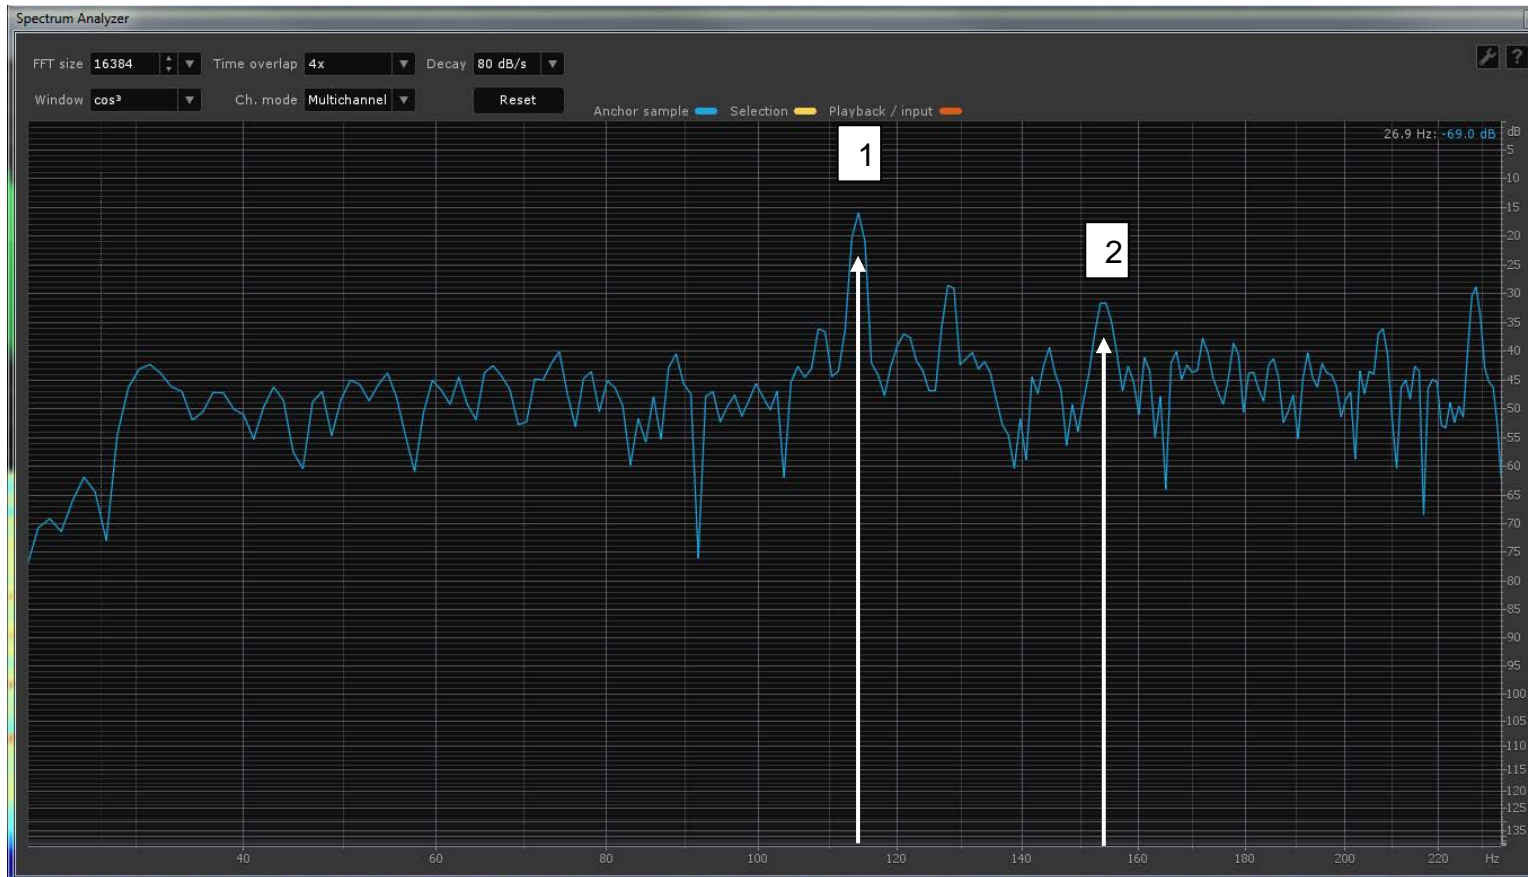
4.4 Data Point 4

Peak 1: 114.24 Hz, identified as Np
Peak 2: 154 Hz, identified as tire overtone

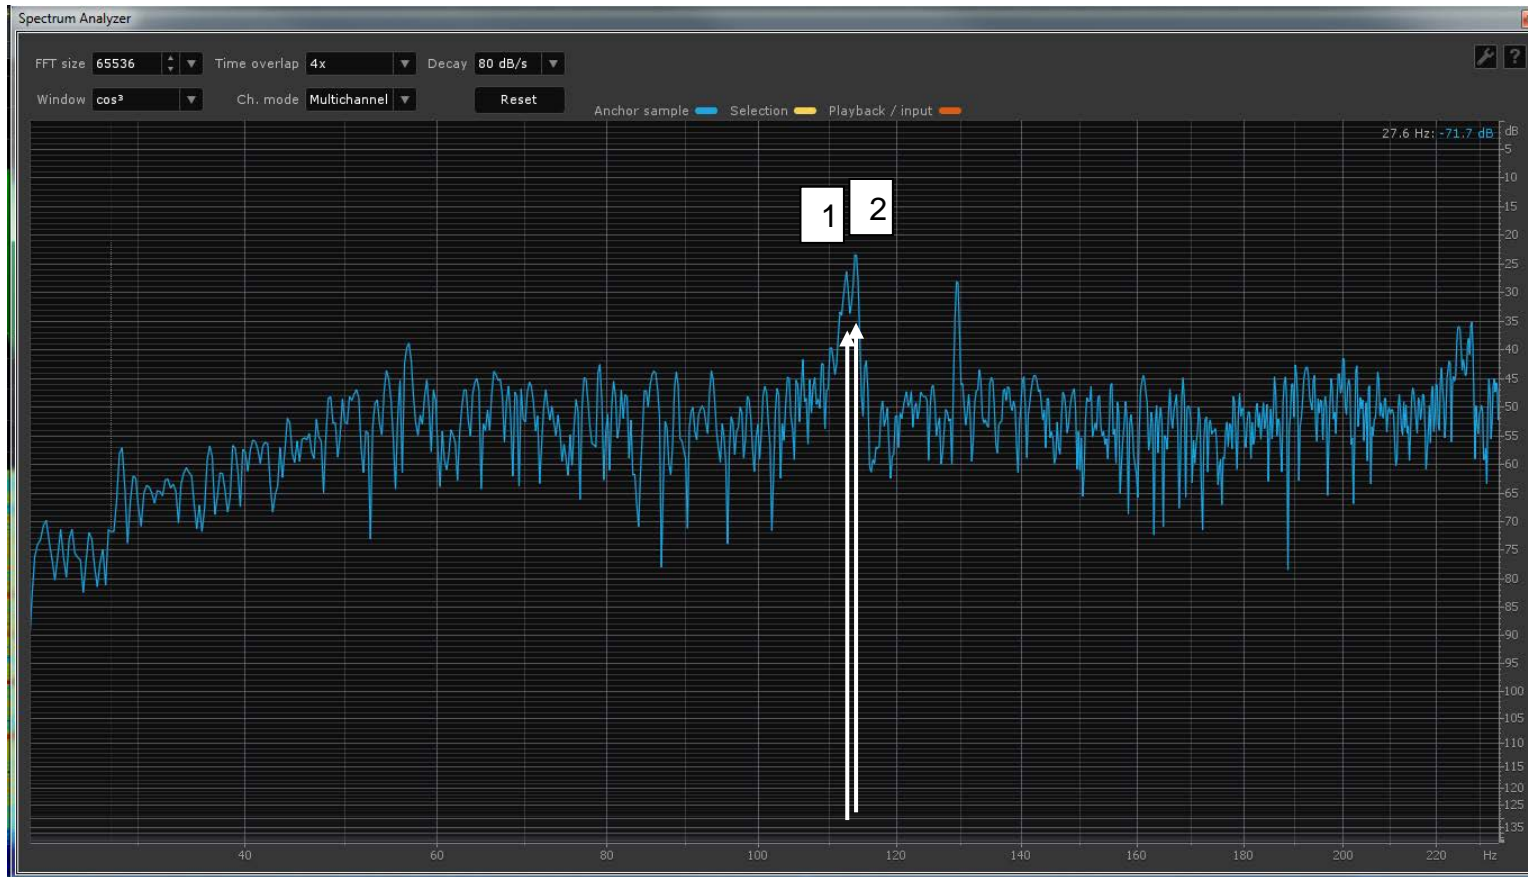
4.5 Data Point 5

Peak 1: 112.56 Hz, identified as Np 1

Peak 2: 113.8 Hz, identified as Np 2

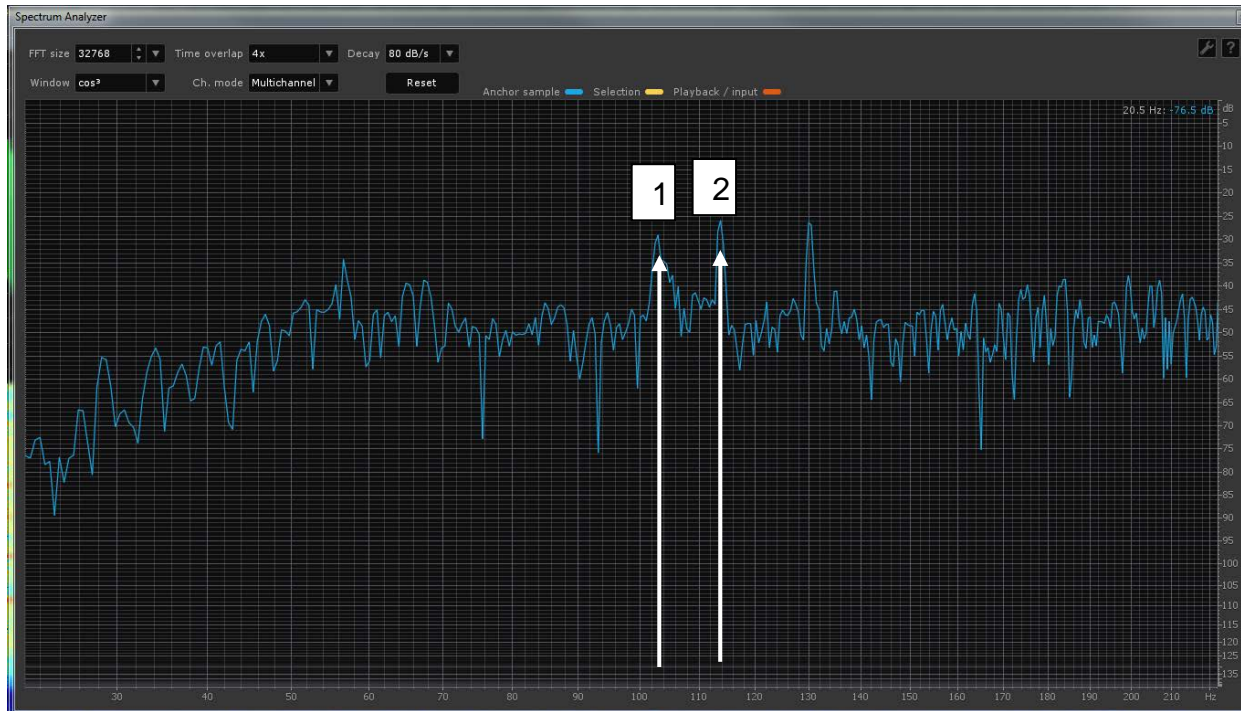
4.6 Data Point 6

Peak 1: 102.99 Hz, identified as Np 1
Peak 2: 113.66 Hz, identified as Np 2

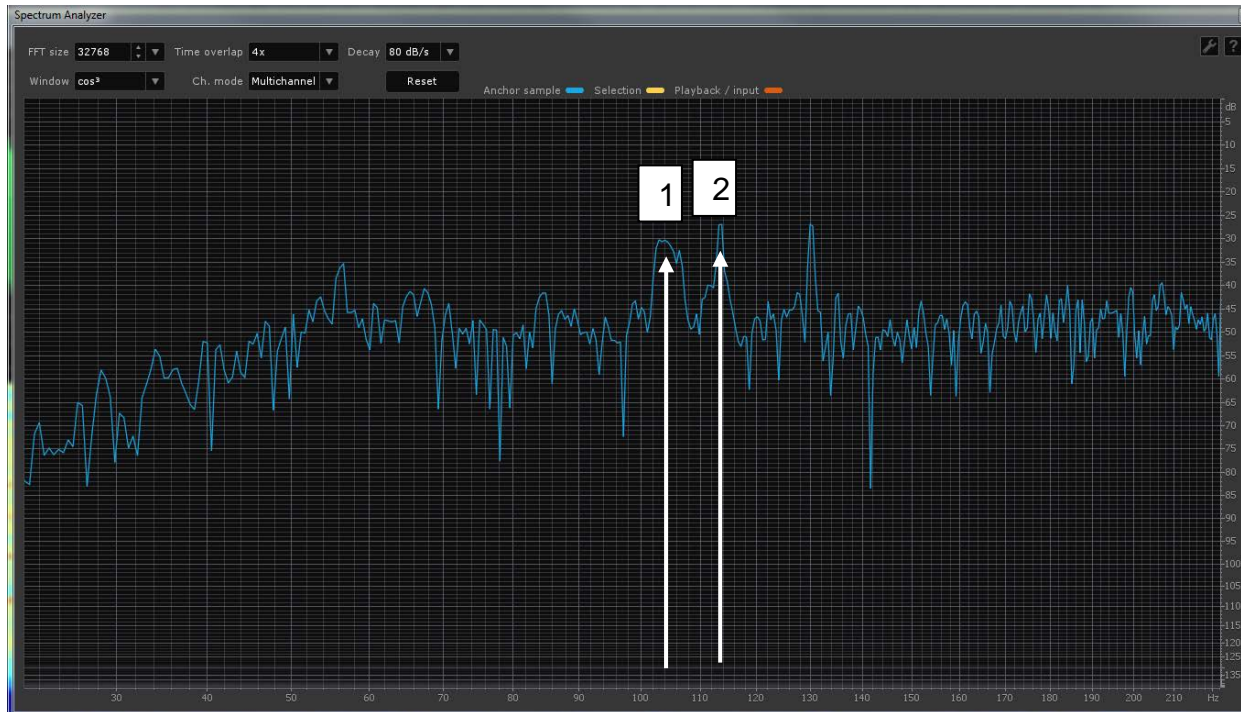
4.7 Data Point 7

Peak 1: 104 Hz, identified as Np 1
Peak 2: 113.5 Hz, identified as Np 2

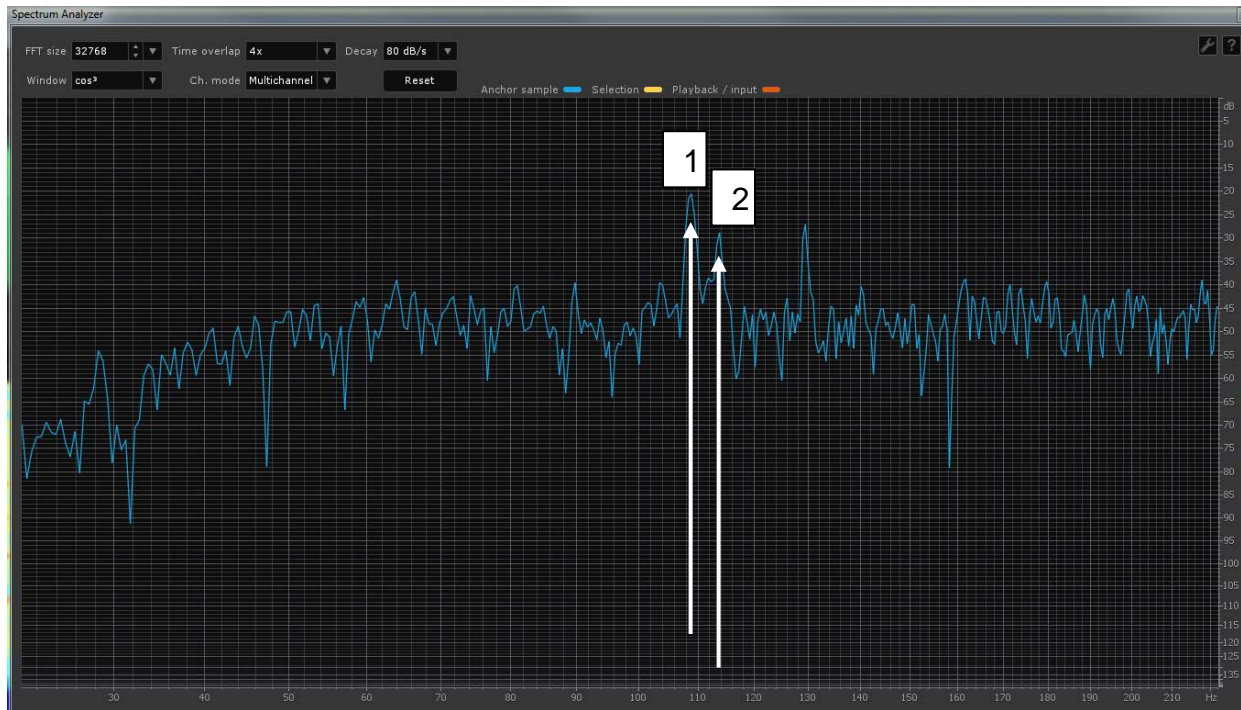
4.8 Data Point 8

Peak 1: 108.8 Hz, identified as Np 1
Peak 2: 113.7 Hz, identified as Np 2

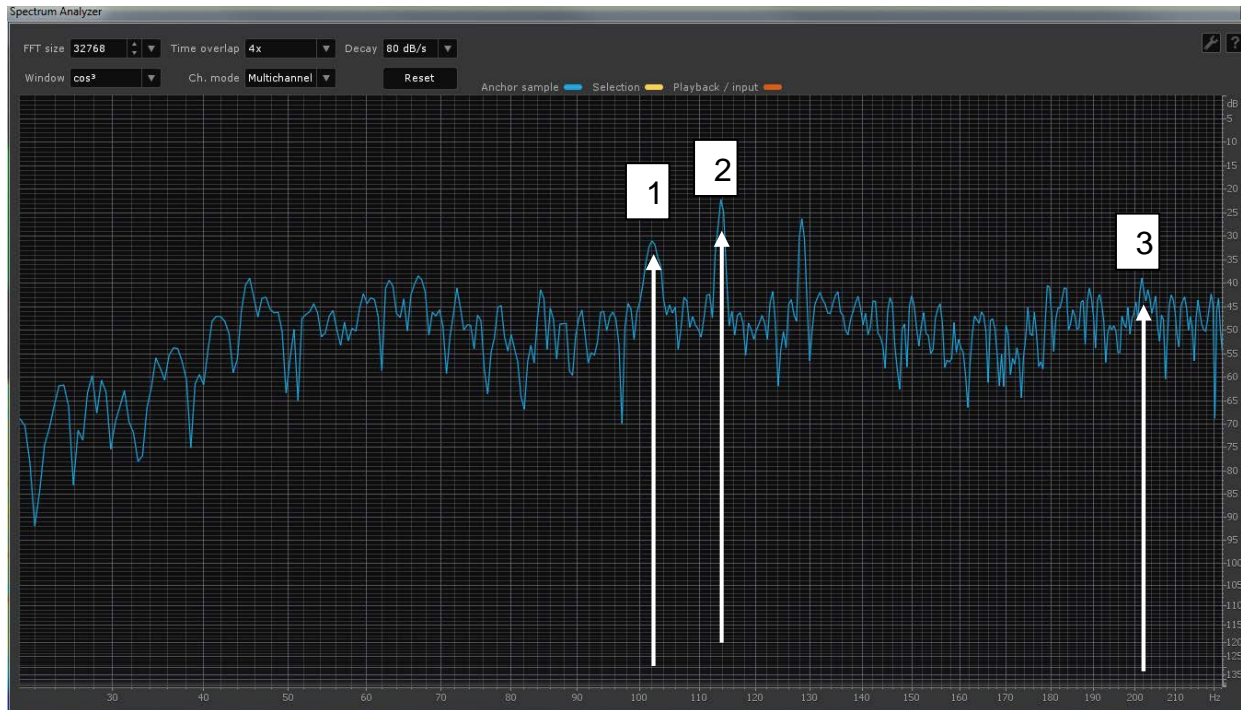
4.9 Data Point 9

Peak 1: 102.1 Hz, identified as Np 1

Peak 2: 113.9 Hz, identified as Np 2

Peak 3: 201.6 Hz, identified as Np 1 overtone

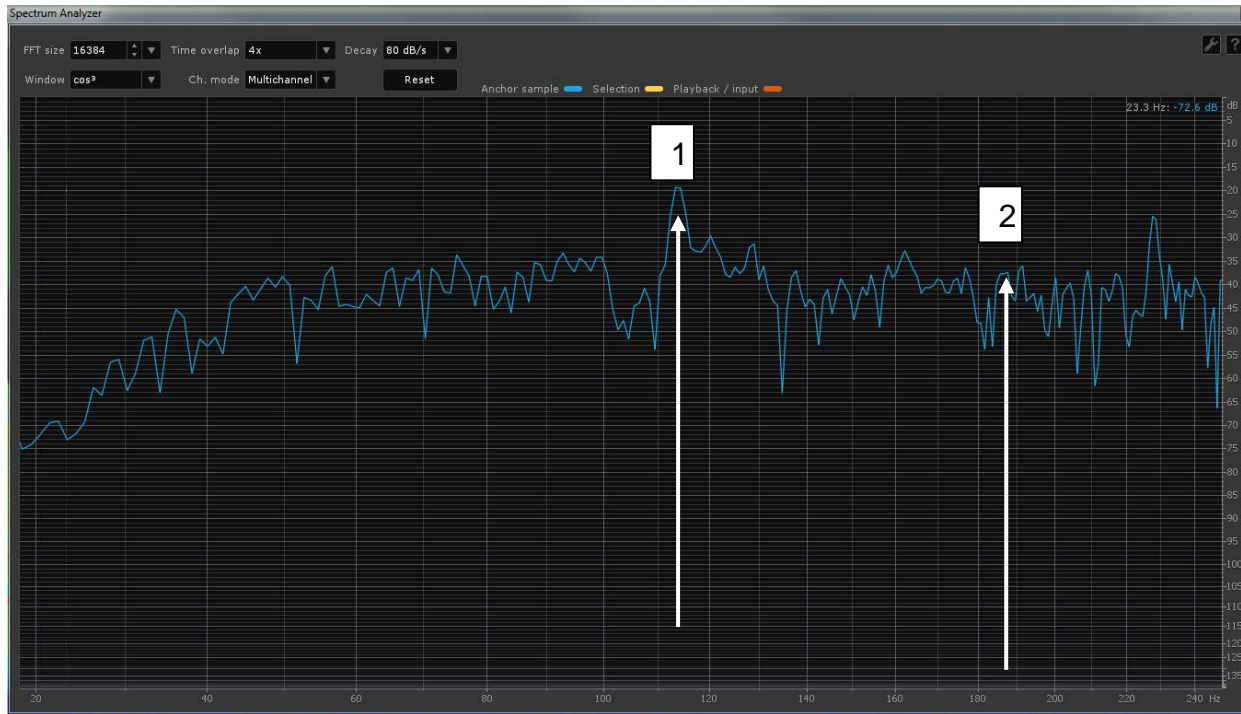
4.10 Data Point 10

Peak 1: 113.6 Hz, identified as Np 2

Peak 2: 187.09 Hz, identified as Np 1 overtone
