**NATIONAL TRANSPORTATION SAFETY BOARD**  
Office of Aviation Safety  
Washington, D.C. 20594

**Structures Group Chairman's Factual Report**

**A. ACCIDENT                      CEN19MA190**

Location:                      Addison Airport, Addison Texas  
Date:                              June 30, 2019  
Time:                              0911 central daylight time  
Aircraft:                        Textron Aviation B300, registration N534FF

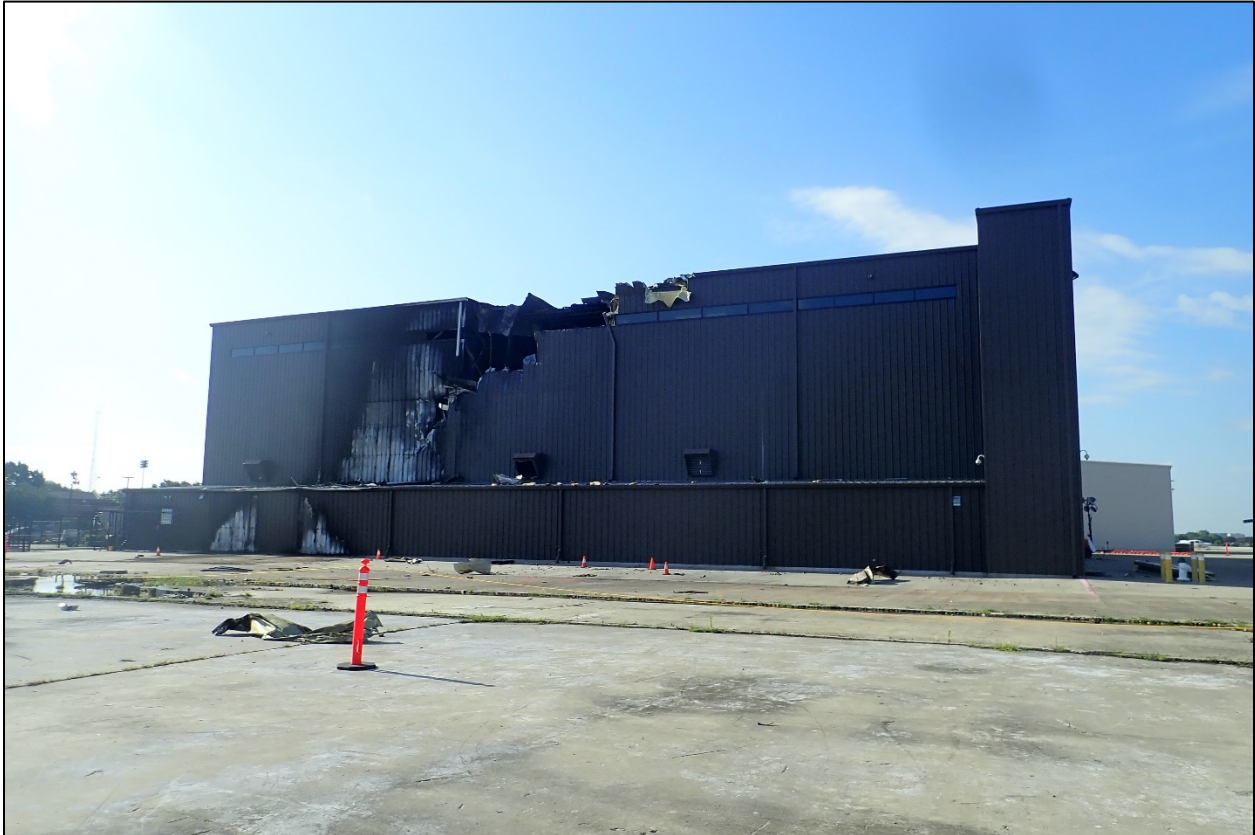
- A (east/west) hangar wall at the first impact point (Figures 2 and 3)

Figure 2 - Side of hangar with initial impact site (at top of wall).

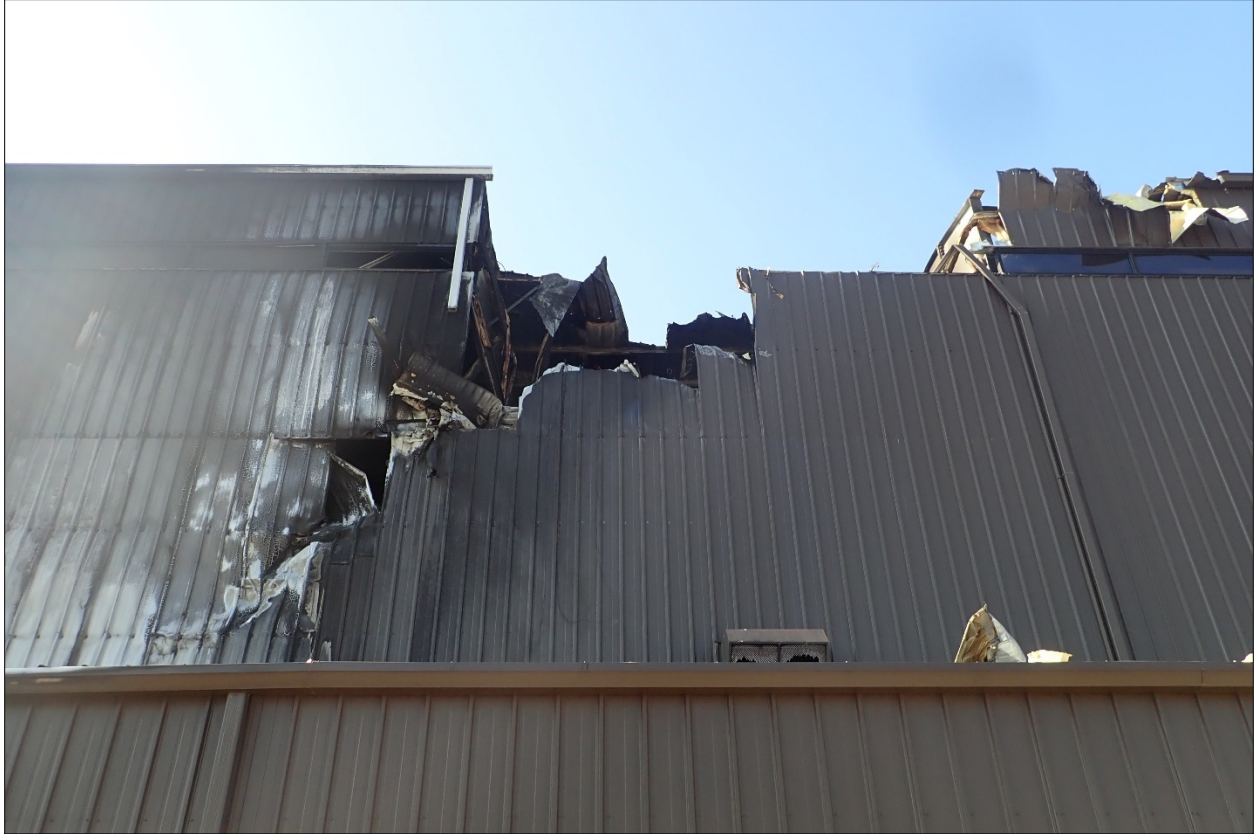
Figure 3 - Close up detail of initial impact location.

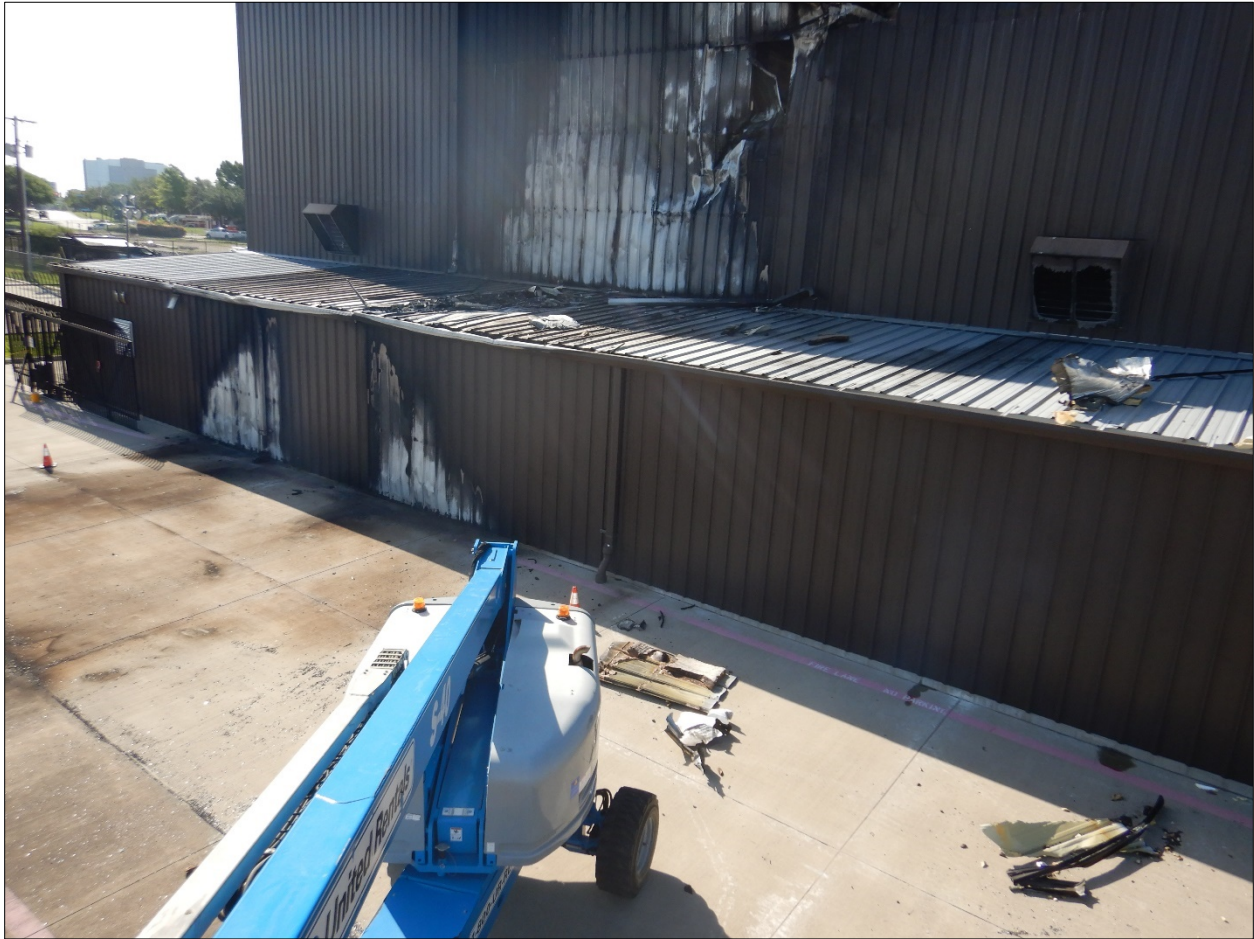
Figure 4 - Lower roof area with airplane debris.

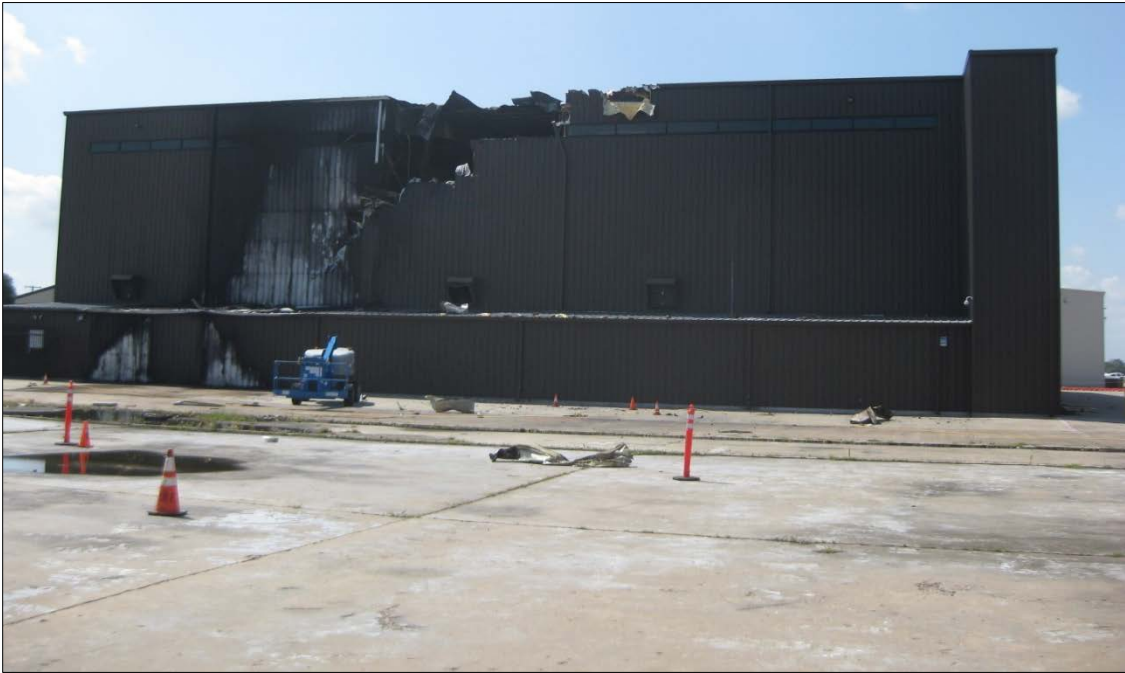
Figure 5 - Ramp area outside hangar, with airplane debris.

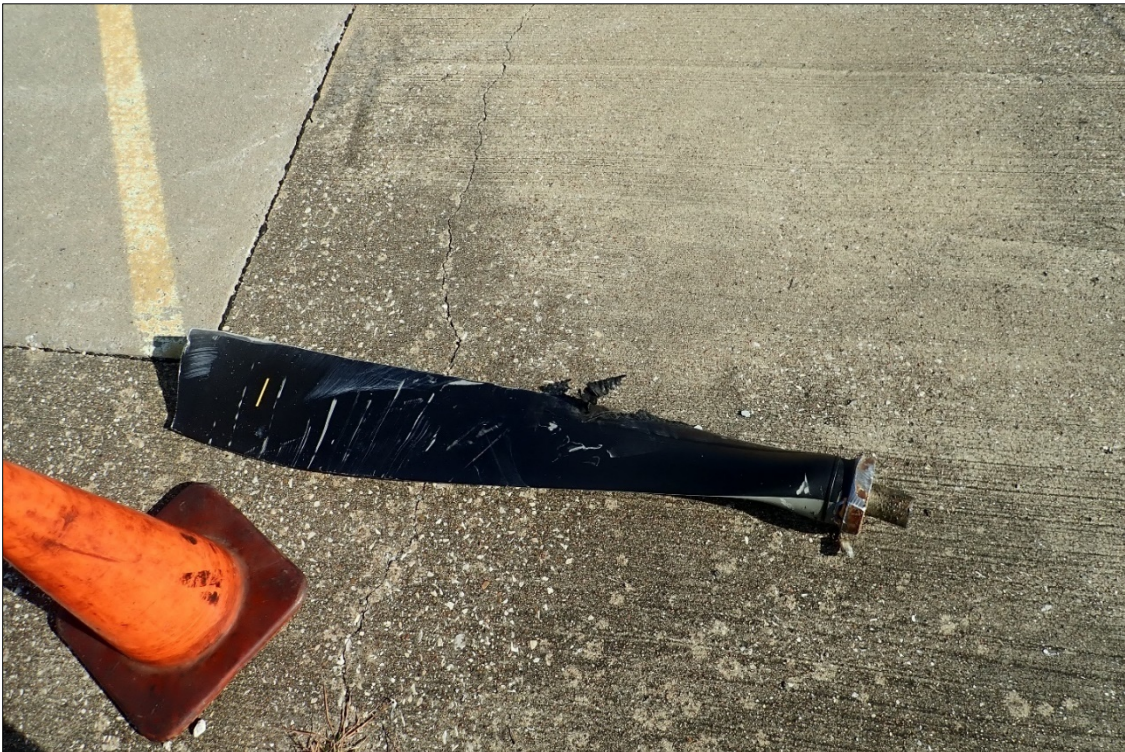
Figure 6 - Example of airplane debris (propeller blade) found on ramp.

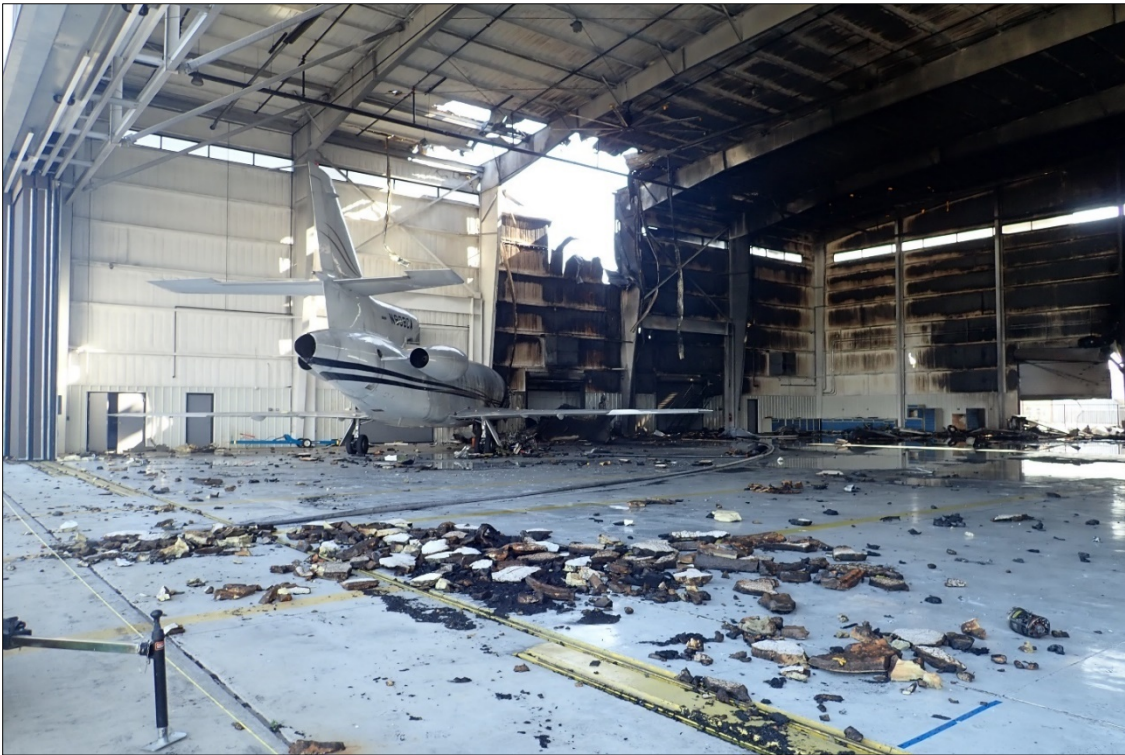
Figure 7 - Airplane and hangar debris located inside hangar.

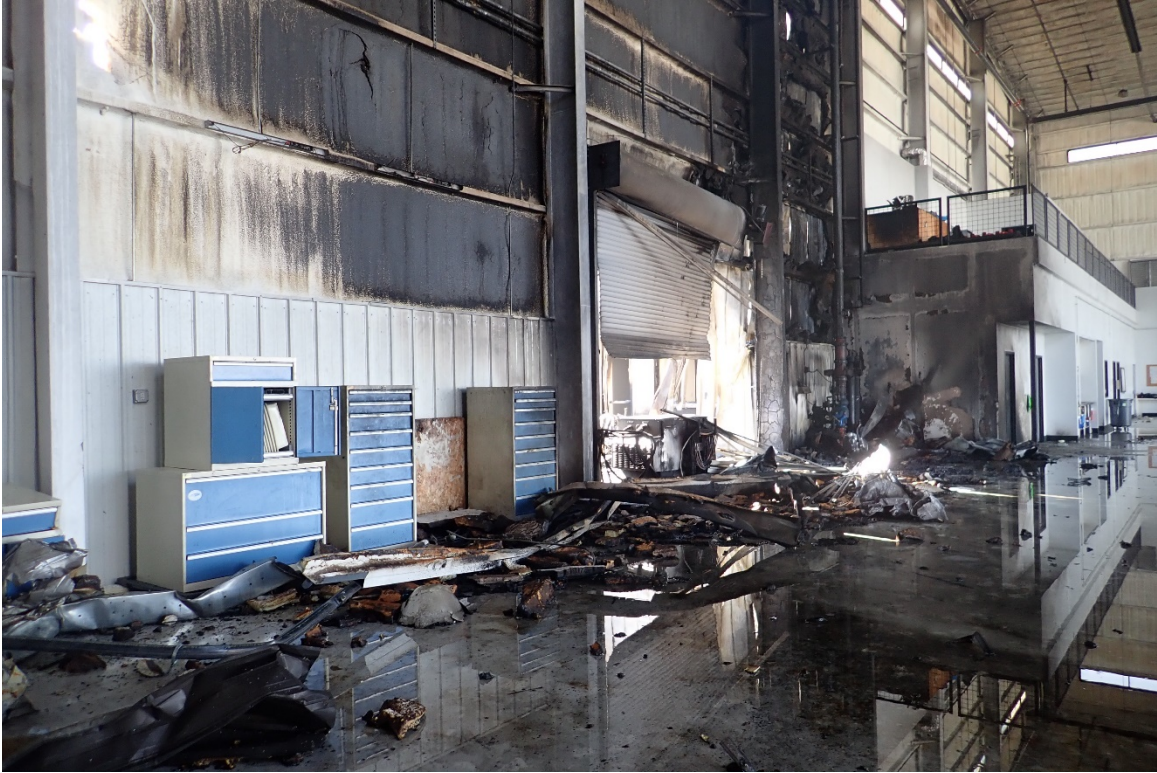
Figure 8 - Inside the hangar, looking at the roll-up door.

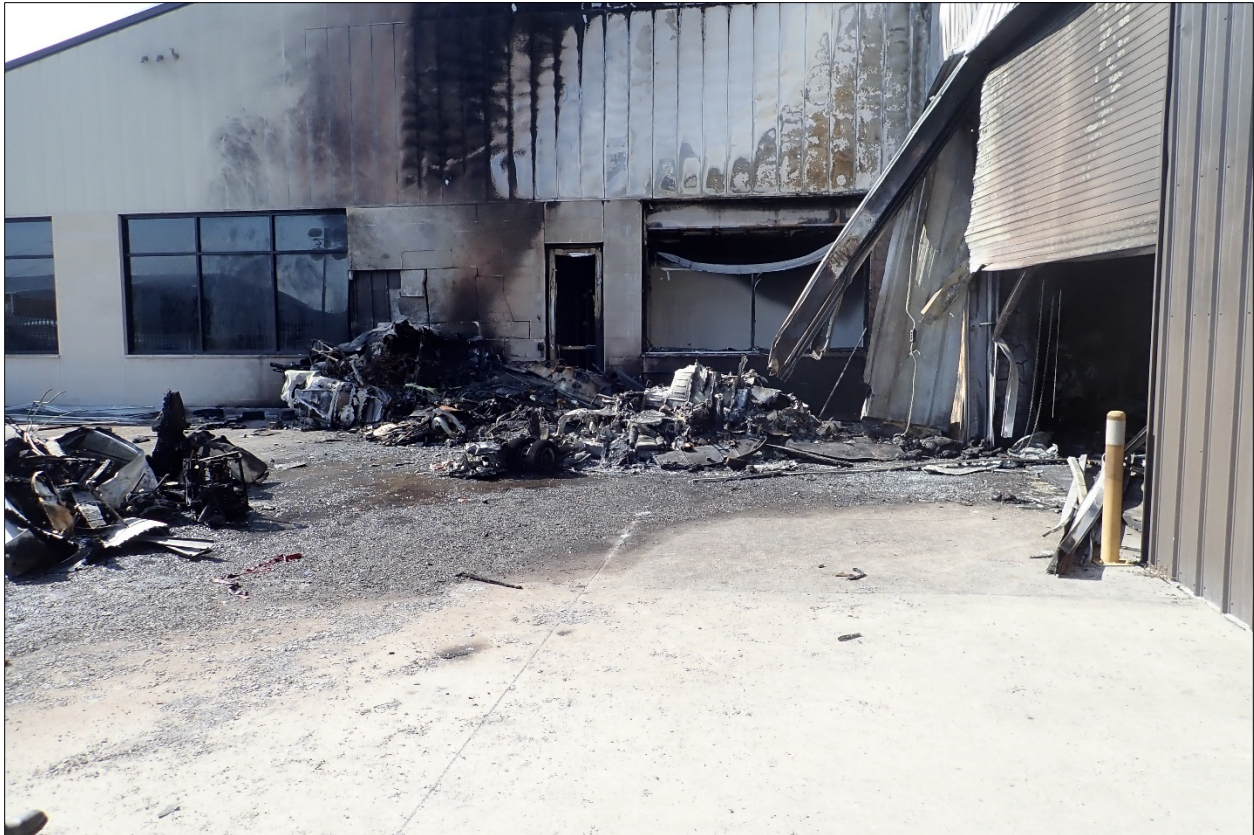
- Behind the hangar. After impacting the hangar roof, the airplane impacted the floor and traveled across the hangar, went through a 14' x 14' roll-up door, and came to rest against an outer wall of the offices attached to the hangar. The lower half of the roller door was separated from the door by the impact. (See Figure 9)

Figure 9 - Wreckage location outside the hangar.

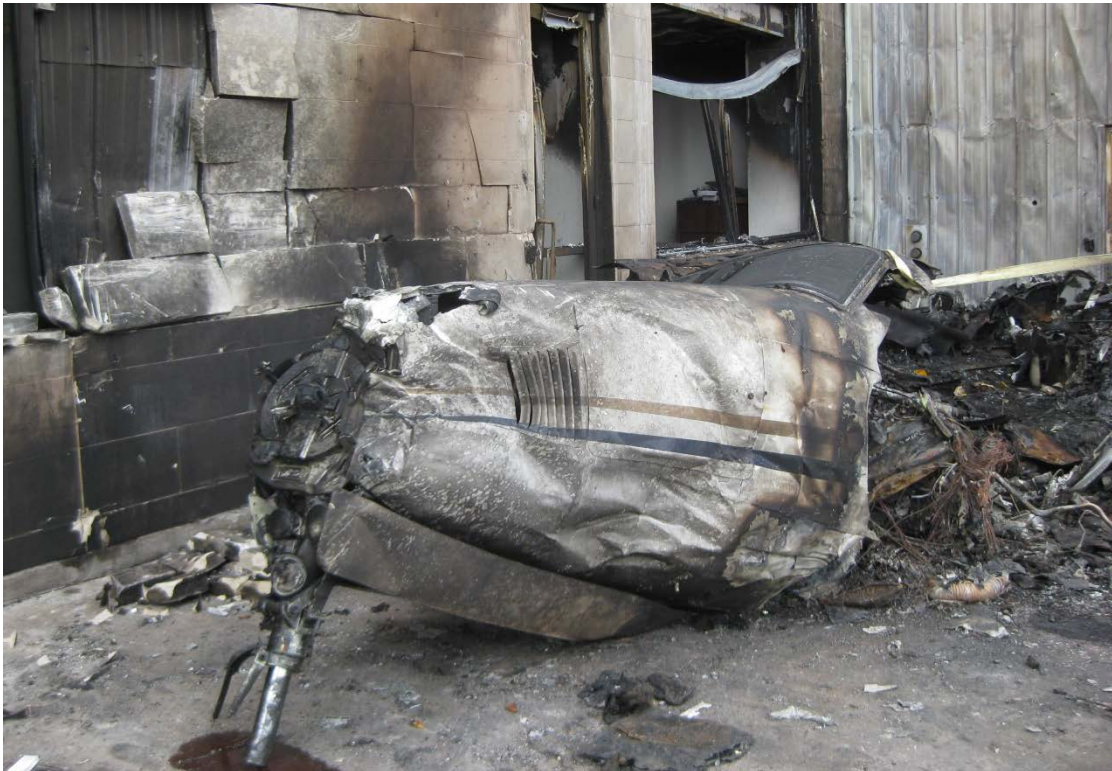
The forward fuselage area, from FS 30 to FS 100 received impact and fire damage. The windshield and overhead cabin were intact aft to FS 147, with sooting and fire damage in the area. Portions of the left side and belly were consumed by fire. The nose landing gear bay area exhibited scorching and sooting. See Figure 10.

Figure 10 - Forward fuselage

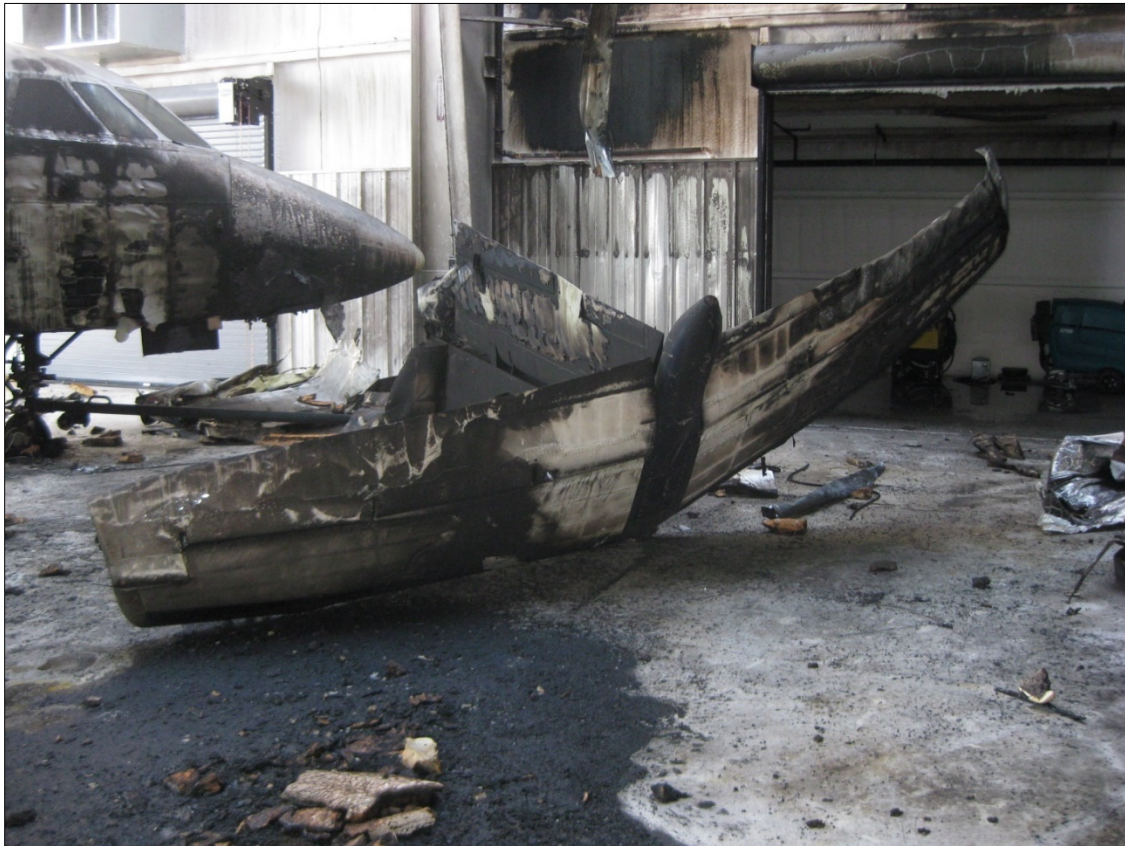
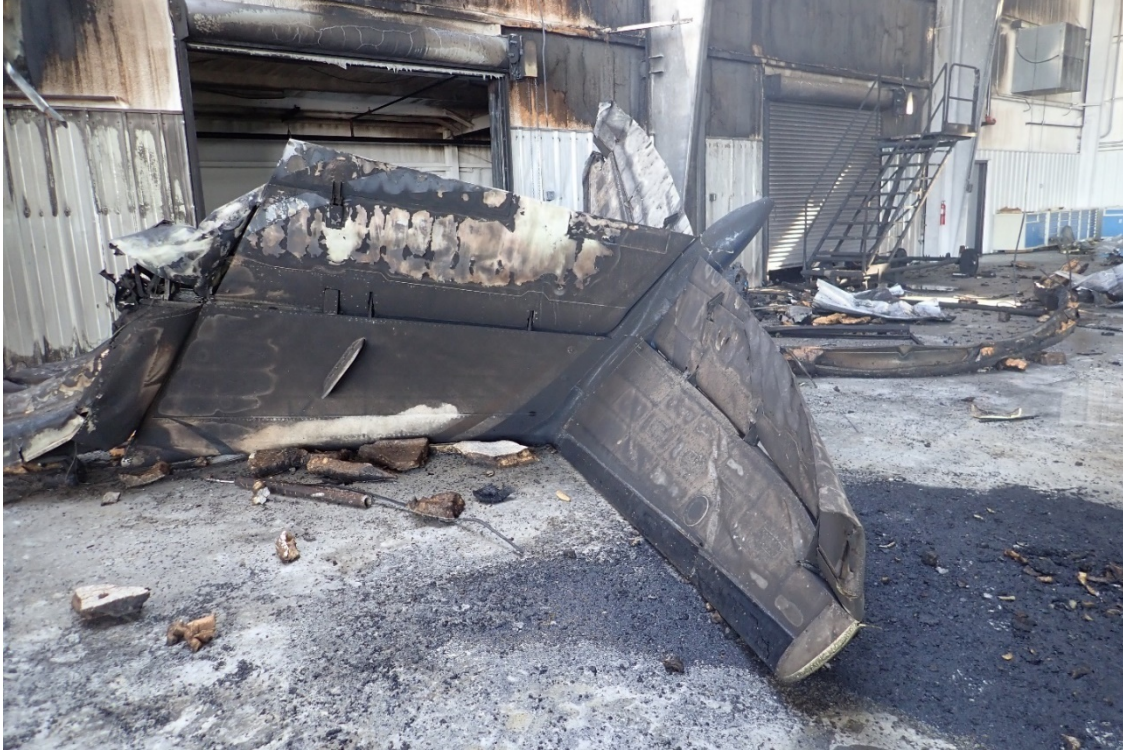
The horizontal and vertical stabilizers were located together in one piece of wreckage, separated from the fuselage. The segment of wreckage was found on the hangar floor, beneath the initial impact point of the airplane with the hangar (Figures 11 and 12). The segment was damaged by fire.

Figure 11 - Horizontal and Vertical Stabilizers, as found.

Figure 12 - Vertical Stabilizer and underside of horizontal stabilizer, in hangar.

The horizontal stabilizers were still connected to the vertical stabilizer. Also connected to the vertical stabilizer was the aft fuselage and tail cone, from CANT FS 435 to CANT FS 471. The fuselage structure below the stabilizer was crushed up to the vertical stabilizer.

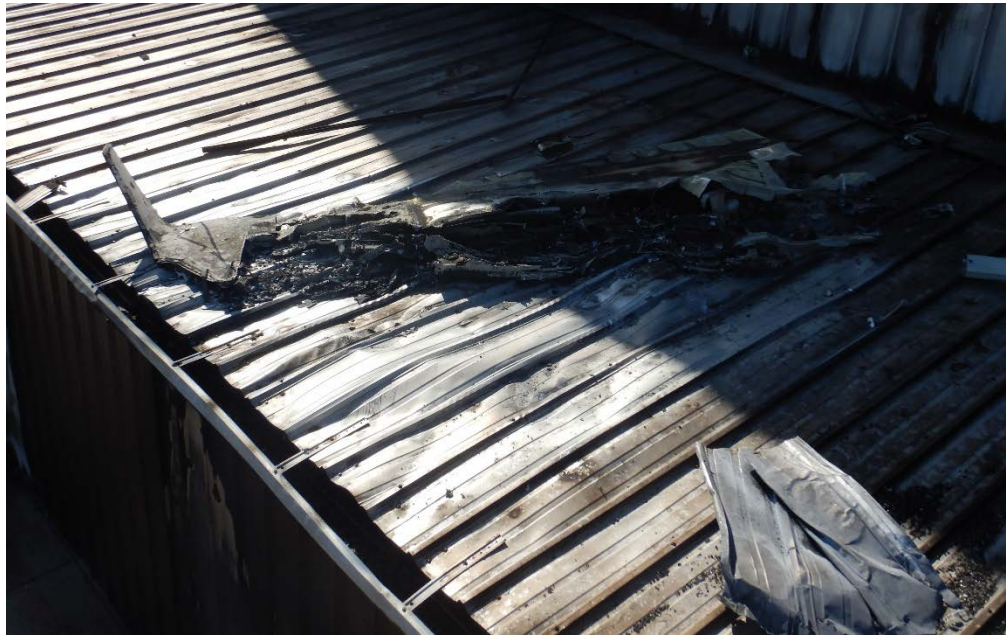
This section of right wing, from wing tip inboard to Wing Station (WS) 328, was recovered from the lower roof of the hangar. This segment may have been broken off from the next piece during recovery. The section sustained fire damage and the fuel cell was compromised. The composite portion of the wing tip was fire damaged and was flexible, exhibiting a loss of structural strength (Figure 13).

Figure 13 - Outer Right Wing and Wingtip, on lower roof. (Pieces A and B)

The piece was recovered from the lower roof of the hangar. Section of the outboard portion of the wing from WS 320 to WS 194. The piece was melted and damaged by fire; the leading-edge section of the wing was consumed by fire. The upper forward spar extended past the section to WS 176. See Figure 13.

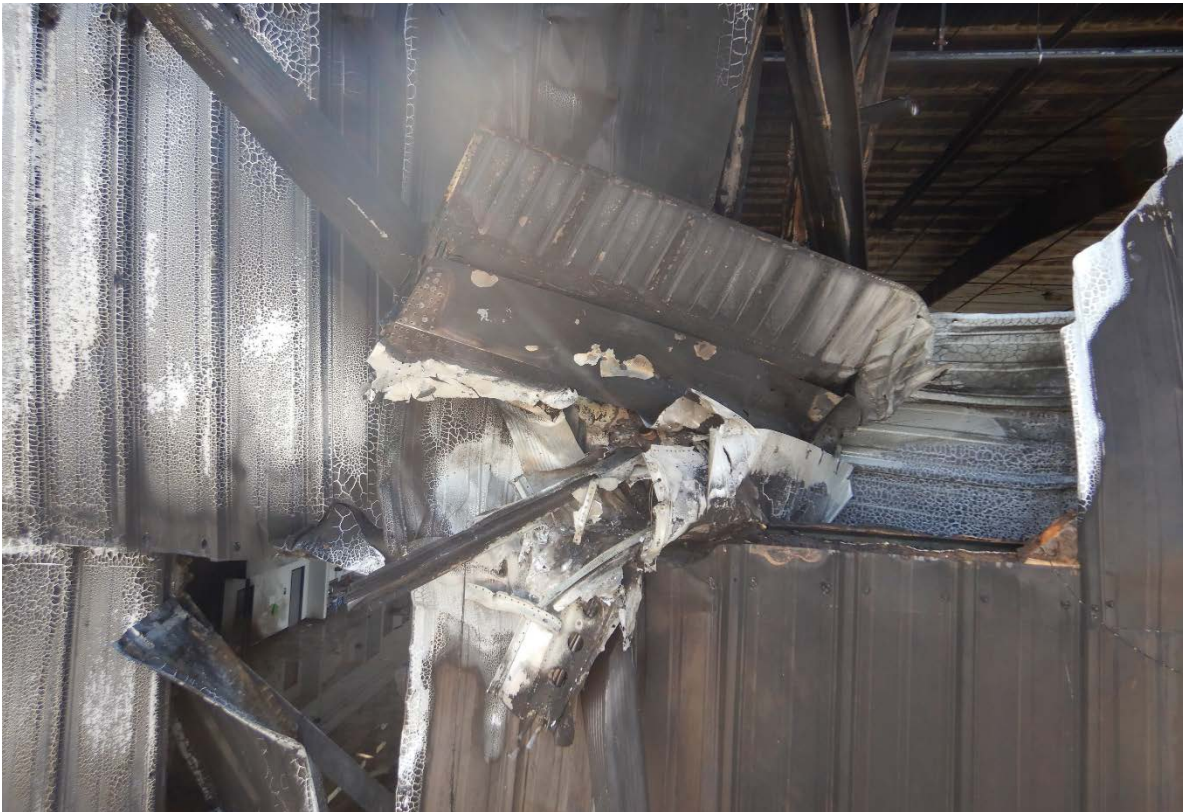
The piece of wreckage was recovered from the hangar wall – the segment was wrapped around a vertical structural member of the hangar wall. The leading edge of the wing segment was “wrapped” about the vertical structural member at about WS 159. The piece extended from WS 194 (the intersection of the aileron and outboard flap) to WS 124 (the outboard end of the nacelle). See Figure 14.

Figure 14 - Section of right wing found in hangar wall at initial impact point (Piece C).

The inner spar portion of the piece was mostly consumed by fire. The leading-edge section and trailing edge (TE) flap sections were damaged by heat.

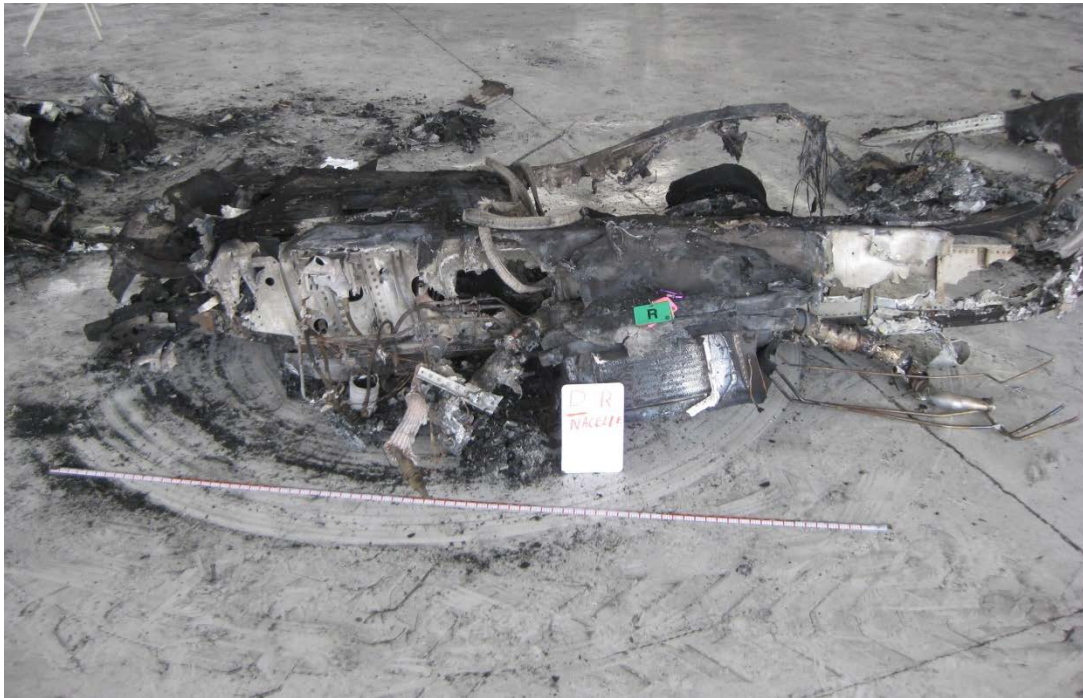
The piece was inboard of nacelle into the center wing section. The piece was found underneath the main fuselage behind the hangar, against the outer hangar wall. The segment extended from WS 124/122 (at the bathtub fitting) to WS 25 (or Buttock Line {BL} 25). A portion of the right main landing gear was noted in the segment, but the gear was noted displaced inboard. See Figure 15.

Figure 15 - Right hand wing Piece D, moved from found location outside the hangar.

The segment exhibited fire/heat damage. The lower main spar cap extended into BL 0 and was partially consumed by fire. The upper main spar appeared to extend to the cabin line at the tip at approximately BL 25.

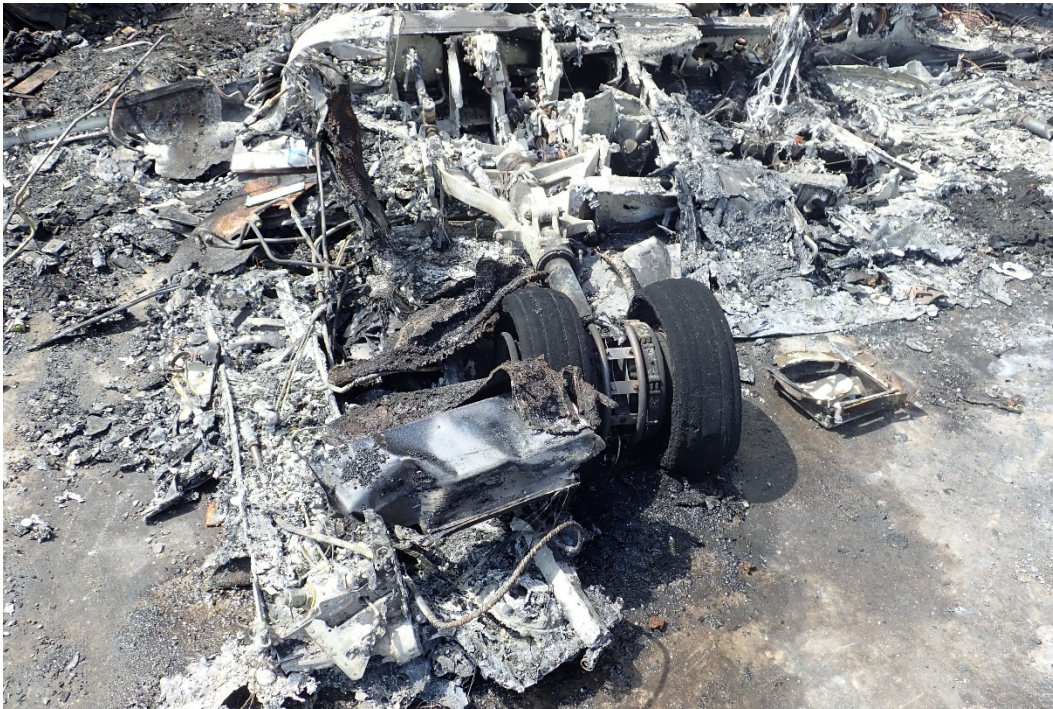
The piece was laid upside down, as it was located and identified upside down, behind the hangar, partially underneath the main fuselage. The piece was damaged by fire and heat and mostly consumed. The piece extended from BL 25 to WS 194, where the outboard flap meets the aileron. The flap was mostly consumed by fire. Some rear spar was noted in the area near the main landing gear. Most of the lower wing consumed by fire. The leading edge was only identifiable in a short segment. See Figure 16.

Figure 16 - Portion of Left Wing (Piece E) found with main wreckage.

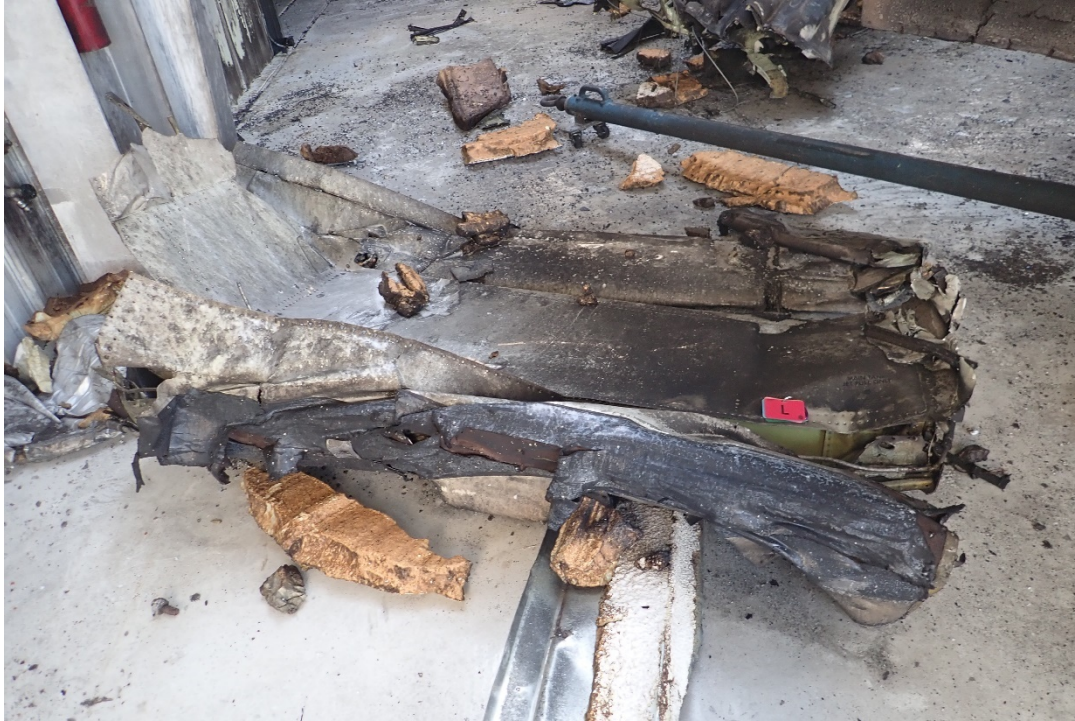
The piece was estimated in length from WS 194 to WS 296 and was found inside the hangar, near the nose of another airplane parked in the hangar. The piece was crushed and sooted, but little fire damage was noted. See Figure 17.

Figure 17 - Portion of Left Wing (Piece F), as found in the hangar, below the initial impact point.

The aileron was attached to the inner spar section at the inboard hinge point. The aileron showed impact damage out to WS 296, the entire aileron was noted but crushed.

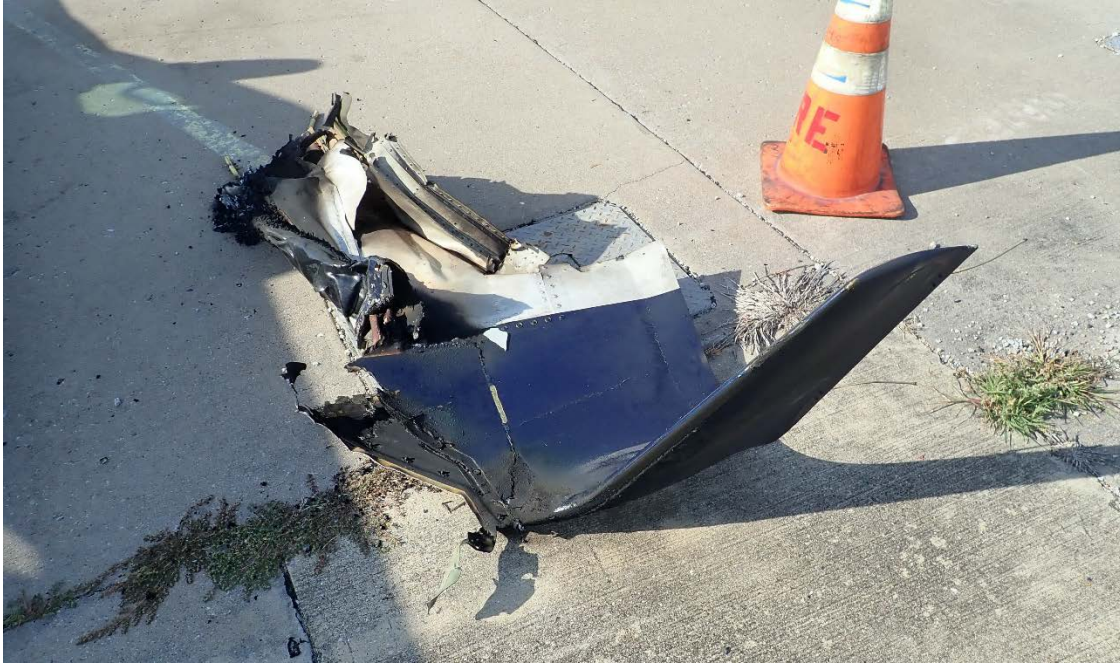
The piece was from WS 296 to the wing tip. The piece was recovered from the ramp area outside the hangar. The leading edge was bent upward and aft at about WS 328. The inner spar section at WS 294, the trailing edge was folded forward and outboard. See Figure 18.

Figure 18 - Left wing tip section (Piece G), found outside hangar on the ramp area.

The wingtip light assembly was missing from the wreckage piece, but the light assembly was noted elsewhere in the wreckage. The wingtip was scorched but some paint was still visible.

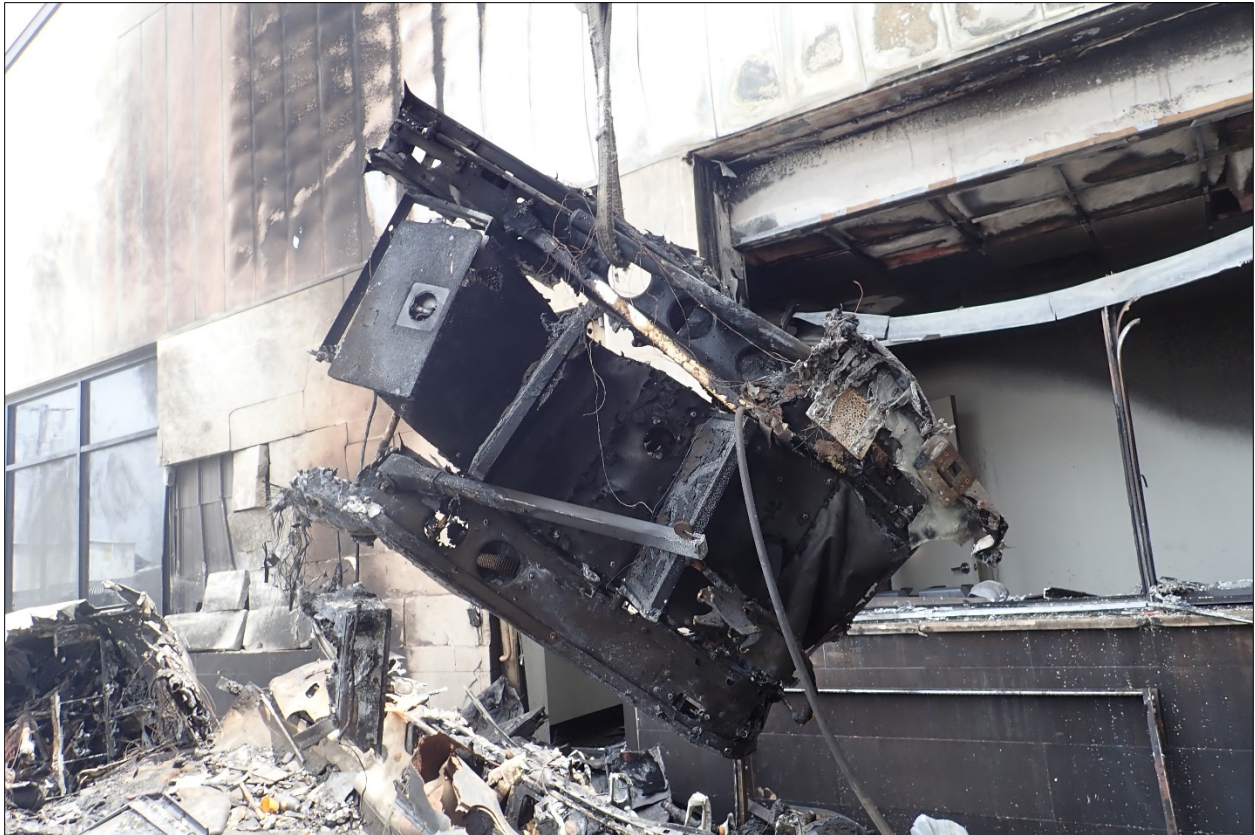
The aft cabin door was located in the wreckage. There was no evidence that the door was opened. See Figure 19.

Figure 19 - Cabin Door

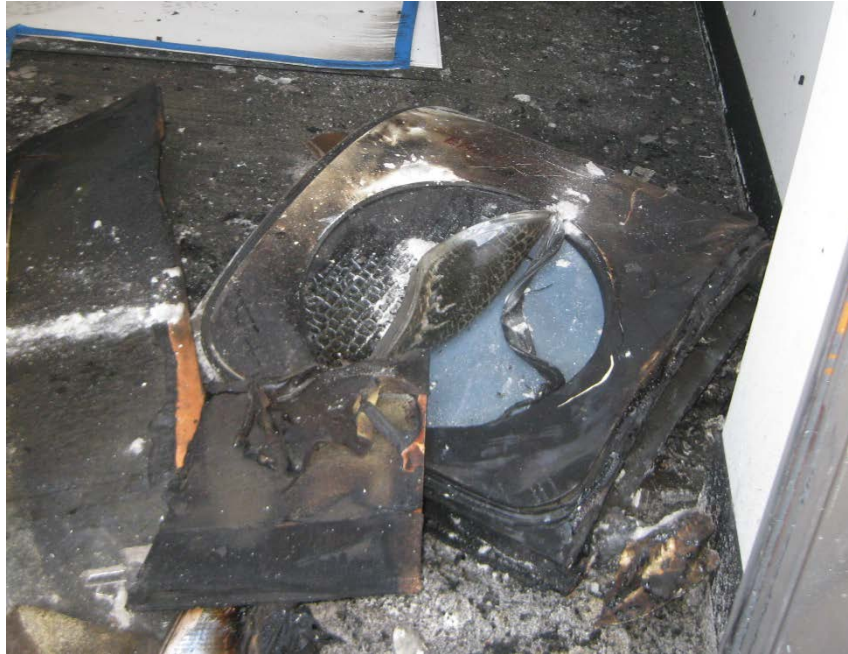
The airplane was equipped with two emergency exit doors, one on each side of the cabin. One door was located in the wreckage, inside the hangar office door hallway, next to the main fuselage wreckage site. See Figure 20. The exit was too damaged by fire and impact forces to determine whether the hatch had been opened. The other door was not identified in the wreckage.

Figure 20 - Emergency Exit Hatch
