National Transportation Safety Board

Performance Study

Specialist Report

Location: Addison, Texas
Date: June 30, 2019
Time: 0911 central daylight time (CDT)
Aircraft: Textron Aviation B300, N534FF
NTSB Number: CEN19MA190

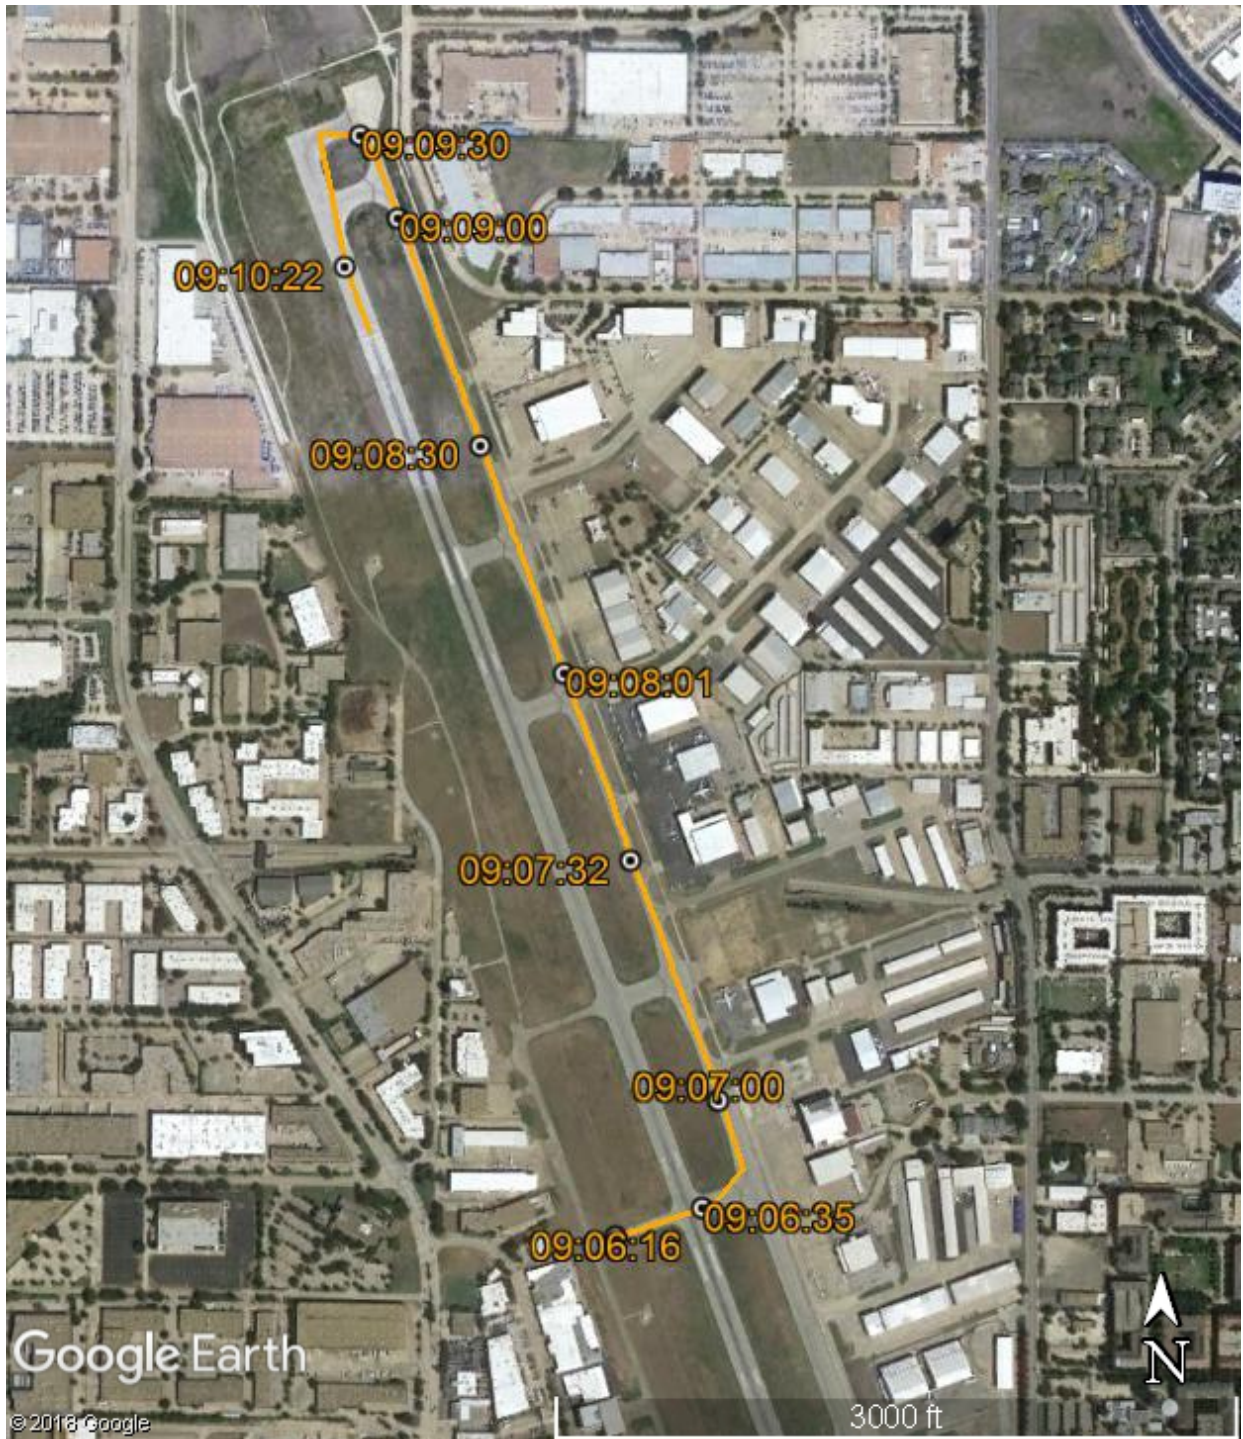
Figure 1. Accident airplane's taxi path from ADS-B.

The airplane was taking off from runway 15 at Addison Airport at the time of the accident. Runway 15 is 7,203 ft long and 100 ft wide and it has a 979 ft long displaced threshold. Its elevation is 636 ft. Figure 1 shows the airplane taxiing from the west side of the airport, across taxiway E, and then north to the displaced threshold of runway 15. The total time from the start of the ADS-B data to runway 15 was less than four minutes.

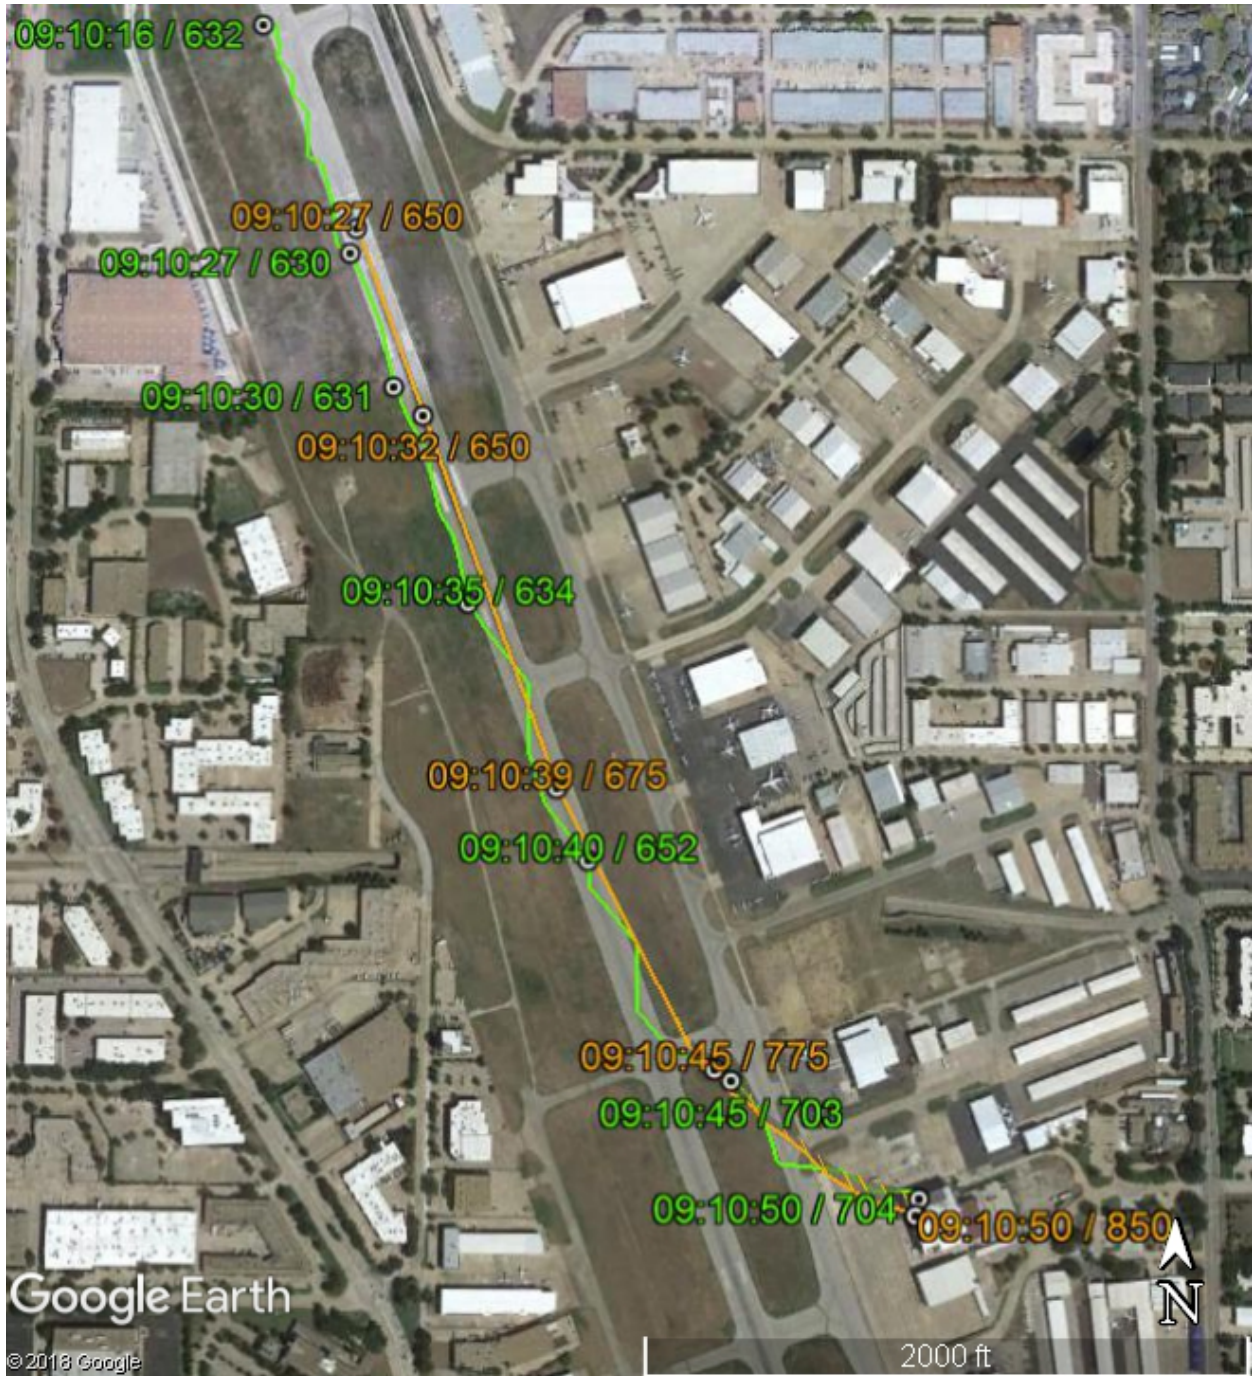
Figure 2. Accident flight with ADS-B data in orange and TAWS data in green.

Figure 2 shows a both the ADS-B (orange) and TAWS (green) data of the take-off roll and accident flight. The ADS-B data was sparse during the take-off roll, only recording five data points between 09:10:27 and 09:10:44. The ADS-B path tracked the centerline of the runway until sometime between 09:10:39 and 09:10:44 when it began to track left. The TAWS data was recorded once a second, but the position data was noisy and showed the airplane path along the right edge of the

runway, which was not consistent with the ADS-B data and other accident accounts. However, the TAWS path did track left in a similar manner to the ADS-B data, beginning just after 09:10:40. Additionally, the TAWS recorded roll angles (which will be discussed further in *Reduction in left engine propeller speed*), and it recorded a left roll beginning about the same time. Note the recorded altitudes between the two data sources also disagreed throughout the flight.

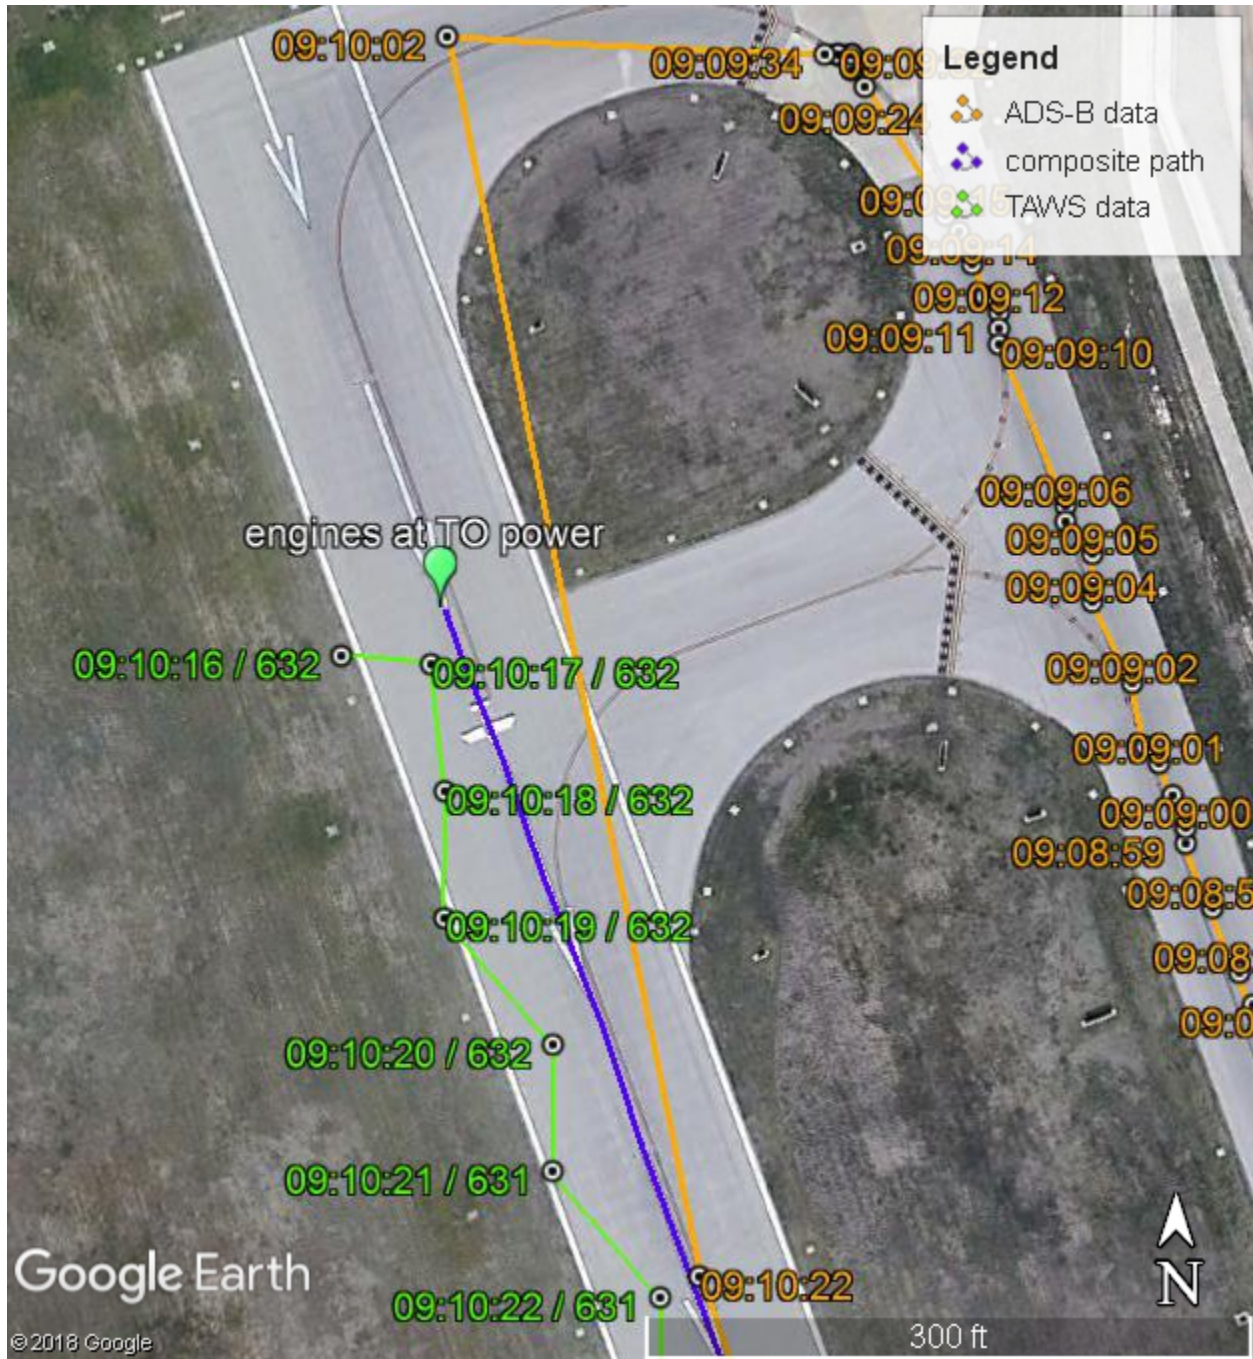
Figure 3. TAWS (green) and ADS-B (orange) at beginning of take-off roll.

Figure 3 shows TAWS and ADS-B data before the runway threshold. The engines were at take-off power at 09:10:16. There was no ADS-B data between 09:10:10 and 09:10:22, and so ADS-B could not be used to determine the location of the beginning of the ground roll. TAWS data was recorded during this time, but the latitude and longitude were irregular. Therefore, the TAWS data was shifted to align with the runway centerline to be consistent with the ADS-B data and the beginning of the ground roll was determined to be at 09:10:16, about 700 ft before the threshold of runway 15. The composite path, shown in purple, is a combination of the ADS-B and TAWS data.

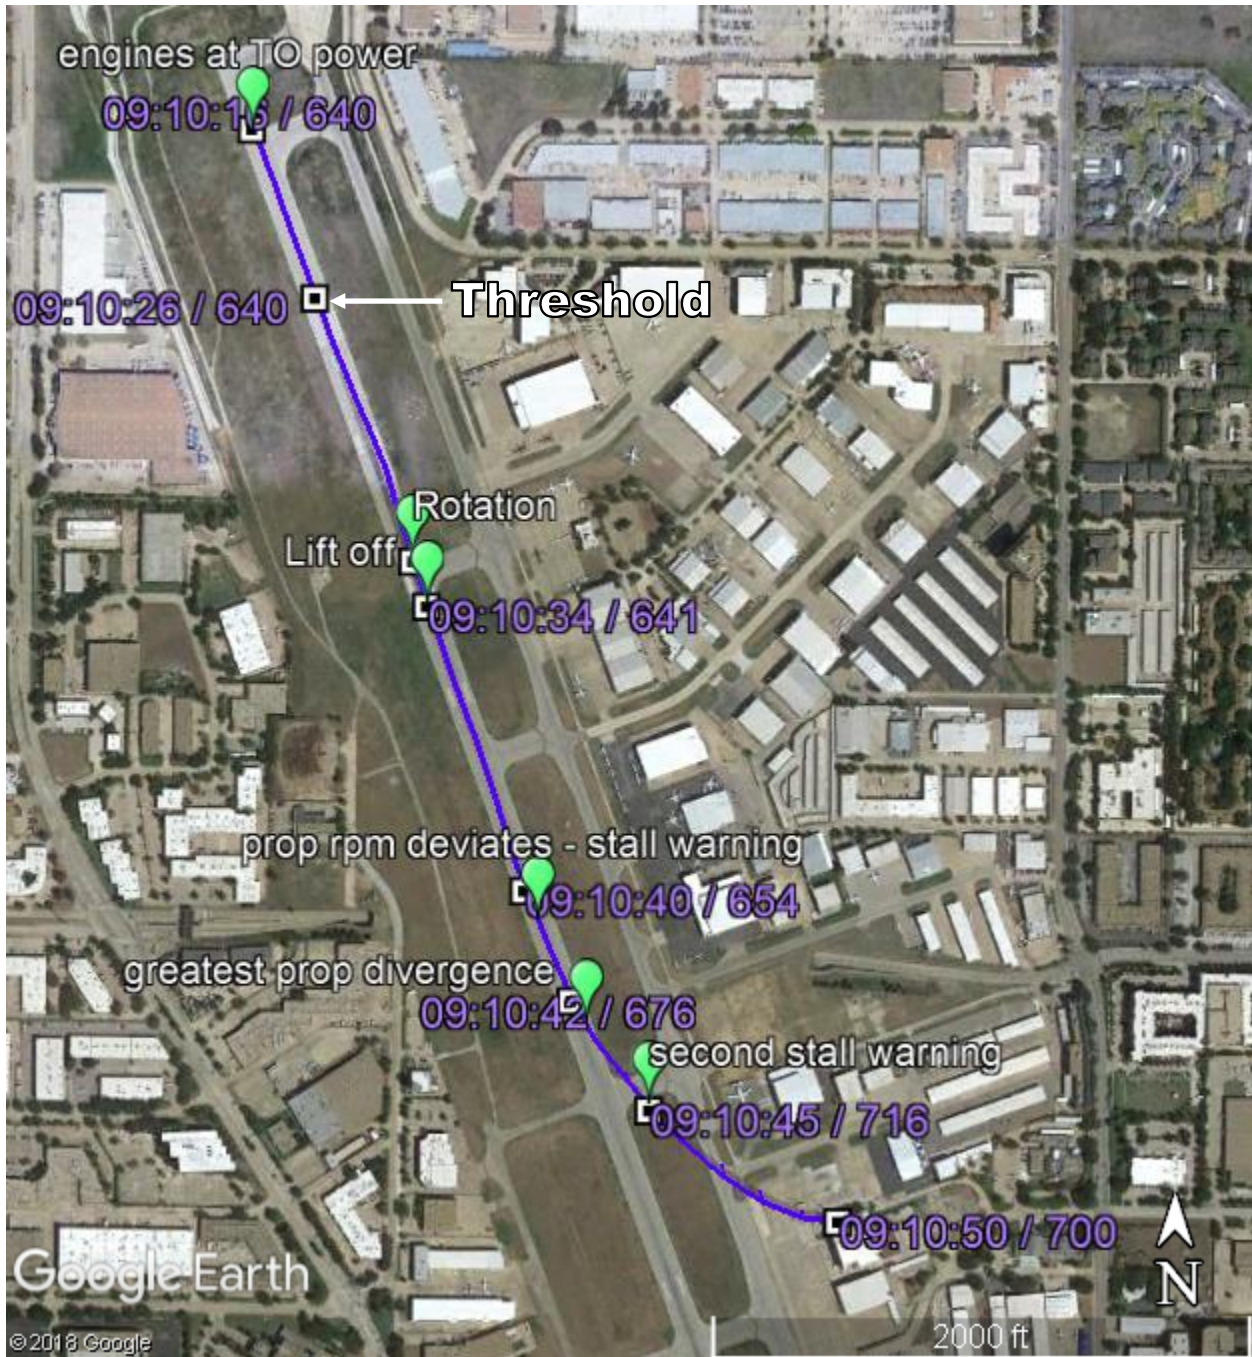
Figure 4. Composite flight path with CVR events.

Figure 4 shows the composite path of the airplane with CVR annotation. The airplane followed a straight path along the runway until, at 09:10:40.5 on the CVR, the propeller sounds diverged, and the airplane's stall warning annunciated. At this point, the airplane began to track left. The greatest recorded difference in propeller sound was noted at 09:10:42.7 and the stall warning continued until 09:10:43. The stall warning began again at 09:10:45 and continued until the end of flight.

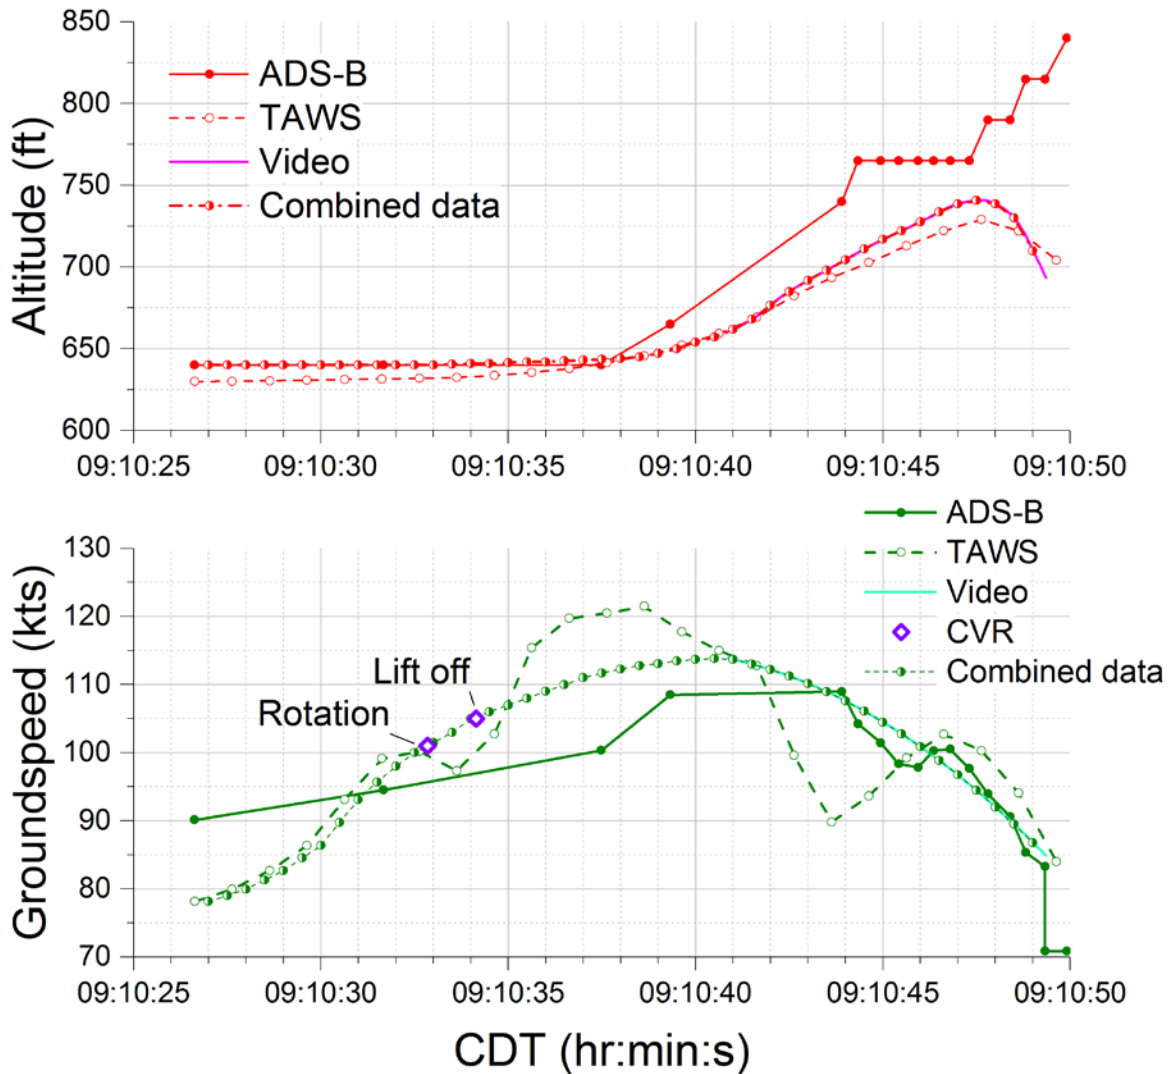
Figure 5. Accident flight altitude and groundspeed from multiple sources.

The altitude for the composite path is shown in Figure 5 with the recorded altitude from ADS-B, TAWS, and the video analysis (height above ground plus a ground elevation of 640 ft). Also included is the calculated groundspeed from ADS-B, a smoothed TAWS track, the video analysis, and the CVR groundspeed estimate at rotation and lift-off. The composite flight path altitude and groundspeed derived from the recorded data are labeled as “combined” in the figure. Data from the CVR and video analysis were weighted heavily, but ADS-B and TAWS data were also incorporated.

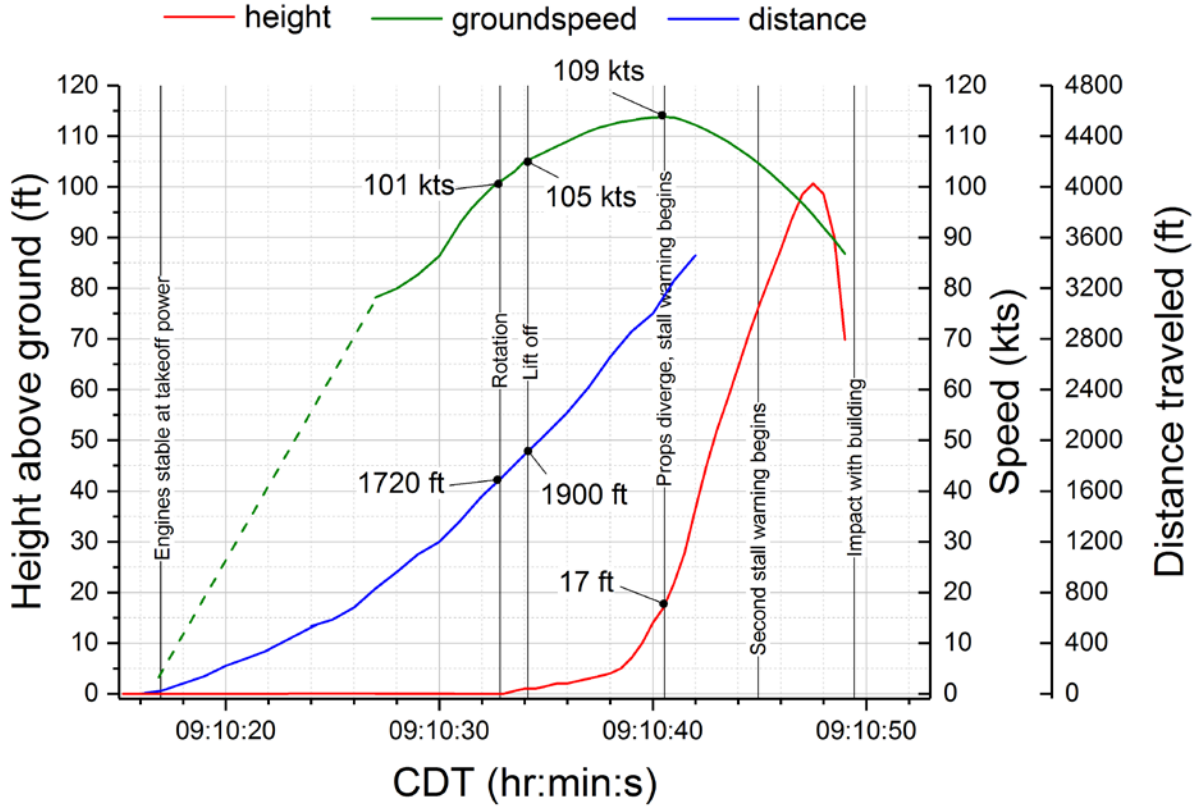
Figure 6. Height above ground, groundspeed, distance traveled, and selected CVR events.

Figure 6 shows the height above ground and groundspeed of the accident flight with selected CVR events. Engines were stable at take-off power at 09:10:16, which was selected to be the start of the take-off roll and the beginning of distance traveled down the runway. Rotation occurred at 09:10:32.8 according to the CVR, when the groundspeed was estimated to be 101 kts (102 kts calibrated airspeed), 1,720 ft down the runway. The airplane lifted off at 09:10:34, at a groundspeed of 105 kts (106 kts calibrated airspeed) and 1,900 ft from the beginning of the take-off roll. At 09:10:40.5, at 109 kts (calibrated airspeed 110 kts) and 17 ft above the runway, the CVR recorded the sound of the left and right propeller speeds diverging and a stall warning alarmed in the cockpit. The initial stall warning ended at 09:10:43, then a second began at 09:10:45.

By 09:10:43, the airplane passed over the left edge of runway 15. It continued to climb while turning to the left, reaching a maximum altitude of 100 ft above the ground just before 09:10:48, shortly before impacting the hangar.

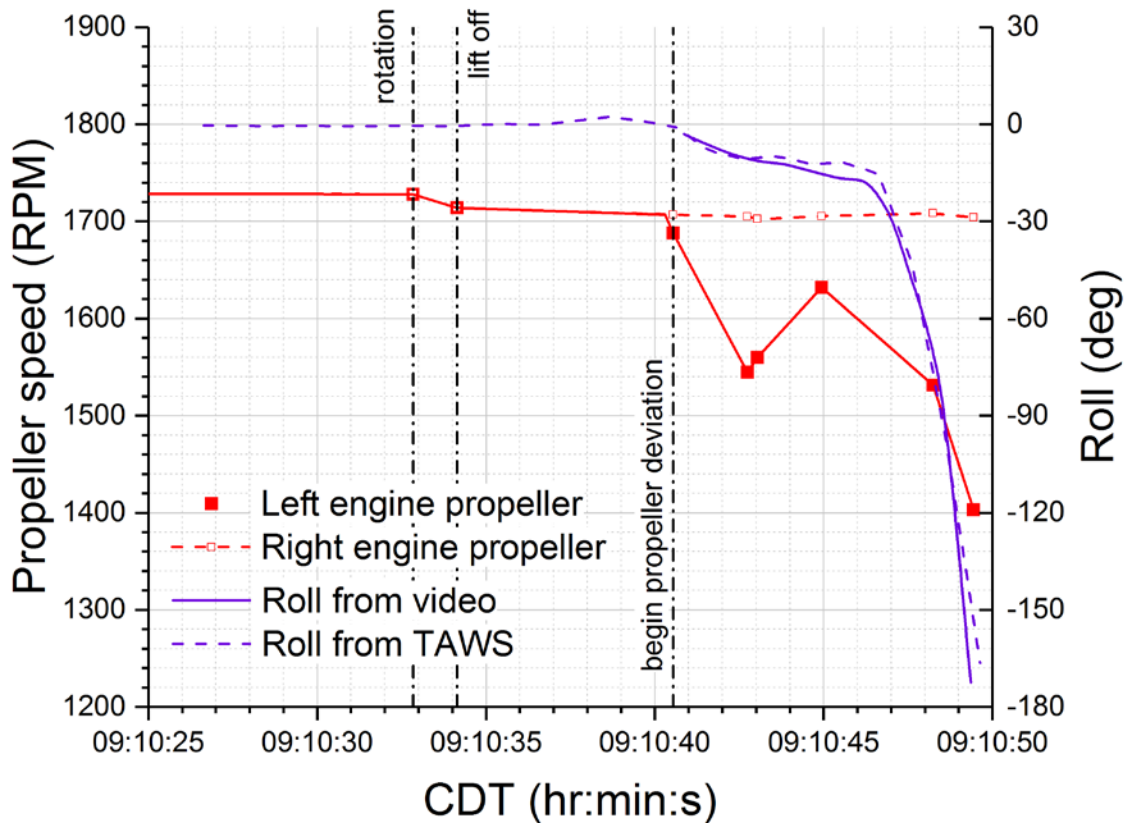
Figure 7. Accident flight propeller speeds and airplane roll angle.

Figure 7 shows the propeller speeds as determined from the CVR. Propeller speeds at the time of lift-off were estimated to be 1,714 RPM to 1,748 RPM. The CVR report found that the propeller sound was consistent between engines until 09:10:40.5 when the left engine’s propeller speed (1,688 RPM) slowed in comparison to the right (1,707 RPM). By 09:10:42.7, the left engine propeller speed was 1,545 RPM. It rebounded to 1,632 RPM by 09:10:44.9 before further falling. By the end of the recording, the left engine was at 1,403 RPM, while the right was above 1,700 RPM. The propeller speed deviation corresponded with the airplane’s left roll. The figure shows the roll from the video and the roll recorded by the TAWS. The airplane rolls from a wings level attitude to -10.6° in the two seconds after the beginning of the propeller speed deviation. This initial roll rate for the first five seconds after the event was about $-5^\circ/s$. Then, the roll rate rapidly increased to over $-60^\circ/s$ by 09:10:49 and the airplane rolled inverted.

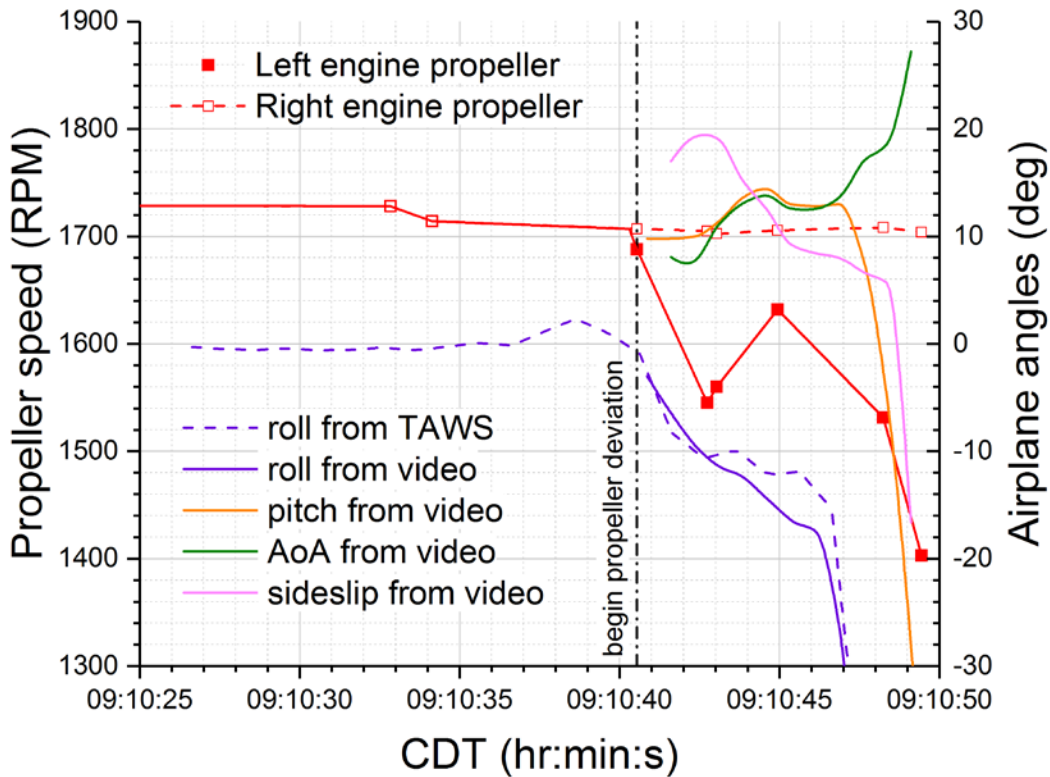
Figure 8. Accident flight propeller speeds and airplane roll, pitch, angle of attack (AoA), and sideslip.

In addition to roll, the video analysis estimated the airplane’s pitch, angle of attack (AoA), and sideslip angle. In Figure 8, the roll angle is truncated to more clearly show the changes in pitch, AoA (α), and sideslip (β). Sideslip was greater than 16° nose left one second after the first record of propeller speed deviation but decreased as the airplane continued to roll to the left. By 09:10:42, the airplane’s flight path was tracking to the left (Figure 4). Pitch and angle of attack increased together to about 13° , when the roll rate drastically increased. AoA increased to nearly 30° while the airplane rapidly pitched down. After the propeller speed deviation, the airplane was slowing and experiencing large changes in attitude, which is consistent with the stall warnings heard in the cockpit.

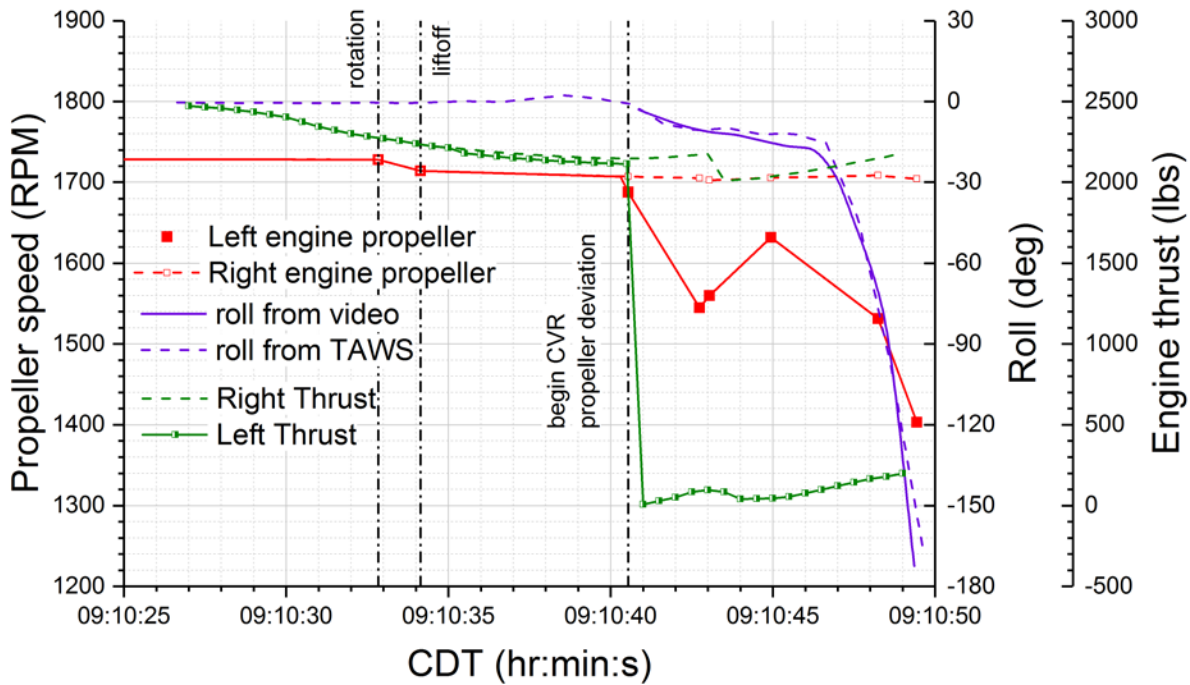
Figure 9. Accident flight propeller speeds, engine thrust, and airplane roll.

Hartzell Propeller Inc. provide engine power and propeller thrust estimates based on the airplane's speed and propeller RPM from the CVR. Hartzell stated that propeller thrust is relatively insensitive to inflow angles (angle of attack and sideslip) less than 30°. Figure 9 shows that when the left engine propeller speed dropped from 1,700 to 1,550 RPM, the thrust produced by the left engine dropped to near zero. The right engine was still producing over 2,000 lbs of thrust until the end of flight. The thrust disparity was consistent with the left yaw and roll of the airplane.

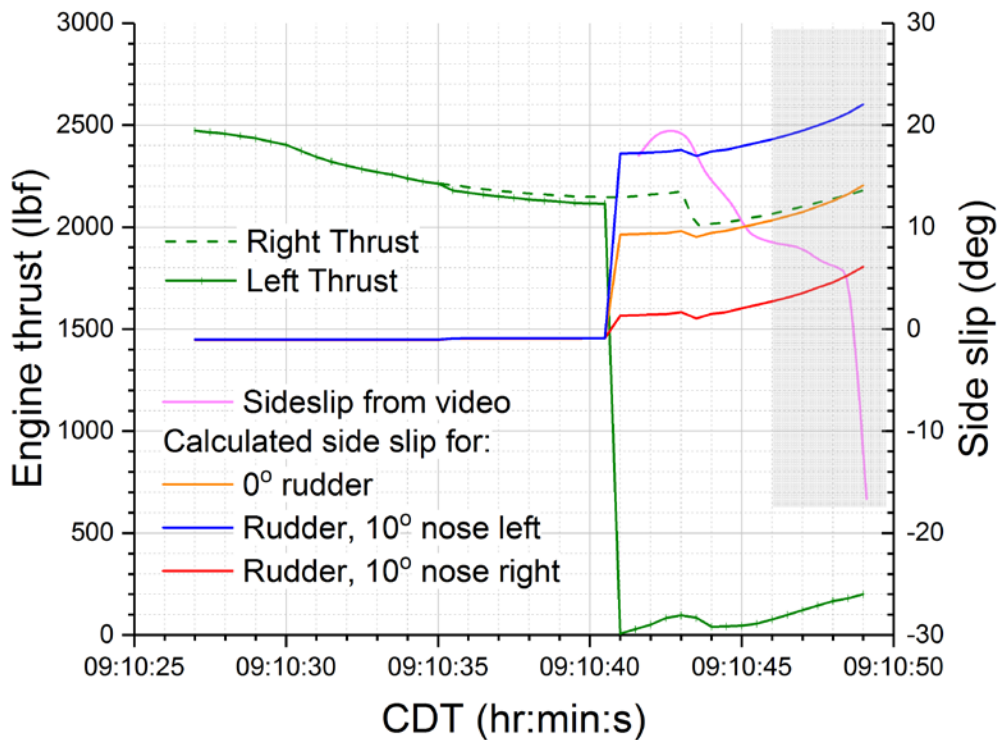
Figure 10. Calculated sideslip for 10° nose left rudder, no rudder, and 10° nose right rudder versus accident sideslip from the video analysis.

Figure 10 shows the resultant calculated sideslip from no rudder, 10° nose left rudder, and 10° nose right rudder versus the accident sideslip from the video analysis. The shaded region is a region of lower calculation confidence as the airplane roll angle rapidly increased. The initial accident sideslip angle is consistent with nose left rudder before moving towards nose right rudder. Figure 11 shows only the calculated rudder to result in the accident sideslip. Two seconds after the divergence in engine thrust, calculated rudder is about 11° nose left. Two seconds later, left rudder has decreased, passing through zero rudder to right rudder input.

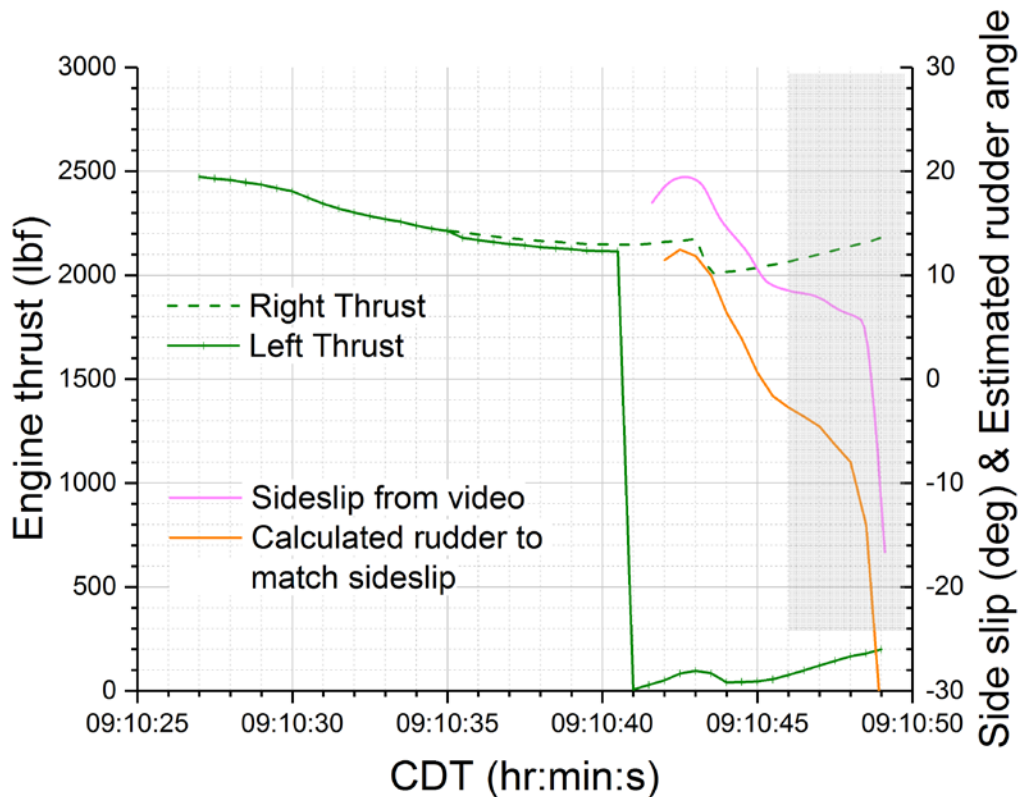
Figure 11. Calculated rudder to match sideslip from video.

This result, that initial rudder input may have been opposite the rudder input needed to balance the yawing moment imparted by the reduction of left engine power, is similar to the result of the Sideslip Thrust and Rudder Study from a similar King Air accident in 2014 [5]. For that accident, the investigation concluded the pilot applied inappropriate rudder pedal at the reduction in left engine power. However, there is uncertainty in the yawing moment imparted by the thrust imbalance, and the yawing coefficients used in these calculations cannot be considered as accurate for the high sideslip values seen and control inputs by the pilot were not recorded for confirmation.

Flight certification data show the loss of left engine power is controllable with appropriate right rudder input. Yawing moment data from wind tunnel testing indicate that initially left rudder may have been incorrectly applied, increasing the sideslip to more than what would be expected from the loss of left engine thrust.
