**NATIONAL TRANSPORTATION SAFETY BOARD
OFFICE OF AVIATION SAFETY
WASHINGTON, D.C. 20594**

**POWERPLANTS GROUP CHAIRMAN'S FACTUAL REPORT
NTSB ID: CEN19MA190**

Location: Addison, Texas
Date: June 30, 2019
Time: 0911 Central Daylight Time (CDT)
Aircraft: Textron Aviation B300, N534FF, operated by EE Operations LLC

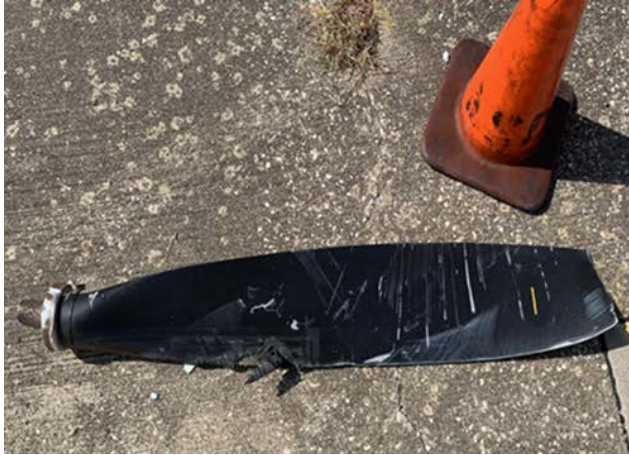
Figure 3. Liberated propeller blade showing transfer of white paint

A propeller blade was found on the tarmac near the initial point of impact. Approximately five inches of the tip were missing. Chordwise white paint transfer marks were noted on its camber side. See Figure 3.

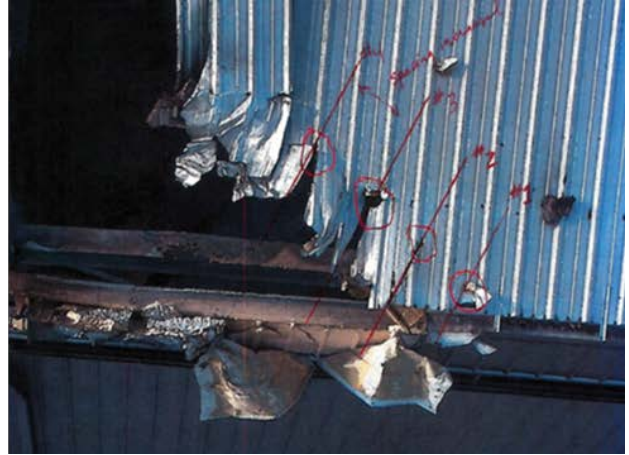
Figure 4. Propeller blade strikes at entry hole

Propeller blade strikes were observed at the point of entry. See Figure 4. There was another blade strike in the truss web. The truss had a white coating. See Figure 5.

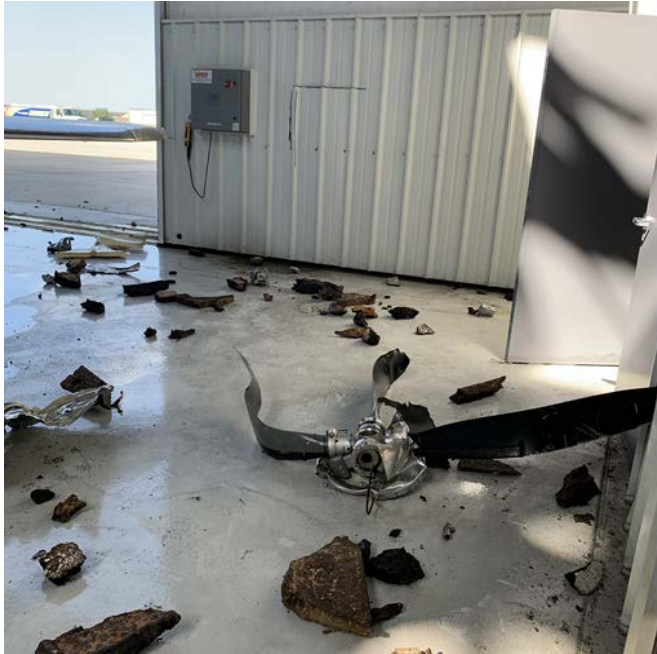
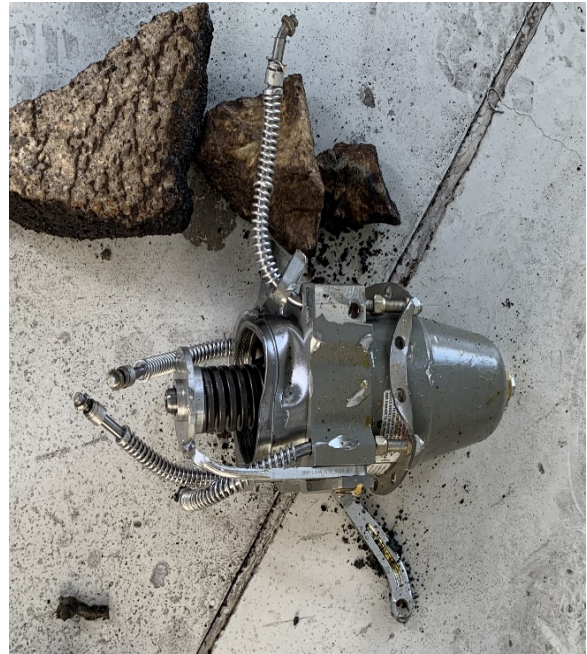
Propeller S/N FWA6013 was found on the floor next to the north wall. A blade was missing from the hub. A section of engine propeller shaft flange was attached. The pitch-change mechanism was separated. The spinner dome was crushed and fragmented. Two counterweights were liberated from their clamps. See Figures 6 and 7.

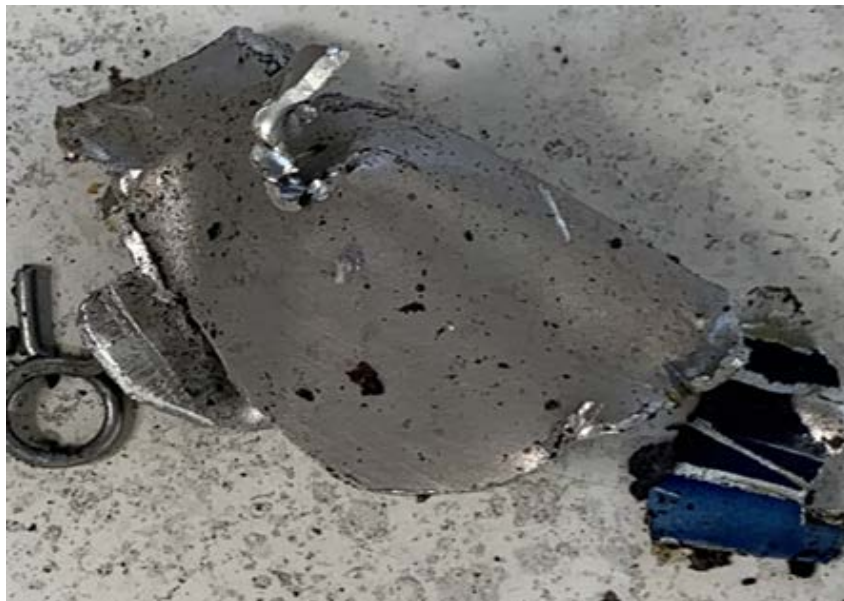
Figure 8. Propeller blade tip recovered inside hangar

Propeller blade tip material was found nearby. See Figure 8.

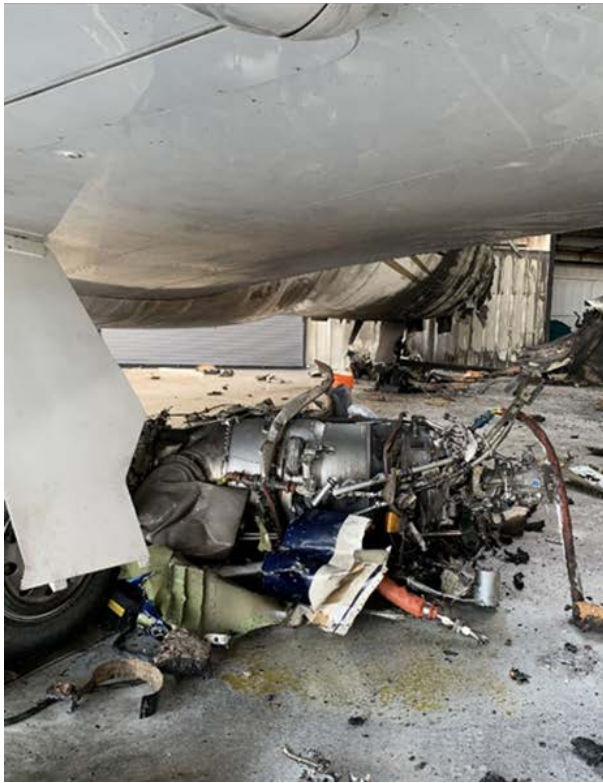
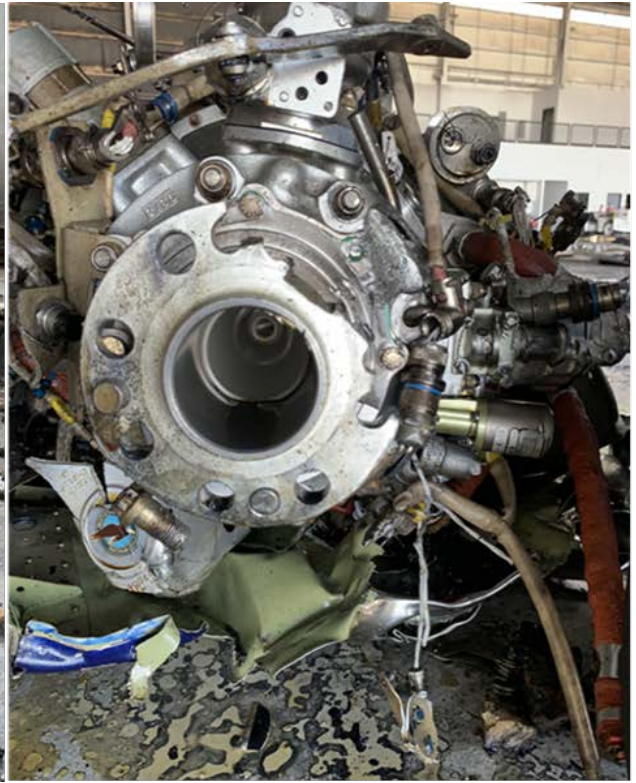
Engine S/N PCE-PK2221 was found approximately 50 feet southeast of the propeller. See Figure 9. Its fractured propeller flange matched the propeller flange section found attached to the nearby propeller. See Figure 10. There was some minor thermal damage. Engine cases and external components were deformed and fractured consistent with impact. The power control and reversing linkage was fractured and was disconnected at the fuel control unit (FCU). The compressor discharge pressure (P3) air filter was missing. The accessory gearbox fuel pump drive pad studs were sheared. The top of the propeller governor was fractured off. The first stage (S1) compressor rotor was intact⁶ as viewed through the inlet case. The S2 PT blades were intact as viewed through the exhaust ducts. Both engine rotors were seized. Liberated components, including the P3 filter, propeller governor flyweights, and the fuel heater were recovered in the vicinity of the engine.

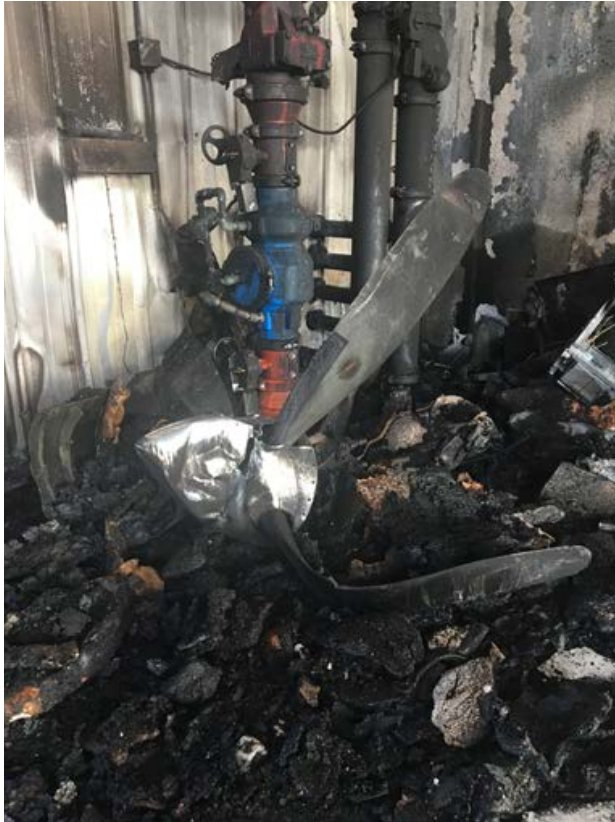
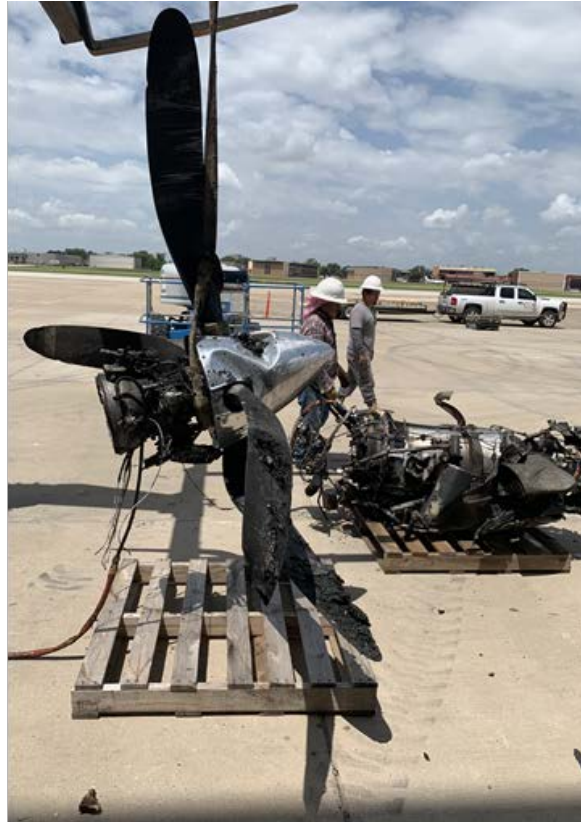
Propeller S/N FWA6019 was found lying near the east wall, just south of the roll-up door. It was charred and sooted. The spinner was in place but crushed. Two blades exhibited forward bending and two exhibited aft bending. The front case of the engine reduction gearbox was attached. See Figures 11 and 12.

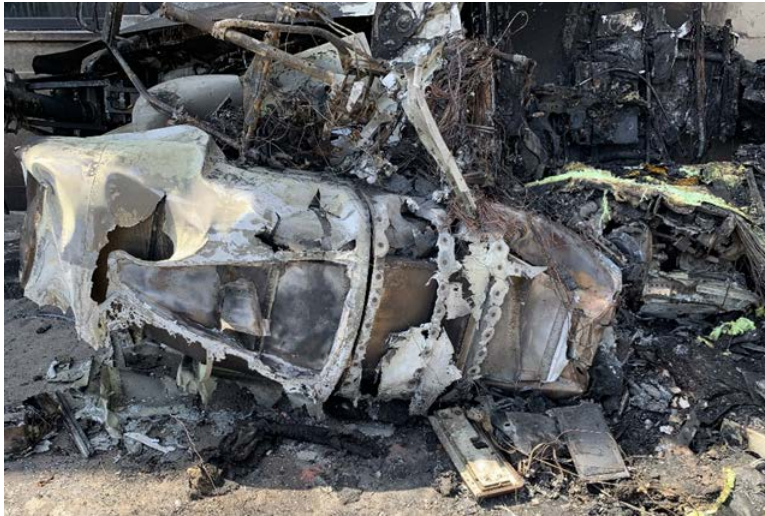
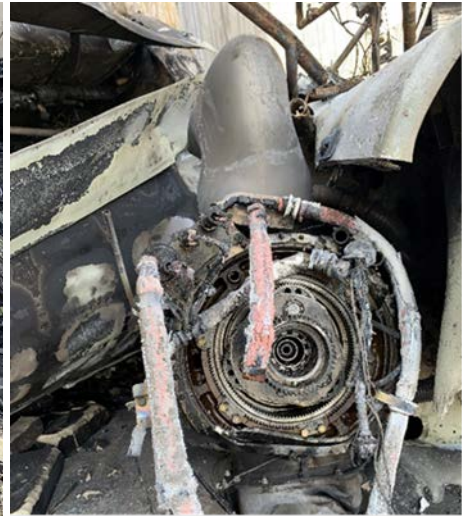
Engine S/N PCE-PK2222 was found with the airplane fuselage, in the main wreckage area. It was covered with soot and debris, and residue from fire extinguishing chemicals. See Figure 13. The reduction gearbox front housing was separated at the A flange.⁷ See Figure 14. The ignition exciter box was thermally destroyed. Other thermal damage appeared limited to engine externals. The S2 reduction gearbox planet gear carrier was separated at the web and was found nearby; it was fractured in the web area. The S1 compressor rotor was intact as viewed through the inlet case. The S2 PT blades were intact as viewed through the exhaust exit ducts. Both engine rotors were seized. The power control and reversing linkage was fractured. The P3 line was damaged but continuous. The governor pressure (Py) line was fractured at the A flange. The propeller governor speed lever was missing. Liberated components, including the S2 reduction gearbox planet carrier and the propeller governor speed lever were found nearby.

Figure 14. Right engine, showing A-flange separation

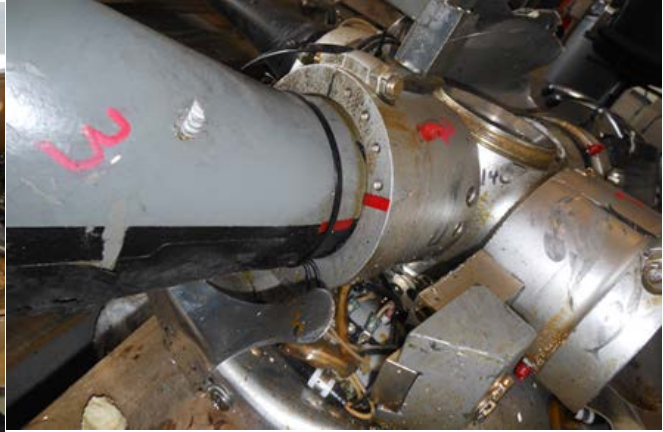
Figure 16. Blade-clamp interface showing slippage

blade	as-received blade-to-clamp angle	blade slip in clamp?	clamp rotation possible?
L1	Beyond low pitch	YES - 80° toward high pitch	YES
L2	N/A (liberated)		
L3	Beyond low pitch counterweights missing	YES - 10° toward low pitch	YES
L4	Beyond low pitch	Not remarkable	YES

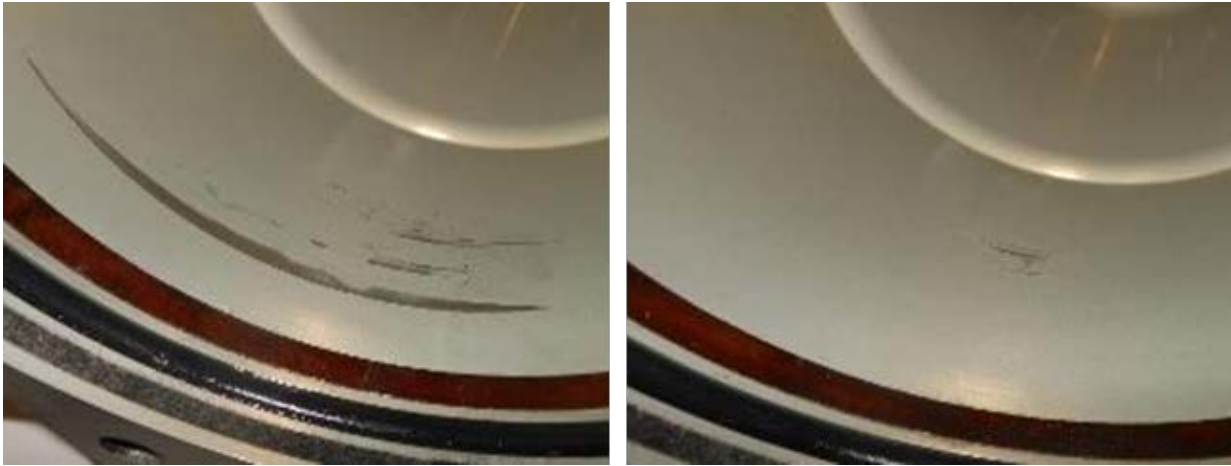
Figure 17 . Left propeller internal piston witness marks

Multiple cylinder-to-piston impact marks were observed on the internal piston surface. See Figure 17.

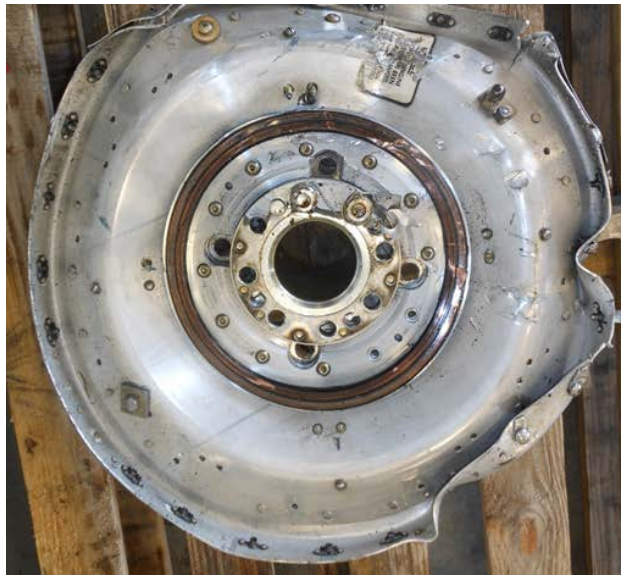
Figure 18. Left propeller flange

The L2 pilot tube was pulled from the hub unit. One of the four propeller flange dowel pins remained lodged in the propeller flange. Two of the eight propeller mounting bolts also remained in the propeller flange with a segment of the propeller shaft flange attached. See Figure 18.

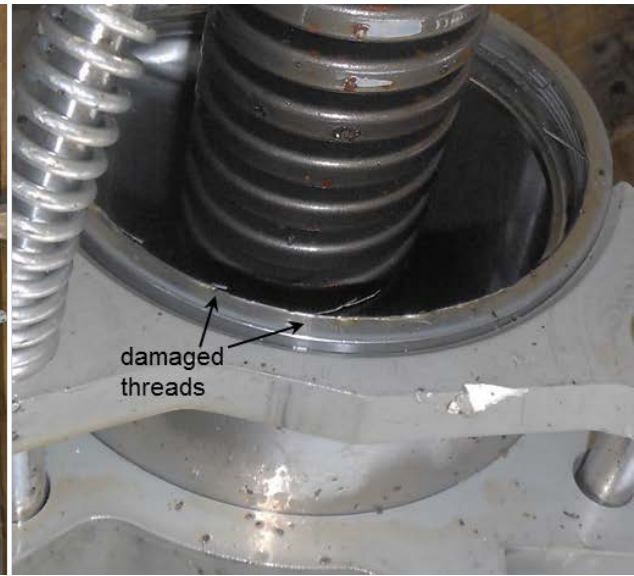
Figure 19. Cylinder separation from hub

Remnants (whiskers) of cylinder threads typical of forcible separation of the cylinder were noted on the hub. See Figure 19.

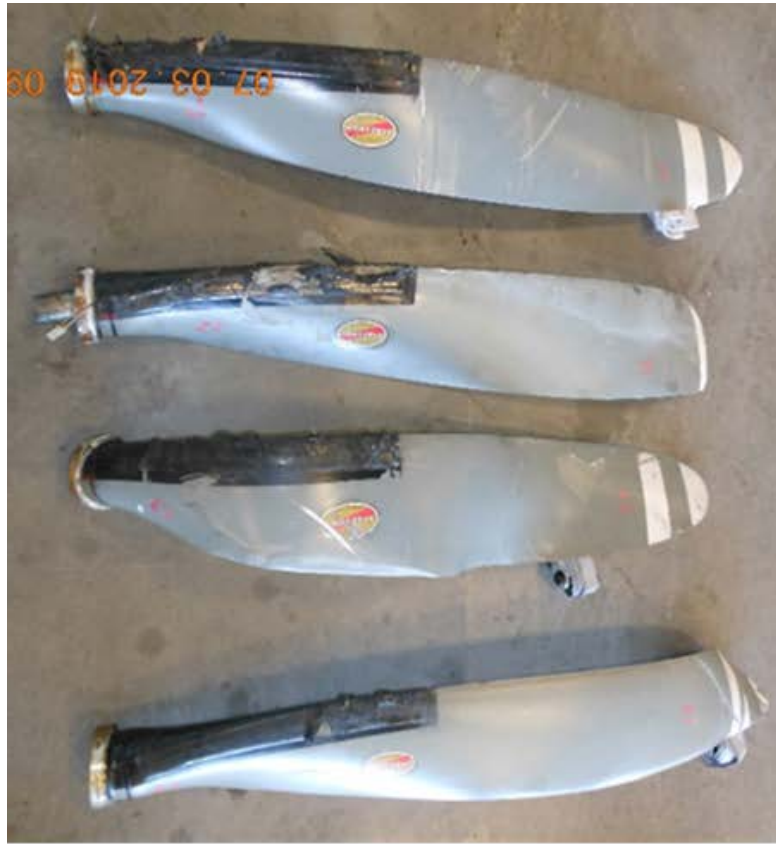
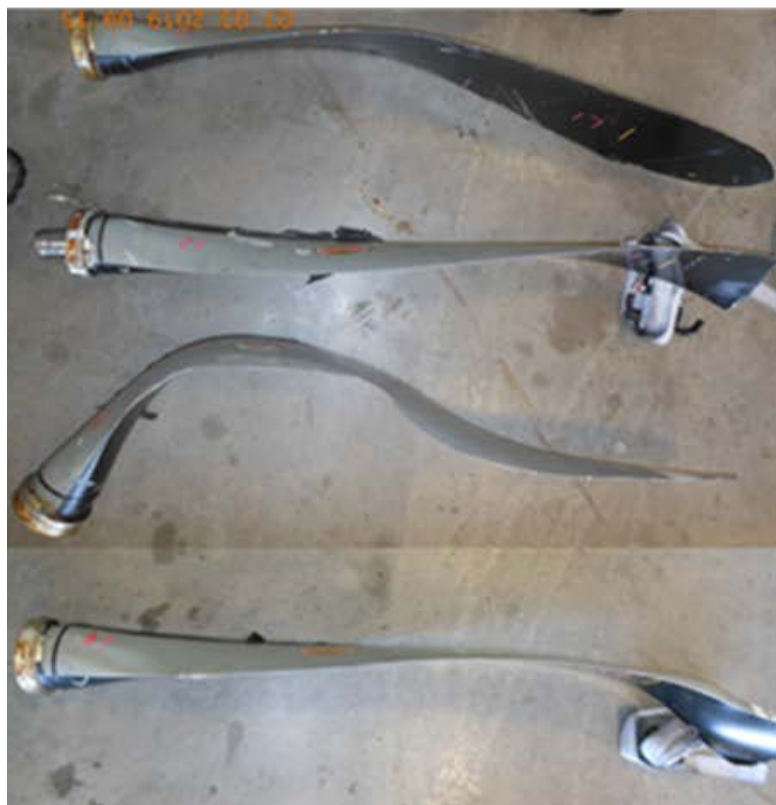
Figure 20. Left propeller blades

The L1 blade was bent aft, opposite the direction of rotation, and was twisted toward low pitch. Both camber and face sides exhibited chordwise scoring. The leading edge (LE) of the blade was gouged, with material deformed toward both high and low pitch. The blade TE was not remarkable. The de-ice boot was torn. There was impact damage to the needle bearing face area. Two crescent witness marks were noted:

The L2 blade was bent aft, opposite the direction of rotation. Approximately 5 inches of the blade tip was separated. The tip fracture surface showed overload features. Chordwise white paint transfer was noted on the camber side and there was chordwise scoring on the face side. The LE was gouged. The de-ice boot was torn. There was impact damage to the needle bearing face area. The L2 blade pilot tube was liberated with the blade. Two crescent impact marks were noted:

The L3 blade was bent aft with some S-bend characteristics. The camber side exhibited chordwise and random scoring. The face side exhibited spanwise scoring. The LE was gouged and there was a distinct crease 19 inches from the tip. The TE was bent TE-down, typical of impact forces. The de-ice boot was torn. There was impact damage to the needle bearing face area. An impression from raised lettering on the butt of the blade could be observed in the L3 hub arm. There were two crescents on the hub arm and two on the butt:

The L4 blade was bent aft at the tip and was twisted toward low pitch. There was chordwise scoring near the tip, on the camber side. Approximately 1.5 inches of the blade tip were missing. There was a distinct crease in the LE approximately 4 inches from the tip end. The TE displayed TE-down impact bending. The de-ice boot was torn. There were no discernible blade butt/hub arm witness marks.

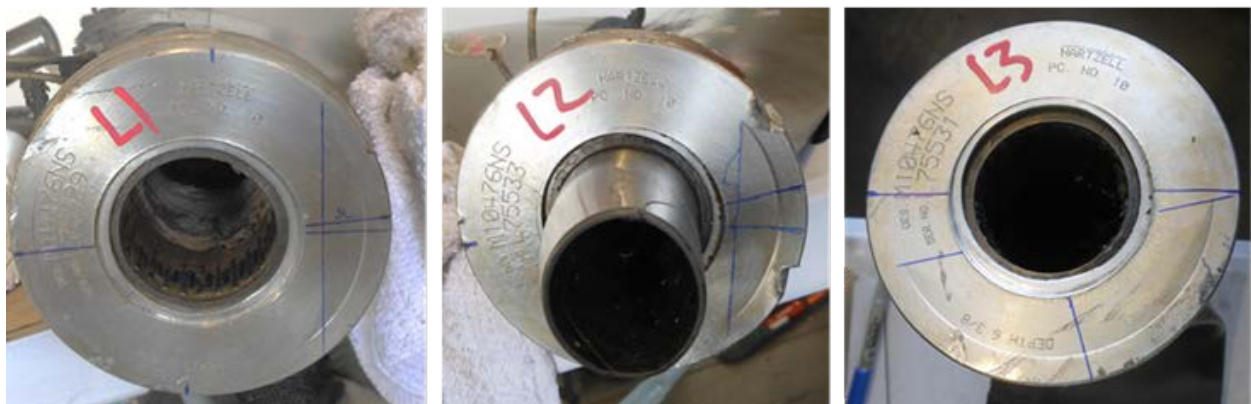
Figure 21. Blade butts showing impact marks (L4 had no marks)

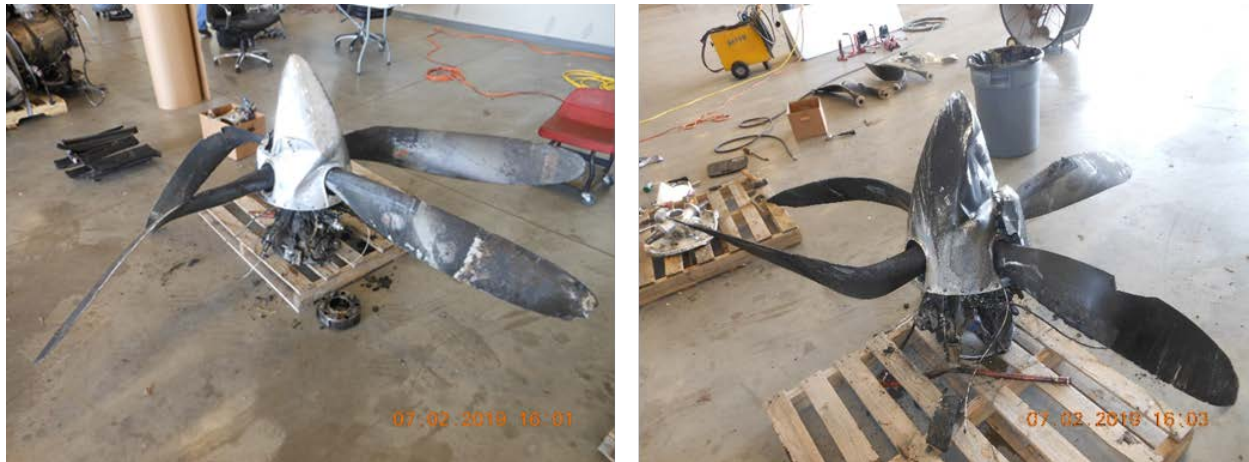
The right propeller remained attached to the engine reduction gearbox with all mounting hardware secured. The beta ring was intact, and the beta arm was under the guide pin. The propeller was charred and sooted.

Figure 22. Two views of the right propeller as recovered

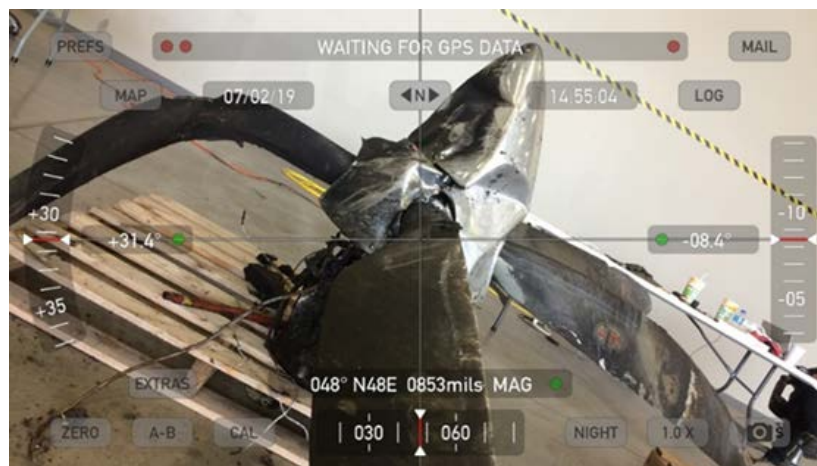
Figure 23. Right propeller spinner dome measurement

The spinner dome was torn and partially crushed. There was a counterweight penetration. The penetration angle was measured as approximately 31° . See Figure 23.

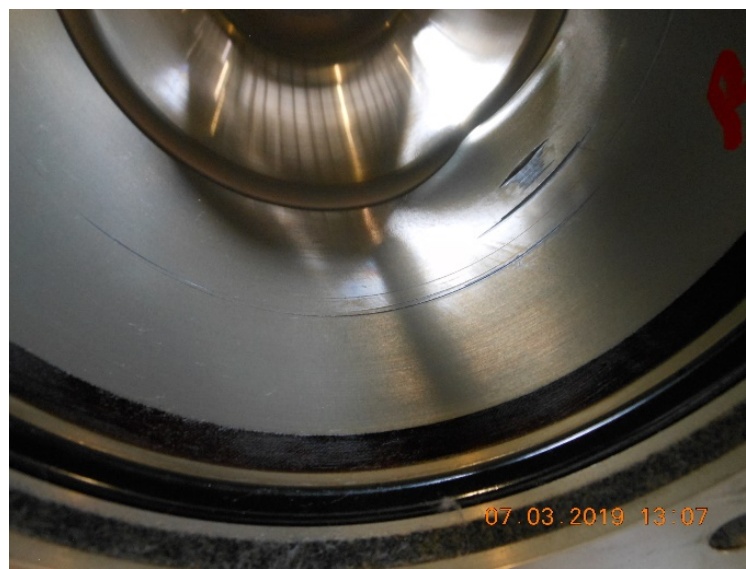
Figure 25. Internal piston impact marks

Multiple cylinder-to-piston impact marks were observed on the internal piston surface. See Figure 25.

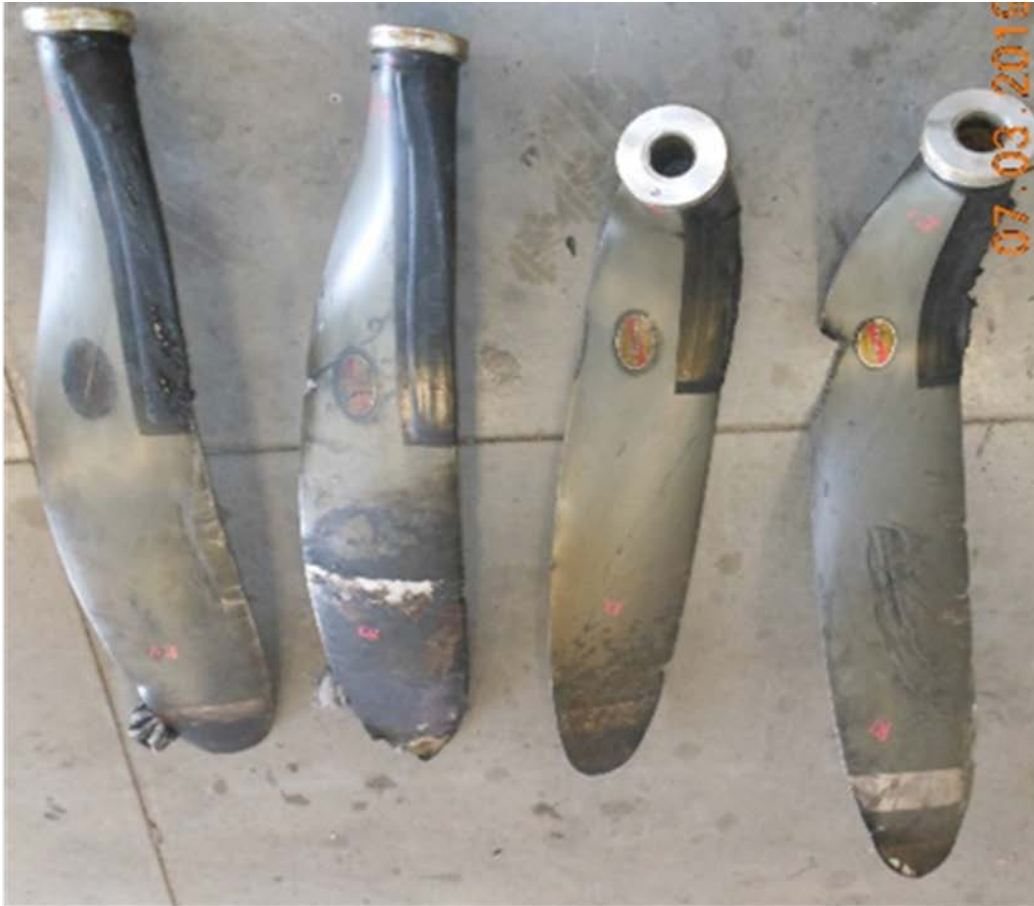
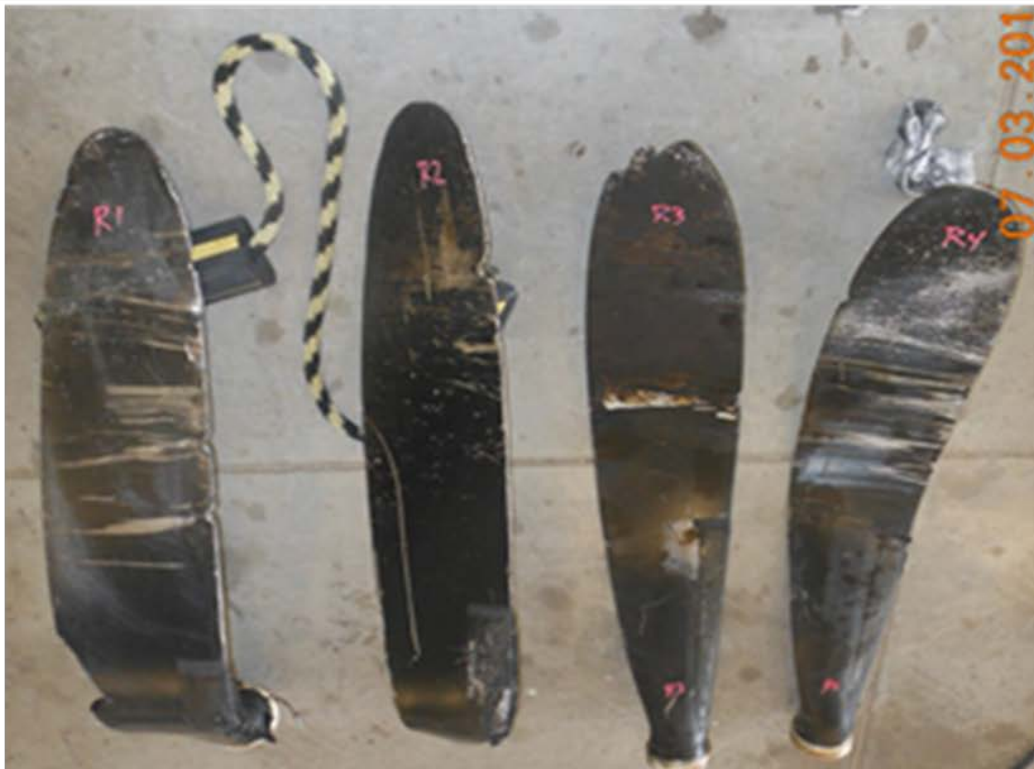
Figure 26. Right propeller blades

The R1 blade was bent in the forward/thrust direction and was untwisted toward high pitch. Both camber and face sides exhibited chordwise scoring. The LE was gouged. The TE was gouged and torn at the tip, and there was a triangular puncture at mid-blade. The de-ice boot was torn. Crescent witness marks were noted on the blade butt and the hub arm:

The R2 blade was bent in the forward/thrust direction. The camber side was scored chordwise and was charred and sooted in the tip area. The face side was scored chordwise and there was spanwise scoring at mid-blade. The de-ice boot was scored. Crescent witness marks were noted on the blade butt and the hub arm:

The R3 blade was bent aft and twisted LE-down. The camber side was scored chordwise and was charred and sooted mid-blade, with the paint burned off from the outboard surface mid-blade to the tip. The face side was scored chordwise near mid-blade, and the TE tip was fractured off. The LE was gouged. The TE was gouged and nicked. There was a small puncture at the outboard end of the de-ice boot. No blade butt or hub arm impact marks were found.

The R4 blade was bent aft. Both camber and face sides exhibited chordwise scoring. The LE was gouged and there was a local bend in the TE eight inches from the tip. The de-ice boot was torn, and heat damaged. There were no discernible blade butt or hub arm impact marks.

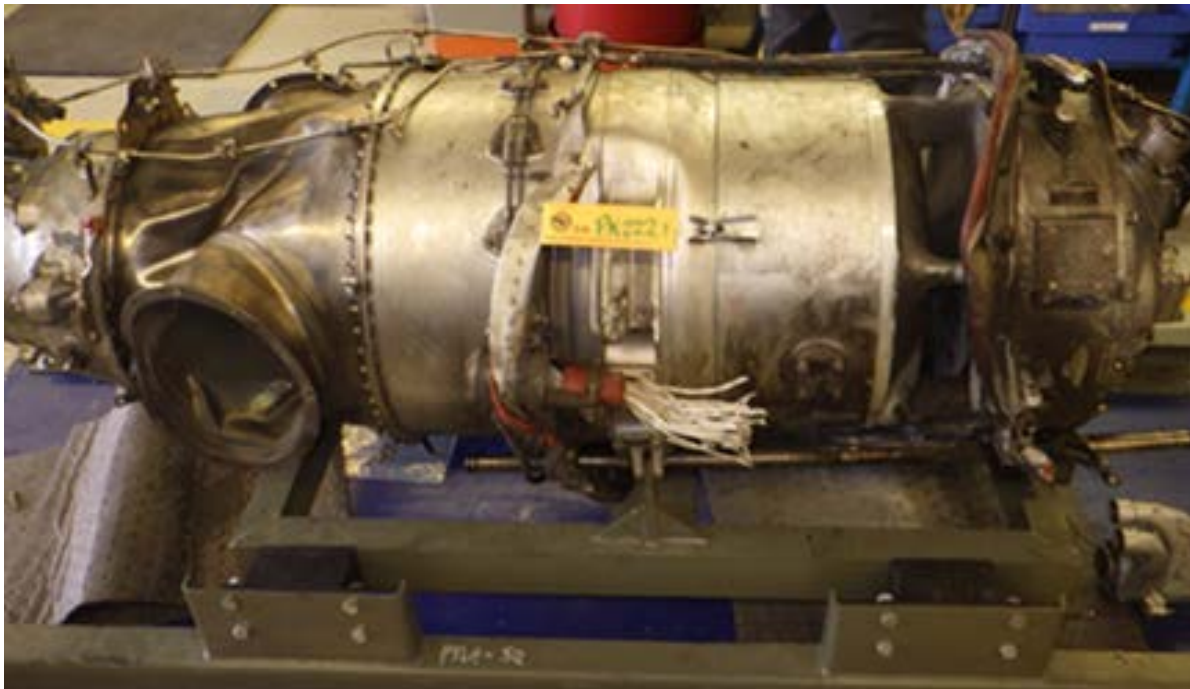
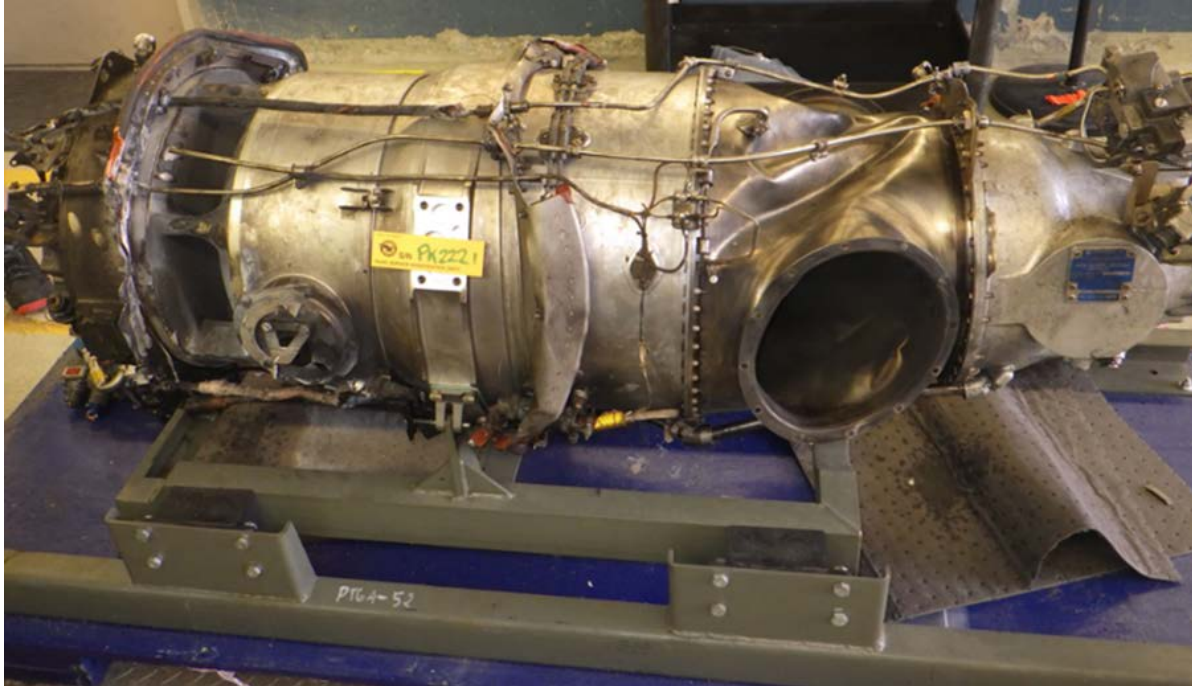
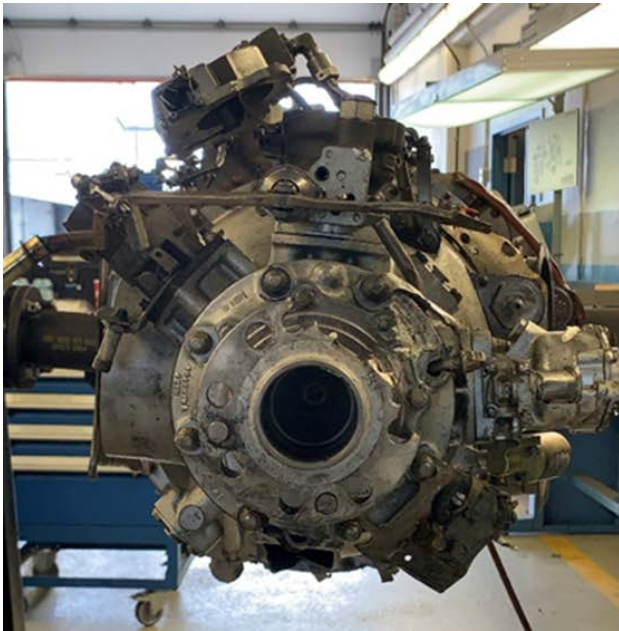
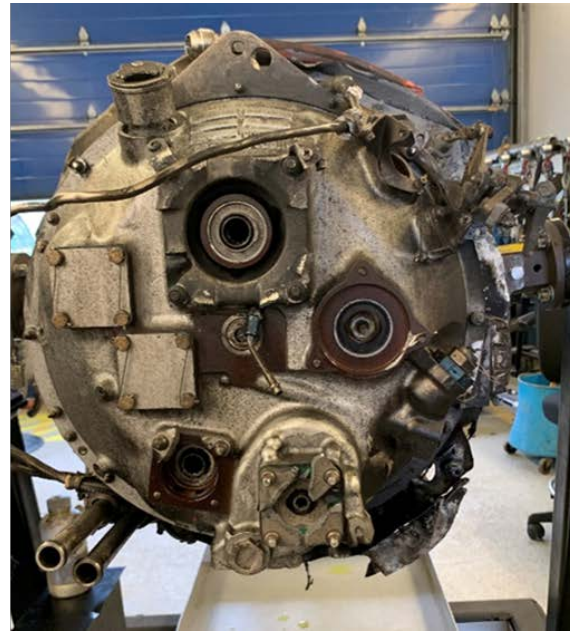
The left engine exhibited some case deformation and local impact damage. It was coated with soot and with chemical residue from the hangar fire suppression system. See Figures 28-31.

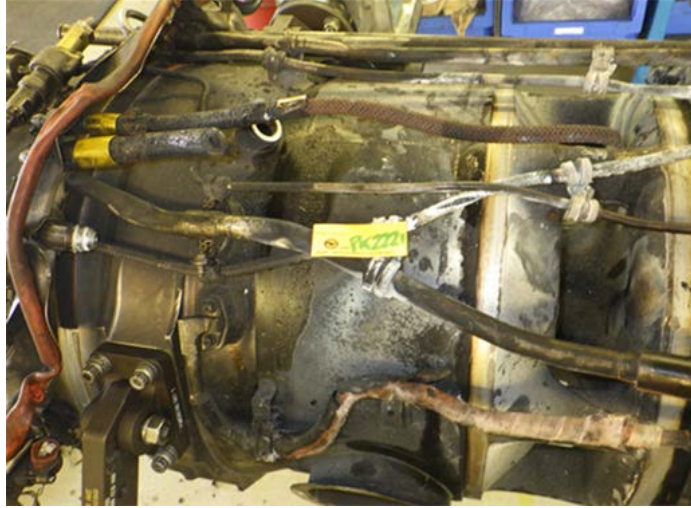
Figure 32. Typical left engine thermal damage

Thermal damage to line insulation and attachment hardware indicated some local exposure to fire. See Figure 32.

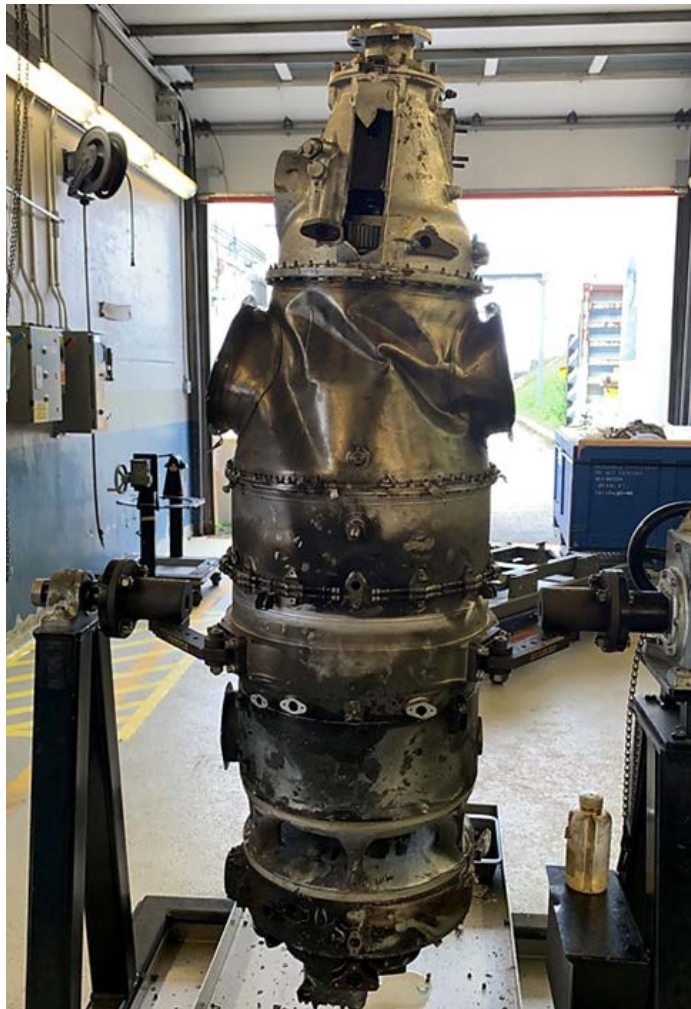
The front of the engine was twisted out of axis and displaced 5°-10° off centerline. See Figure 33.

Figure 33. Bottom view of engine showing distortion

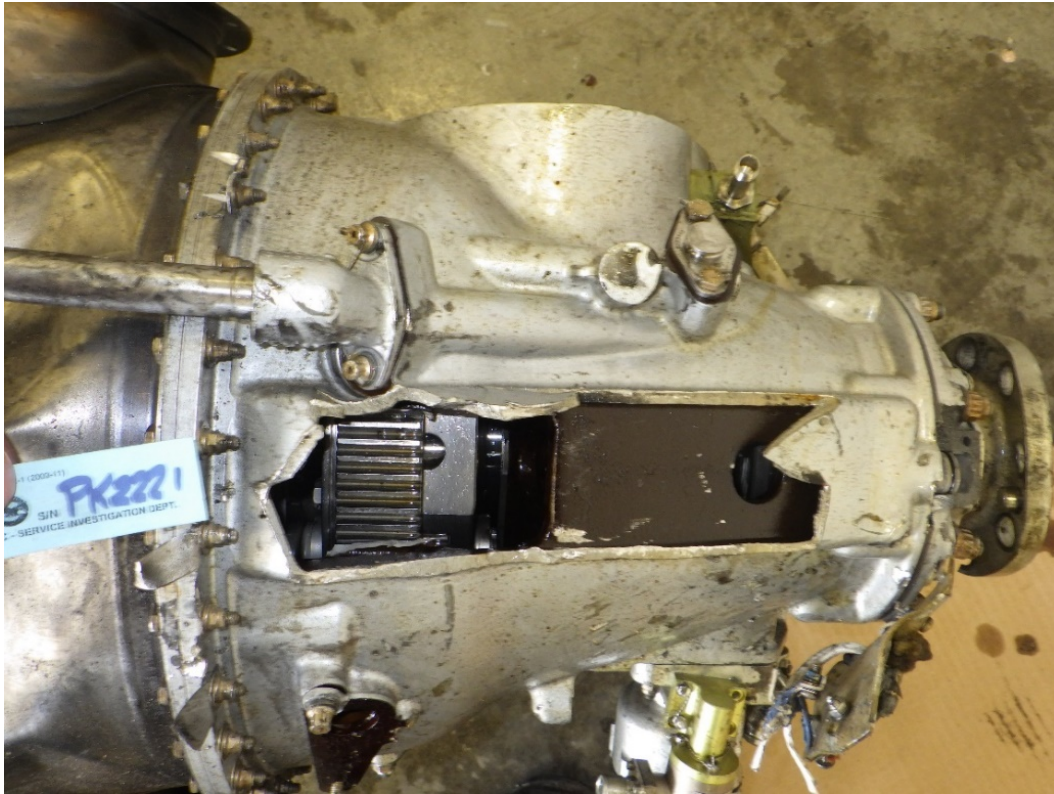
Figure 34. Reduction gearbox front housing sump area

Much of the reduction gearbox forward housing scavenge sump was fractured off, along with the oil strainer, chip detector, and a section of the S2 ring gear support. See Figure 34.

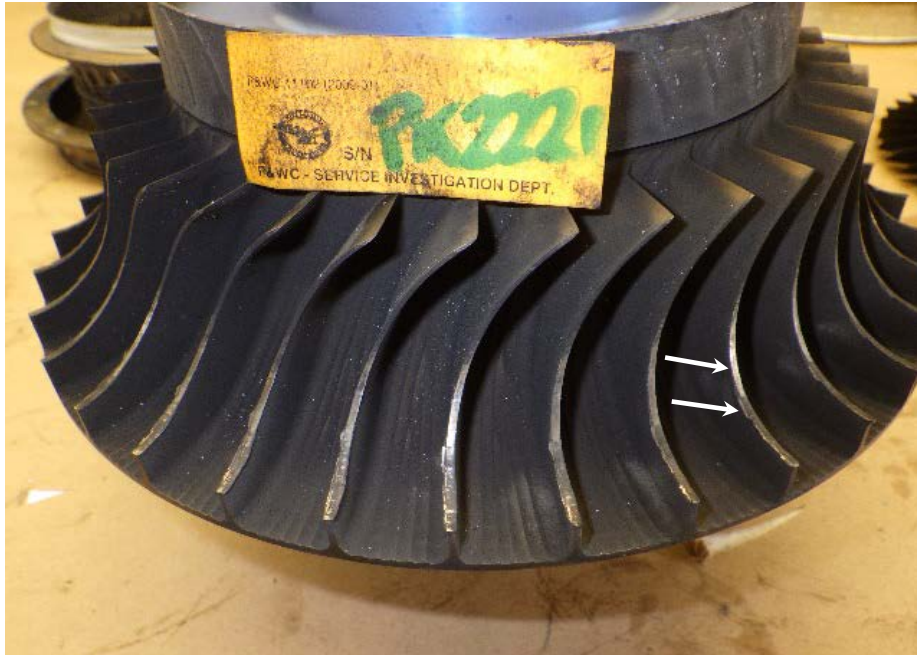
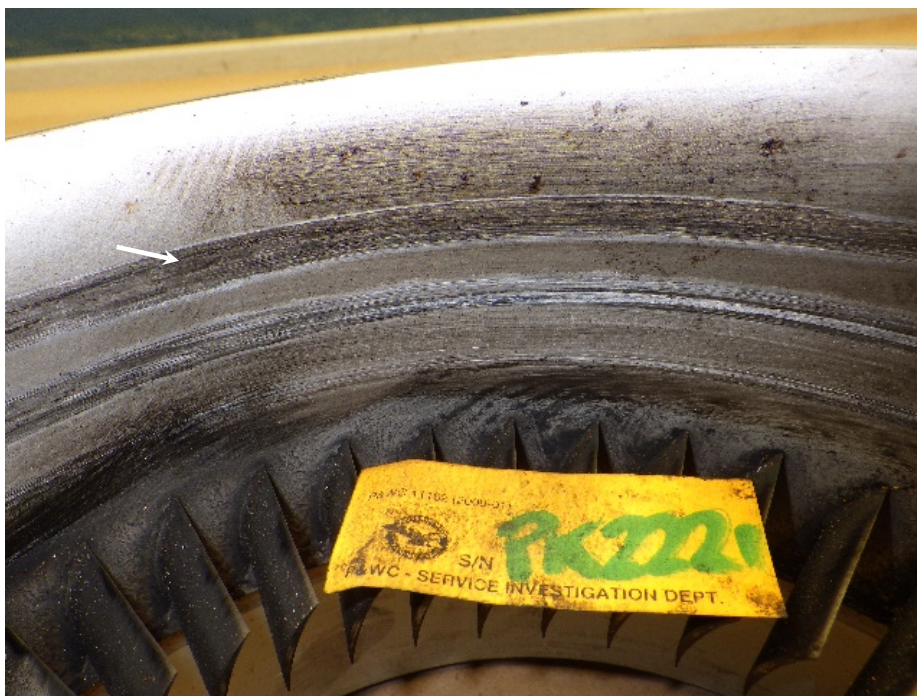
The S1 axial compressor blade tips were lightly rubbed, with corresponding rub along the S1 axial blade path. There was no evidence of rotor-to-stator contact at the other axial stages. The centrifugal impeller vanes were rubbed, with rollover burring, in the exducer area. See Figure 35. The impeller shroud exhibited 360° rub damage, consistent with the damage observed on the impeller. See Figure 36.

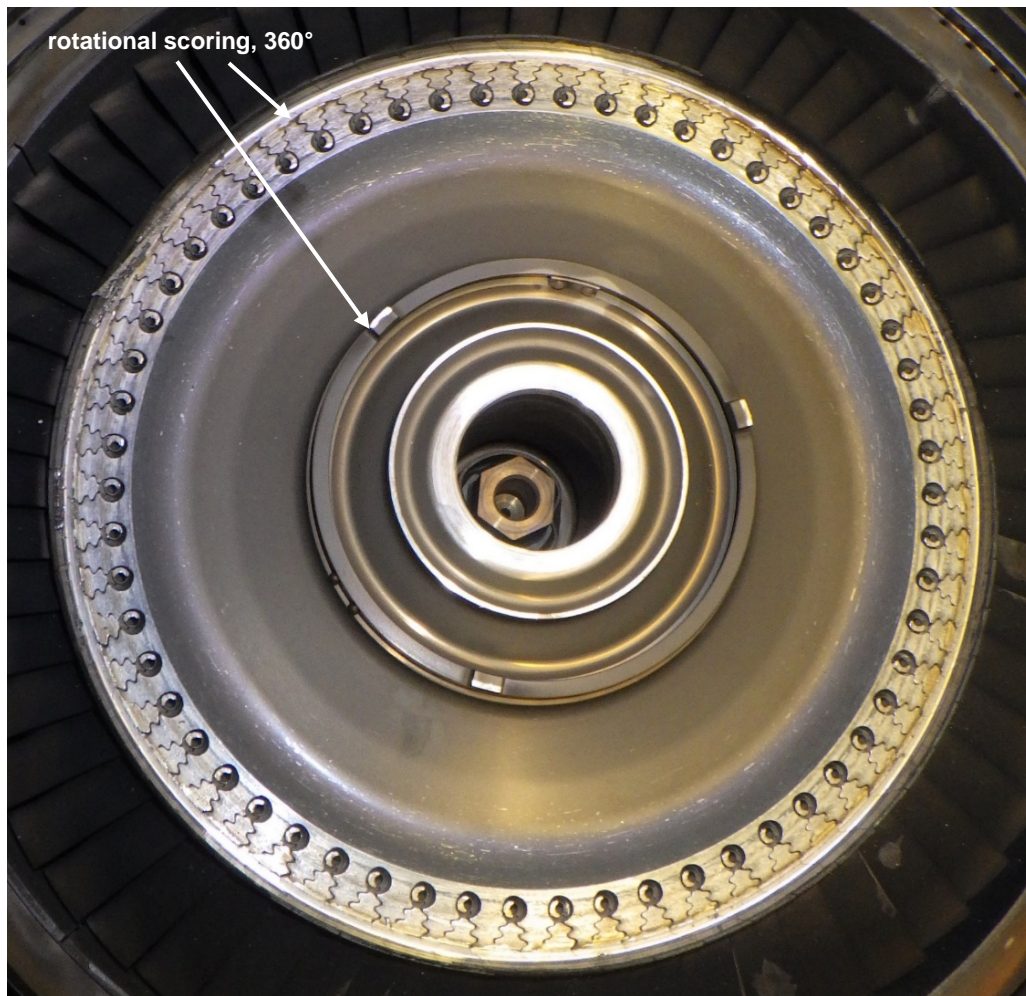
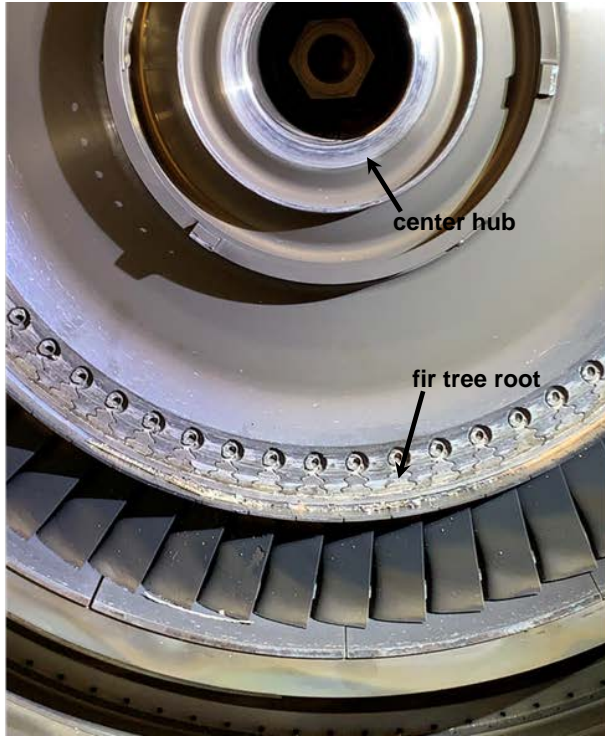
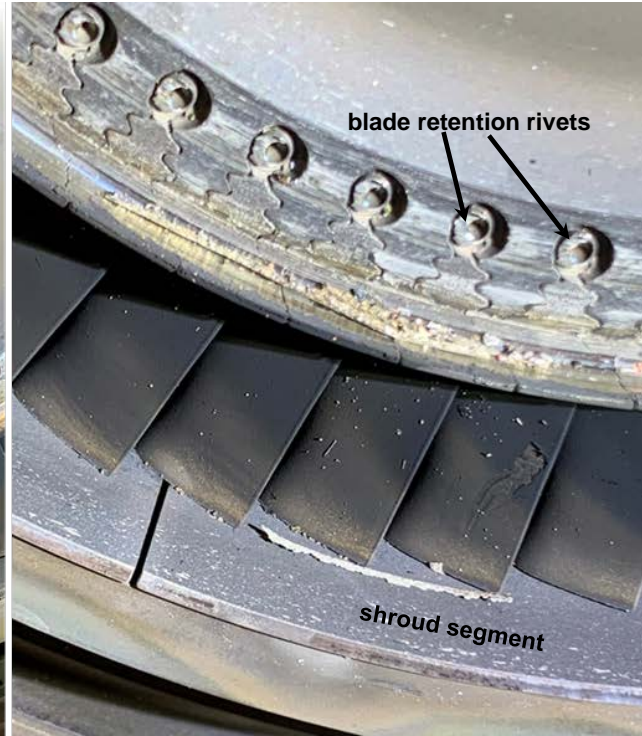
The upstream face¹² of the CT disk assembly was undamaged. The downstream face was scored 360° along the blade retention fir tree roots and rivets, the center hub, and across the tooling lugs.¹³ See Figures 37 through 39. The compressor turbine blades tips were rubbed.

Figure 37. Downstream face of CT showing 360° scoring in the fir tree root area and tooling lugs

¹³ Rotational scoring can occur when clearances between stationary and rotating components are lost while the engine is operating.

Figure 38. CT downstream face, showing fir tree root and center hub scoring

Figure 39. Detail of fir tree area and shroud segment scoring

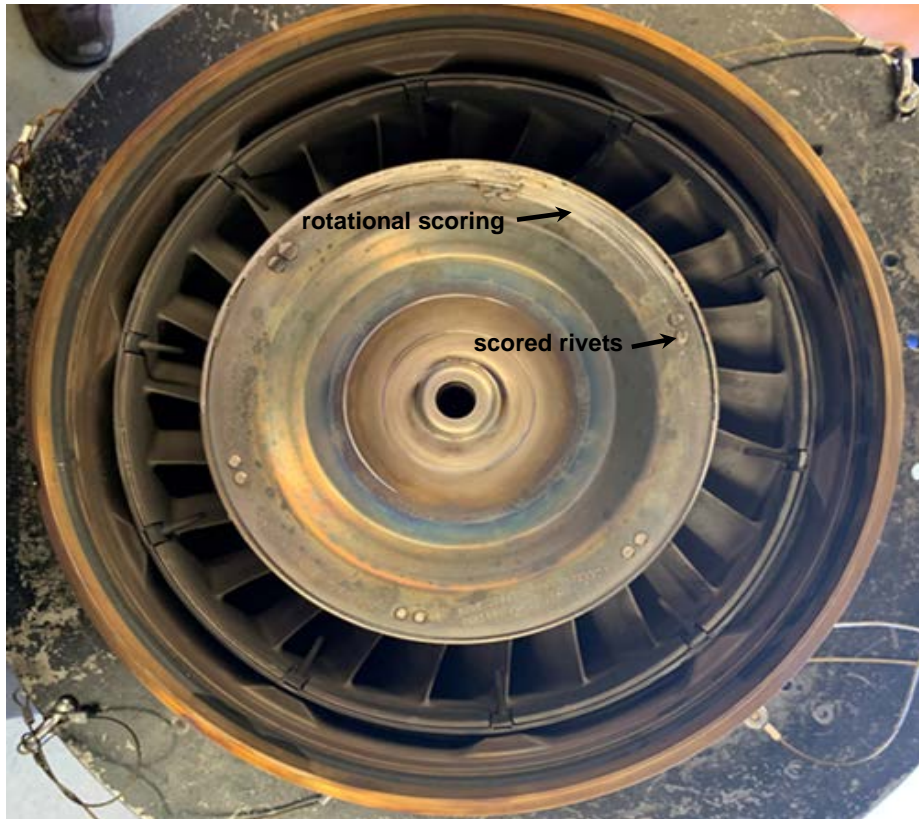
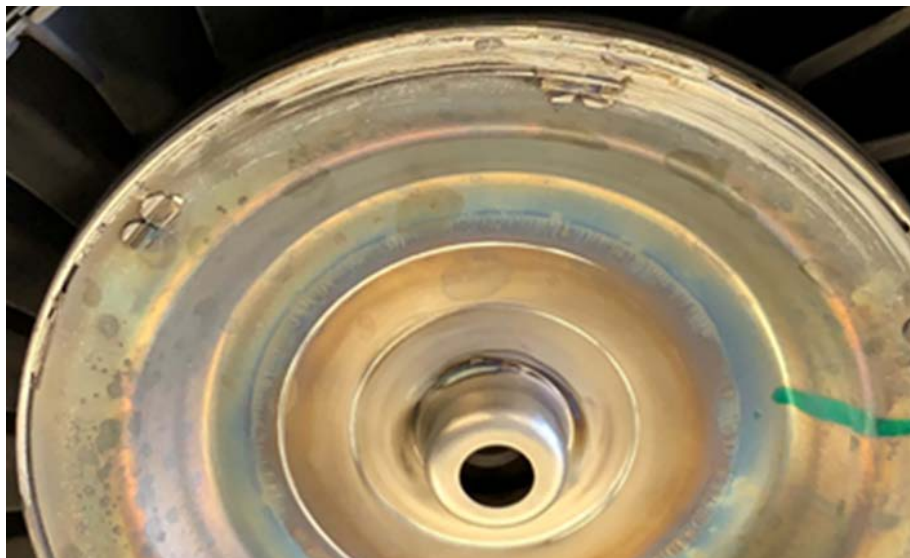
The upstream face of the S1 PT guide vane ring and interstage baffle was scored 360° near the center of the baffle and along the retaining rivets; all retaining rivets were missing material. There was circumferentially oriented scoring on the face of the baffle and at its outer edge, with heavy rub between 6 and 11 o'clock. See Figures 40 and 41.

Figure 40. Upstream face of S1 PT guide vane ring and interstage baffle showing 360° scoring/material loss across retaining rivets

Figure 41. Detail of Figure 40 showing rotational damage signatures
