**NATIONAL TRANSPORTATION SAFETY BOARD
OFFICE OF AVIATION SAFETY
WASHINGTON, D.C. 20594**

**POWERPLANTS GROUP CHAIRMAN'S FACTUAL REPORT
NTSB ID: CEN19MA190**

Location: Addison, Texas
Date: June 30, 2019
Time: 0911 Central Daylight Time (CDT)
Aircraft: Textron Aviation B300, N534FF, operated by EE Operations LLC

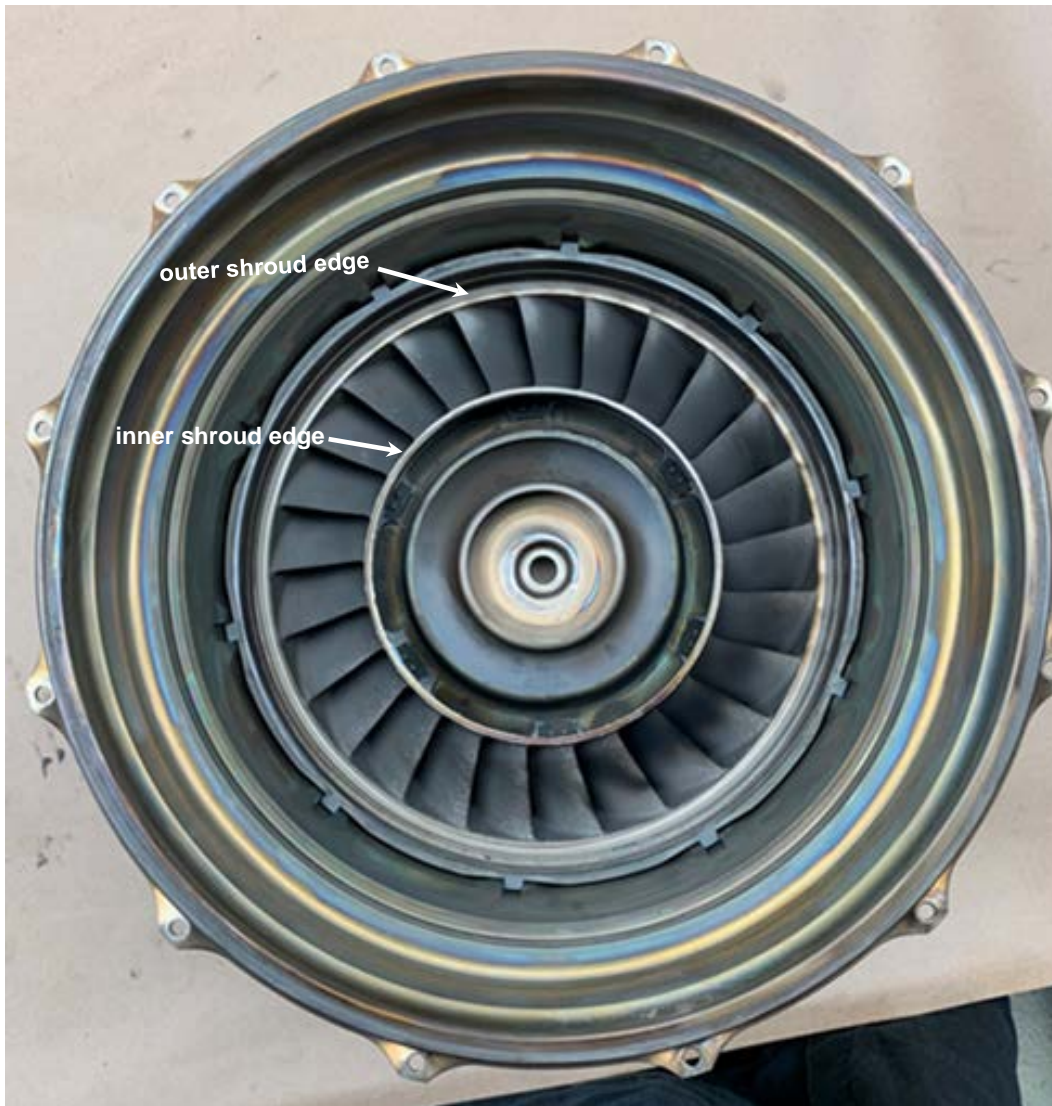
The downstream face of the S1 PT guide vane ring and interstage baffle was scored 360° along the inner and outer shroud edges and scored at the center baffle surface. See Figure 42.

Figure 42. Downstream face of S1 PT guide vane ring and interstage baffle showing 360° inner and outer baffle shroud edge scoring

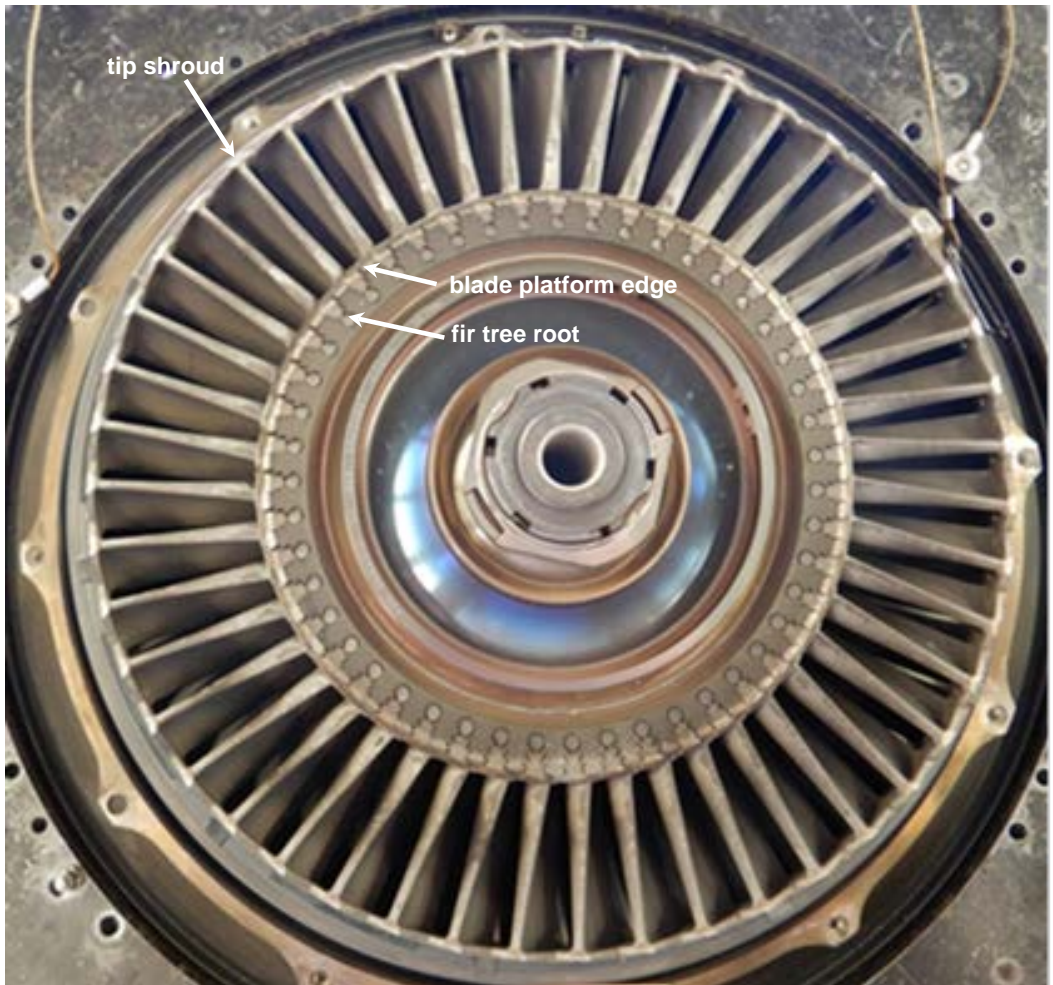
The upstream face of the S1 PT disk assembly was heavily scored 360° along the fir tree roots and blade platform edges, and at the blade tip shrouds. See Figure 43.

Figure 43. Upstream face of S1 PT disk assembly showing 360° scoring along the fir tree roots and blade platform edges, and at the blade tip shrouds

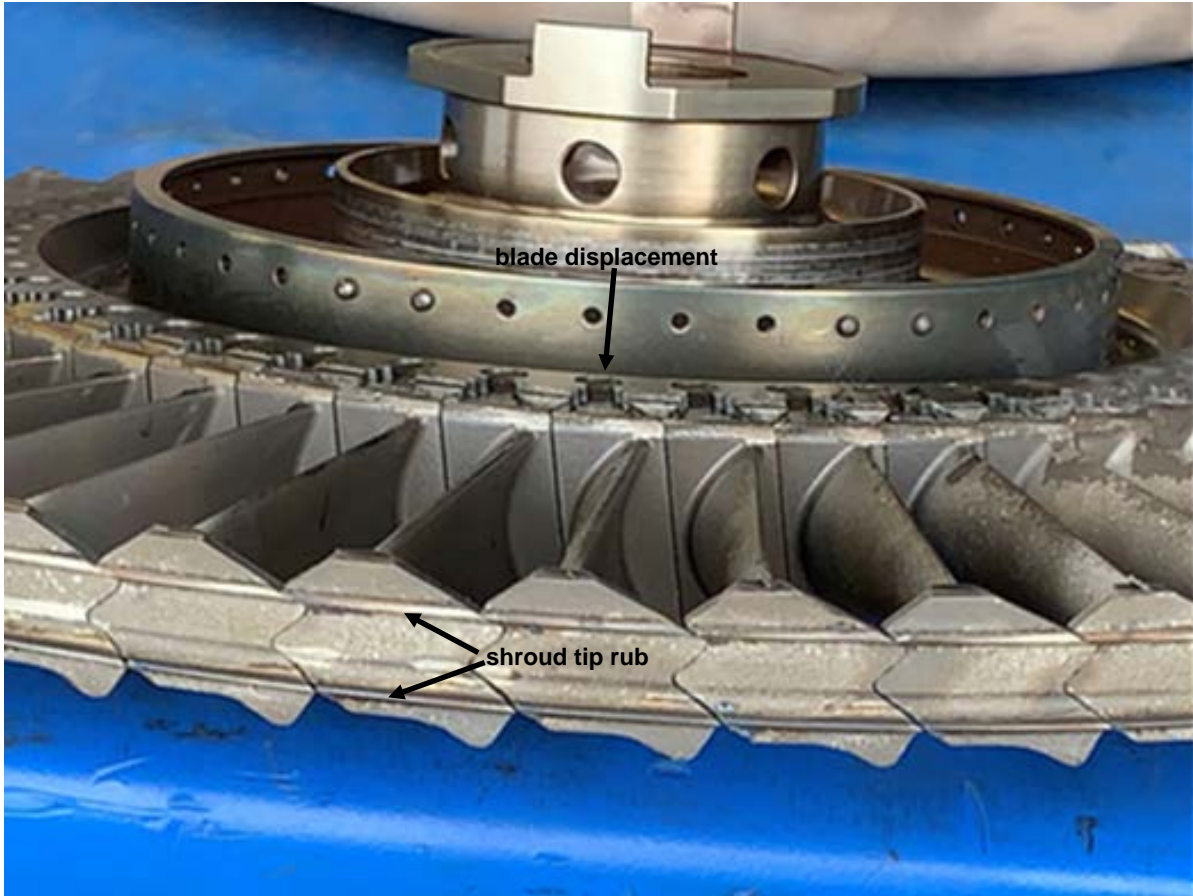
Figure 44. S1 PT disk assembly showing blade displacement and shroud tip rub

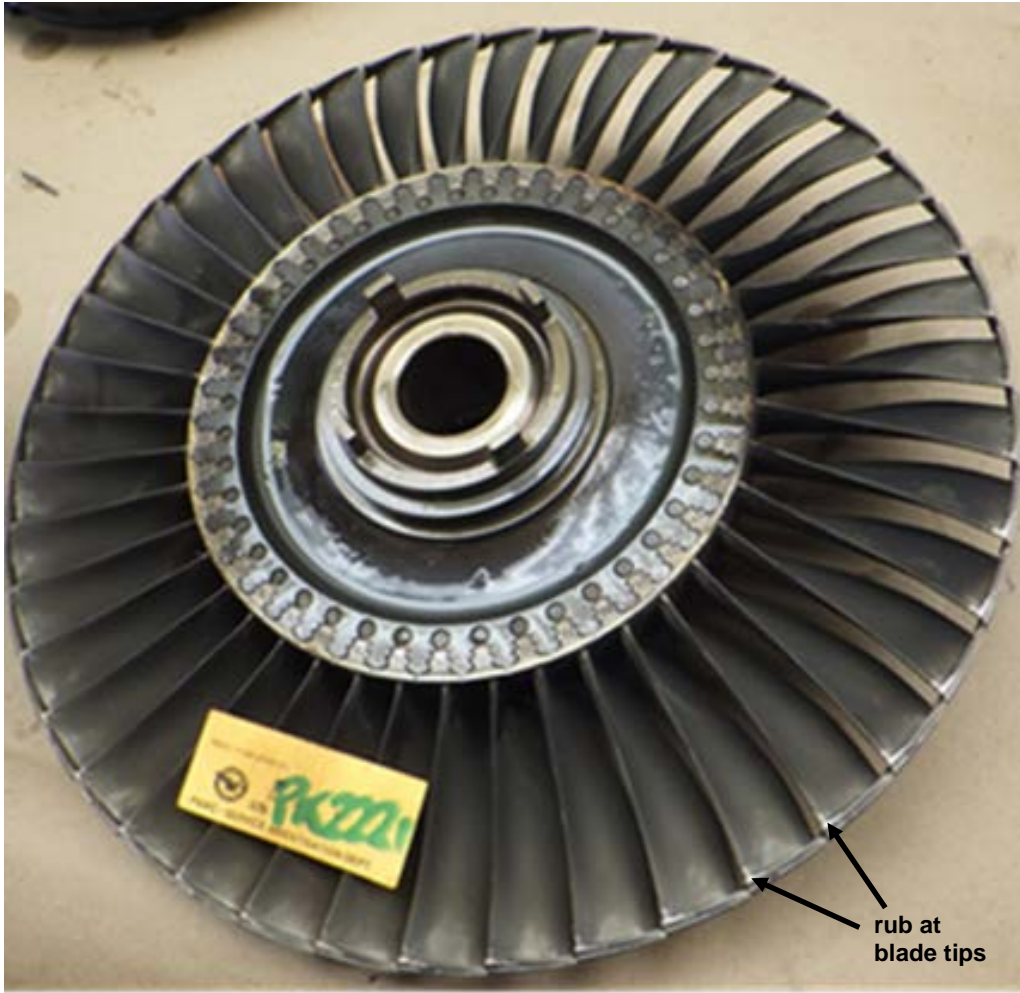
Fragments of interstage seal material were found on the upstream face of the S2 PT disk assembly. The blade tip shrouds were rubbed 360° on the upstream face. See Figure 45.

Figure 45. S2 PT disk assembly upstream face showing 360° blade tip rub

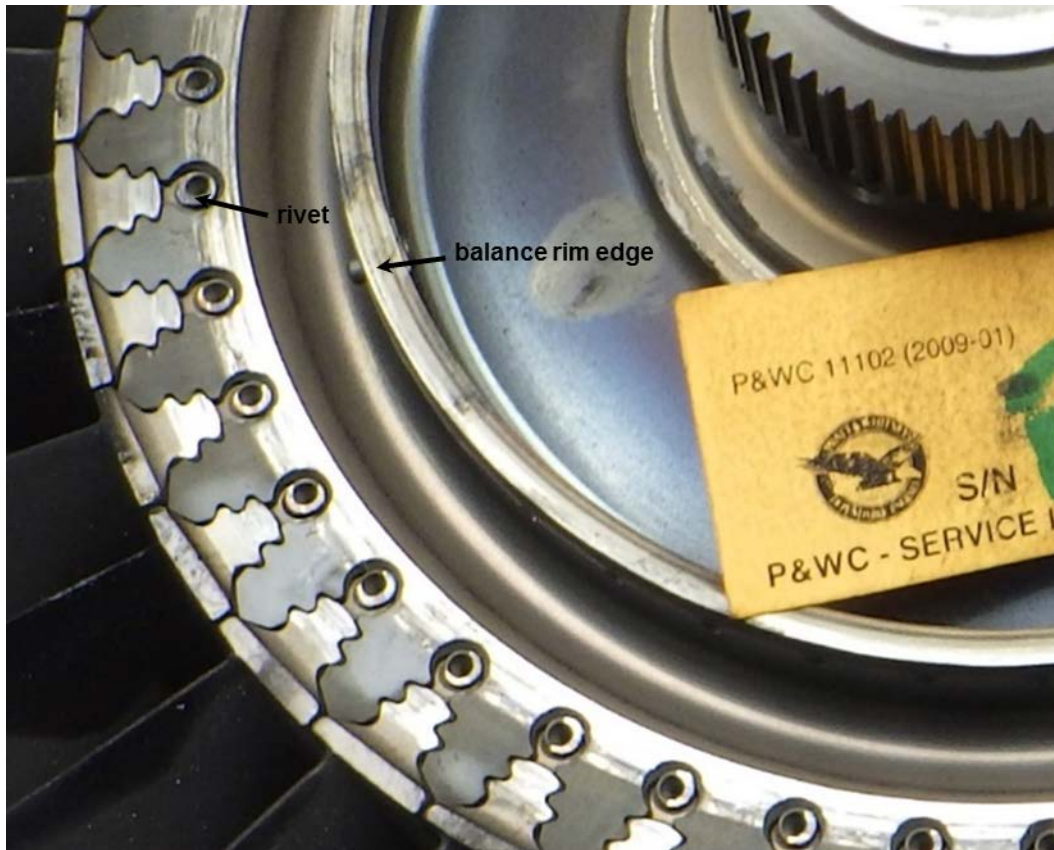
Figure 46. S2 PT disk assembly downstream face showing 360° scoring along retaining rivets and edge of balance rim

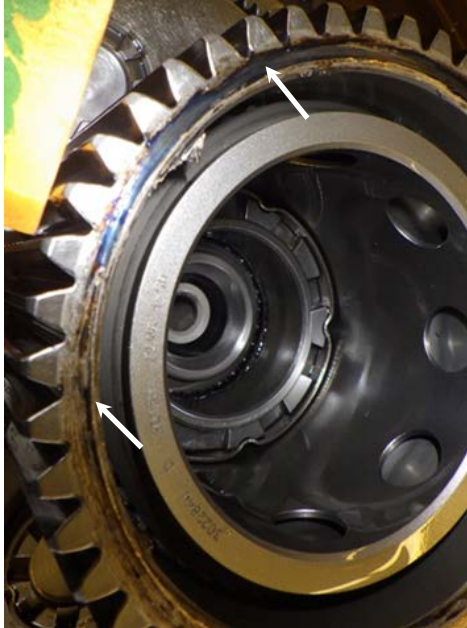
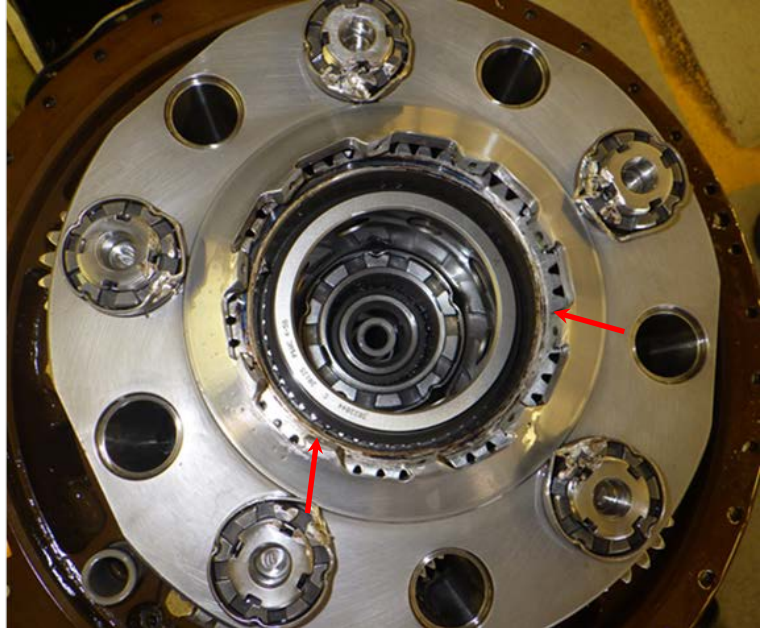
P&WC evaluation of representative fracture surfaces found ductile torsional overload features. The material was as specified. There was no evidence of fatigue.

Figure 47. S2 sun gear showing scoring damage

Figure 48. S2 planet gear carrier fracture surfaces, 2 of 10 indicated

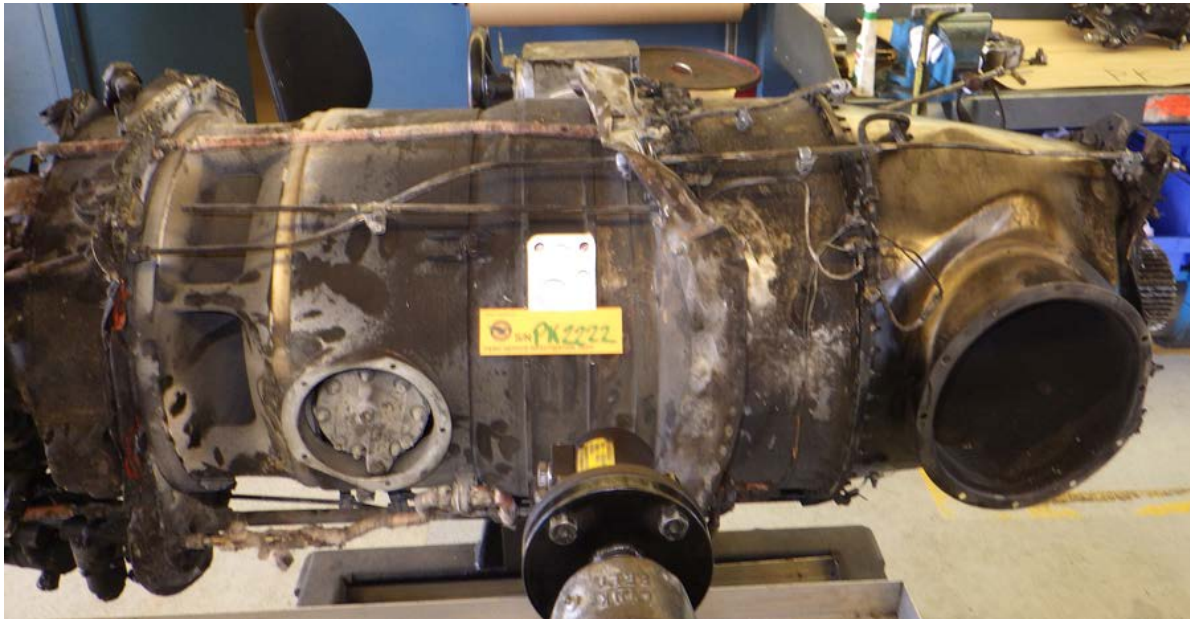
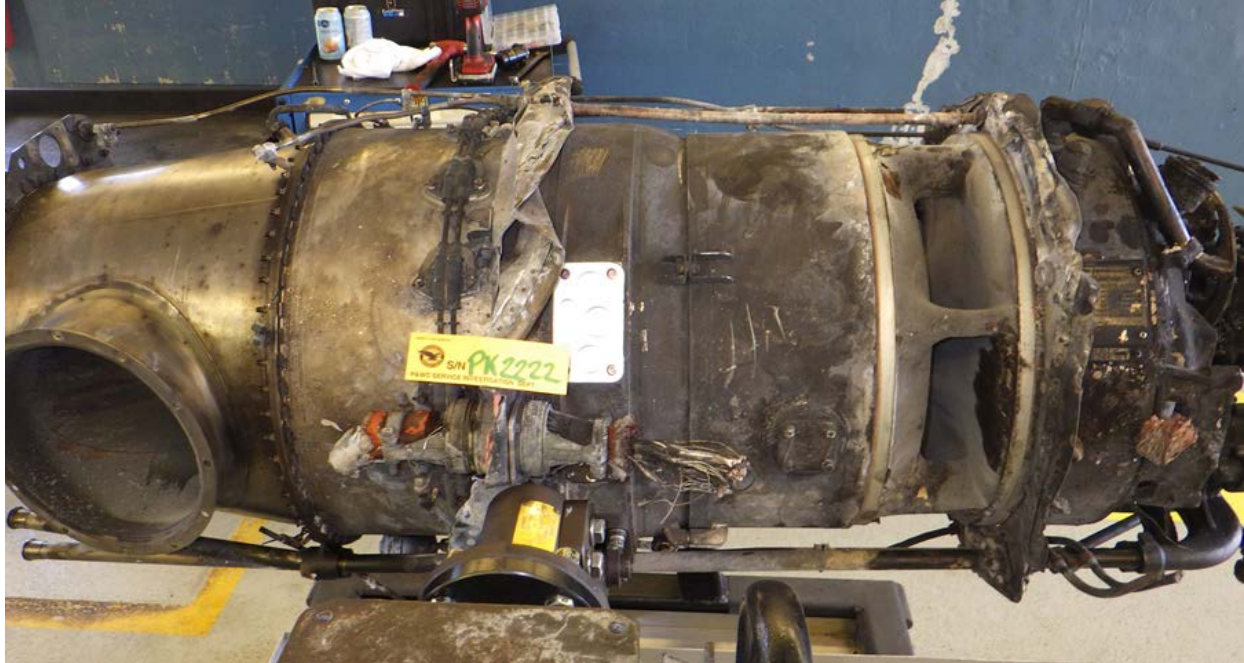
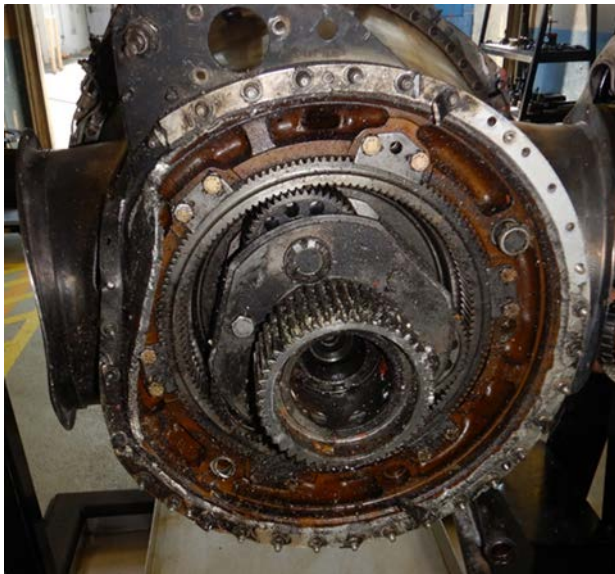
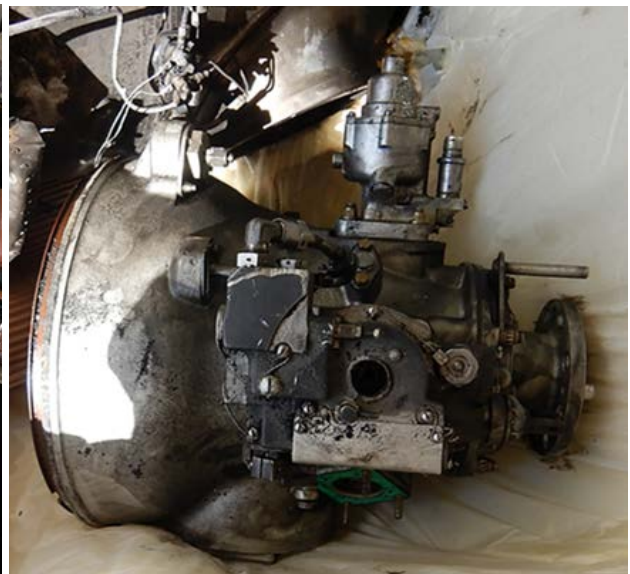
The engine exhibited light thermal damage. The gas path was coated with dirt/soot. Both rotors were seized. The reduction gearbox was fractured at the A flange and the forward section of the reduction gearbox was found attached to the right propeller. See Figures 49 through 52.

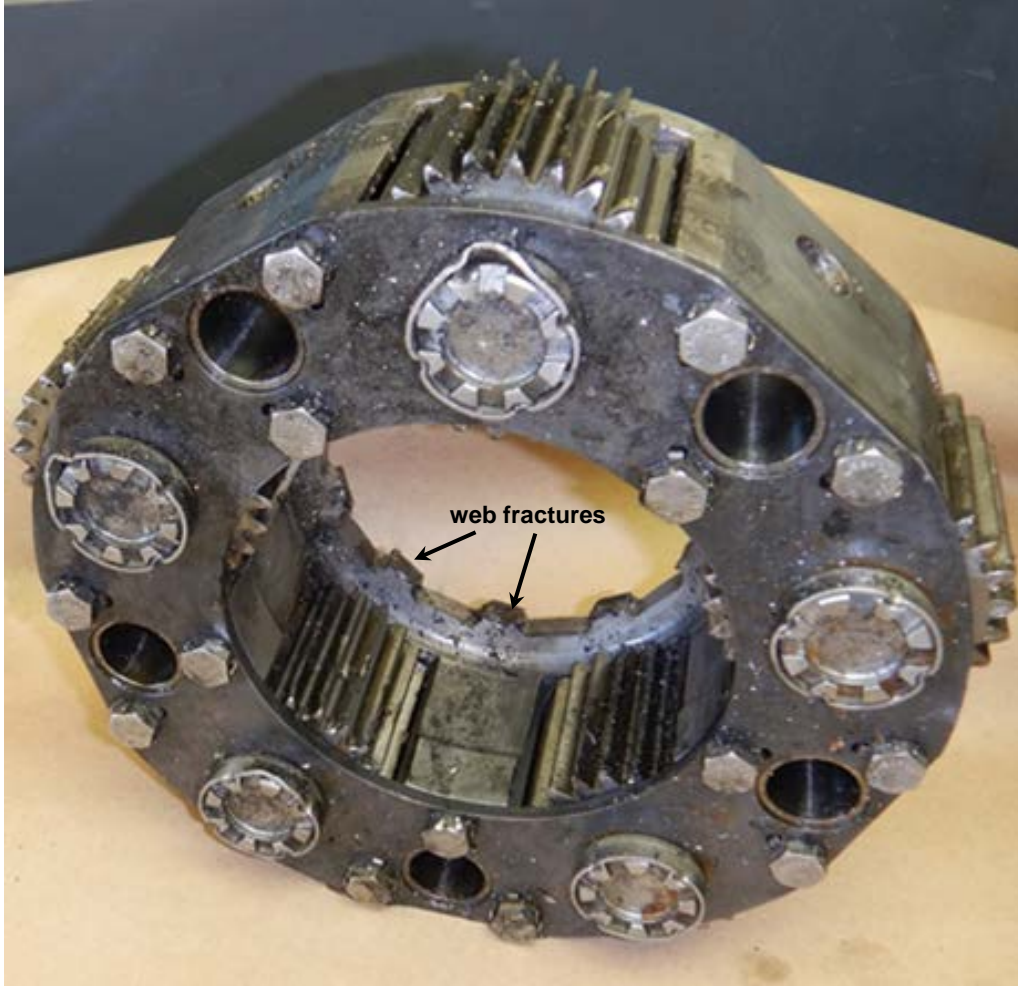
The S2 planet gear carrier was separated at the web and was found nearby.

Figure 53. Liberated S2 planet gear carrier with several of the 10 web fractures noted

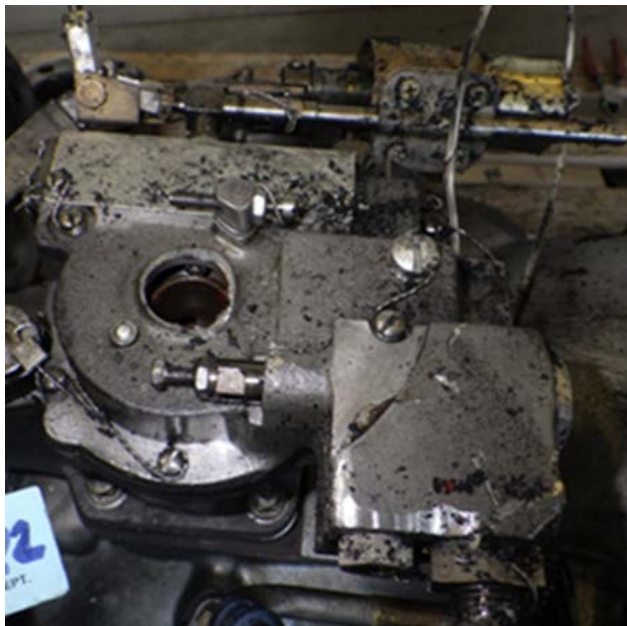
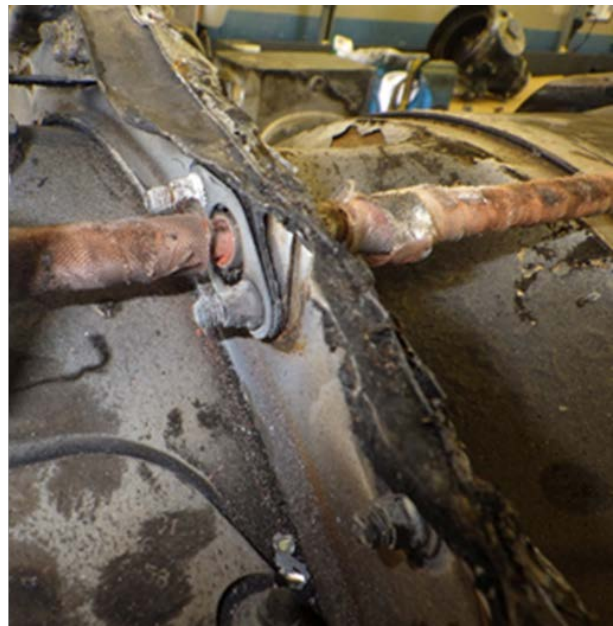
The engine externals were randomly damaged by the impact sequence and were coated with soot, fire debris, and fire extinguishing chemicals. See Figure 54. The exciter box was thermally destroyed. There was local thermal damage to line insulation and attachment hardware. The center and rear fire seal mount ring assemblies were displaced and deformed. See Figure 55.

Figure 54. Propeller governor, showing impact damage Figure 55. Typical right engine thermal damage

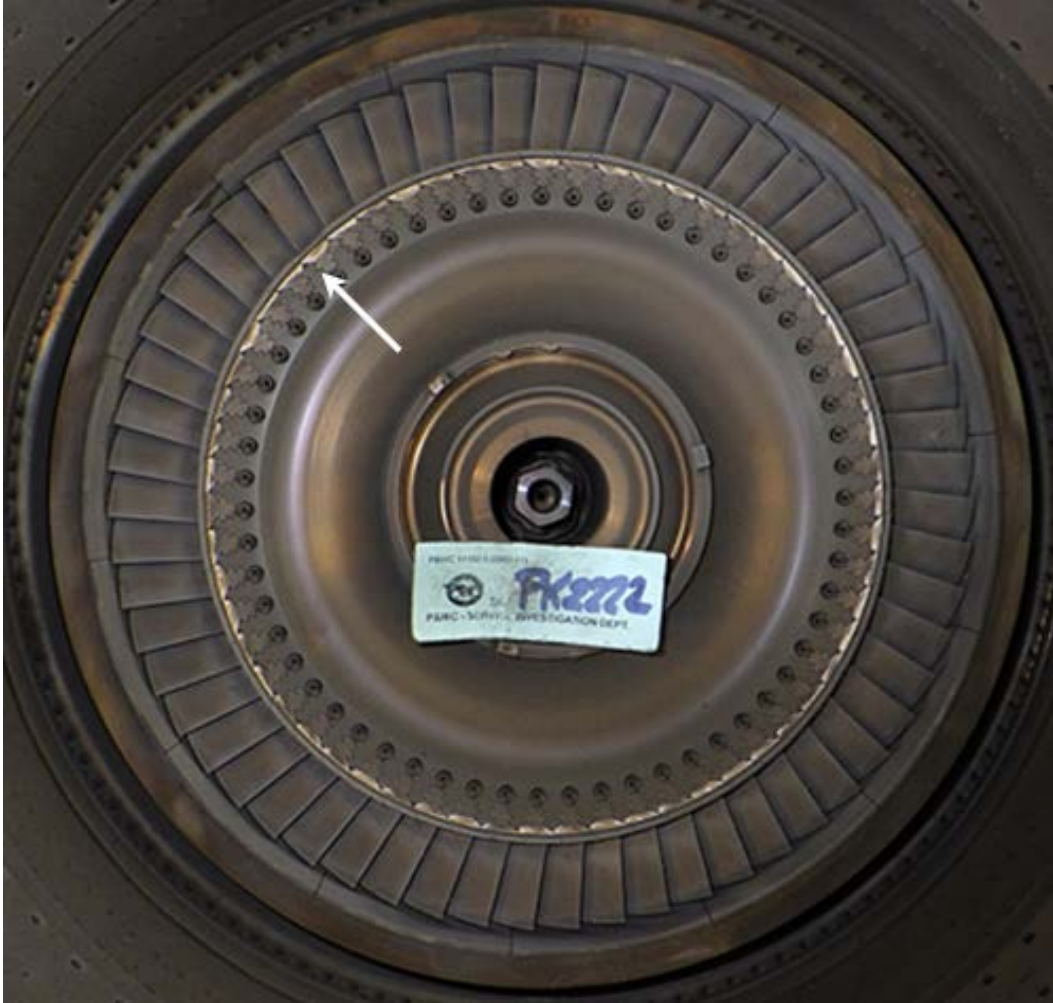
The downstream face of the CT disk assembly was scored 360° in the blade fir tree root area adjacent to the platforms. See Figure 56.

Figure 56. CT disk assembly downstream face showing 360° scoring in the fir tree root area

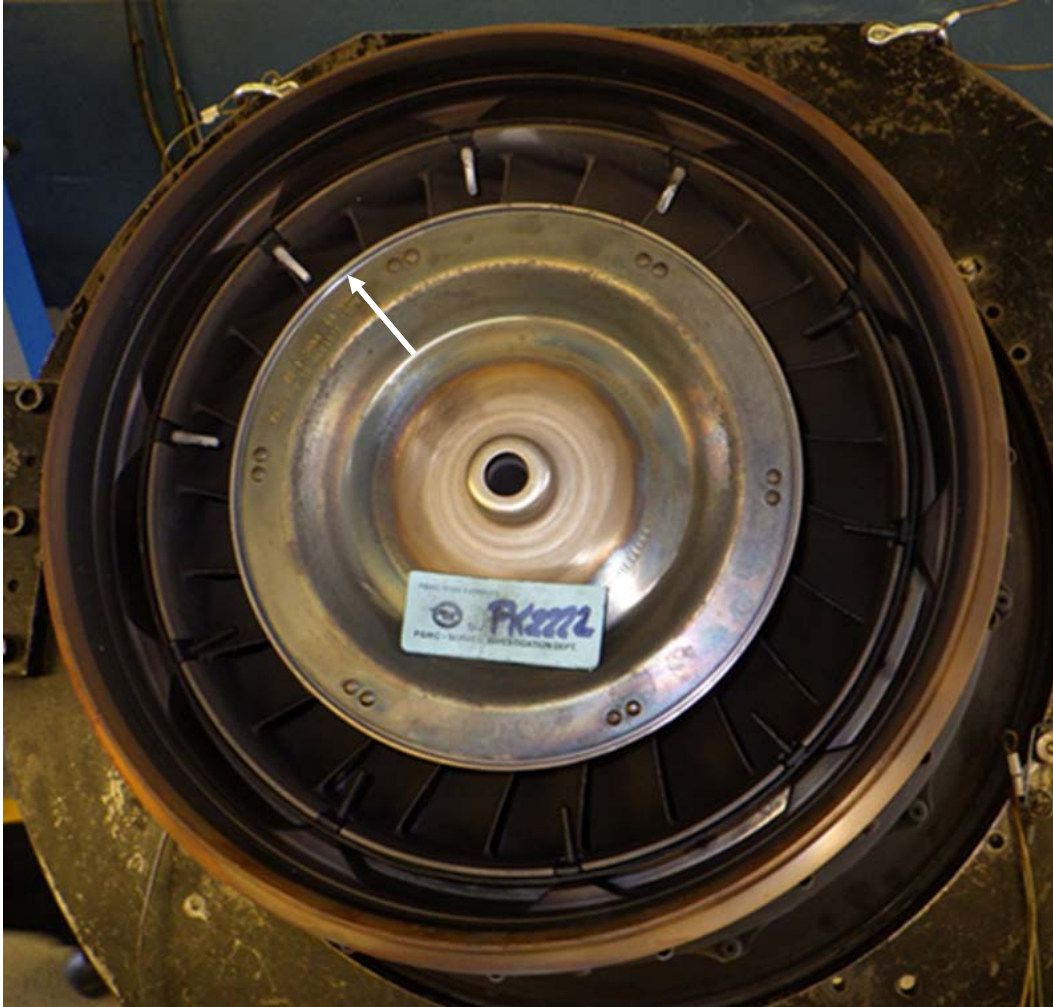
The upstream face of the S1 PT guide vane ring and interstage baffle was lightly scoring along the inner shroud edge. See Figure 57.

Figure 57. Upstream face of S1 PT guide vane ring and interstage baffle showing shroud edge scoring

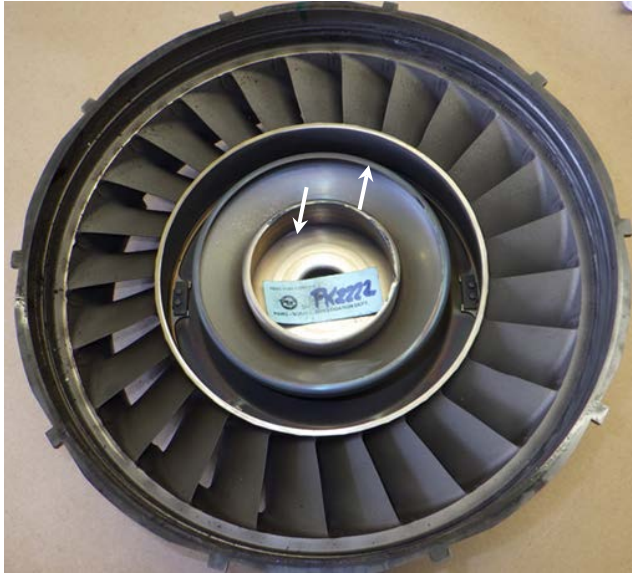
The downstream face of the S1 PT guide vane ring and interstage baffle was scored along the inner shroud and center baffle edge. The S1 PT vanes were undamaged. See Figure 58.

Figure 58. Scoring on downstream face of S1 PT guide vane ring and interstage baffle

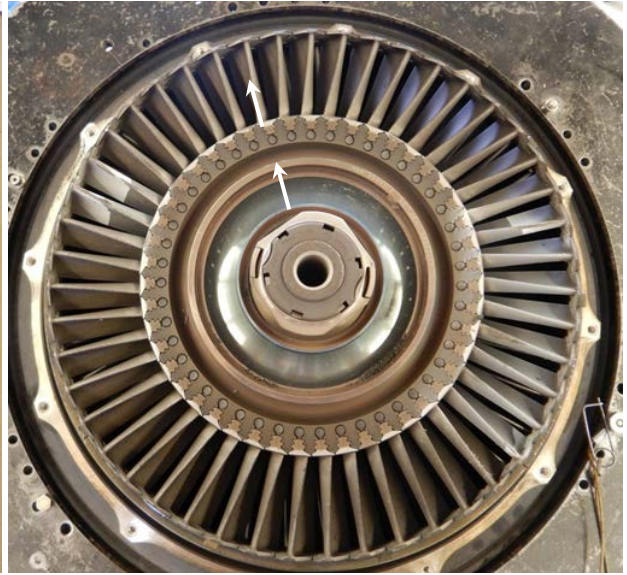
Figure 59. Rotational scoring S1 PT disk upstream face

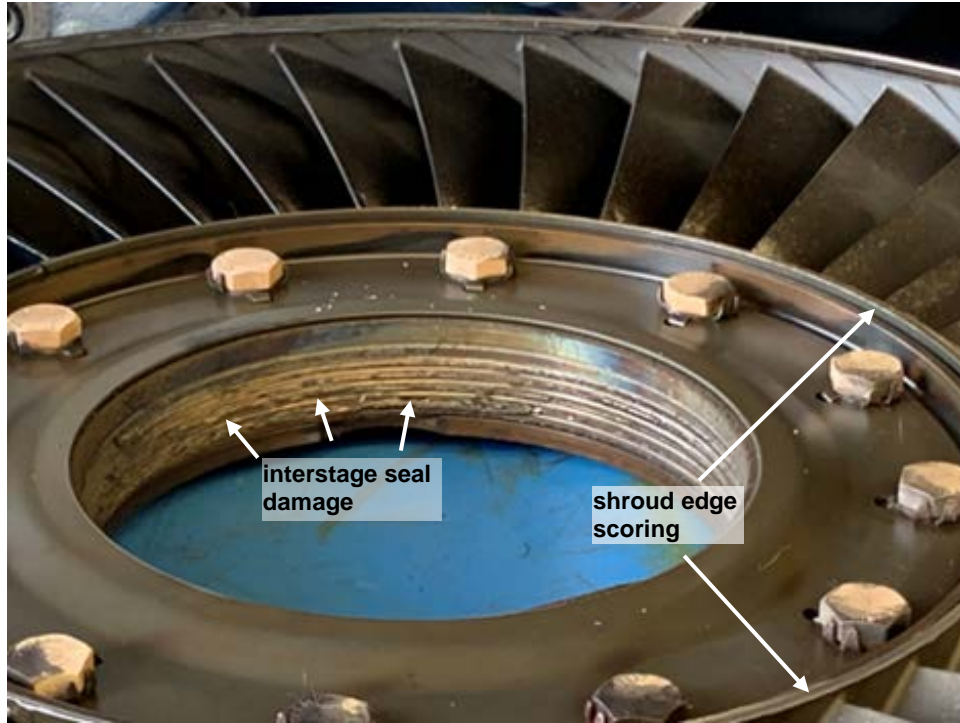
Figure 60. S2 PT guide vane ring and interstage baffle showing outer shroud edge scoring and interstage seal damage

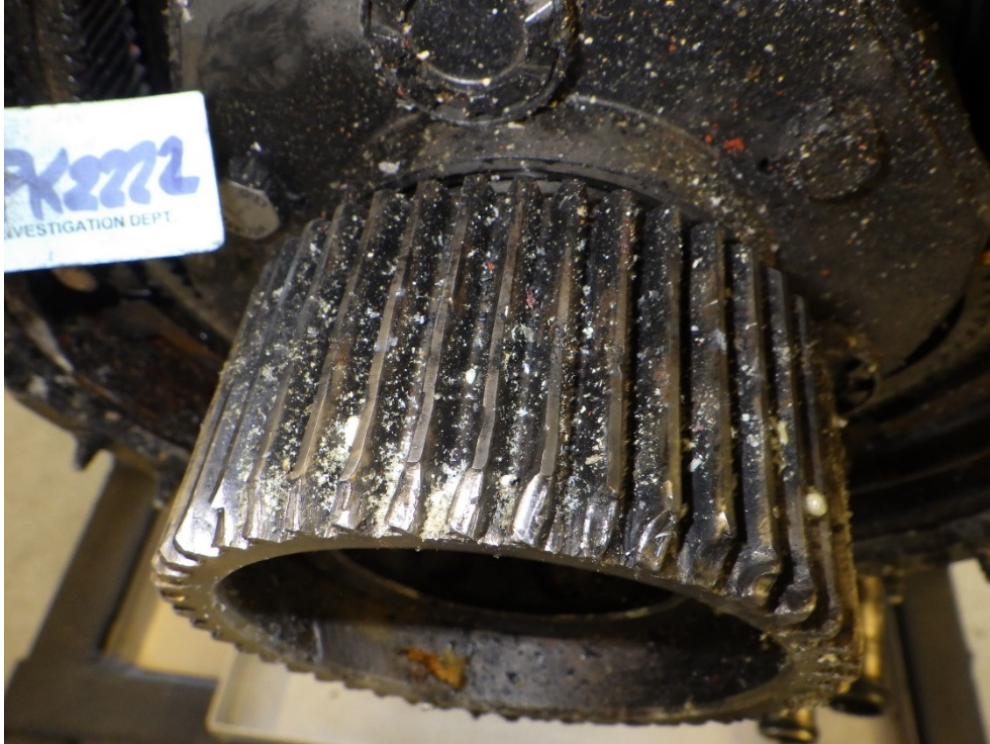
Figure 61. S2 sun gear tooth damage

The S2 sun gear and flex coupling gear were coated with debris consistent with exposure to site debris after flange separation. The gear teeth displayed impact damage and damage consistent with spiral mis-meshing. See Figure 61.

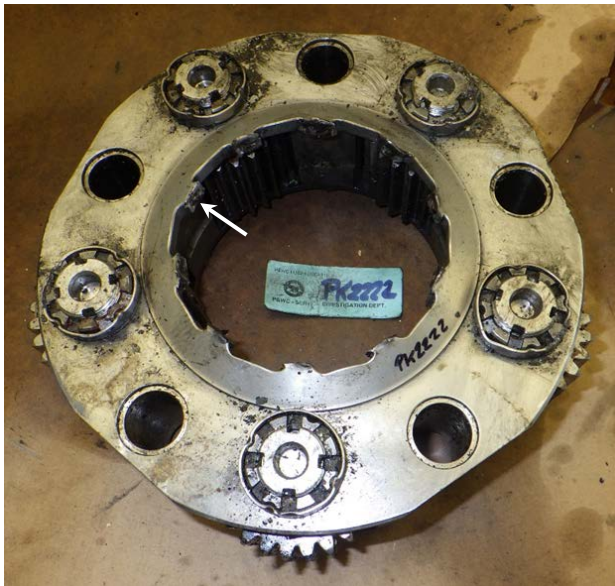
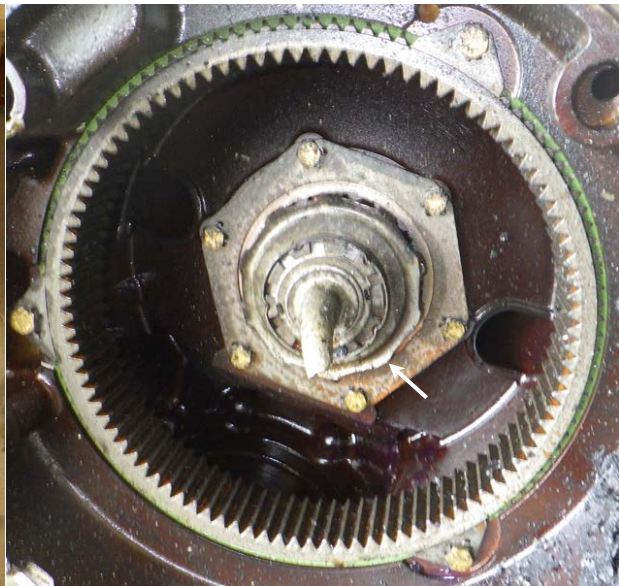
The S2 planet gear carrier was separated at the slotted diameter of its web. See Figures 62 and 63.

Figure 62. Aft side of S2 reduction gearbox planet gear with one web fracture surface noted

Figure 63. Forward side of S2 planet gear carrier with one web fracture surface noted

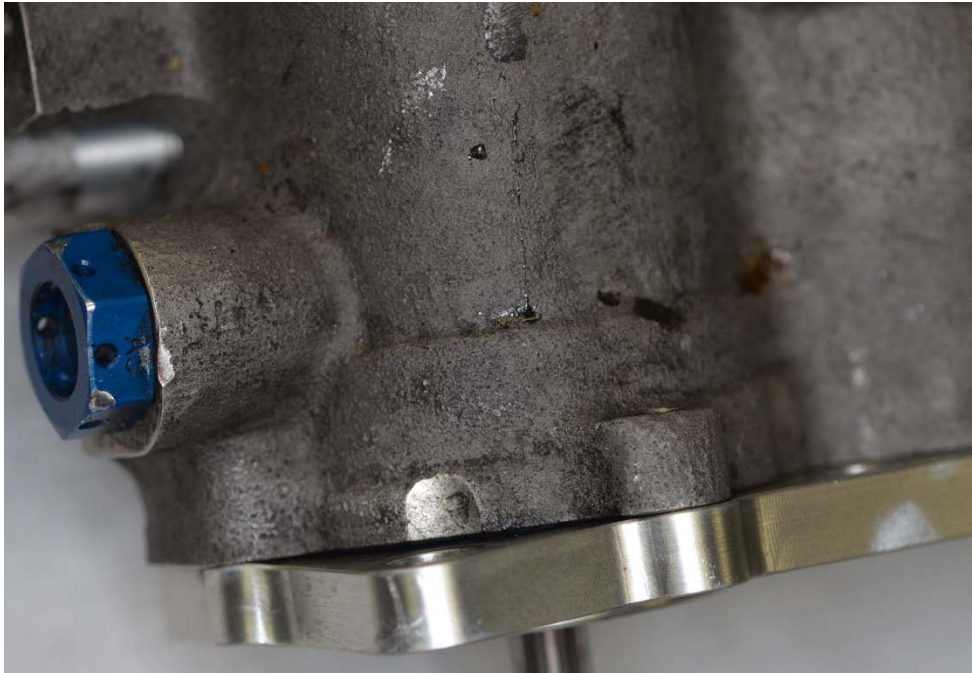
adjusted in the field. All remaining lockwire was Woodward-installed. The min speed and min flow-to-delta P adjustor lockwires were broken. The base plate was bent consistent with impact damage. See Figure 64.

Figure 64. Deformed baseplate, FCU S/N 20565991
