NATIONAL TRANSPORTATION SAFETY BOARD
Office of Research and Engineering
Washington, D.C. 20594

Video Study

**NTSB Case Number:
CEN19MA190**

Location: Addison Airport (KADS), Addison, Texas
Date: June 30, 2019
Time: 0911 central daylight time (CDT)
Aircraft: Textron Aviation B300

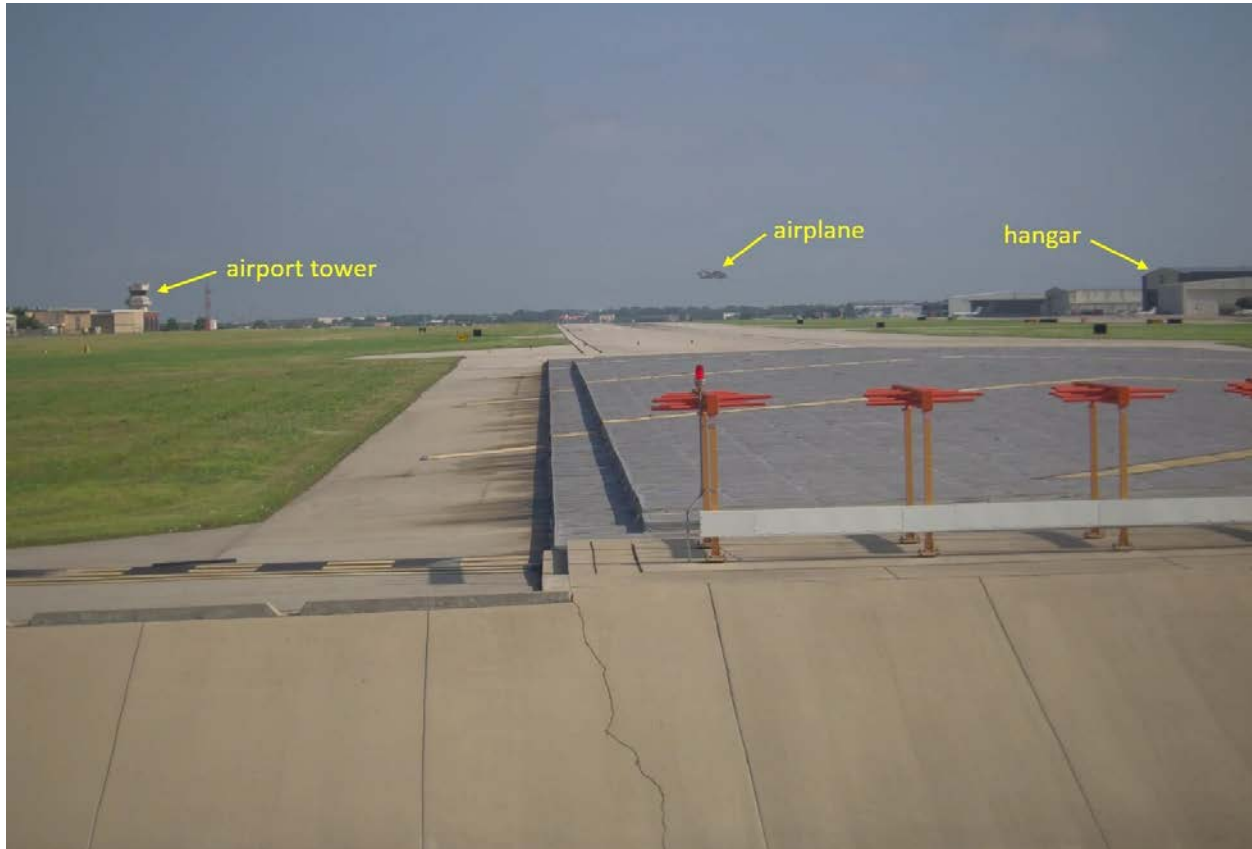
Figure 2. Frame from the Analyzed EMAS Video

Figure 2 displays a frame from the EMAS video that shows the airborne airplane about six seconds before it crashed into the northern wall of the hangar marked in the figure.

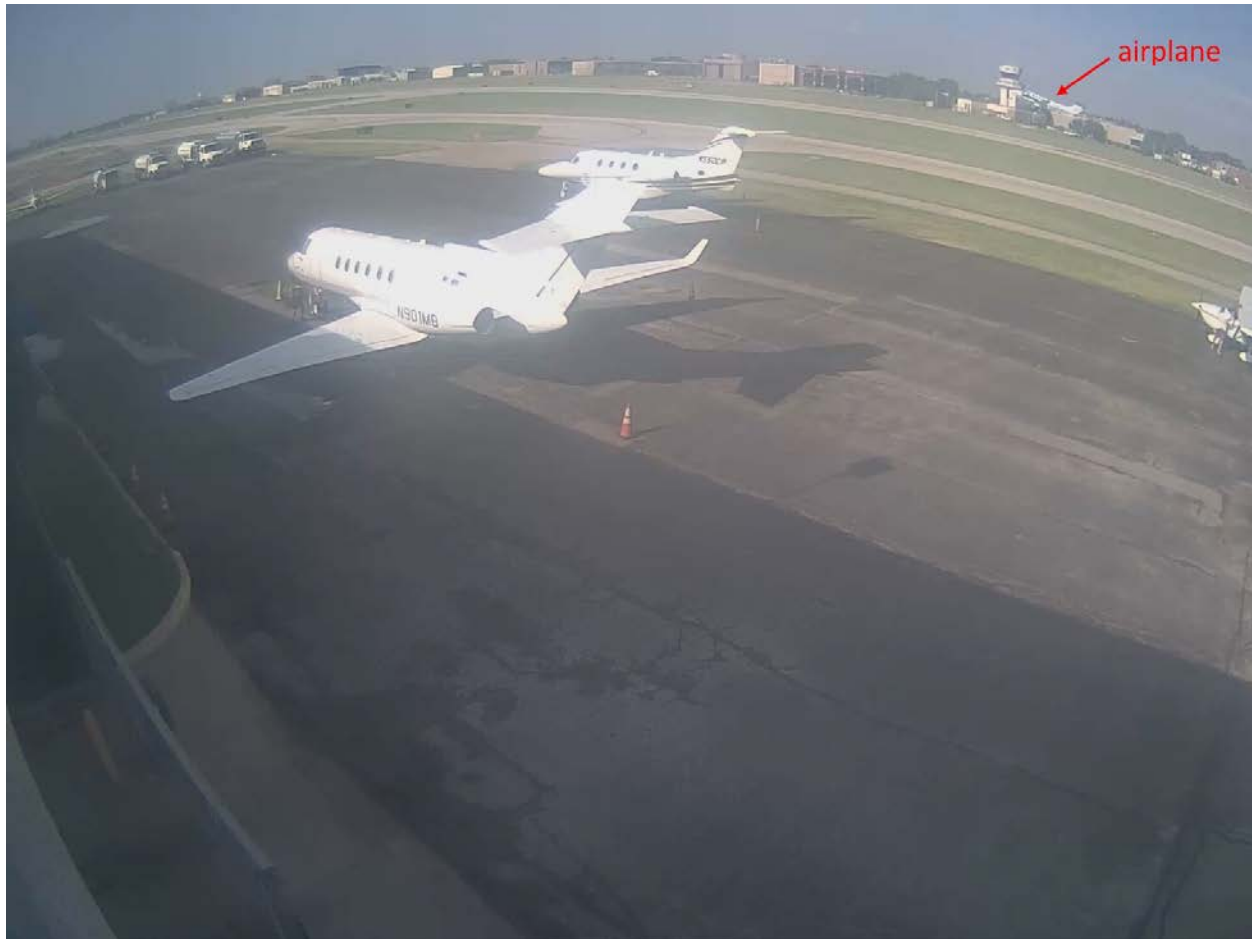
Figure 3. Frame from the Atlantic Aviation Video

The video recorded by a camera on the Atlantic Aviation building provided the most accurate speed estimate. Figure 3 shows a frame from that video recorded when the airplane was above the runway at a location on the line of sight from the camera to the airport tower. The airplane location and speed estimates based the Atlantic Aviation video provided a reference point from which the analysis proceeded based on the EMAS camera video, as described next.

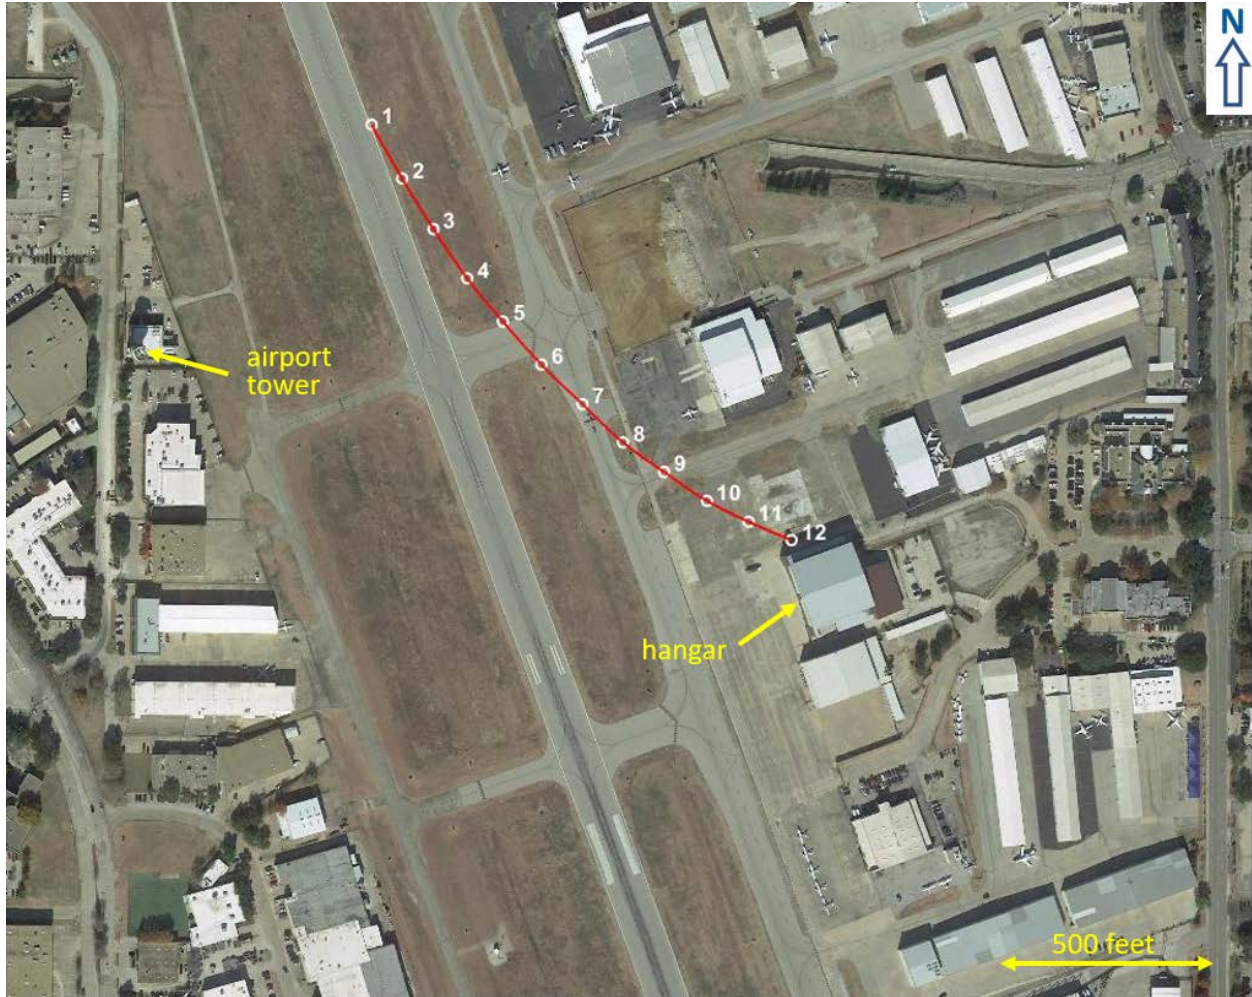
Figure 4. Estimated Ground Track of the Airplane

Figure 4 shows the ground track of the airplane superimposed on an aerial image of the area. The twelve white markers on the red trajectory curve are at the ground locations where the airplane nose was when the twelve analyzed video frames were recorded. The red line interpolates in between the twelve markers. The figure shows that when analysis started, the airplane was already deviating to the left and was approximately above the left edge of the runway at the first analysis point.

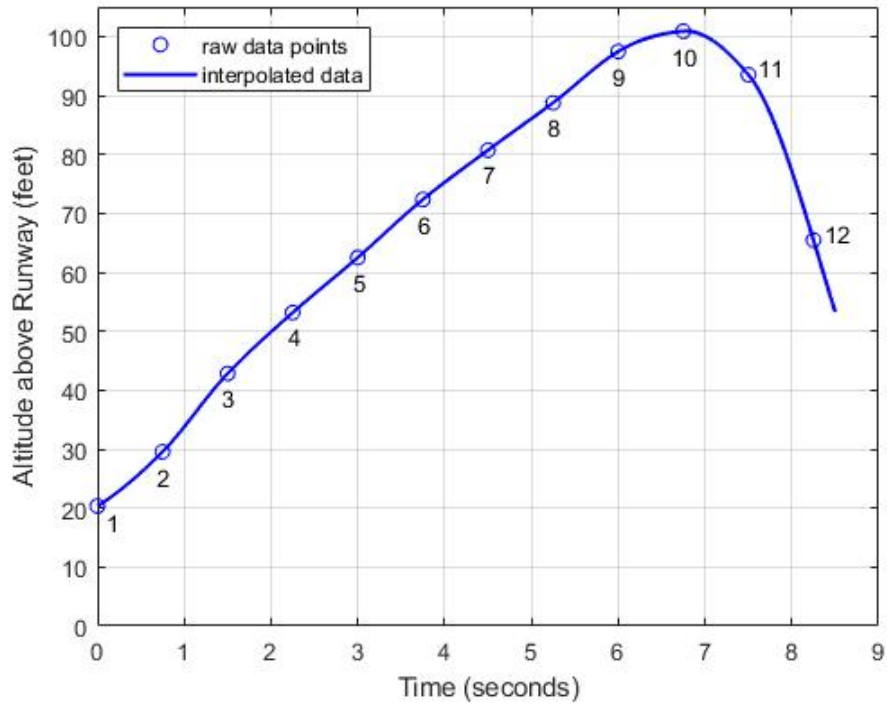
Figure 5. Estimated Altitude of the Airplane

Figure 5 shows the estimated altitude of the airplane above the north end of the runway at the times when the twelve analyzed frames were recorded. Altitude in Figure 5 was set to zero when the airplane was still on the ground. Once airborne, altitude in the figure is the altitude of the nose of the airplane. The time when the first analyzed frame was recorded was set to zero in the figure. This time corresponds to 09:10:40.762 CDT based on the time stamp on the first analyzed frame.

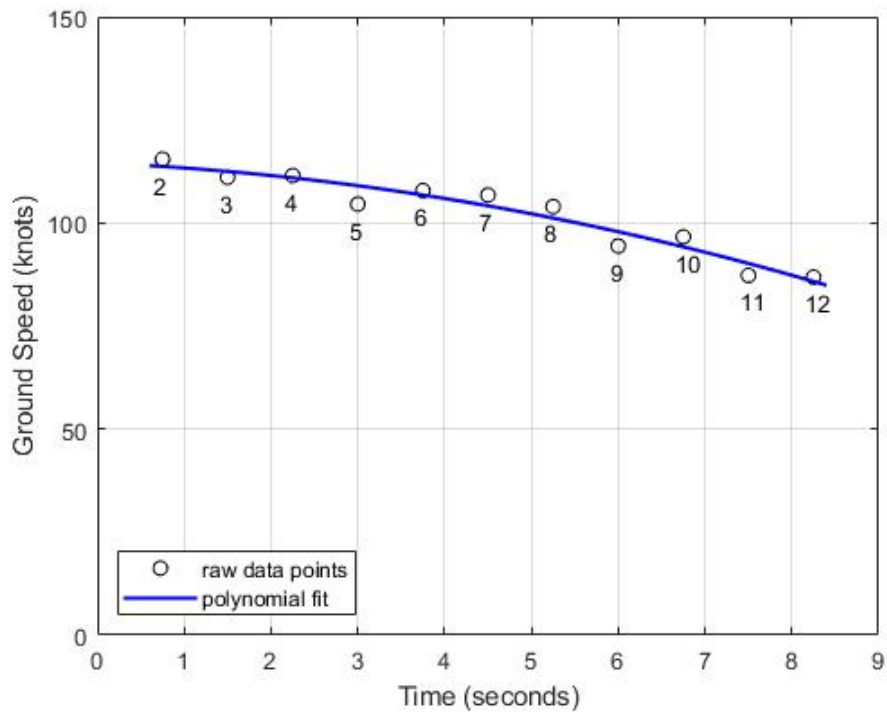
Figure 6. Estimated Ground Speed of the Airplane

Figure 6 shows the estimated ground speed of the airplane. The speed was estimated in segments between pairs of adjacent trajectory points. The eleven numbered markers in the figure are at the estimated speeds in segments ending at that trajectory point. The speed fluctuations indicated by the raw data points are due to the unavoidable high sensitivity of the estimated speed to the accuracy of the segment lengths. The segments are 150 feet long or shorter and a 5-foot segment length error causes a 3-knot speed estimation error. To provide a more reliable speed estimate, a polynomial curve was fitted to the raw data points and is shown in the figure.

Note in Figure 10 that during the analyzed time, either the sideslip angle was above 15° or the angle of attack was above 12° . Both high sideslip angle and high angle of attack cause significant decrease in the lift-to-drag ratio (primarily due to increased drag) that could explain the ground speed decreasing from about 114 knots to about 85 knots during the analyzed time, as shown in Figure 6.

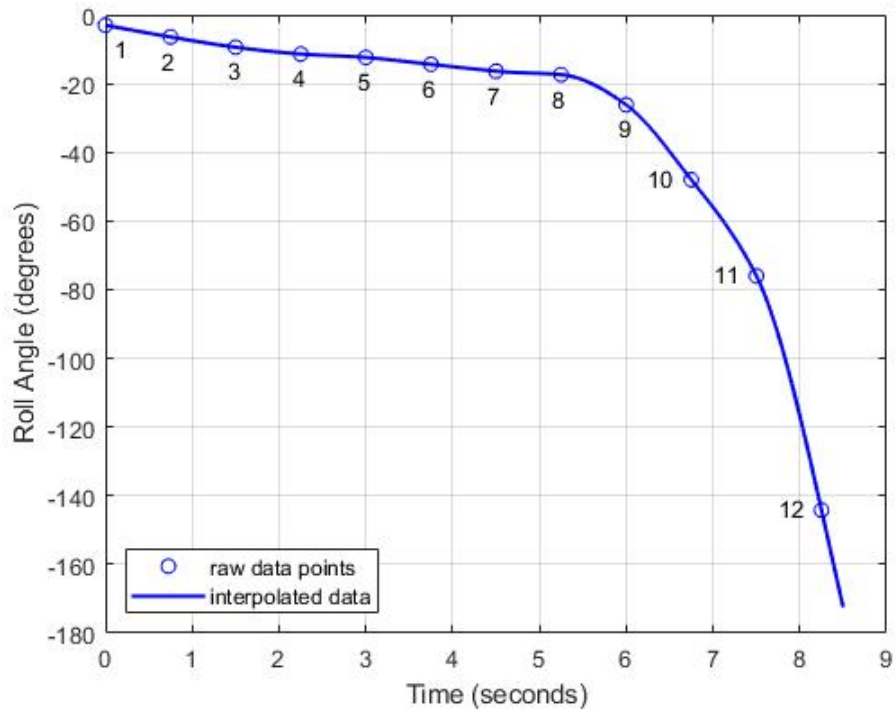
Figure 7. Estimated Roll Angle of the Airplane

Figure 7 shows the estimated roll angle of the airplane at the twelve analyzed times. The blue line interpolates in between the markers. Positive roll angle corresponds to right wing down. The roll angle was negative during the entire flight as could be expected from the shape of the ground track in Figure 4.

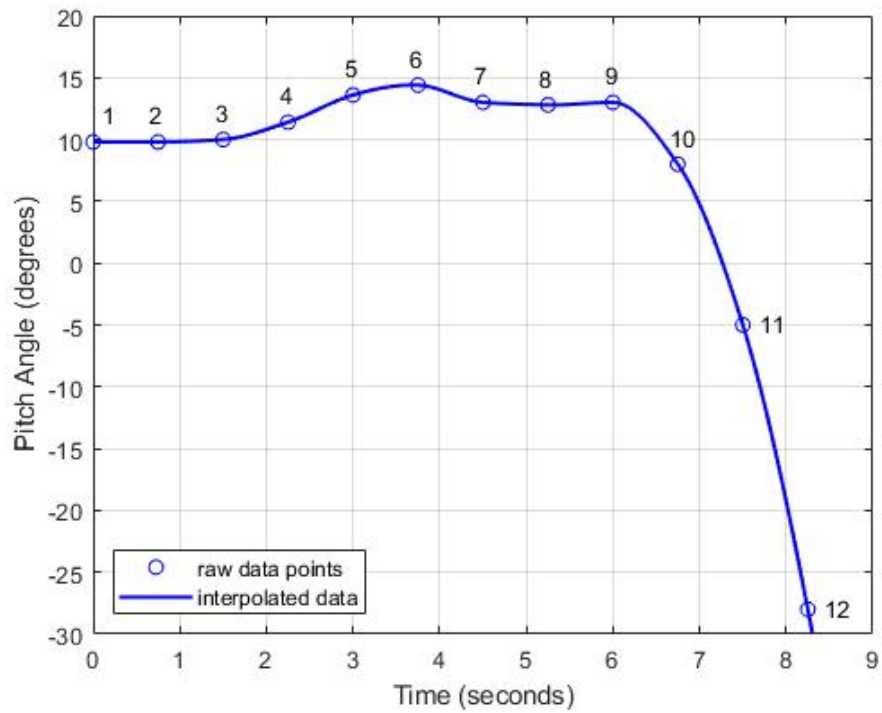
Figure 8. Estimated Pitch Angle of the Airplane

Figure 8 shows the estimated pitch angle of the airplane at the twelve analyzed times. Positive pitch angle corresponds to nose up. The blue line interpolates in between the markers.

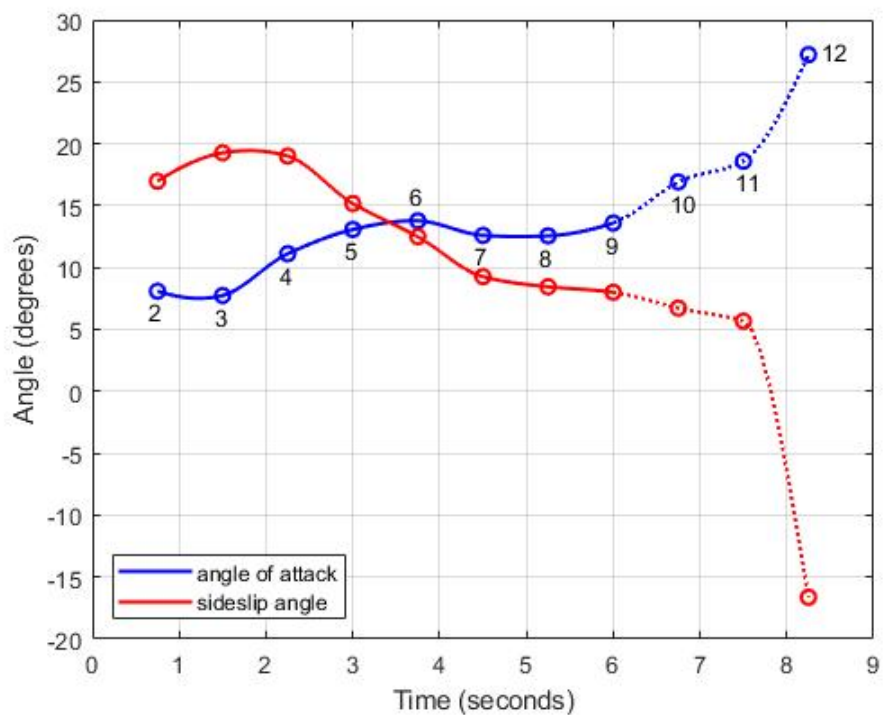
Figure 10. Estimated Angle of Attack and Sideslip Angle

Figure 10 shows the estimated angle of attack and sideslip angle of the airplane. Up to point No. 9 at time 6 seconds, the lines interpolating between the raw data point markers are solid, indicating that the airplane was still mostly in normal controlled flight. Past time 6 seconds, the interpolating lines are shown dotted, indicating that the airplane was no longer in normal controlled flight. Figure 11 shows the airplane at time 7.5 seconds, when its left-wing-down roll angle was approaching 90° and it was losing altitude.

The polarity of the sideslip angle in Figure 10 is positive when the relative wind is coming from the right of the nose of the airplane. The relative wind was mostly due to the forward motion of the airplane and partially due to the wind conditions at the airport at the time of the accident. The wind at the airport at time 0847 CDT was reported as 6 knots from 100° . The sideslip angle was positive up to shortly before the impact into the hangar. It was positive because the airplane was yawed to the left (CCW in top view) more than the slope to the left of the ground track shown in Figure 4.

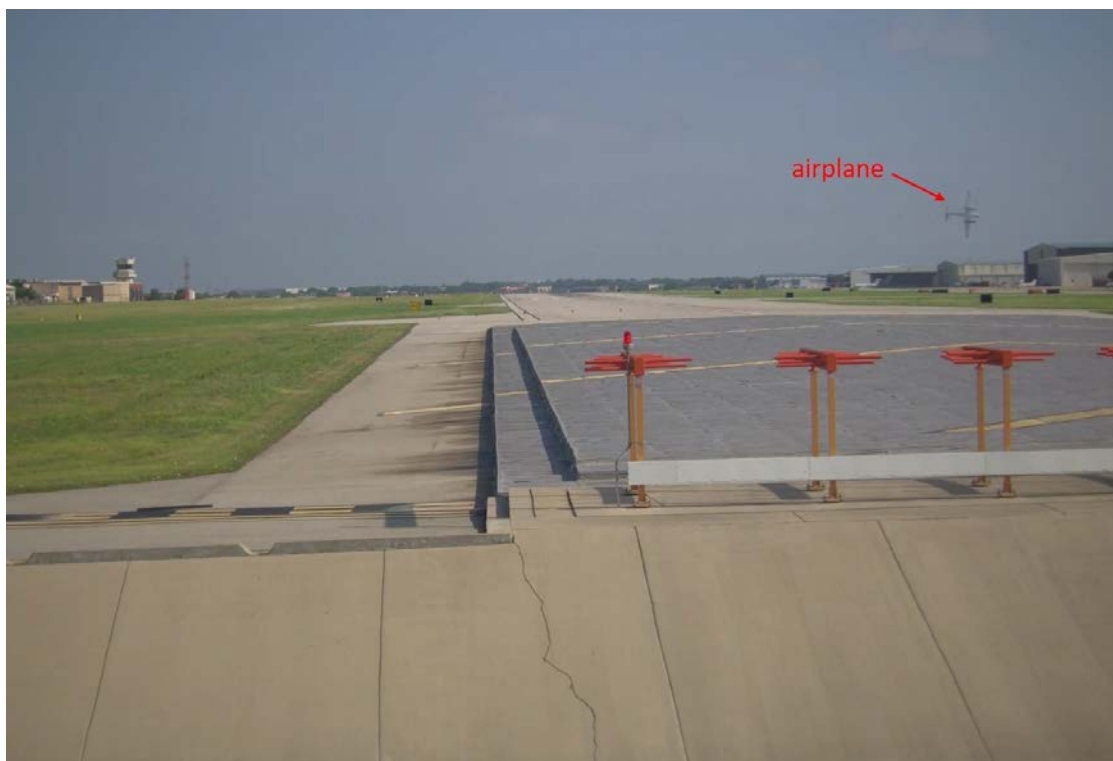
Figure 11. Frame from the Analyzed EMAS Video at Time 7.5 seconds
