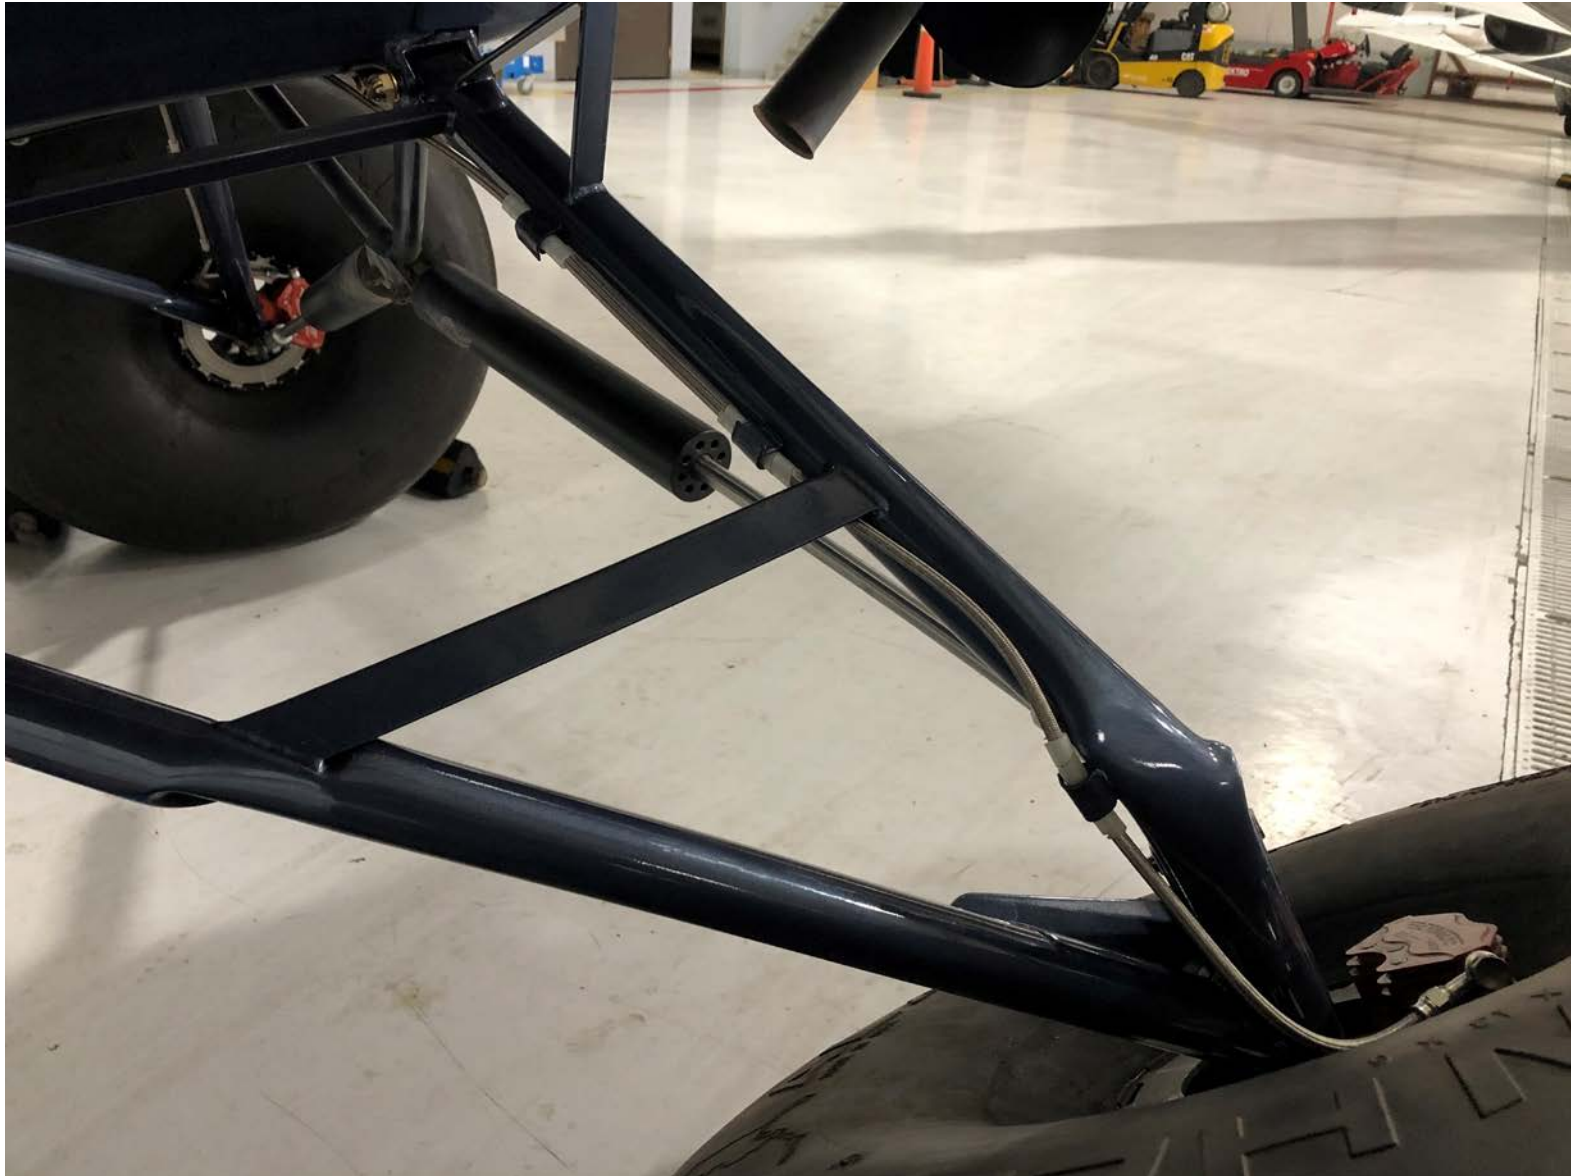
Photo 1 – Damage to Right Main Landing Gear Strut

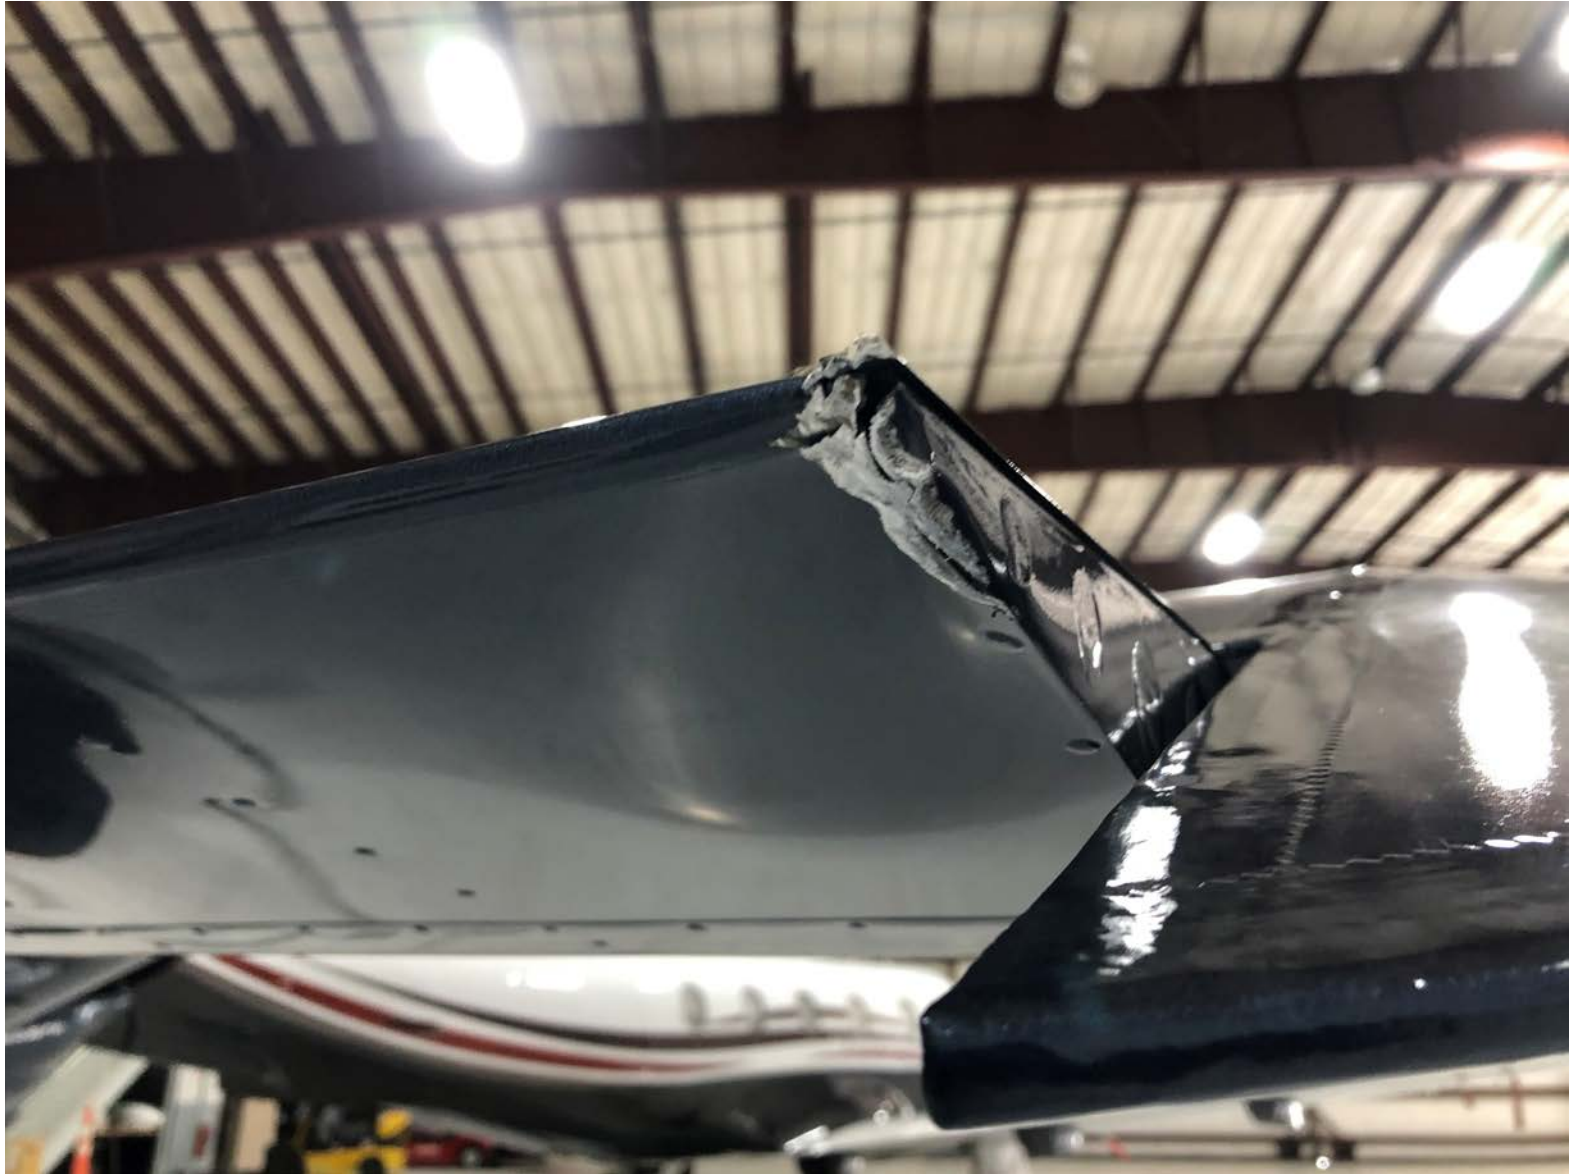
Photo 2 – Damage to Right Aileron
