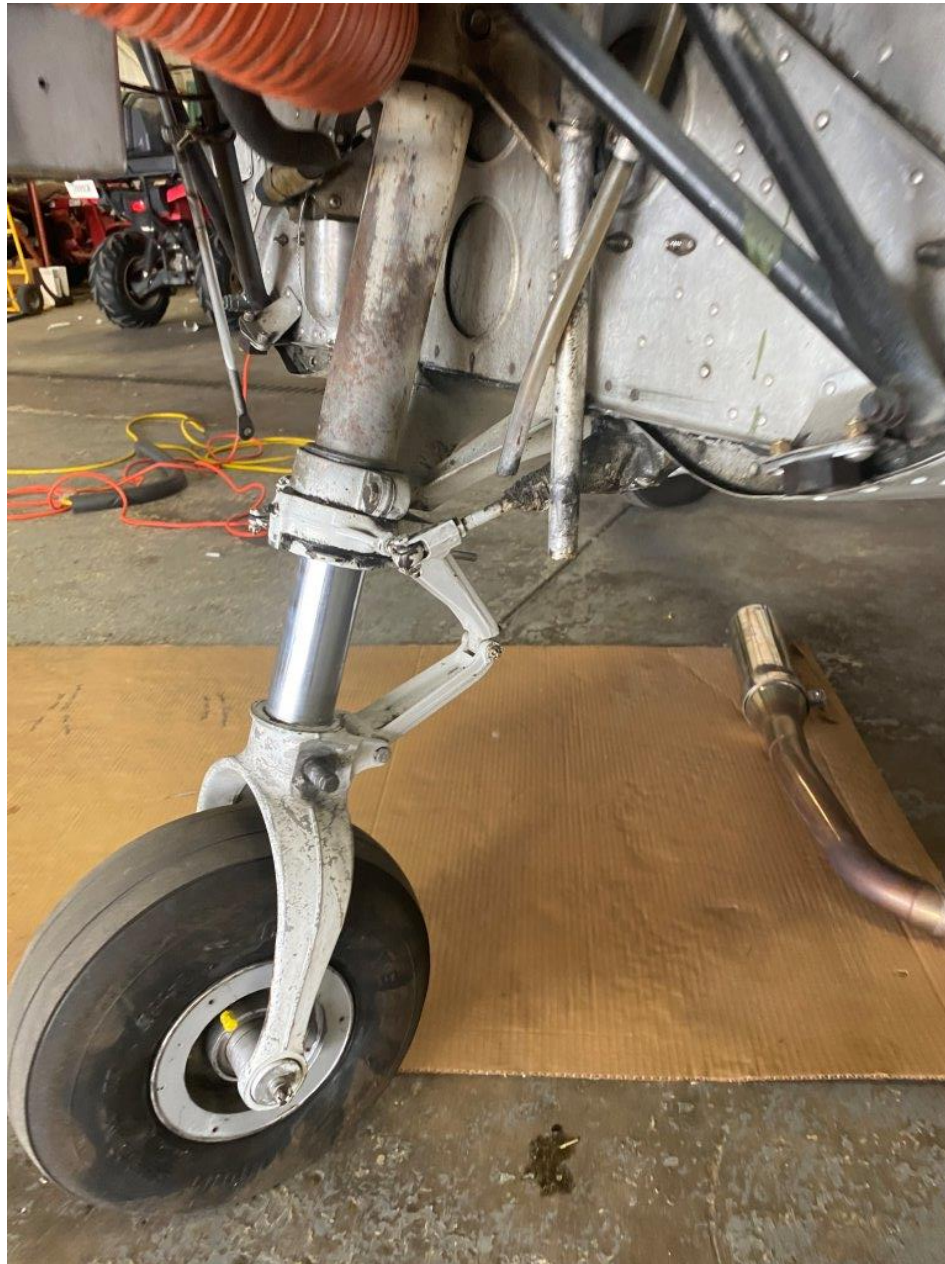
Photo 1 – Damage to the Nosewheel and Lower Fuselage

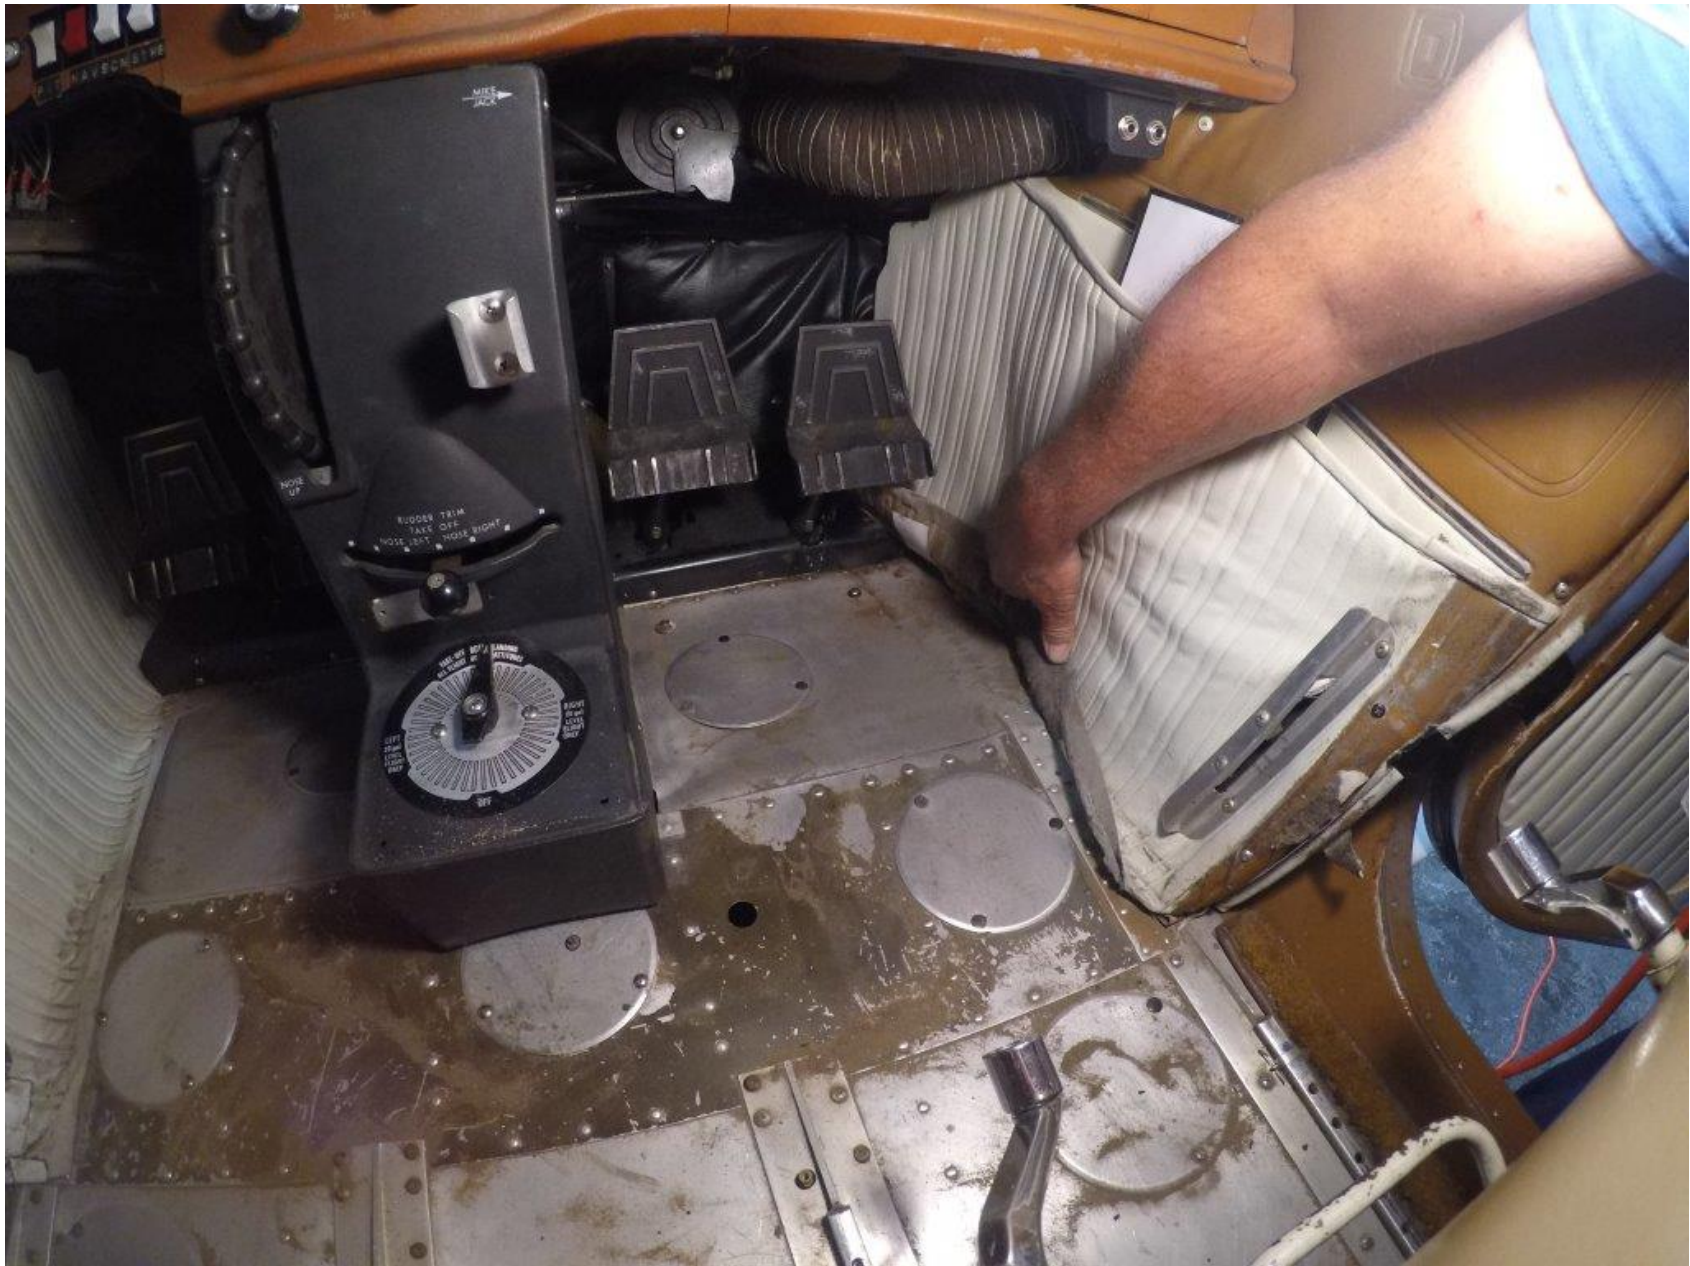
Photo 2 – Damage to Interior Floorboards on Passenger Side
