NATIONAL TRANSPORTATION SAFETY BOARD
Office of Aviation Safety
Washington, D.C. 20594

Airworthiness Group Chairman's Factual Report

CEN20FA022

Location: Near the Chamberlain Municipal Airport, (9V9), Chamberlain, South
Dakota
Date: November 30, 2019
Time: 1235 central daylight time
Airplane: Pilatus PC-12/47E airplane, N56KJ

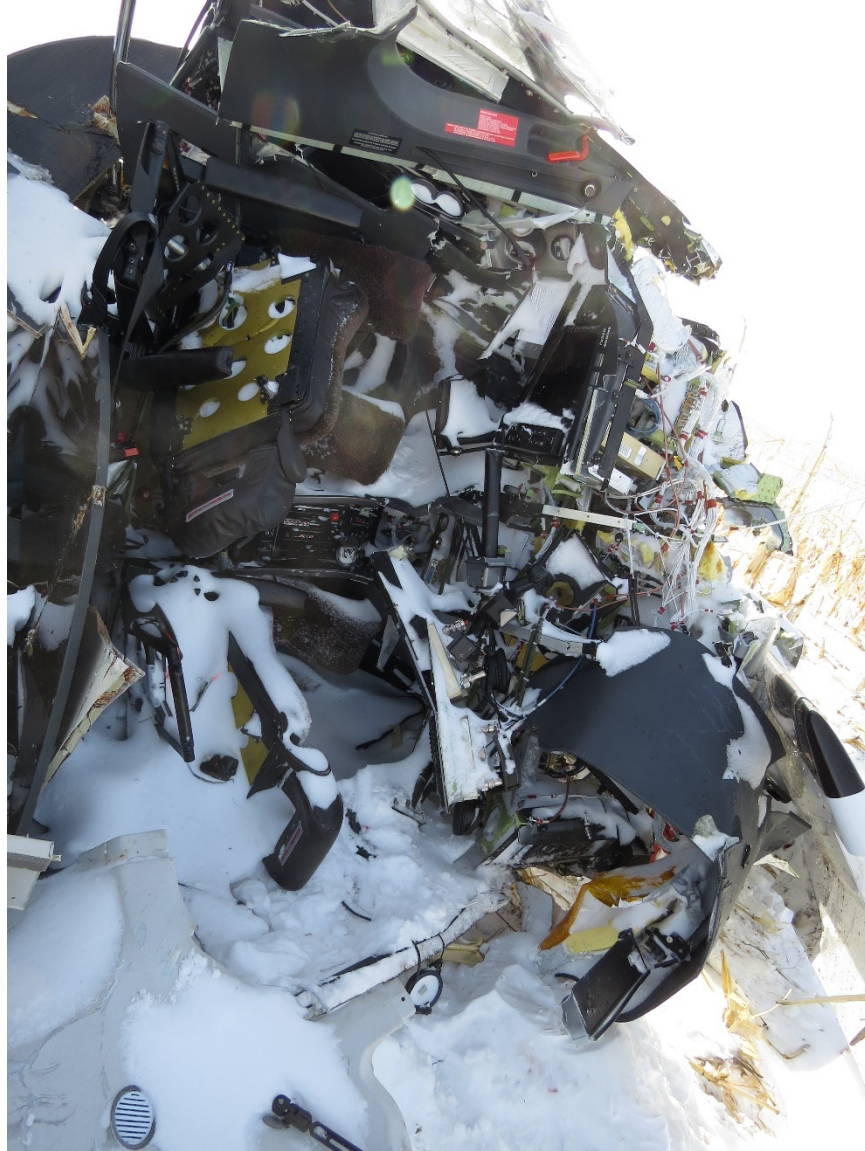
Figure 1
Cockpit Area

The cockpit area wreckage was extensively damaged during the impact. The control wheels, throttle quadrant, rudder pedals, and instrument panel all sustained significant impact damage. The left hand display was still attached to the instrument panel. The center displays were broken from their mounting, and the upper display was cracked. The right hand display was loose from its mounting and was cracked.

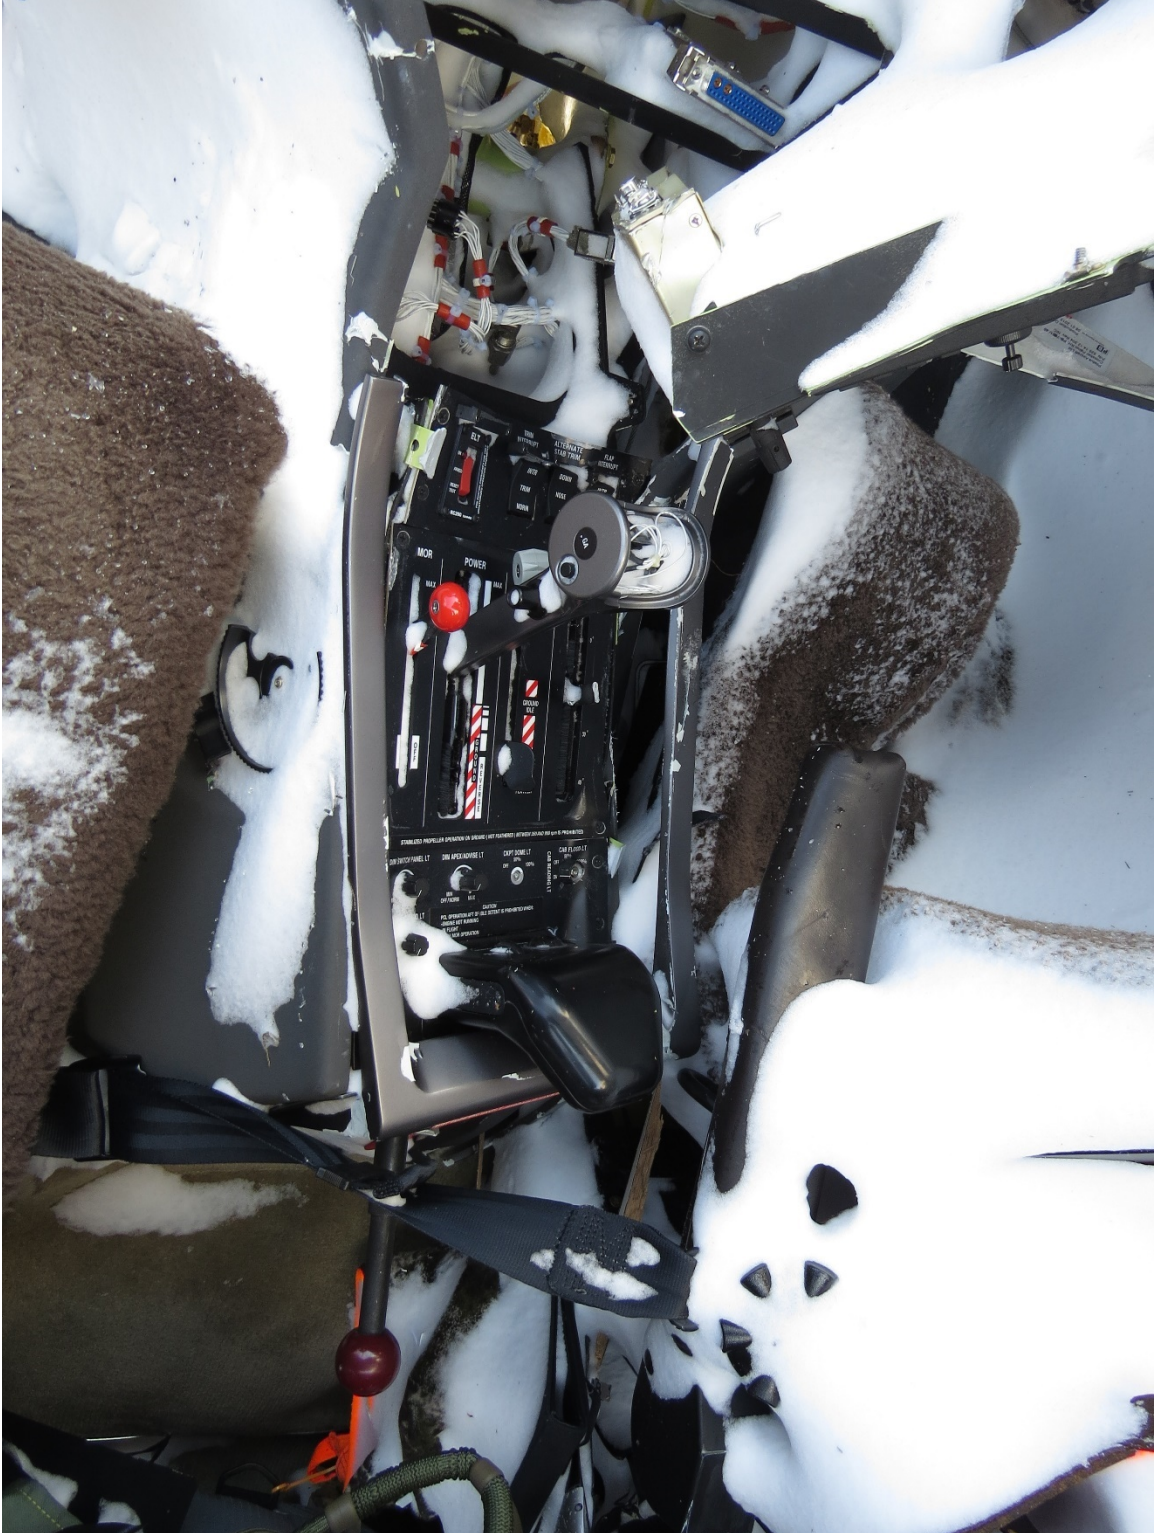
Figure 2
Cockpit Pedestal – side view

The cockpit pedestal was displaced from its normal position. The manual override (MOR) lever and power lever were both at a position of approximately 75% of maximum. The flap lever was at the 15 deg position.

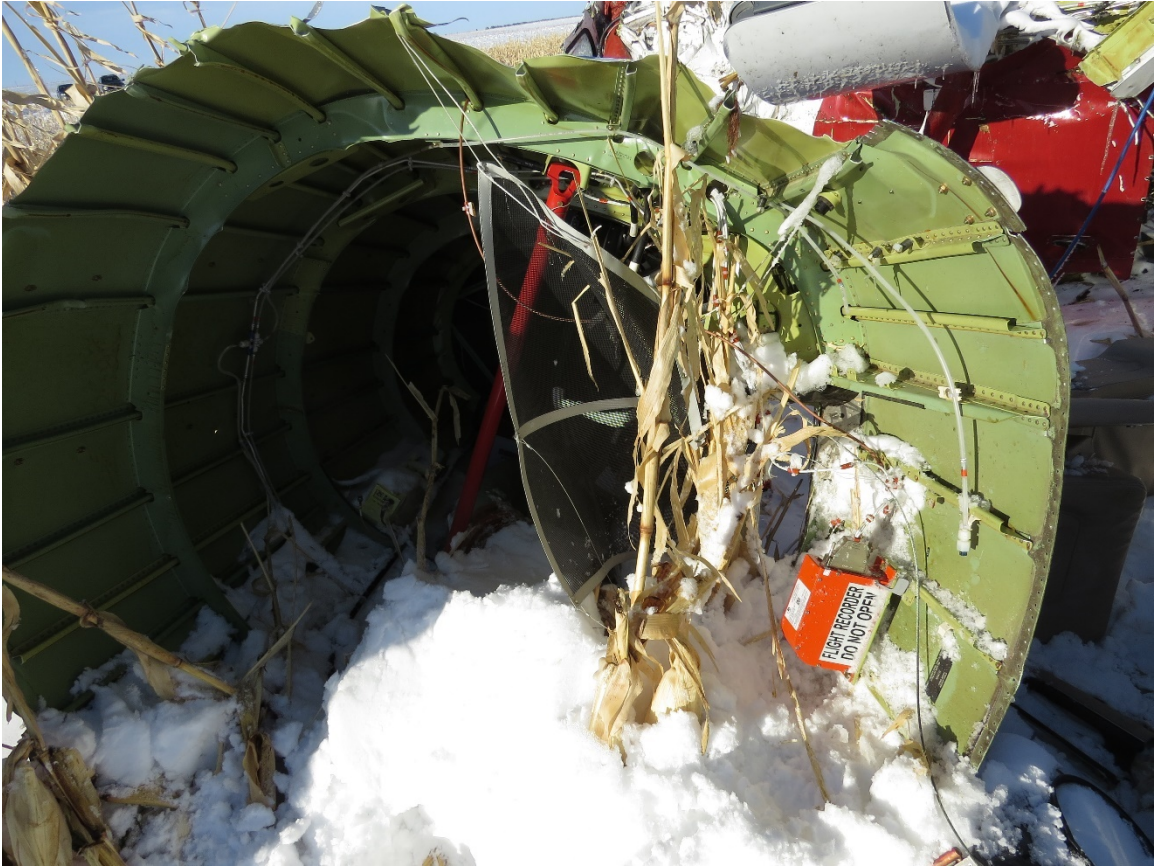
Figure 4
LDR mounted in the aft fuselage

The lightweight data recorder (LDR) was recovered on December 2 and sent to NTSB headquarters for further review. The unit was manufactured by L3 Aviation Recorders in Sarasota, FL. The part number was 1000-1000-00, and the serial number was 000891678.
