National Transportation Safety Board
CEN20LA005 – Airframe Examination Report

Airplane: Aero Commander 100 (N5573M)

Date: 11/12/2020

Location: Air Salvage of Dallas, Lancaster, Texas

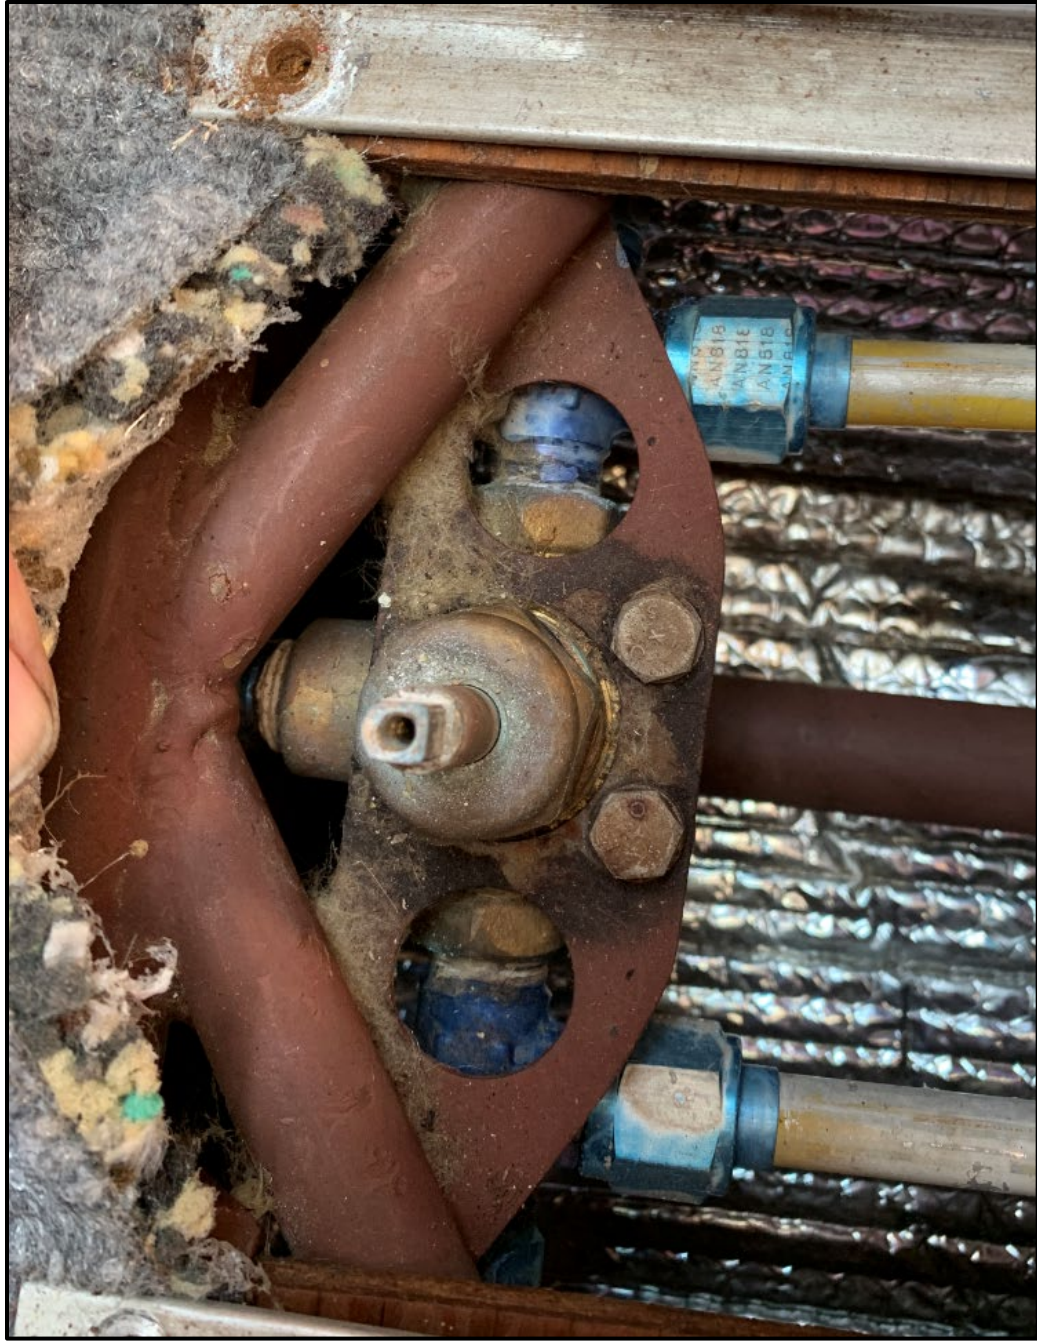
Figure 1 – View of the installed fuel selector.

- The fuel selector detents were hard to identify and took some manipulating to get set into position.
- The fuel selector was removed and examined.
- It was determined that the fuel selector handle or the pointer was installed 180° out of position. When the selector handle was selected to BOTH, the valve was completely closed in what should have been the OFF position. When the selector handle was selected to OFF, the valve was open in what should have been the BOTH position.

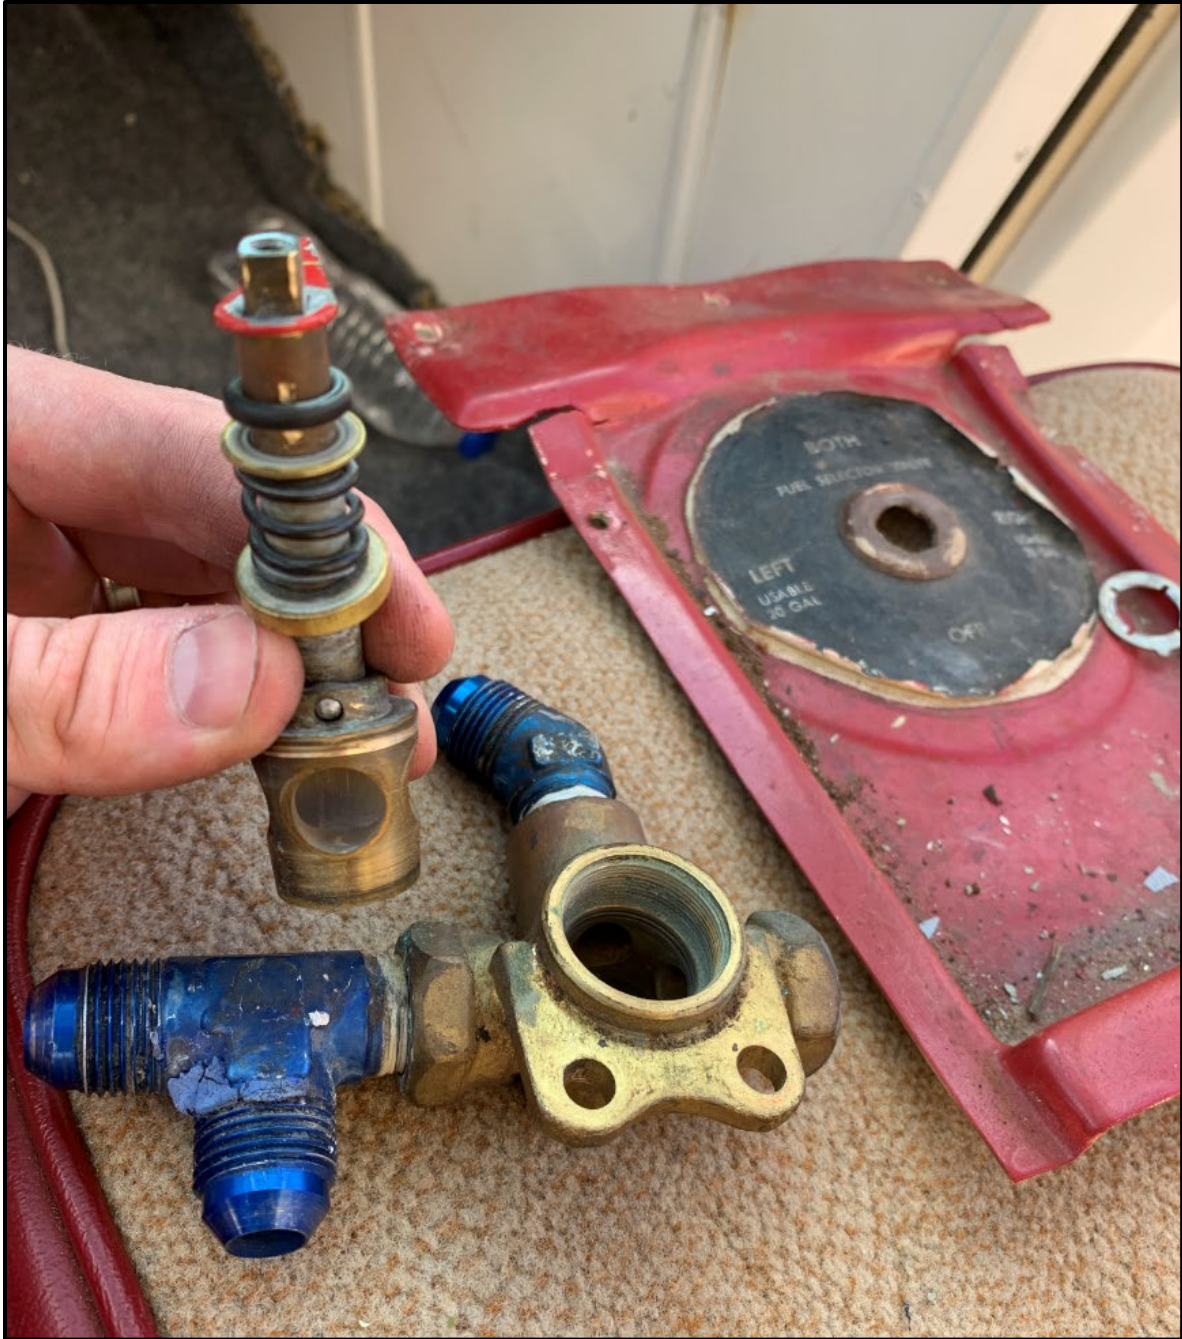
Figure 2 – View of the removed fuel selector.

- The hole on the end of the pointer that slid over the shaft featured a round side and a flat side which helps to correctly orient the pointer during installation. The hole was worn out enough that the pointer would fit over the shaft in both directions.

- The examination could not determine if the selector handle or the pointer was installed incorrectly.
