NATIONAL TRANSPORTATION SAFETY BOARD
Office of Aviation Safety
Washington, DC 20594

SUMMARY OF ENGINE EXAMINATION

CEN20LA365

Location: Peyton, Colorado
Date: August 26/2020
Time: 11:37 am MDT
Aircraft: Cessna T210N (S/N 21063032) N64EM

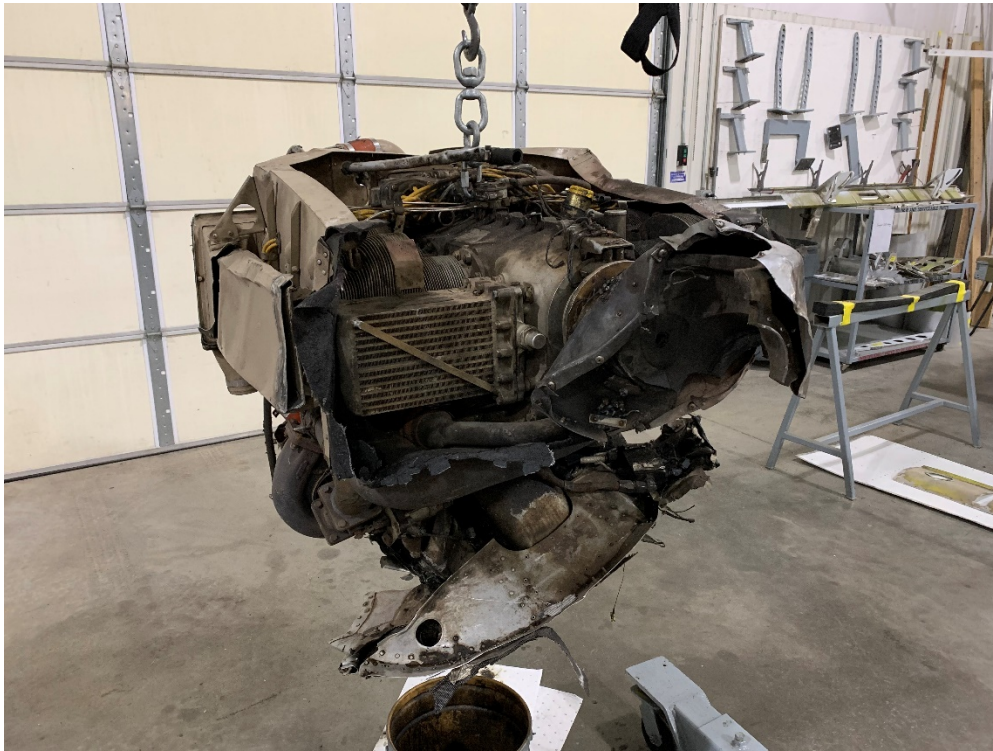
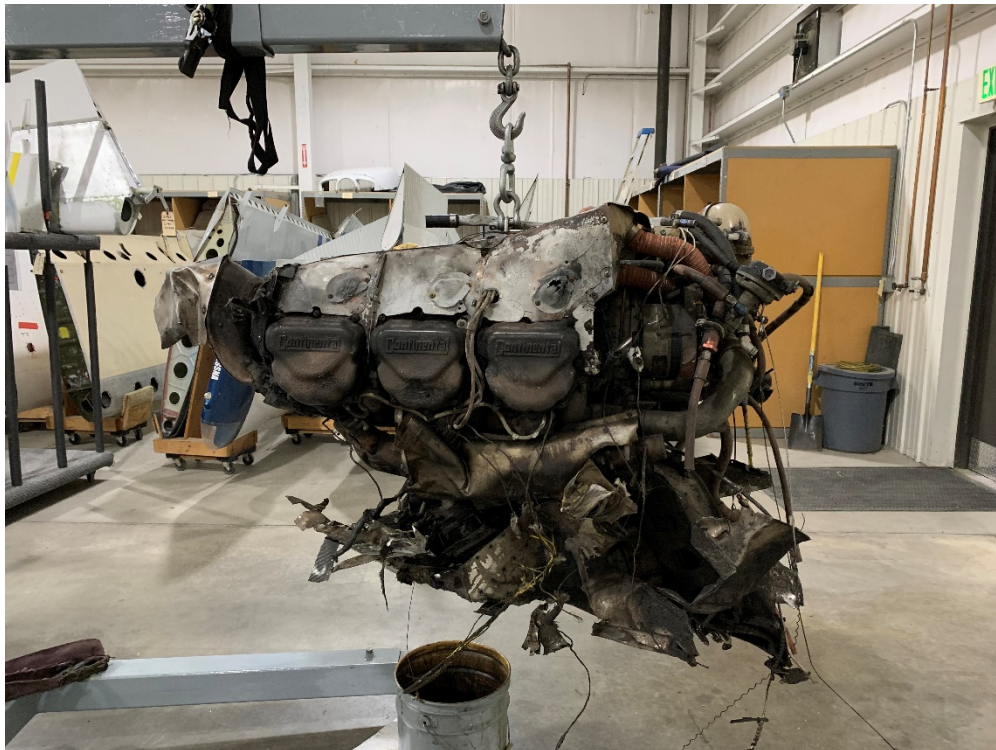
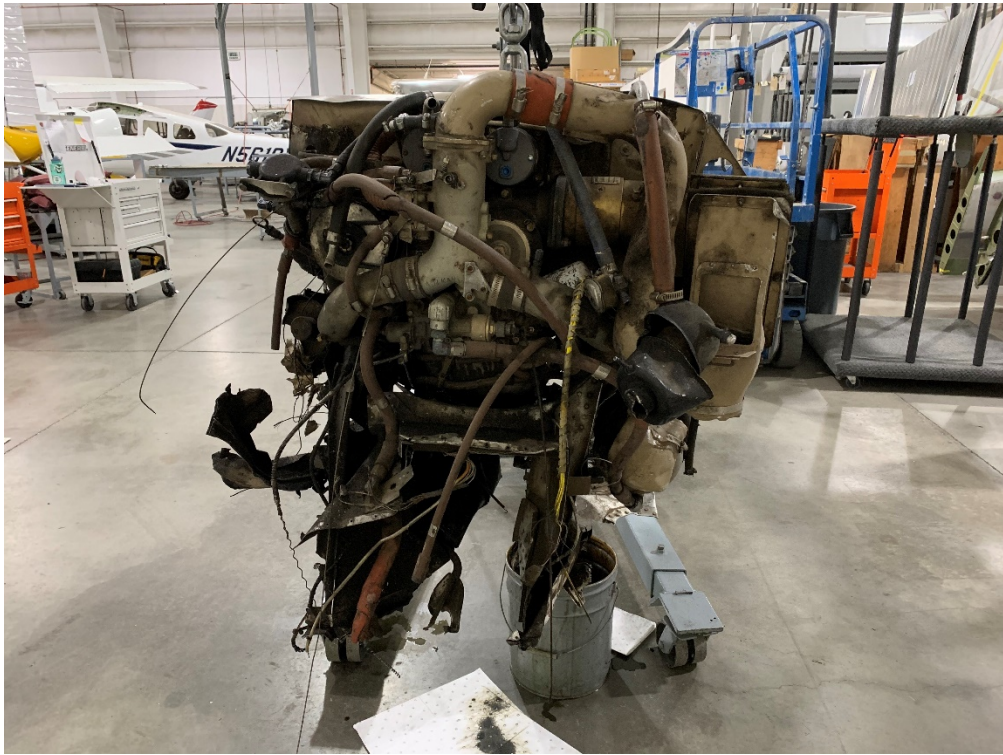
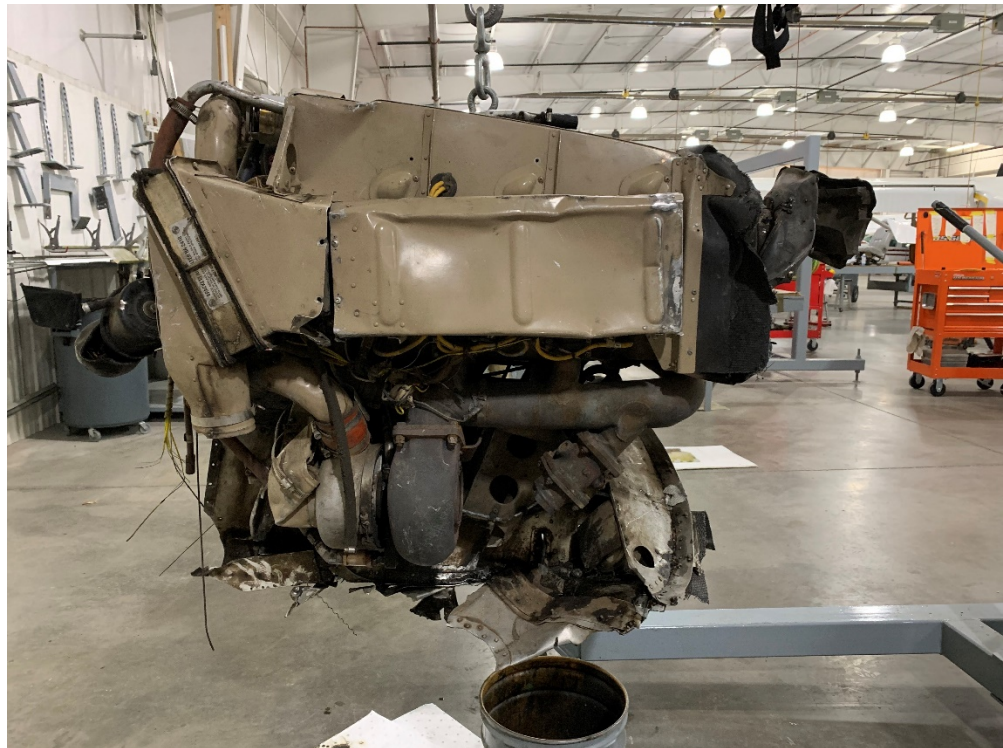
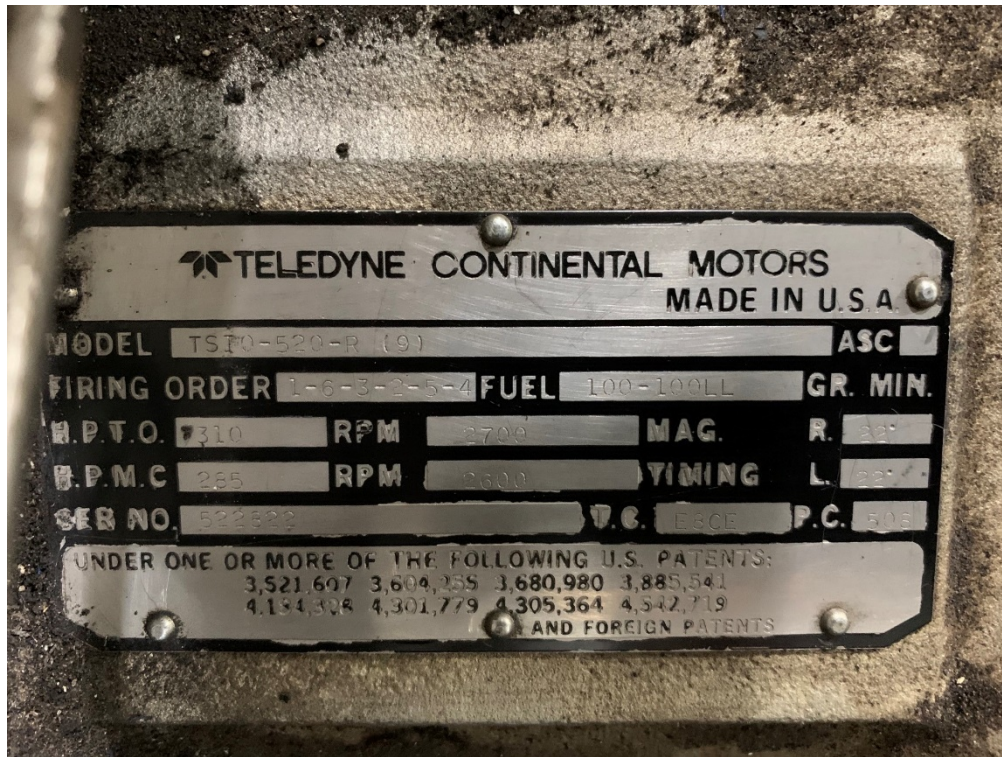
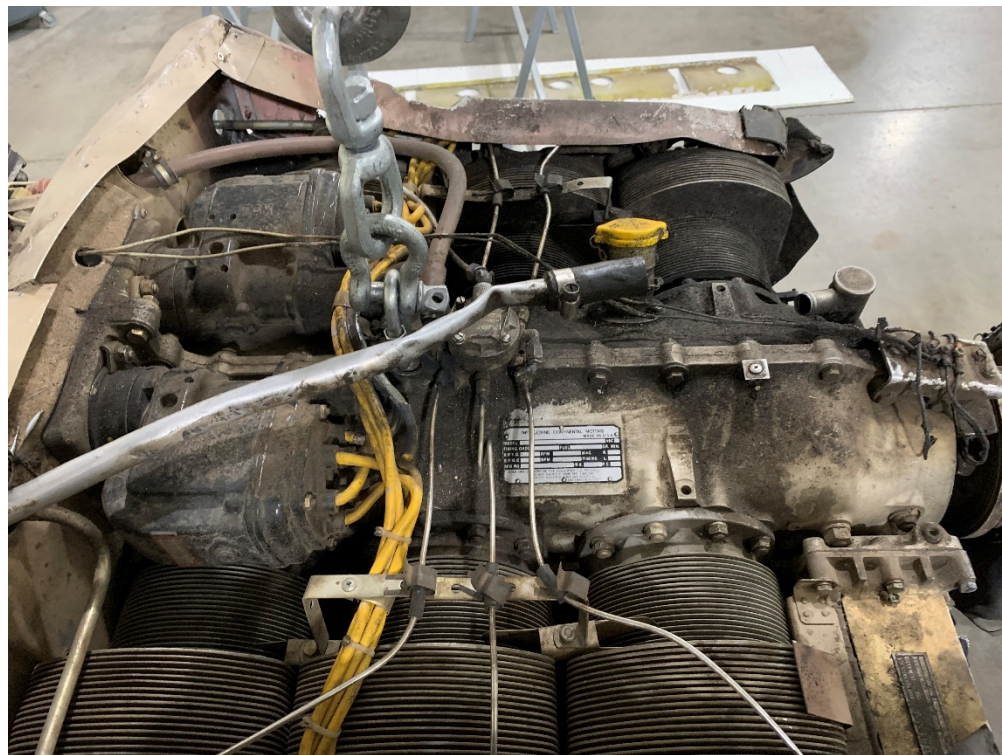
The exterior of the engine was photographed. The engine was mostly intact and showed signs of fire damage. Much of the right side exhaust piping and the muffler were crushed upward and aft. Most of the aft accessories; alternator, suction pump, and fuel pump were intact. See figures 1-6. The propeller hub and spinner were broken open. The aft portion of the propeller hub remained attached to the crankshaft flange. See figure 9.

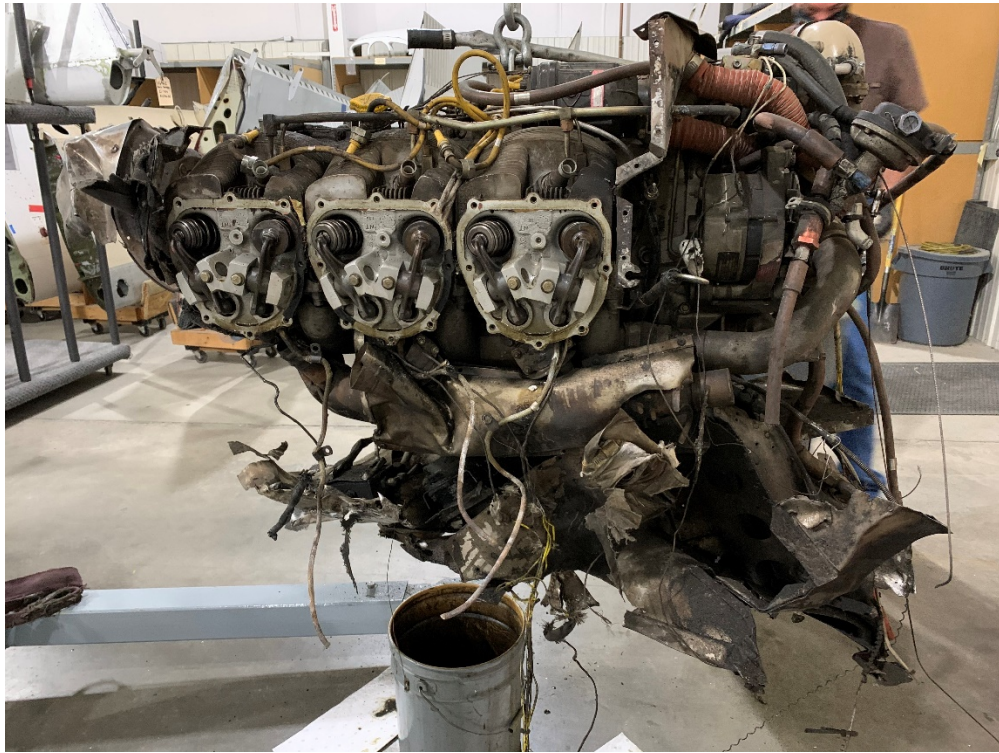
Figure 7, Left Side Cylinders

The wiring harness, baffling and exhaust were removed and the rocker box covers were removed exposing the engine cylinders rockers, pushrod ends, and intake and exhaust valves. All of these components were undamaged. See figures 7 and 8. The wiring harness leads were removed from the top spark plugs. Plugs 2 and 6 showed heat damage and oil. All plugs showed normal wear.

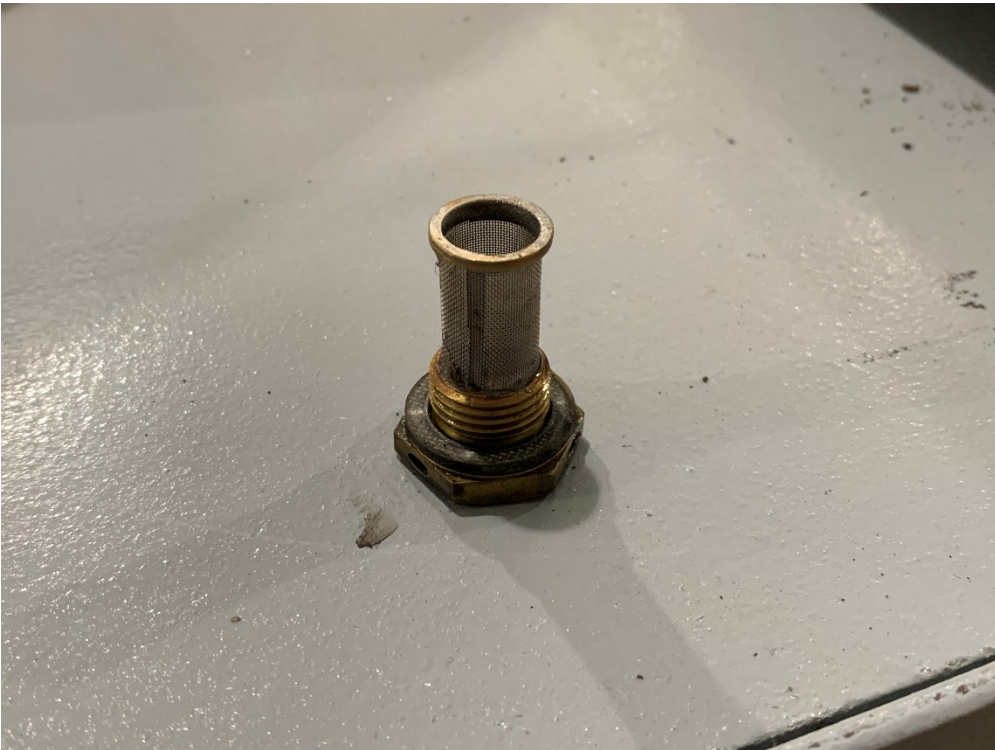
Figure 10, Fuel Screen

The fuel screen was removed and examined. The screen was clean showing no debris. See figure 10. The fuel distribution manifold and fuel lines to the cylinder was examined and showed no external damage. The top of the fuel distribution manifold was removed exposing the filter. The filter was clean and showed no debris. See figures 11 and 12.

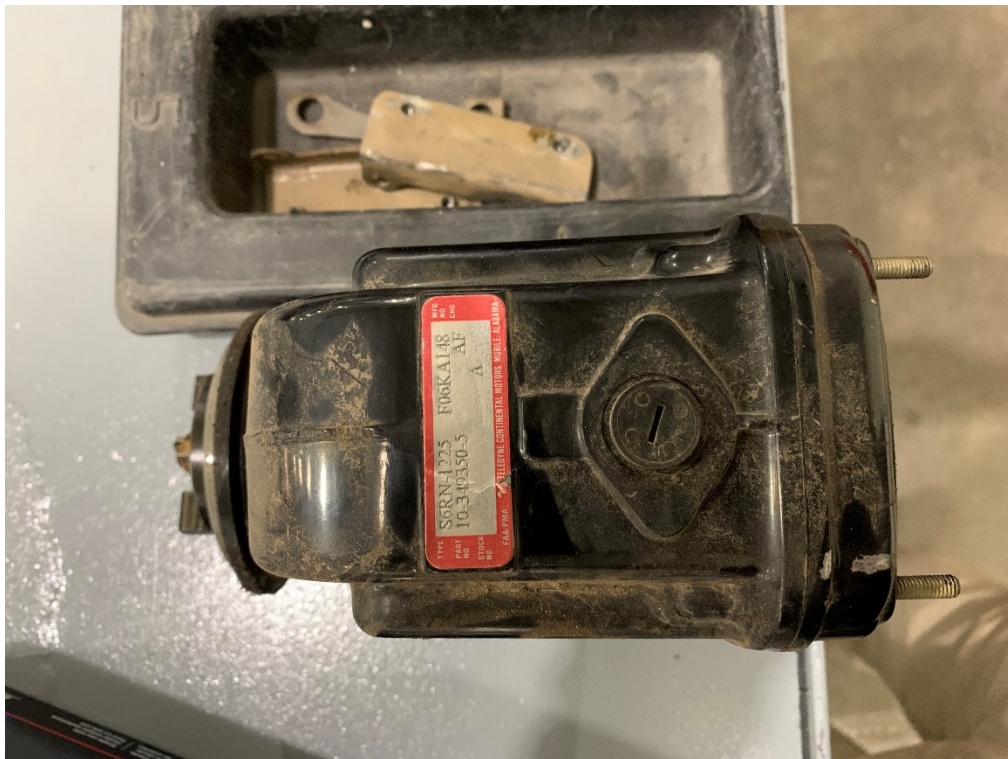
Figure 13, Right Magneto

The left and right magnetos were removed and the wiring harness was removed from the magnetos. Both magnetos were intact and showed some external heat damage. See figures 13 and 14.

The magneto was in good condition. The distributor cover was removed. The magneto coupling was rotated and spark was observed at all six magneto block towers.

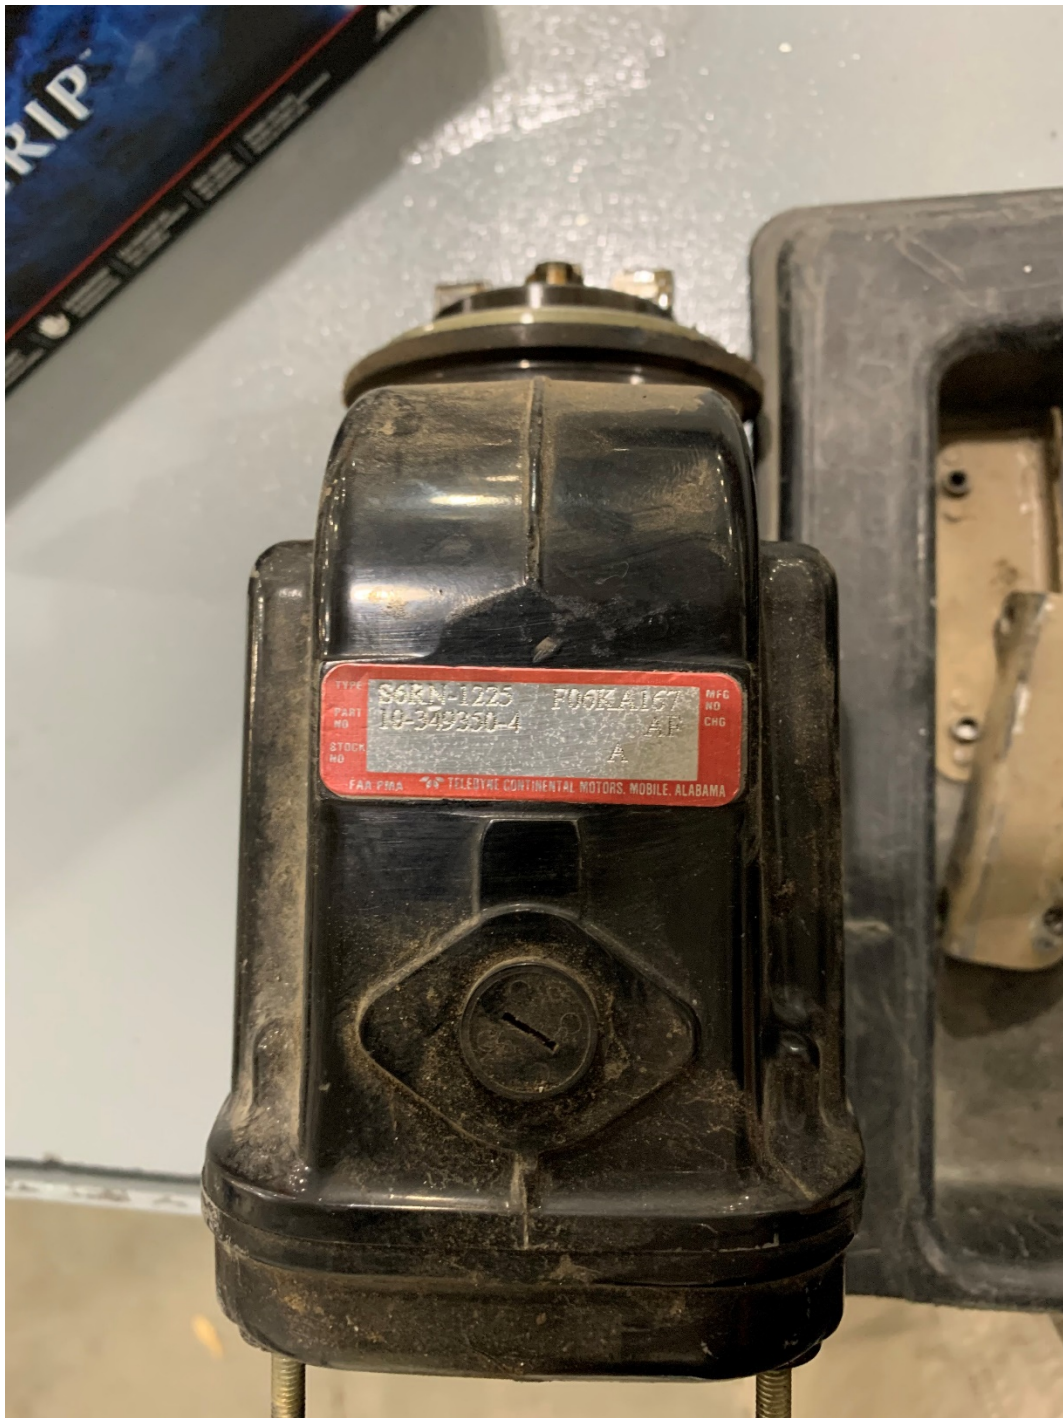
Figure 14, Left Magneto

The magneto was in good condition. The distributor cover was removed. The magneto coupling was rotated and spark was observed at all six magneto block towers

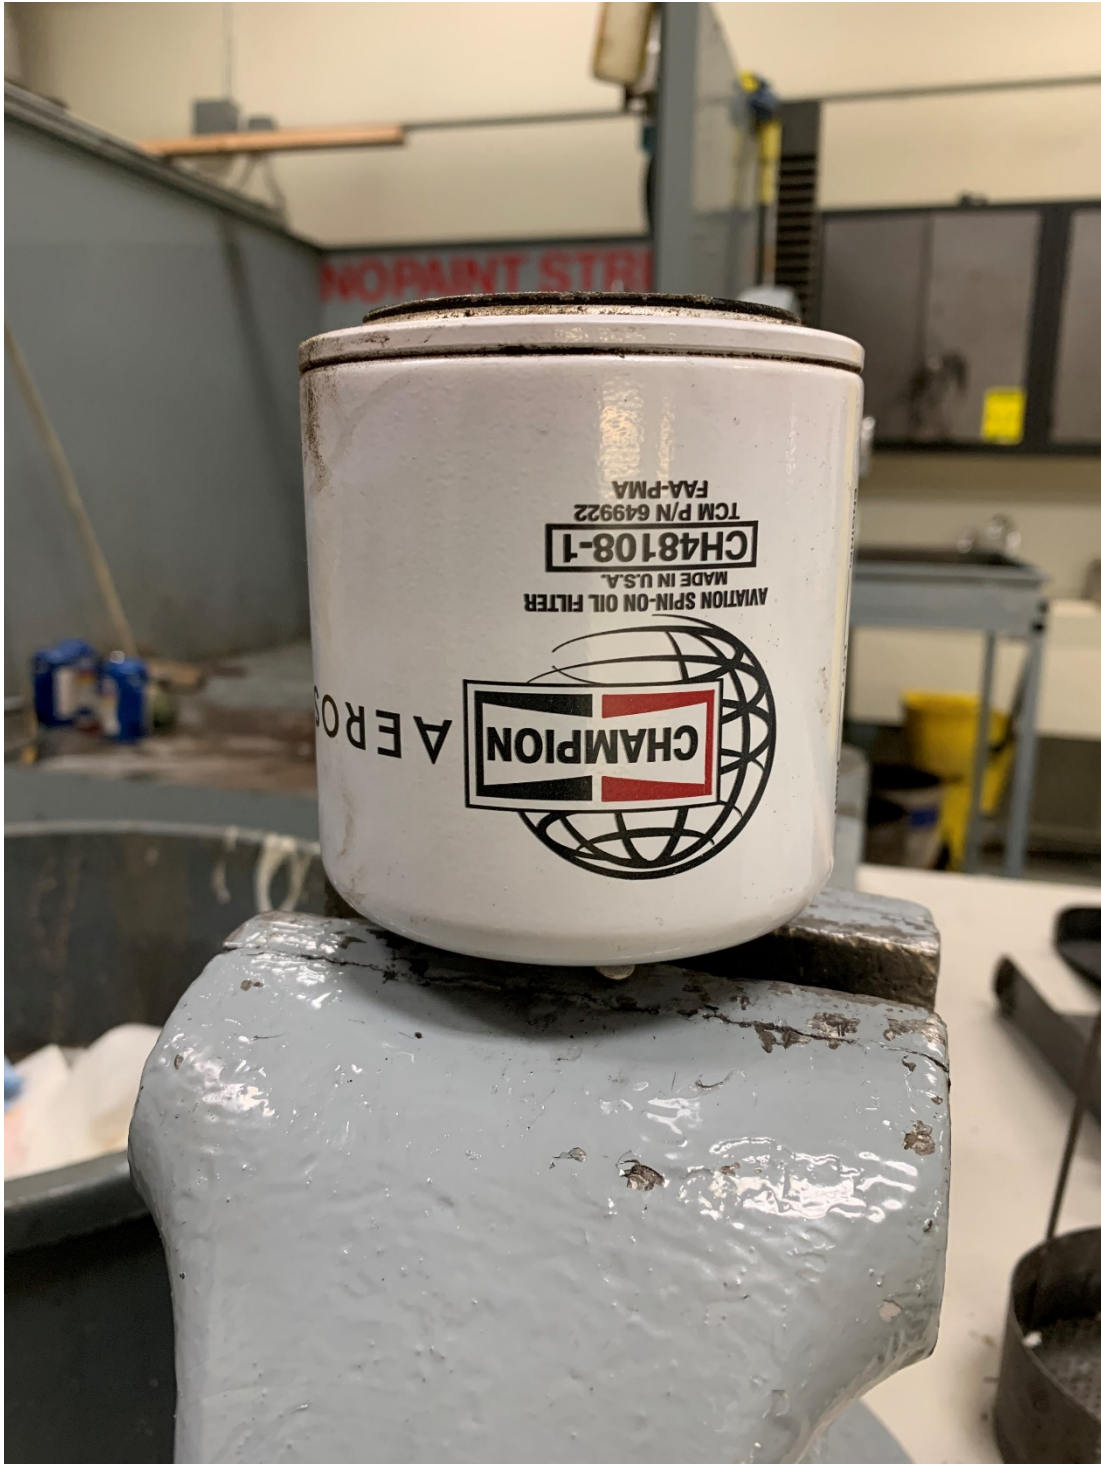
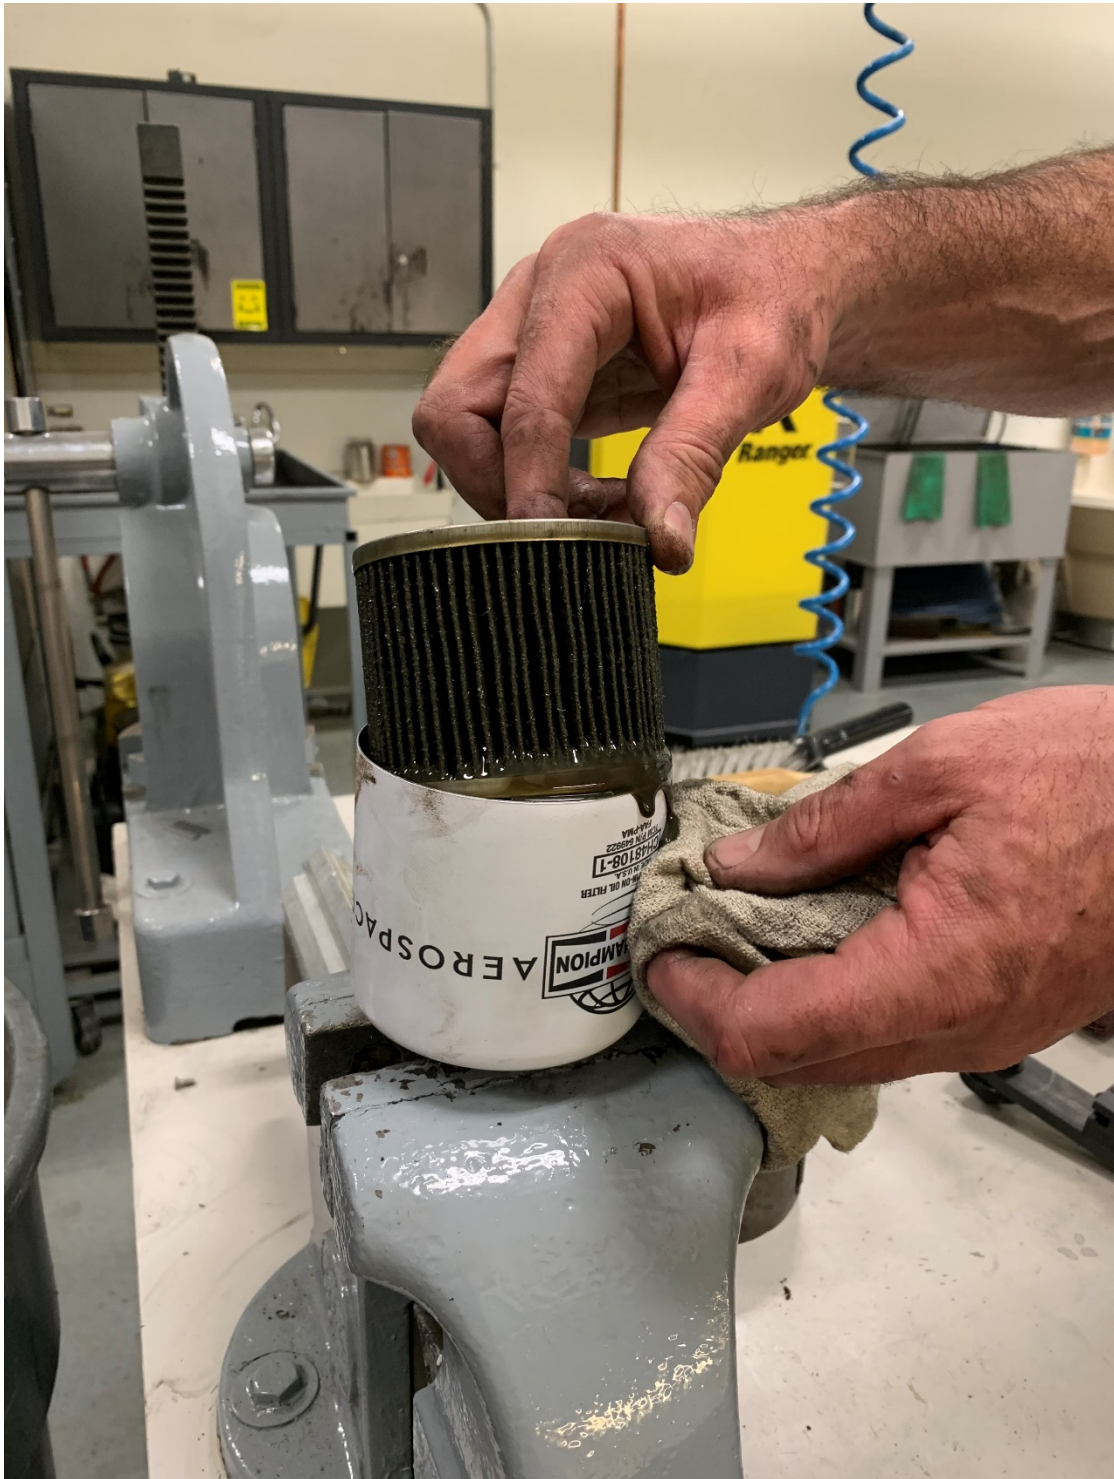
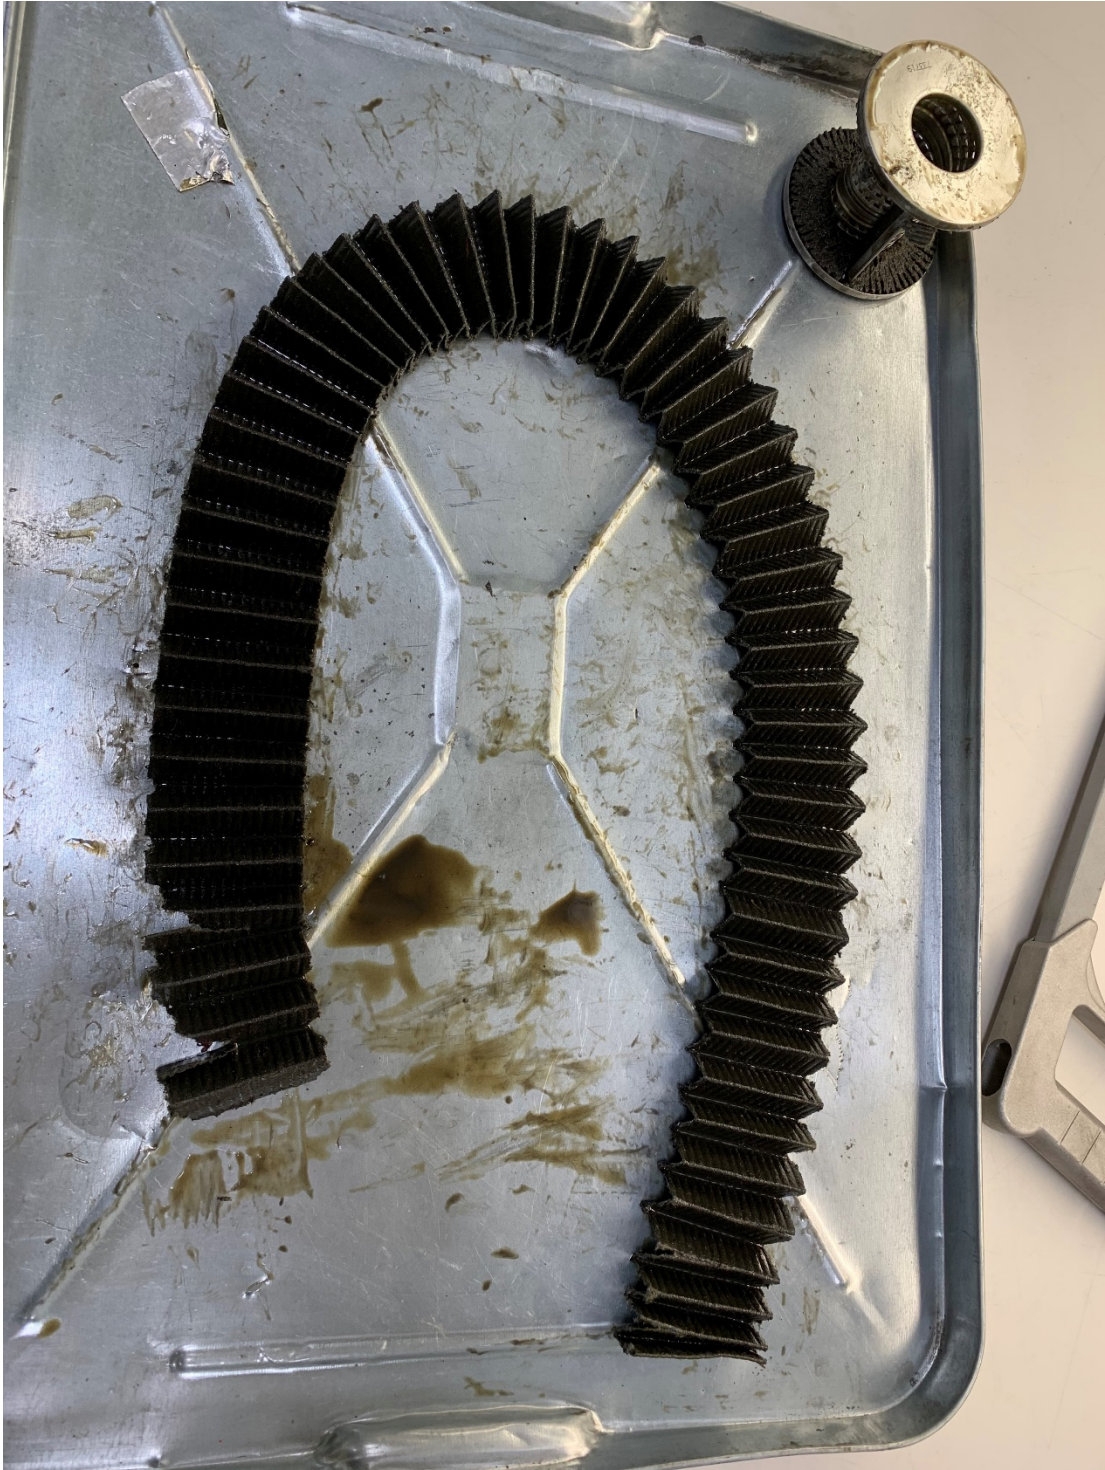
The oil filter was removed. There was oil present. The oil collected and examined. The oil was clean, showed good viscosity, and no particulates. The oil filter was cut open. The filter showed no particulate save a few flakes of carbon. See figures 15-17.

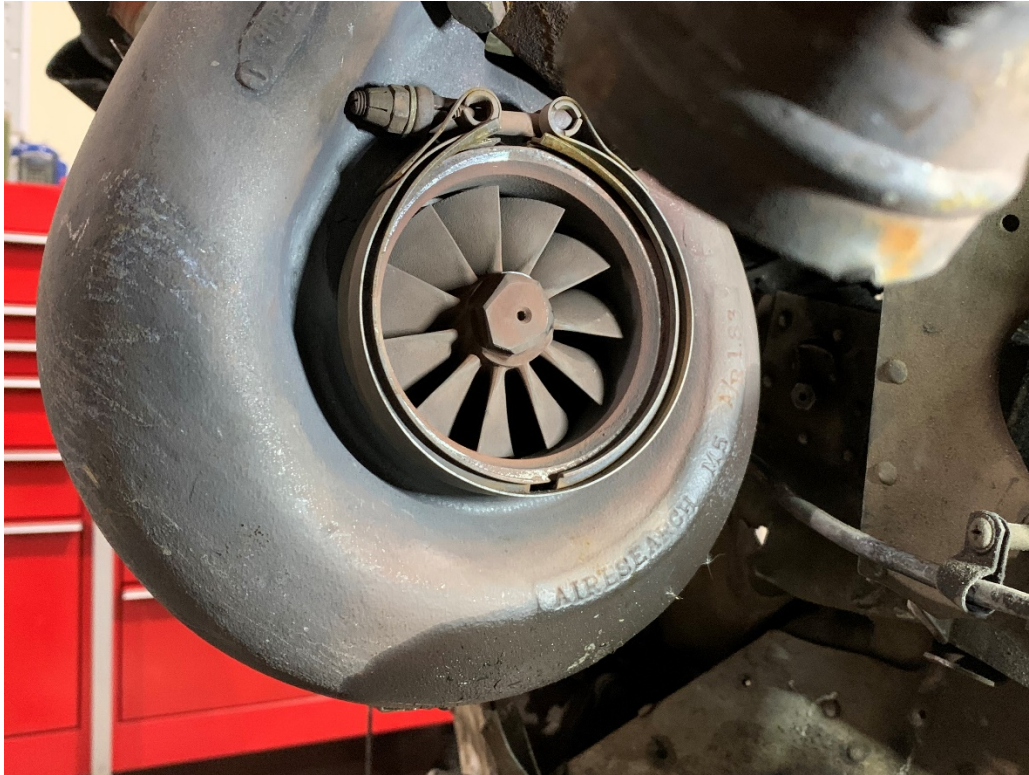
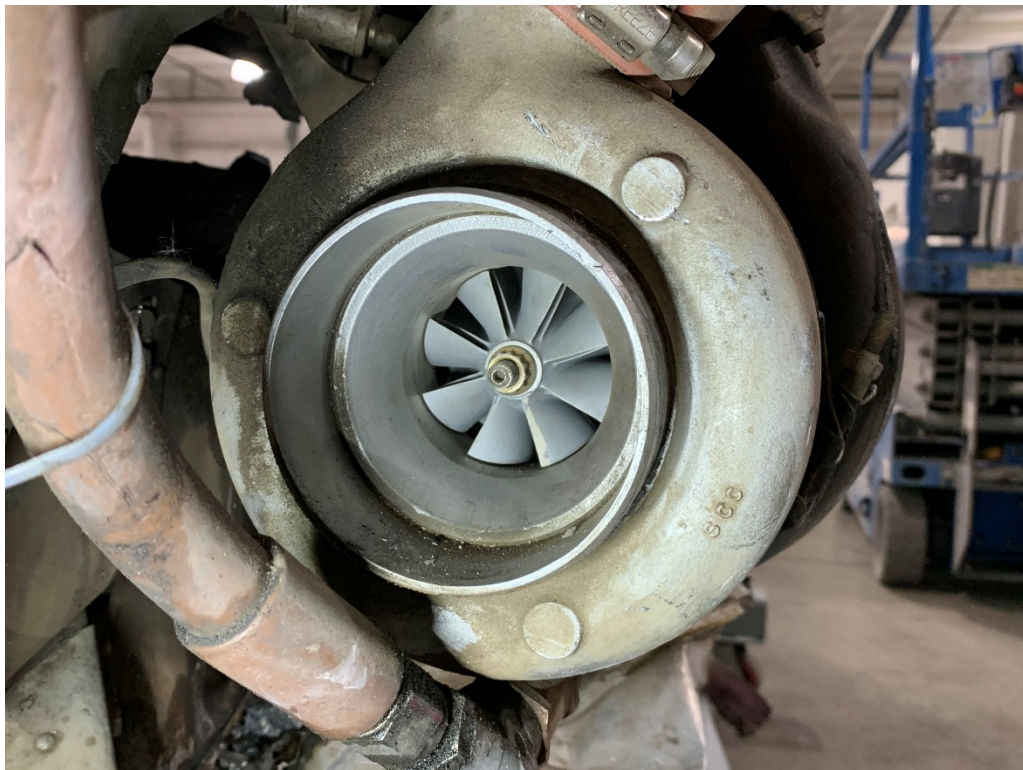
The turbocharger was located at the lower right side of the engine. The turbocharger was intact. The case showed some impact marks and heat signatures. The intake ducting was crushed upward. The ducting was removed and the compressor was observed. The compressor showed no damage and rotated freely. The turbine was also examined. It was intact and showed no damage. It too rotated freely. See figures 18 and 19.
