National Transportation Safety Board

Performance Study

Specialist Report

Location: Cottage Grove, Minnesota
Date: September 13, 2020
Time: 14:32 Central daylight time (CDT)
Airplane: Cessna 172, N8488L
NTSB Number: CEN20LA392

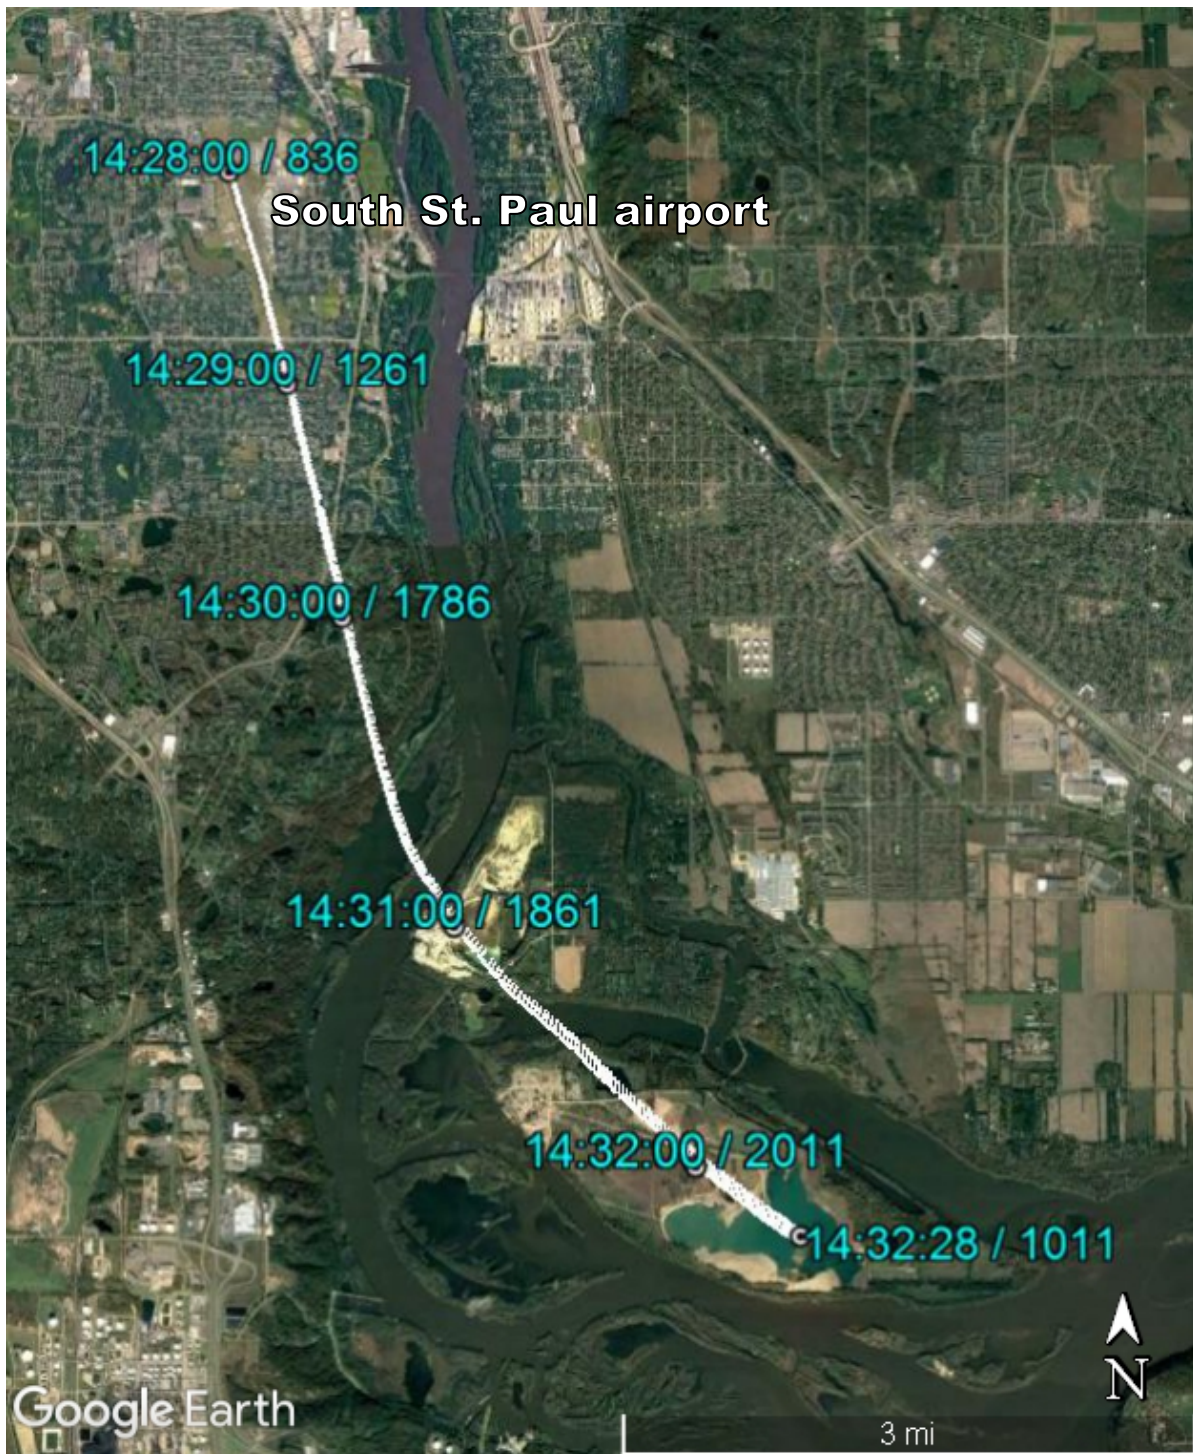
The airplane took off on a south-southeasterly heading from South St. Paul Airport (SGS) at about 14:28 (Figure 1). It climbed while at an airspeed of about 70 kts until it reached about 1,700 ft above mean sea level (msl) where it leveled and increased its airspeed to 90 kts (Figure 2). The airplane turned onto a southwesterly heading and resumed climbing until reaching about 2,000 ft msl. It maintained this altitude at a speed of about 90 kts for the final minute of flight.

Figure 1. Accident flight in white with select times and altitudes (msl) annotated in blue.

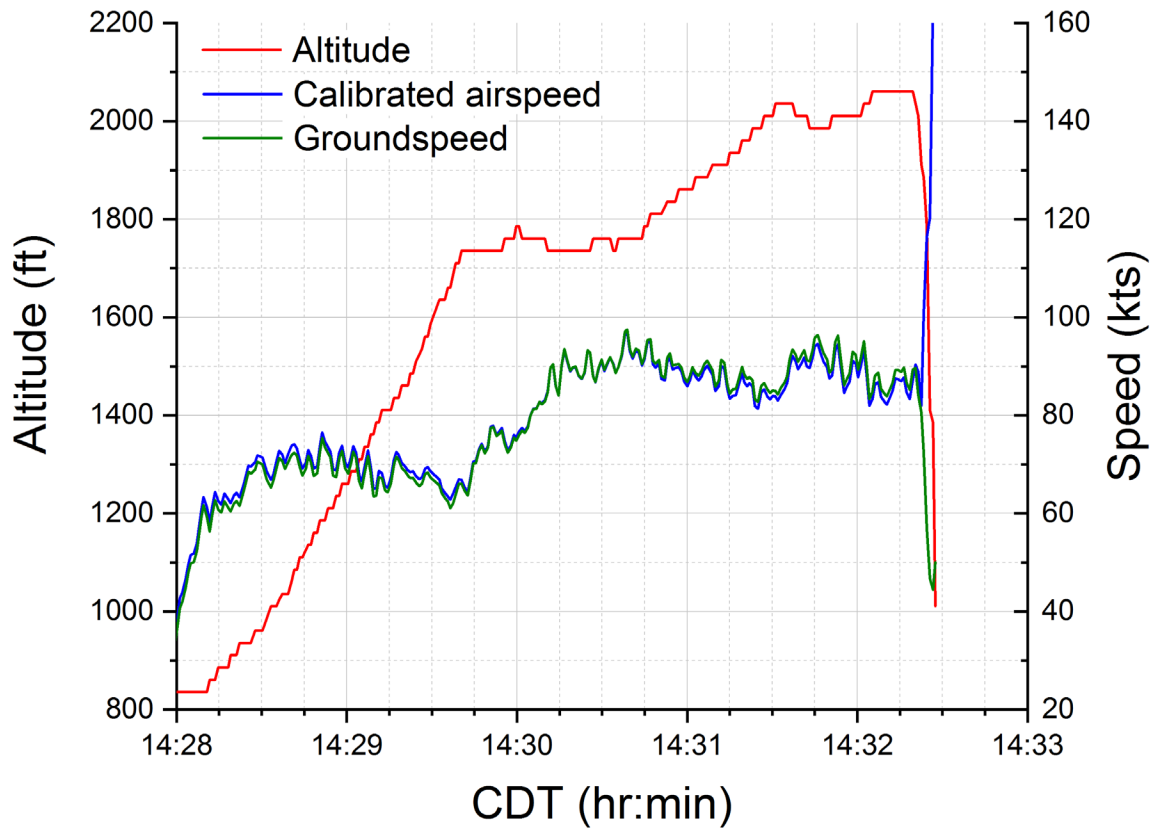
Figure 2. Altitude (msl) and calculated groundspeed and calibrated airspeed.

The airplane's maximum maneuvering speed is listed as 122 mph or 106 kts [1]. Its wings-level, flaps up stall speed is 57 mph or 50 kts. The airplane's speed of 90 kts before the sudden loss of altitude was within normal flight and not close to any listed limitations.

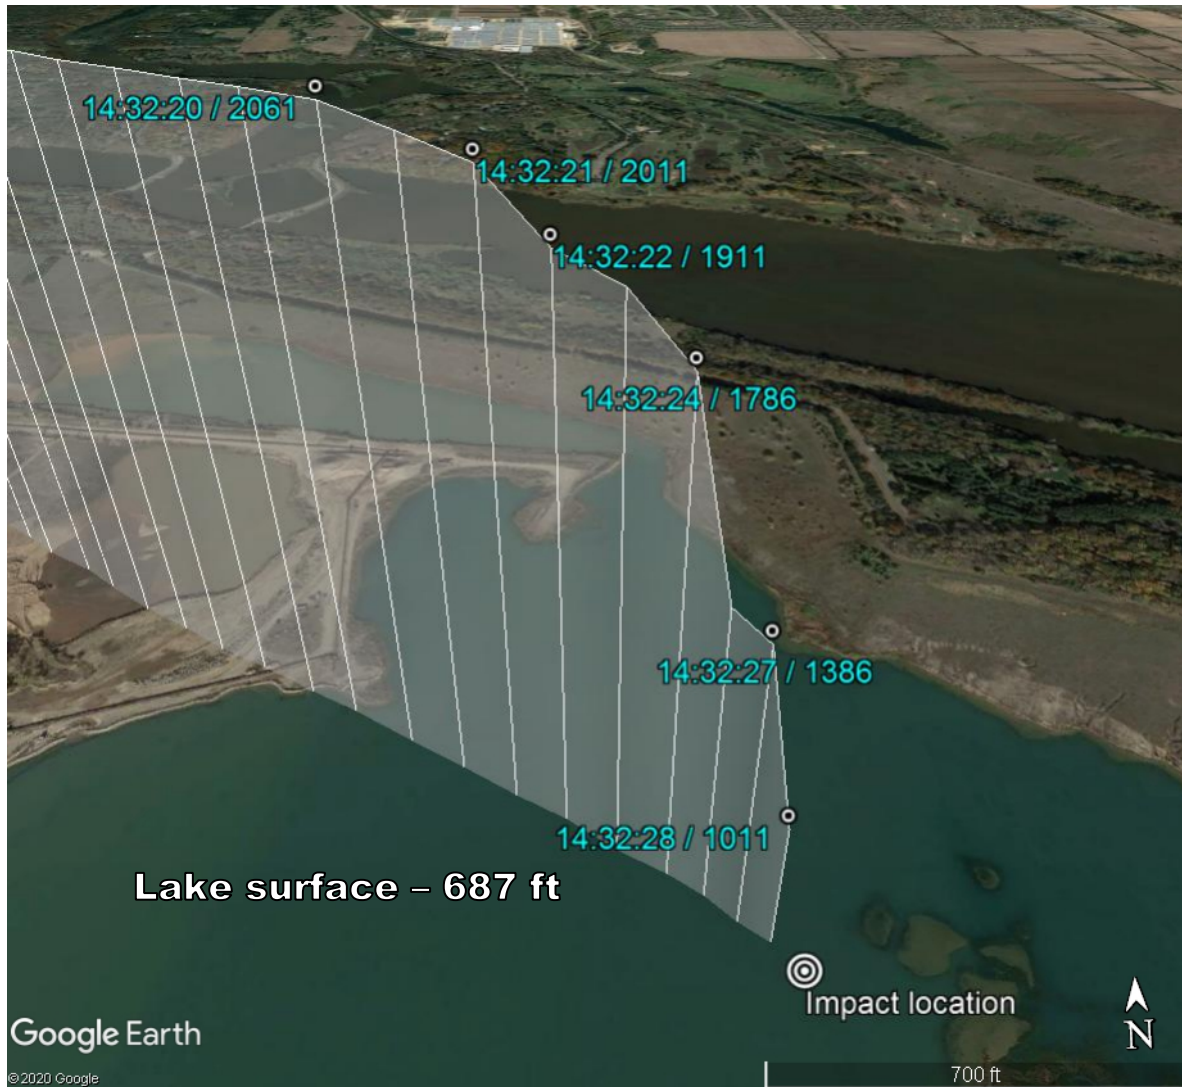
At 14:32:20, the airplane began to rapidly descend, losing over 1,000 ft of altitude in seven seconds for a descent rate over 8,000 fpm. The final ADS-B return at 14:32:28 was at about 1,000 ft msl, about 300 ft above the surface of the lake the airplane impacted (Figure 3). During the descent, the airplane's heading did not change. The FAA reported the impact coordinates as 44:46:45 North and 92:58:20 West.

Figure 3. End of flight with selected times and altitudes (msl) in blue. The elevation of the lake surface was 687 ft.

The airplane's flight path and speed do not show any evidence of performance-related issues leading up to the sudden descent. The airplane began to descend at a rate greater than 8,000 fpm and the time from the beginning of the descent to the last ADS-B data point was a little more than seven seconds.
