National Transportation Safety Board

CEN21FA130

VEHICLE PERFORMANCE

Location: Janesville, Wisconsin
Date: February 16, 2021
Time: 0917 CST
1517 GMT
Airplane: Velocity V-Twin, N13VT

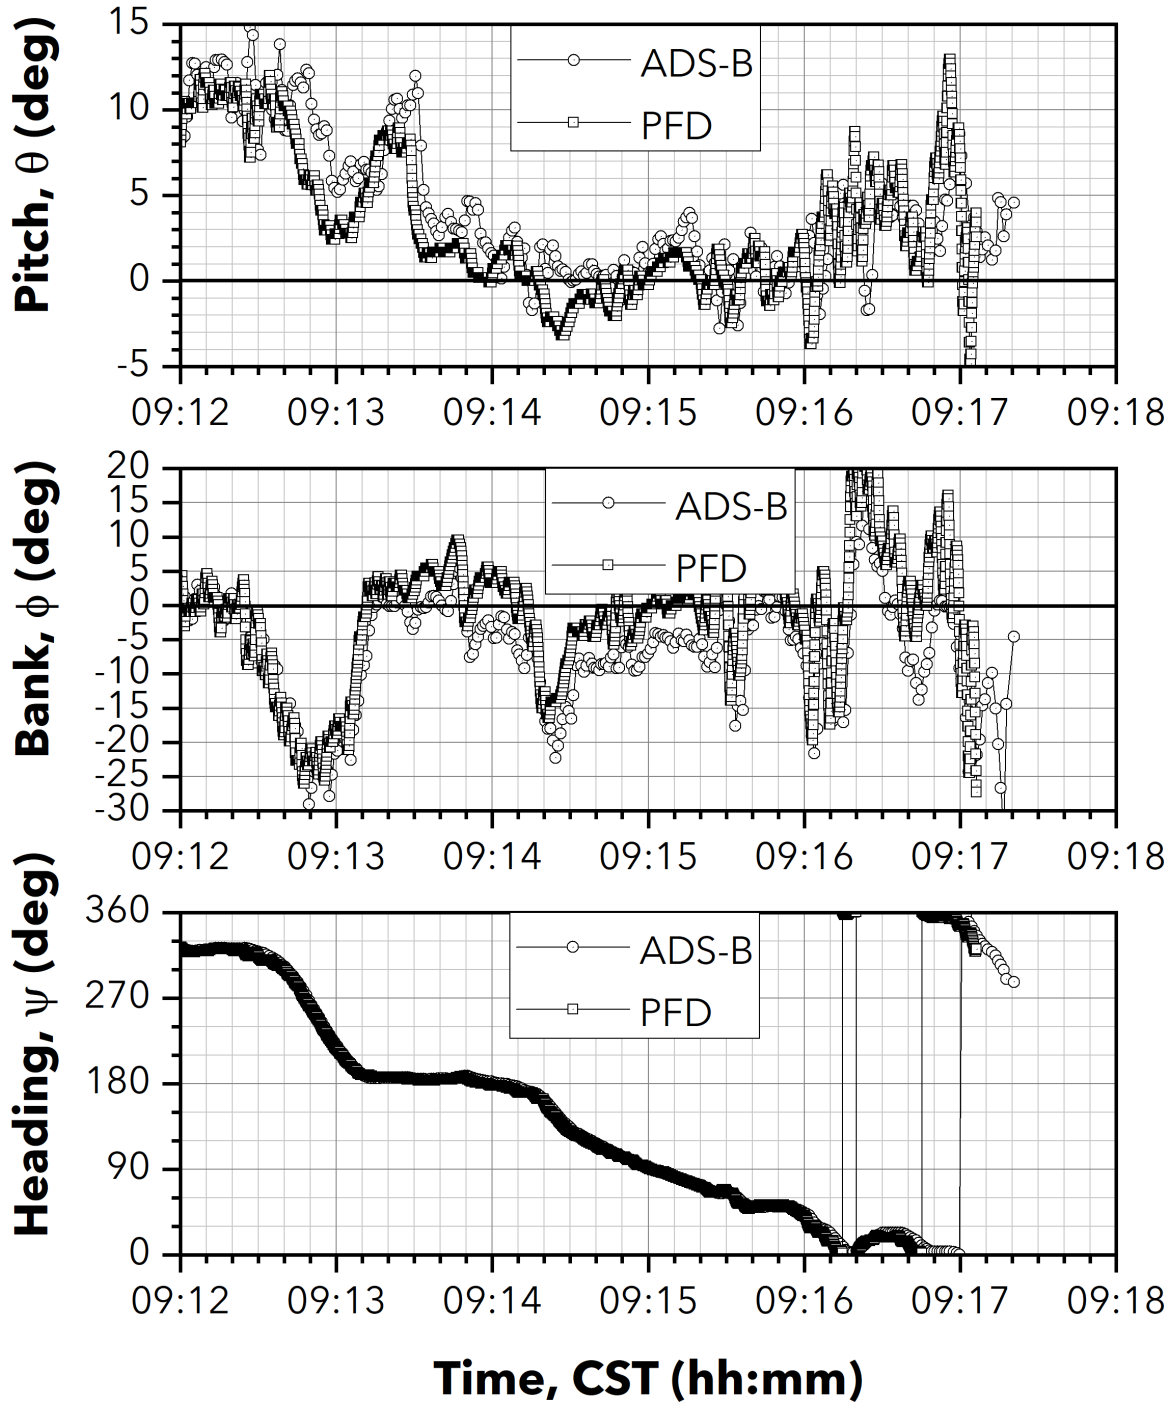
Figure 5 includes airplane attitude information from both the PFD and that estimated from ADS-B data. The bank angle momentarily reached a maximum magnitude of approximately 30°.

Figure 5: Pitch, Bank, and Heading Angles for Accident Flight

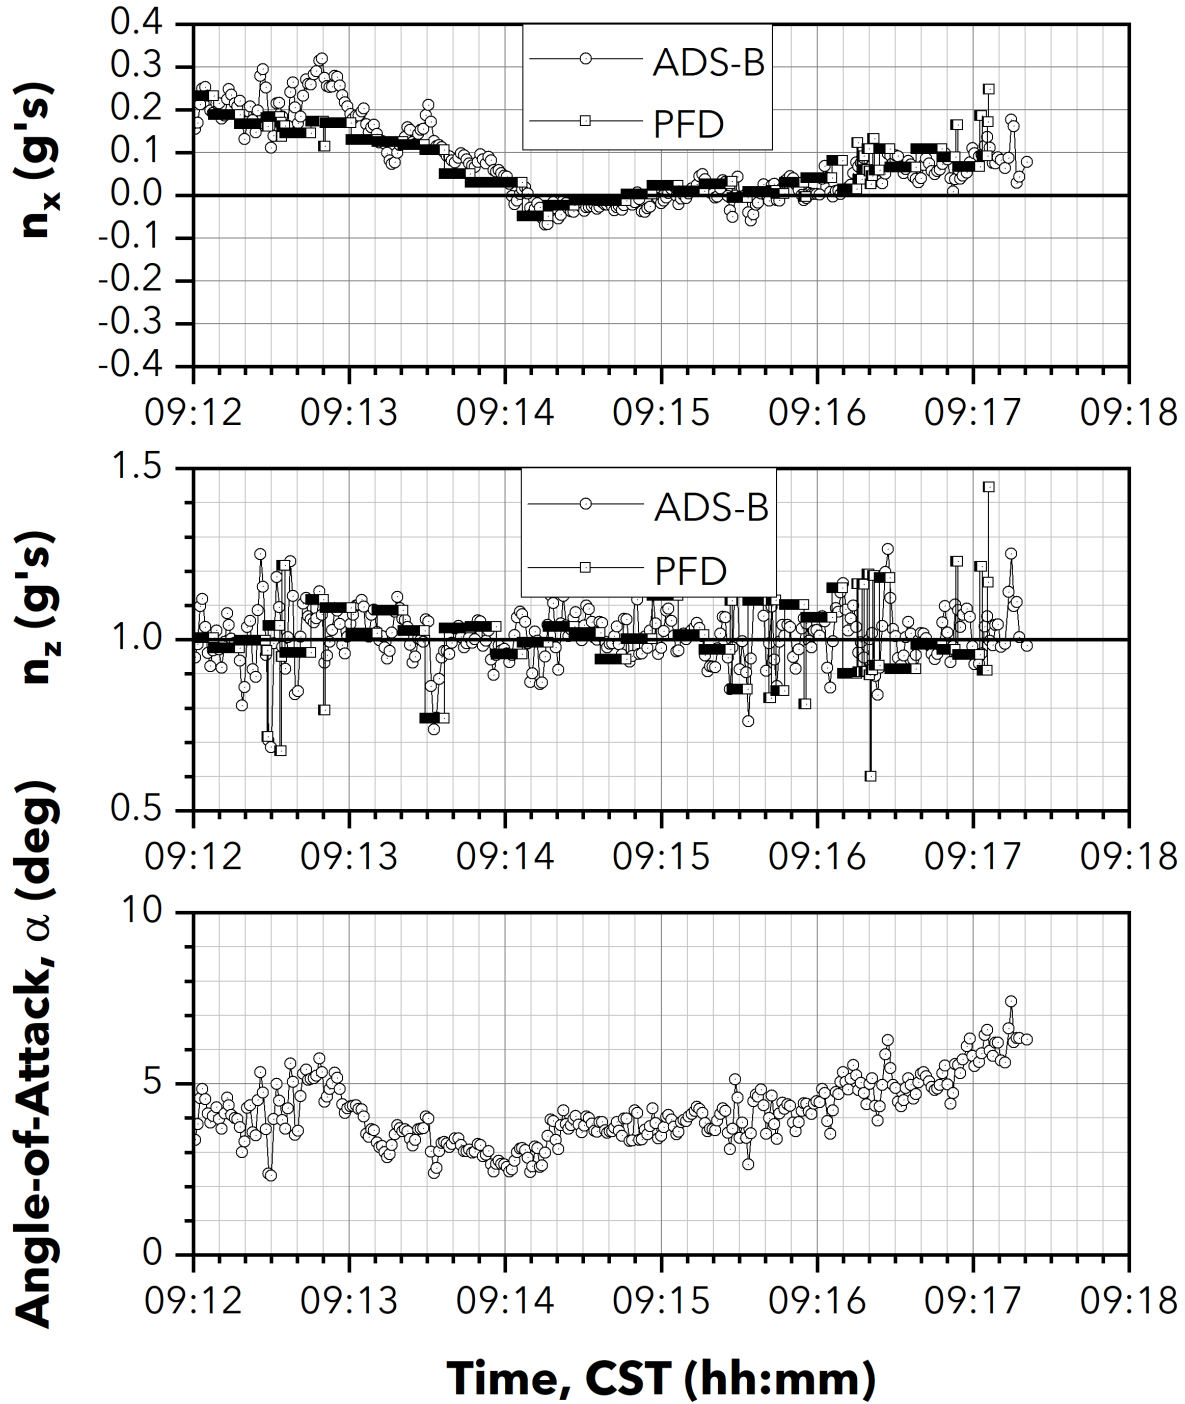
The PFD also recorded linear accelerations except in the lateral direction. Longitudinal and vertical accelerations for the flight are shown in Figure 6 along with an estimated angle-of-attack. Nothing in the acceleration data indicate a problem.

Figure 6: Longitudinal / Normal Load Factors and Estimated Angle-of-Attack for Accident Flight

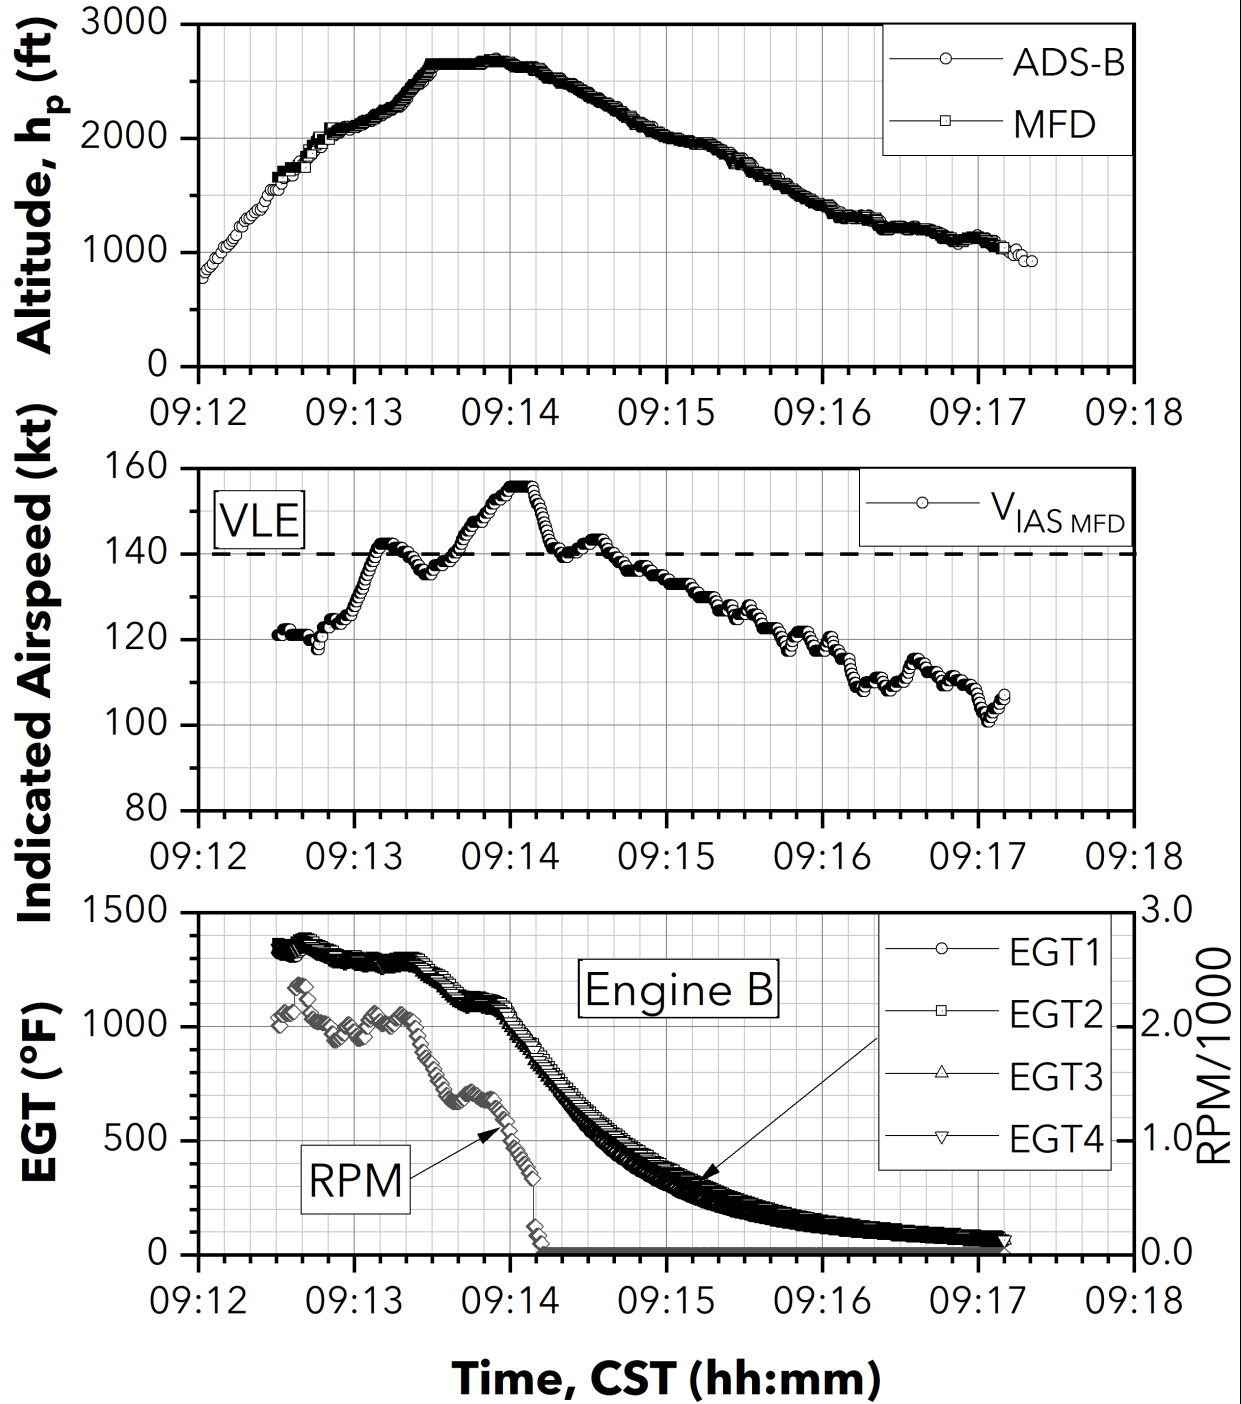
However, Figure 7 includes engine parameters recorded by the MFD for "Engine B" that indicate one of the engines, most likely the right engine², stopped producing power around 0913:55 when N13VT began its descent to JVL. The engine exhaust gas temperature (EGT) decreased from normal operating temperatures at the top of N13VT's climb to less than 100°F over a four-minute period.

² N13VT is experimental, amateur-built, and it could not be confirmed how the Garmin G3X's were configured. "Engine B" is likely the right engine, and data for the other engine were not stored.

Figure 7: Altitude, Airspeed and Engine EGT for Accident Flight

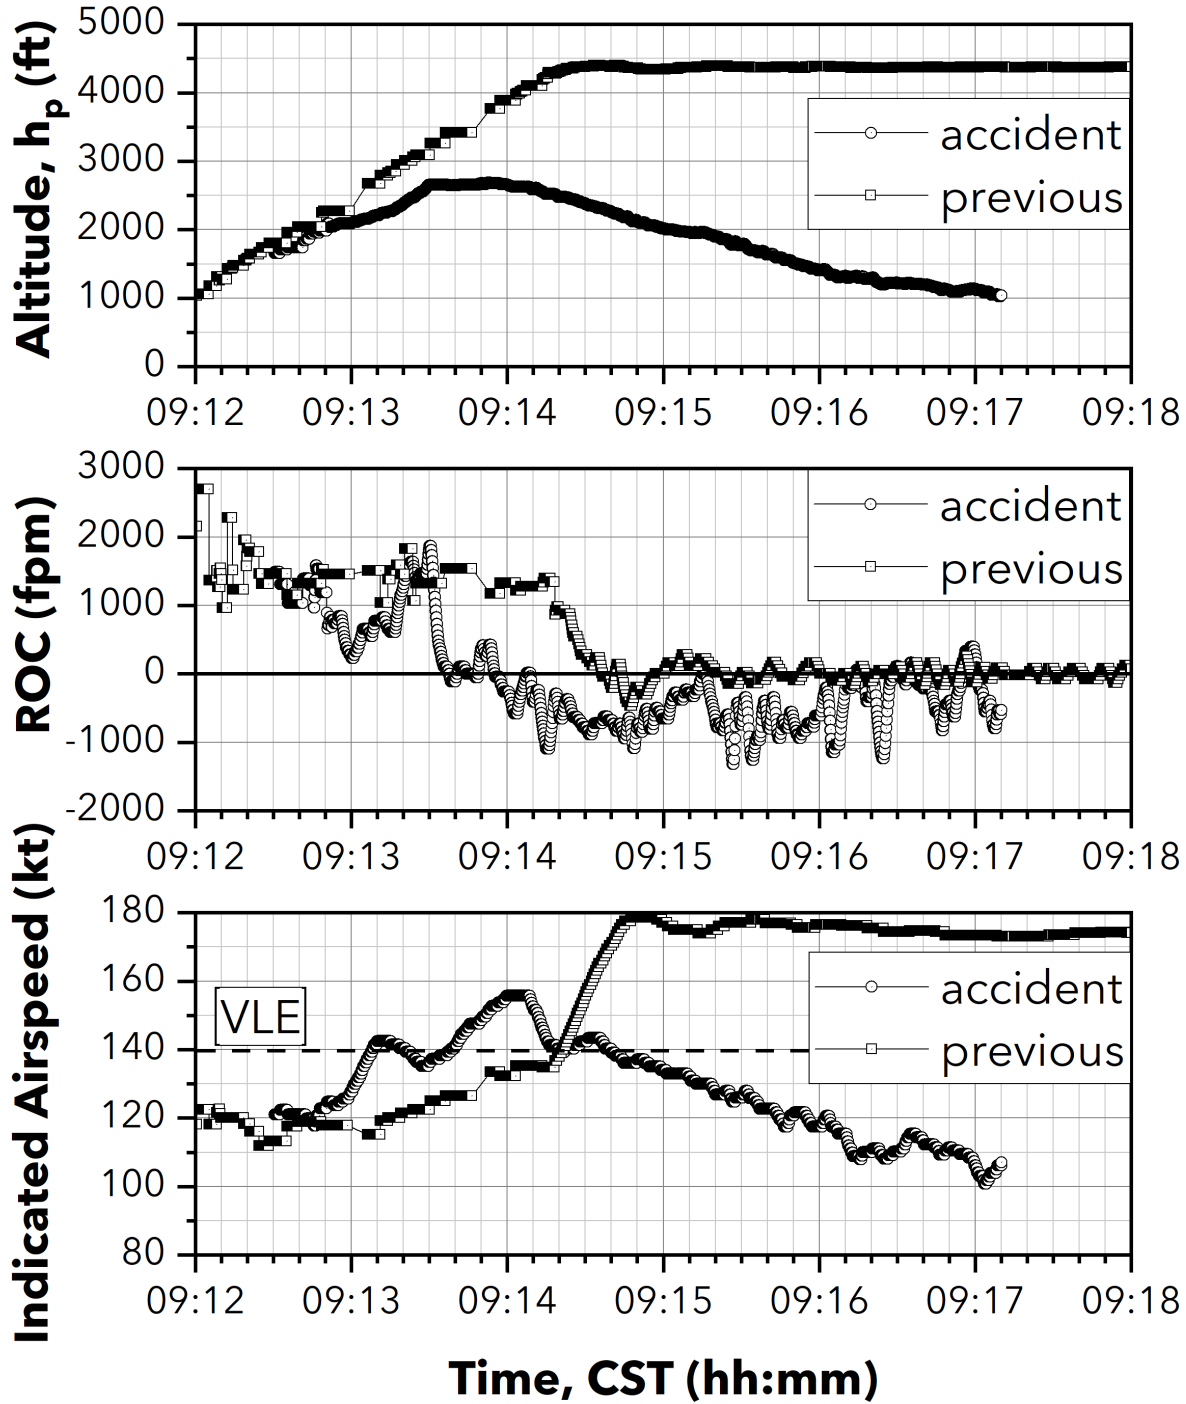
Figure 8 is a comparison of the accident take-off with the previous take-off from ATW. Altitude data show a reduction in the flight path angle³ for the accident flight about nine seconds after the flight crew indicated that they would like to circle back to land and work through an engine issue at 0912:46.0. There is no reduction in flight path angle for the previous take-off.

Figure 8: Altitude, ROC, and Airspeed for Accident and Previous Take-offs

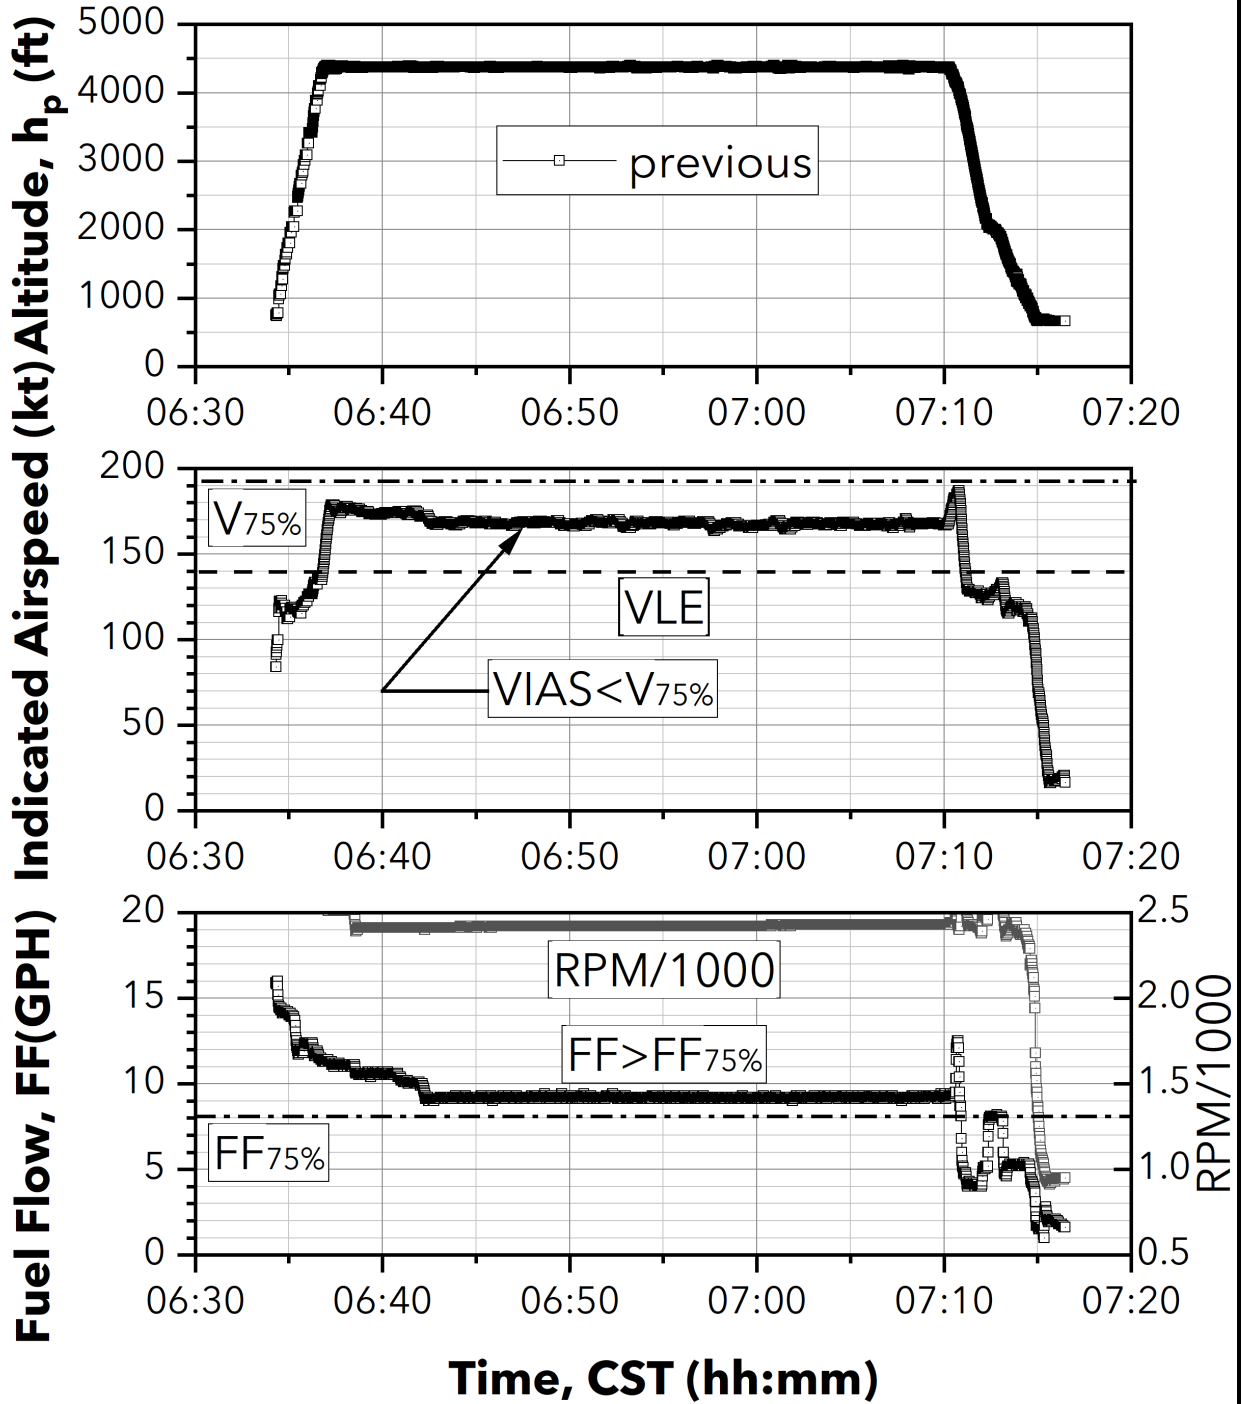
Figure 9 shows MFD airspeed, altitude, fuel flow, and engine crankshaft speed in revolutions per minute (RPM) for the entire flight from ATW. The flight was a CFR Part 91 ferry flight, and the FAA-issued Special Flight Permit stipulated that occupancy was "limited to the pilot, essential crew required to operate the aircraft and its equipment and personal baggage". Additional limitations were added stipulating that "gear to remain down during flight, co-pilot authorized," even though the airplane only required one flight crewmember⁴.

However, the MFD data indicate that the previous flight was operated well above the landing gear down extended speed, VLE, of 140 kt calibrated airspeed (KCAS) and the landing gear operation speed, VLo, of 120 KCAS, despite the ferry

permit limitation. In addition, the recorded fuel flow was close to that for an engine at 75% cruise power as per the Pilot's Operating Handbook (POH)⁵.

⁵ While the fuel flow was higher and the cruise speed lower for the flight from ATW as compared to those published in the POH at 75% cruise power, this could be a result of the additional drag associated with having the gear extended.

Figure 9: Altitude, Fuel Flow, and Engine RPM for Previous Flight

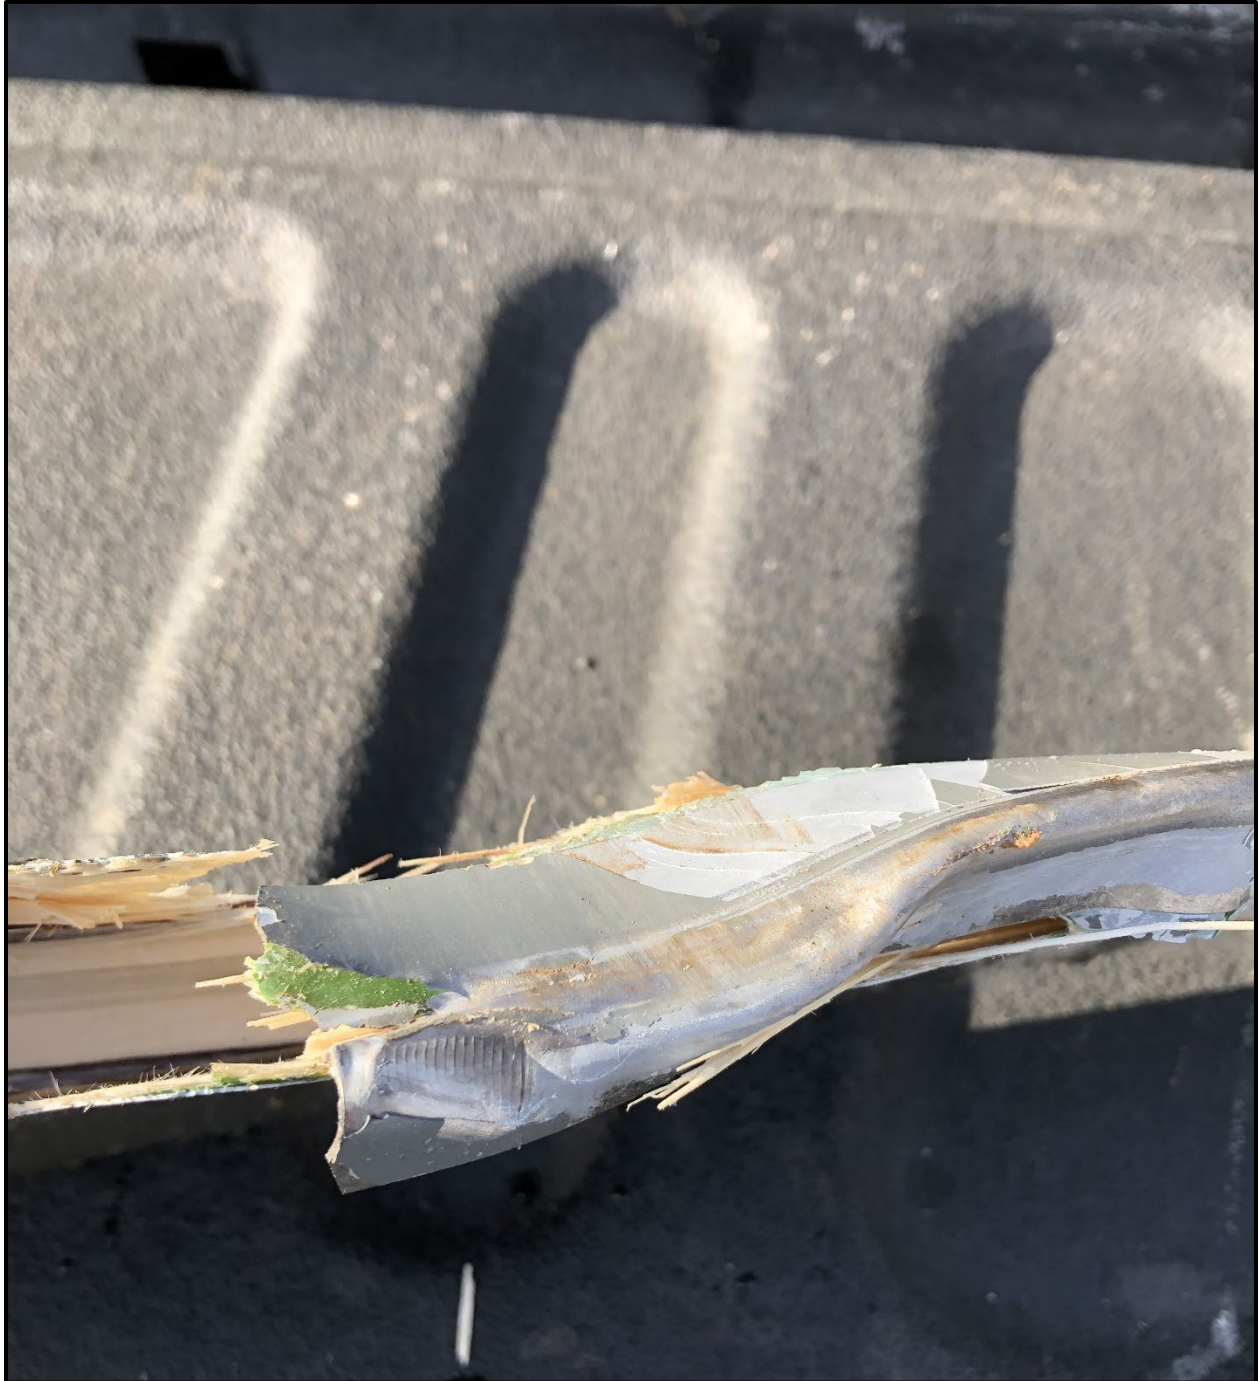
The MFD also recorded what is likely the right engine shutting down about the time of descent or 0913:55. In addition, a thread impression was found on one of the recovered wood propeller blades from the right engine. See Figure 10. It is possible that the right gear door (which has not been found) along with one or more of the attachment screws detached from the airplane and struck the right propeller resulting in a loss of power on the right engine. See Figure 11 for a representative gear door.

Figure 10: Thread Impression on Right Engine Propeller

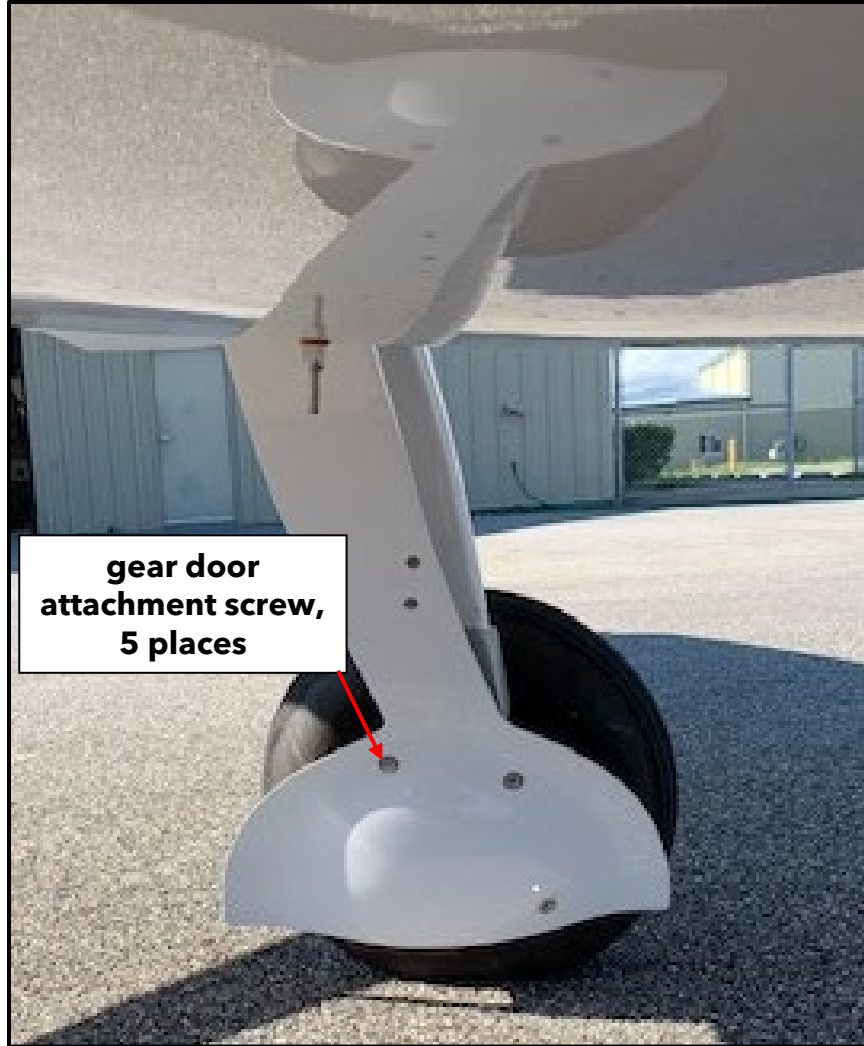
The right gear door attachment points may have been weakened by the higher air loads associated with airspeeds exceeding VLE (with the gear down) as well as higher-than-normal sideslip angles that would have been required with the left engine shut down.

Figure 11: Representative Gear Door

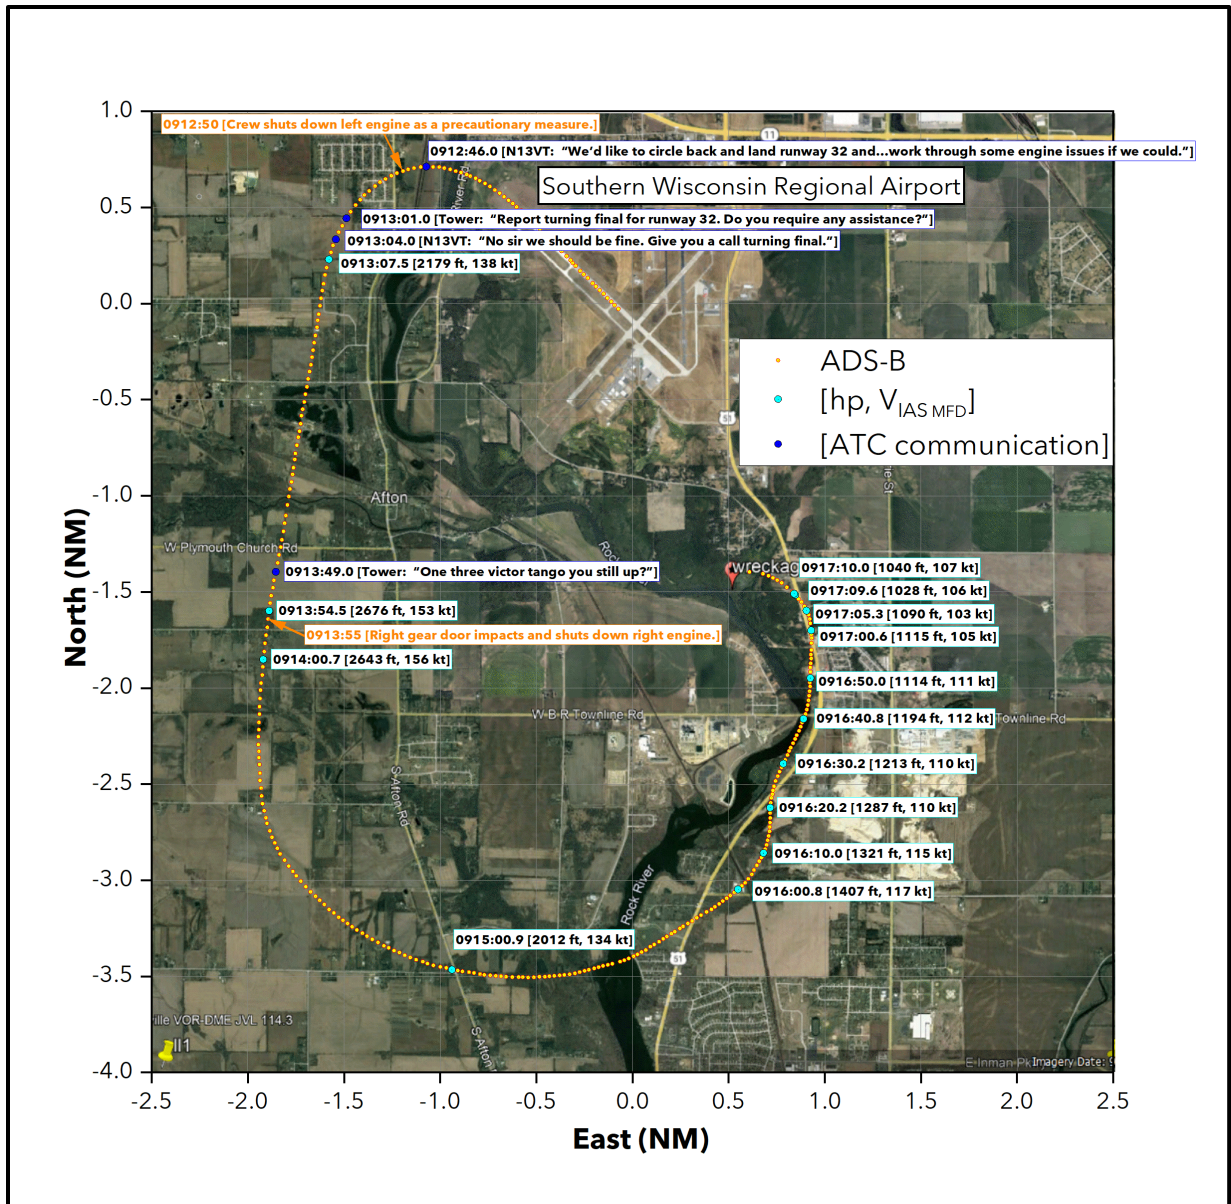
With both engines inoperative, N13VT likely did not have the energy required to glide back to the airport⁸. The airplane location when the engine shut-downs likely occurred are highlighted in orange in Figure 12.

Figure 12: Position, Altitude and Airspeed for the Accident Flight Possible Engine Shut-downs Highlighted in Orange
